Photomonitoring at Weippe Prairie, Idaho

Importance: Status and Trend of a Degraded Stream

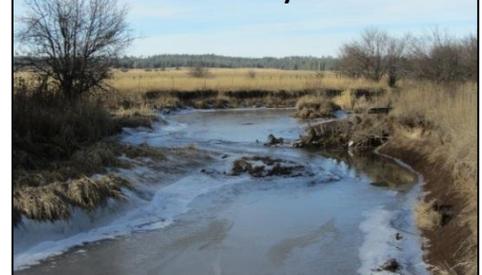
2012- January

Repeat photographs are analyzed for change. Note the missing shrub on the right and the erosion of the stream's bank.
