Niobrara National Scenic River
Water Quality Report
Summer 2012

Niobrara National Scenic River Headquarters
October 5, 2012

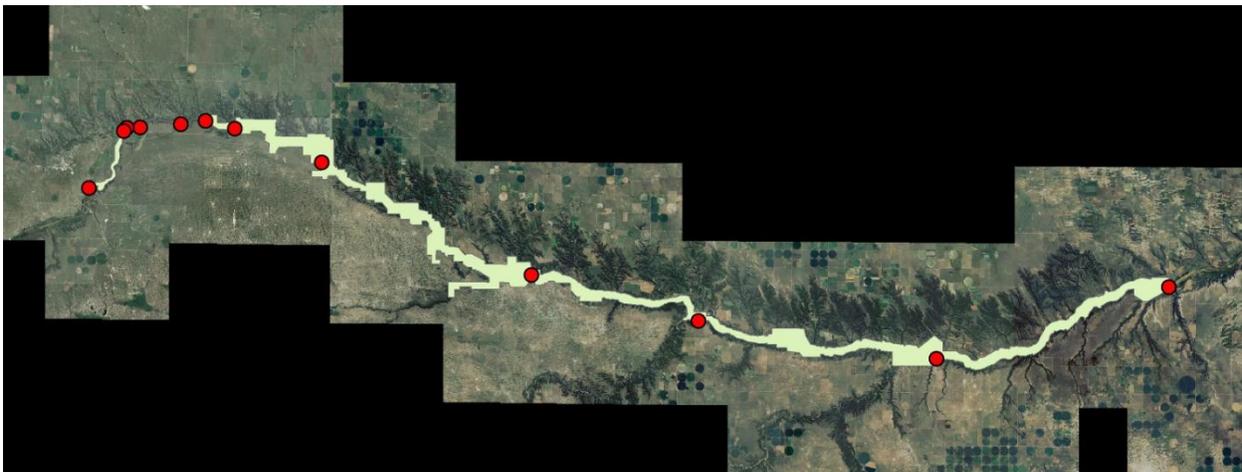
Figure 1

Relative locations of 2012 summer water quality sampling sites along Niobrara NSR (lands within the boundary are shown in light fill). The western- and eastern-most sites were Borman and Highway 137 Bridge, respectively.

Sampling in 2012 spanned the entire length of Niobrara NSR (Figure 1) and took place between May 17 and August 13. Primary sampling sites included Borman, Cornell, Berry, Brewer, Norden, Meadville, and Highway 7 and Highway 137 Bridge. Samples were collected approximately weekly between Borman and Brewer Bridge, and approximately biweekly between Norden and Highway 137 Bridge. In addition, biweekly samples were collected from Minnechaduza and Ft. Falls Creek on the Ft. Niobrara National Wildlife Refuge (NWR), and at the request of the U.S. Fish and Wildlife Service (USFWS), samples were occasionally collected from Big Beaver and Crooked Creek, both located within the designated wilderness area of the refuge.
