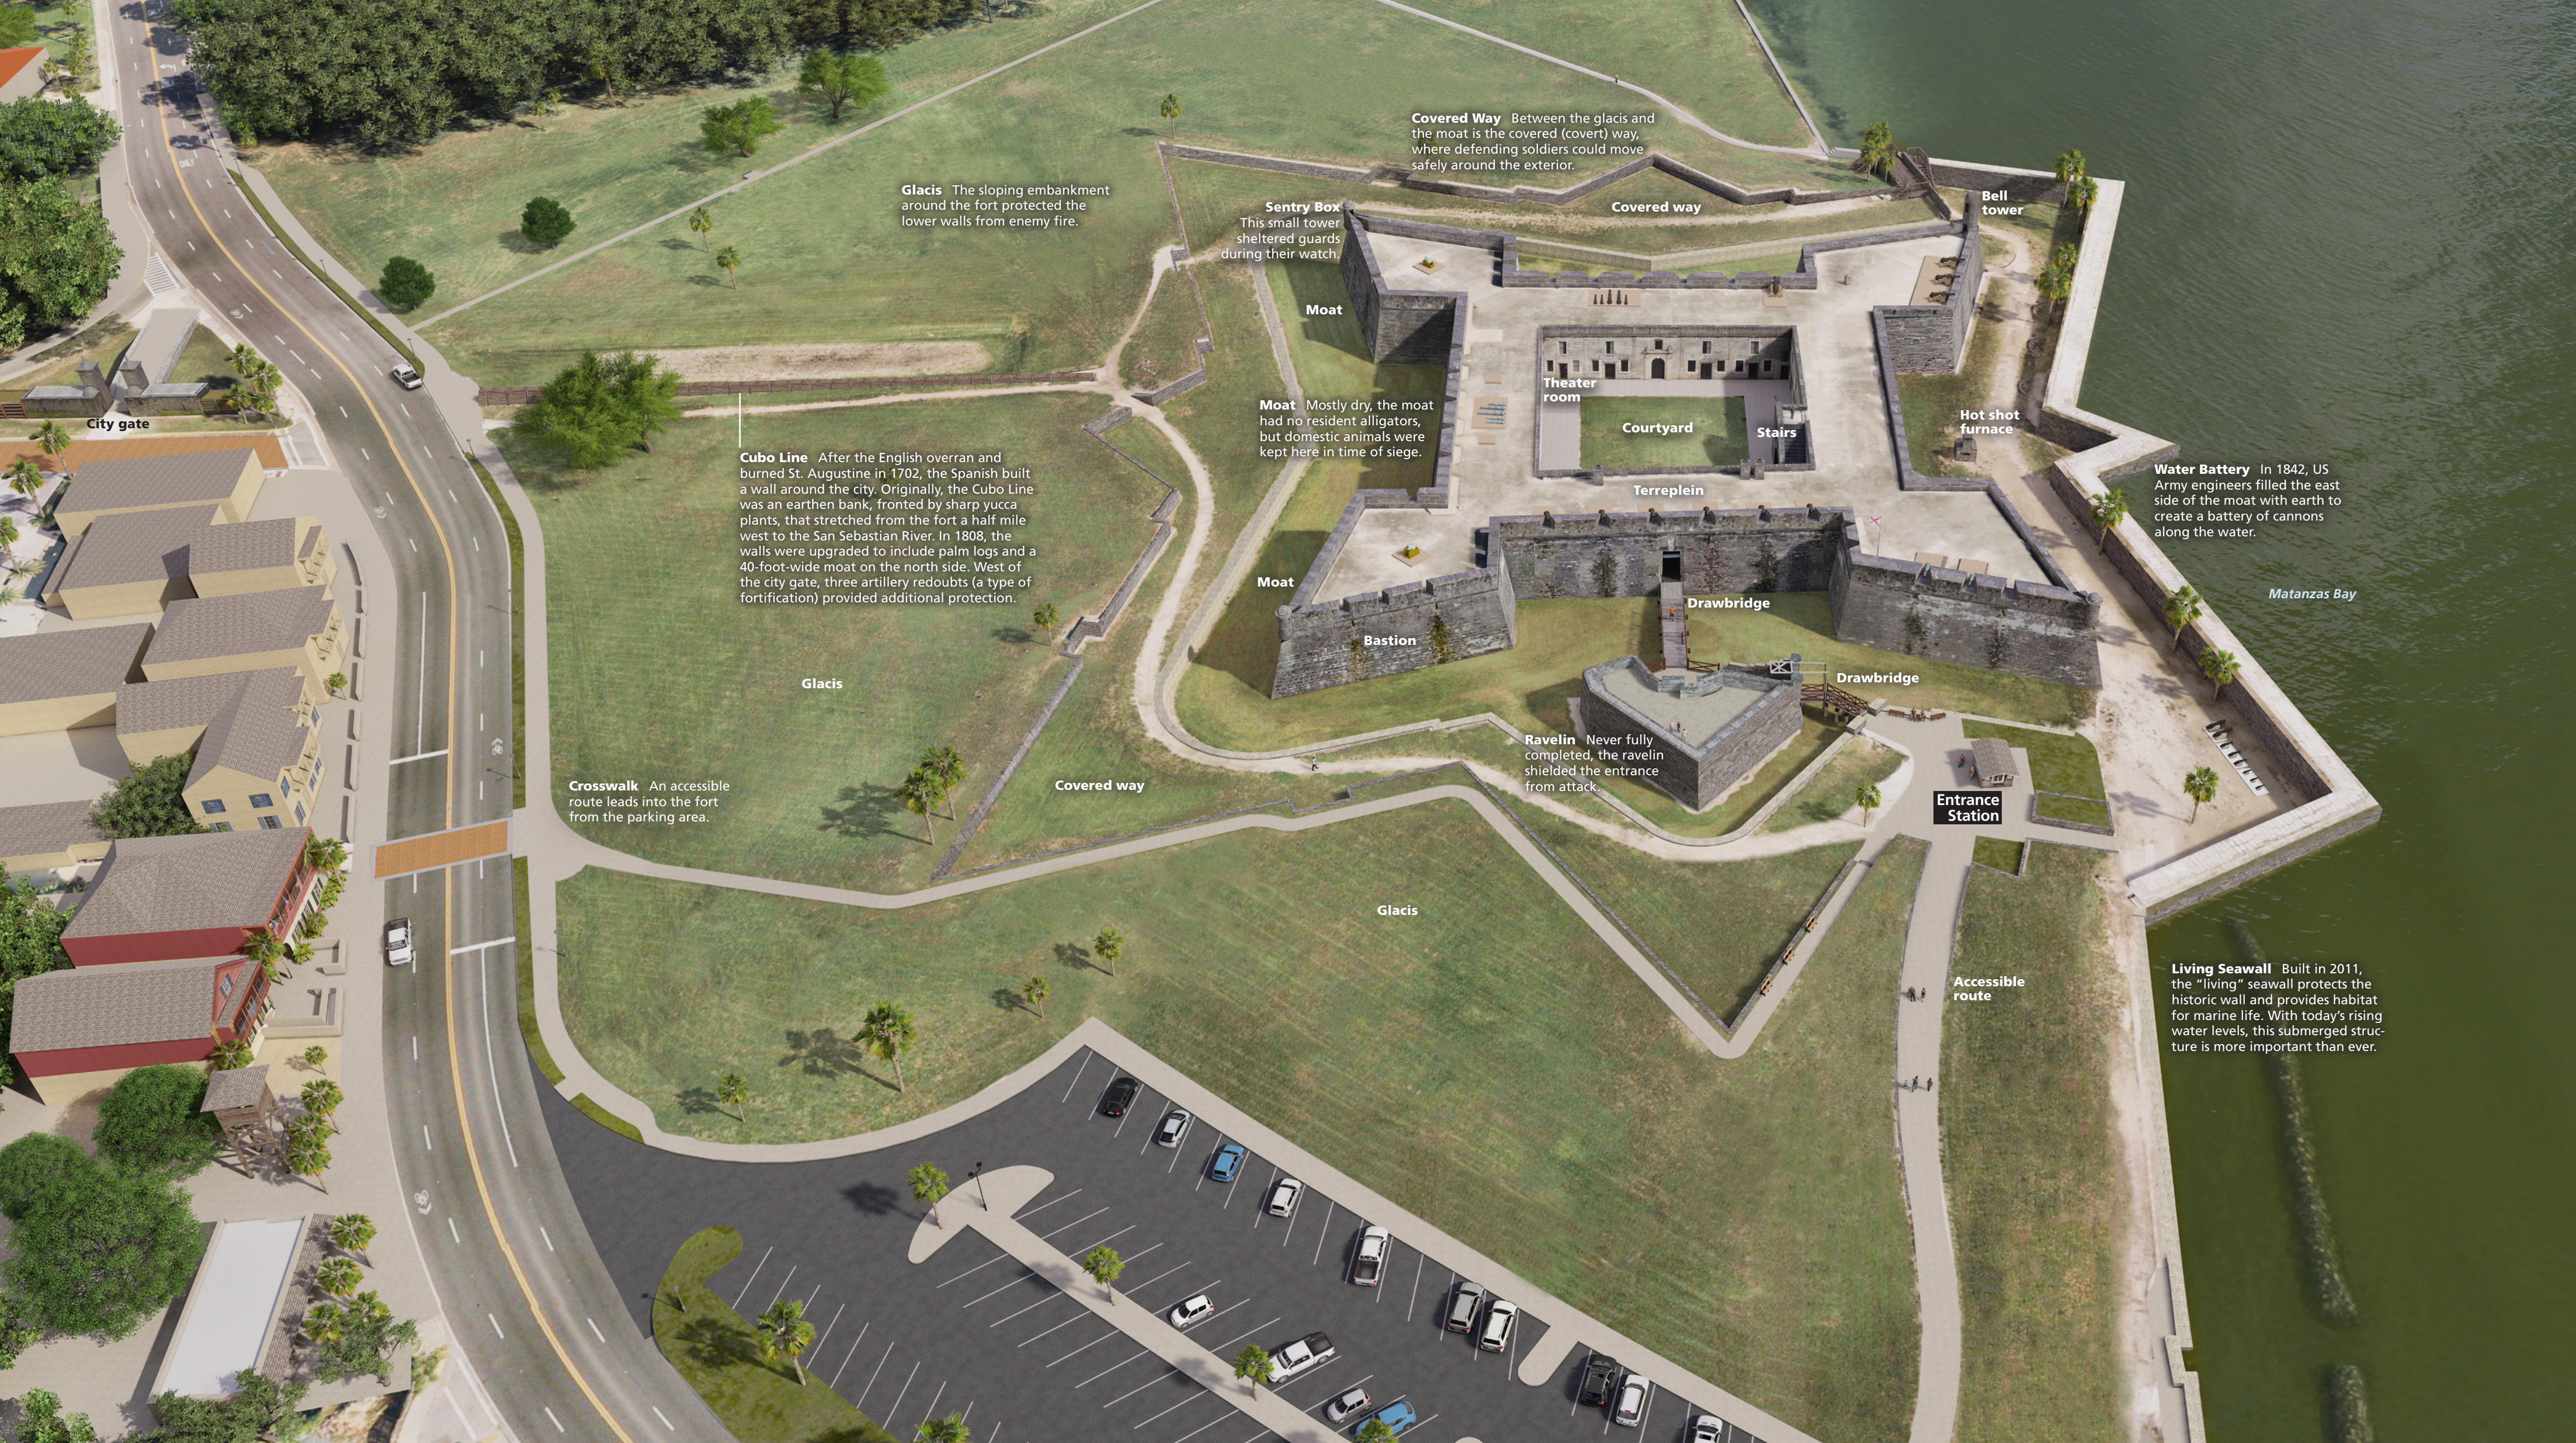
**Glacis** The sloping embankment around the fort protected the lower walls from enemy fire.

**Covered Way** Between the glacis and the moat is the covered (covert) way, where defending soldiers could move safely around the exterior.

**Sentry Box** This small tower sheltered guards during their watch.

**Moat** Mostly dry, the moat had no resident alligators, but domestic animals were kept here in time of siege.

**Water Battery** In 1842, US Army engineers filled the east side of the moat with earth to create a battery of cannons along the water.

**Cubo Line** After the English overran and burned St. Augustine in 1702, the Spanish built a wall around the city. Originally, the Cubo Line was an earthen bank, fronted by sharp yucca plants, that stretched from the fort a half mile west to the San Sebastian River. In 1808, the walls were upgraded to include palm logs and a 40-foot-wide moat on the north side. West of the city gate, three artillery redoubts (a type of fortification) provided additional protection.

**Ravelin** Never fully completed, the ravelin shielded the entrance from attack.

**Living Seawall** Built in 2011, the "living" seawall protects the historic wall and provides habitat for marine life. With today's rising water levels, this submerged structure is more important than ever.
