National Register of Historic Places Registration Form

Historic name: Duplex at 73-75 Sherman Street

The Historic and Architectural Resources of Burlington, Vermont

City or town: Burlington State: VT County: Chittenden

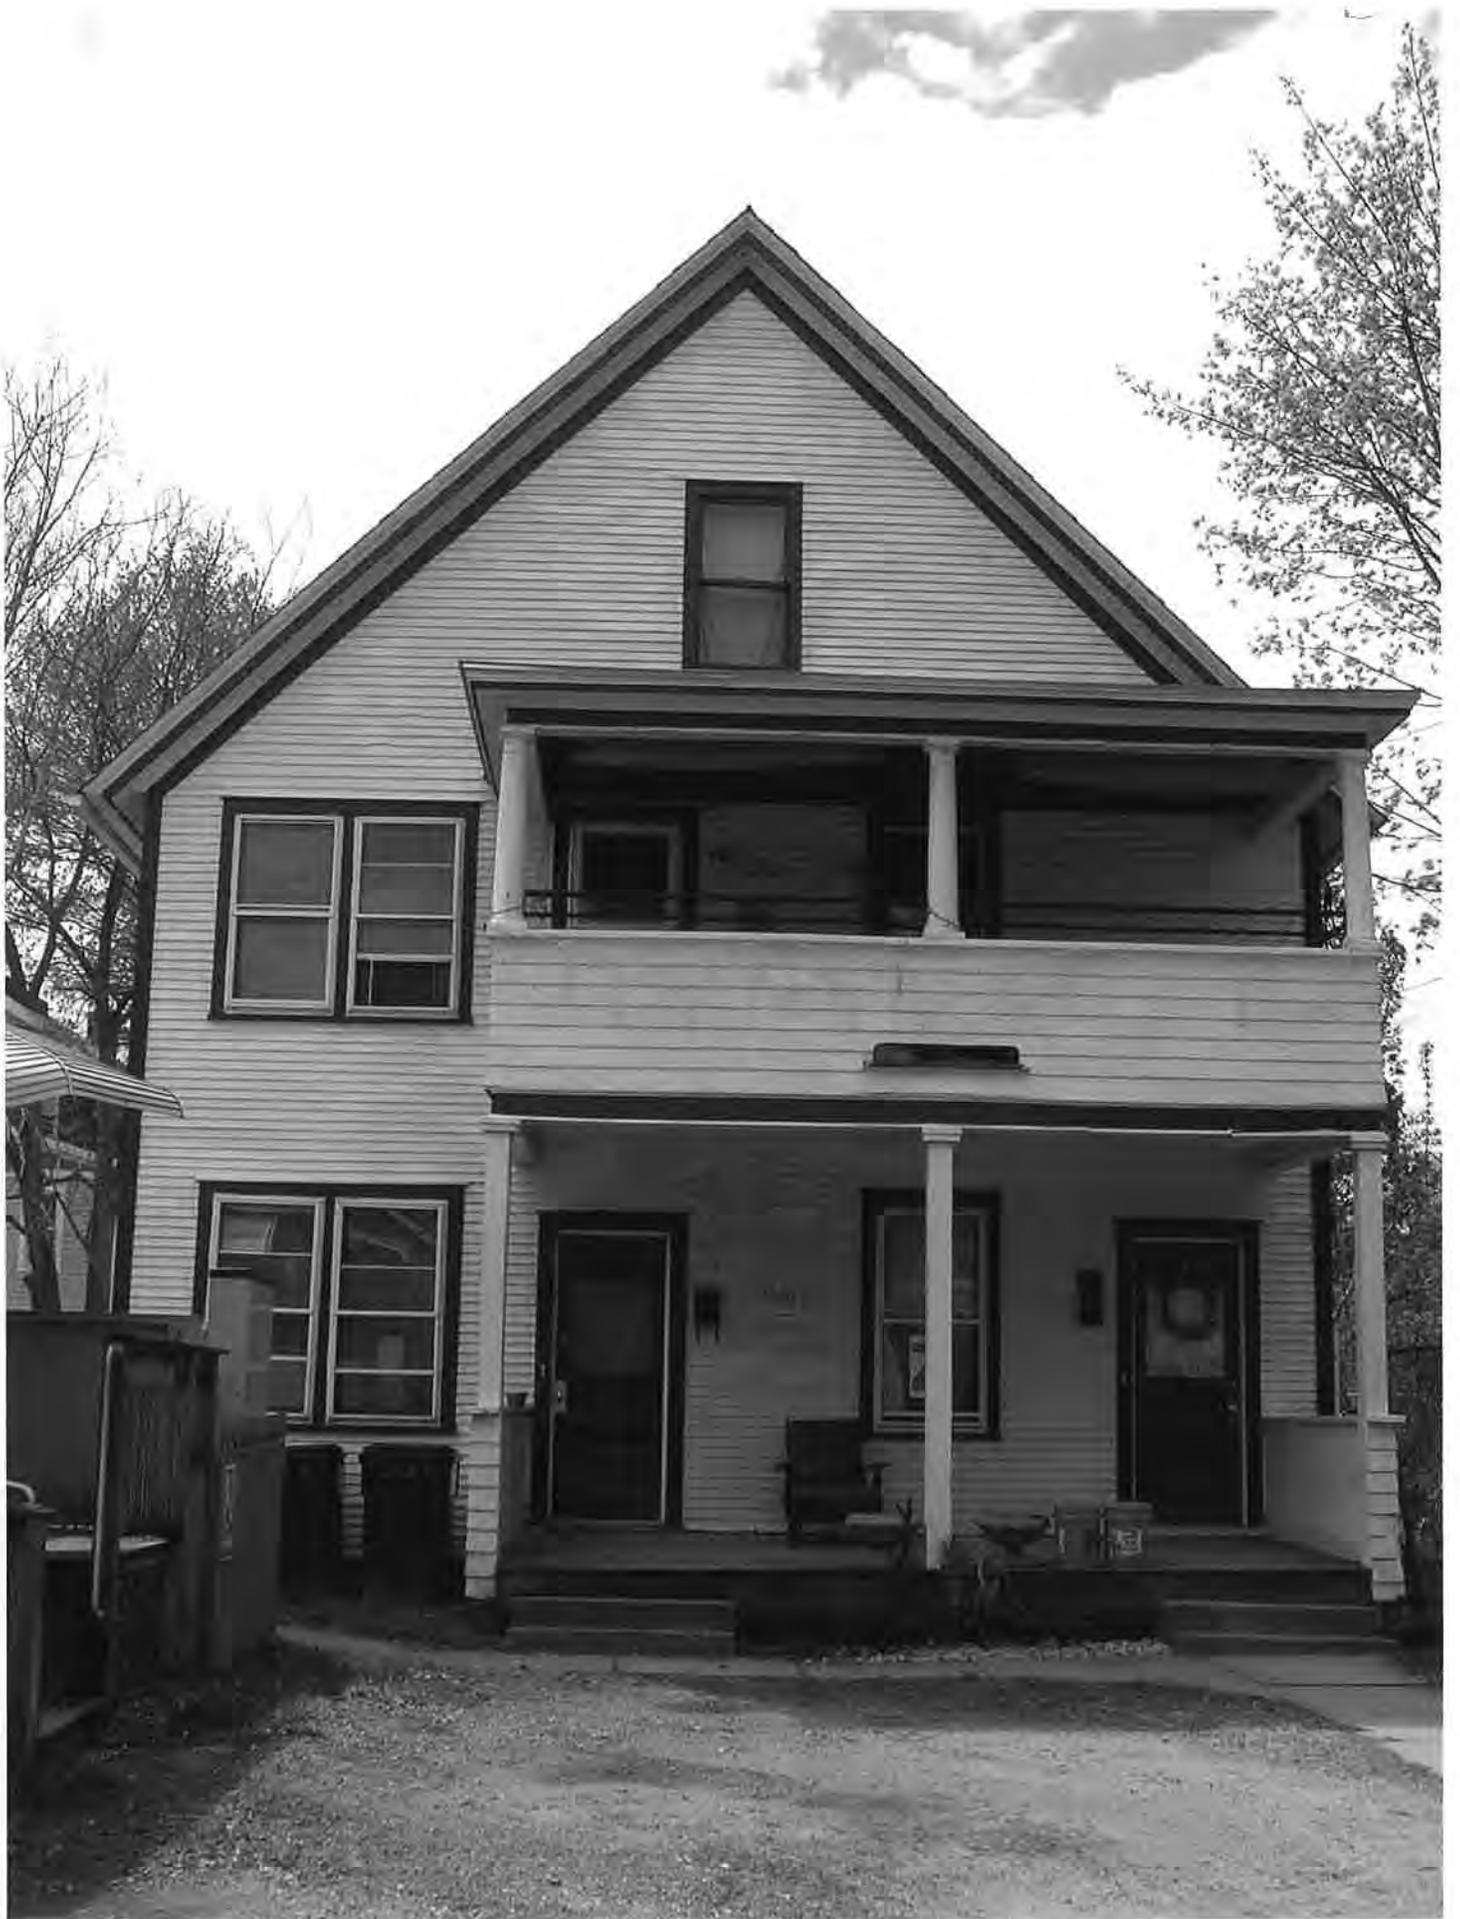
- 3 of 7: Looking south at the north (front) elevation of #73-75.
- 4 of 7: Looking southwest at the rear end of the east (side) elevation. Note the exposed rafter tails on the second-story porch and band of scalloped slate shingles on the roof of the main block.
- 5 of 7: Looking southeast at the north (front) and west (side) elevations.
- 6 of 7: Looking west and up, along the south (rear) elevation. The garage of an abutting property stands several feet from the building.
- 7 of 7: Interior view of the unit on the second floor. Note the wide opening between the living room and dining room, the natural finish trim and hardwood floors. Door to stairs is on right.

The duplex is a rectangular, wood frame, 2½-story, 4x5 bay, gable front, vernacular Colonial Revival style building with a two-story open porch on its front elevation and smaller two-story porch at the rear end of the eastern elevation. The building has a board-formed concrete foundation visible on the exterior and rests on a stone foundation that is one of the only vestiges of its original construction. It has a slate roof with bands of decorative scalloped shingles on the east slope and a molded cornice. Twin brick chimneys rise from the ridge. Clapboard siding and wide plain trim, including water table, corner boards, and fascia, finish the structure. Window and door trim is narrow and plain with narrow cornices. Windows are replacement 1/1 wood sash with aluminum storms and are set individually and in pairs. Exterior doors are all natural-finish wood with a single large pane of glass over three horizontal recessed panels.

Spanning the western three bays of the front elevation is a flat roofed, Colonial Revival style, two-story open porch. To the left of the porch, in the first bay of each story, is a pair of 1/1 windows. On the first story, the porch has full-length square posts and shingled half-walls on the east and west sides. The northern, front elevation of the porch is open with two short sets of concrete steps accessing the replacement wood deck and historic entry doors. A single double-hung window is located between the two entry doors, sheltered by the porch. On the second
