National Register of Historic Places Registration Form

Historic name: Roberge-Desautels Apartment House

Street & number: 54 North Champlain Street

City or town: Burlington State: VT County: Chittenden

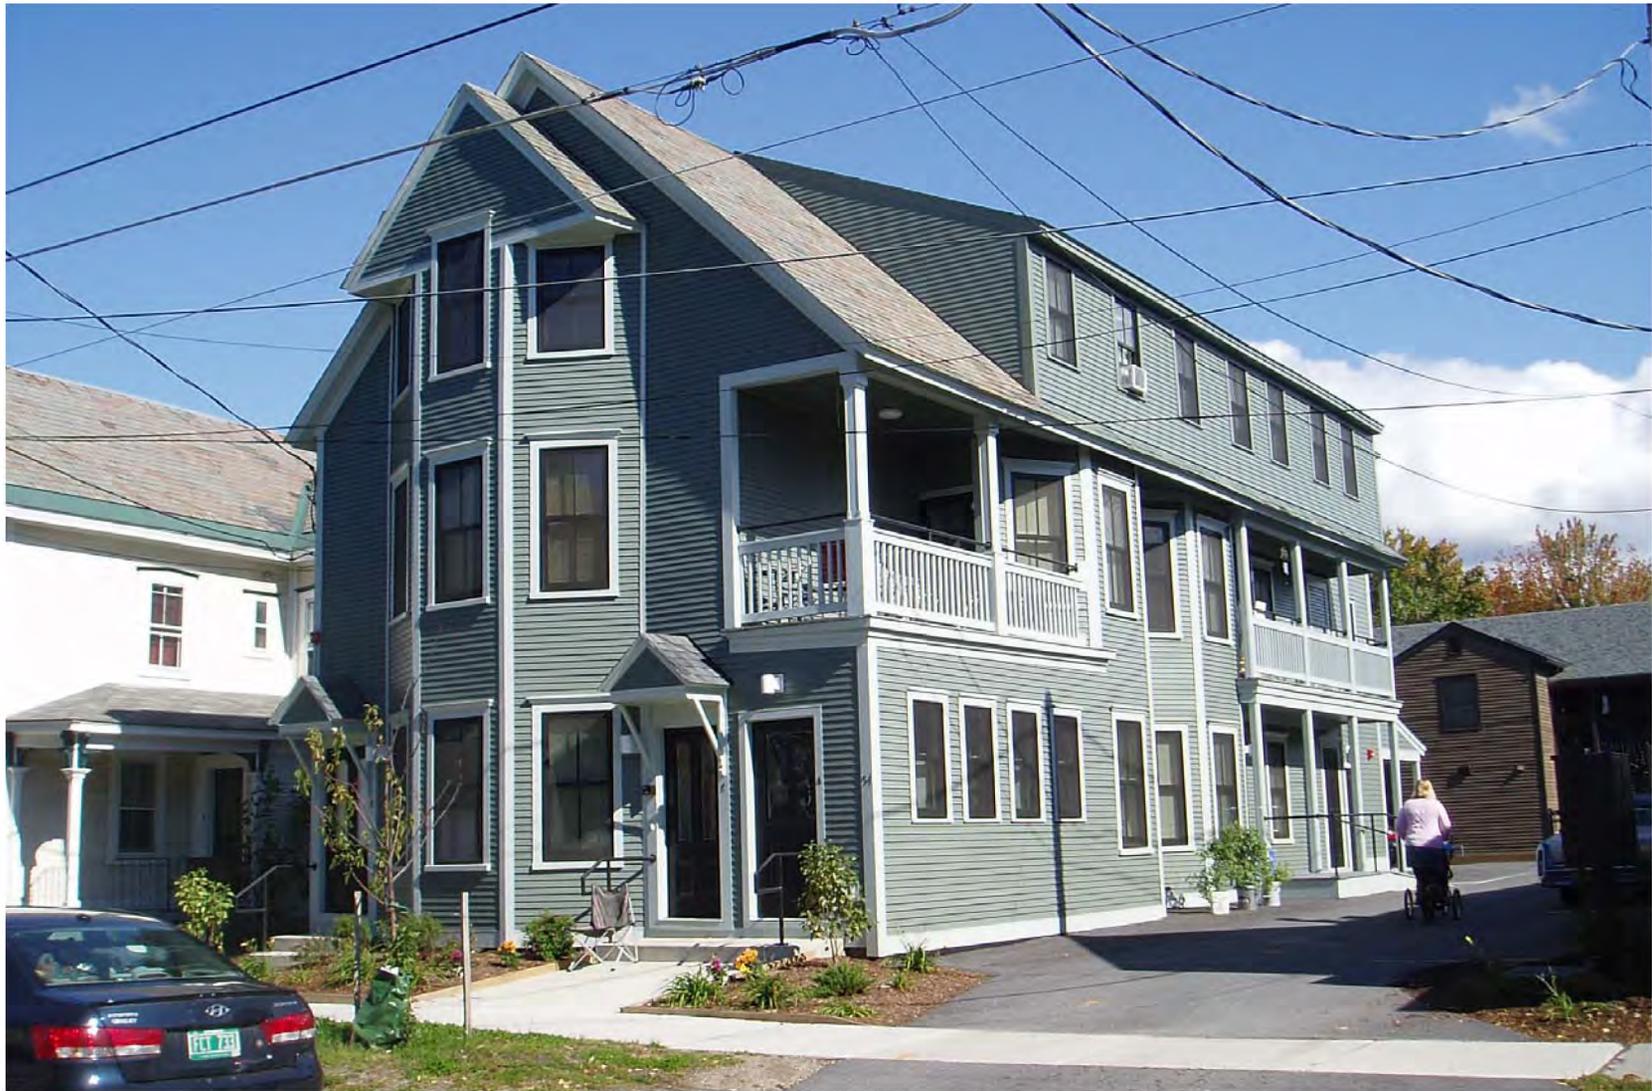
Roberge-Desautels Apartment House
54 North Champlain Street
Burlington, Chittenden County, Vermont
View looking east of front (west) and north elevations
Credit: Liz Pritchett, October 2012
Photograph 2

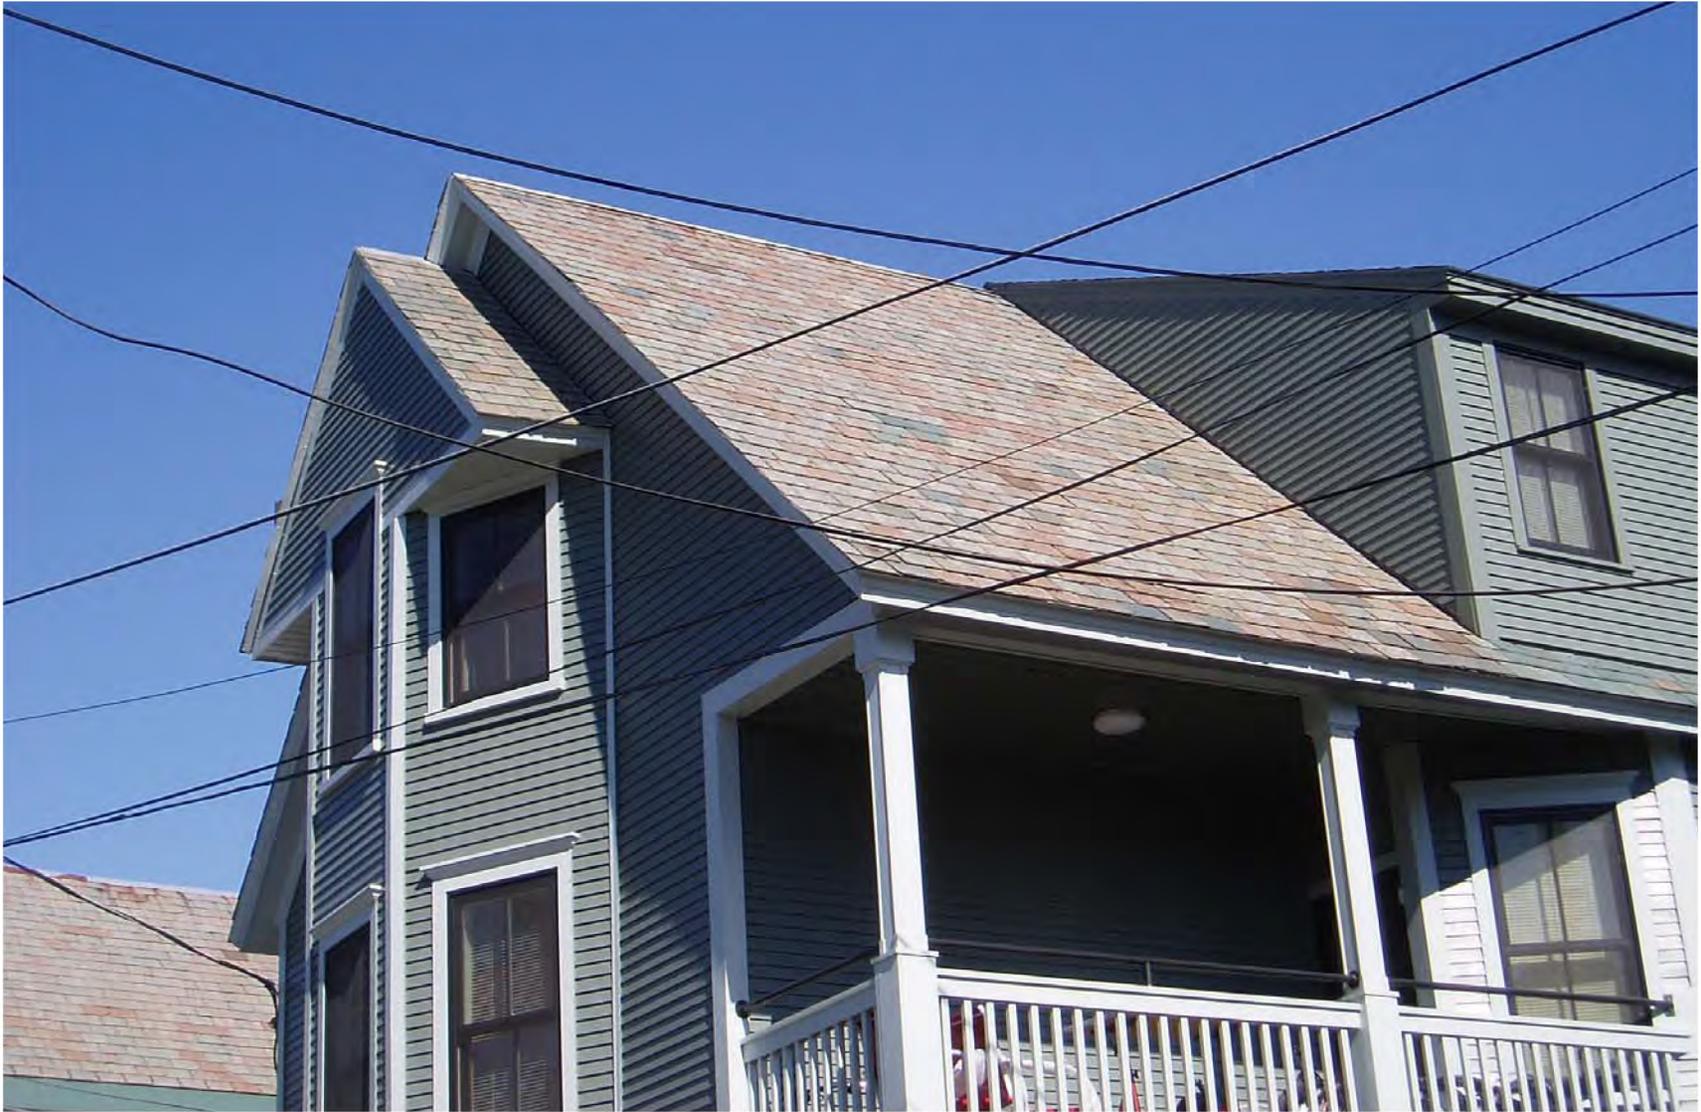
Roberge-Desautels Apartment House
54 North Champlain Street
Burlington, Chittenden County, Vermont
View looking east of front (west) and north elevations
Credit: Liz Pritchett, October 2012
Photograph 3

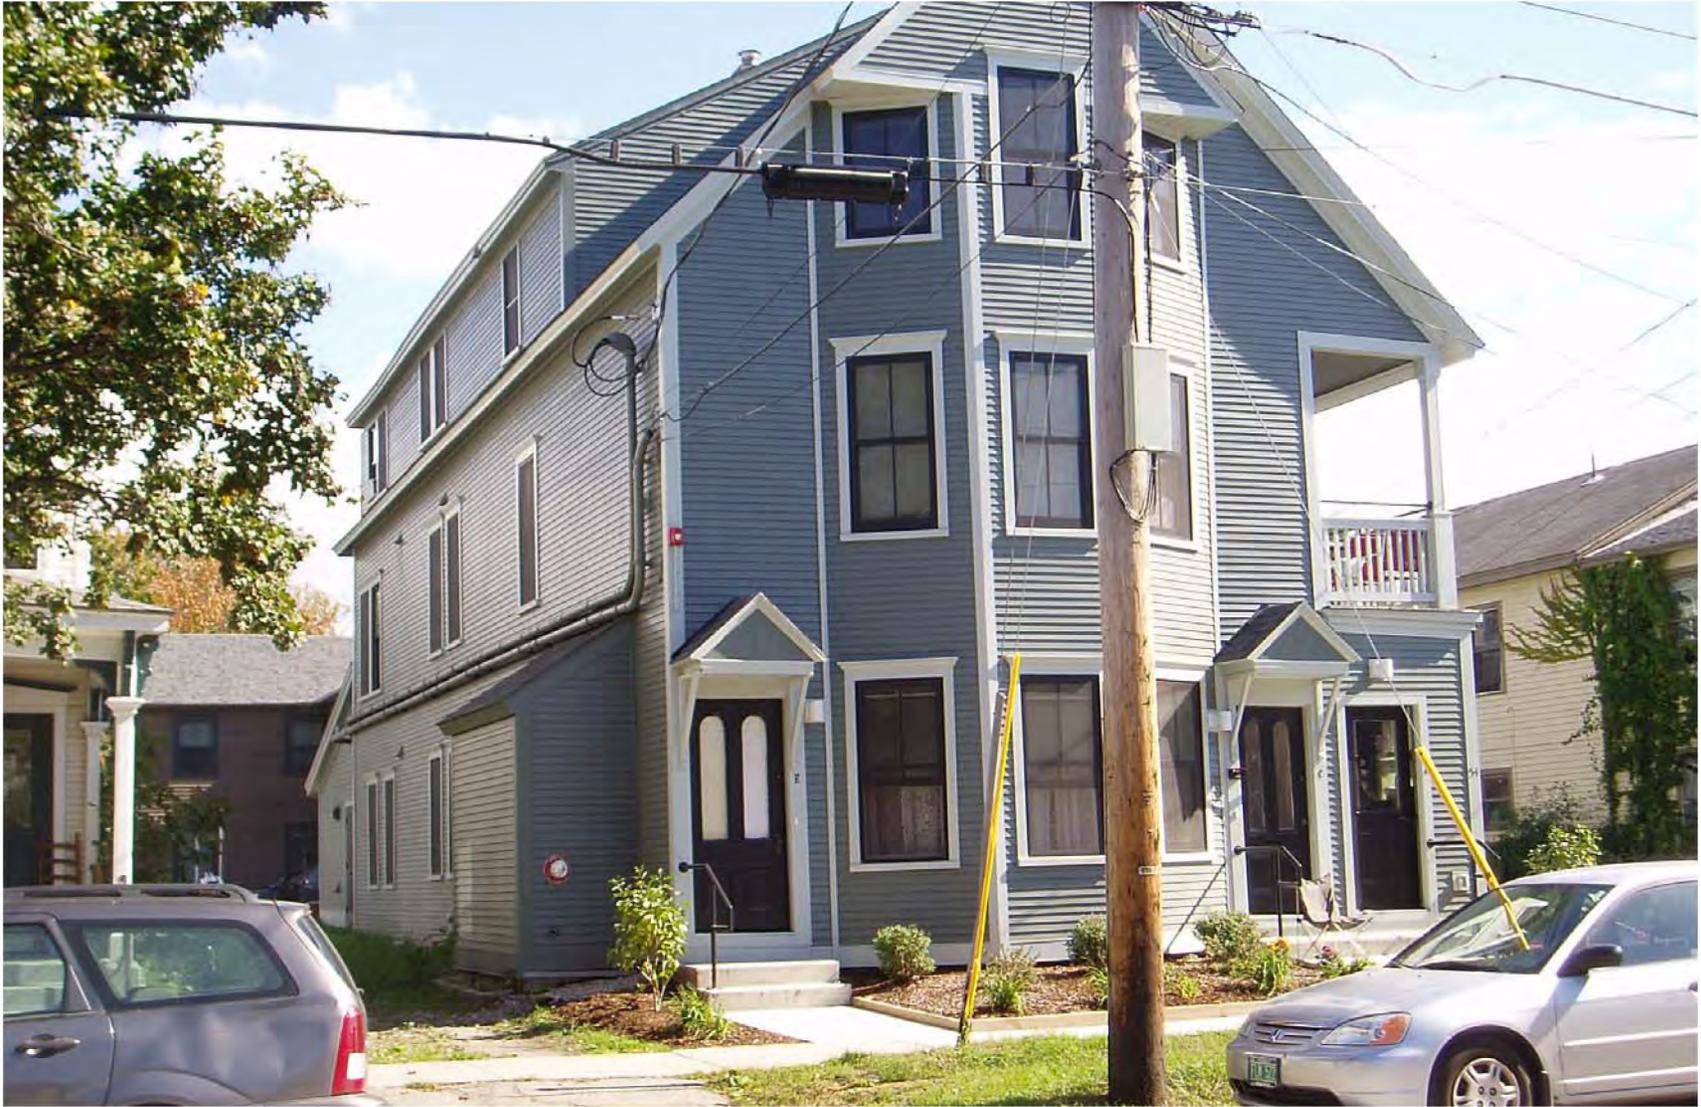
Roberge-Desautels Apartment House
54 North Champlain Street
Burlington, Chittenden County, Vermont
View looking east of front (west) and north elevations
Credit: Liz Pritchett, October 2012
Photograph 4

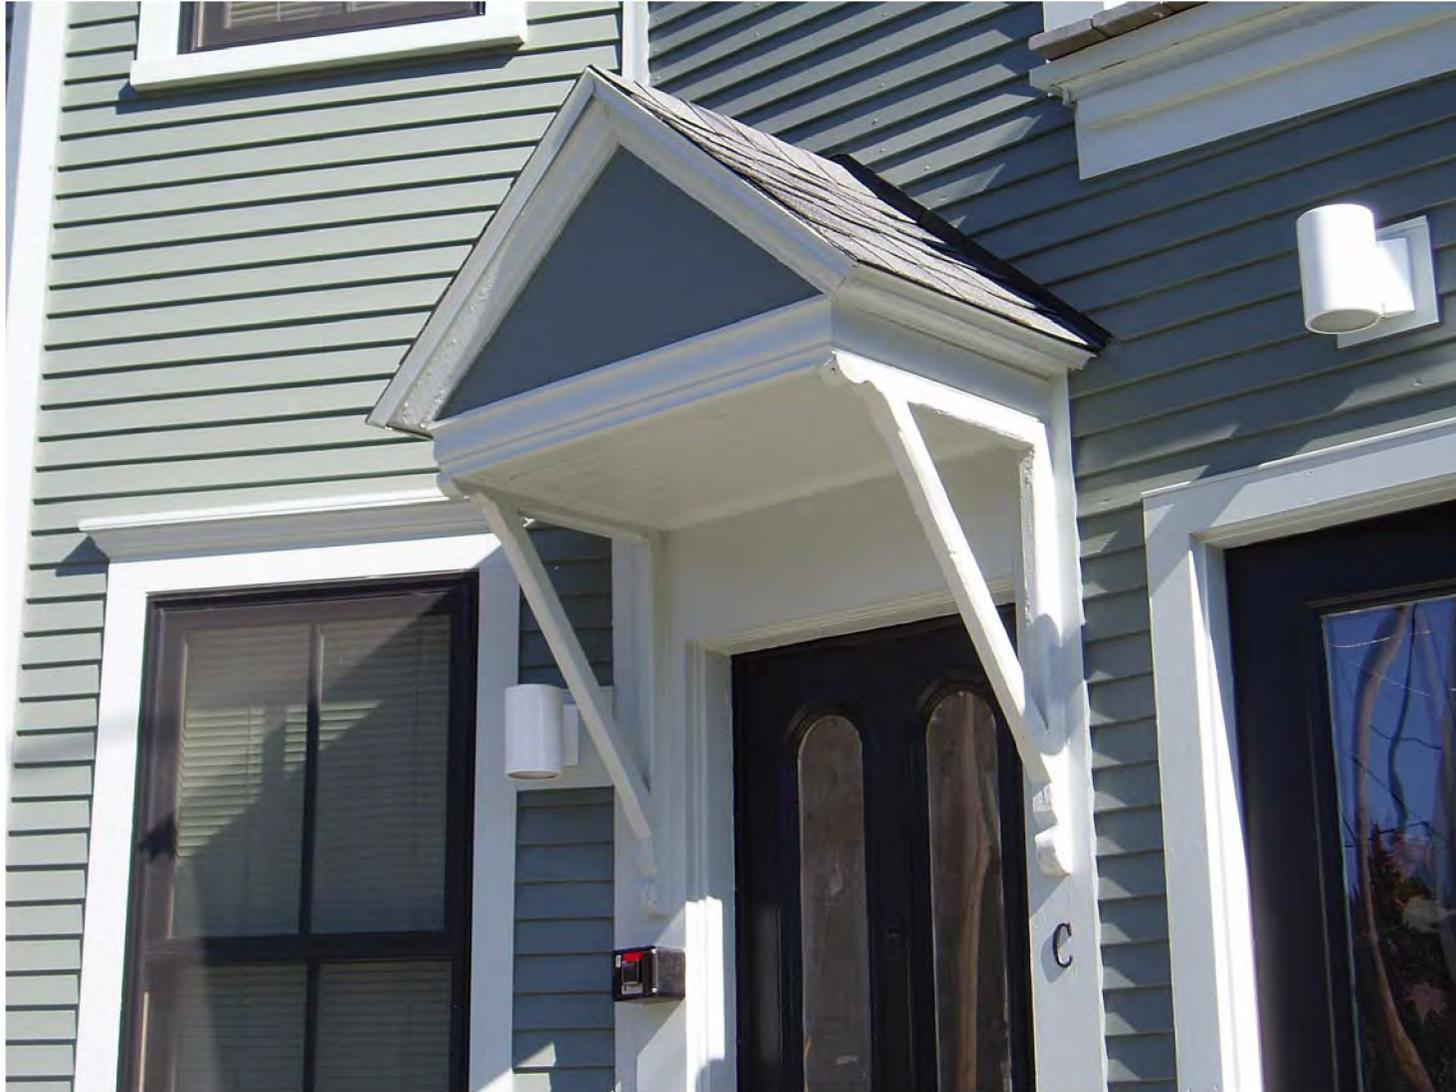
Roberge-Desautels Apartment House
54 North Champlain Street
Burlington, Chittenden County, Vermont
View of entries to Unit C (left, second floor front unit) with historic door hood, and Unit A, (right, first floor front unit).
Credit: Liz Pritchett, October 2012
Photograph 5

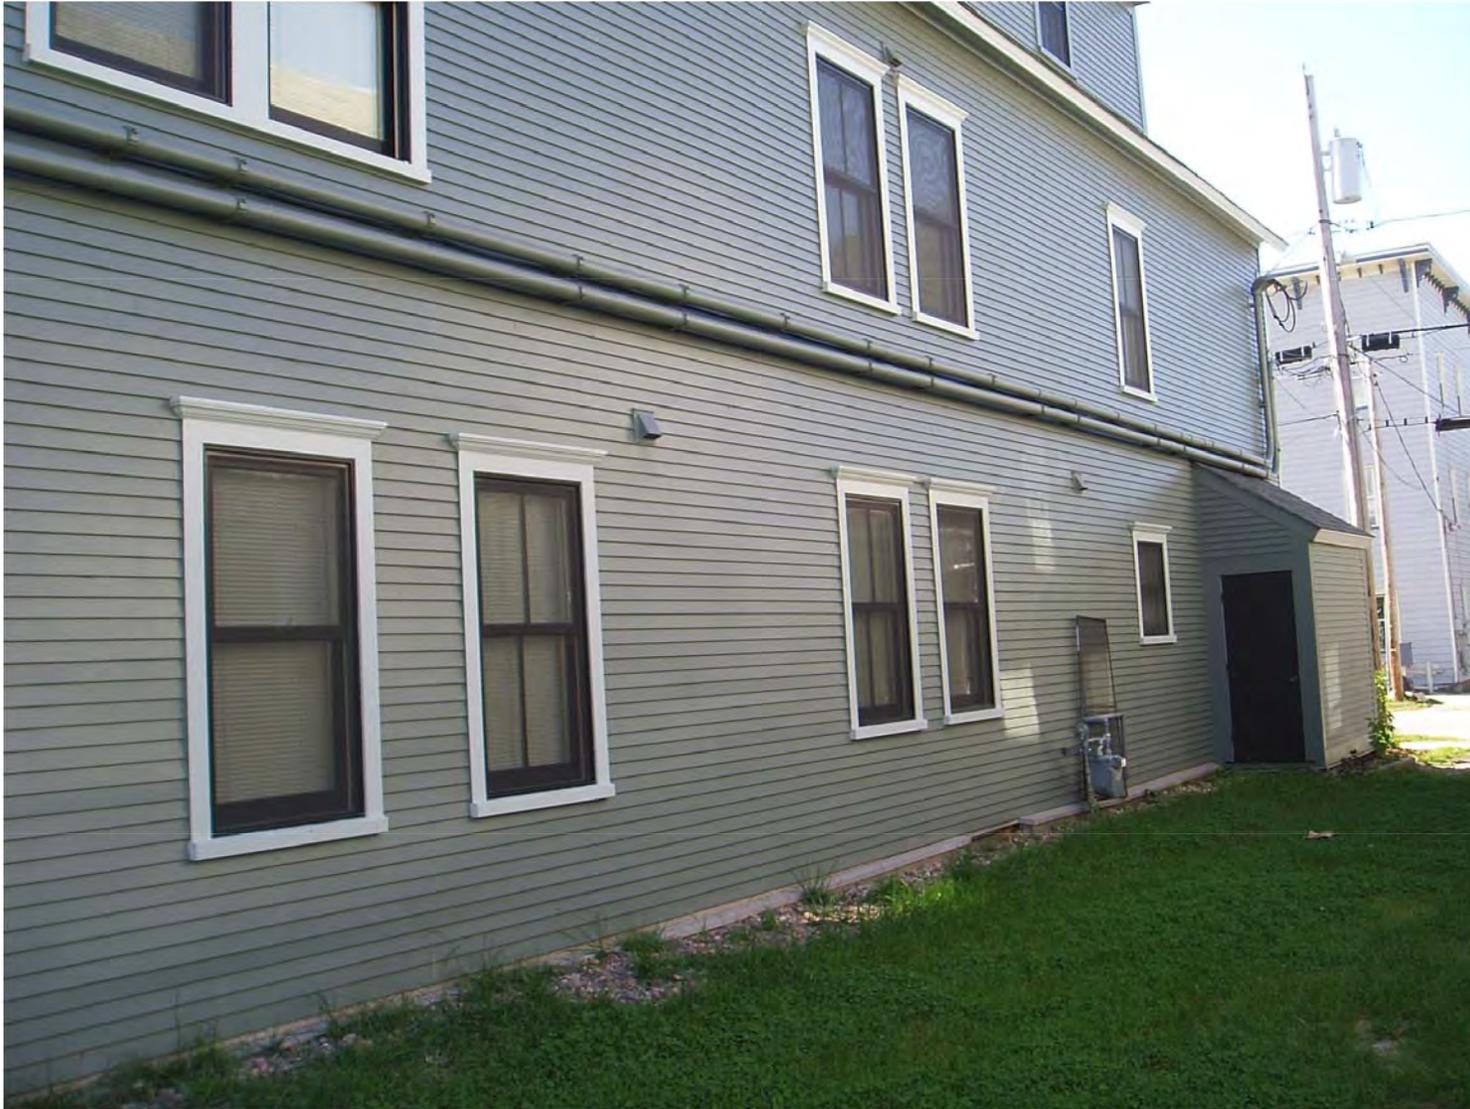
Roberge-Desautels Apartment House
54 North Champlain Street
Burlington, Chittenden County, Vermont
View looking west along the north elevation.
Credit: Liz Pritchett, October 2012
Photograph 7

The north elevation shed dormer has one-over-one windows; reading from left to right, the first two windows are paired, as are the two that are centered in the wall plane; the right window is a single window. The fenestration patterns in the two lower floors are similar to that of the dormer. On the first floor, from left to right, the first two windows are grouped together as are the next two; a smaller single sash window is located on the right. On this floor, windows one and four are in new openings so they have one-over-one windows. On the second floor, the first two windows are paired, one-over-one windows, the next two that are grouped have a new opening on the right, and the far right window is in an original opening. Also on the first floor, the far left bay consists of a modern pass door to the laundry room addition, and the enclosed stair appendage on the far right at the northwest corner of the building has a paneled pass door that provides access to stairs to the basement.

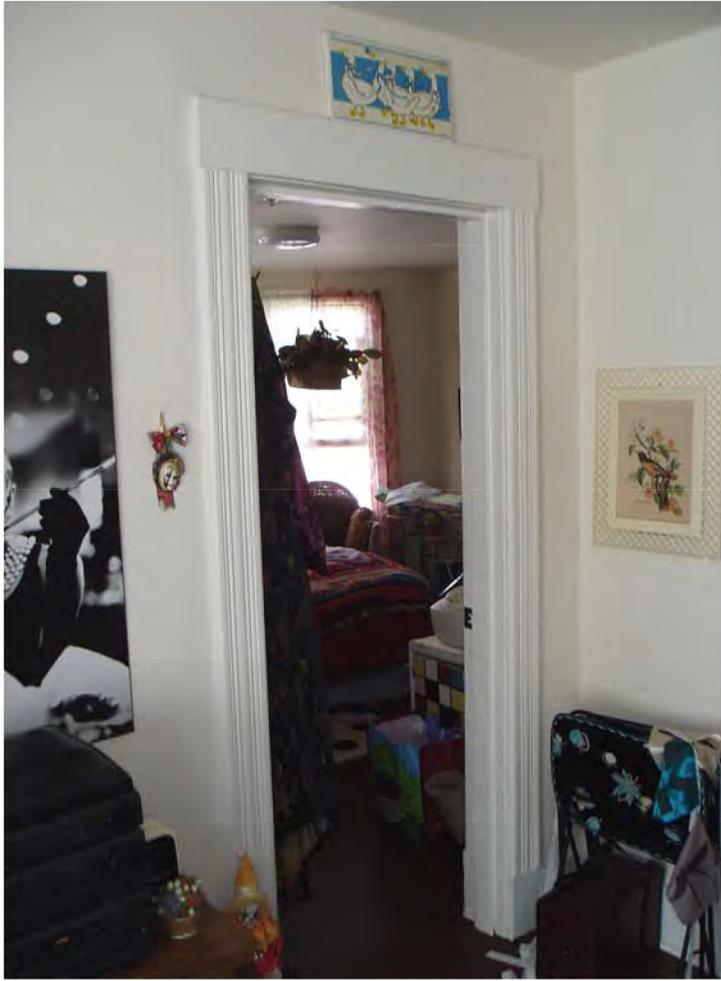
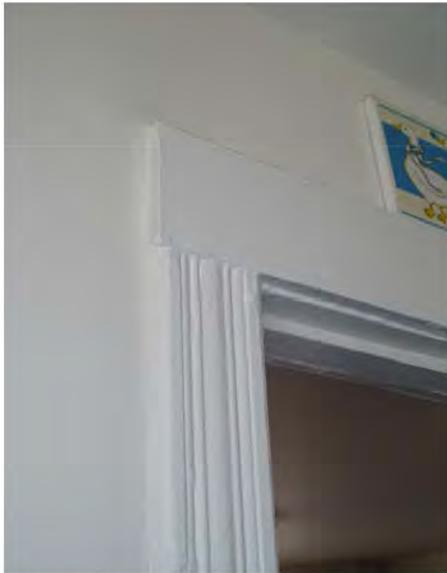
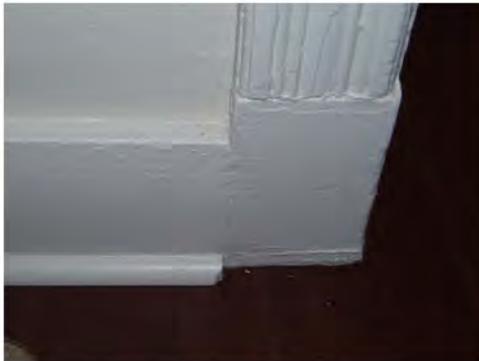
Roberge-Desautels Apartment House
54 North Champlain Street
Burlington, Chittenden County, Vermont
Views of typical retained historic door trim.
Credit: Liz Pritchett, October 2012
Photograph 9

The interior of the Roberge-Desautels Apartment House remains somewhat intact, especially in the more significant three front units and in the two front stair systems leading to the upper floor front units. The three front units occupy the front half of the building. These units have bay windows in the front and south side rooms on the first and second floors, and many interior doors have heavily molded surrounds. The three rear units have flat stock door and window surrounds. The distinctive front stair systems retain their steep rise, as well as historic beadboard and matchboard wall paneling. The new rear addition contains stairs to the second and third floor rear units. All six units have modern sheetrock wall and ceiling finishes. Some historic paneled interior doors remain in use.

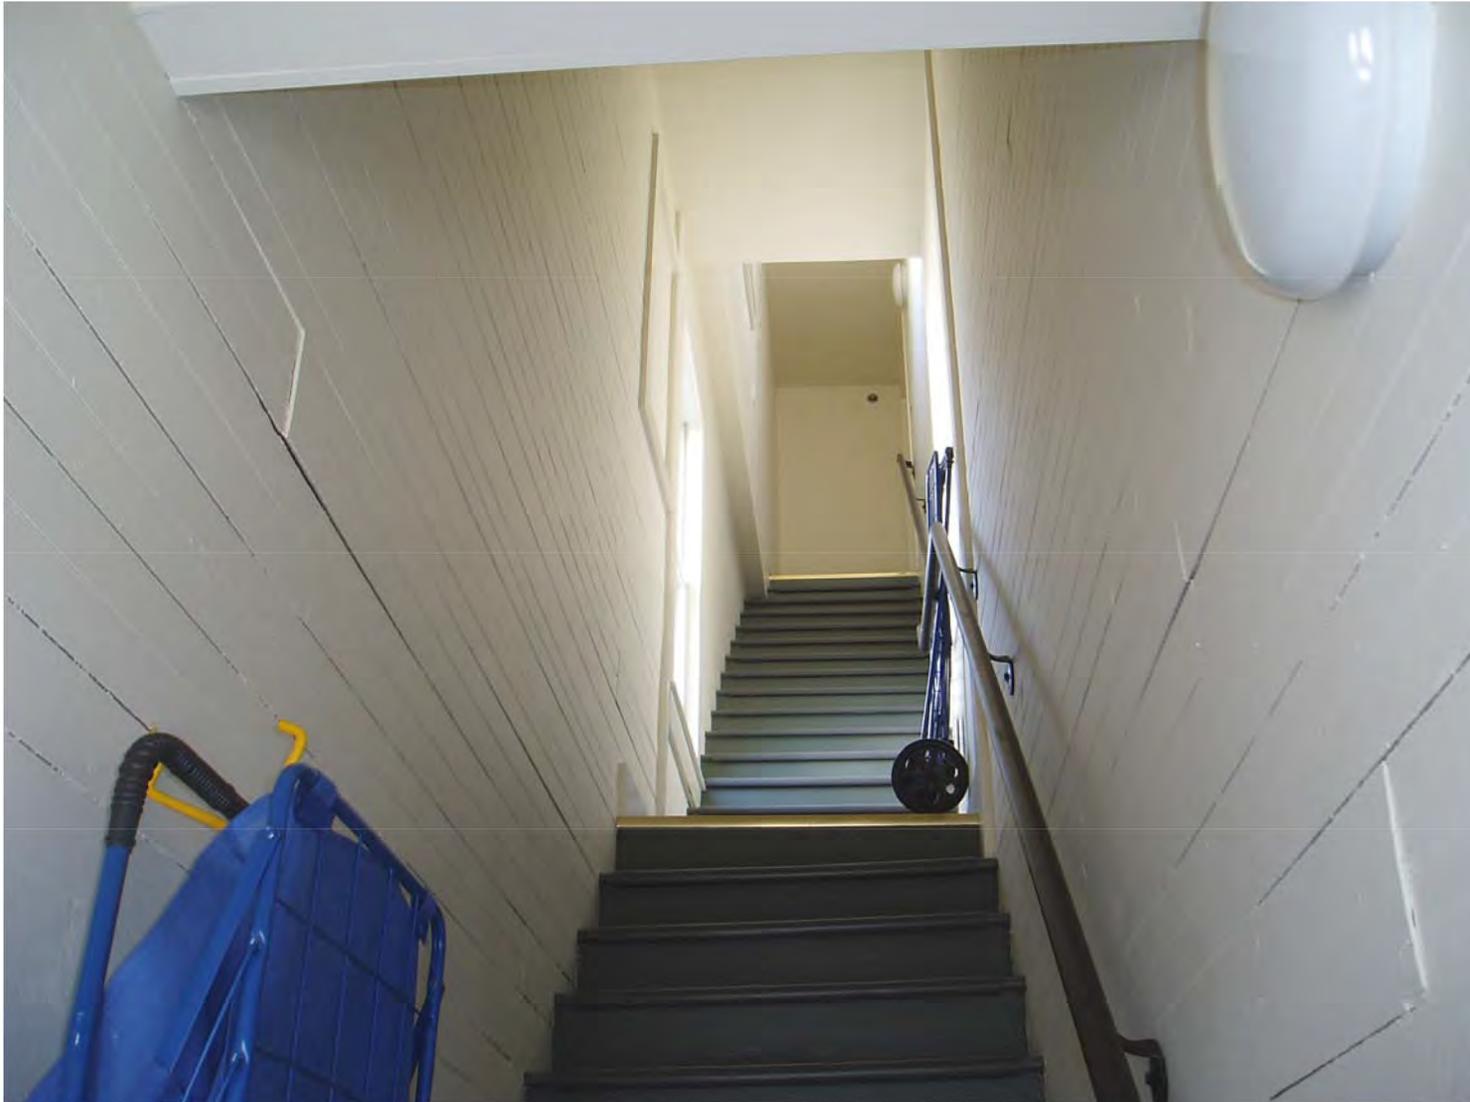
Roberge-Desautels Apartment House
54 North Champlain Street
Burlington, Chittenden County, Vermont
Retained historic stairs from the west (front) elevation, far left entry, to third floor front unit.
Credit: Liz Pritchett, October 2012
Photograph 10
