National Register of Historic Places Registration Form

Historic name: Wilkins Farm
Other names/site number: VDHR File No. 085-0216
Name of related multiple property listing:
N/A
(Enter "N/A" if property is not part of a multiple property listing)

Street & number: 989 Swover Creek Road
City or town: Edinburg State: Virginia County: Shenandoah
Not For Publication: N/A Vicinity: X

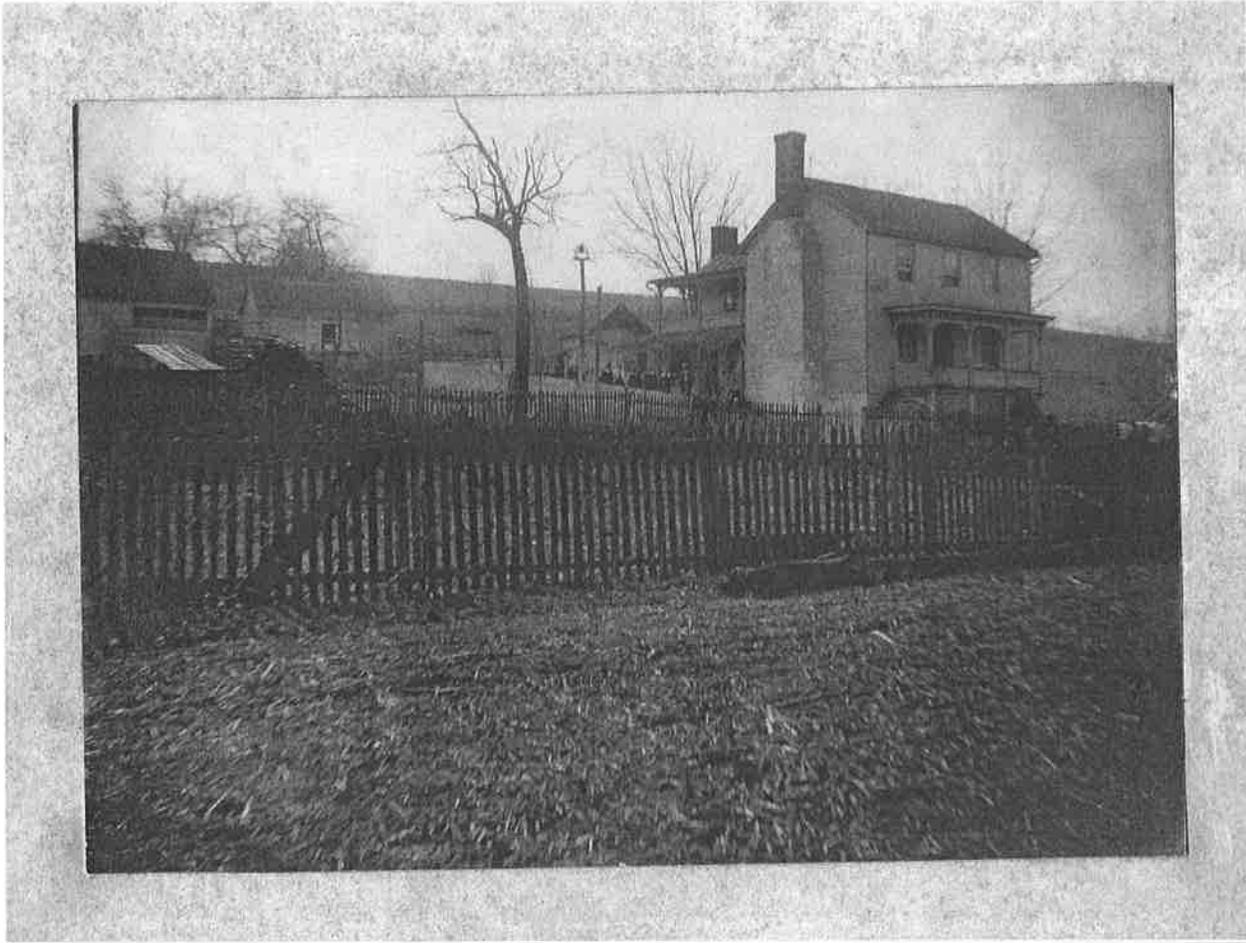
Wilkins Farm, Shenandoah County, Virginia, 1913.

In 1843, the buildings were valued at \$275.00 according to the land tax records. By this time Jacob Wilkins was deceased and he had two remaining sons, Isaac and Emanuel. Isaac, the heir, probably carried out the last remaining major changes to the house. To the hall-and-parlor-plan rear ell he had added a second story with a second-story porch to the east elevation. To the south he added a nine-foot by sixteen-foot kitchen which was cut into the descending hill. The exterior doors were replaced with two-vertical-panel Greek Revival-style doors and fitted with cast Blake thumb latches and fastened with blunt screws, a remnant of the pre-industrial tapered screw which changed ca. 1846. He also created two interior doorways to join the two houses. In the late 19th century, Isaac replaced most of the windows with the extant two-over-two, double-hung-sash wood windows, and also updated the porches with decorative Victorian flat-sawn balustrades, chamfered posts, and a spandrel on the main house porch. Faux painting executed on the back of a chamber door and a built-in chamber closet survives to date. The faux painting on wood was a simple wood graining with intermittent squiggles. All of the interior trim boards used during this period were plain boards with no beading. The house was complete as it is shown in a 1913 photo. No other alterations appear to have been made until the mid-20th century.

area is limited, any potential for archaeology appears to be confined to an elongated 50-foot by 300-foot area. A 1913 photo reveals additional small outbuildings east of the main house. Irregular land forms in the current pasture suggest the possibility of a larger on-ground log barn. A possible foundation base of limestone rubble fashioned into a 24-inch-wide platform with an undetermined length was found 50 feet east of the main house. Potentially this area might explain the source of the reused logs in the summer kitchen. West of the granary, a barrow pit was found that may have been used to build the ca.1776 fireplace. The mortar seems to be made of local gritty clay which was repointed at a later date. It was back filled with limestone rubble and flakes from the chimney construction. The exterior dimensions are unknown. Two non-diagnostic aboriginal surface finds were a fire reddened low-grade jasper end-scraper and a fired quartzite preform. Large quantities of historic pottery shards have been found and include ca. 1750, English cream-ware, pearl-ware, transfer-ware, buff to red-bodied earthen-ware with lead-glaze and salt-glaze stoneware, and white-ware. A lot of the red-ware shard rims indicate dairy pots and pans. A single piece of an English pipe stem from the mid-19th century and an 18th-century bone button were found.

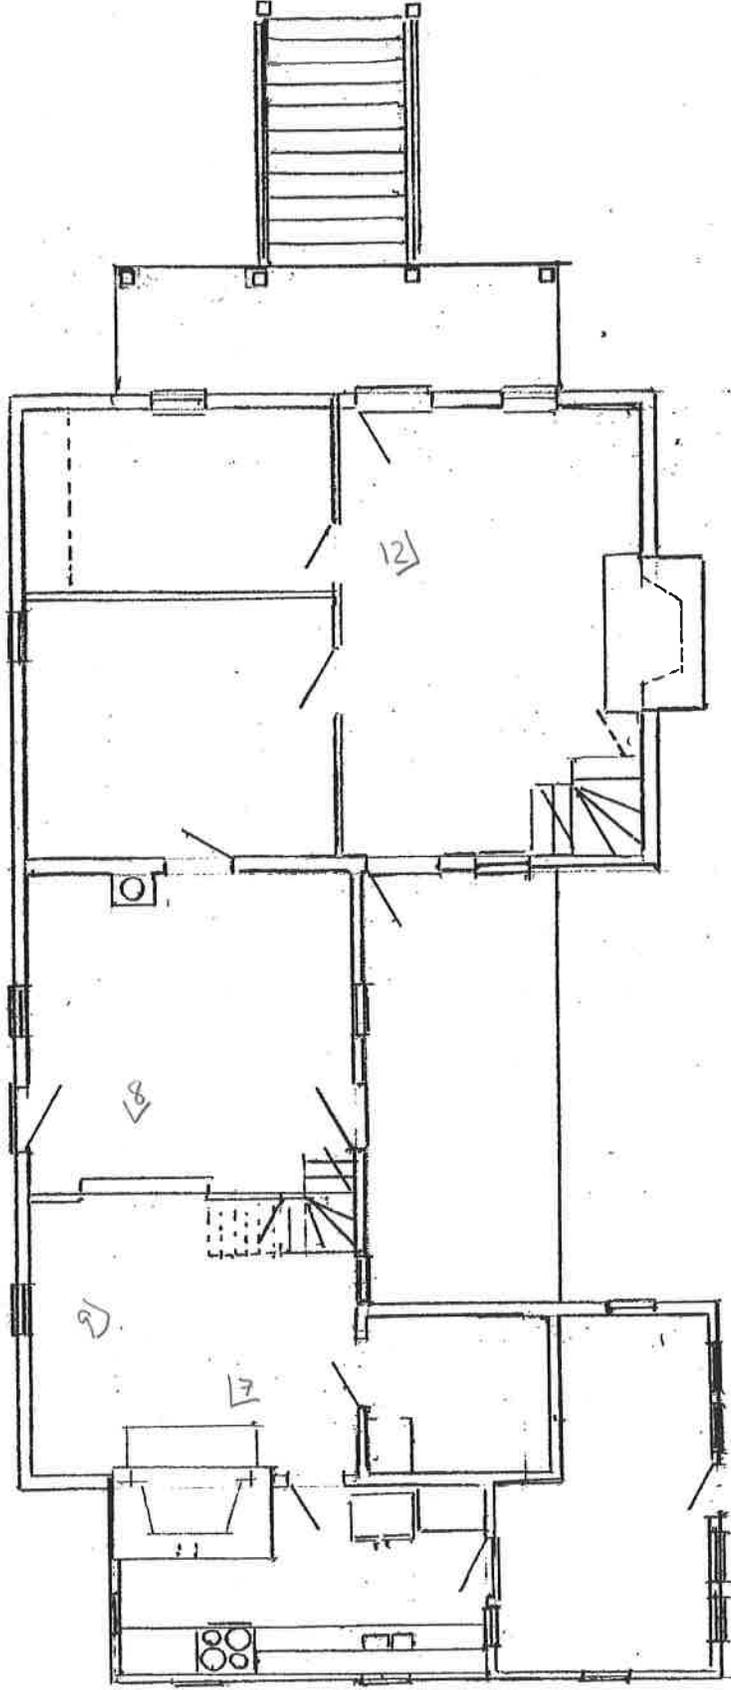
WILKINS FARM
SHENANDOAH COUNTY, VA
VDHR FILE NO. 085-0216
PHOTO KEY/SITE PLAN
