Historic name U.S. Inspection Office, Morley Gate—Nogales, Arizona  
Other names/site number Dennis DeConcini U.S. Port of Entry; East Garita; Morley Gate

### National Register of Historic Places Registration Form

*U.S. Inspection Office, Morley Gate—Nogales  
Santa Cruz County, Arizona*

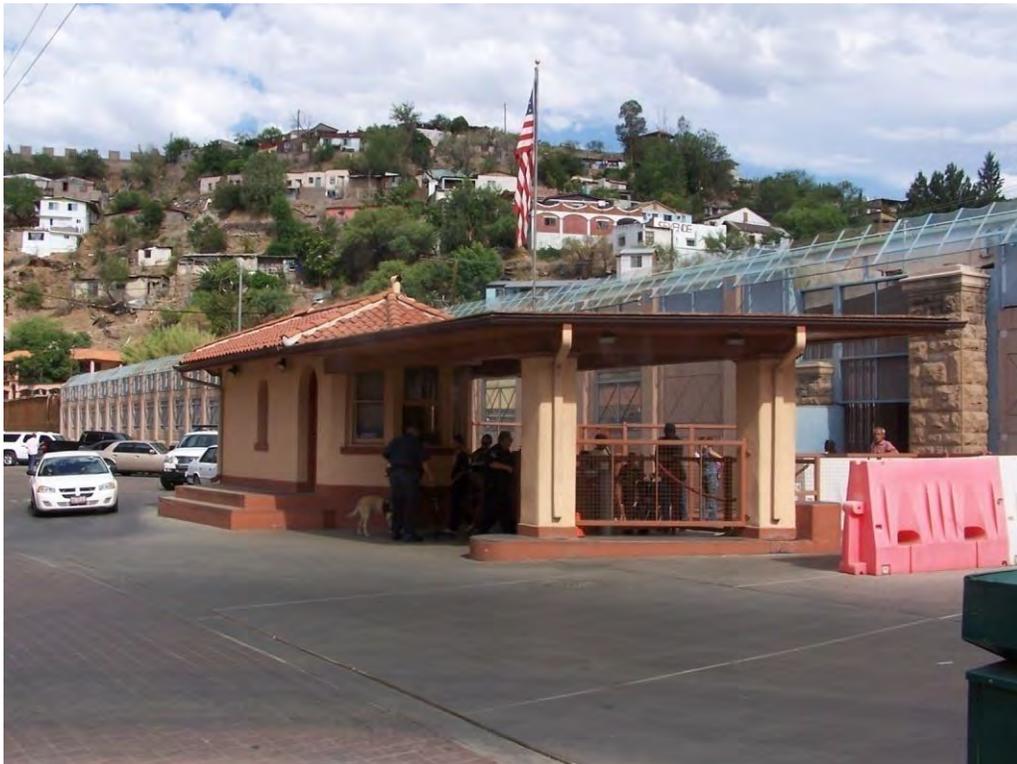
Photo number: AZ\_SantaCruzCounty\_BorderStation1.tiff

Description of view: Morley Gate, north and west elevations, view southeast.

Morley Gate is a 1-story, rectangular plan, stucco clad inspection kiosk featuring a Spanish tile clad, low-pitched, hipped roof with wide overhanging eaves. An affixed, flat roofed one-lane porte-cochere is a dominant feature of the resource, and covers a floor area equal to that of the building itself. The building is oriented to the west, with its width-ends as the front and rear elevations and its length as the side elevations.

The arched entry to the Morley Gate office is located at the north side of the building. At this same elevation is an arched check-in window that is underscored with a concrete sill. Both the entry and this window are deeply recessed into the wall. The west-facing front of the kiosk is chamfered, and features a band of three 1/1 double hung windows. These windows face the area within the porte-cochere, and share a continuous sill and a single set of window surrounds. The east-rear side features a pair of vertical 1/1 double hung windows with round headers. A course of wood base molding runs across the building beneath these windows and directly above a set wrap-around concrete stairs that run along the length at either side of the building.

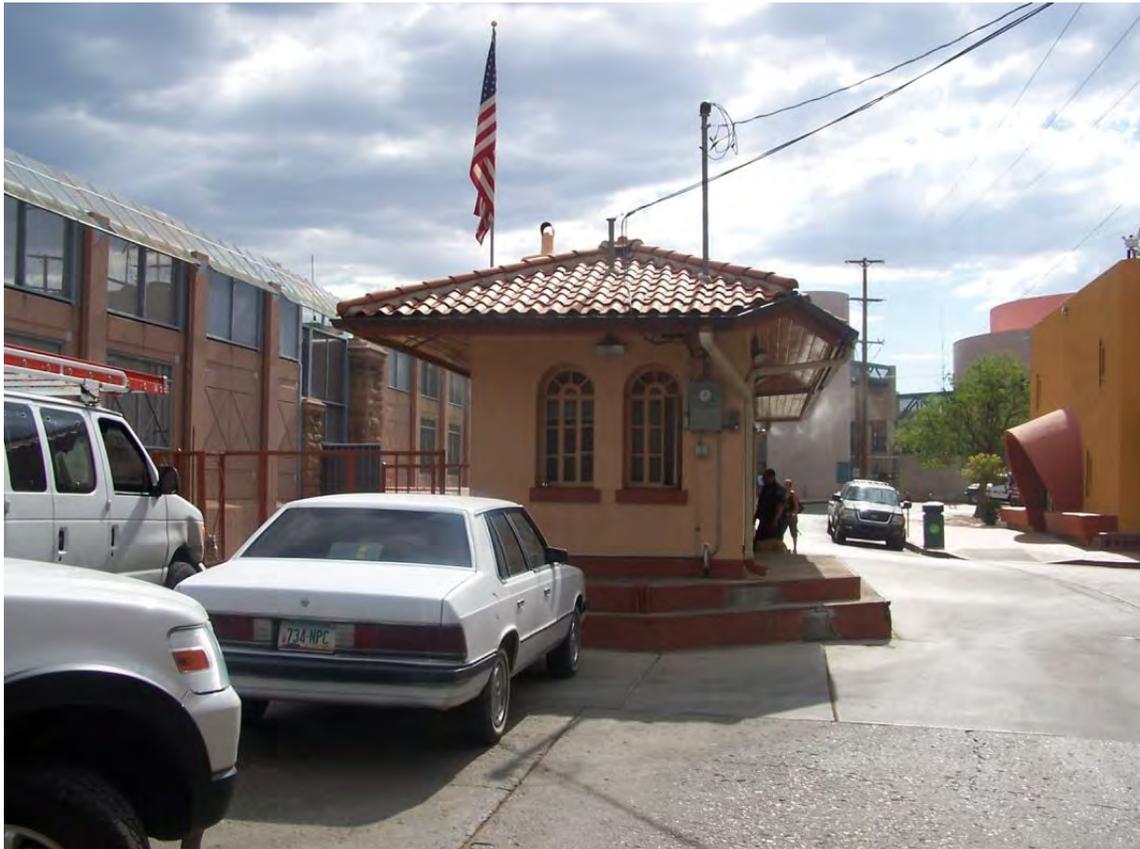
U.S. Inspection Office—Morley Gate  
Santa Cruz County, Arizona  
Photographer: Elizabeth Weaver, ICF Jones & Stokes  
Date of photograph: June 17, 2008  
Negative: GSA  
Description of view: Morley Gate, east elevation, view west.  
Photo number: AZ\_SantaCruzCounty\_BorderStation2.tiff

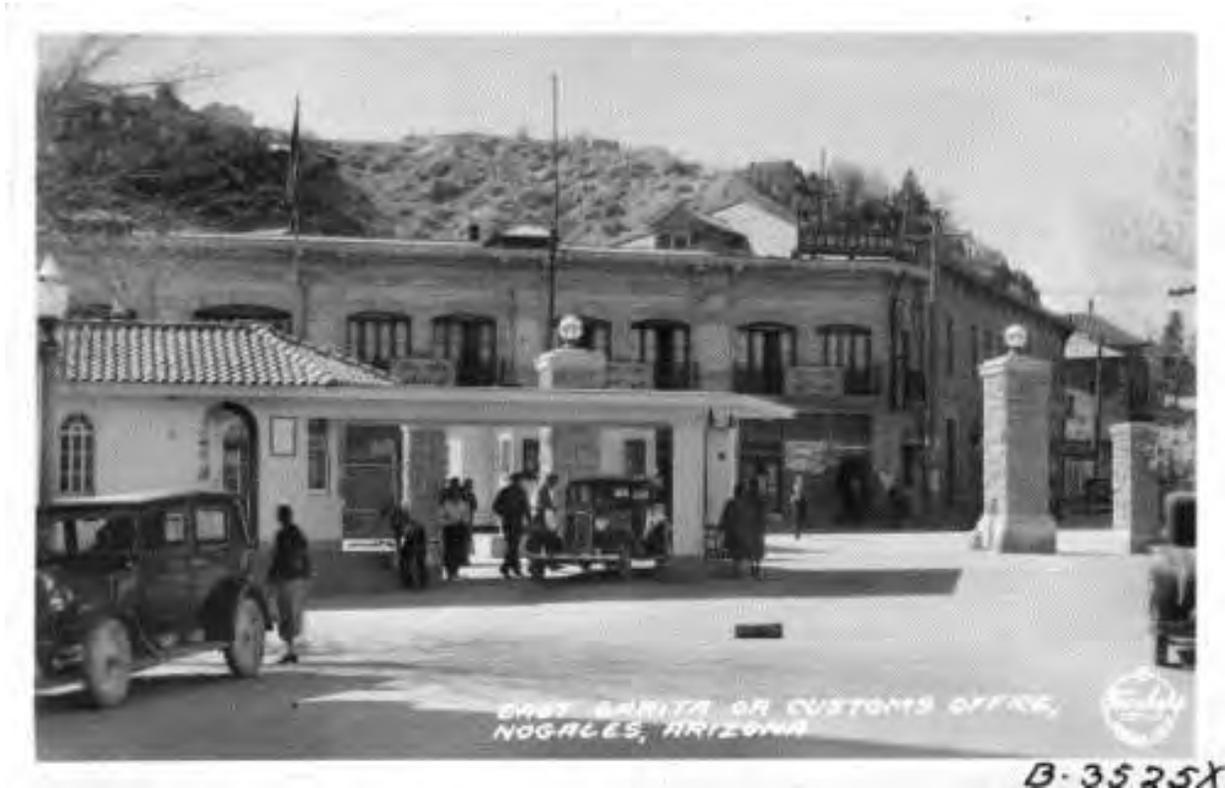
U.S. Inspection Office—Morley Gate  
Santa Cruz County, Arizona  
Photographer: Fisher  
Date of photograph: 1936  
Negative: Pomona Public Library  
Description of view: East Garita (Morley Gate)

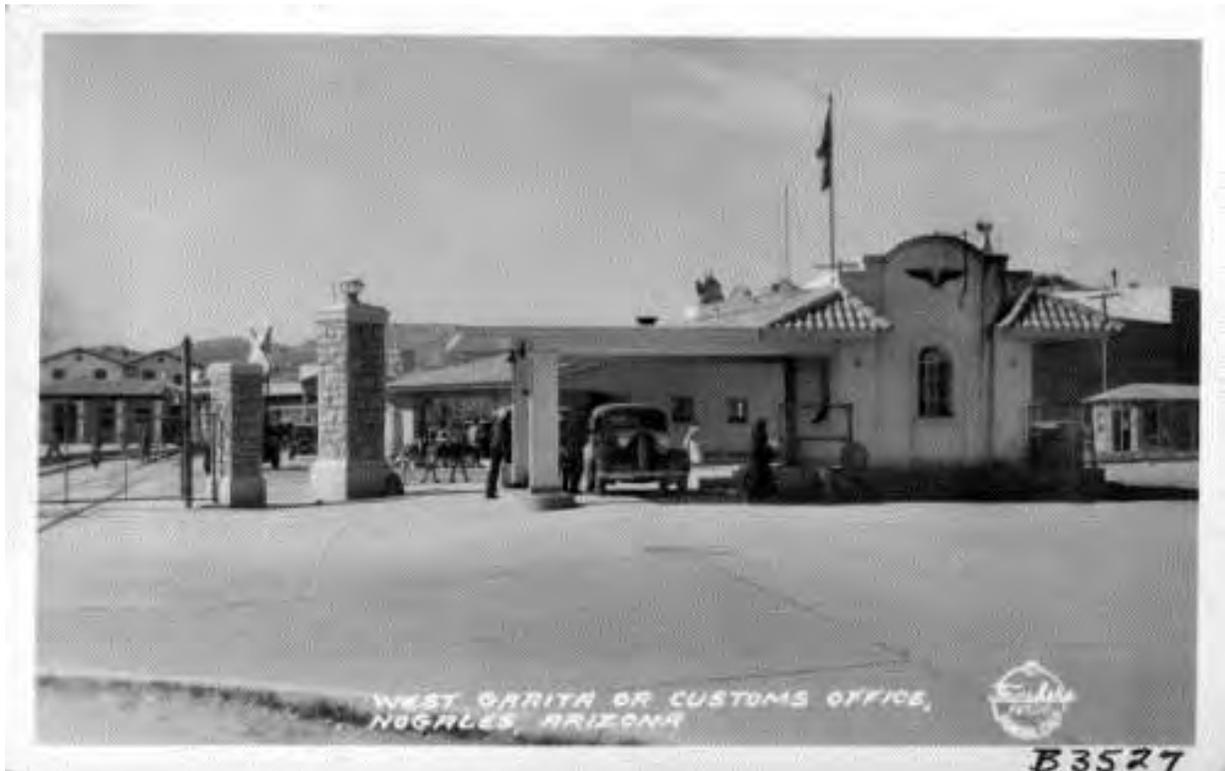
U.S. Inspection Office—Morley Gate  
Santa Cruz County, Arizona  
Photographer: Fisher  
Date of photograph: n.d.  
Negative: Pomona Public Library  
Description of view: West Garita (West Gate, demolished)
