Frog Creek Cabin
Property Name

Yosemite National Park MPS
Multiple Name

National Register of Historic Places Registration Form

historic name Frog Creek Cabin
other names/site number Frog Creek Egg-collecting Station, Lake Eleanor Egg-Collecting Station
Yosemite National Park Building No.MA2300

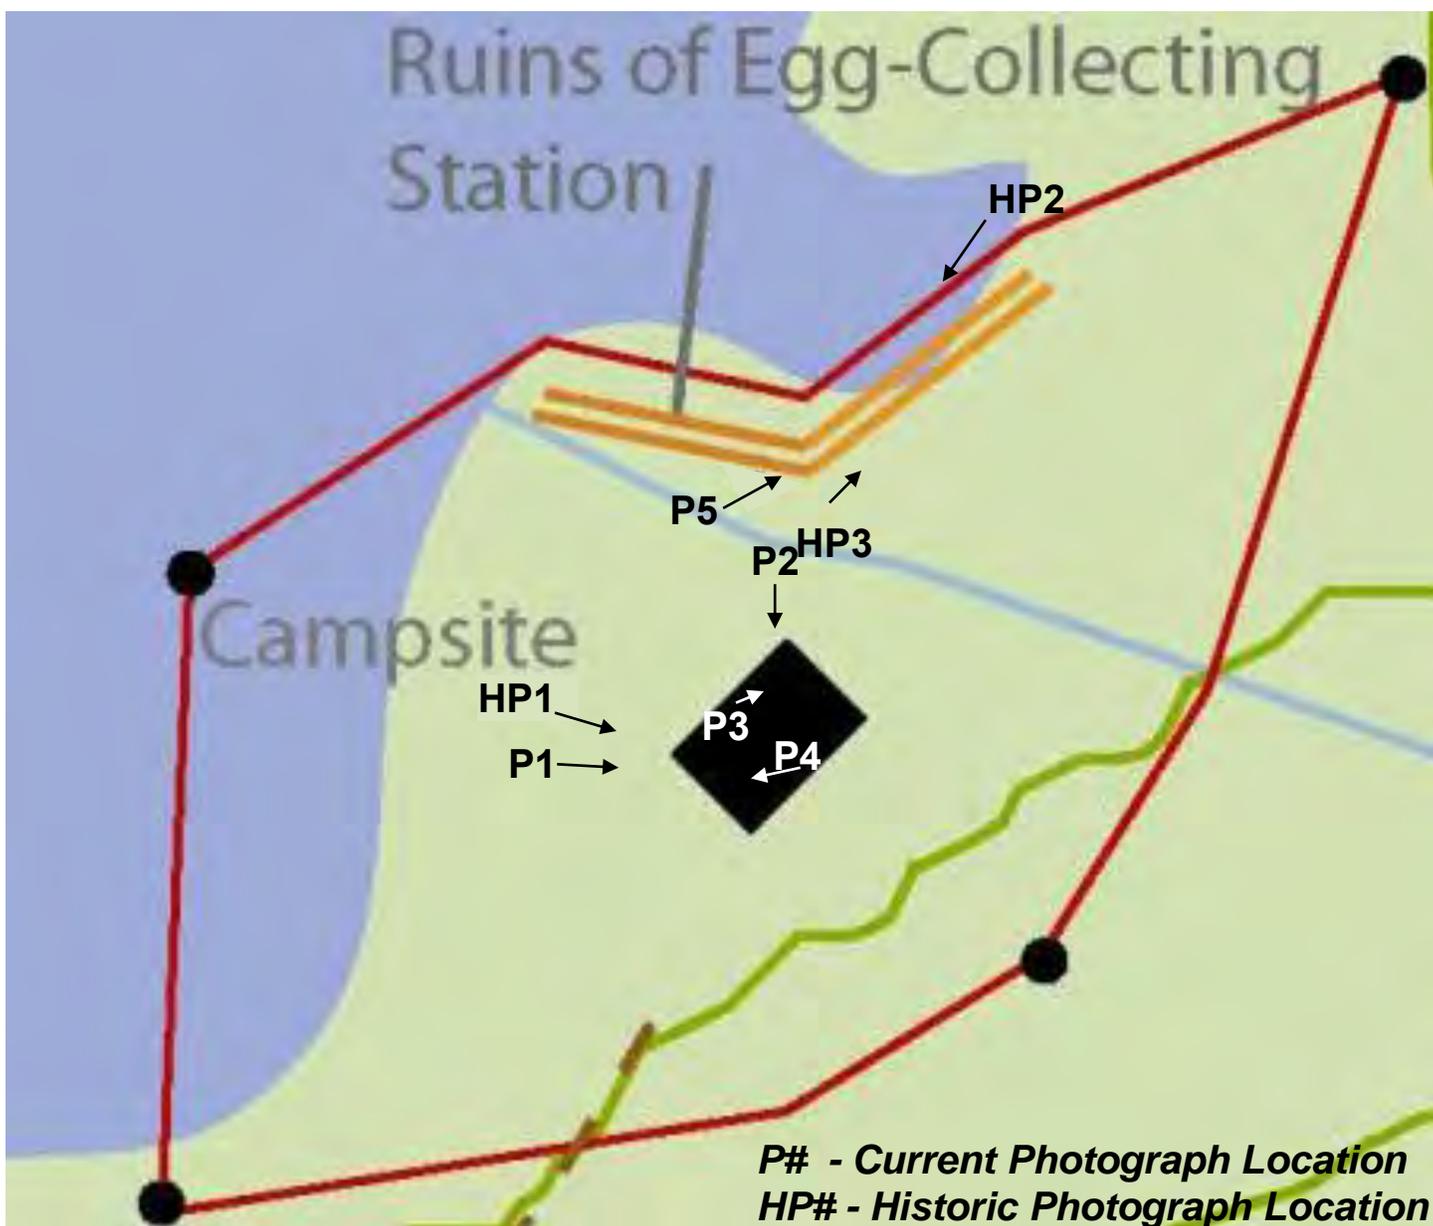
Reference map showing the approximate location of each photograph taken. Information pertaining to each individual photograph can be found below in the “Photograph Index” section.

P# - Current Photograph Location
HP# - Historic Photograph Location

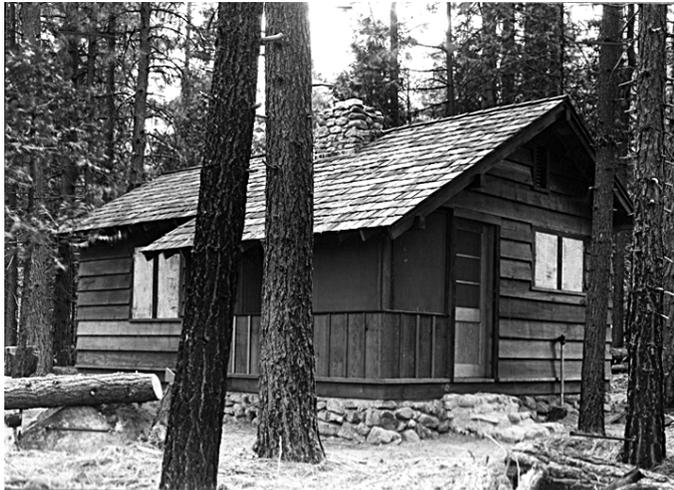
Historic Photo 1

Frog Creek Cabin shortly after construction. This photo is the same image seen on the Oct.1936 Monthly Report. Photographer: unknown. Date Photographed: October, 1936.

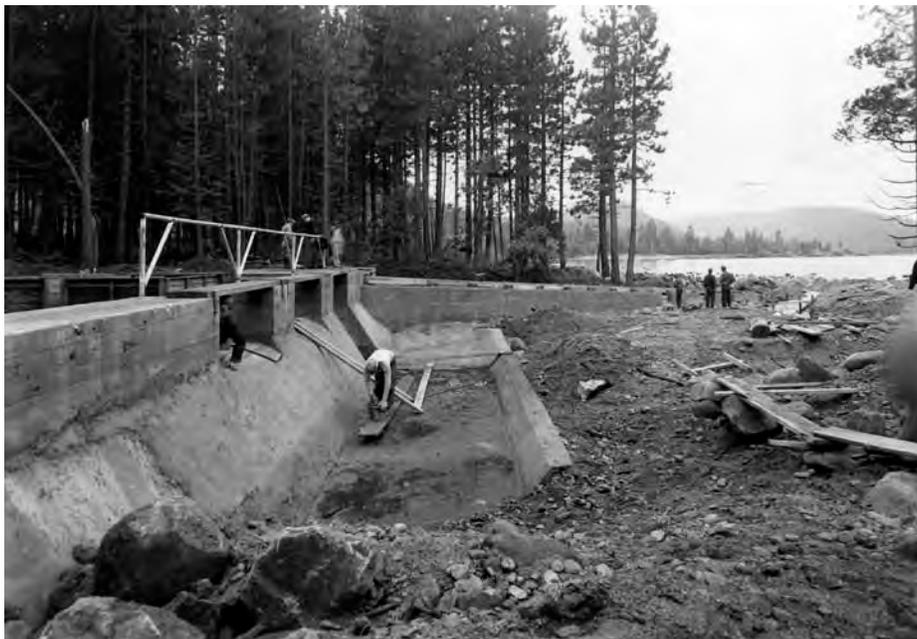
Historic Photo 2

Construction photograph of egg-collecting station in the south fork of Frog Creek, facing southwest.

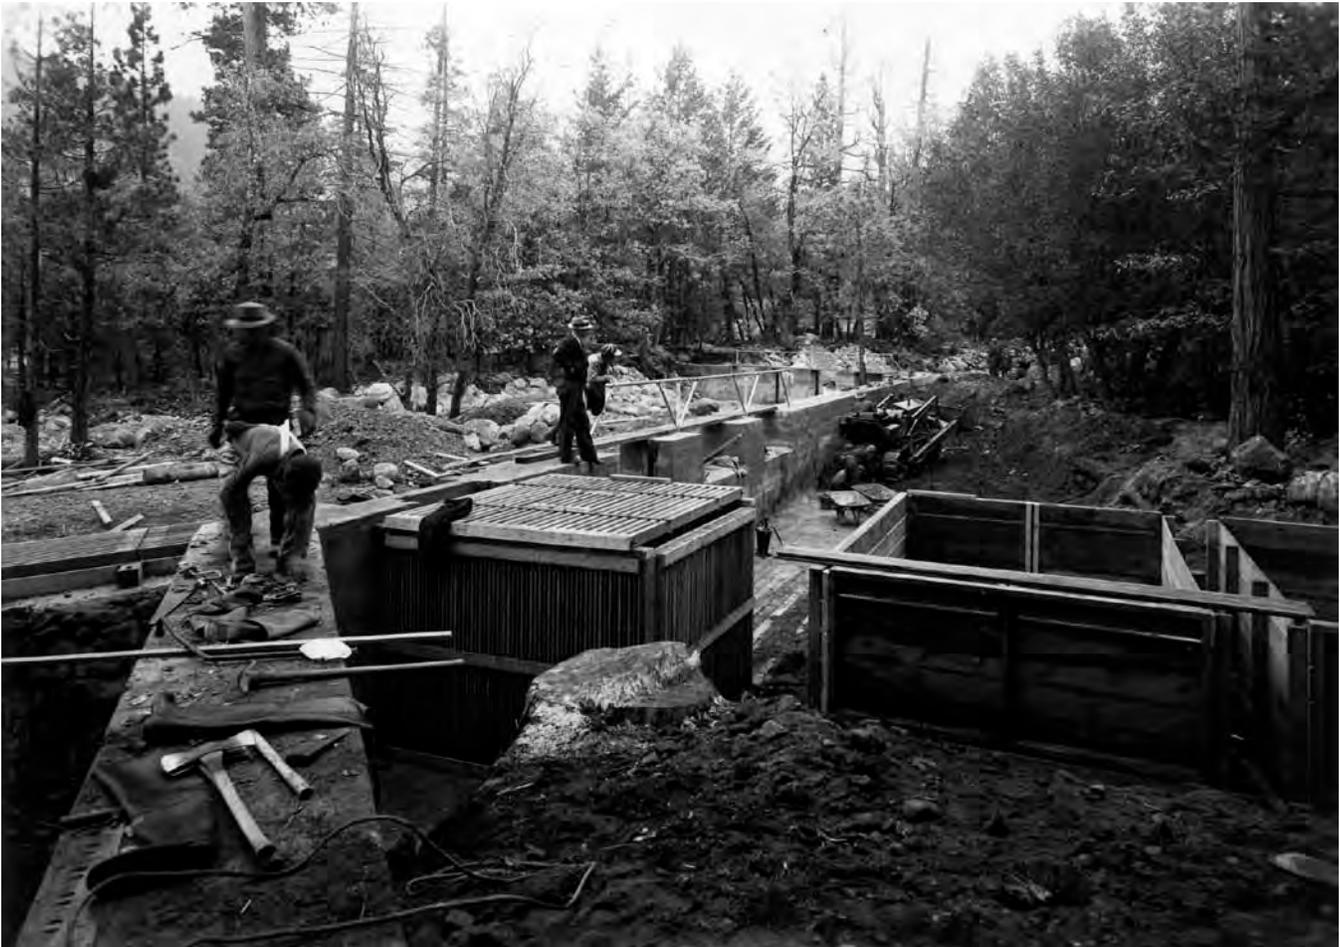
Historic Photo 3

Construction photograph of egg-collecting station at Frog Creek, facing northeast.
