Lake Vernon Snow Survey Shelter  
Property Name

# National Register of Historic Places Registration Form

historic name Lake Vernon Snow Survey Shelter  
other names/site number Lake Vernon Cabin, Lake Vernon Patrol Cabin, Yosemite National Park Building No. MA2450

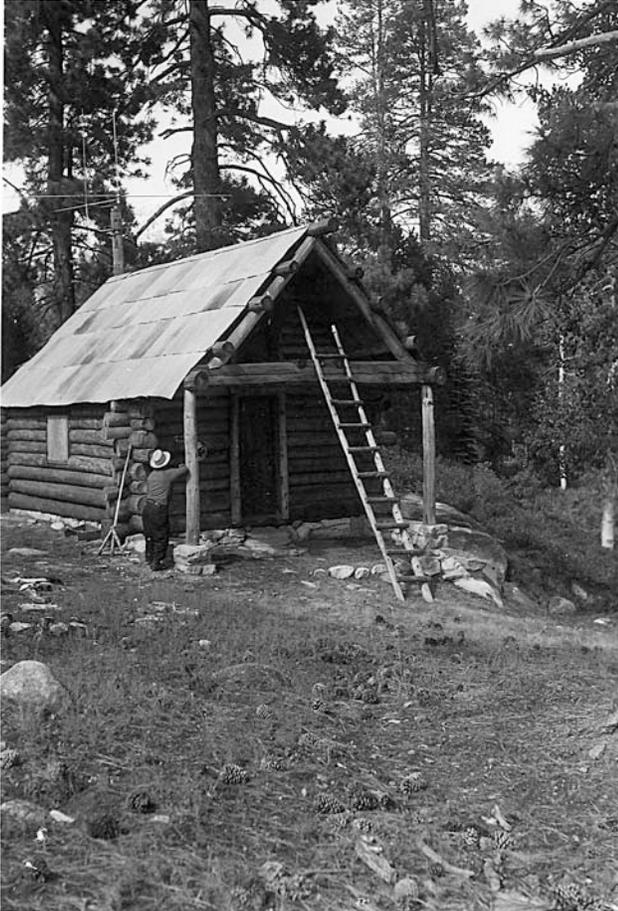
Historic Photo #1. Lake Vernon Shelter, 1952. Photographer: unknown  
Yosemite National Park, Division of Facilities Management  
Building Files, Folder "Lake Vernon Cabin". El Portal, CA.

- The six-lite window located on the east elevation was replaced by a four-lite window sometime between 1986 and 2008.
- A large radio antenna was attached to the north gable end of the building by 1952 and then later removed sometime between 1964 and 1986.
