National Register of Historic Places Registration Form

Historic name U.S. Inspection Station—Trout River, New York
Other names/site number Trout River Inspection Station; Trout River Border Station

*U.S. Inspection Station— Trout River
Franklin County, New York*

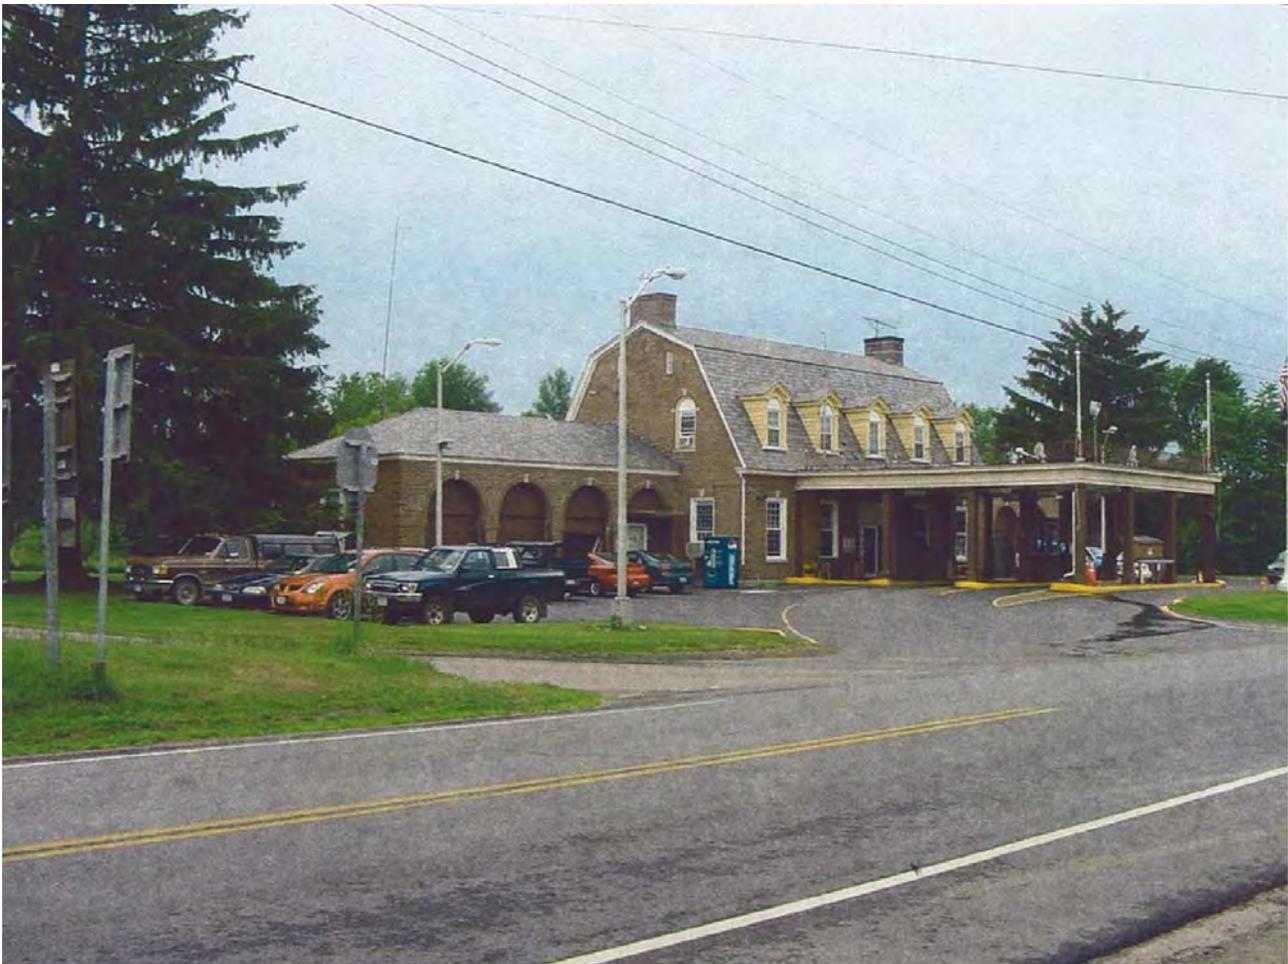
Photo number: NY_FranklinCounty_Trout RiverBorderStation1.tiff

Description of view: Front and side elevation, view: northwest

The Trout River Inspection Station is a rectangular plan, woodframe, 2-story inspection station designed in a Georgian inspired Colonial Revival design system. The 2-story center block (primary building) is side gabled with a gambrel roof, and on either side of the primary building is a one-story, 4-bay, hipped roof garage wing. Both wings and the primary building are clad in English bond brickwork and have roofs covered with green and purple slate tiles. A flat roofed porte-cochere that covers three bays is affixed to the front elevation of the inspection station. The front elevation of the inspection station faces northeast, and the total building program runs axially from northwest to southeast.

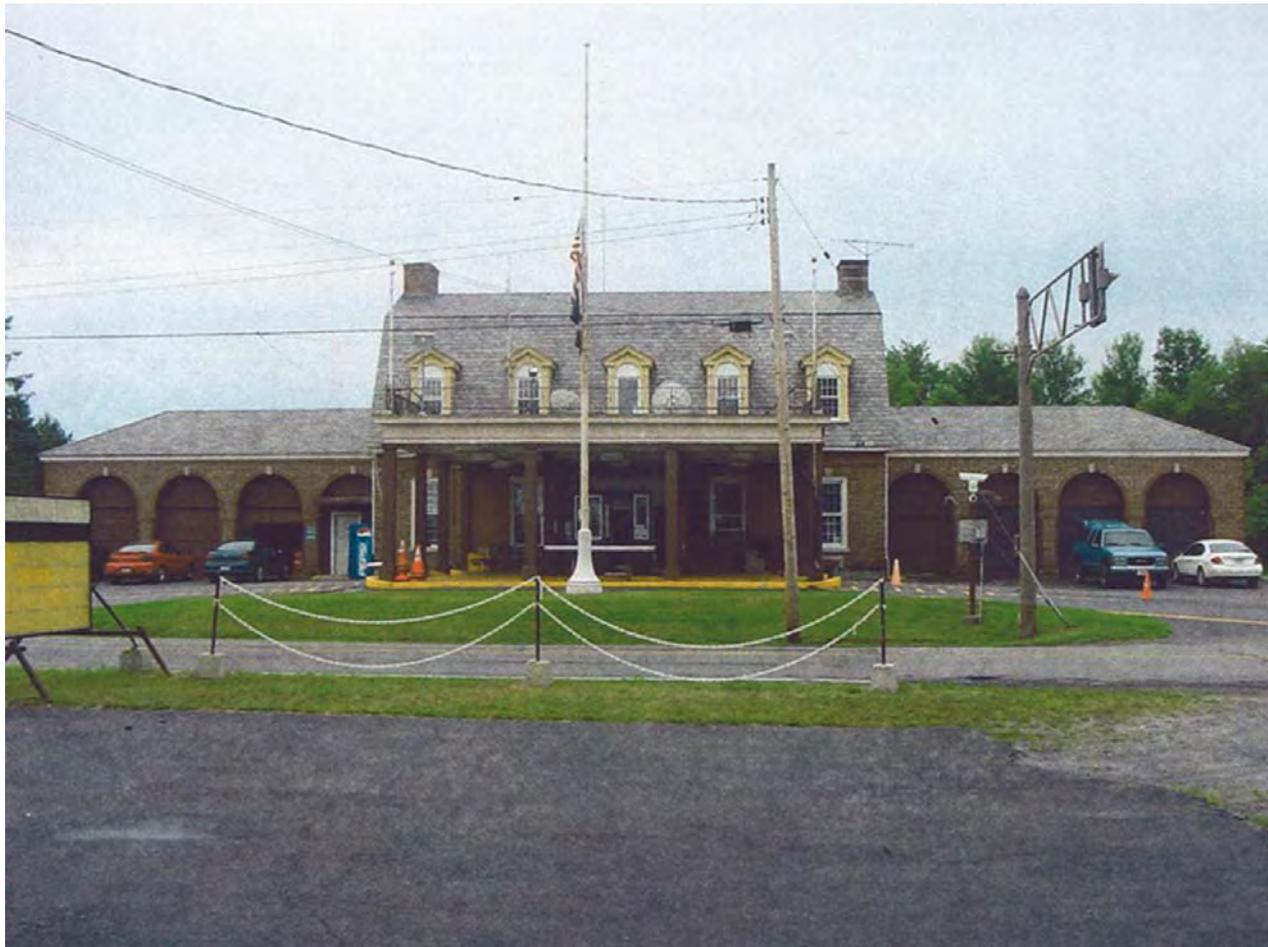
Photo number: NY_FranklinCounty_Trout RiverBorderStation2.tiff

Description of view: Front elevation, view: southwest

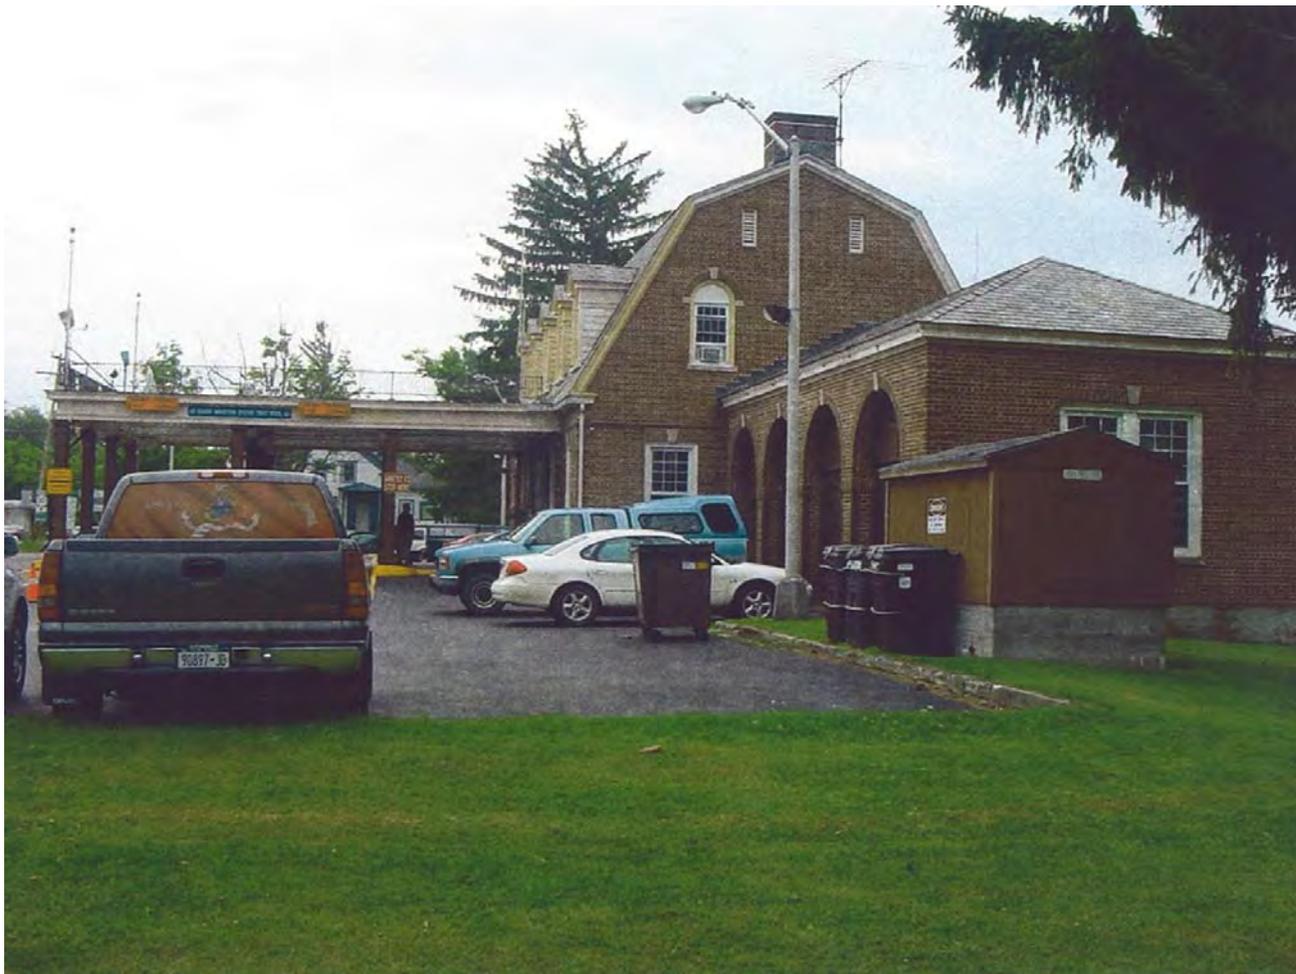
Photo number: NY_FranklinCounty_Trout RiverBorderStation3.tiff

Description of view: Side elevation, view: southeast

The front portion of each lower level side elevation features a woodframe multi-glazed double hung window. The rear portions of the Inspection Station's lower level side elevations are connected to the garage wings. Stepped copper flashing is present above where the roof of the garage wing meets the side elevation. In the upper front portion of the primary building's side elevations is an 8/8 woodframe double hung window topped by a latticed pattern lunette window head identical to those found in the dormers. The lunette portion is circumscribed in a soldier course voussoir with a marble keystone centered above it and smaller marble blocks at either spring end. Beneath the gable peak at each side elevation of the primary building are thin, vertical attic vents, each underscored with brick sills and crowned with flat arch work. Ogee style cornice molding underscores the gambrel roofline at each gable end. Below this are molded cornice returns that continue from the front and rear elevation molding.

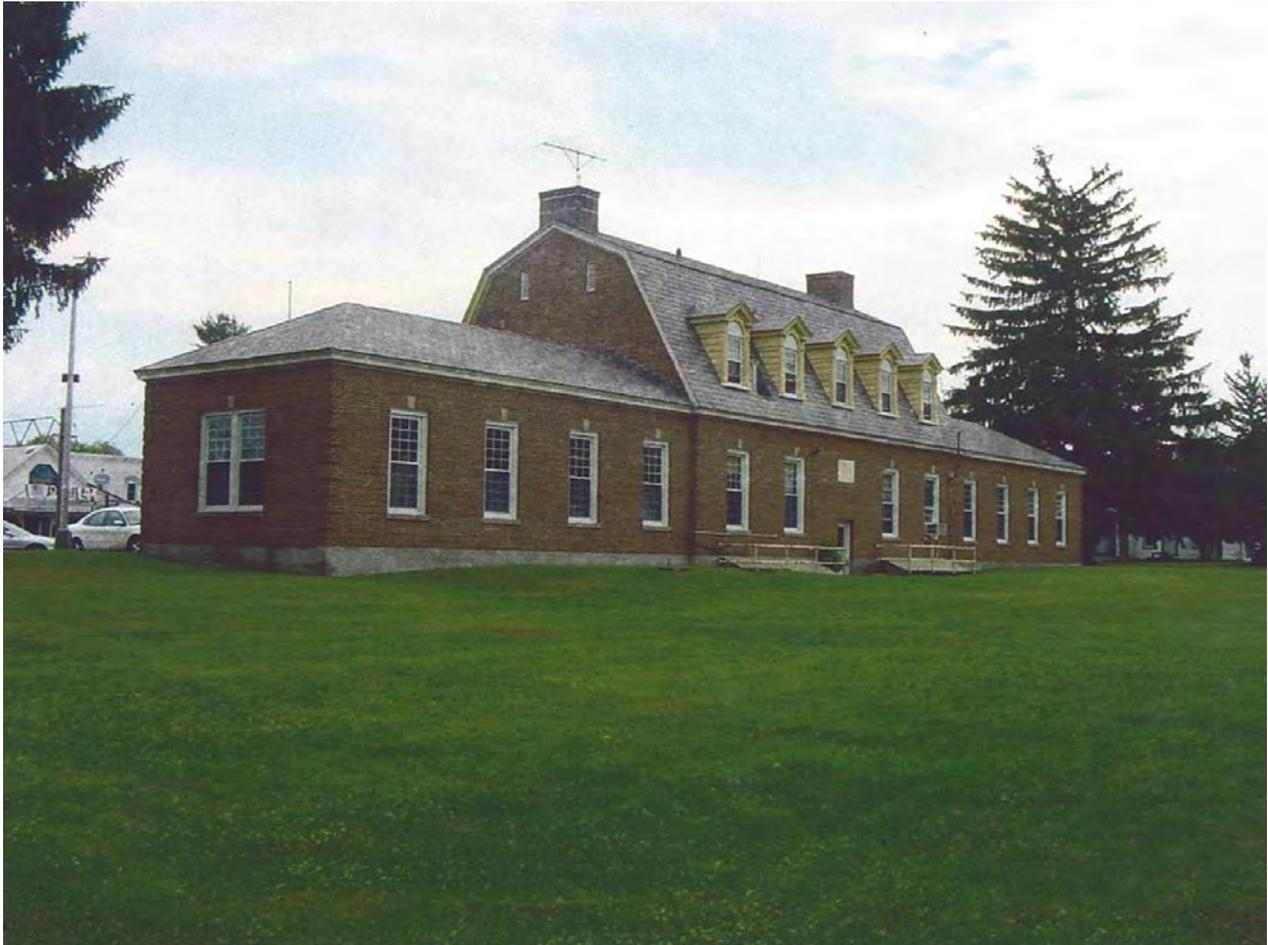
Photo number: NY_FranklinCounty_Trout RiverBorderStation4.tiff

Description of view: Rear elevation, view: southeast

The rear elevation of the Trout River Inspection Station primary building is five bays wide. A low, concrete watertable/foundation underscores the rear elevation of the primary building and the garage wings. The center bay of the rear elevation features a square marble slab about 2'x2' situated flush with the upper ranking of the adjacent window bays. In the two bays at either side of the center are 12/12 woodframe double hung windows accentuated in a manner similar to those at the front elevation. A centered basement entry is present at the rear elevation, and features a wood door with single unit upper panel glazing. Pipe railing runs parallel to the building at either side and above this entry. Basement access covers are also present on the ground at either side of the rear entry. The rear elevation roof contains five dormers of an identical design to those described atop the front elevation. A small dormer with a 1/1 window is present between the two northernmost front gabled dormers at the rear elevation.

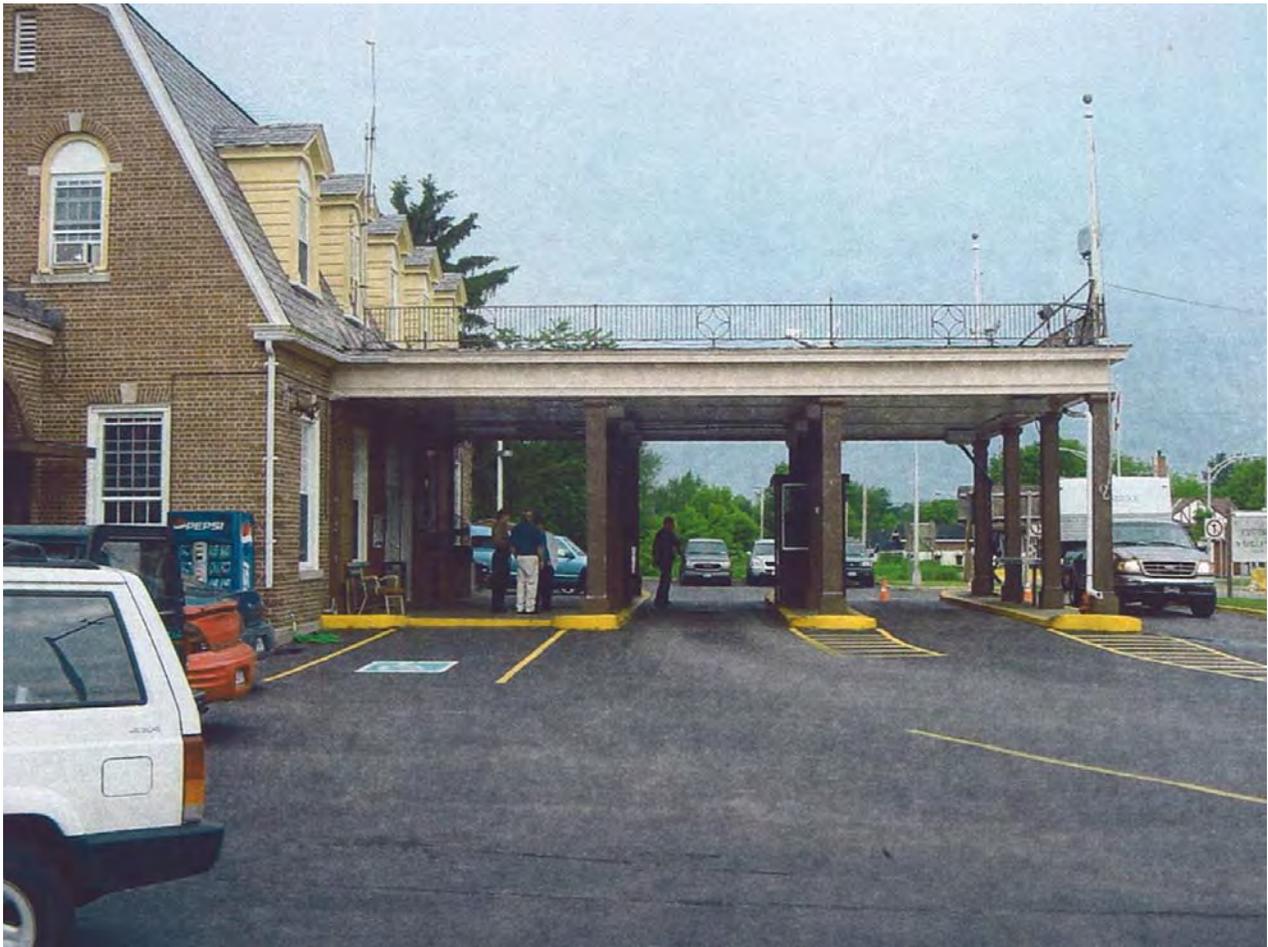
Photo number: NY_FranklinCounty_Trout RiverBorderStation5.tiff

Description of view: Port-cochere, view: north

Affixed to the front elevation of the Trout River Inspection Station is a flat roofed porte-cochere supported by sixteen square shaped columns and covering three bays. The columns and the porte-cochere roof are painted gold-yellow. Each of the columns features a square shaped capital. All of the columns rest on elevated concrete islands with rounded curbing. The four columns closest to the front elevation are engaged. Oversized cornice ogee cornice molding and a running fascia underscore the roof of the porte-cochere. Running atop the edge of the roof is a metal balustrade with a repeating concave diamond-in-circle motif. A short flag pole topped by a balloon finial is present at

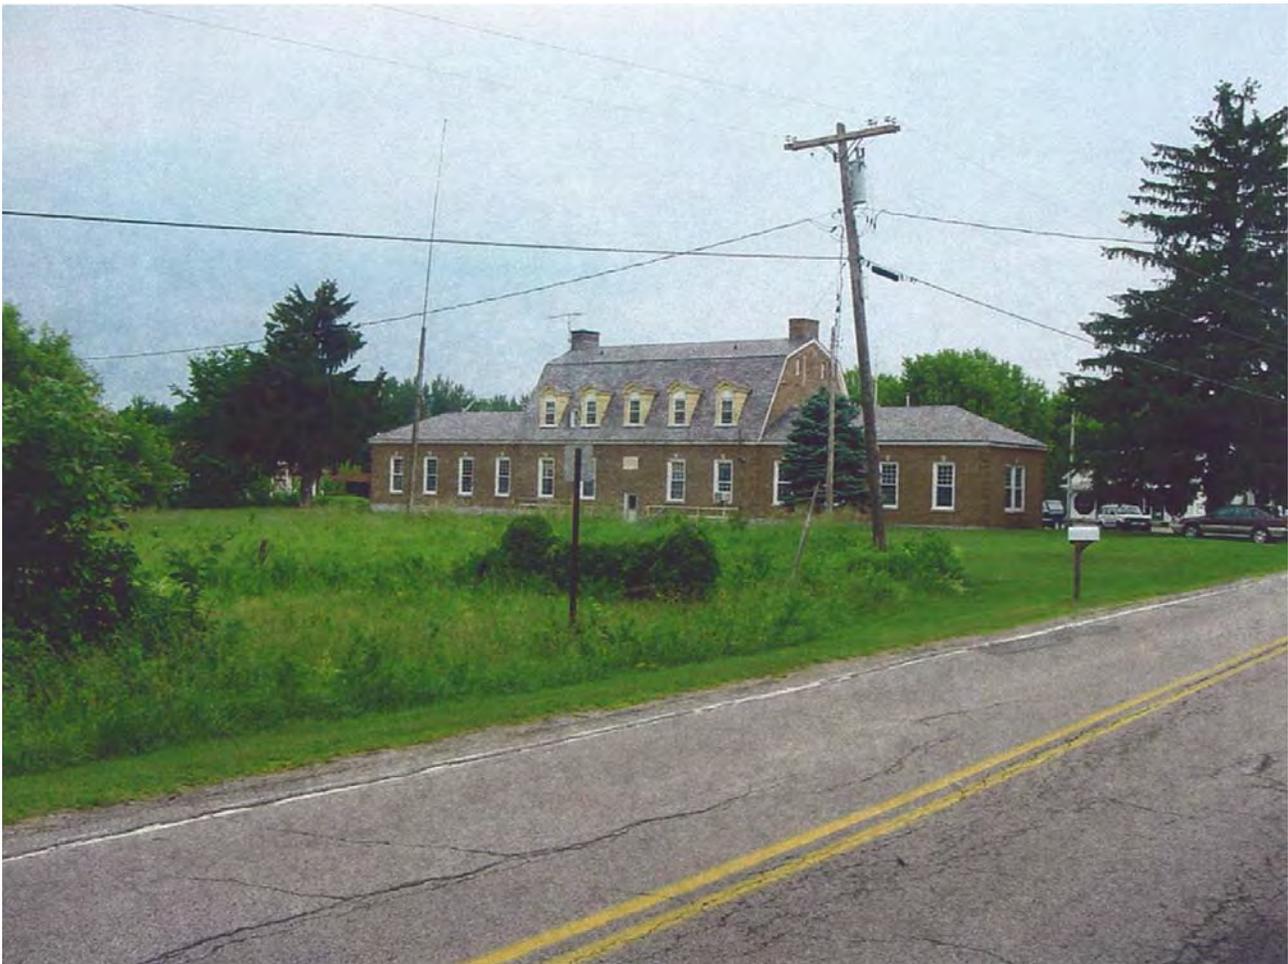
Photo number: NY_FranklinCounty_Trout RiverBorderStation6.tiff

Description of view: Rear yard and rear elevation, view: northeast
