National Register of Historic Places Registration Form

Historic name: East Rockford Historic District (Additional Documentation, Boundary Expansion)

City or town: Rockford State: IL County: Winnebago

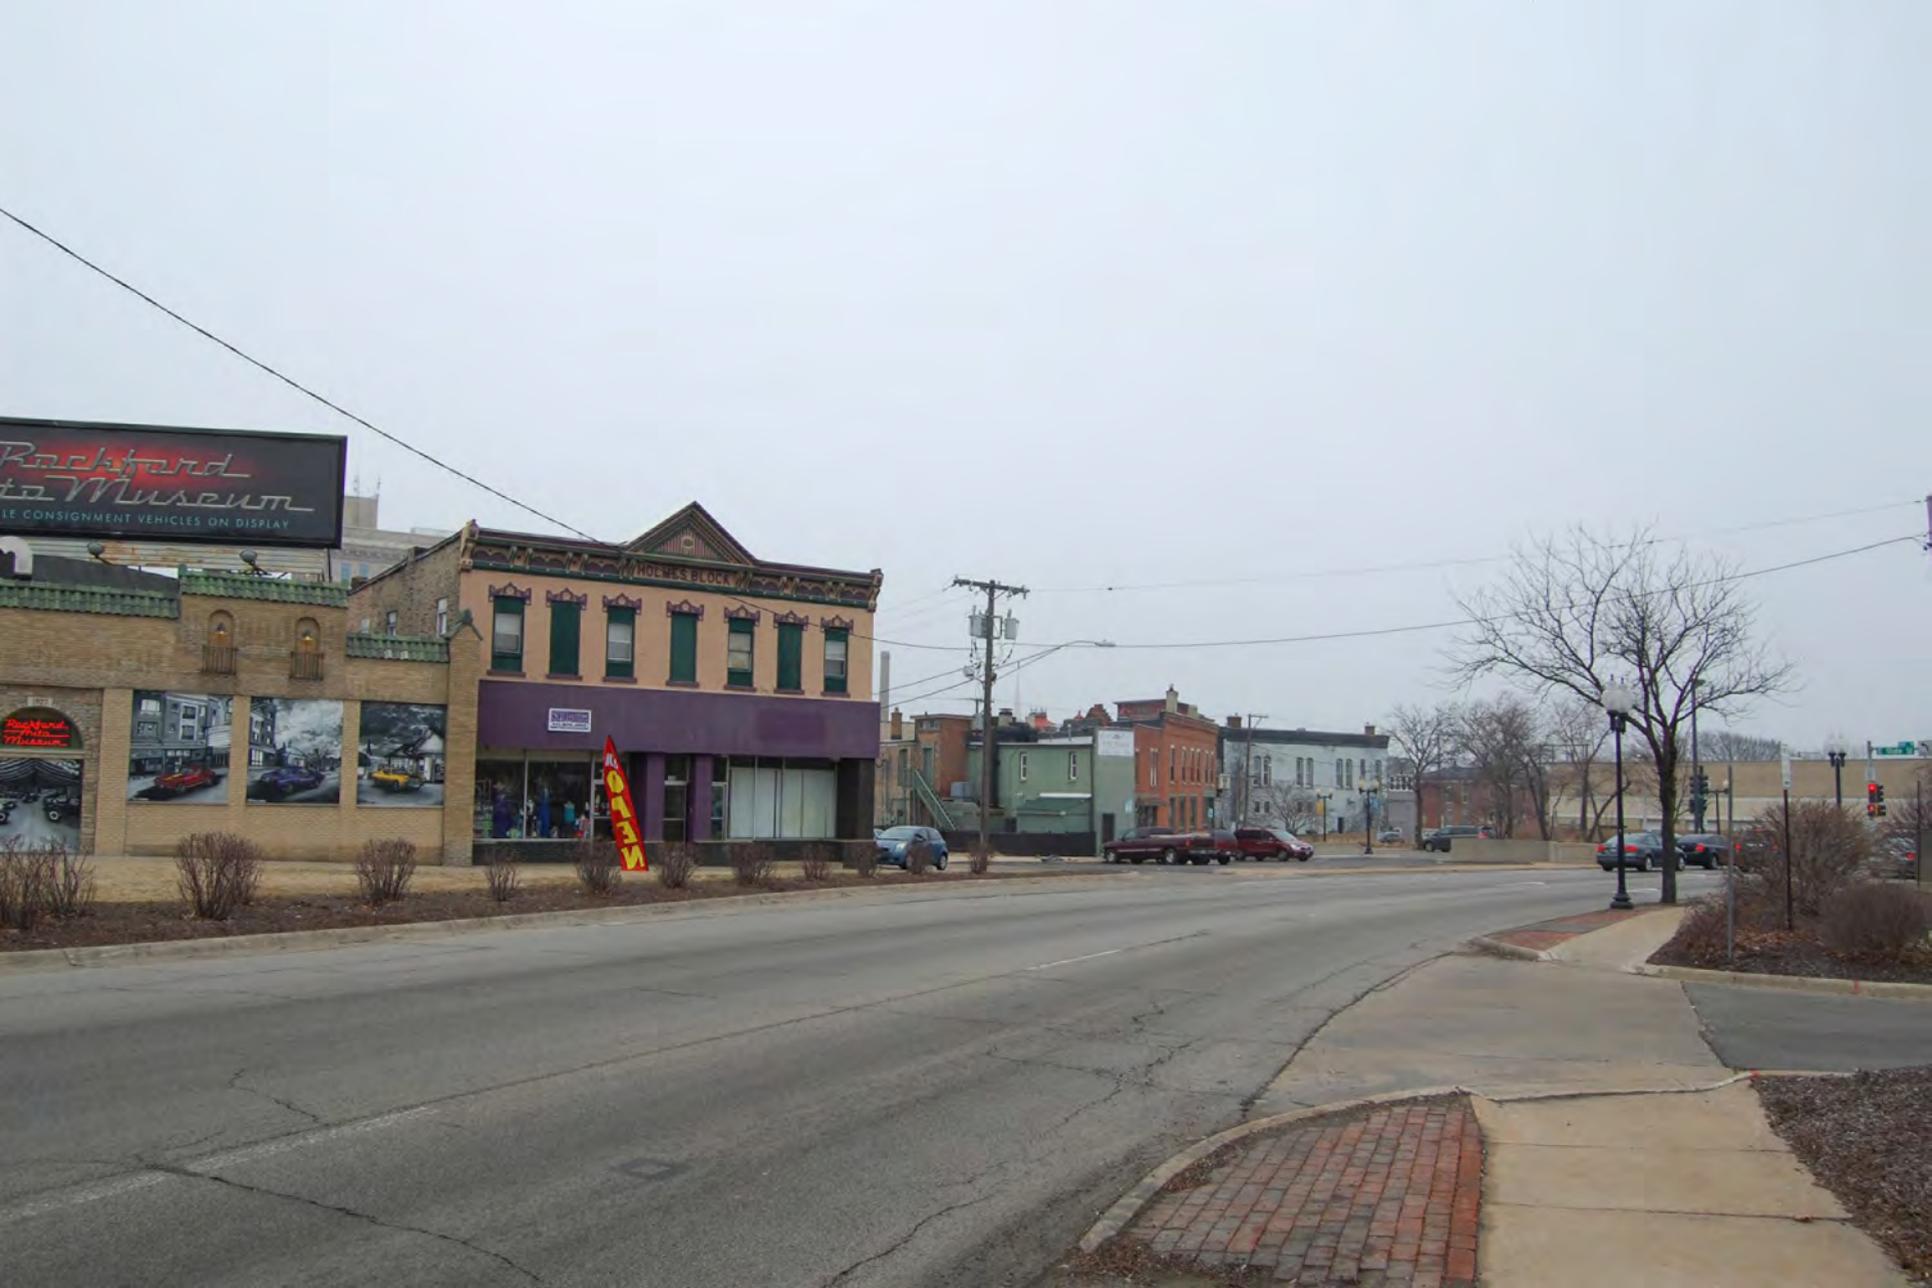
A three-story brick building with a purple storefront. The top story has five windows with green shutters. A sign above the entrance reads 'HOLMES BLOCK'. A 'SALE' sign is visible in the window. A 'SPRING' sign is also present.
