Historic name U.S. Border Inspection Stations

Combined Customs and Immigration Inspection at Land Crossings along the International Borders, 1930-1943

### ***E. Statement of Historic Context***

#### **Combined Customs and Immigration Inspection at Land Crossings along the International Borders, 1930-1943**

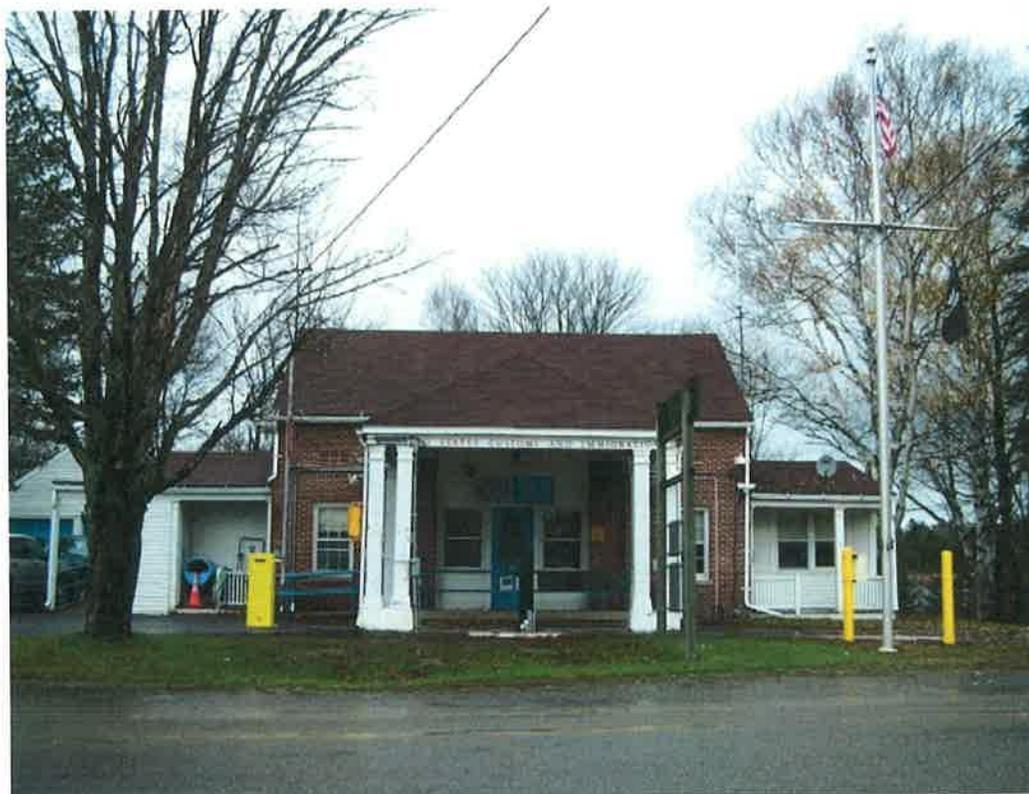
*Figure 1: Example of Property Type Number 1 at Orient, ME.*

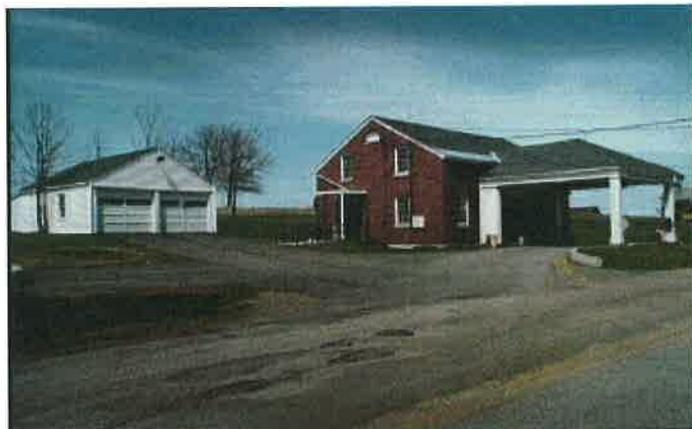
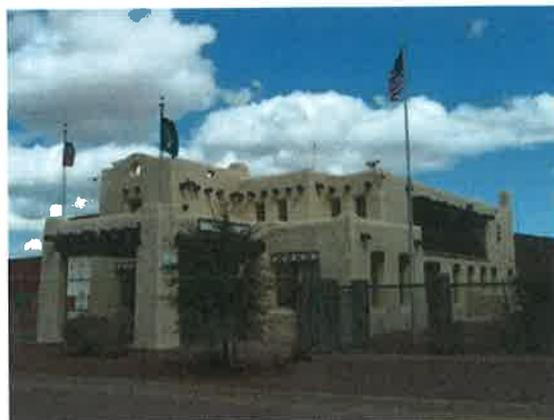
*Figures 2a and 2b: Examples of Property Type No. 1 at Alburg Springs, VT (left) and Naco, AZ (right)*

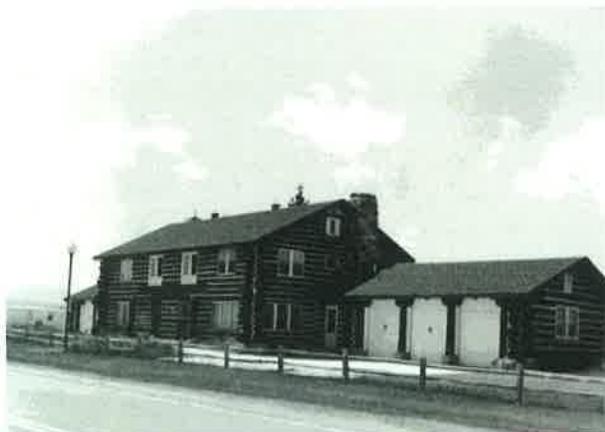
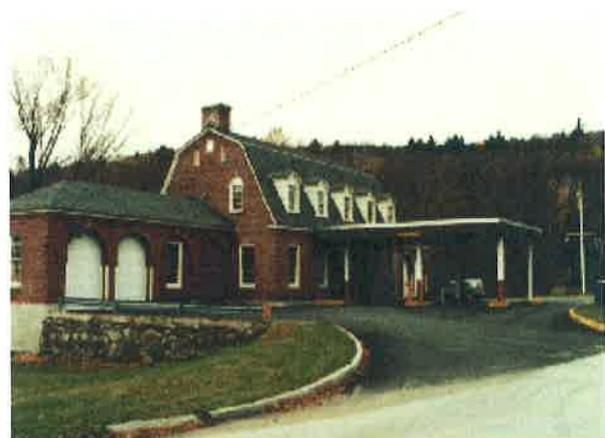
Figures 3a and 3b: Examples of Property Type No. 2, Babb-Piegan, MT (left), and East Richford, VT (right).

- Tecate, CA. **NRHP listed, 2/14/1992.** 1 ½-story, 5-bay, detached residences, Spanish Colonial Revival style.
- Babb Piegan, MT. **NRHP Listed 4/12/2006.** The Babb-Piegan station is a 2-story Rustic Log Cabin design, with a 4-bay main building (deviation from typical five) and 3-bay garage wings.
- Sweetgrass, MT (not on GSA list because it was moved and is no longer under federal ownership.)<sup>46</sup>
- San Luis, AZ (not on GSA list.) This was a full 2-story height with side gables and 3- and 4-bay garage wings.
- Douglas, AZ. 5-bay, 2-story Spanish Colonial Revival style station with 4-bay garage wings, no separate residences.
- Newport, VT (not on GSA list.) Only 3-bays, but full 2-stories in height with front gable, Colonial Revival style.

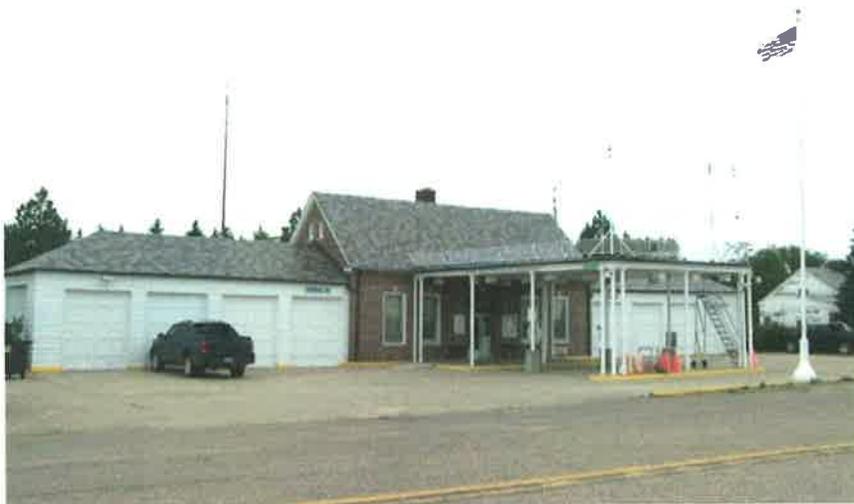
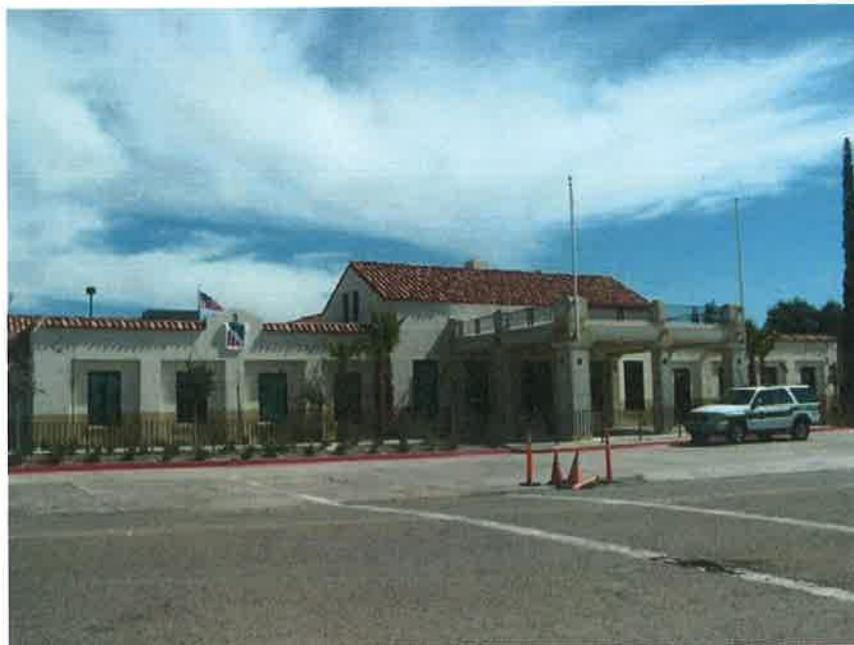
*Figures 4a and 4b: Examples of Property Type No. 2, Ambrose, ND (top) and Tecate, CA (bottom)*

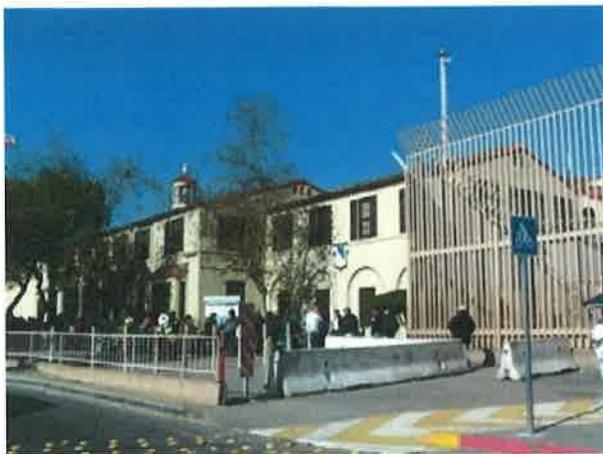
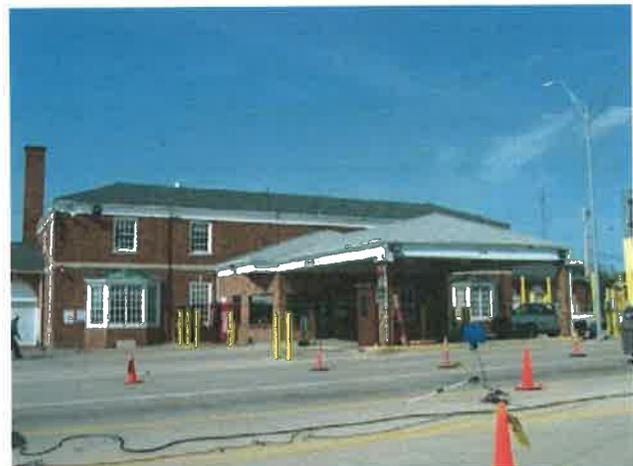
Figure 5a and 5b: Examples of Property Type No. 3, San Ysidro, CA (left) and Portal, ND (right)
