PROPERTY NAME: Hall, Rev. Plummer T., House

**REQUEST FOR NATIONAL PARK SERVICE PRIOR APPROVAL OF THE  
PROPOSED NEW LOCATION OF THE REVEREND PLUMMER T. HALL HOUSE,  
814 OBERLIN ROAD, RALEIGH, NORTH CAROLINA**

**PLUMMER T. HALL HOUSE: NEW LOCATION ARCHAEOLOGICAL ASSESSMENT  
RALEIGH, WAKE COUNTY, NORTH CAROLINA**

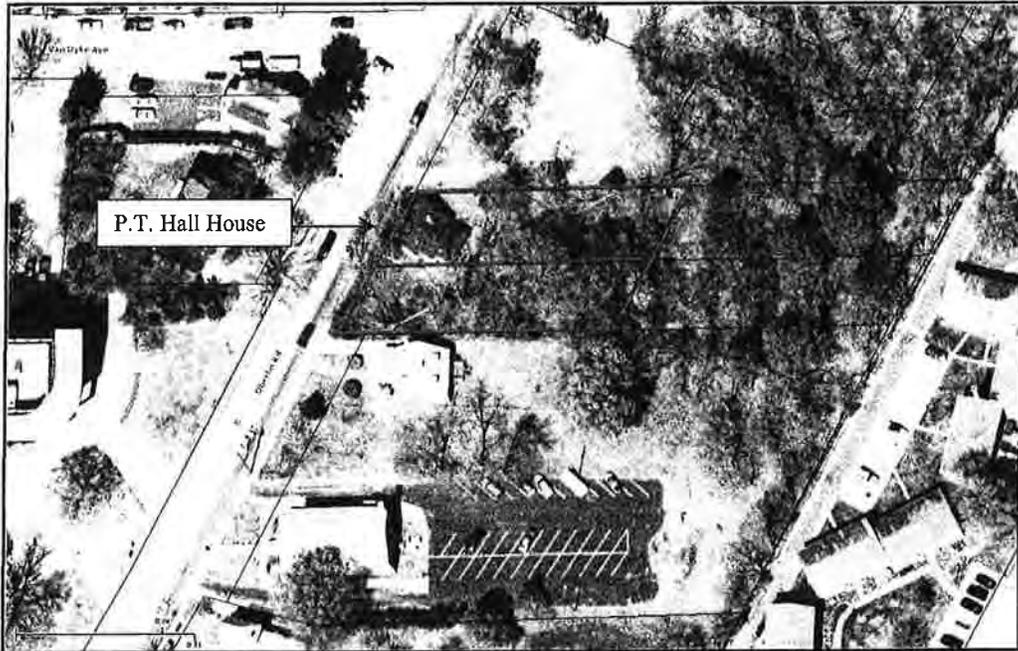
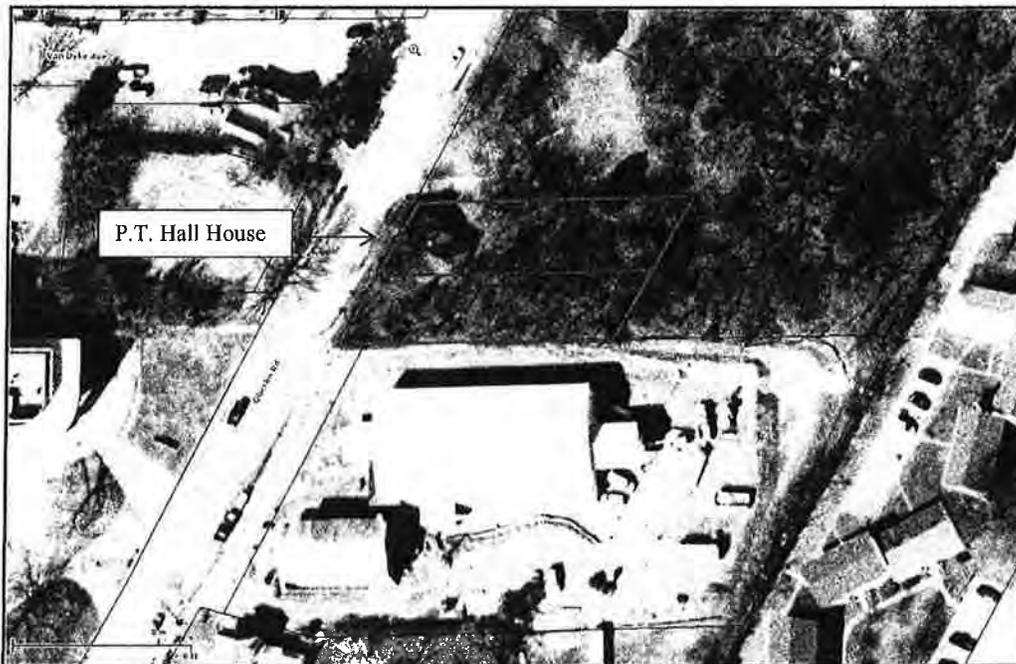
**Figures 10–12** show aerial views of the property from 2002 to 2007. Although no significant changes to the Plummer T. Hall house were noted during this time, the dwellings on either side of the house were demolished and a new church was constructed adjacent to the c. 1955 Oberlin Baptist Church. According to the National Register nomination form, former occupant Ms. Jackson recalled only one outbuilding on the property (a privy); however, the nomination form cited a 1989 local designation report that mentioned two standing metal shed roof outbuildings were located on the property at that time.

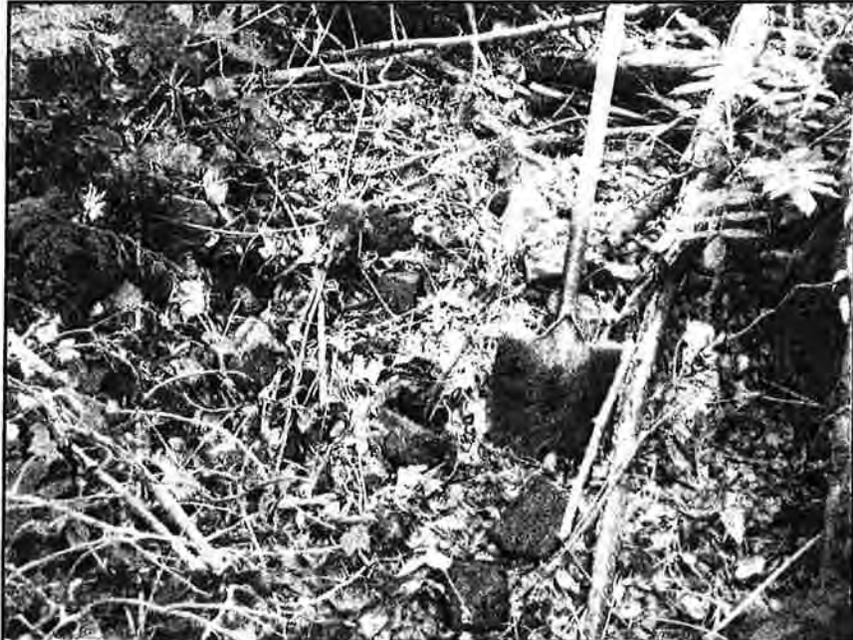
Figure 18: Brick and Concrete Rubble near ST 22.

A long outbuilding consisting of three rooms was noted on the 1914 Sanborn map. Visual inspection and shovel testing noted a small pile of cinderblocks (around ST 22), as well as some brick rubble (near ST 14). Slight elevation changes in this portion of the property appear to denote the approximate footprint of the former structure location. Based on the current plat
