National Register of Historic Places Registration Form

Historic name: St. Christopher's Episcopal Mission (additional documentation)
Other names/site number: St. Christopher's Mission to the Navajo, NRIS #02001042
Name of related multiple property listing:

Street & number: State Highway 163
City or town: Bluff State: UT County: San Juan
Not For Publication: Vicinity:

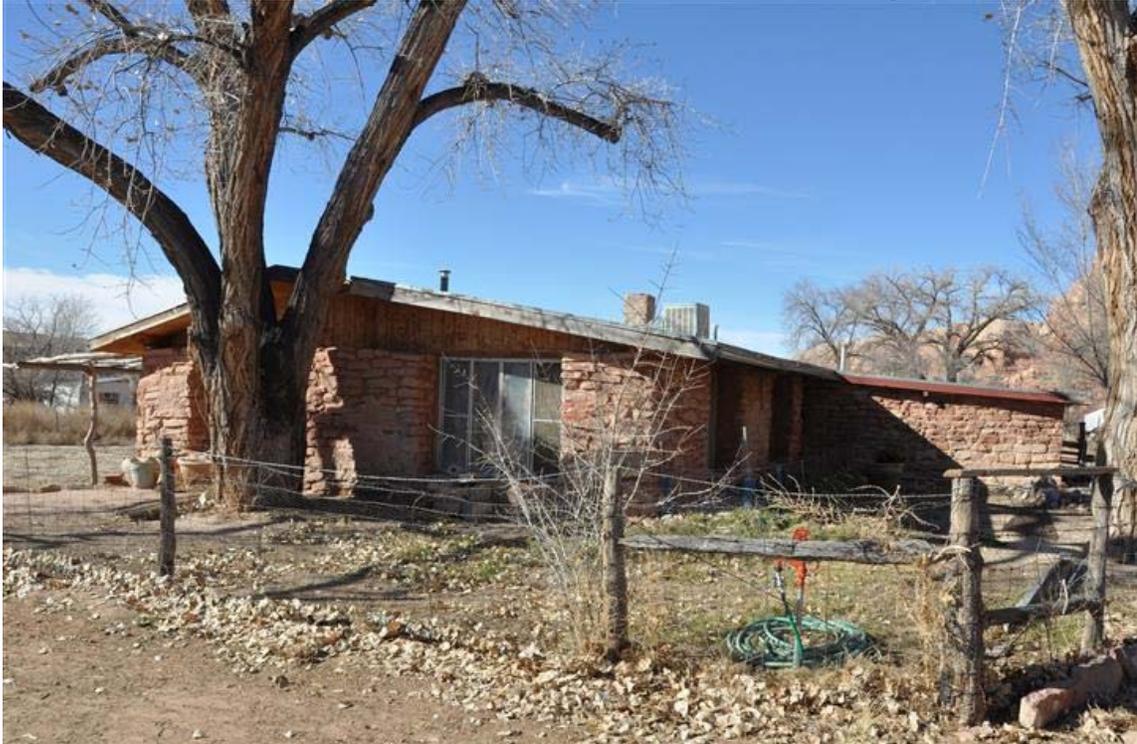
6 of 50. North and east elevations of primary residence. Camera facing southwest.

The primary residence (photos 6-8), located directly north of the hospital/clinic, was originally used as a residence for the doctor and additional staff. It was built in 1958 and is a ranch-style house with gable roof of a fairly flat pitch covered with rolled asphalt roofing. Like the other historical buildings on the complex, the unadorned mid-century modern ranch house is constructed entirely of coursed-rubble sandstone, although it does not have the arched fenestration and rustic appearance of the other stone buildings.

The south-facing primary façade has two entries. The main entrance is a single door. The other doorway, to the right and separated by a window has double doors. Both have wooden doors behind aluminum storm doors. There are three window openings on this facade. All three have a large central pane flanked by narrow double-hung windows. All have the original aluminum sash. The rear (north) façade has a projecting wing which appears to date from the original construction. Attached to the west of the wing is

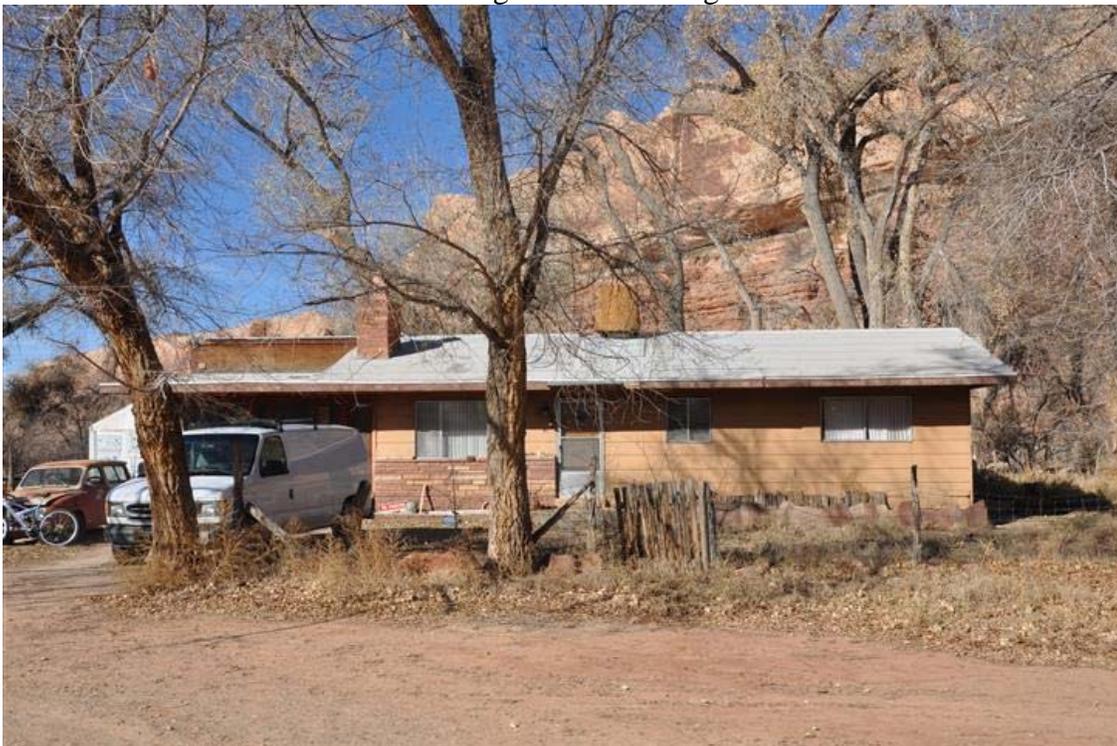
9 of 50. East elevation of rental housing. Camera facing west.

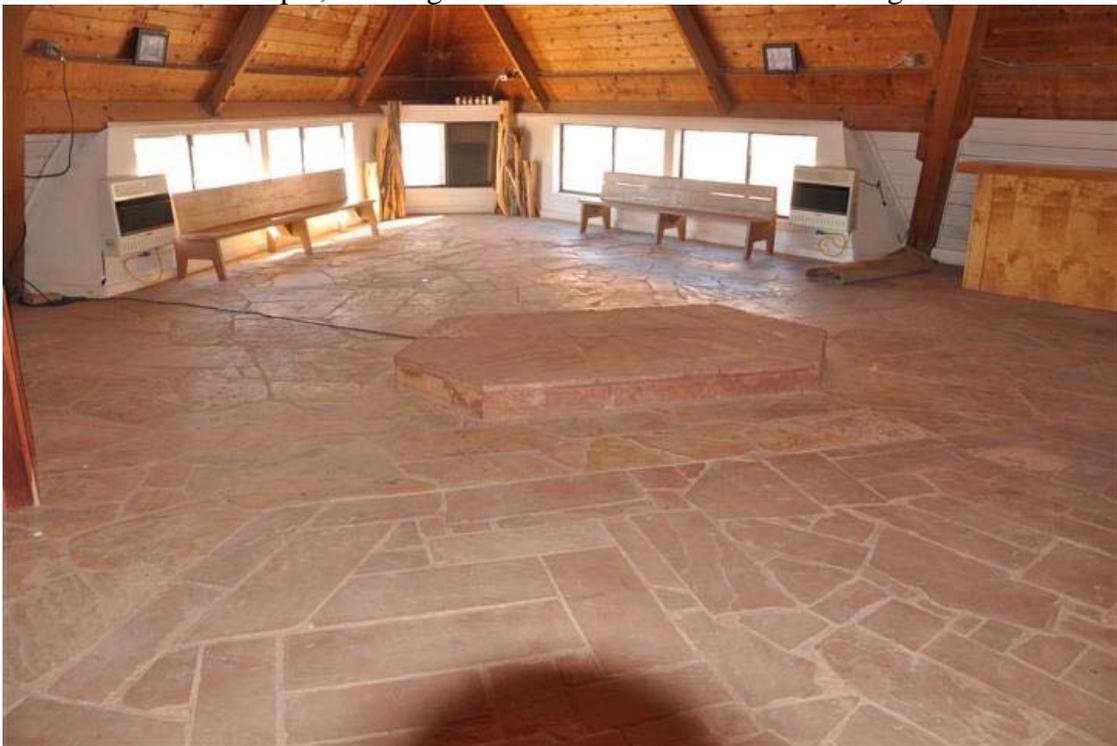
13 of 50. Interior of chapel, showing dais and stone floor. Camera facing west.

The most prominent building, situated in the center of the complex, is the summer chapel (photos 10-15). The tall, three-sided pyramidal chapel was completed c. 1968 and replaced the original log cruciform chapel that was built in 1946 and destroyed by an arson-caused fire in 1964. The building is constructed of cedar shakes and aluminum siding on the exterior. Although it is not yet fifty years old, the summer chapel is the most visible building in the mission, and is the symbolic architectural focus of the complex. The size of the building with its contemporary design and triangular plan stands as an icon, in stark contrast to the vernacular and rustic appearance of the other stone buildings in the mission.

The majority of the chapel structure is the cedar shingle-covered roof which, because of its steep pitch, also acts as the exterior and interior walls of the building. A truncated center tower, covered in aluminum siding, projects vertically from the roof approximately half-way up, and has a smaller flat-pitched hipped cap. This acts as both a light monitor, with small windows at the top, as well as a steeple, supporting a small cross. The entryways to the chapel are located on each of the three sides in projecting gable-roofed dormers. At each corner is a recessed window area with aluminum sliders. These partially extend to each side, and allow light in at the floor level. The interior is an open-plan, being a single large room, open to the ceiling, with horizontal tongue and groove wood siding covering the walls/ceiling. Movable benches are set around the interior for use during mass, and there is a small platform in the middle of the room. The entire building is supported on a raised, stepped concrete platform that extends out to form a deck/walkway around the entire building.

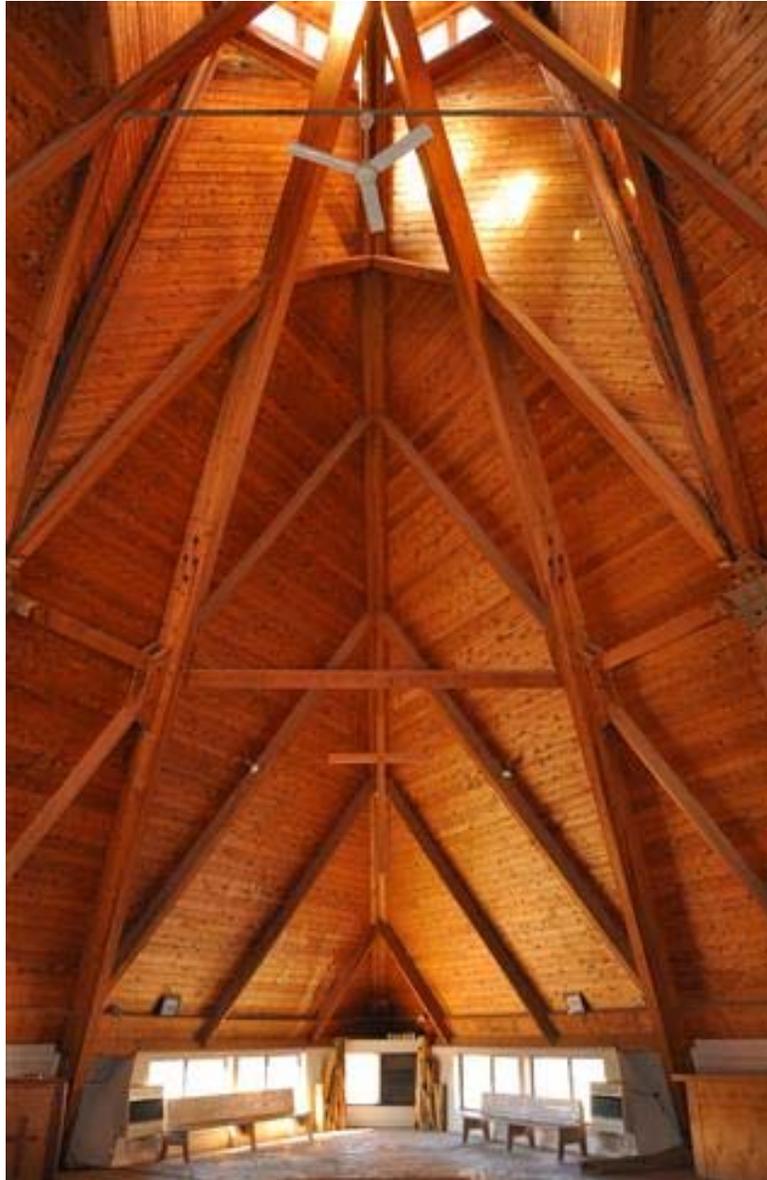
15 of 50. Interior of chapel. Camera facing west.

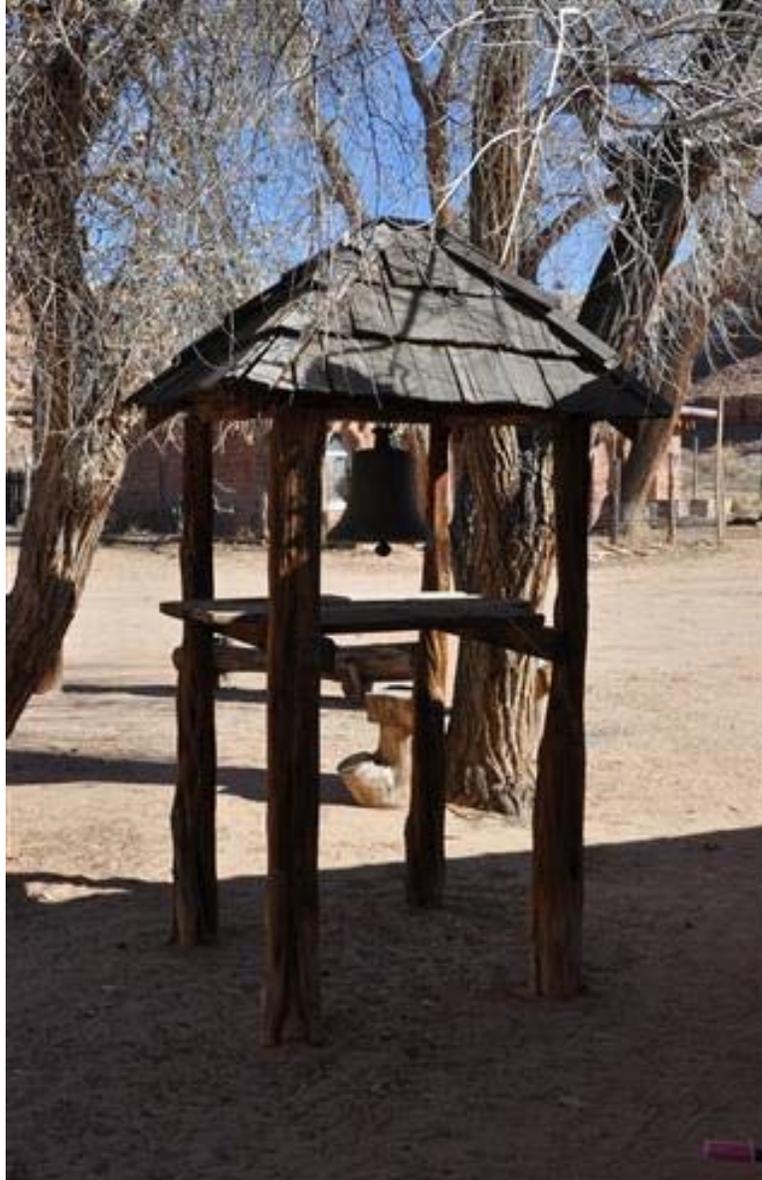
18 of 50. Southwest elevation of bell tower. Camera facing northeast.

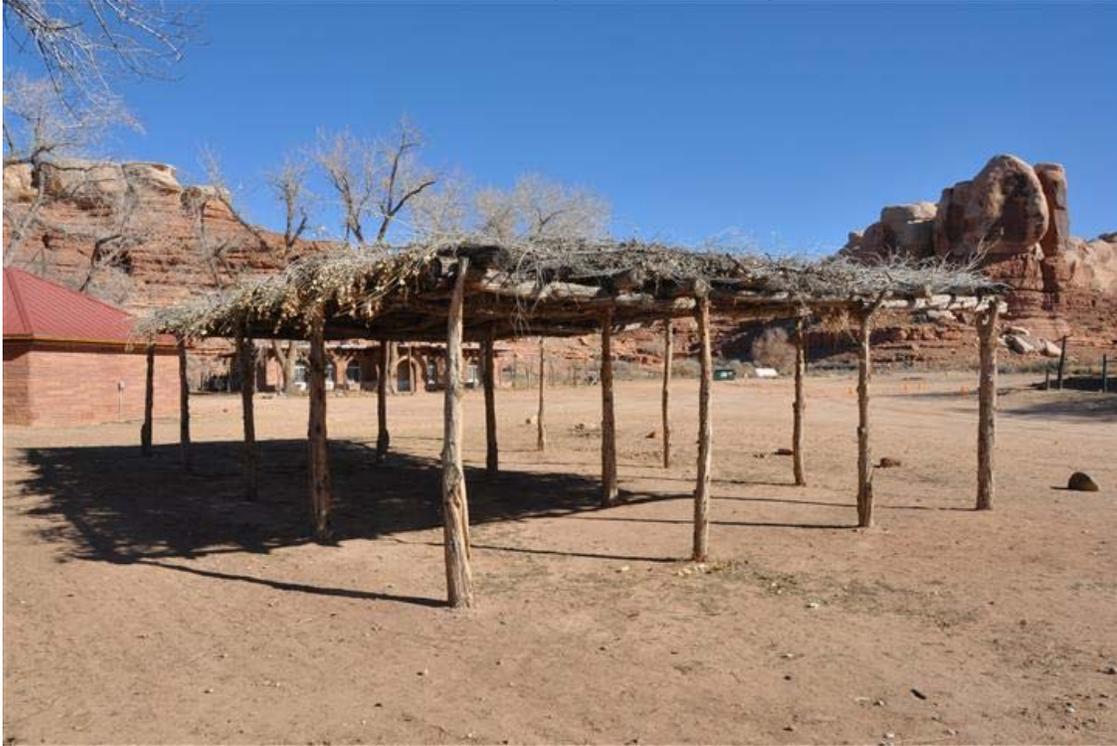
19 of 50. West and south elevations of bowery. Camera facing northeast.

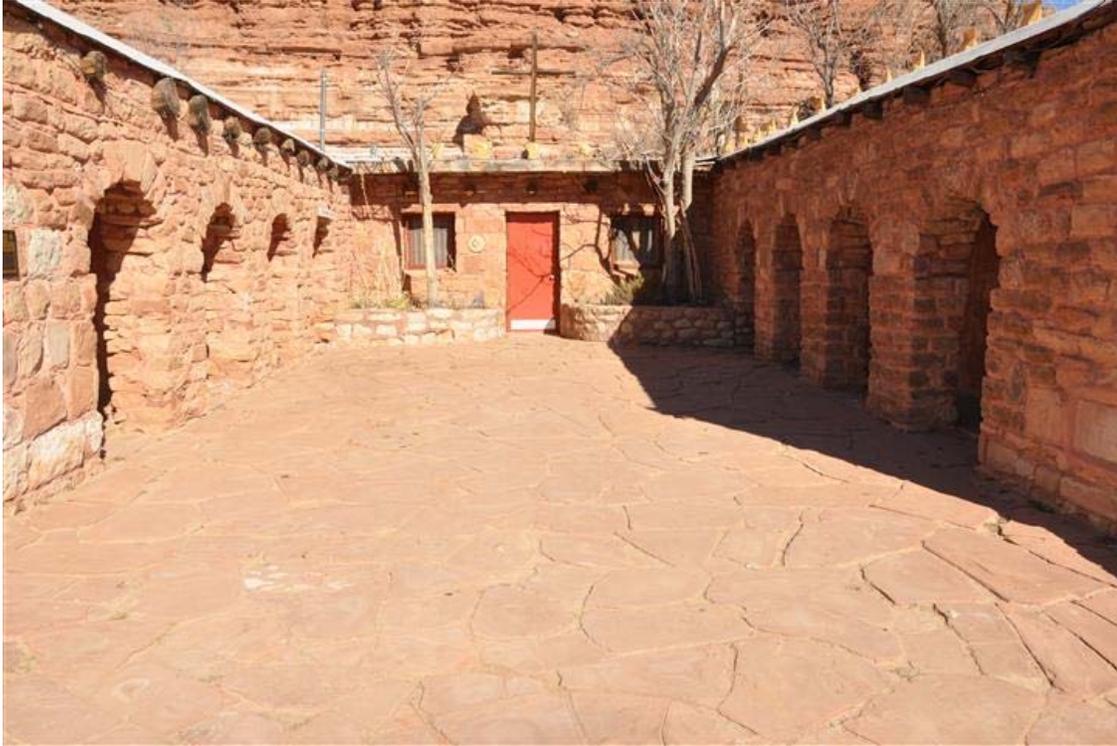
21 of 50. South elevation of mission house courtyard. Camera facing north.

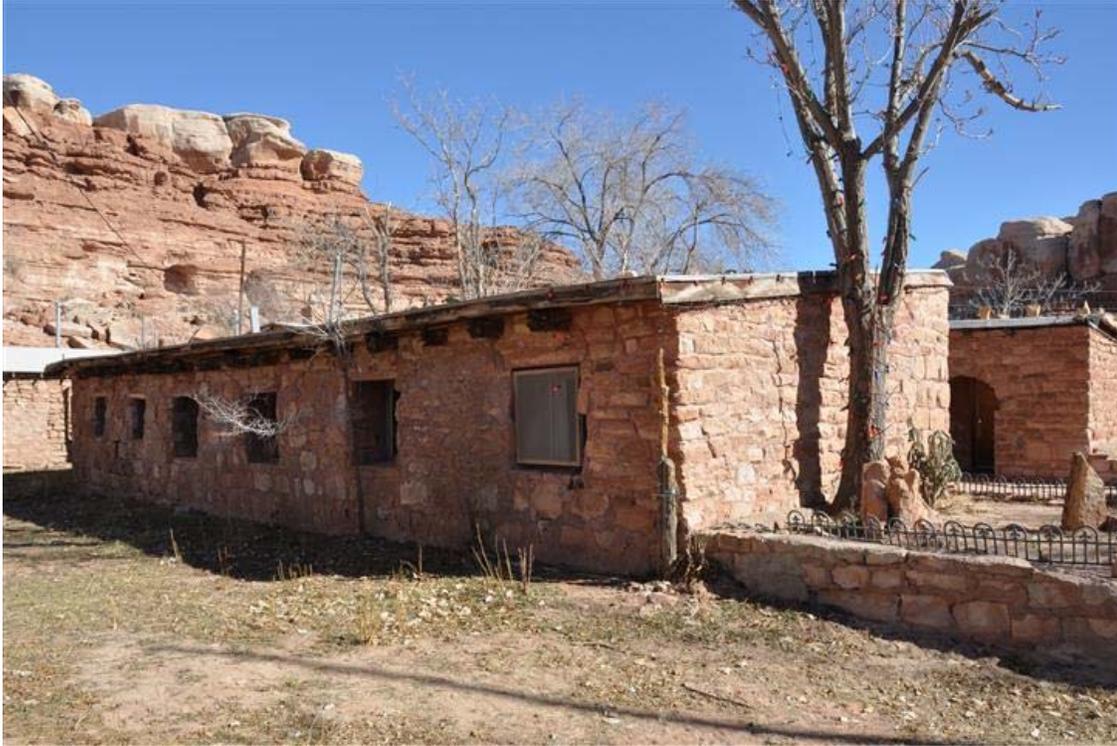
23 of 50. South and west elevations of mission house west wing. Camera facing northeast.

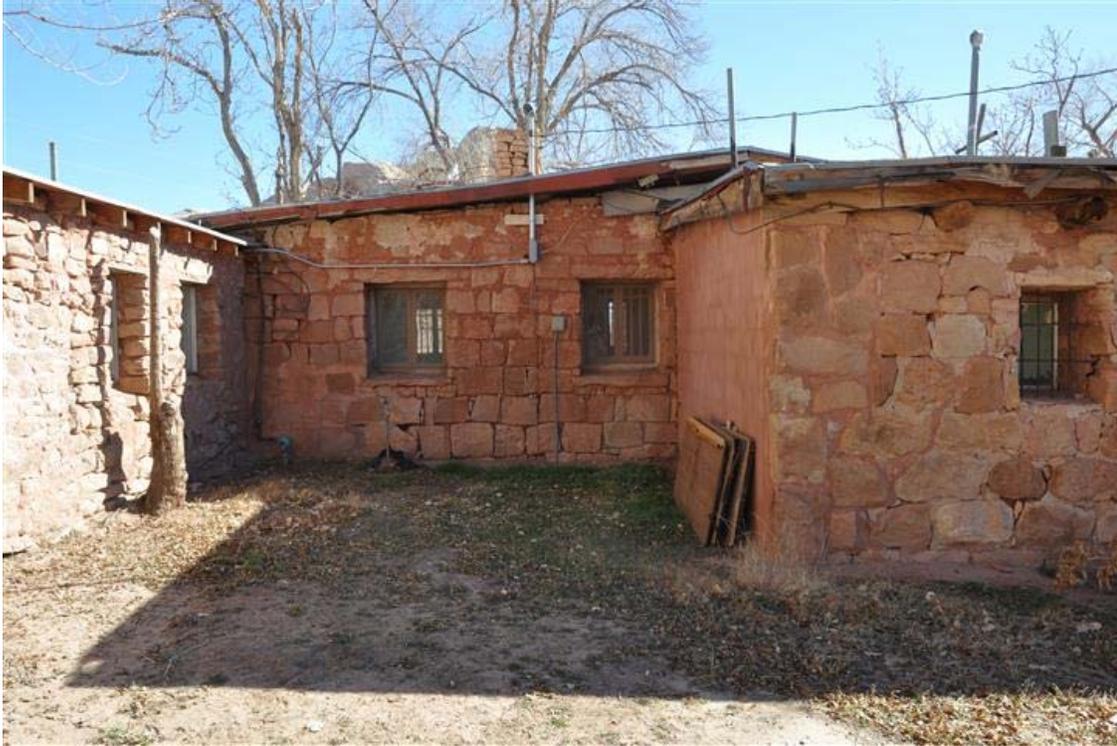
25 of 50. West elevation of mission house center section. Camera facing east.

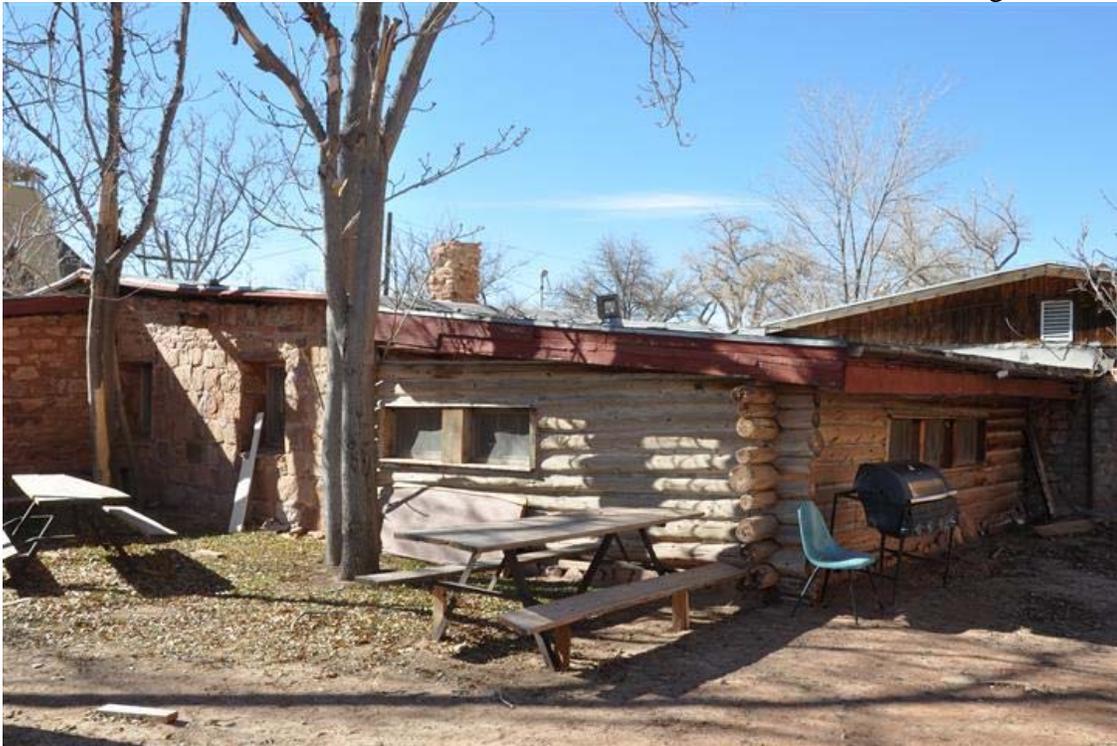
29 of 50. East & north elevations of mission house middle section. Camera facing southwest.

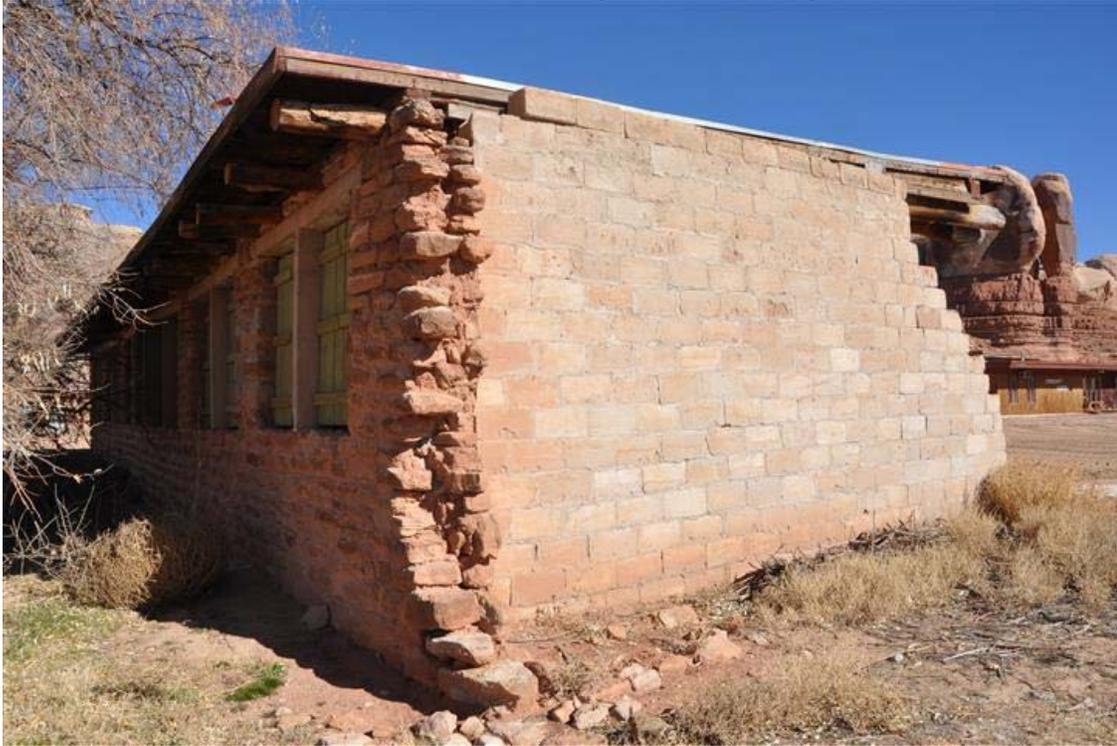
37 of 50. South and west elevations staff housing. Camera facing northwest .

The earliest of the four now-contributing buildings is the staff housing unit (photos 36-39), located northeast of the hospital/clinic. The building was constructed soon after the hospital, being completed in the mid-1950s (the exact date is not known). It was originally used as additional housing for staff and also for storage. It is similar in appearance to the three already contributing buildings, being constructed of coursed-rubble sandstone and designed in a mid-century, but rustic interpretation of the Mission style, with full-width loggia across the front. The loggia has six arched openings that provide access to the individual apartment entryways. The square window openings on the west and north elevations originally featured metal, multi-pane casements, but these have been replaced with fixed wood-plank shutters because of interior modifications noted below.

Although the north and west facades are constructed of stone, the south elevation is made of concrete block, as is the exterior wall on the primary (east) façade behind the loggia. The right half of the block wall has been stuccoed. The south (rear) wall extends out to the east from the building and appears to have been partially removed, although when this occurred is not known. The roof is flat and has projecting log vigas at the roofline under the eaves. The interior was remodeled c. 2004 to alter the space for use as a museum. Some of the original interior walls that divided the apartments were removed to open up the space, and the rear (west) windows covered over in drywall on the interior. The exterior openings were retained, with wood shutters placed in the openings. As noted, the building is now used as a museum for the Mission. Despite the interior alterations, the building retains its overall historic appearance, with all the exterior architectural character-defining features that make it a contributing building in the complex.

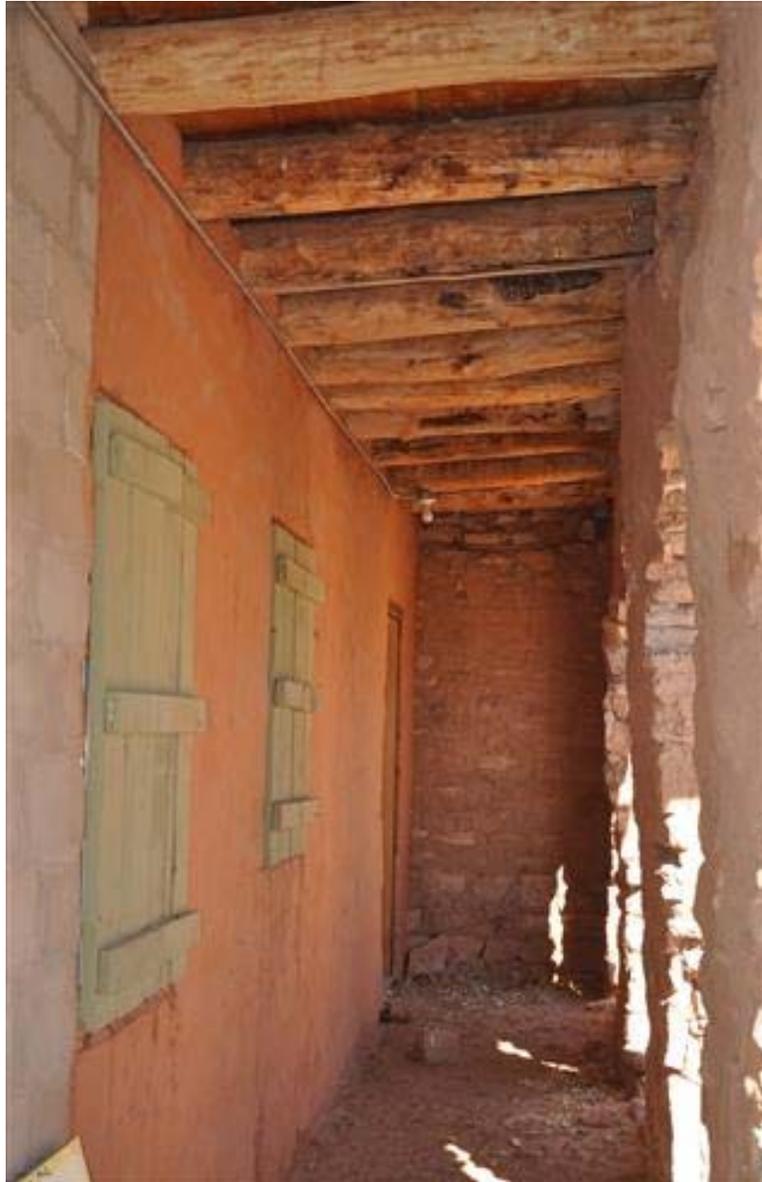
39 of 50. View under loggia, staff housing. Camera facing north.

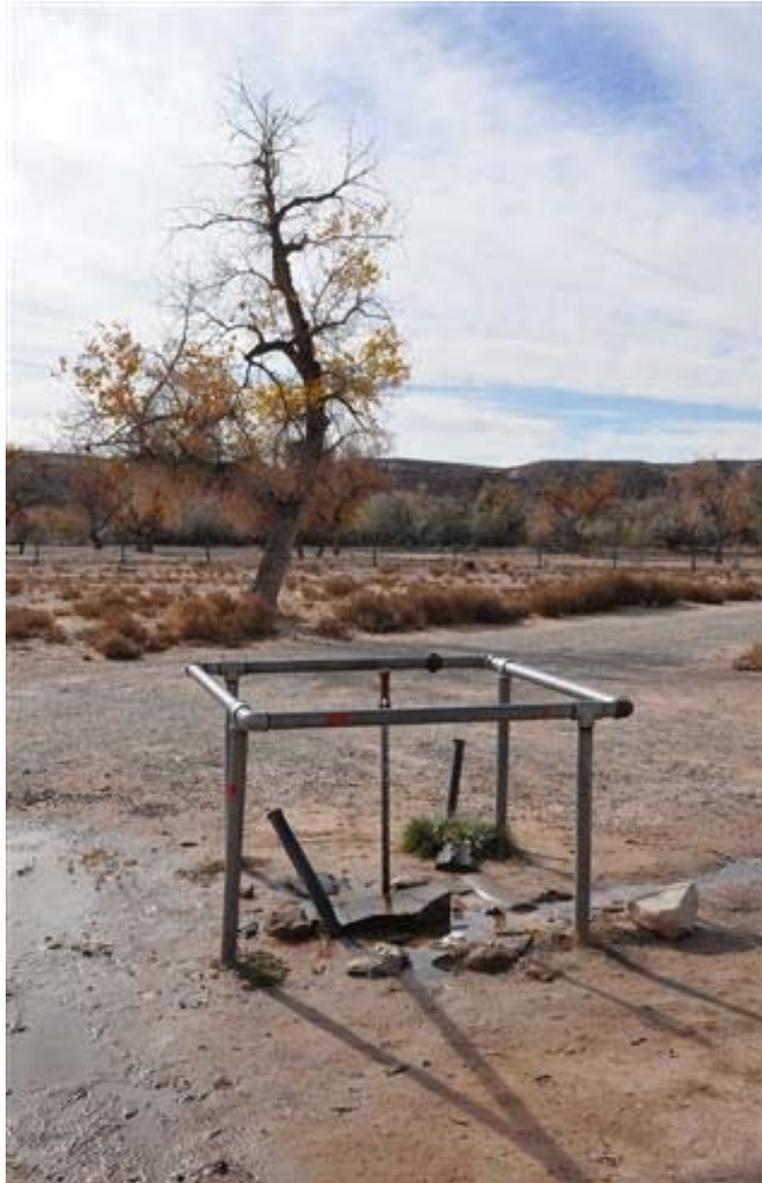
43 of 50. Artesian well. Camera facing southwest.
