National Register of Historic Places Registration Form

Historic name: Augustine Beach Hotel AMENDED – Additional Documentation
Other names/site number: DE CRS# N00150, Augustine Inn, The Piers - NR ID# 73000537
Name of related multiple property listing:

Street & number: 1919 Augustine Beach Road
City or town: Port Penn State: Delaware County: New Castle
Not For Publication: Vicinity:

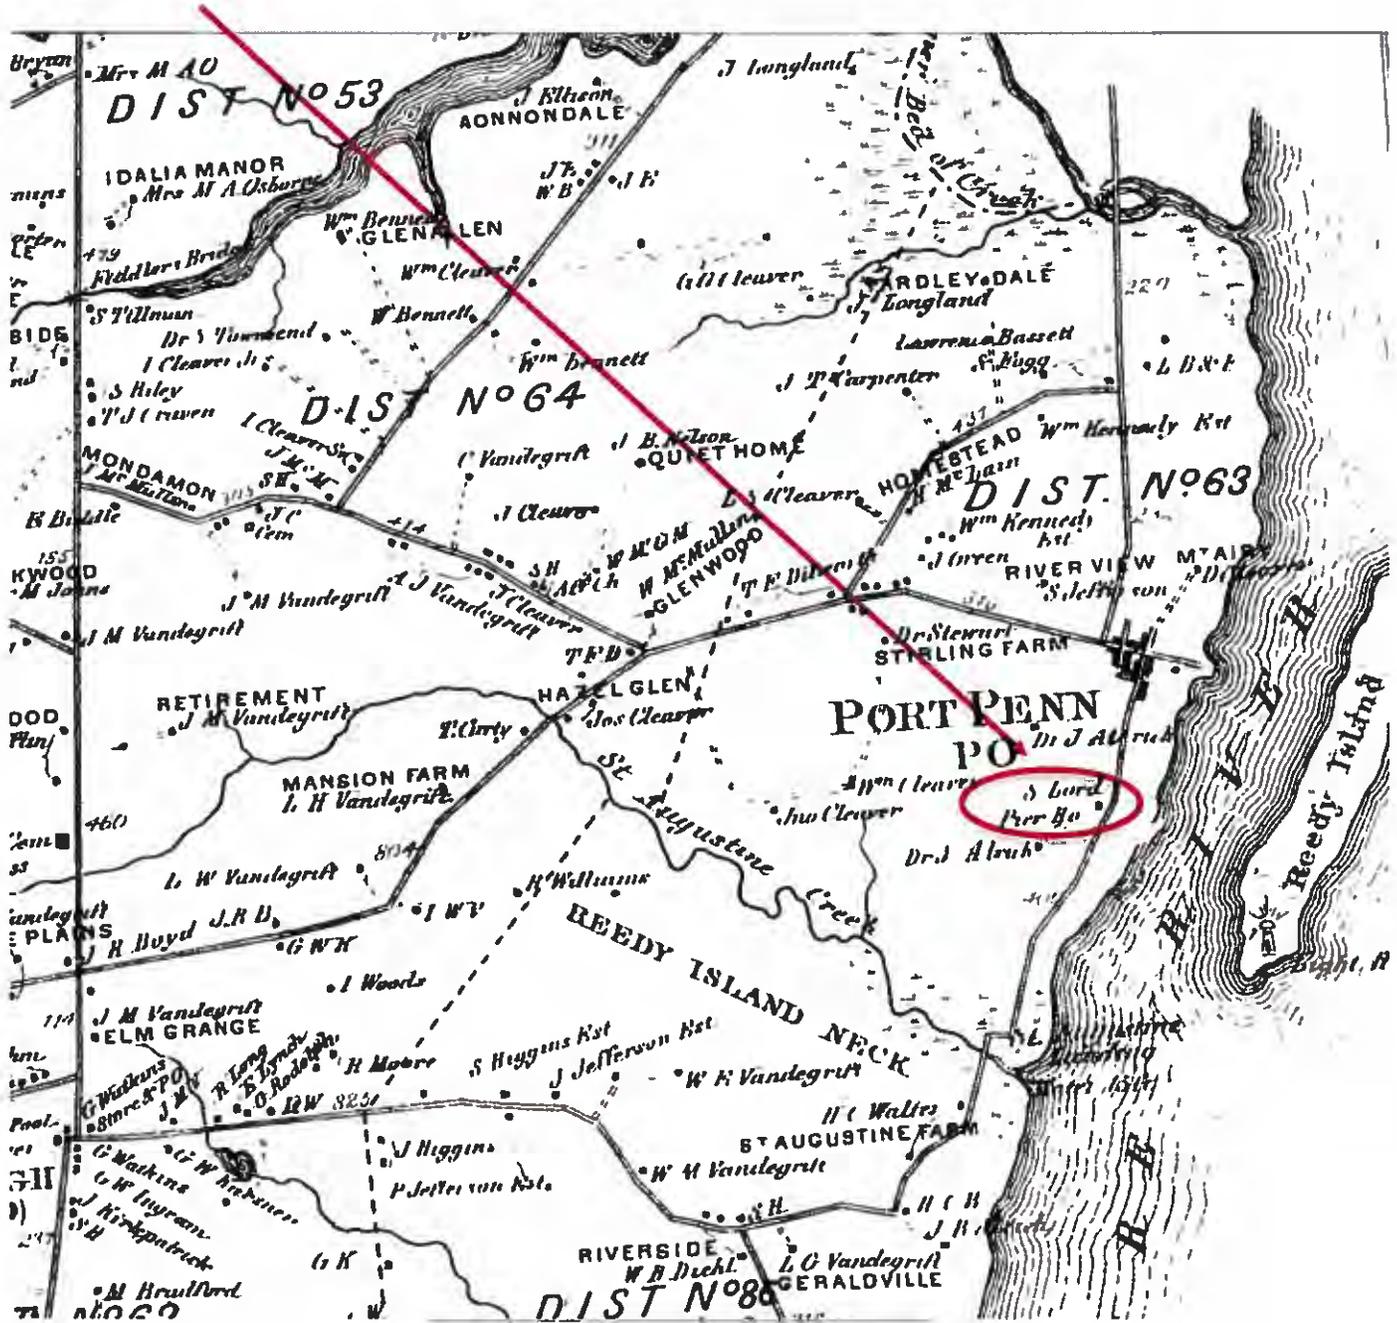
1868 Beers Atlas Map- Saint Georges Hundred

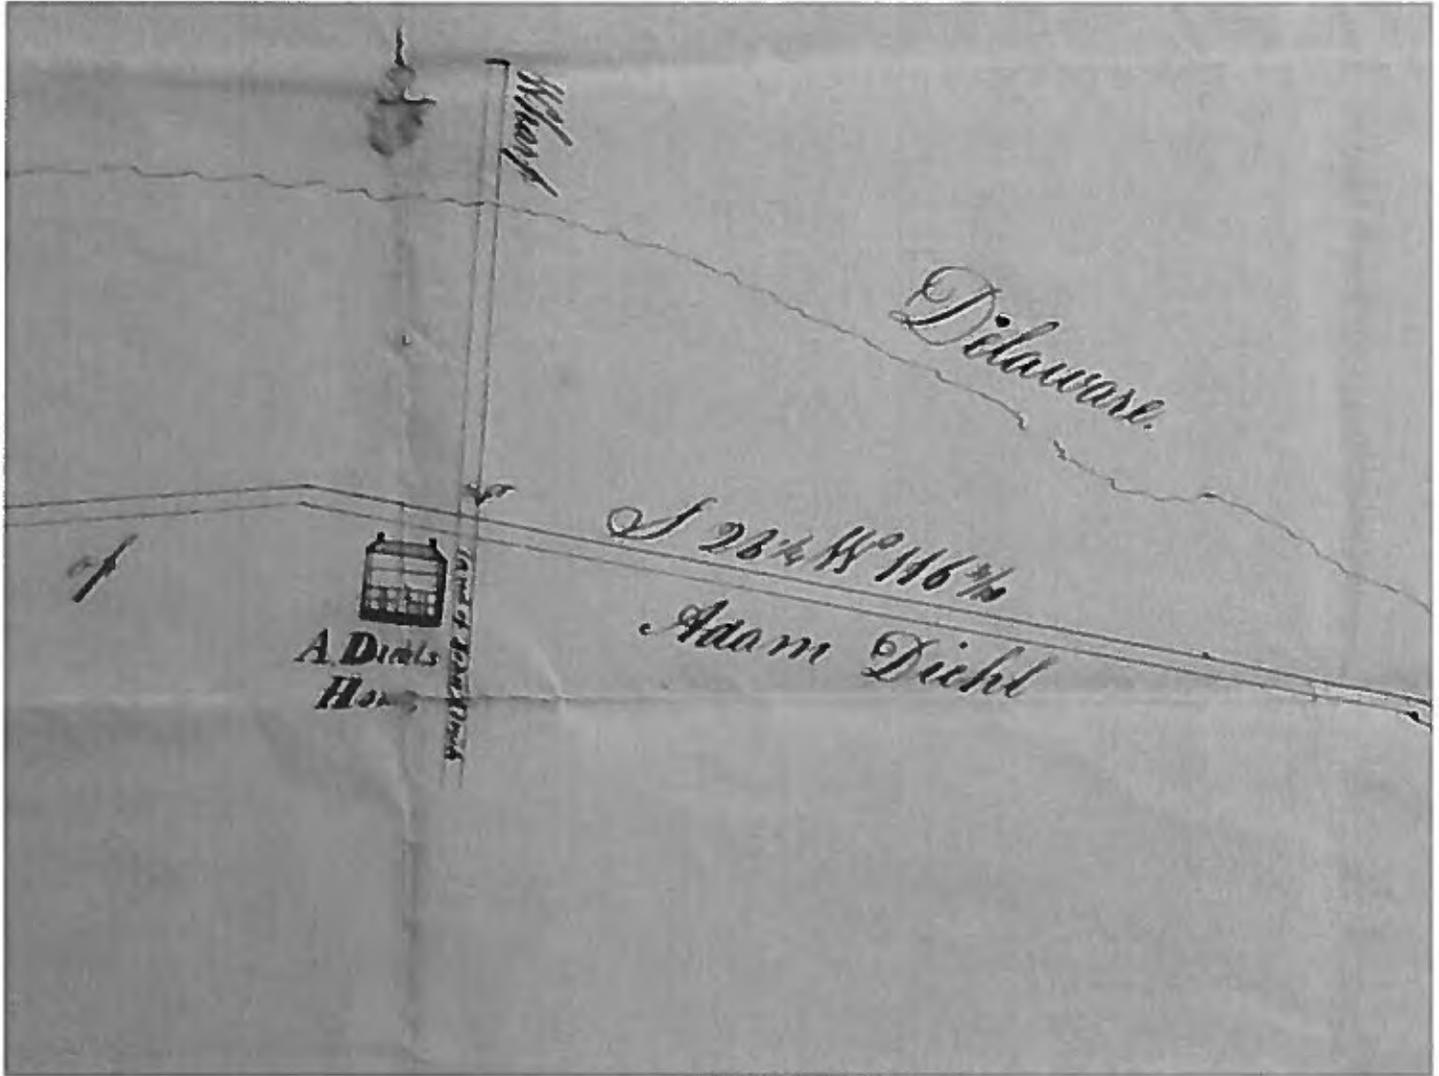
1826 Road Paper "Road from Port Penn South to Augustine Causeway," Augustine Beach Hotel depicted
"A. Deihls House"

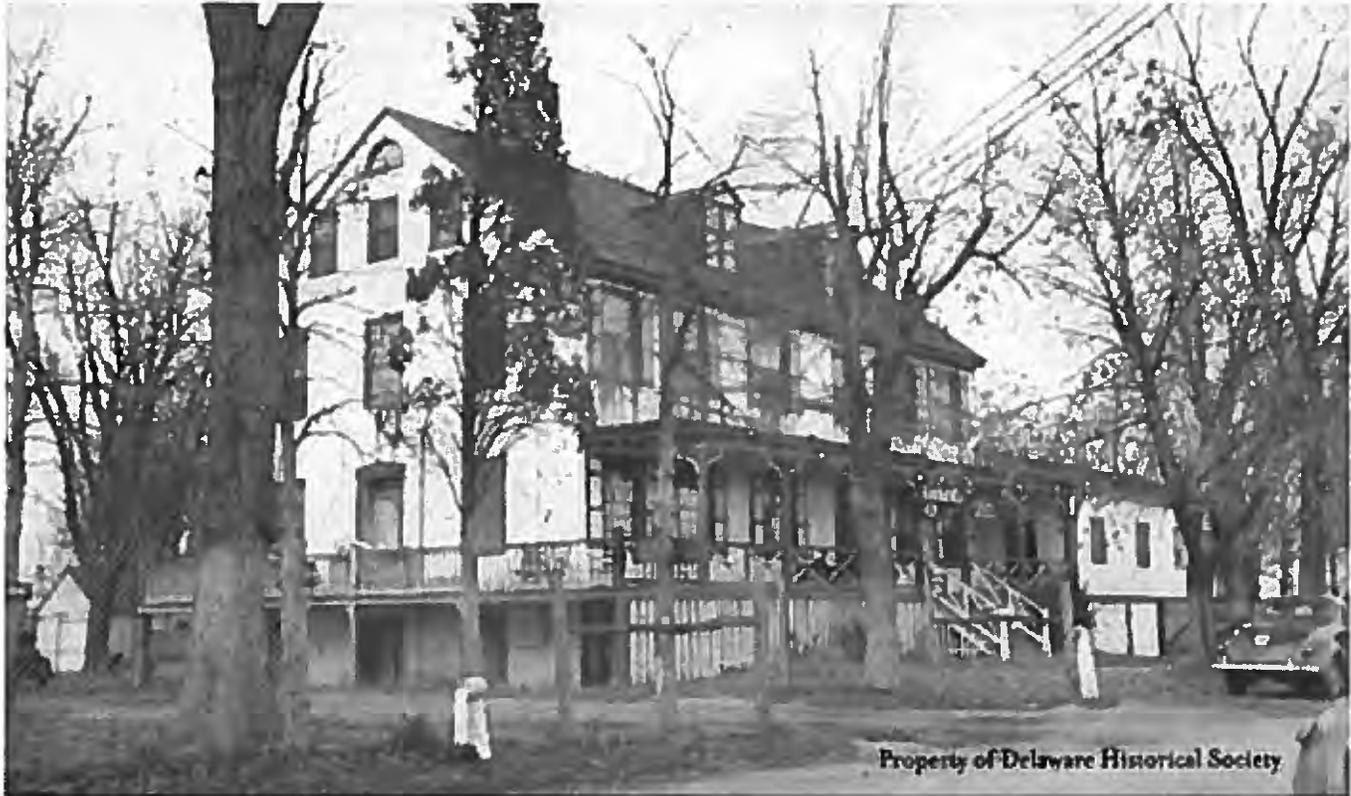
Historic Photo of the Augustine Beach Hotel circa 1940 (Courtesy of Delaware Historical Society)

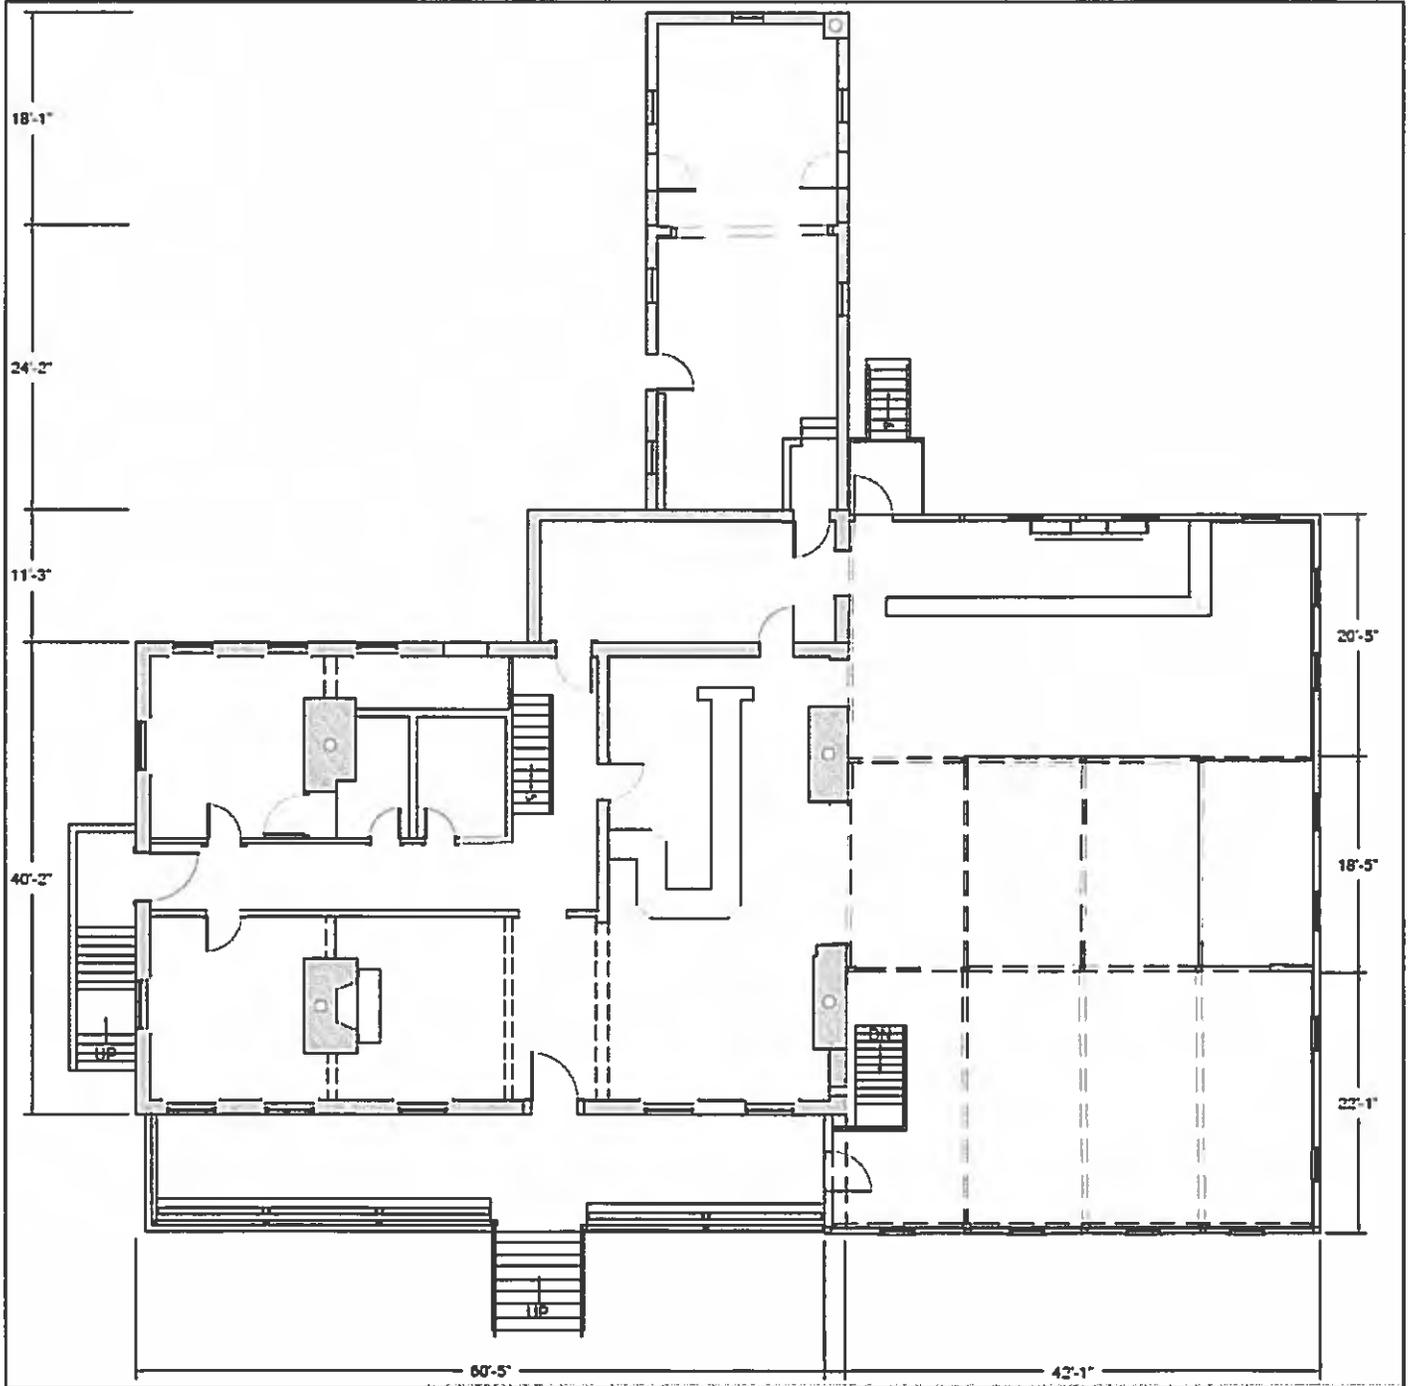
First Floor Plan (Drawn by: Laura Keeley)

The historic floor plan of the Hotel was as large and impressive as the exterior. A front to back hallway spans the entire width of the building, connecting the front entryway to the stairway. A long central hallway that runs longitudinally northeast to southwest bisects the entryway hallway, creating a capital T plan. The hallway configuration is the same as it was in 1816. The first floor boasted four private parlors, two on either side of the hallway, and two drinking and dining spaces to the northeast of the parlors. Each of these six rooms contained a fireplace providing heat to the space. An off-centered stairway, aligned with the front entryway, provides access to the second floor. This stairway is the only known stairway in the Period I block, and

runs from the first floor all the way up to the third floor. Today, three of the parlors survive, while the fourth been divided into modern bathrooms. The two separate eating and drinking spaces have now been combined into one large barroom.

To the northeast of the now enlarged barroom, is the frame dance hall addition. The interior is one large open space, with a bar to the northwest, and a stage centered along the northeast wall. The two gabled ridges are supported by four posts running northeast to southwest. The posts are squared, and have pegged upbraces connecting to the longitudinal plate. Also pegged into the same posts are girts that run the opposite direction. A drop ceiling has been added, but the original roof material still remains. The dance hall retains its original hardwood floor.

Behind the current barroom, to the rear of the main block, is the brick service ell, connected by a one-story piazza or passageway. The brick service ell was once divided into two rooms, separated by a brick dividing wall with a chimney stack, all of which was removed sometime in the twentieth century. Today, this space is used as kitchen-prep space, and it was most likely the historic function as well, with accompanying service space.
