Re: Green Mountain Lookout (NRIS 88000117)

The Mt. Baker-Snoqualmie National Forest is proposing to relocate the Green Mountain Lookout to a similar mountain top at Circle Peak, outside of congressionally designated Wilderness. The reason I am considering this proposal is to comply with the 2012 Summary Judgment by the U.S. District Court, as amended, to remove Green Mountain Lookout from the Glacier Peak Wilderness (*Wilderness Watch v. Y Robert Iwamoto and United States Forest Service*, U.S. District Court for Western Washington, Case No. C10-1797-JCC, 3/27/2012; as amended 9/20/2012).

Proposed Undertaking

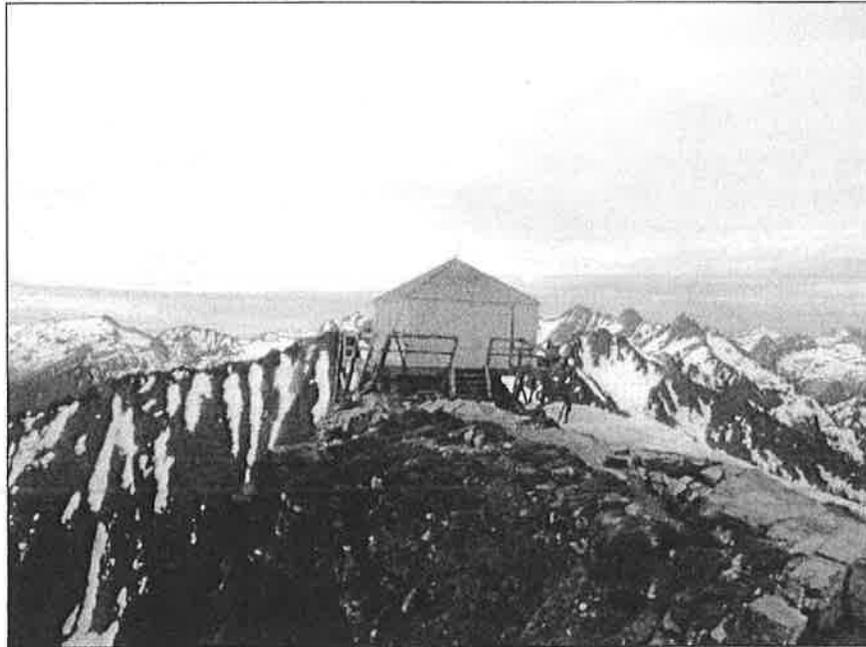
Figure 4. Green Mountain Lookout aerial view of south elevation and foundation damage, view to northeast, July 2, 2002. (HiLine Helicopters photograph).

Through the years, natural elements have taken their toll on the lookout. Maintenance and rehabilitation efforts have been on-going for several decades, including a major effort in 1950. After a structural analysis was completed in 1994, Green Mountain Lookout was closed to the public due to safety concerns. The lookout underwent repairs in 1999-2000 to address deficiencies to the substructure and catwalk using funds received through the White House Millennium Council's "Saving America's Treasures" grant program. During the winter of 2001-2002, the substructure twisted as a result of the harsh snow and ice conditions; subsequently, it was discovered that the foundation repairs were not adequately designed or executed for the conditions (Figure 4). To avoid the potential complete loss of the lookout during the following winter, the Forest Service undertook a piece-by-piece disassembly of the lookout in August, 2002. Each piece was carefully identified and individually tagged so that the structure could be reassembled in the exact location and position, with all salvageable historical materials preserved. During the next several years while the Forest Service sought funding, volunteers worked to repair and re-glaze the multi-pane windows that comprise a large part of the structure.

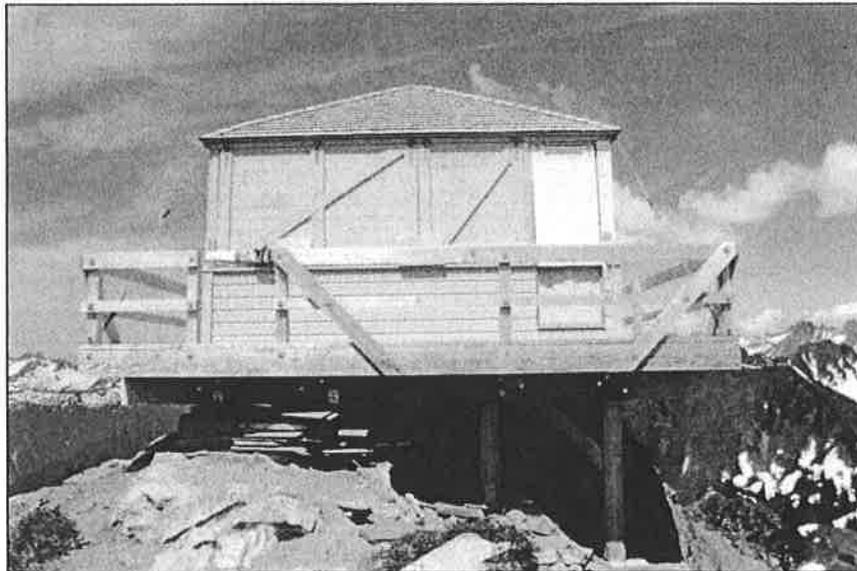
Figure 5. Green Mountain Lookout south elevation, in its current condition, after substructure and catwalk were replaced (stairway not completed), also freshly painted, July 2010 . (Gary Paull, Forest Service photograph).

The lookout was reassembled at its original location in 2009 secured to a new foundation; the catwalk structure is also new.

The new foundation would consist of leveled cross pieces (most likely, cement) bolted to the bedrock, on which the intact lookout/catwalk structure would be placed and bolted. The lookout would be secured by guy wires at each of four corners, as it was originally on Green Mountain (typical, seen in Figure 5). A copper-wire lightning protection system would be installed as it is currently on the Green Mountain Lookout. We are considering placing the original Green Mountain Osborne fire-finder inside the lookout; however, we would install a map of the Circle Peak "seen area" on the fire-finder, so that it would be relevant in its new location.

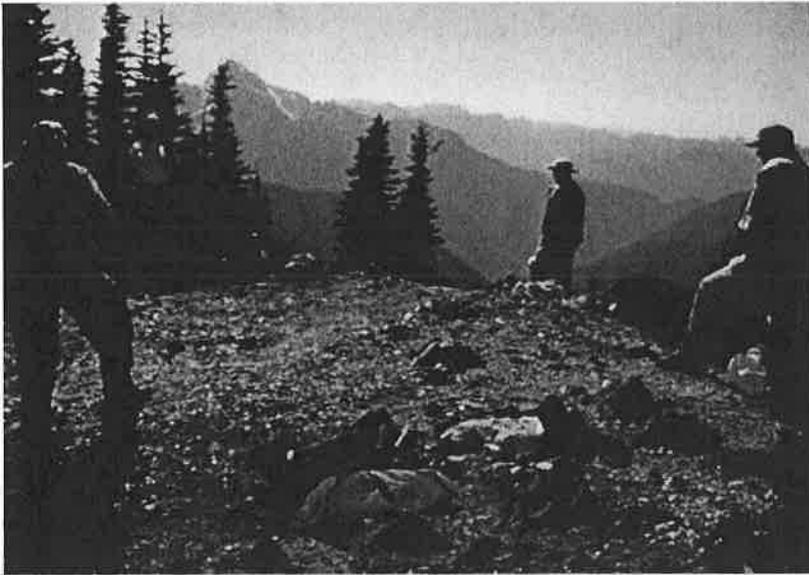
Figure 8. Green Mountain Lookout , 1971 Forest Service photograph. View to north. Mt. Baker in the far-ground, left of lookout.

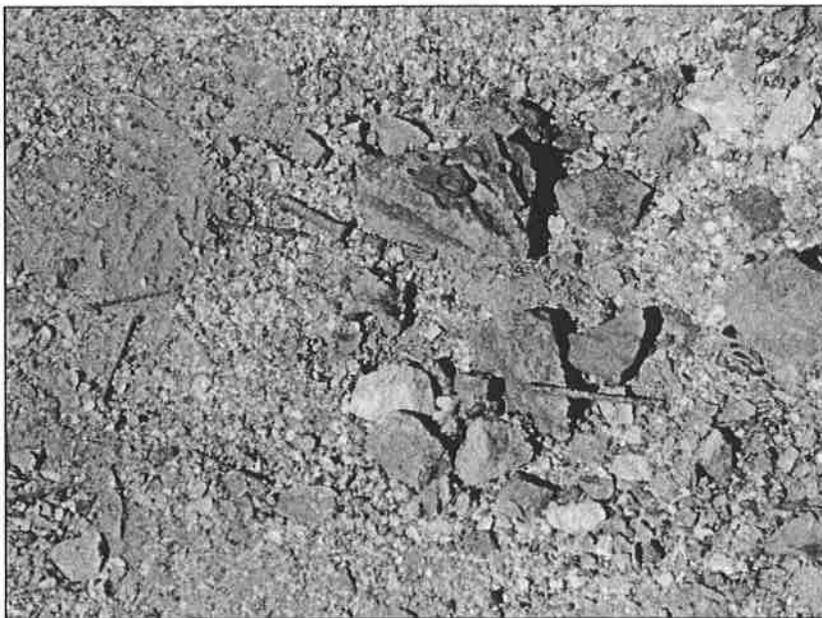
Figure 10. Hardware, nails, bolts, melted glass: remains of Circle Peak Lookout, on Circle Peak project construction site 9/12/2013 (Adrienne Hall, Forest Service photograph).

A visual inspection of the Circle Peak building platform resulted in the identification of (window glass, nails, bolts and other hardware, Figure 9) attributed to the burned-down Circle Peak Lookout. No other remains, historic or prehistoric, were observed at the Circle Peak site. Only one historic photograph has been found of this lookout (1947, Figure 10), and although the period of construction (1930s) suggests that it was likely built by the Civilian Conservation Corps, as was the existing Green Mountain Lookout, it did not have the revised hip-roof configuration, but rather a gable roof design.

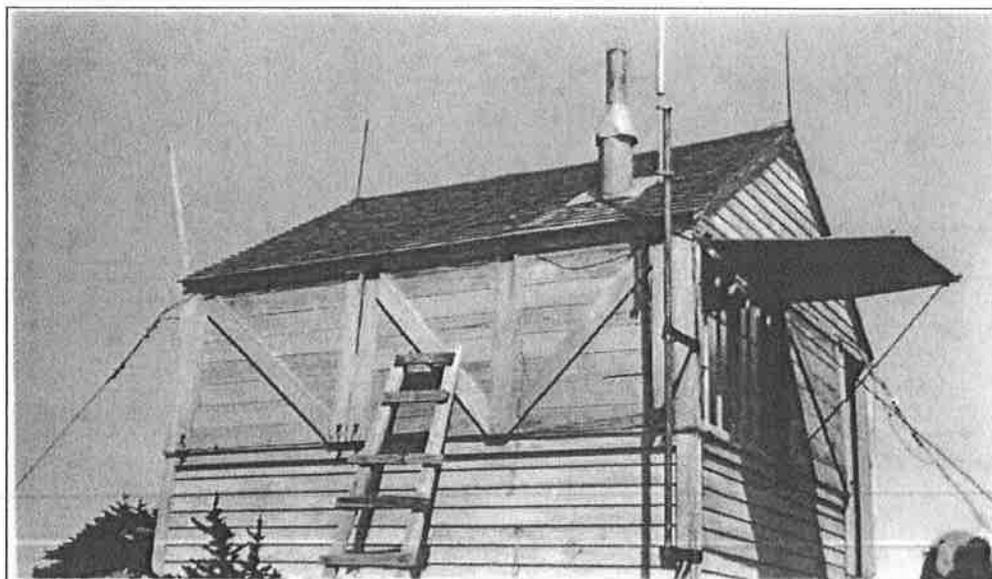
Figure 11. Circle Peak Lookout. Photograph from Forest Service historical files, Darrington Ranger Station, identified as "Circle Lookout, 1947. "
