**NATIONAL REGISTER OF HISTORIC PLACES
CONTINUATION SHEET**

Weber Stake Relief Society Building
Property Name

Historic name: Weber Stake Relief Society Building (amendment, additional documentation)

Street & number: 2104 Lincoln Avenue

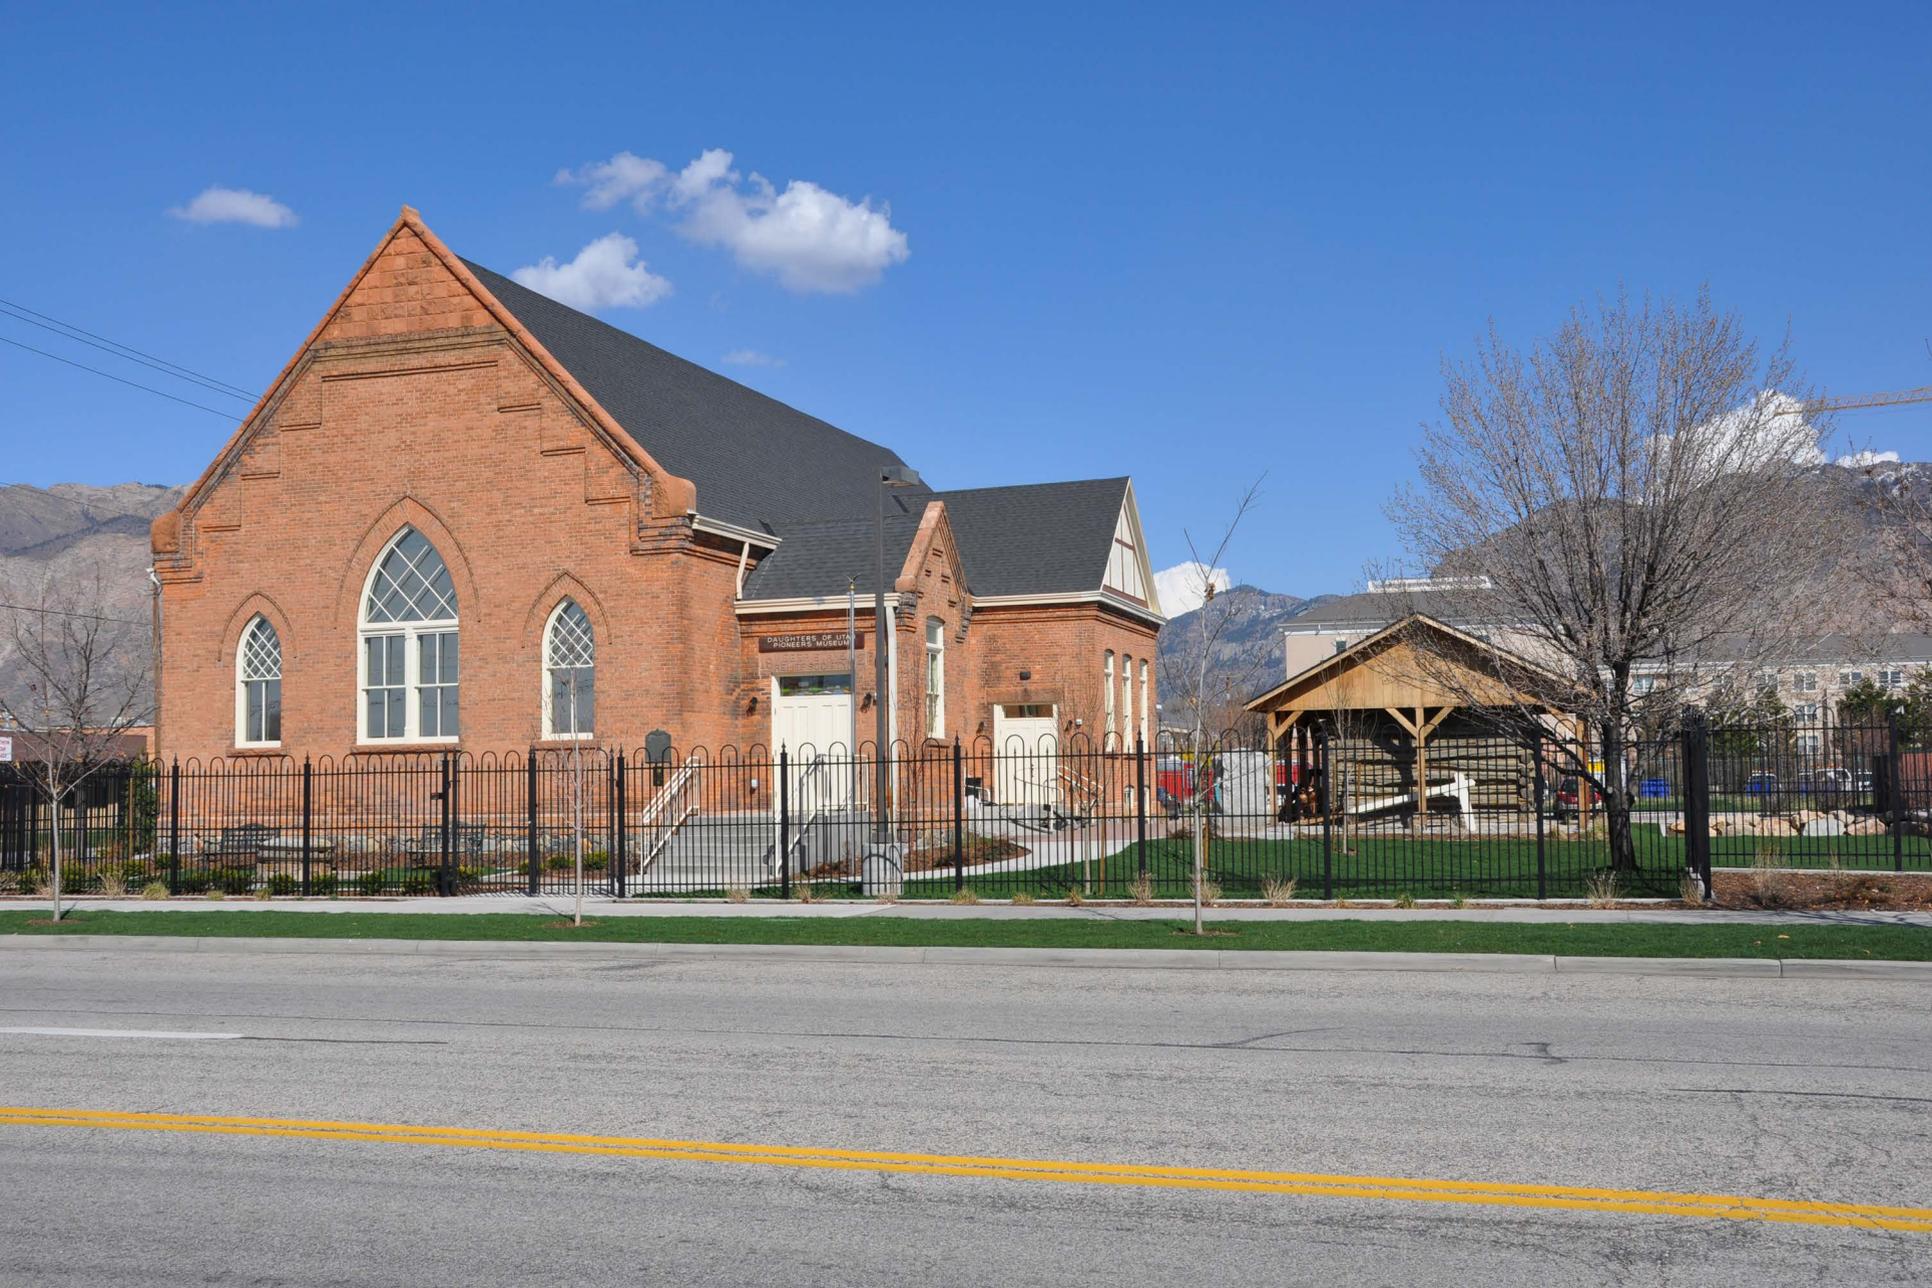
- 1 of 8. South and west elevations of building, showing site. Camera facing northeast.
- 2 of 8. South and west elevations of building. Camera facing northeast.
- 3 of 8. North and west elevations of building. Camera facing southeast.
- 4 of 8. North and east elevations of building. Camera facing southwest.
- 5 of 8. South and east elevations of building. Camera facing northwest.
- 6 of 8. Building in transport to new site. Camera facing west.
- 7 of 8. Building interior, main floor. Camera facing southwest.
- 8 of 8. Building interior, basement. Camera facing southwest.
