NATIONAL PARK SERVICE
NATIONAL REGISTER OF HISTORIC PLACES

THE LOCATION OF THIS PROPERTY IS RESTRICTED INFORMATION.
THIS DOCUMENTATION MAY BE REPRODUCED ONLY WITH THE
CHIEF OF REGISTRATION'S PERMISSION.

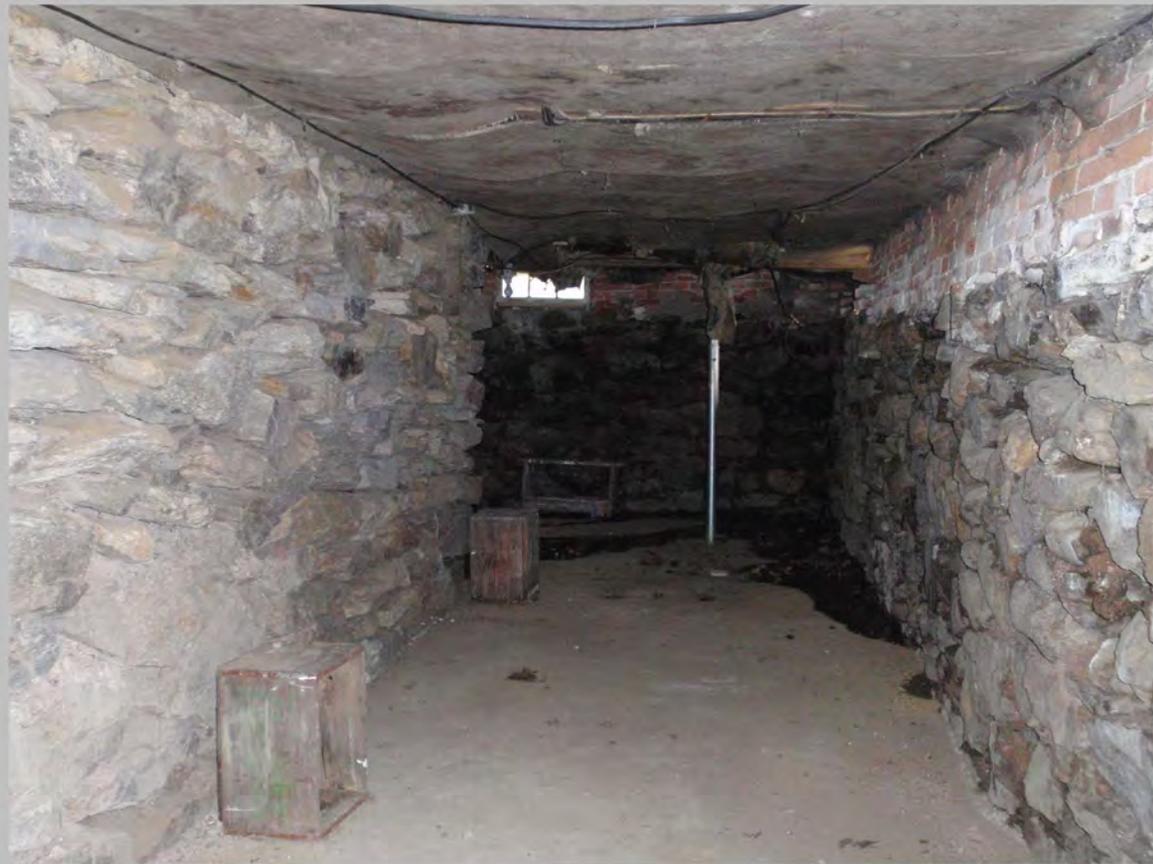
8. South side of basement showing chimney base (left) and foundation (right),
camera facing east. (March 2013)

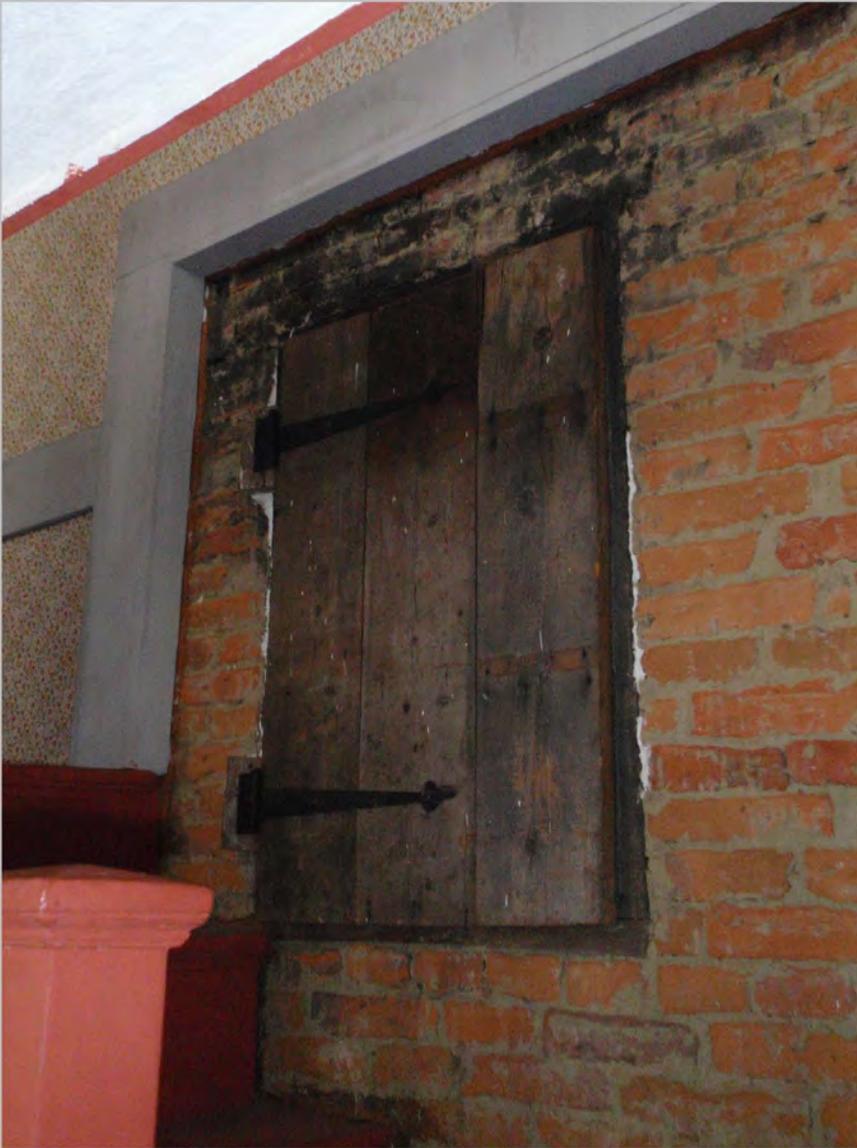
9. Detail of reproduction smokeroom door, camera facing northwest. (March 2013)
