National Park Service
Cultural Landscapes Inventory
1998
Revised 2004

Stanton House
Women's Rights National Historical Park

Executive Summary

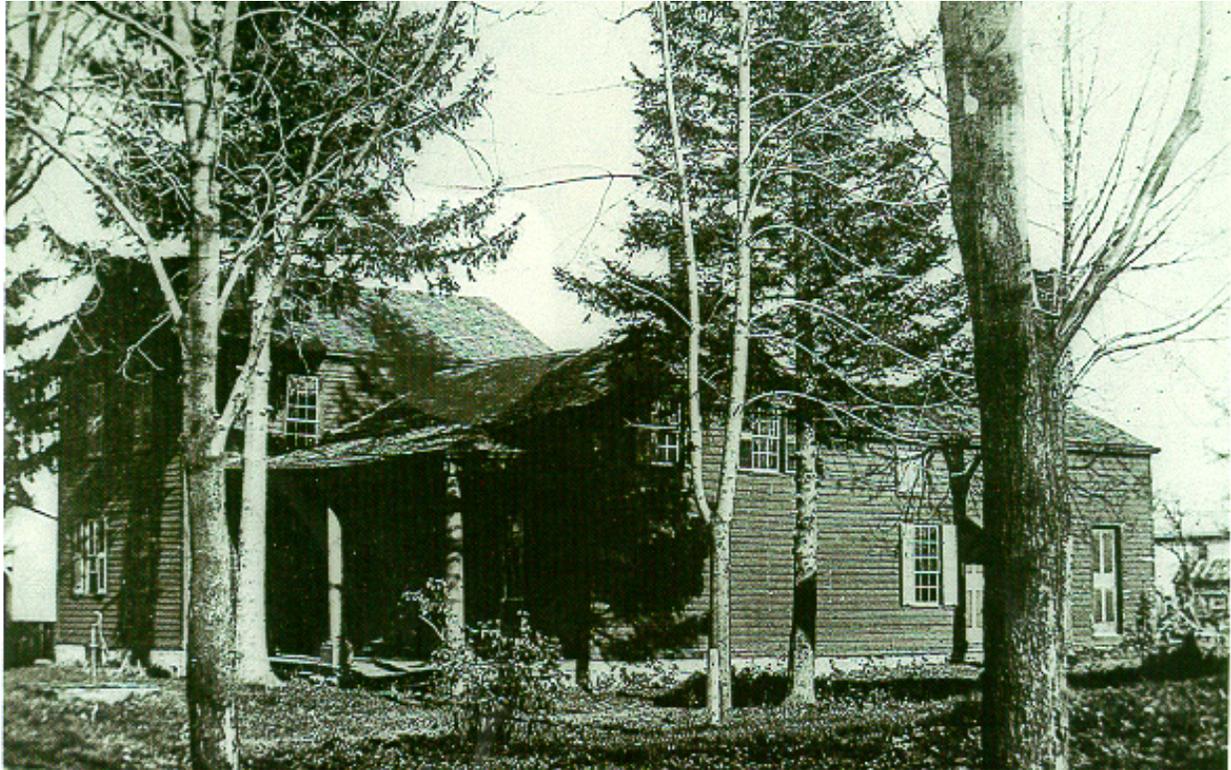
Stanton House, c. 1900 (postcard, Eastern National Park & Mon. Assoc.).

There is reference to a circular drive in front of the Stanton House, evidence of which has been found in archeological surveys [Hsu]. The c.1900 photograph of the Stanton House [postcard] shows a plank sidewalk along Washington Street. It is not known if this feature existed during the period of significance. Elizabeth did write that there were no sidewalks to her home; however, a sidewalk may have been built by the time the Stantons moved in 1862, given that by this period the surrounding property had been subdivided and several houses had been built in the neighborhood. The site has had numerous other circulation features that are no longer present, such as walks and drives associated with the various houses and outbuildings that once stood on the property.

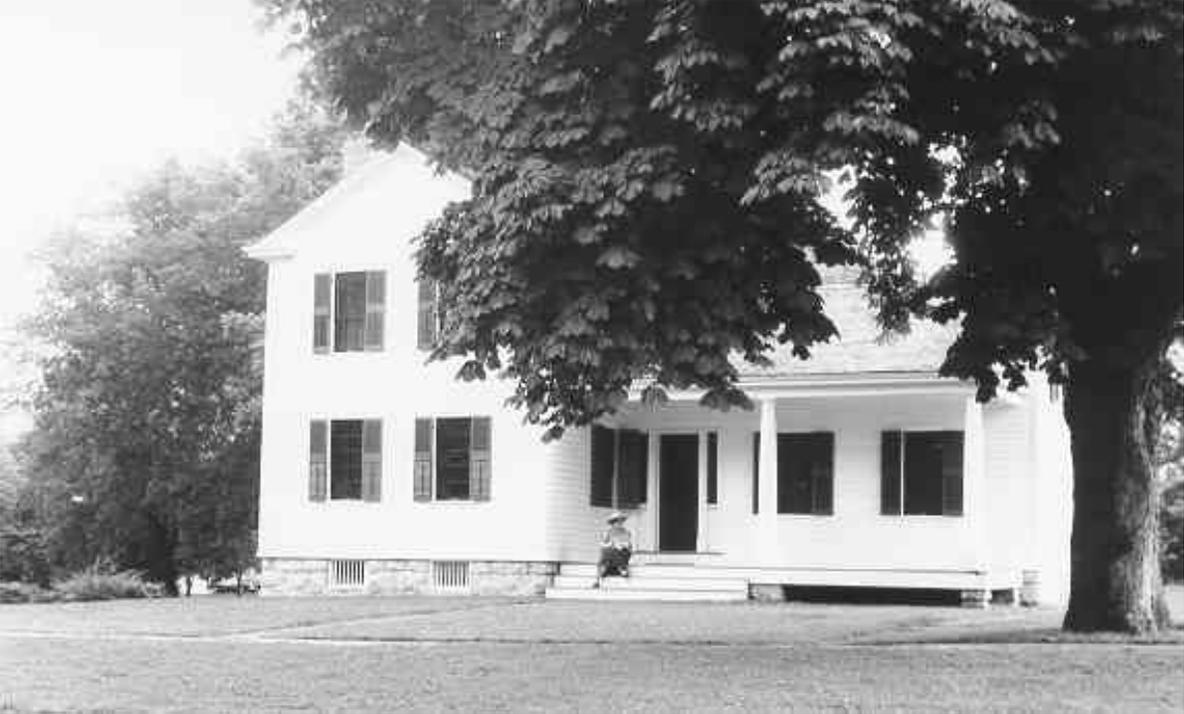
Stanton House, WORI, 1998 (Auwearter).

The Stanton House is the only building or structure on the site that contributes to the historic significance of the property. It was restored in 1982-85, except for two wings and a rear porch. [For detailed information on the house, see Yocum, "The Stanton House Historic Structure Report," 1998.] Three outbuildings--a barn, woodhouse, and smokehouse--existed during the period of significance, but are no longer standing. Little information is known about the location or appearance of these buildings. In addition, five houses were built on the Stanton property after the period of significance. Two of these, the Ranger Station and the Nies House, still stand, but are scheduled for removal. A total of approximately eight additional buildings at one time stood on the Stanton property.

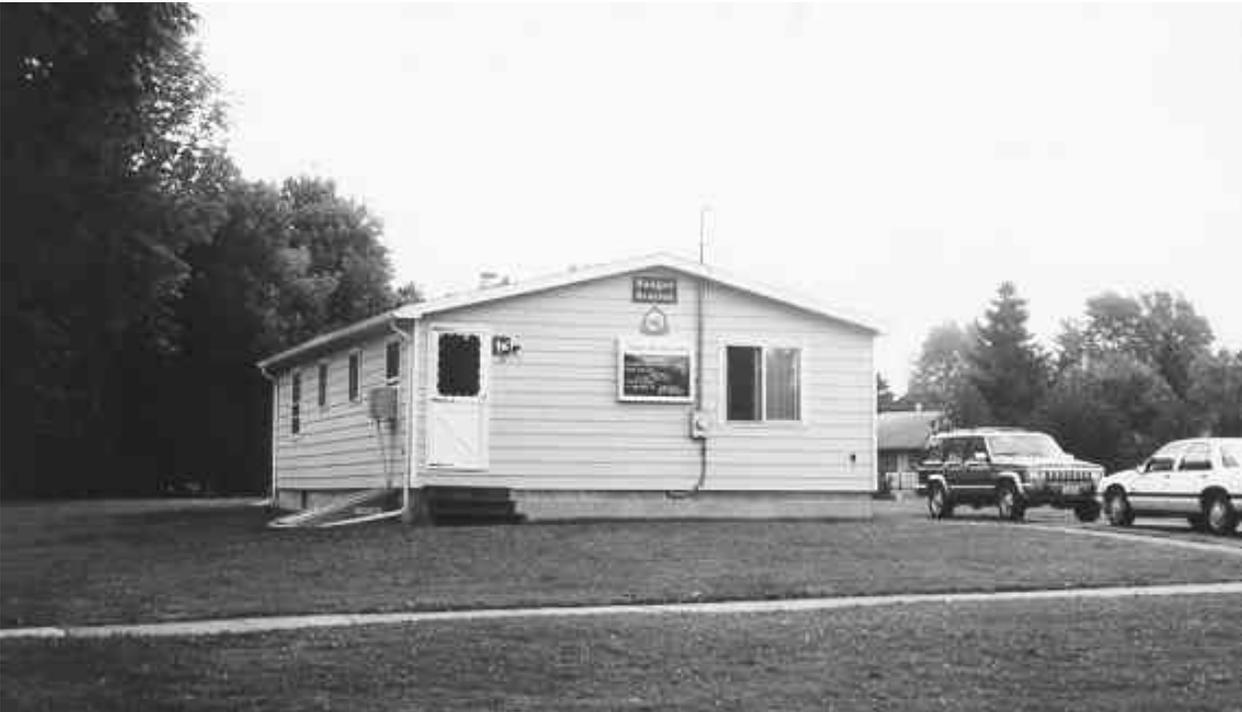
Stanton Historic Site, Ranger Station, WORI, 1998 (Auwaeter).

The Stanton House is the primary building on the historic site. Other buildings include the Ranger Station and Nies House. The Ranger Station, located on Tract 101-04 just south of the Stanton House, is a double-wide modular house manufactured in October, 1977. It replaced the c.1865 Gargan House, which burned c.1974, and is scheduled for removal pending construction of a new ranger station on the adjacent Chamberlain House lot. The Nies House, located at the rear of the site on Tract 101-10, was built by the Woods family about 1895. It is a two-story, gable-front and ell frame house with two-over-two double-hung windows and composition asbestos shingle siding. It is scheduled for removal. Also part of the site, but not historically associated with the Stantons, is the Chamberlain House on non-contiguous Tract 101-09. Research is pending to determine if this building, a small one-story frame house, has any historic significance of its own. If not, it is scheduled for removal, with plans being developed for a new visitors' center and ranger station. The Chamberlain House is located adjacent to the National Register-listed Seneca Falls Village Historic District.

The Nies House and Ranger Station are buildings that were not present during the period of significance, and are planned for removal in the near future. Other non-historic features present on the property include the concrete sidewalks, iron steps, and most of the vegetation. Archeological features likely remain from the three houses and associated outbuildings constructed on the Stanton property after the period of significance but since demolished. Buildings present during the period of significance, but now missing, include the north and east wings of the Stanton House, the barn, woodhouse, and smokehouse. Missing landscape features include the circular front drive and mound, front gates and hedge, board fence, playground, vegetable garden, evergreen trees, and orchard.

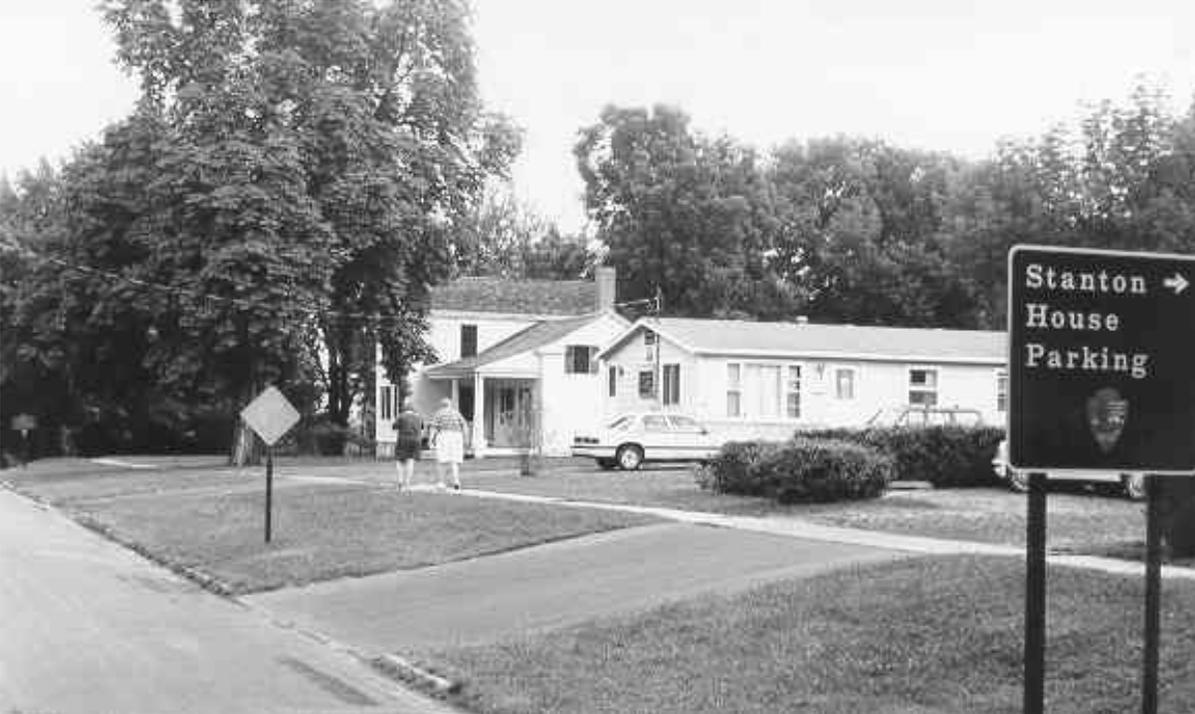
Stanton Site, Circulation Elements, WORI, 1998 (Auwaerter).

The existing circulation features all post-date the period of significance in terms of material. The public sidewalks and walks to the house may be features that were present during the Stanton period, although no information has been found to verify this. There is documentation to support the existence of a circular drive in the front yard of the house.

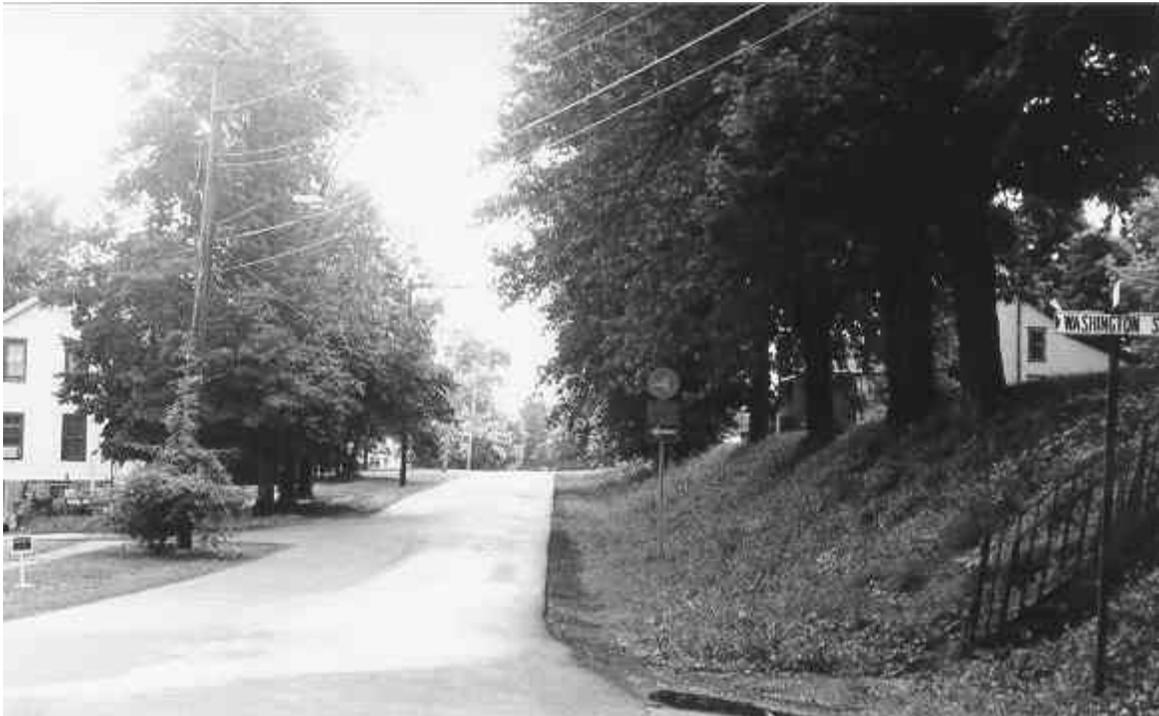
Stanton Site, Seneca Street Embankment, WOR1, 1998 (Auwaerter).

The Stanton House site is fairly level with a relief of approximately 3 feet, but drops off more precipitously, about 12 feet, at the corner of Seneca and Washington Streets. There is also a depression at the rear of the side yard along Seneca Street, and a long, low mound along the south-rear side of the property. Although no information has been found to document the topography during the period of significance, it was likely similar to the existing conditions. Minor modifications may have occurred through construction and demolition of two houses on Tract 101-03 north of the Stanton House; through construction of the modular house on Lot 66; and through construction of the sidewalks and paving/curbing of Washington Street. According to the USGS Seneca Falls quadrangle map, the property is at approximately 450' above sea level. The embankment along the north side of the property is part of a larger ravine that was formed through the erosive action of the Seneca River, later flooded to form Van Cleef Lake.

The topography of the Stanton House site likely remains unchanged from the period of significance, although it is possible the lot to the north was raised and leveled with the construction of two houses there during the 1860s. The prominence of the embankment and sense of height of the site above the Seneca River, however, have been reduced due to the growth of vegetation, the construction of houses, and the flooding of the Seneca River that have occurred since the period of significance.

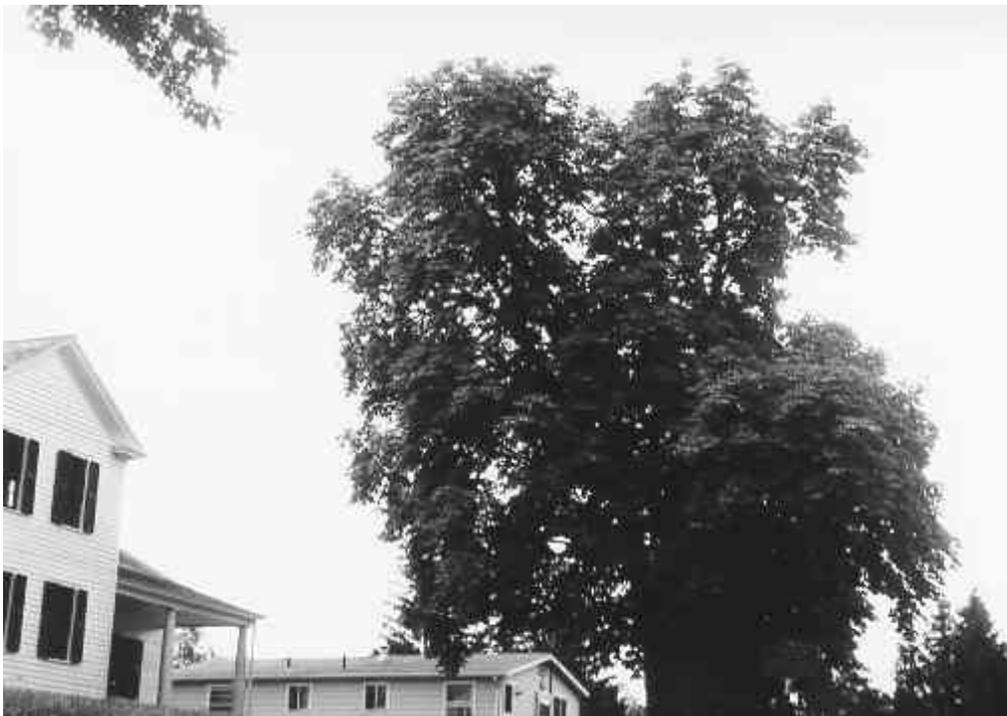
Stanton Site, Horse-chestnut Tree, WORL, 1998 (Auwaerter).

There is very little documentation on the location and type of vegetation that existed during the period of significance. Based on an analysis by Dan Marion, the Horsechestnut in front of the Stanton House is the only "witness" tree on the property. Although several other extant species of trees, vines, and shrubs are referenced in the historic documentation, it is not known if their placement or variety are similar to historic plantings.

Overall, the condition of the landscape at the Stanton House is good, however, the one remaining plant (Horse-chestnut tree on front lawn) that remains from the period of significance is in poor condition. The park staff places an extremely high value on this feature and considers it as significant as the house itself (Renninger, 1998). The tree needs immediate assessment and treatment to stabilize its condition.

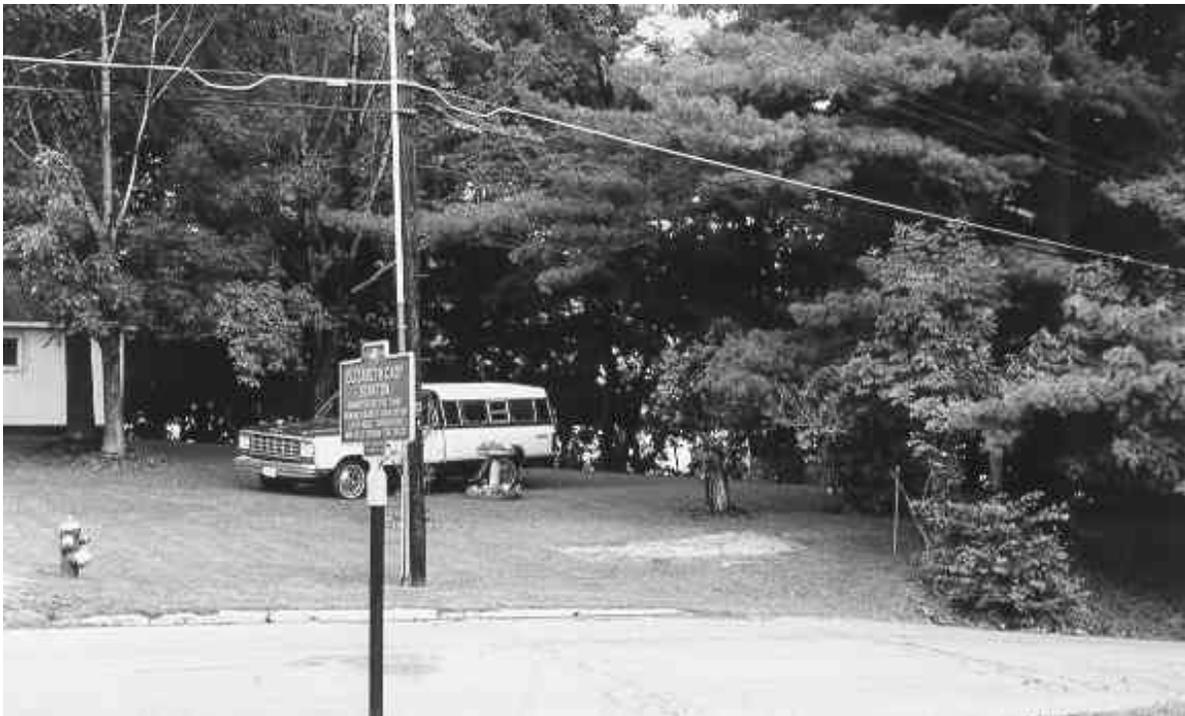
Stanton Site, View toward Van Cleef Lake, WOR1, 1998 (Auwaerter).

The historic views from the Stanton House toward the industrial areas along the canal and the downtown, and across neighboring open space, have largely been lost. Only minor views across open space on the property remain.
