Technical Report No. SRH-2010-23

2010 Survey Report for Lake Mills and Lake Aldwell on the Elwha River, Washington

U.S. Department of the Interior
Bureau of Reclamation
Technical Service Center
Denver, Colorado

April 2011 – Amended June 2011

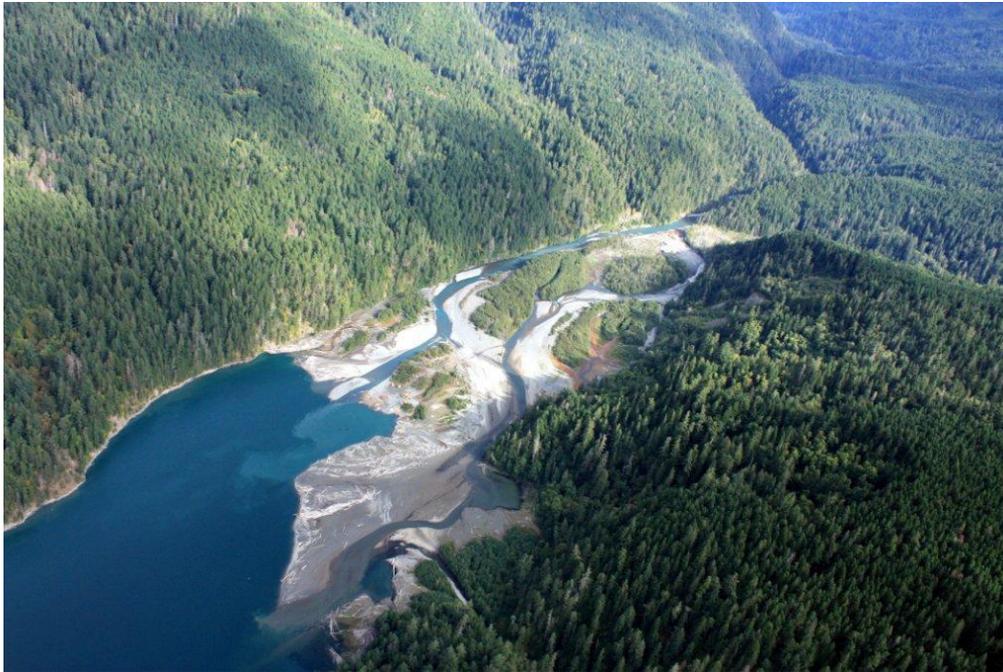
Figure 2. Lake Mills delta prior to construction of pilot channel and removal of vegetation. Photograph taken July 29, 2010 courtesy of Tom Rooda at Northwest Territories Inc.

In September 2010, the NPS hired a contractor to remove the dense alder forest on the Lake Mills delta that existed during the July 2010 survey, and construct a 1000-ft long pilot channel (Figure 2 and Figure 3). The Lake Mills delta, created by the river's sediments as they flow downstream, had become overgrown in recent years by a large number of alder trees. As the trees and root systems developed, the delta became more stable and less easily eroded by the river. The removal of vegetation and channel construction helped to maximize the potential for erosion through the delta before, during and after dam removal. In addition to removing trees and creating a pilot channel through the middle of the delta, workers positioned logs to help direct the river towards the entrance of the new pilot channel. A photograph of the Mills delta area post-construction work is shown in Figure 3 after a low-flow period and in Figure 4 after a flood peak of 22,000 cfs. Modifications to the delta topography are not included in the area-capacity or topographic surfaces provided in this report, since the reservoir surveys occurred prior to the construction work.

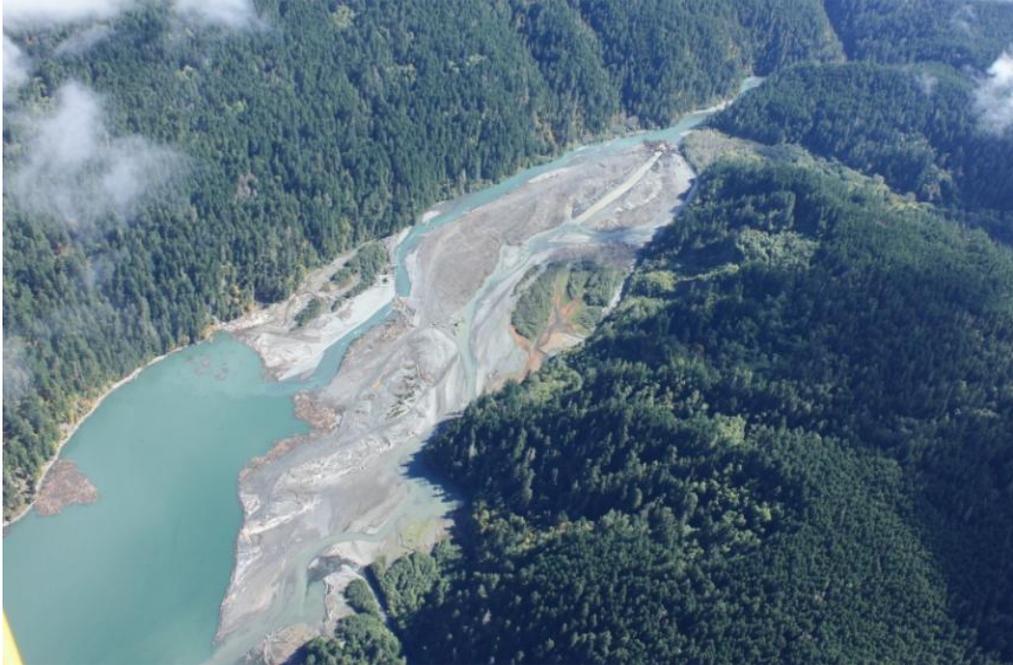
Figure 3. Lake Mills delta with newly constructed center pilot channel and vegetation removal completed. Photograph taken September 28, 2010 courtesy of Tom Rooda at Northwest Territories Inc. The river was diverted into the pilot channel the following day (September 29, 2010) by relocating the log jam at the head of the pilot channel.

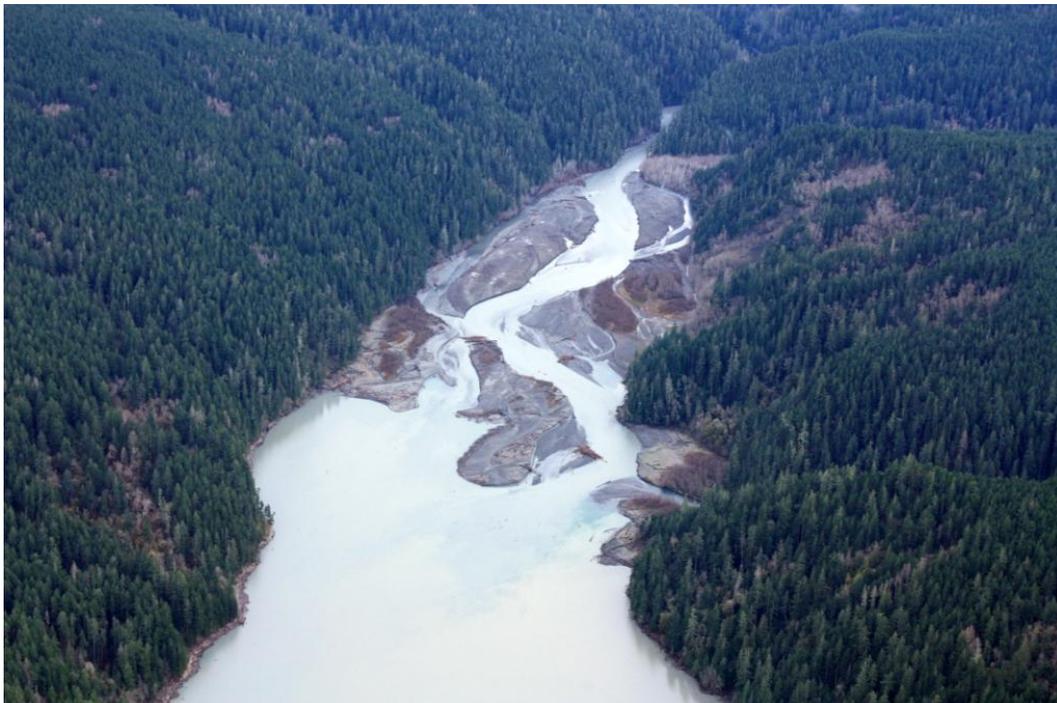
Figure 4. Lake Mills delta on December 15, 2010 following a flood that peaked at 22,000 cfs on December 12, 2010.

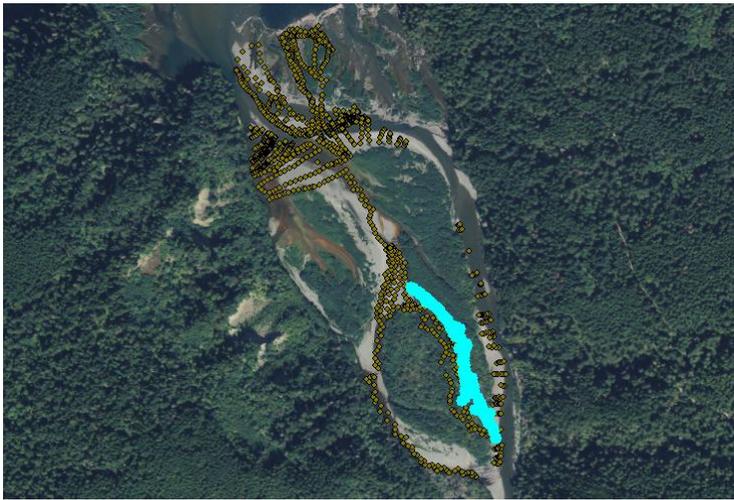
Figure 5. July 2010 RTK topo points on the Lake Mills delta shown on a 2009 aerial photograph. Points highlighted in turquoise were in the middle of the delta in non-wetted areas where little change is expected to have occurred since 2009.

A second comparison was completed for only the points in the middle, non-wetted portion of the delta with vegetation, where the least amount of change is expected to have occurred between 2009 and 2010 (92 points) (Figure 7). In this subset, the elevation difference ranged between -1 and + 3 ft. A negative value indicates that the 2010 surveyed data were lower than the 2009 LiDAR. A mean difference of + 0.6 ft was computed with a standard deviation of 0.5 ft.

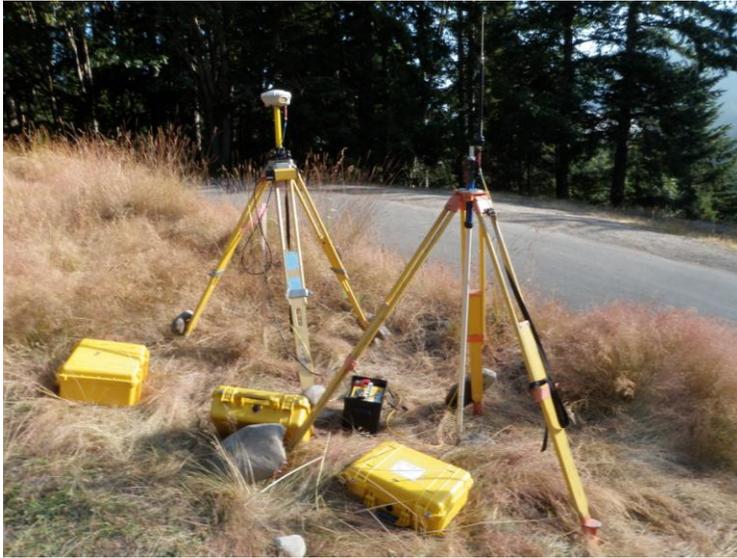
Figure 20. Base station setup for Lake Mills survey.

For Lake Mills the GPS base was set over a Federal Highway Administration cap stamped "Federal Highway Administration, Elwha 1" (Figure 20 and Figure 21). The survey control was set for the Olympic Hot Springs Road Repair. The base was set over ELWHA #1 during all days of the bathymetric and above water survey collection on July 25, July 26 and July 28, 2010. Coordinates for the benchmark could not be located at the time of the survey, so the base was initially set up on July 24, 2010 using the GPS "here" function and later corrected using OPUS. Collected data measurements were shifted to match NAD83/NAVD88 (Table 5).

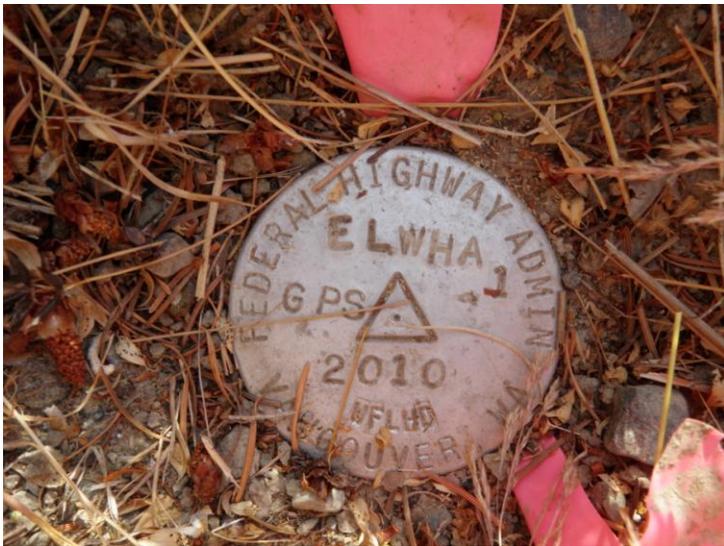
Figure 21. Benchmark where GPS base station was set up for Lake Mills survey work.

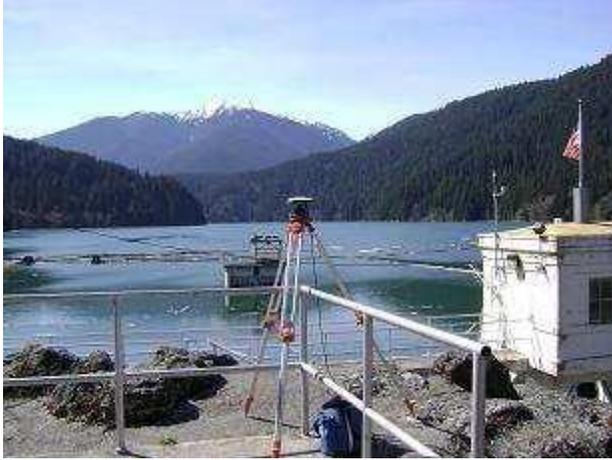
Figure 23. WSDOT benchmark "Gobbling", monument ID: 6513. The mark is a punchmark in the bottom of the hand rail post.

The 2009 LiDAR survey used a WSDOT benchmark for control that is located on Glines Canyon Dam (Figure 23). The LiDAR reported the coordinates of this point as 963,201.162 easting (ft), 377,856.296 northing (ft), and 616.515 ft elevation (NAVD 88). The LiDAR value at this location for elevation was 616.380 ft, with a reported difference of -.14 ft. However, when this monument was looked up on the WSDOT website (www.wsdot.wa.gov/monument), the latest reported coordinates were slightly different at 963,203.4 easting (ft), 377,857.2 northing (ft), and elevation was 616.345 ft (NAVD 88). The differences may be due to rounding error applied when converting the WSDOT monument sheet values from meters to feet (the values reported in this appendix used a conversion function in excel). The July 2010 survey got an elevation near this monument of 616.448 ft which compares within 0.1 ft.

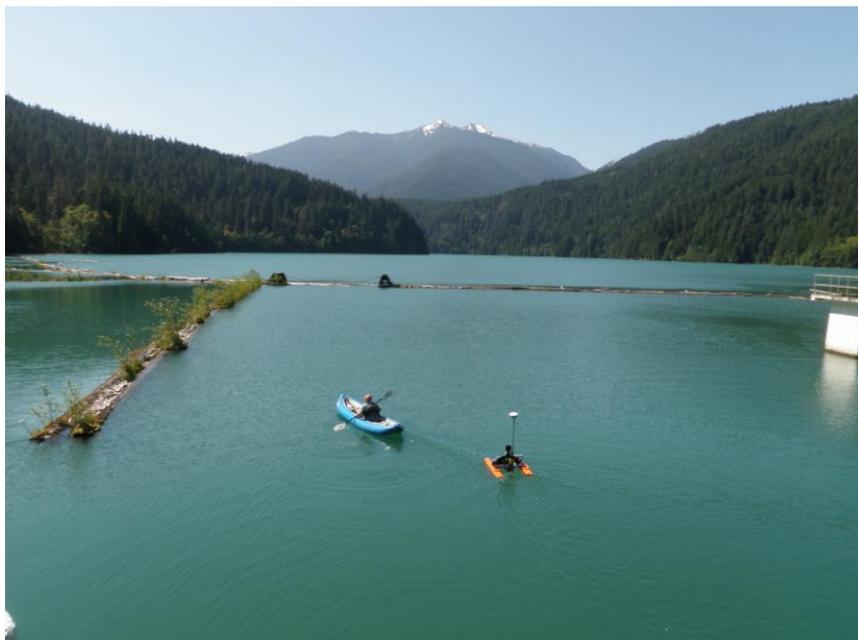
Figure 24. Survey setup for Lake Mills log boom area utilized on July 28, 2010.

On July 28, 2010 three RTK GPS rovers were used. One unit was used to measure depths in the log boom area near Glines Canyon Dam. In the log boom area, it was not possible to get the survey boat over the logs and it would have been difficult to safely navigate near the dam and outlet release gates. Therefore, a Hydrolite depth sounder and RTK GPS antennae was mounted to a small pontoon and pulled with a kayak. Two RTK rovers were used to collect additional topo data points in the upper delta of the reservoir.

The Lake Mills points were post-processed by subtracting the depth from the RTK GPS elevation point to generate a reservoir bottom elevation. A water surface elevation was generated by adding the transducer draft (typically 0.5 to 0.8 ft) to the RTK GPS recorded elevation. A total depth was generated by adding the transducer draft to the recorded depth. Depth soundings were recorded in areas greater than 1.5 ft deep.
