## **Flood Resilience of Traditional Building Materials**

Report of simulated flood immersion according to ASTM E3075 standard procedures

May 2019

Under Project 473944, "Resilience Of Traditional Materials"

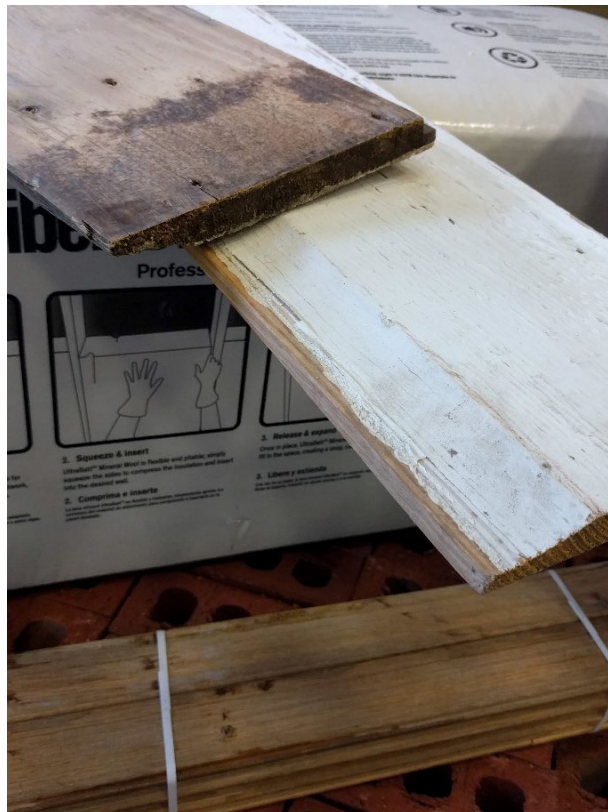
Figure 3. Selection of new and reclaimed materials procured for this project, with evidence of existing mold and coatings on the two styles of reclaimed siding.

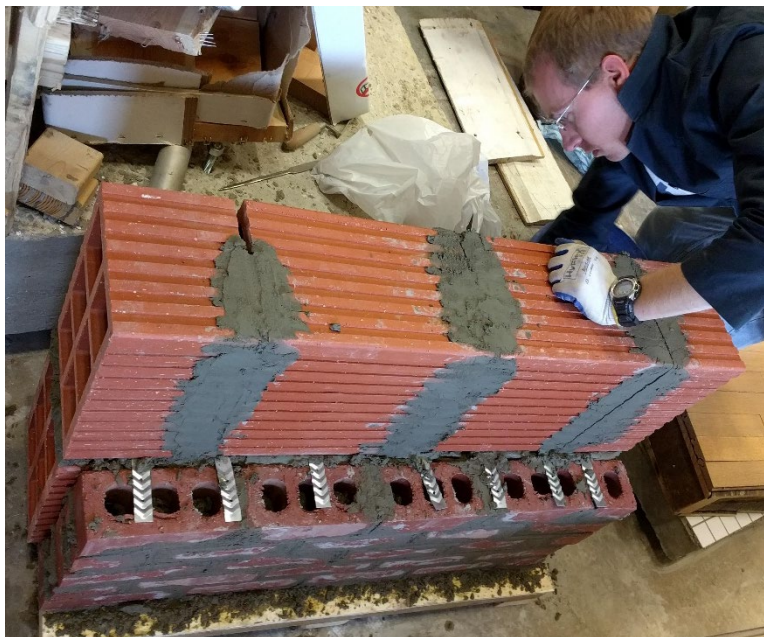
Figure 4. Construction of Wall B.

Extruded and handmade bricks and tiles were used in as-received condition, except when it was necessary to brush off excessive dust. Partial bricks were cut using a diamond-tipped concrete saw. Lime mortars were mixed at an approximate volume ratio of 2.5 parts sand to 1 part lime putty with no added water. Portland-lime mortars contained about 3 parts sand to 1 part cement by volume, with lime added at 15% of the volume of cement. Limewash was produced using lime putty and water to create a proper consistency for coating applications. Figure 4 shows Wall B under construction.

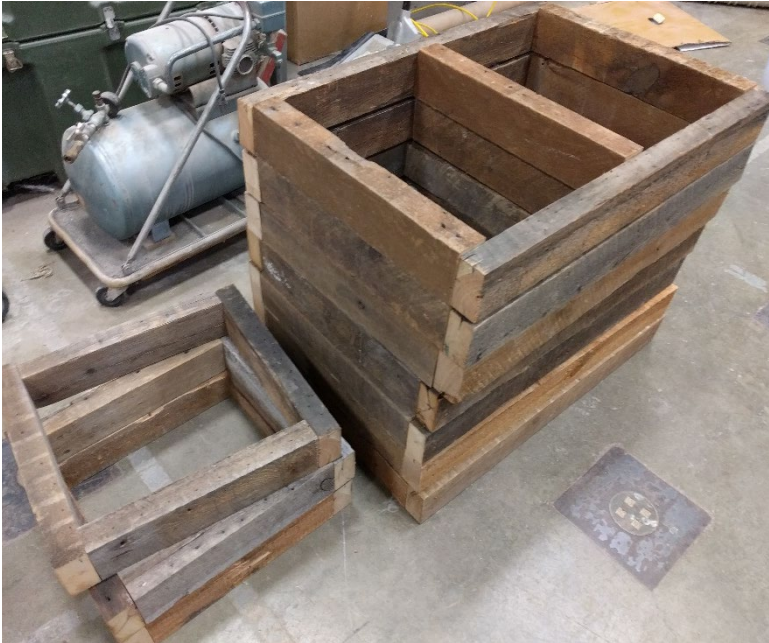
Figure 5. True-dimension wood wall and floor joist framing.

Wood wall framing was constructed of reclaimed true-dimension lumber, as pictured in Figure 5. Walls were constructed in groups (Figure 6) in order to maximize labor efficiency. Wall interiors of three-coat plaster over reclaimed wood lath were constructed with appropriate keys and scoring in the scratch coat (Figure 7) and appropriate drying times between scratch, brown, and surface coat applications (Figure 8). Stucco for Wall K was prepared in a similar manner as Portland-lime mortars for Wall B.

Floor joist framing was constructed of reclaimed true-dimension lumber, as pictured in Figure 5. Figure 9 is a photograph of the sides of Floors A and D. The depth of penetration of tung oil into the heart pine of Floor A is visible forward in the frame and the diagonal sheathing construction of Floor D is in the background. Nails were added to the bottom of wood floor sections in order to meet the standard specification of spacing from the bottom of the treatment container, while maintaining the minimum specified depth below the simulated flood water line. Floor C was constructed of normal weight concrete with ASTM #67 limestone, graded

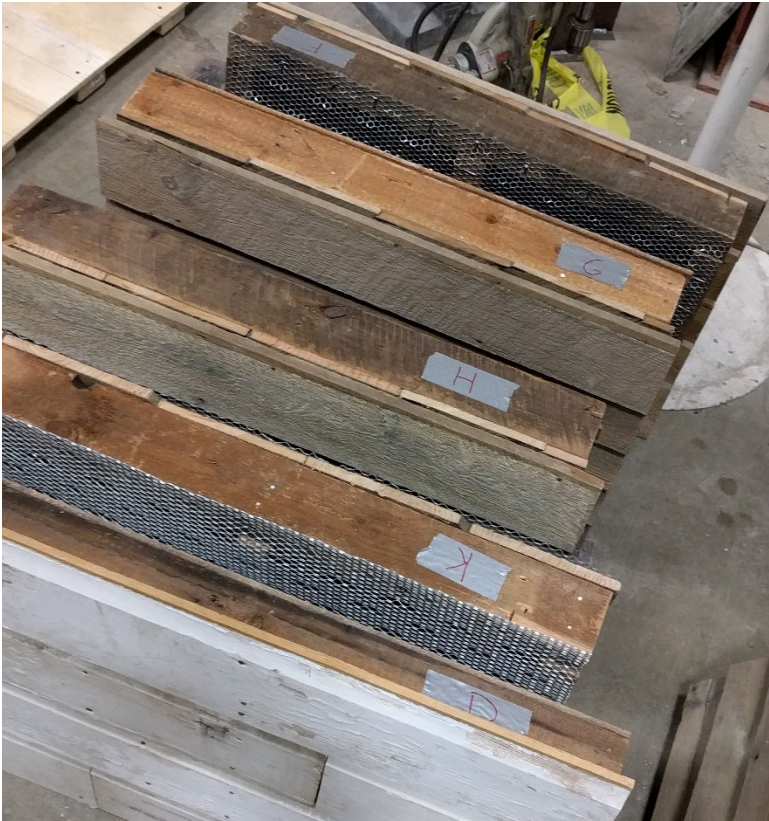
Figure 6. Walls D, F, G, H, and K prepared for plaster and stucco application.

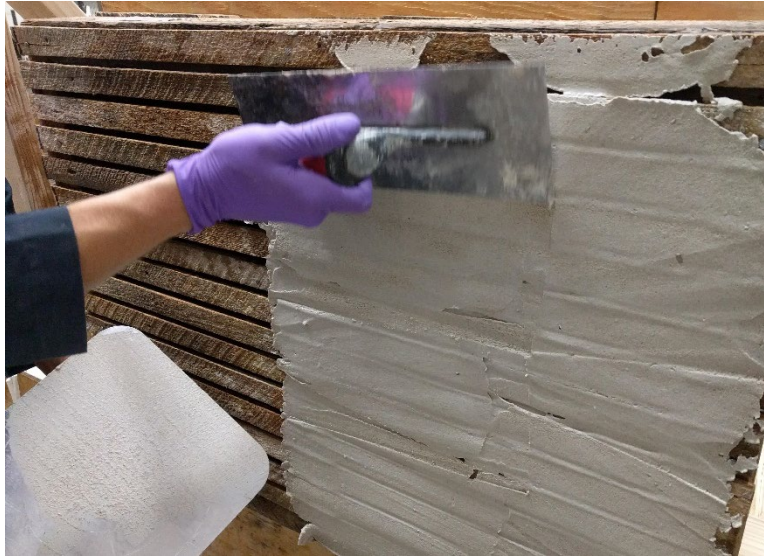
Figure 7. Plaster scratch coat application.

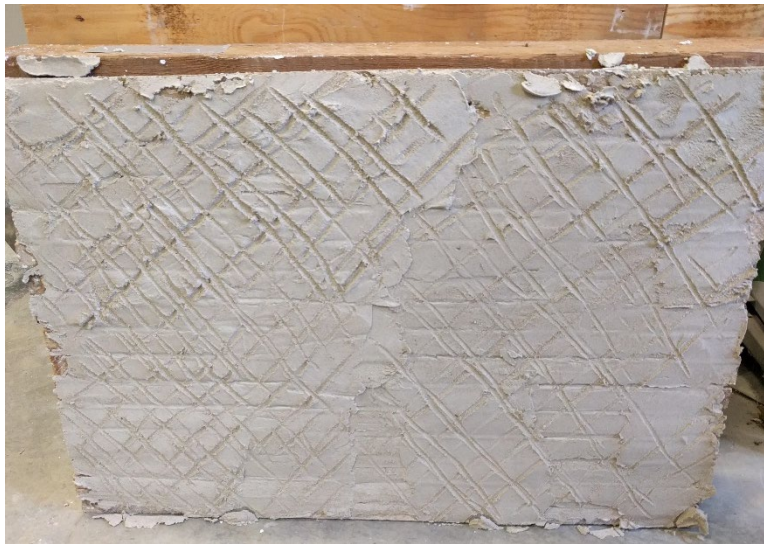
Figure 8. Plaster scratch coat with scoring allowed to dry.

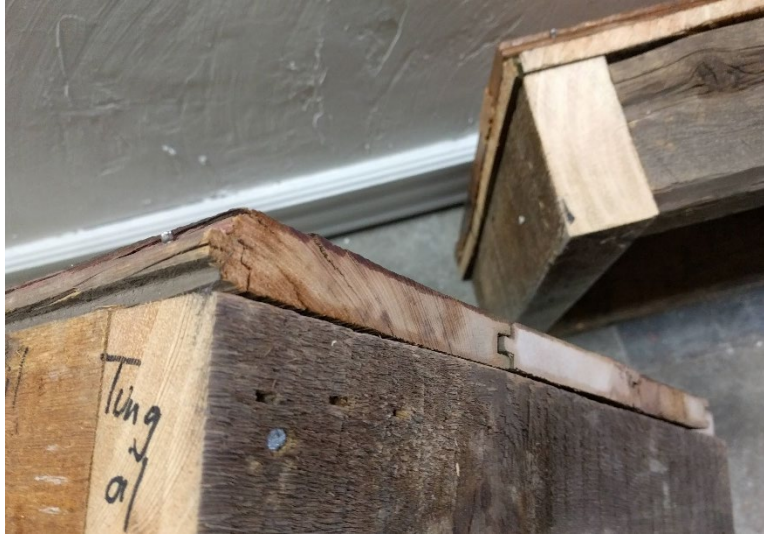
Figure 9. Floors A and D showing depth of penetration of tung oil finish.

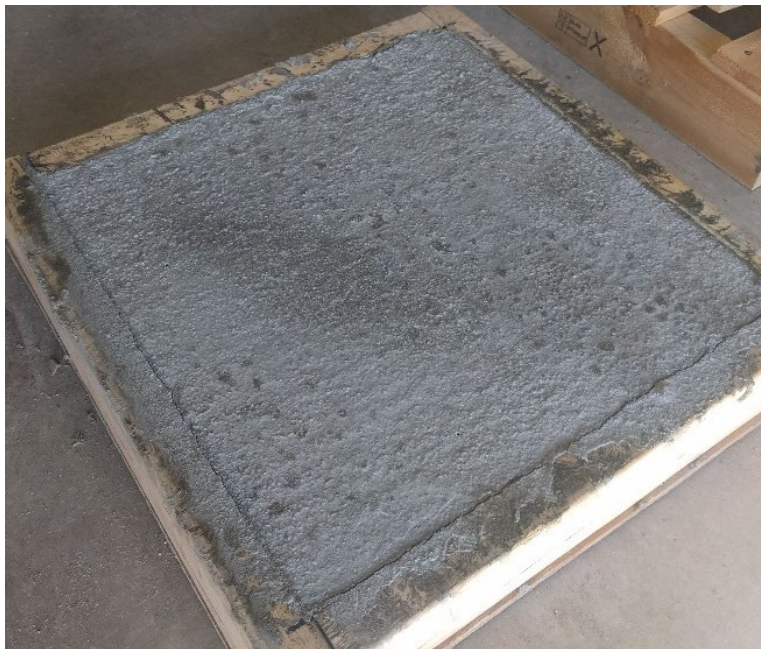
Figure 10. Formwork containing the limestone concrete base of Floor C.

sand, and Portland cement (Figure 10). After curing, four anchor bolts were sunk partially into the sides of the base to enable lifting of the specimen.

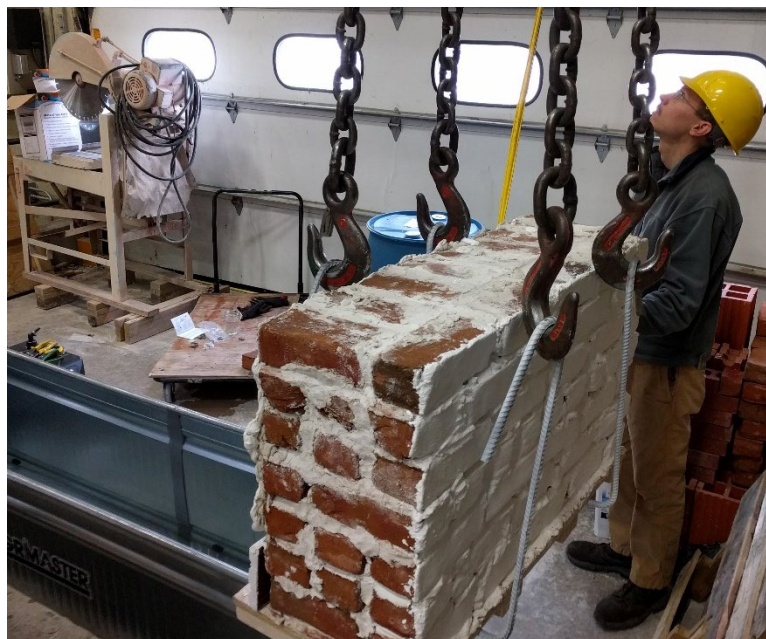
**Figure 11. Lifting Wall A into position at the beginning of Test 1.**

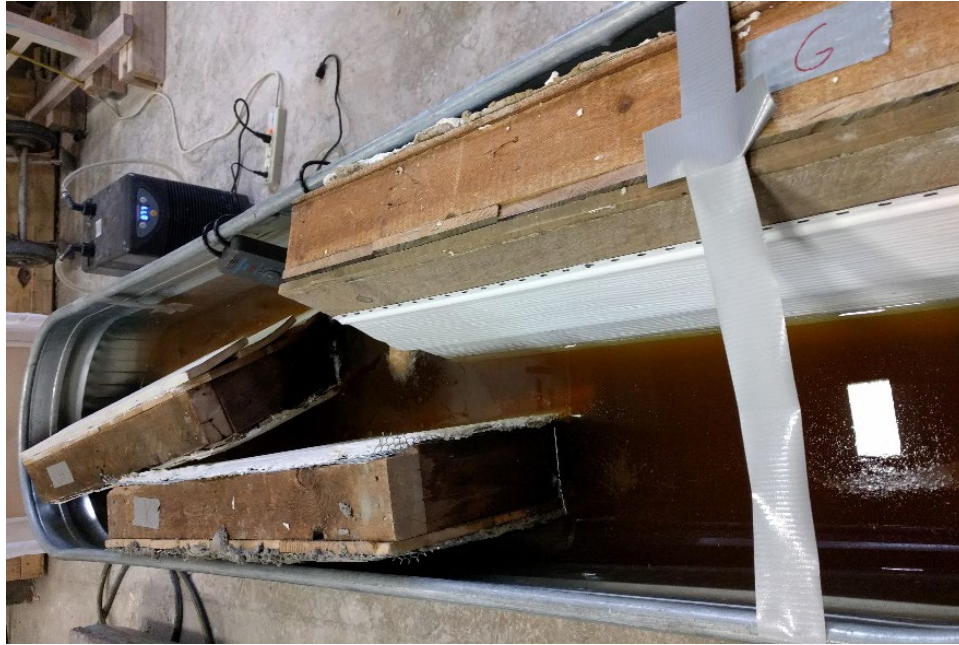
Figure 13. Photograph taken at the completion of Test 4.

1. Test 1 was under-filled with a 40-gal. batch size, so displacing bricks were used to raise the water level to above the top of the baseboard. The remaining tests, except Test 5, used 80-gal. batch sizes.
2. At some time during Test 4, the duct tape holding Walls H and G vertically failed, allowing Walls H and G to tilt about 10 to 15 degrees toward their interior sides (Figure 13).
3. At some time during Test 5, the pump flow was blocked by a pinched hose. The lack of flow to the chiller resulted in a treatment temperature of 80 °F, which remained within specification. Flow and chilling to 75 °F were restored for the final 8 hours of treatment.

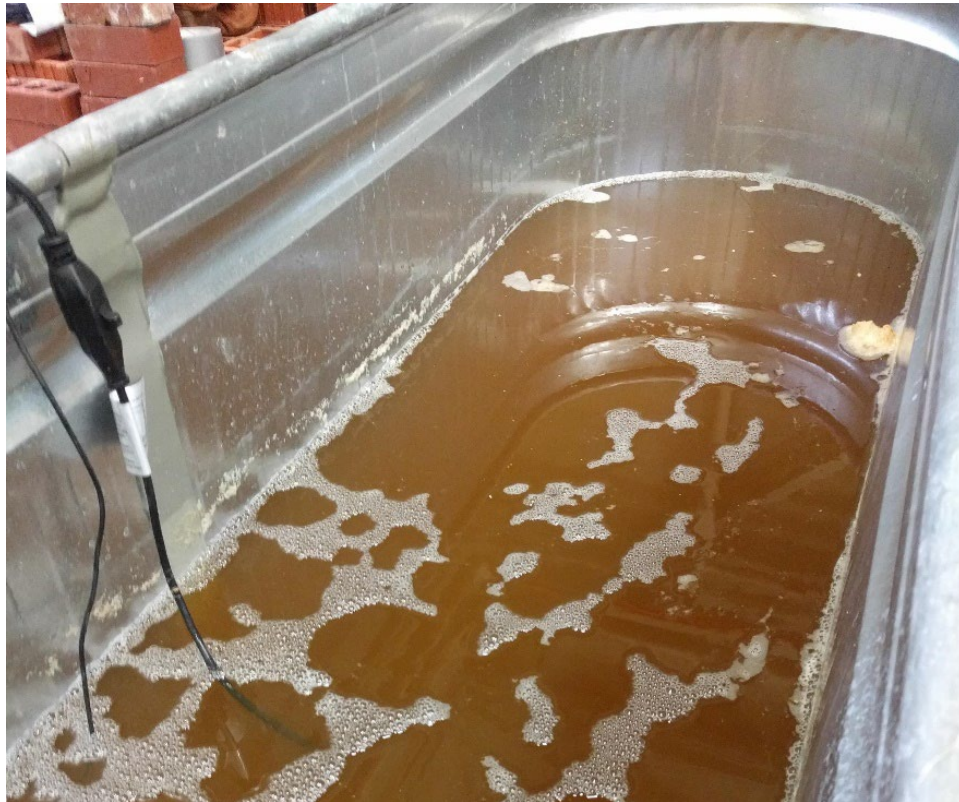
Figure 14. Typical appearance of treatment solution after removing specimens.

Figure 14 shows the typical appearance of the treatment solution after the removal of test specimens.

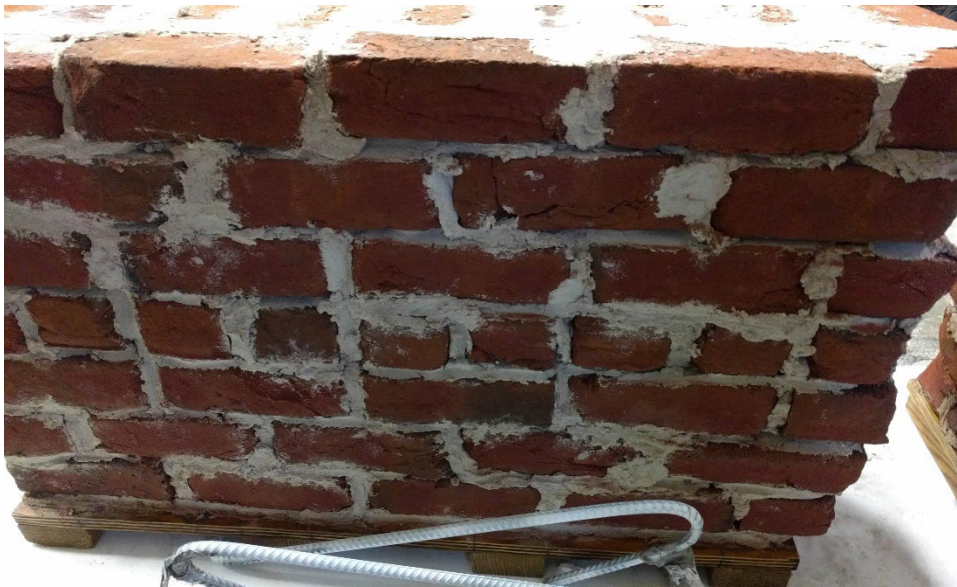
Figure 15. Photograph of Wall A exterior after treatment.

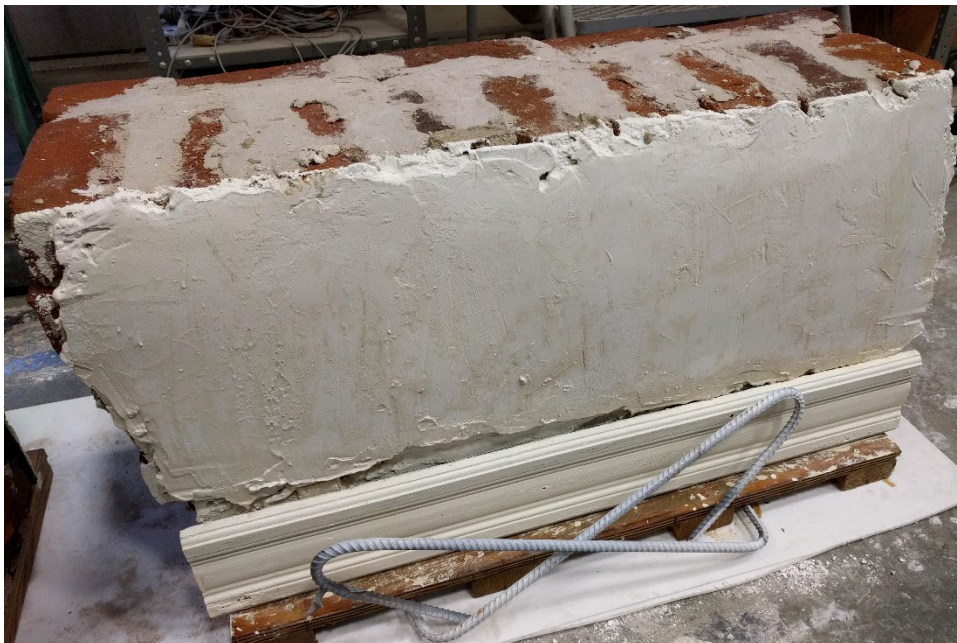
Figure 16. Photograph of Wall A interior after treatment.

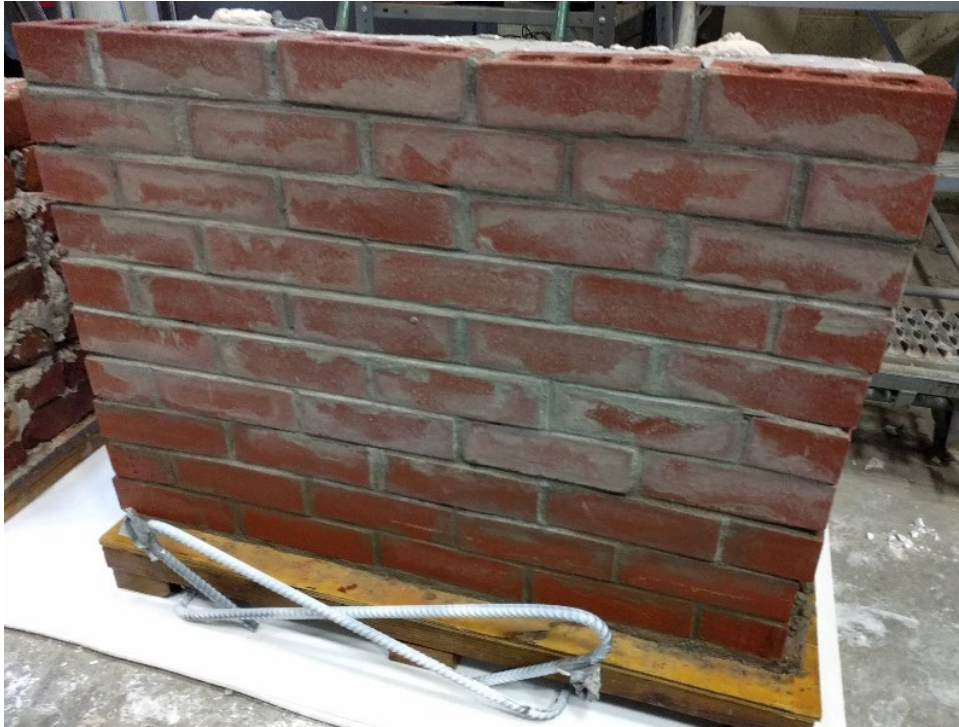
Figure 17. Photograph of Wall B exterior after treatment.

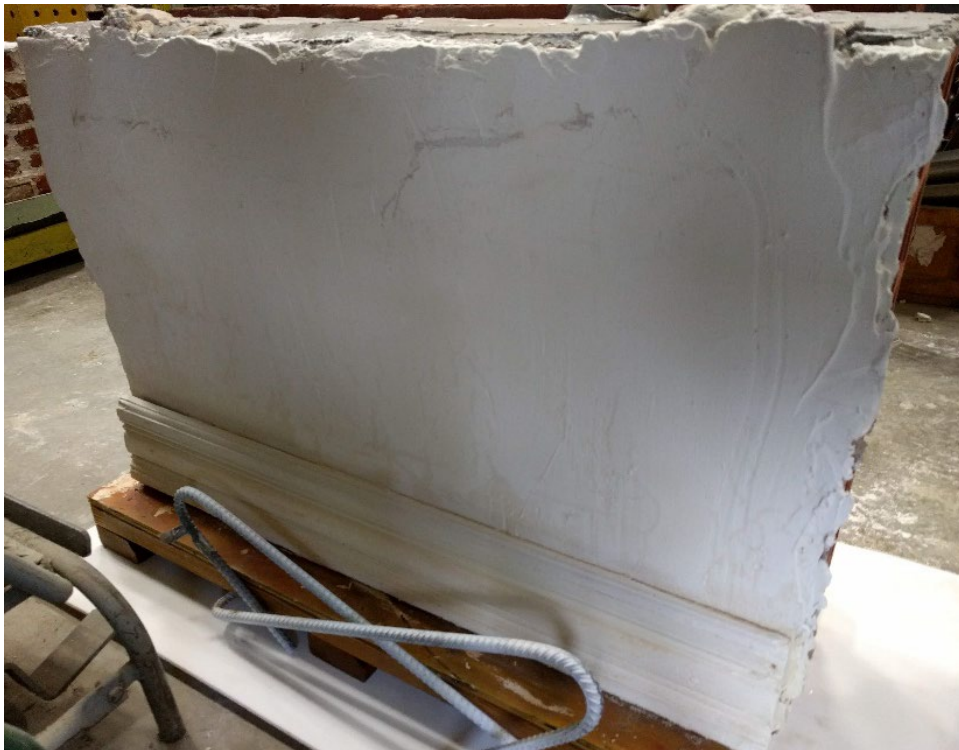
Figure 18. Photograph of Wall B interior after treatment.

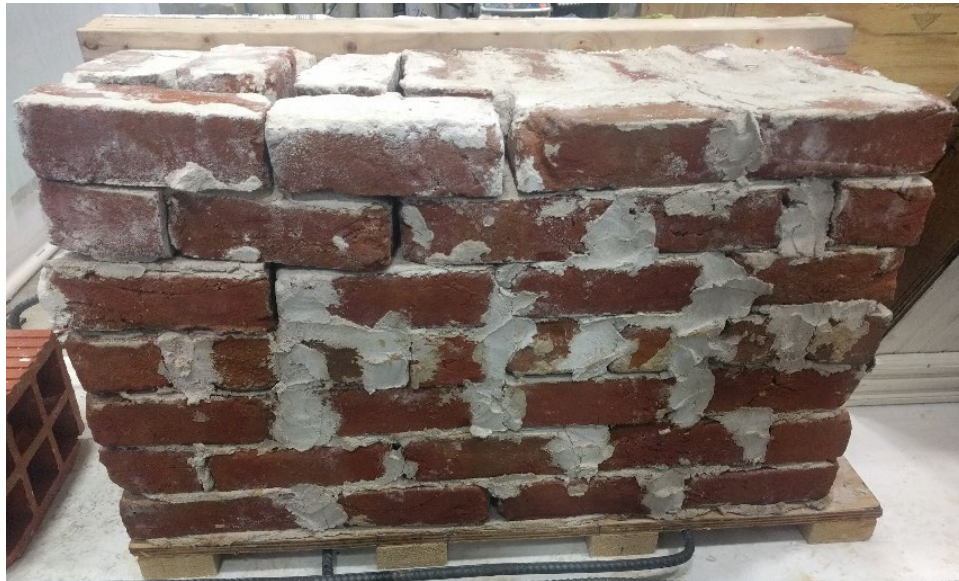
Figure 19. Photograph of Wall E exterior after treatment.

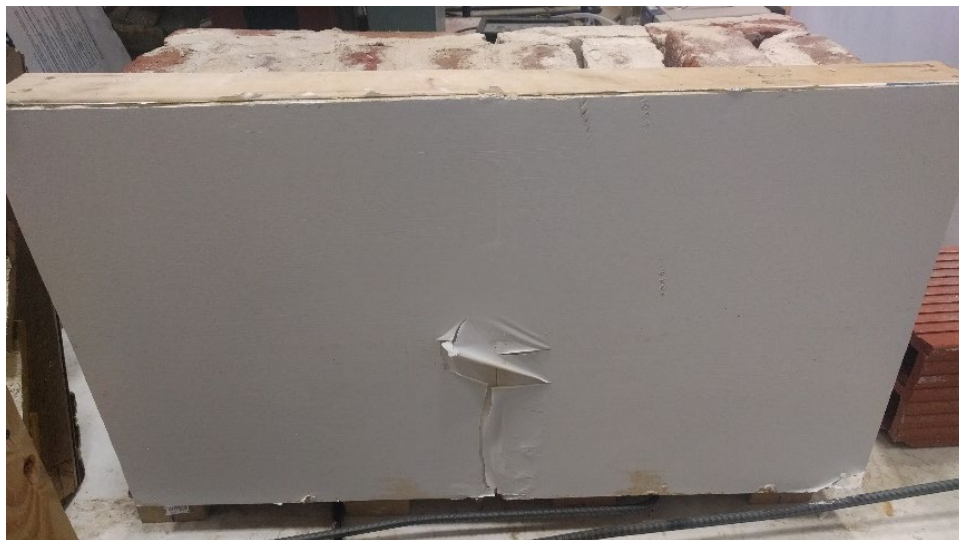
Figure 20. Photograph of Wall E interior after treatment.

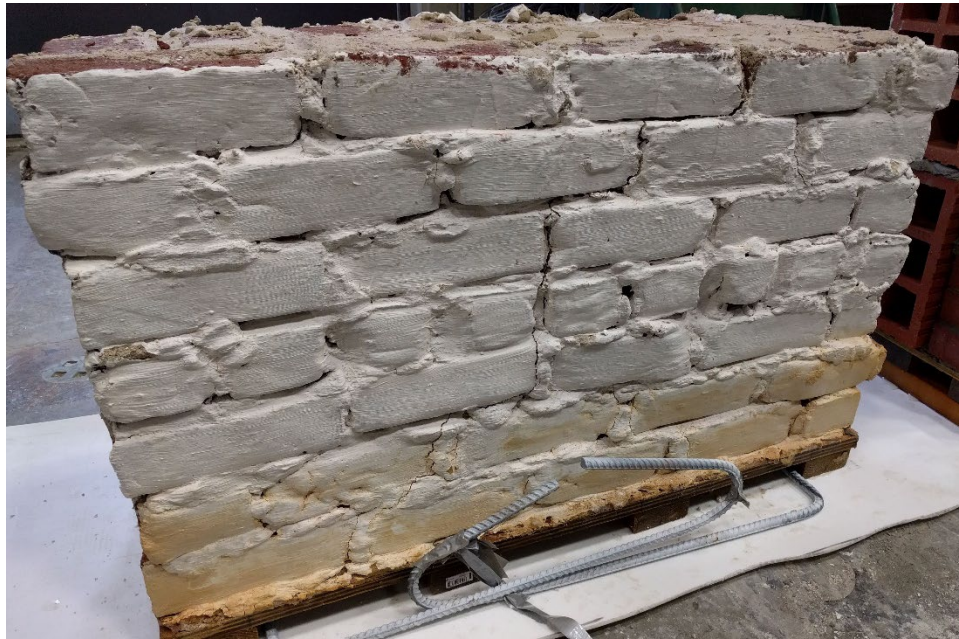
Figure 21. Photograph of Wall I exterior after treatment.

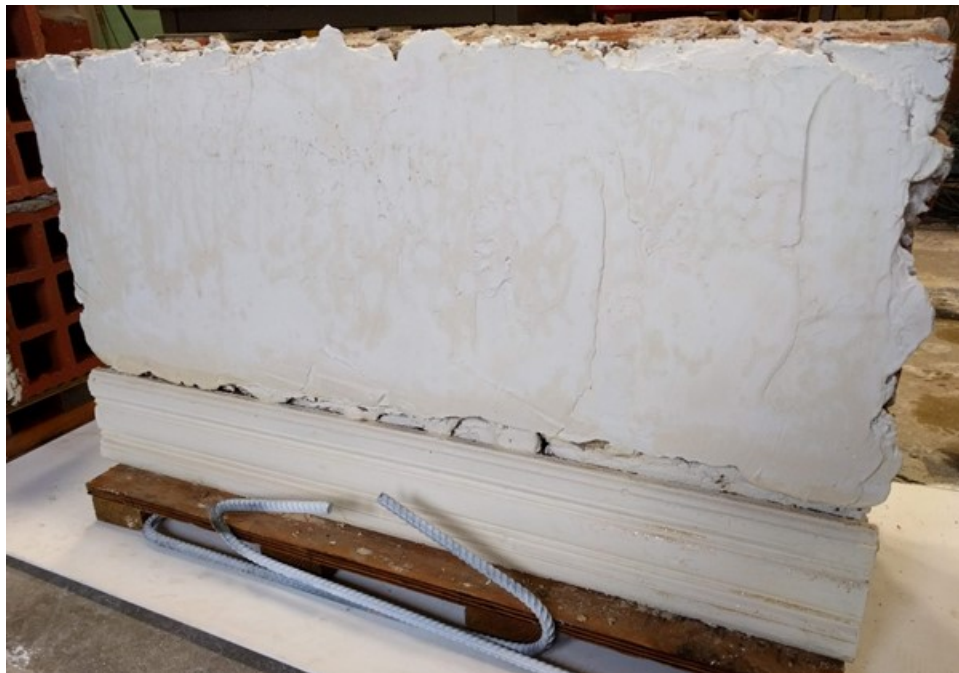
Figure 22. Photograph of Wall I interior after treatment.

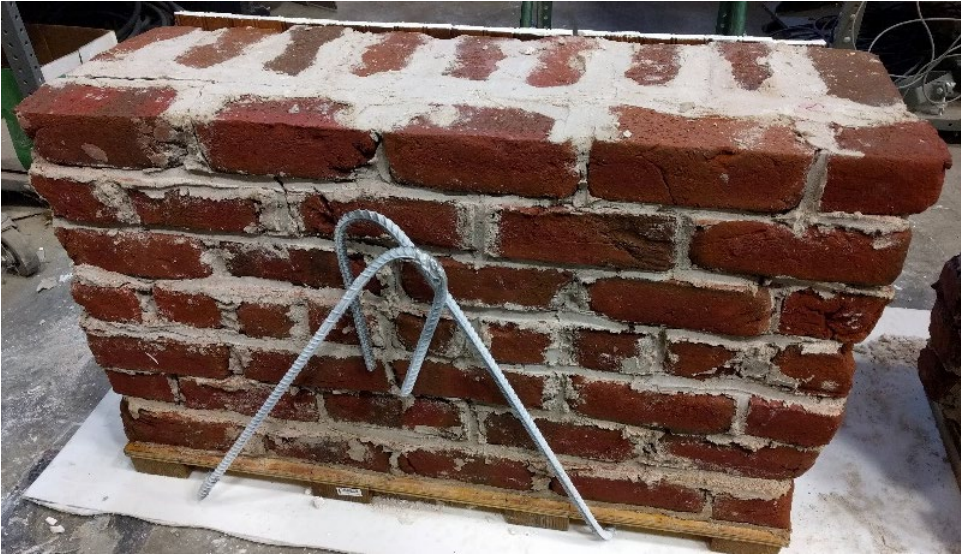
Figure 23. Photograph of Wall J exterior after treatment.

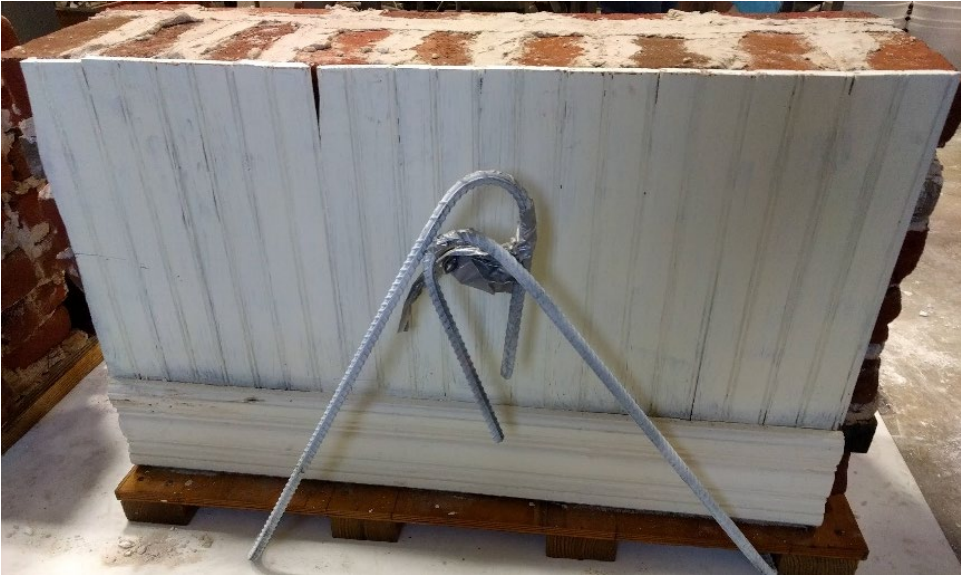
Figure 24. Photograph of Wall J interior after treatment.

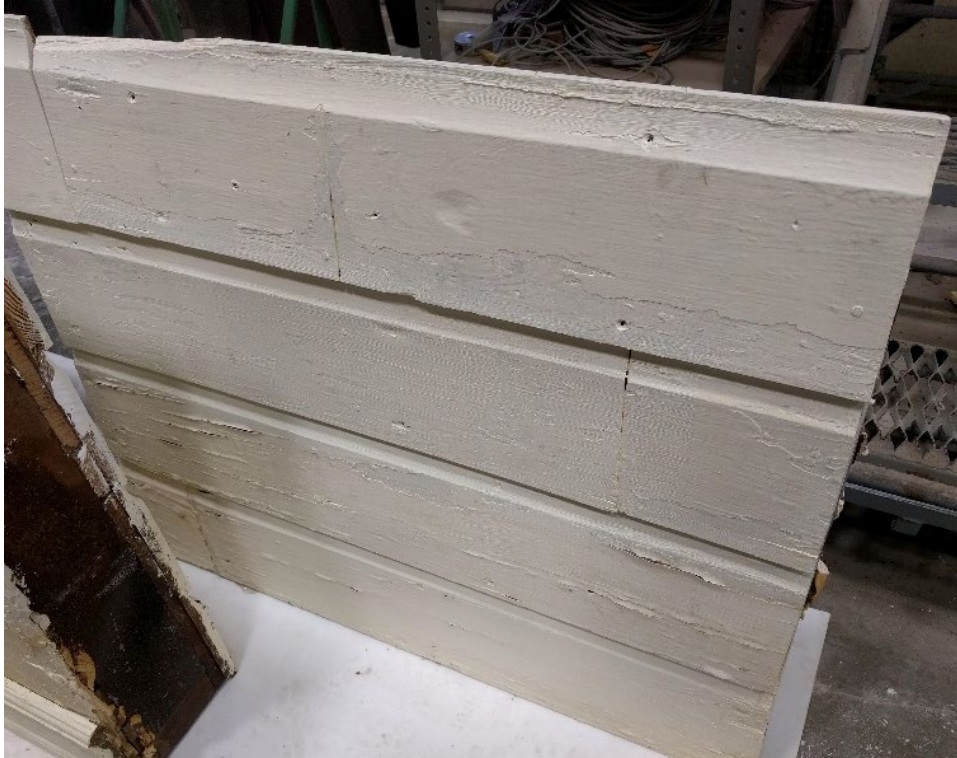
Figure 25. Photograph of Wall C exterior after treatment.

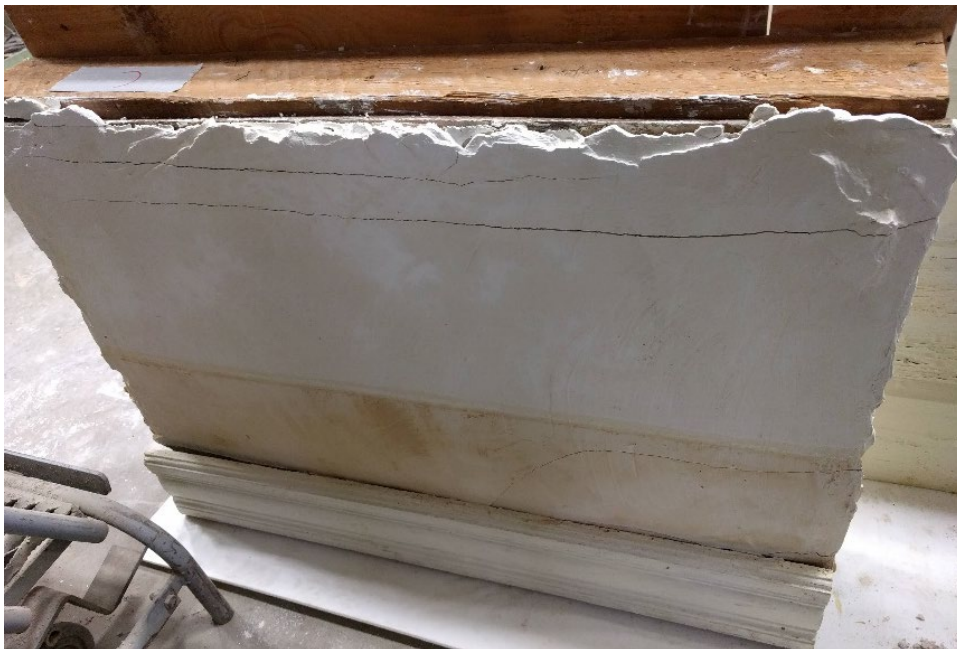
Figure 26. Photograph of Wall C interior after treatment.

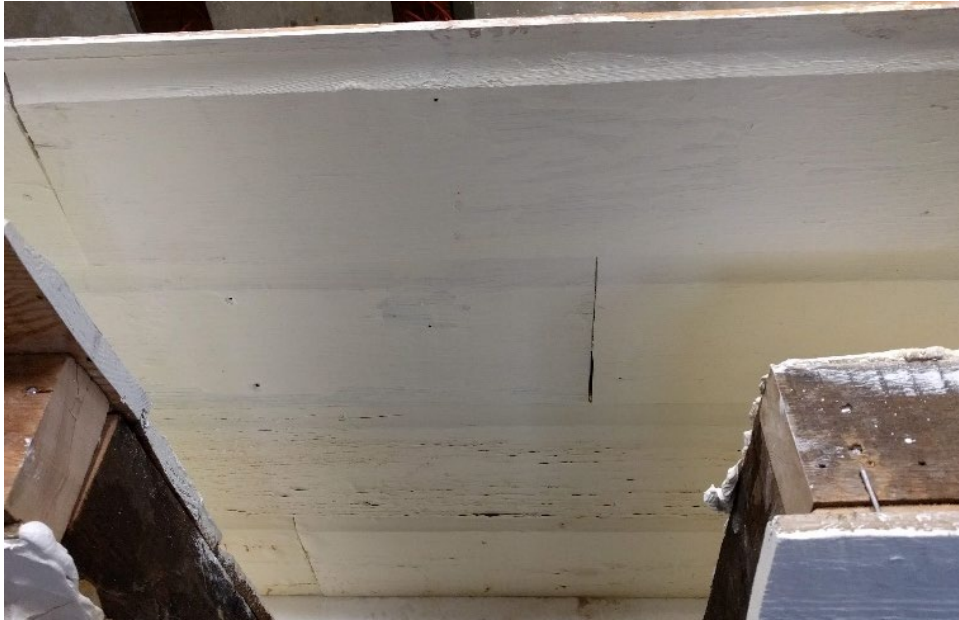
Figure 27. Photograph of Wall D exterior after treatment.

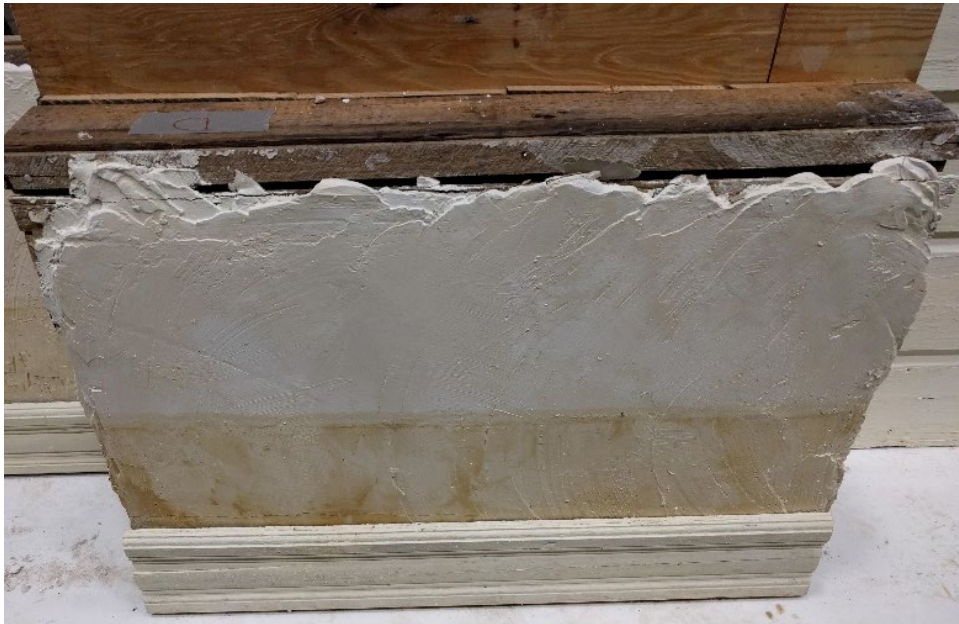
Figure 28. Photograph of Wall D interior after treatment.

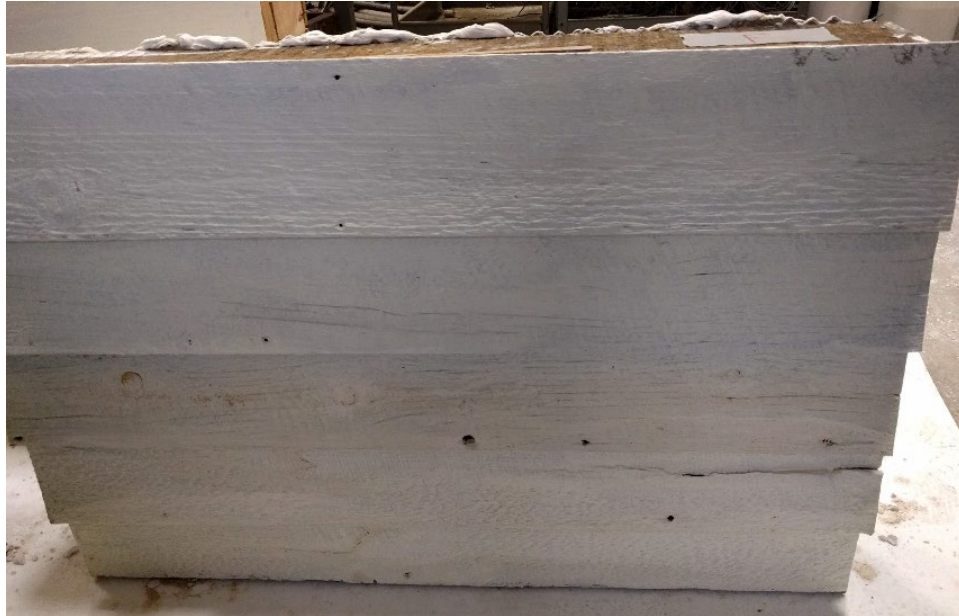
Figure 29. Photograph of Wall F exterior after treatment.

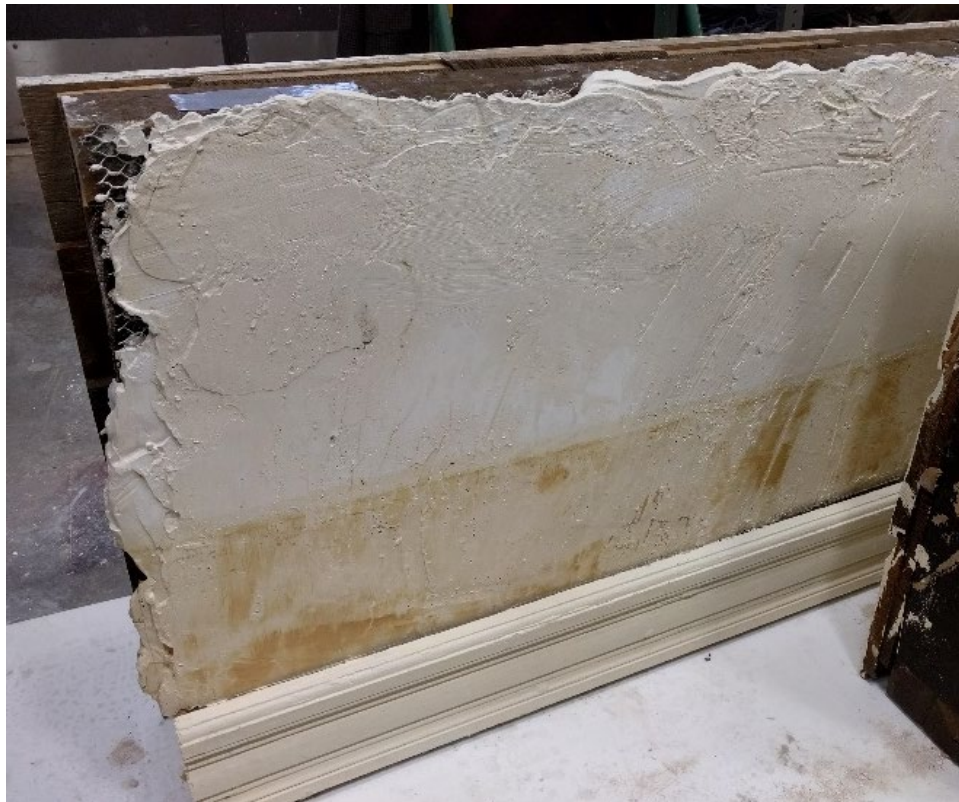
Figure 30. Photograph of Wall F interior after treatment.

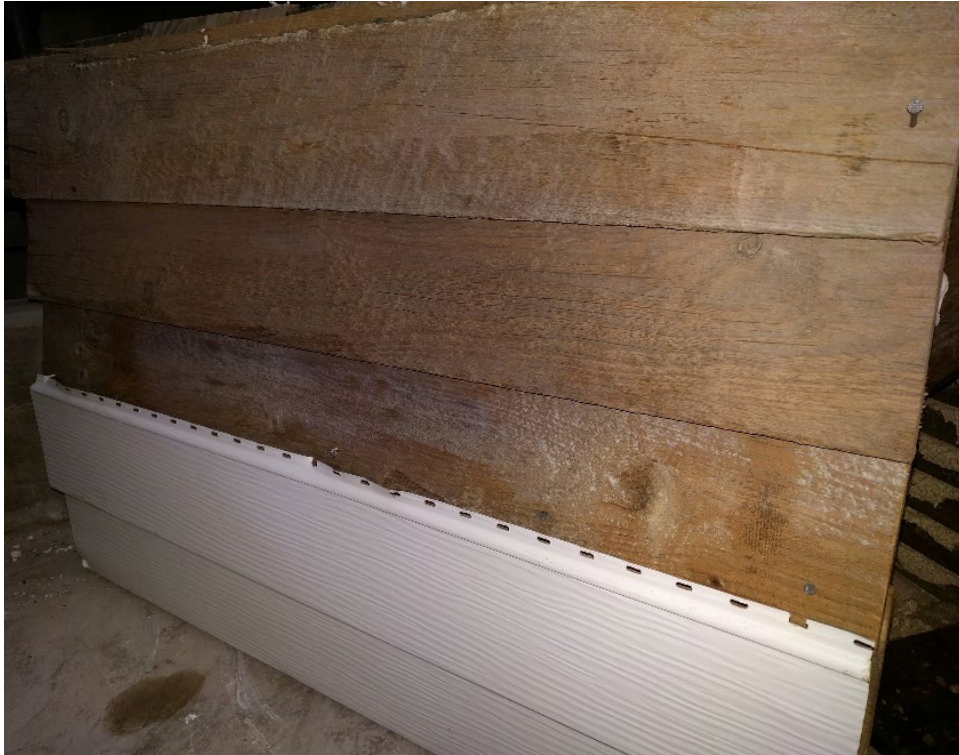
Figure 31. Photograph of Wall G exterior after treatment and disassembly.

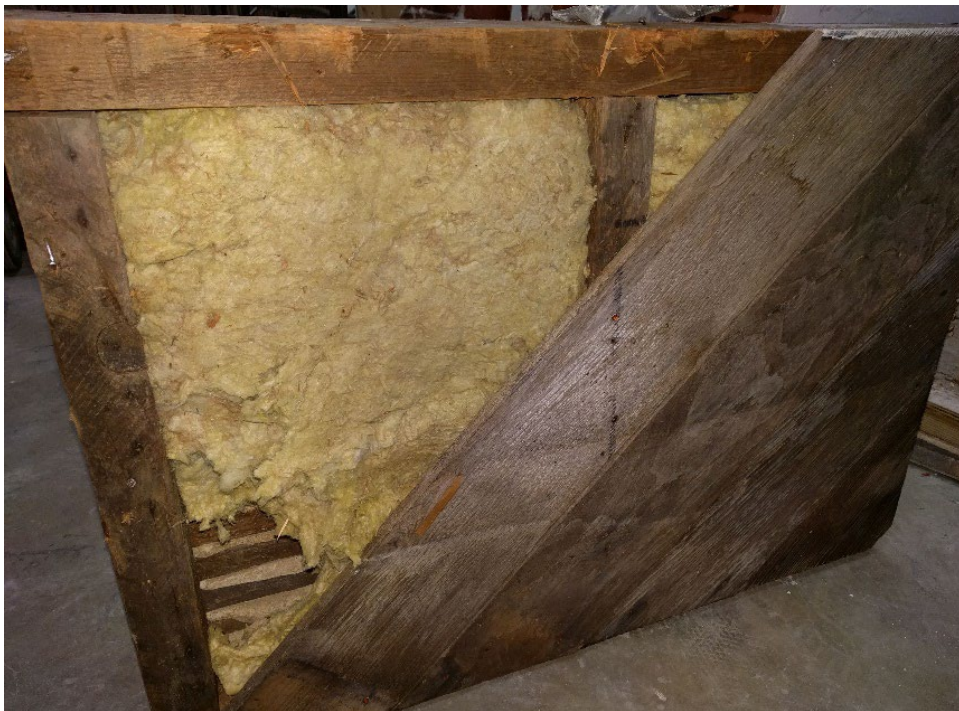
Figure 32. Photograph of Wall H cavity after treatment and disassembly.

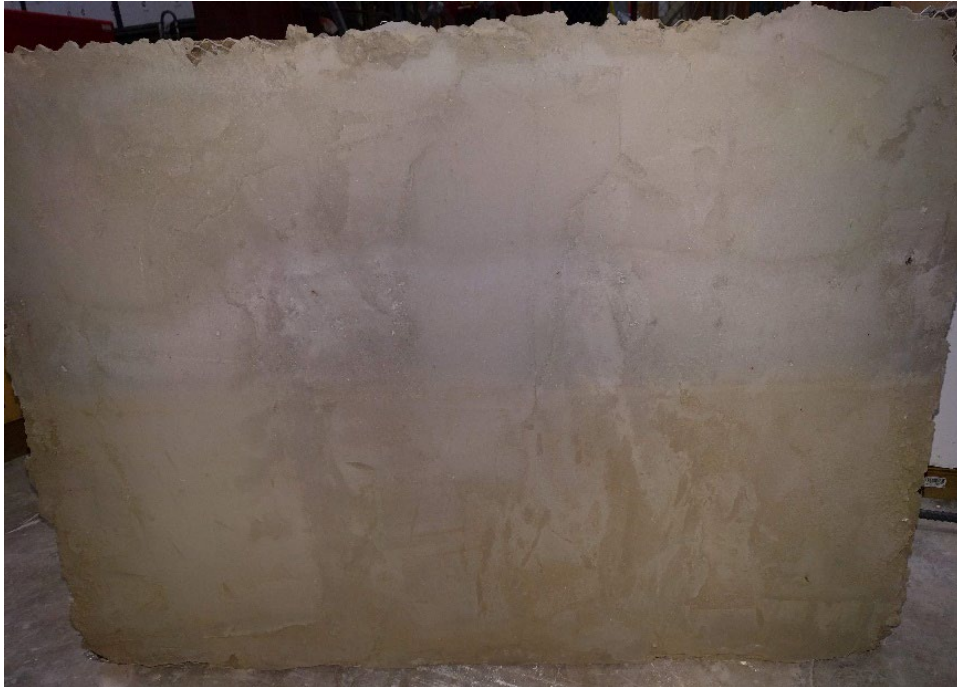
Figure 33. Photograph of Wall K exterior after treatment.

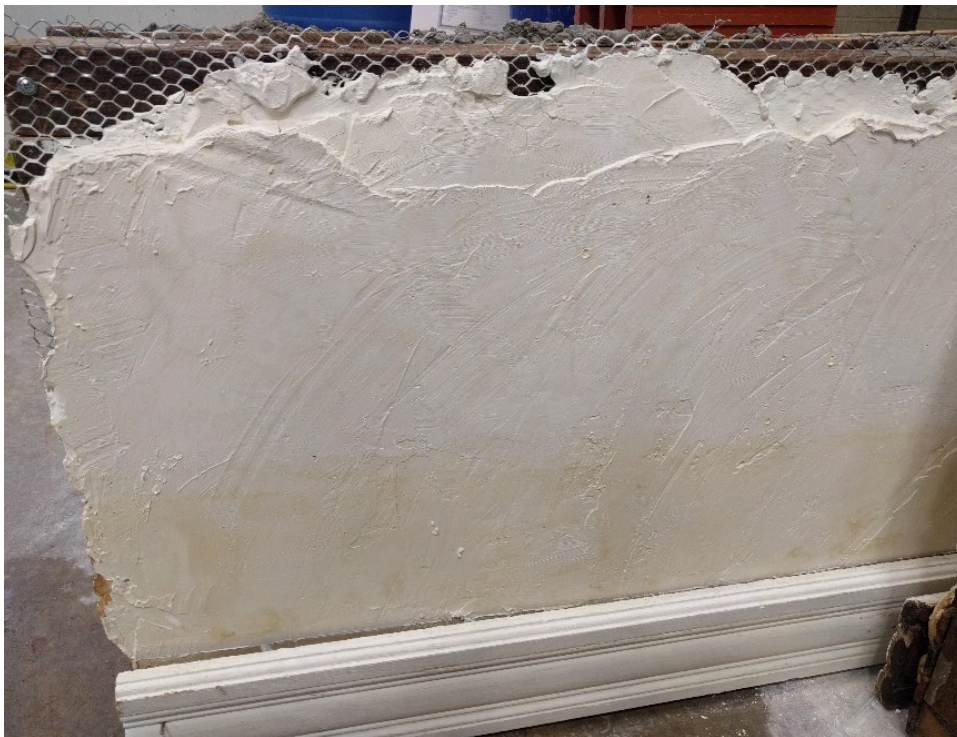
Figure 34. Photograph of Wall K interior after treatment.

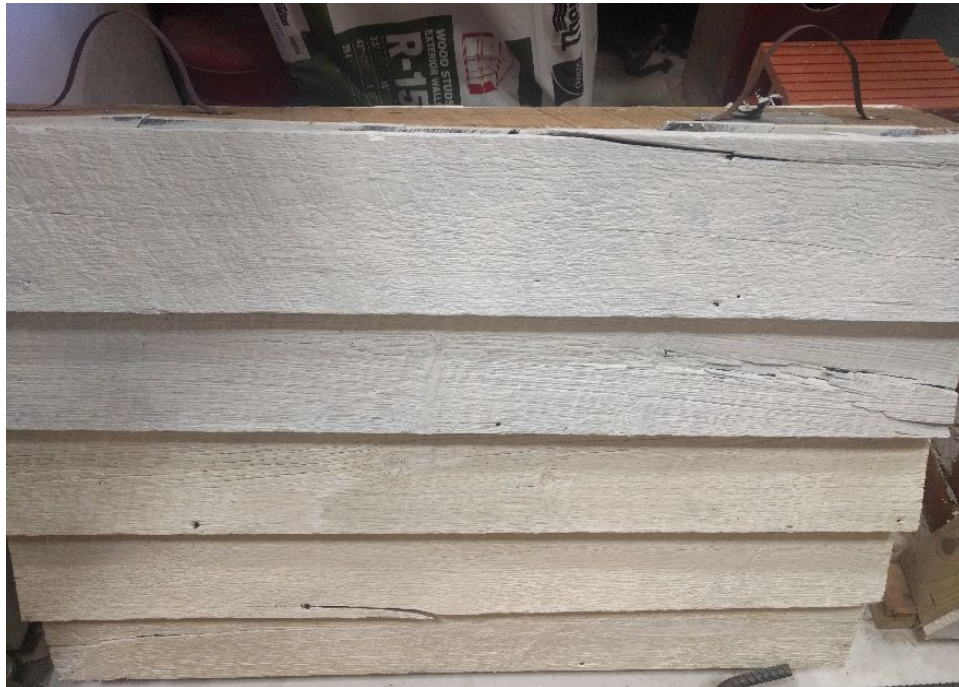
Figure 35. Photograph of Wall L exterior after treatment.

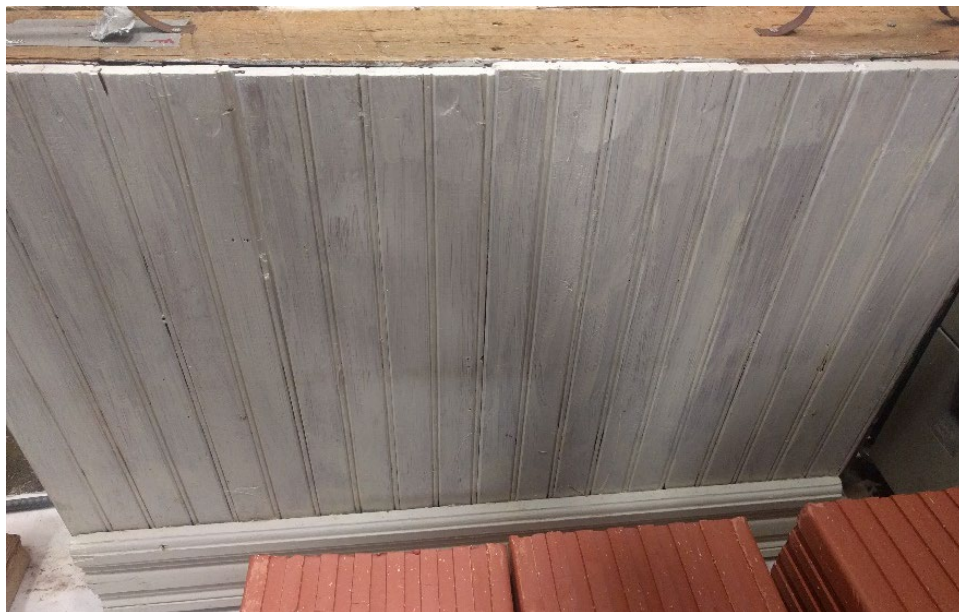
Figure 36. Photograph of Wall L interior after treatment.

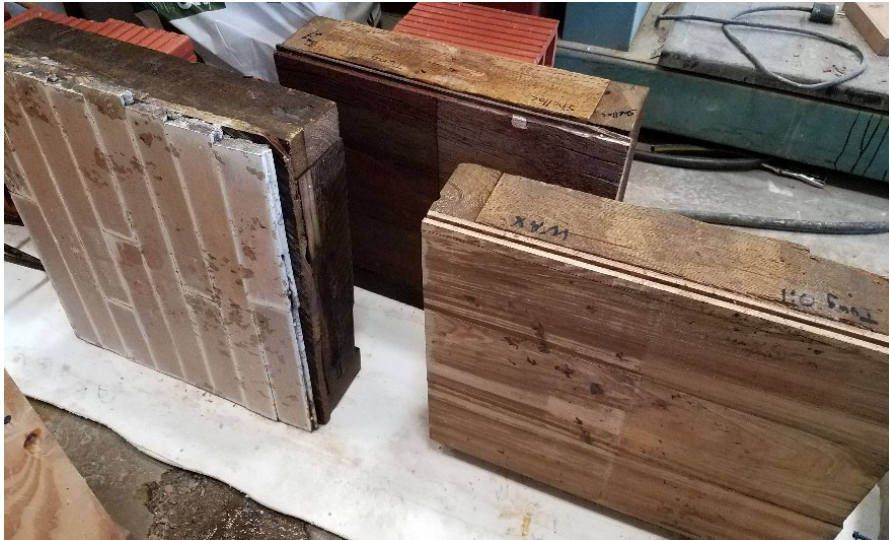
Figure 37. Photograph of Floors A, B, and D after treatment.

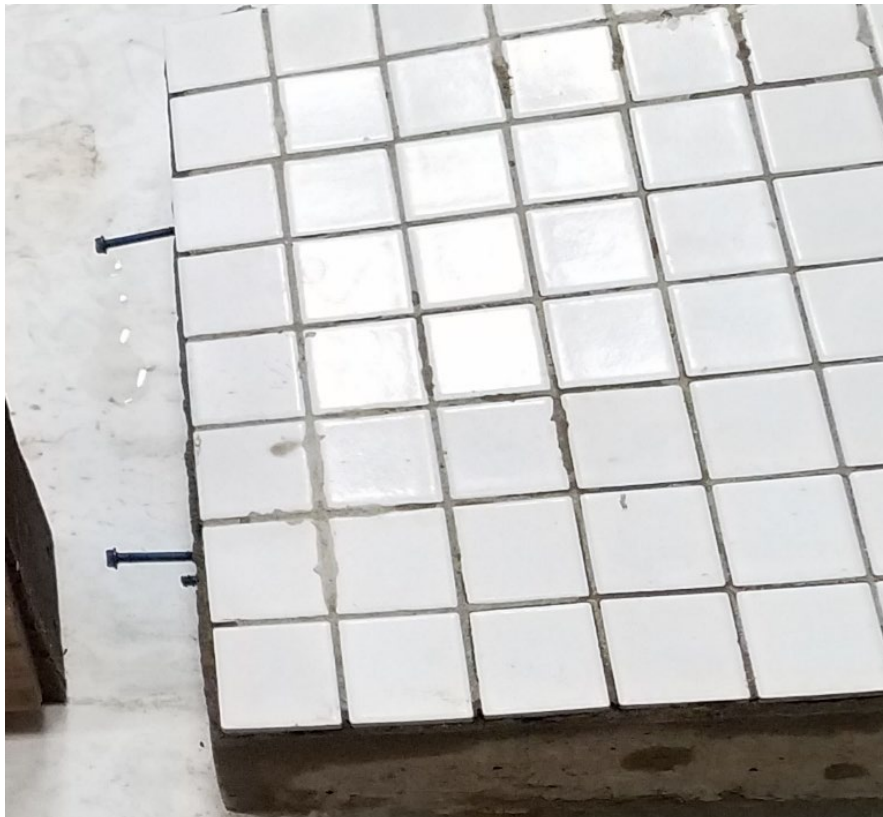
Figure 38. Photograph of Floor C after treatment.
