## **Flood Resilience of Traditional Building Materials**

Report of simulated flood immersion according to ASTM E3075 standard procedures

May 2019

Under Project 473944, "Resilience Of Traditional Materials"

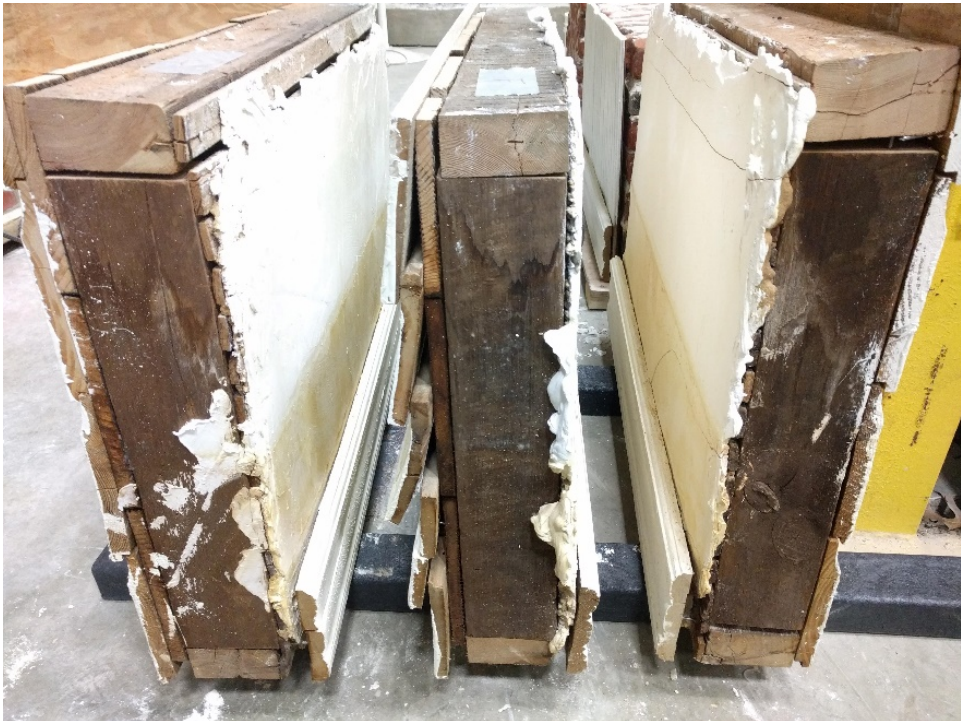
Figure 42. Photograph of Wall C, D, and F frames showing wicking of the treatment solution and subsequent mold growth during the drying phase.

In the tests reported here, most new ceramic and hard materials (Wall B, Floor C) took on little water and cleaned easily, returning <1 MPN and cfu in swab tests. Surfaces coated with lead-based paint also fared well, except where the paint had peeled. Specimens containing porous materials, such as plaster and lime-based mortar, required significantly longer drying times. The flood solution tended to wick upward above the flood water line, especially within plaster, lime mortar, and wood frames (Figure 42). The mineral wool insulation held the most water by far and was not able to dry within the allotted time frame of the project, but the closed-cell spray foam (Wall E, Figure 43) performed well, despite high counts of surviving mold and bacteria. Cavities, subfloors, surfaces behind baseboards, and sheathing all showed high coliform activity and/or fungal counts due to the lack of physical access during cleaning. Considering these results, recommended classifications of materials tested during this project are provided in Table 9.

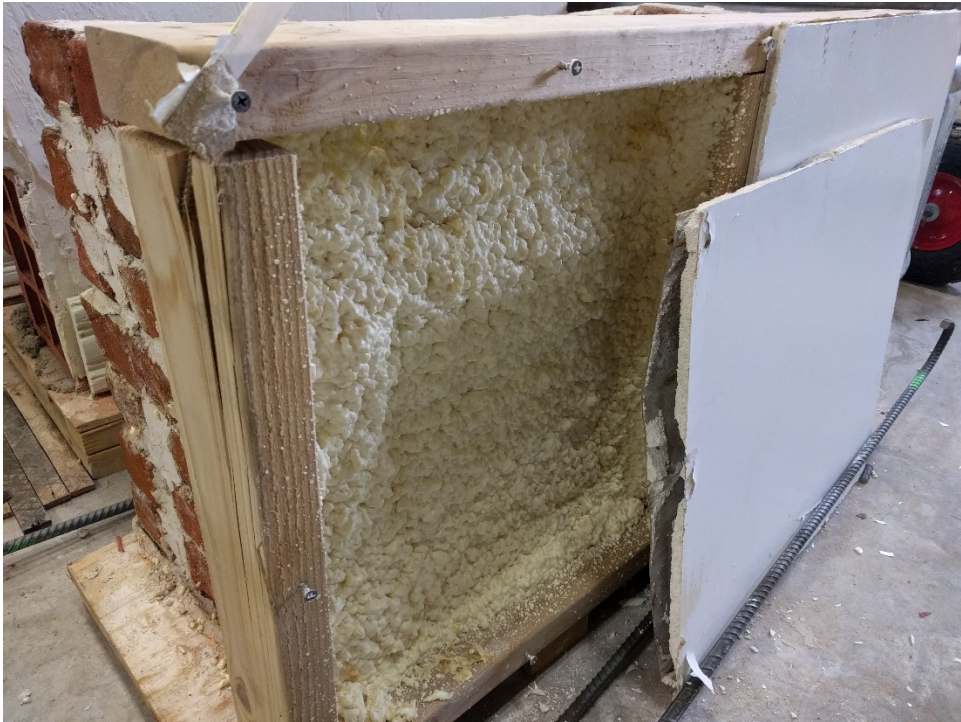
Figure 43. Photograph of Wall E cavity showing resilience of spray foam insulation.

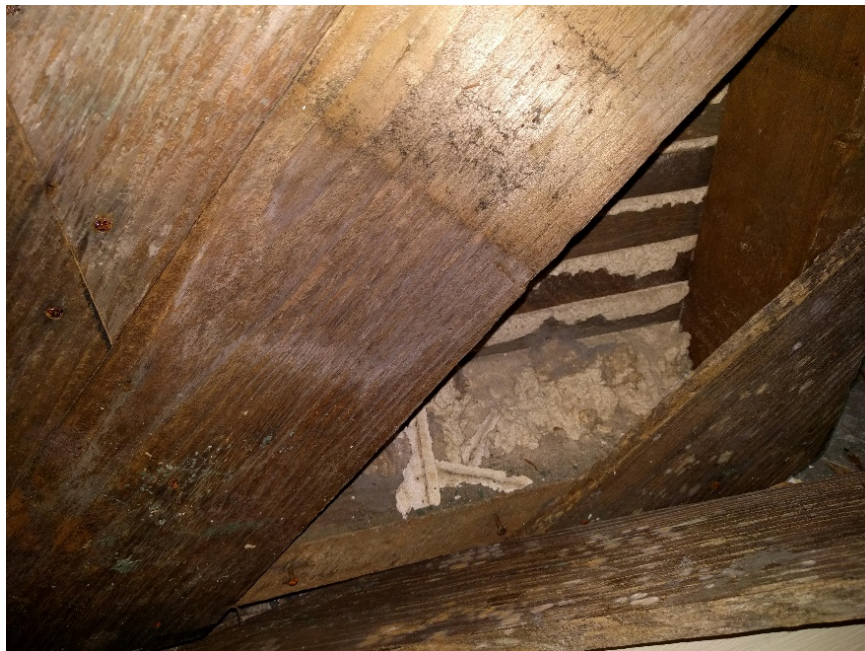
Figure 44. Photograph of Wall D cavity after drying, showing heavy contamination.

- Include tests for individual materials of interest. Wall and floor assembly tests are instructive for specific scenarios (Figure 44). However, individual material tests can better control variables and improve the accuracy of conclusions about specific materials.
