ITS  
NUMBER 3

Interpreting  
The Secretary of the Interior's Standards for Rehabilitation

Subject: New Additions to Mid-size Historic Buildings

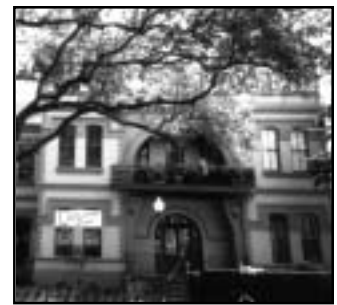
*The main front entrance of the orphanage after its conversion to residential apartments.*

used for offices. This building, L-shaped in plan, extends along a major street for most of a city block, and it is anchored by a three-story double-towered entrance at one end and a smaller simpler tower at the other end. The developer determined that more room was needed to ensure the financial success of the conversion of this building into residential apartments. Accordingly, a new two-story addition was planned at the rear and side of the former orphanage. Constructed of brick, and painted to help blend with the historic building that is also painted, the addition is simply designed, and features flat-arched windows with two-over-two sash that contrast with the rounded arches of the historic windows. This new addition meets the Standards. It is clearly differentiated from the historic building, and it is compatible in materials, design, size, and scale. A row of townhouses in front of the new addition further minimizes its visibility from the street.

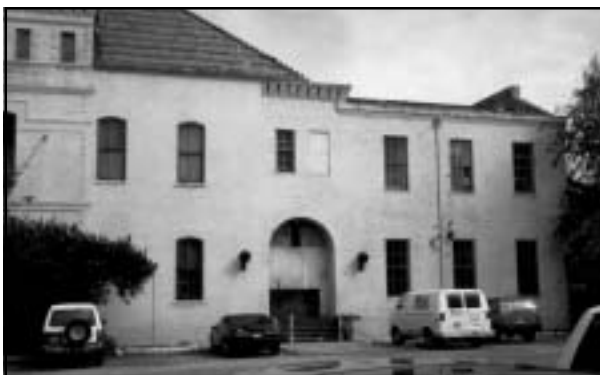
*The side wing that extends behind the main entrance to the building prior to rehabilitation, and construction of the new addition.*

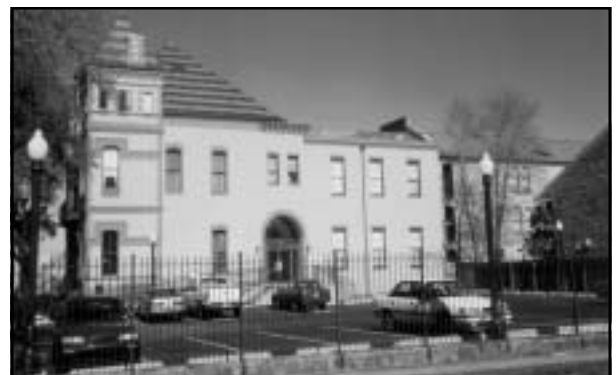
*The new addition at the rear of the side wing is unobtrusive, and compatible with the building's historic character. Townhouses (on the right) in front of the addition further limit its visibility.*

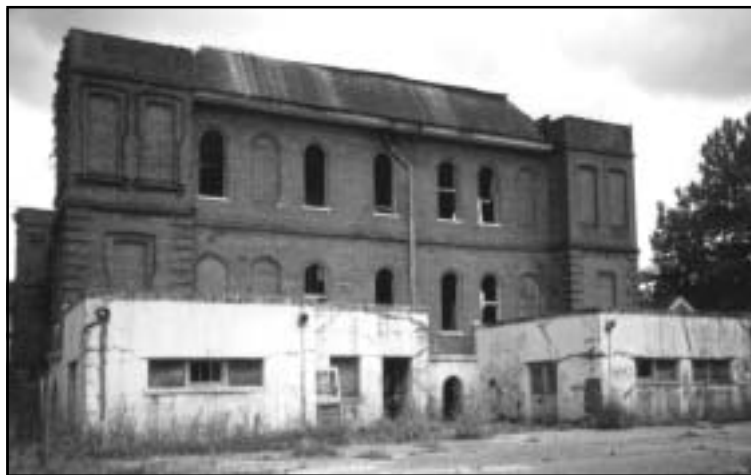
*The rear elevation of the school building before the removal of the two later, non-significant additions.*

**Application 2 (Compatible addition):** A historic three-story, 1879 brick school building, long abandoned, was rehabilitated for use as a women's and children's center. The school is a square, Italianate building with decorative towers at each corner, now flat-roofed since the loss many years ago of their Romanesque-arched open bell towers. Although the existing building was not small, it lacked sufficient space to fulfill the center's needs for private and communal living and dining areas for the residents, as well as for administration and staff offices. To provide additional space, two small non-significant additions were removed and a three-story brick addition was constructed at the rear of the school. The new brick is harmonious with the historic brick and the design of the addition is very simple. To further differentiate the addition from the historic building, the windows in the new addition have flat arches and are very plain and unadorned in contrast to the more decorative window openings and stone sills on the original schoolhouse. The new addition is compatible in size, scale, materials and location with the historic building and, thus, meets the Standards.

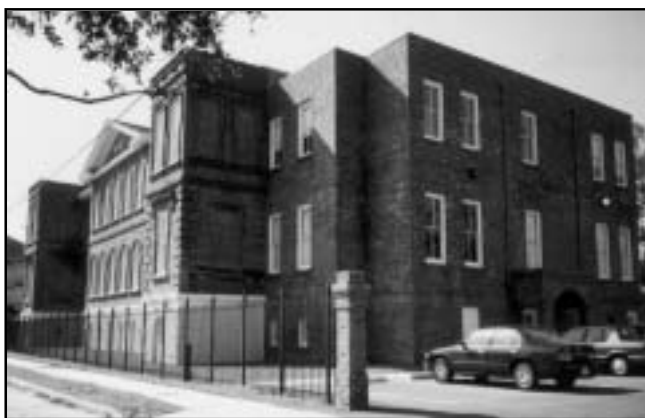
*The simple design of the new addition at the rear of the building is completely compatible with the historic character.*

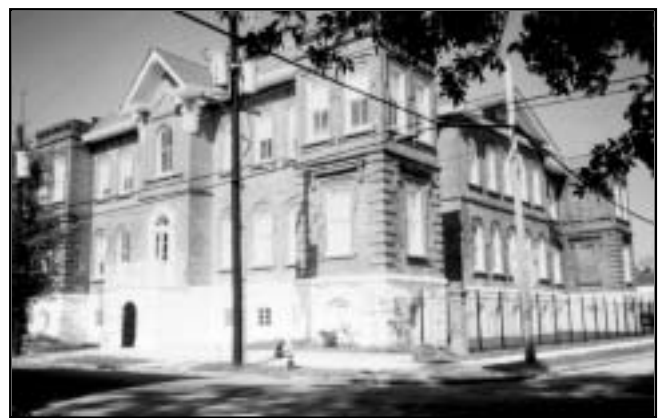
*The school, which is prominently situated on a corner, is shown after rehabilitation. The new addition at the back (right) cannot be seen from the corner.*
