Subject: Installing New Systems in Historic Corridors

Applicable Standards: 2. Retention of Historic Character

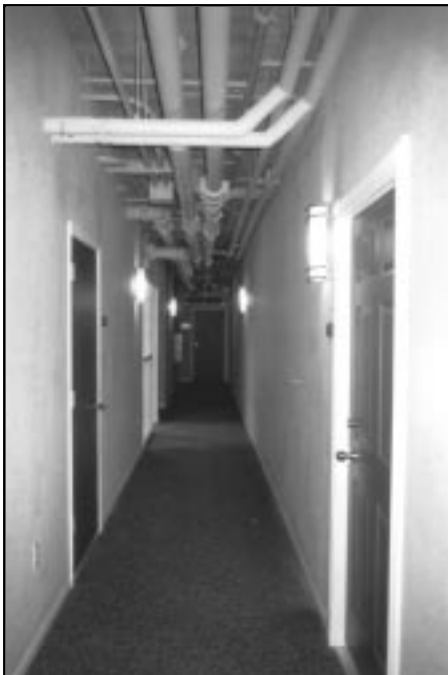
Left: The exposed pipes give the corridor, although quite plain, an unfinished appearance which is not compatible with the historic character of this 1926 bank building.

Application 1 (*Incompatible treatment*): The tangle of pipes along the corridor of this 1926 bank building, which was rehabilitated into apartments, creates a sharp visual distraction. Given the straightforward detailing of this corridor, installing a new ceiling to hide the overhead pipes would have been the preferred treatment, even if it meant lowering the original height of the ceiling. Where there is insufficient room in the corridor space to drop a new ceiling without significantly altering the volume of the space or interfering with existing features such as door transoms, trim, or other features, other solutions are required.

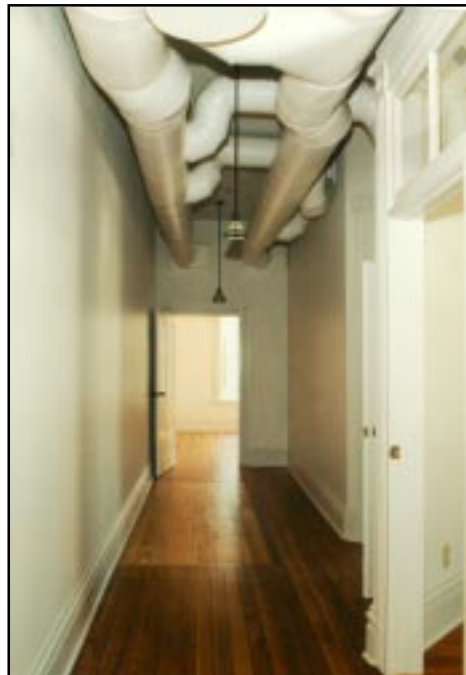
Right: These ducts should have been installed in a secondary space since lowering the corridor ceiling would have concealed the transoms.

Application 2 (*Incompatible treatment and suggested remedial treatment*): A new dropped ceiling would have not been the appropriate solution for hiding the large ducts in the corridors of this 1886 commercial building. Dropping the ceiling height low enough to conceal the ducts above would have required the ceiling to drop below the door transoms. In this case, if the ducting could not be reduced in size, a possible treatment could entail routing the ductwork parallel to the corridor in less significant interior spaces. The first drawing illustrates a scheme in which the ductwork is encased by a soffit above the existing transom. When the ceiling height does not allow sufficient room above the transom, other compromises might be required, such as the one depicted in the second drawing. In this case, the new mechanical equipment was also installed parallel to the corridor, but the lack of clearance between the top of the door transom and the existing overhead structure requires that the new soffit cover the transom behind the corridor wall. Although obscuring existing historic features is generally not recommended, when such alterations cannot be avoided, it is preferable to limit these treatments to less significant or secondary service areas such as closets, bathrooms, or kitchens inside new offices or apartments to avoid altering more significant public spaces such as corridors.

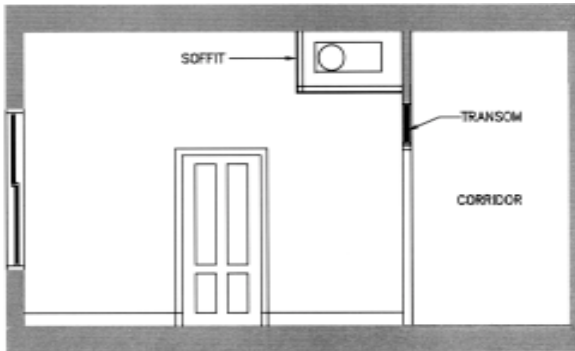
Routing HVAC and other systems along spaces on either side of corridors is a more sensitive approach that often works well in rehabilitations of historic office buildings.

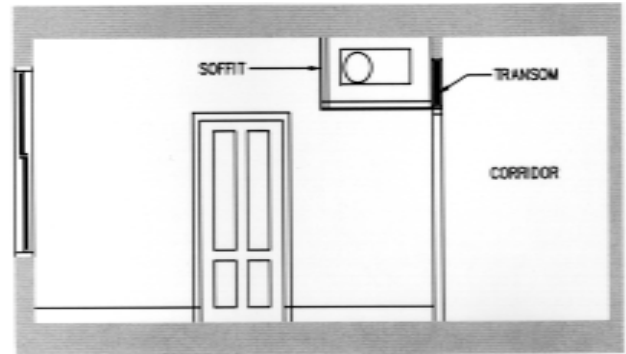
Although obscured on one side, the transom can be retained on the more visible corridor side.

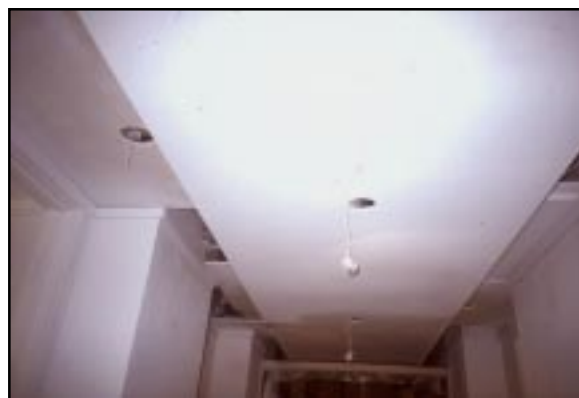
A partial ceiling can cover new systems in a corridor without obscuring existing historic features.

Application 3 (*Compatible treatment*): Another possible approach is illustrated in the conversion of this 1925 office building into a hotel. The design of this new floating ceiling allows covering new HVAC systems without obscuring or damaging existing features along the corridor walls. Holding the ceiling back away from the walls allows the existing trim and other details to be retained and kept visible.
