**Subject:** Corridors in Historic Highrise Apartment Buildings and Hotels

- Applicable Standards:**
- 2. Retention of Historic Character
  - 5. Preservation of Distinctive Features, Finishes and Craftsmanship

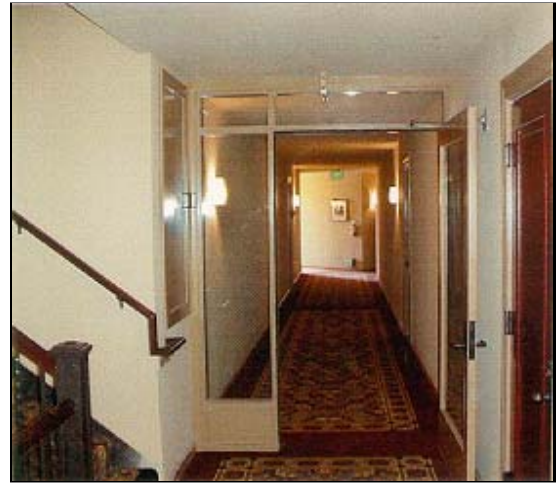
*RIGHT: Post-rehabilitation view of typical corridor showing retention of historic trim, drywall finishes that match the appearance of the original flat plaster, and a slightly lower ceiling that conceals new systems. Also shown are a compatible, largely glazed fire door and a portion of the preserved open stair (lower left of image).*

**Application 2 (Compatible treatment):** Opened in 1927 to serve as an apartment hotel (originally, 85 apartment suites and 32 hotel rooms), this building is a fifteen-story, reinforced-concrete tower. Over the years, virtually all of the building became a hotel. Then, as part of the recent rehabilitation, the building shifted back to apartment building use. Above lobby level, the floors are served by double-loaded corridors that follow the footprint of the wide central section of the building and its diagonal end wings. The rehabilitation retained the elevator lobbies, corridors, and the associated historic fabric, with a few minor modifications (the basic room configuration was also retained, with some grouping of rooms to create apartments). Two small corridor “access ways” for fire escapes were converted to private space for adjacent apartments (as the fire escapes themselves were eliminated); drywall was laminated to the deteriorated plaster walls (historic trim and detailing were retained); and a drywall ceiling was dropped slightly below the historic flat plaster ceiling to accommodate the new mechanical, electrical and plumbing systems. This work preserves the historic character of the corridors and, thus, meets the Standards.

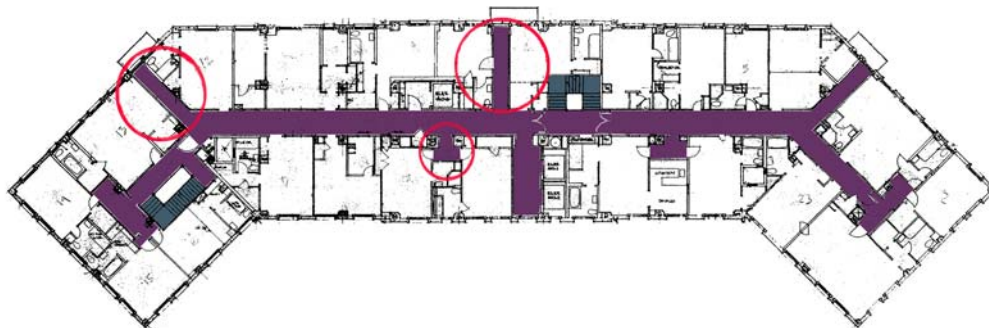
*Pre-rehabilitation plan of typical upper floor. Circled areas indicate the only major changes to the corridor plan to take place during rehabilitation.*

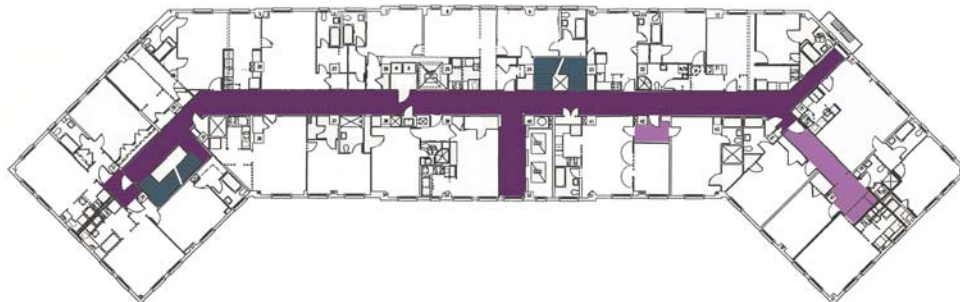
*Post-rehabilitation plan of typical upper floor. Corridors and staircases have survived intact. Former fire escape “accessways” have been absorbed into two apartments and a vestibule is absorbed into one apartment on each floor. Shown in lavender are intact, previously public areas (a small vestibule and the end leg of the corridor) that have been incorporated into two of the apartments on each floor.*
