Subject: Changes to Historic Site

- Applicable Standards:**
1. Compatible Use
 2. Retention of Historic Character

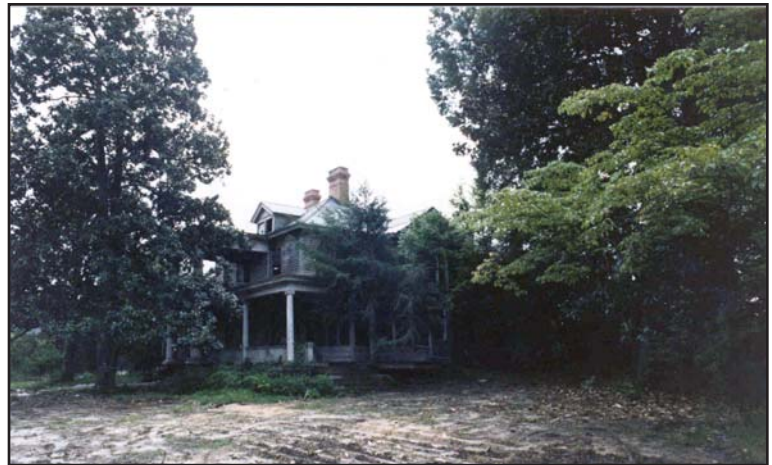
Top: Although the site was overgrown, the character of this 1900 house as a large suburban residence had survived.

Application (*Incompatible treatment*): A large, finely detailed Neo-Classical mansion, built in 1900 and representing the wealth of prosperous mill owners, was listed individually in the National Register of Historic Places. Although the large lot on which it stood was overgrown prior to the start of the rehabilitation, the character of the house as an imposing suburban residence on a spacious lot had survived.

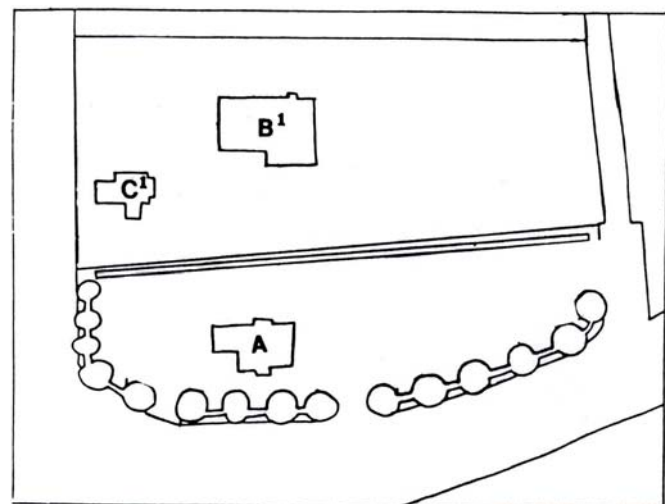
Bottom: Site plan before rehabilitation. The 1900 house (A) stood alone on its lot. On the adjoining property stood another large house (B1) and a dependent cottage (C1)

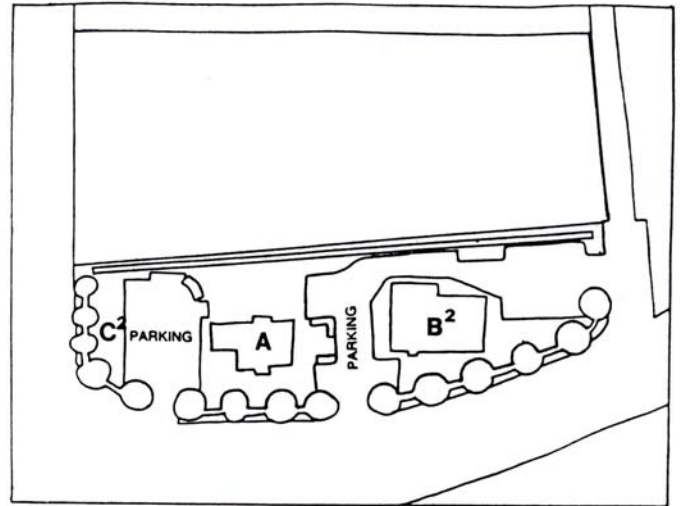
Site plan after rehabilitation of buildings. The neighboring house was moved and turned around (B2) to face the 1900 building (A) across a new paved parking lot. The cottage associated with the moved house was relocated (C2) behind the 1900 building.

Although both of the moved buildings were saved from demolition, their relocation in the manner shown here has greatly altered the historic setting of the listed build-

ing. The central parking lot, has become a dominant new feature of the site. The historic building now appears as but one element in a new composition bearing little relationship to the historic appearance of the property. As a result, the historic character of the overall property has been greatly diminished, and the project does not meet the Standards.

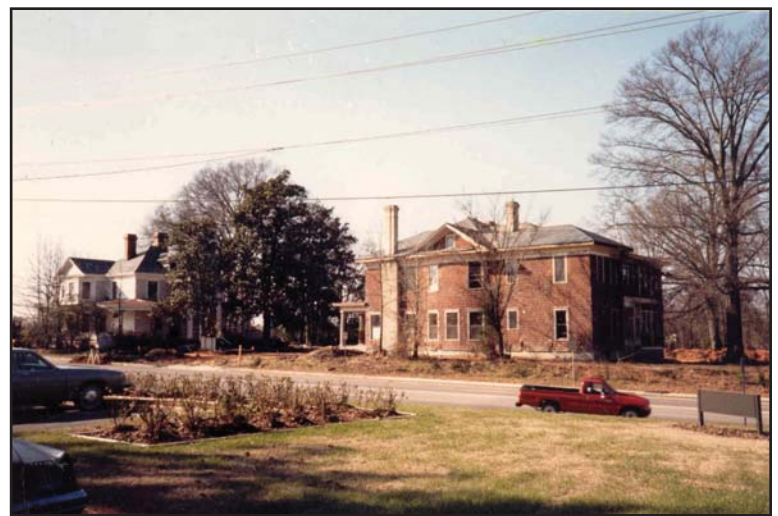
Turned 180 degrees, the moved building (B2) faces the historic one from a distance of 60 feet.

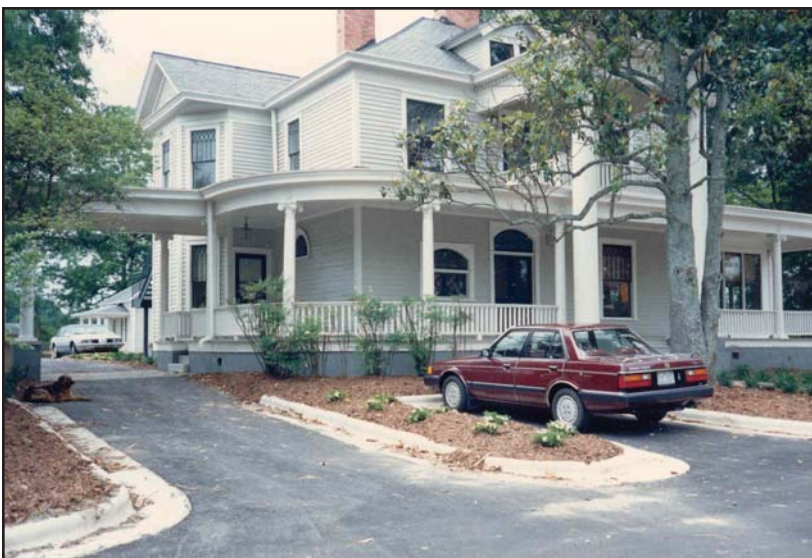
The new parking lot completes the drastic alteration of the setting. The second relocated structure (C2) can be seen through the porte-cochere at left.
