InterpretingThe Secretary of the Interior's Standards for Rehabilitation

Subject: Reusing Special Use Structures

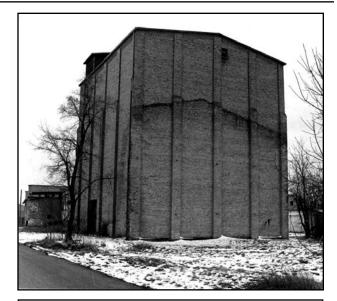
Top: The solid windowless walls are the character-defining features of this building, indicative of its function of ice-storage. **Bottom:** The proposal to insert windows, doors, and balconies in the building would have greatly altered the monolithic appearance of the structure.

The rehabilitation to convert the structure into residential apartments proposed the insertion of numerous openings for windows and doors. Balconies were also proposed. Yet, the blank, monolithic appearance of the ice storage house was its defining characteristic. The changes proposed to accommodate the residential use would have dealt a serious blow to the historic character of the building. The proposed rehabilitation did not meet the Standards.

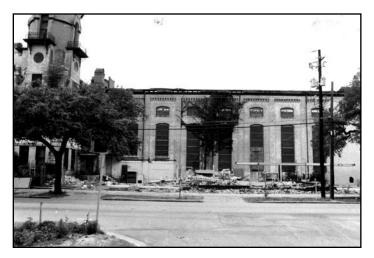
Top left: The historic jail featured a three-story warden's house (partially visible, left), and a four-story cell block.

Top right: Cell block interior. Cell walls were five feet by eight, separated by 18 inch load-bearing walls.

property consisted of a warden's house and a cell block. The stark interior of the cell block reflected the building's historic use. The cells, five feet by eight feet, were separated by 18 inch load-bearing masonry walls. The internal structural system was thus independent of the exterior walls. To accommodate the insertion of apartments on all floors, the plans called for the total demolition of the historic floor plan in the largest and oldest section of the jail. The planned removal of the load-bearing cell walls also meant that the floor and roof structure resting upon them would be lost as well.

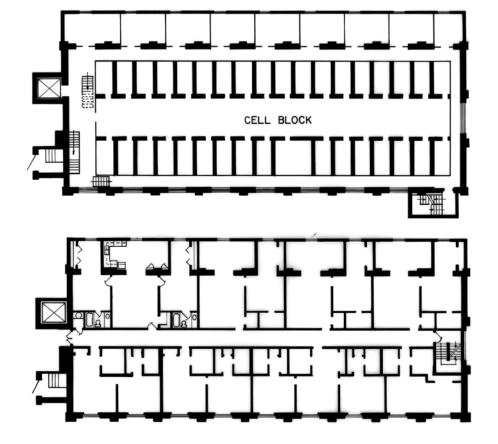
Center: Floor plan before rehabilitation. Section at top was added in the 1950s.

Bottom: Floor plan showing proposed insertion of apartments and the removal of nearly all the historic fabric.

While modifications to the interior of buildings are permitted within the scope of the Standards for Rehabilitation and the Guidelines for Rehabilitating Historic Buildings, the changes required to convert the jail to housing would have removed virtually all vestiges of the character-defining features of the historic structure.
