National Park Service U.S. Department of the Interior Technical Preservation Services

## Interpreting The Secretary of the Interior's Standards for Rehabilitation

## Installing Green Roofs on Historic Buildings

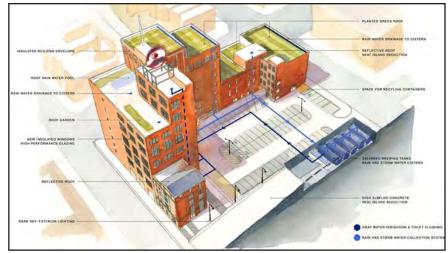
*Above:* The plantings are low and are not visible from the surrounding streets due to the high parapets of the historic buildings. *Below:* View of the green roofs after installation.

**Application I** (*Compatible treatment*): A defunct brewery complex, constructed in the late-nineteenth century, was rehabilitated for mixed use including office space, storage, and retail. The owners wanted to integrate green features into the project to make it more sustainable and to take advantage of local energy tax credits as well as the Federal Historic Preservation Tax Incentives. Accordingly, green roofs were constructed on several of the buildings with flat roofs that were suitable for such an installation. These buildings are tall with sufficiently high parapets so that the roof plantings are not visible from the public right of way. The incorporation of green roofs on these historic brewery structures meets the Standards.

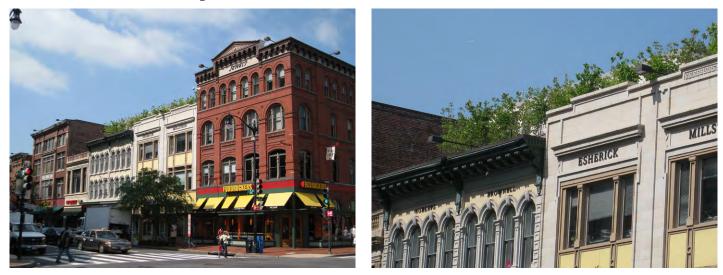
The plantings on these commercial buildings—highly visible above the parapets—are not in keeping with the historic character of the structures.

**Application 2** (*Incompatible treatment*): Two neighboring late-nineteenth and early-twentieth century commercial buildings added green roof features to take advantage of the energy benefits and to provide a pleasant space for building occupants. The three-story buildings front a busy city street where they are highly visible from many vantage points along the street. Although the buildings have substantial parapets, the trees, which can be seen from the street below, negatively impact the character of these historic buildings.

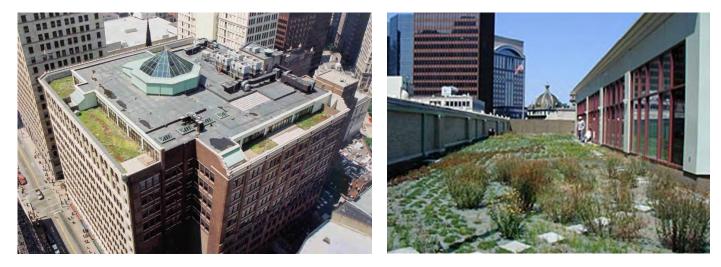
*Left:* Roof of the rehabilitated department store building with of green roof sections. *Right:* The tall parapet conceals the plantings and the penthouse from the street below.

**Application 3** (*Compatible treatment*): The rehabilitation of this early-twentieth century former department store for office and retail use included large sections of green roof. The green roof consists of planted terraces used by tenants of the penthouse offices that were also added as part of the rehabilitation. The sustainable green roof increases the energy efficiency of the building, and the green groundcover also acts as an acoustical damper for the rooftop offices. The tall parapets completely hide the green roof from view—and also conceal the new penthouse addition, ensuring that the historic character of the building is retained while incorporating this energy-efficient and environmentally-friendly feature. This project meets the Standards.
