8 PRESERVATION BRIEFS

Aluminum and Vinyl Siding on Historic Buildings

The Appropriateness of Substitute Materials for Resurfacing Historic Wood Frame Buildings.

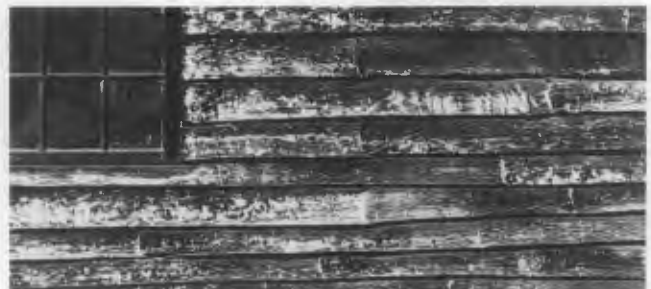
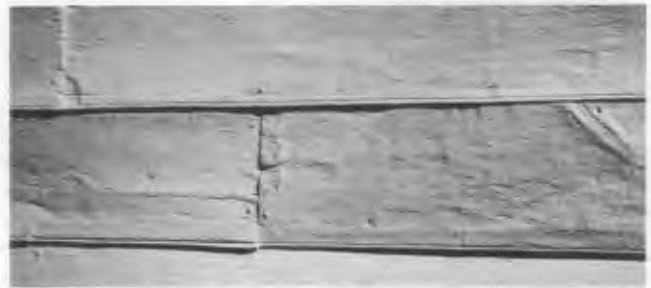
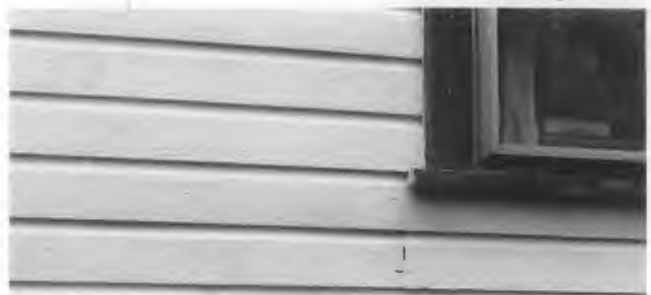
Historic wood sidings exhibit rich and varied surface textures. They range from hand-split clapboards of short lengths with feather-edged ends, to pit or mill sawn boards which can be beveled, rabbeted, milled, or beaded.

The variety of tools used, coupled with regional differences in design and craftsmanship, has resulted in a richness and diversity of wood sidings in America. For example, narrow boards with beveled, lapped joints called "clapboards" were used on New England frame dwellings. The size and shape of the "clapboards" were determined by the process of hand splitting or "riving" bolts of wood.

The width, the short lengths, the beveled lapping, the "feathered" horizontal joints, and the surface nailing of the clapboards created a distinctive surface pattern that is recognizable as an important part of the historic character of these structures.

The sawn and hand-planed clapboards used throughout the Mid-Atlantic and Southern states in the eighteenth and early nineteenth centuries, by contrast, have a wide exposure—generally between six and eight inches. The exposure of the siding, frequently coupled with a beaded edge, created a very different play of light and shadow on the wall surface, thus resulting in a different character. The "German" or "Novelty siding"—a milled siding that is thin above and thicker below with a concave bevel—was used throughout many parts of the United States in the late nineteenth and early twentieth century but with regional variations in material, profile, and dimensions. One variation of this type of milled siding was called "California siding" and was milled with a rabbetted or shiplap edge to insure a tight installation of the weatherboards. Shingles were also commonly used as an exterior cladding material, and in buildings such as the Bungalow style houses, were often an important character-defining feature of the exterior. Shingles were often applied in decorative patterns by varying the lap, thus creating alternating rows of narrow exposures and wide exposures. Shingles were also cut in geometric patterns such as diamond shapes and applied in patterns. This treatment was commonly used in the gable end of shingled houses. Siding and wood shingles were often used in combination with materials such as cobblestone and brick in Bungalow style buildings to create a distinctive interplay of surfaces and materials.

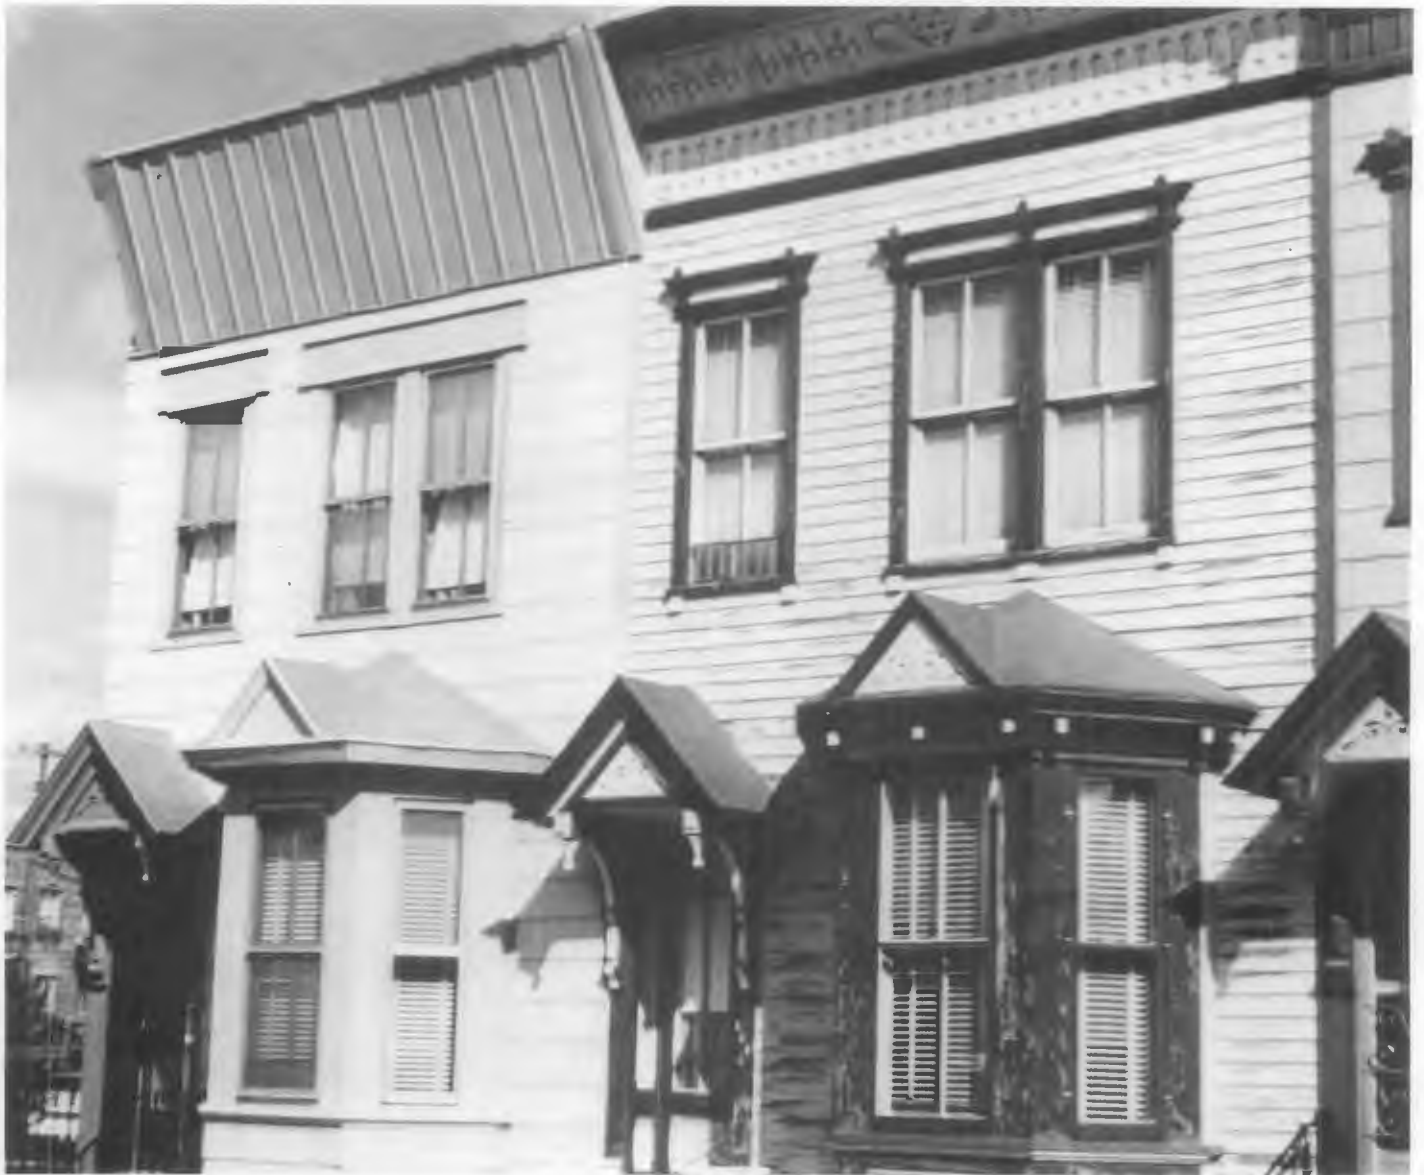
When a building is in need of maintenance, such as the house on the right which needs painting, some owners consider installing aluminum or vinyl siding. The result, like the house on the left, can be a complete loss of architectural character due to the covering of details (cornice), the removal of features (window trim), and a change of scale due to inappropriate siding dimensions.

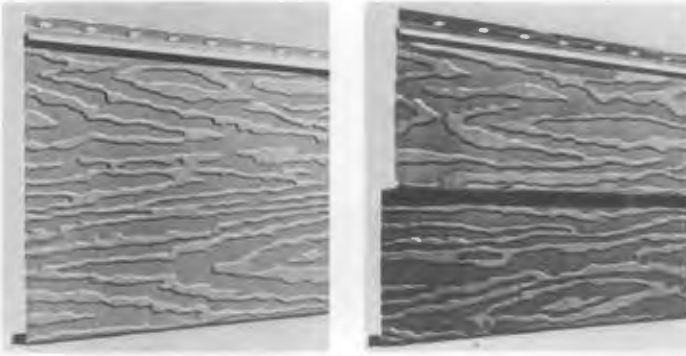
Aluminum and vinyl siding are available in a variety of widths and colors, but the optional wood graining is not characteristic of real wood siding.

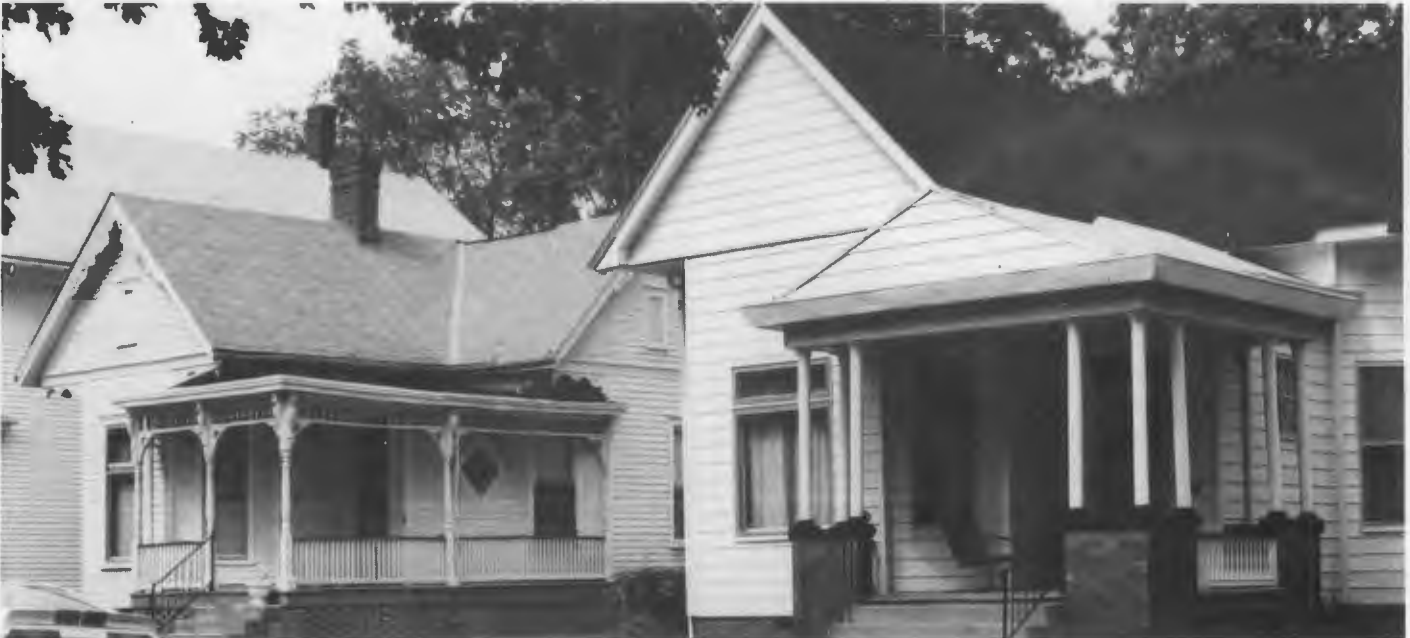
Two originally similar houses. When aluminum was installed on the house on the right, the barge boards, scrollwork, columns, and railings were removed. The distinctive shingled gable and attic vent were covered, further compromising the building's architectural integrity.

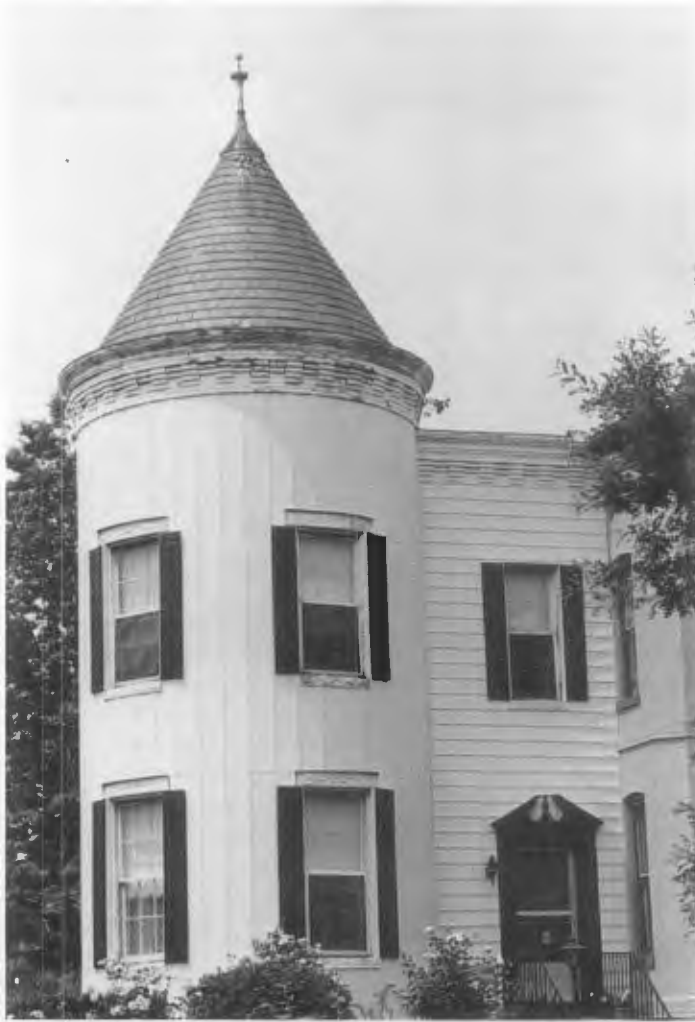
This brick rowhouse was covered with vertical and horizontal aluminum siding. Such treatment is inappropriate for historic masonry buildings.

The existing wall fabric is further damaged by the nailing necessary to apply siding. Either by nailing directly to the building fabric or by nailing the furring strips to the old siding, the installation of aluminum or vinyl siding will leave numerous holes in wood siding, molding, trim, window and door frames. When applied to brick or other masonry units, the nail penetrations attaching the furring strips and siding can cause irreversible cracking or spalling of the masonry. Although this reference to damaging masonry is included as a point of fact, the application of aluminum or vinyl siding is highly inappropriate to historic masonry buildings.
