16 PRESERVATION BRIEFS

The Use of Substitute Materials on Historic Building Exteriors

National Park Service
U.S. Department of the Interior
Technical Preservation Services

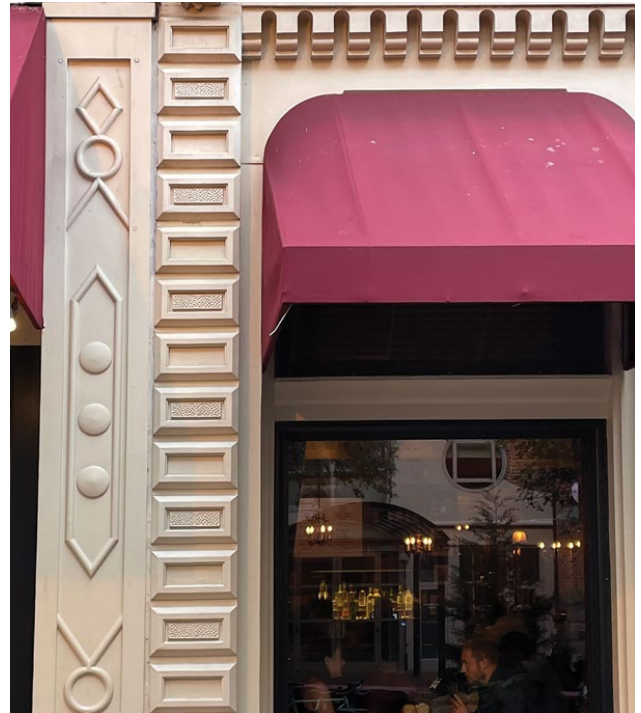
Figure 2b: The 19th century also produced a variety of metal products used to imitate other materials. Across the country, cast iron was used in storefronts to imitate stone. Photo: John Sandor, NPS.
