19 PRESERVATION BRIEFS

The Repair and Replacement of Historic Wooden Shingle Roofs

Sharon C. Park, AIA

U.S. Department of the Interior, National Park Service
Preservation Assistance Division, Technical Preservation Services

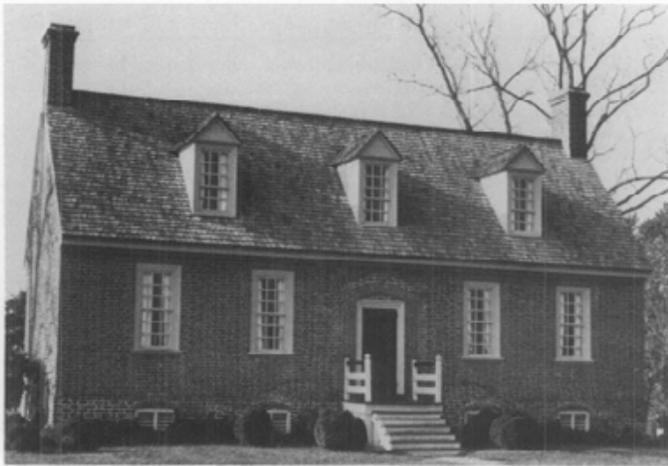
1. The Rolfe-Warren House, a tidewater Virginia property, was restored to its 18th-century appearance in 1933. The handsplit and dressed wooden shingles are typical of the tidewater area with special features such as curved butts, projecting ridge comb and closed swept valleys at the dormer roof connections. Circa 1970 Photo: Association for the Preservation of Virginia Antiquities.

Wooden shingle roofs are important elements of many historic buildings. The special visual qualities imparted by both the *historic shingles* and the *installation patterns* should be preserved when a wooden shingle roof is replaced. This requires an understanding of the size, shape, and detailing of the historic shingle and the method of fabrication and installation. These combined to create roofs expressive of particular architectural styles, which were often influenced by regional craft practices. The use of wooden shingles from the early settlement days to the present illustrates an extraordinary range of styles (see illus. 1, 2, 3, 4).

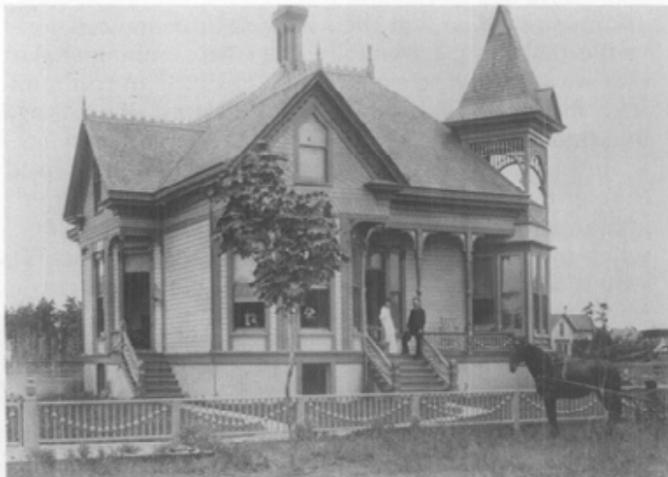
3. Readily available and inexpensive sawn shingles were used not only for roofs, but also for gables and wall surfaces. The circa 1891 Chambers House, Eugene, Oregon used straight sawn butts for the majority of the roof and hexagonal butts for the lower portion of the corner tower. Decorative shingles in the gable ends and an attractive wooden roof cresting feature were also used. Photo: Lane County Historical Society.

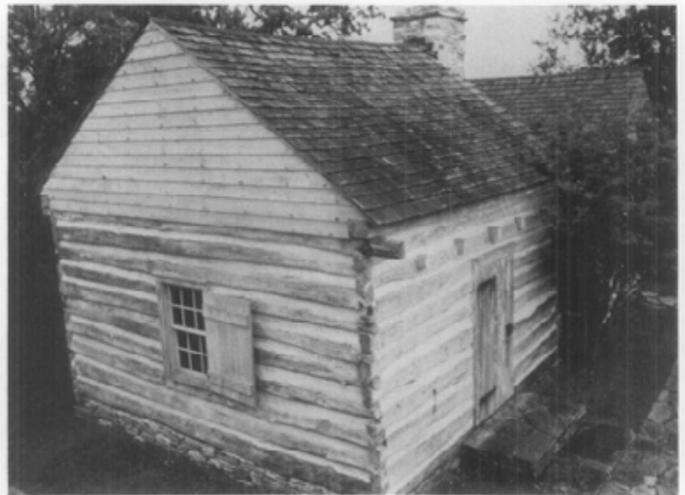
2. Handsplit and dressed shingles were also used on less elaborate buildings as seen in the restoration of the circa 1840 kitchen at the Winedale Inn, Texas. The uneven surfaces of the handsplit shingles were generally dressed or smoothed with a draw-knife to keep the rainwater from collecting in the wood grain and to ensure that the shingles lay flat on the sub-roof. Photo: Thomas Taylor.

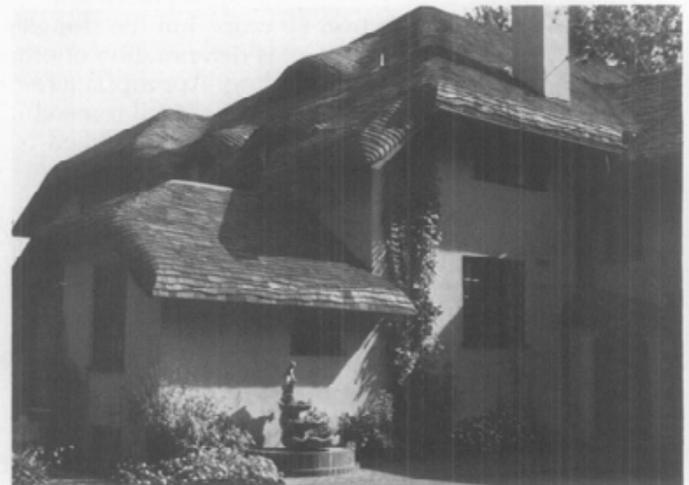
4. With the popularity of the revival of historic styles in the late 19th and early 20th centuries, a new technique was developed to imitate English thatch roofs. For the Tudor Revival cottages, steaming and curving of sawn shingles provided an undulating pattern to this picturesque roof shape. Photo: Courtesy of C.H. Roofing.

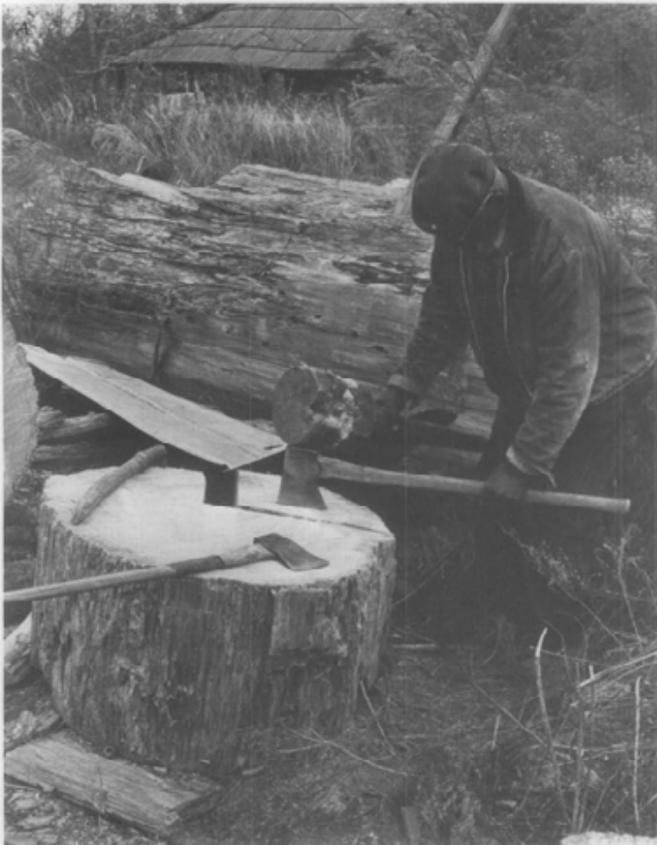
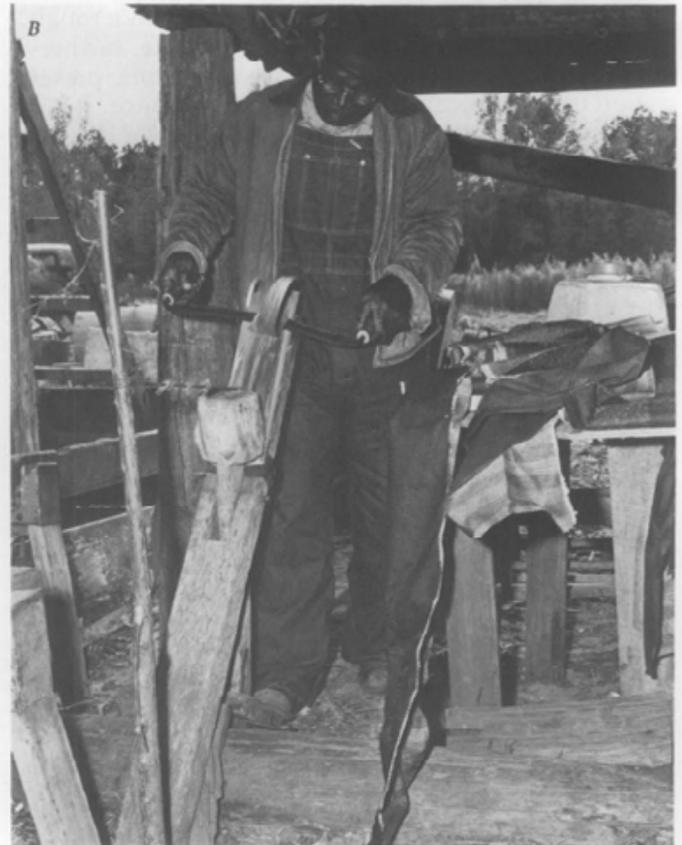
5. Custom Handsplit shingles are still made the traditional way with a mallet and froe or ax. For these cypress shingles, a "bolt" section of log (photo A) the length of the shingle has been sawn and is ready to be split into wedge-shaped segments. Handsplit shingles are fabricated with the ax or froe cutting the wood along the grain and separating, or riving, the shingle away from the remaining wedge. The rough surfaces are dressed on a shavinghorse using a draw-knife as shown above (photo B). Note the long wooden shingles covering the work shed in photo A. Photos: Al Honeycutt, North Carolina Division of Archives and History.

to dress or plane the shingles on a shavinghorse with a draw-knife or draw-shave (see illus. 5B) to make them fit evenly on the roof. This reworking was necessary to provide a tight-fitting roof over typically open shingle lath or sheathing boards. Dressing, or smoothing of shingles, was almost universal, no matter what wood was used or in what part of the country the building was located, except in those cases where a temporary or very utilitarian roof was needed.

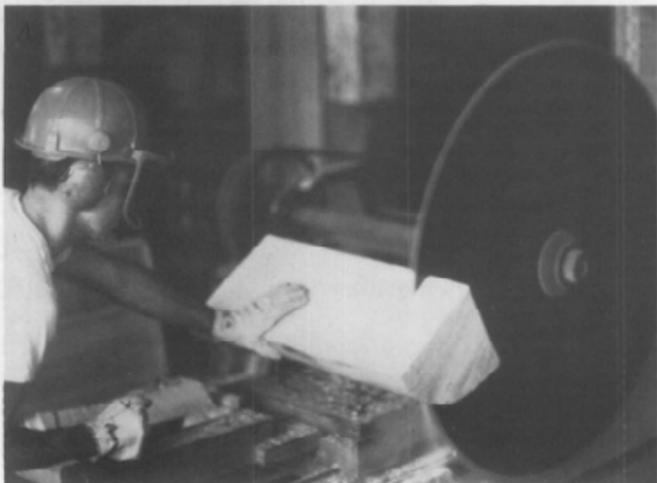
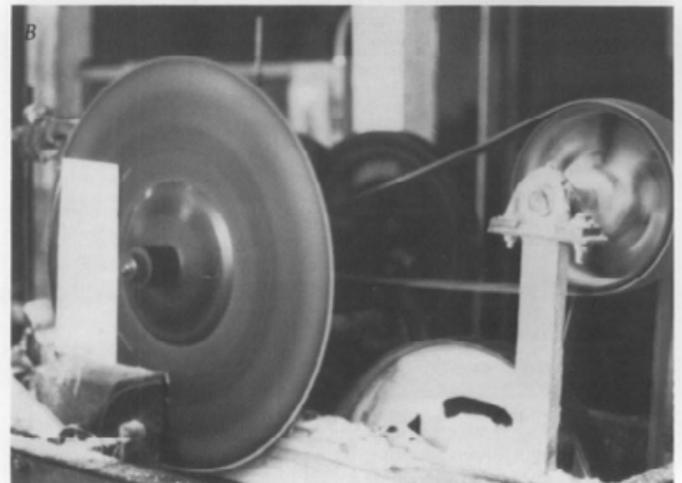
6. Modern machine-made shingles are sawn. Shown are: (photo A) Eastern White Pine quarter split shingle block on equalizer saw being trimmed to parallel the ends; and (photo B) the restored 19th-century shingle mill saw cutting tapered flitches or shingles. The thickness and taper can be precisely controlled. Photo: Steve Ruscio, The Shingle Mill.

Shingle fabrication was revolutionized in the early 19th century by steam-powered saw mills (see illus. 6). Shingle mills made possible the production of uniform

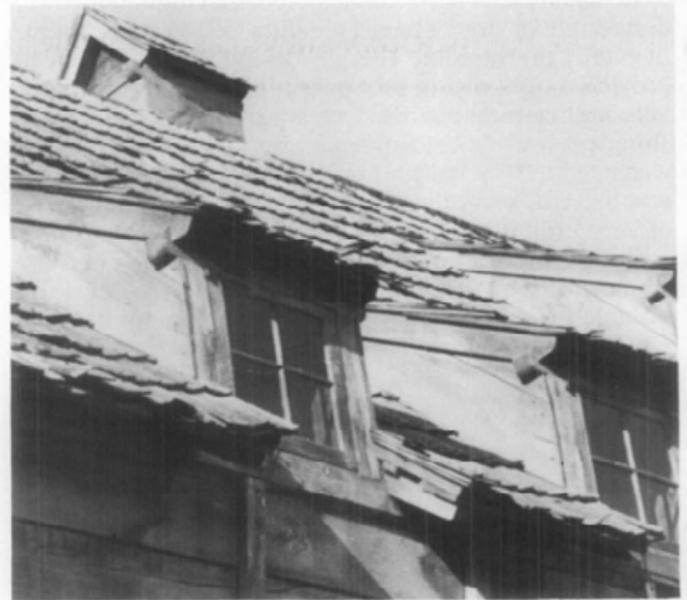
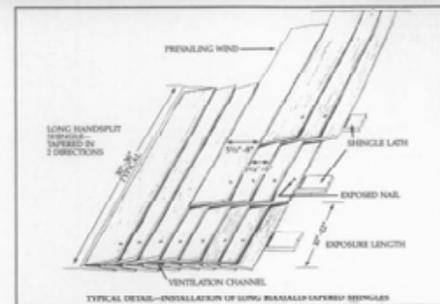
8. The long biaxially tapered handsplit shingles on the Ephrata Cloisters in Pennsylvania were overlapped both vertically and horizontally. The insert sketch shows channels under the shingles that provided ventilation and drainage of any trapped moisture. The aged appearance of these handsplit and dressed shingles belies their original smoothness. Replacement shingles should match the original, not the aged appearance. Photo: National Park Service; Sketch: Reed Engle.

Not all shingles were laid in evenly spaced, overlapping, horizontal rows. In various regions of the country, there were distinct installation patterns; for example, the biaxially-tapered long shingles occasionally found in areas settled by the Germans (see illus. 8). These long shingles were overlapped on the side as well as on top. This formed a ventilation channel under the shingles that aided drying. Because ventilation of the shingles can prolong their life, roofers paid attention to these details (see illus. 9).

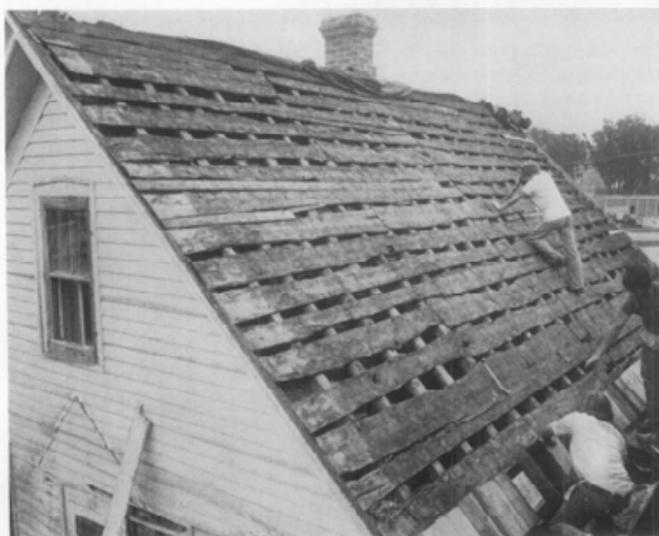
7. The reshingling of the circa 1856 Stovewood House in Decorah, Iowa, revealed the original open sheathing boards and pole rafters. Sawn cedar shingles were used as a replacement for the historic cedar shingles seen still in place at the ridge. A new starter course is being laid at the eaves. Photo: Norwegian-American Museum, Decorah, Iowa.

In order to have a weathertight roof, it was important to have adequate coverage, proper spacing of shingles, and straight grain shingles. Many roofs were laid on open shingle lath or open sheathing boards (see illus. 7). Roofers typically laid three layers of shingles with approximately 1/3 of each shingle exposed to the weather. Spaces between shingles (1/8"–1/2" depending on wood type) allowed the shingles to expand when wet. It was important to stagger each overlapping shingle by a minimum of 1-1/2" to avoid a direct path for moisture to penetrate a joint. Doubling or tripling the starter course at the eave gave added protection to this exposed surface. In order for the roof to lay as flat as possible, the thickness, taper and surface of the shingles was relatively uniform; any unevenness on handsplit shingles had already been smoothed away with a drawknife. To keep shingles from curling or cupping, the shingle width was generally limited to less than 10".

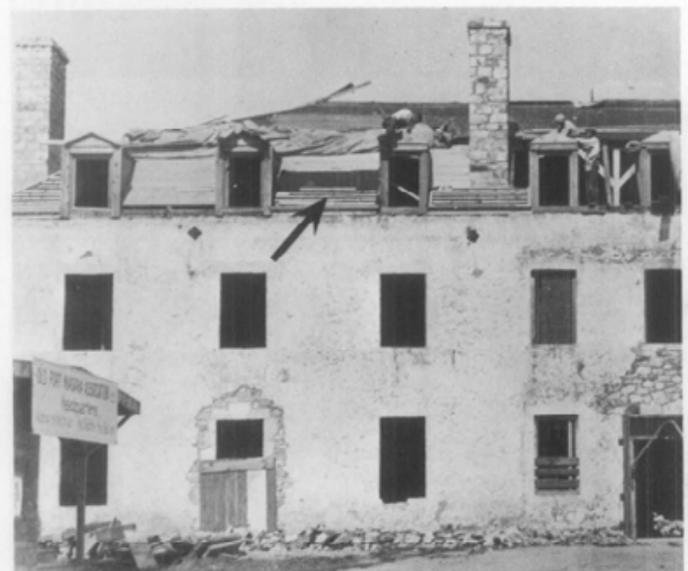
9. This 1927 view of the reshingling of the French Castle at Old Fort Niagara, N.Y., shows the wooden sleepers being laid (see arrow) over solid sheathing in order to raise the shingles up slightly to allow under-shingle ventilation. Note that the horizontal strips are not continuous to allow airflow and trapped moisture to drain away. This cedar roof has lasted for over 60 years in a harsh moist environment. Photo: Old Fort Niagara, Assoc. Inc.

Beware of heavily insulated attic rafters. Historically, the longest lasting shingle roofs were generally the ones with the best roof ventilation. Roofs with shingling set directly on solid sheathing and where there is insulation packed tightly between the wooden rafters without adequate ventilation run the risk of condensation-related moisture damage to wooden roofing components. This is particularly true for air-conditioned structures. For that reason, if insulation must be used, it is best to provide ventilation channels between the rafters and the roof decking, to avoid heavy felt building papers, to consider the use of vapor barriers, and perhaps to raise the shingles slightly by using "sleepers" over the roof deck. This practice was popular in the 1920s in what the industry called a "Hollywood" installation, and examples of roofs lasting 60 years are partly due to this under-shingle ventilation (refer to illus. 9).

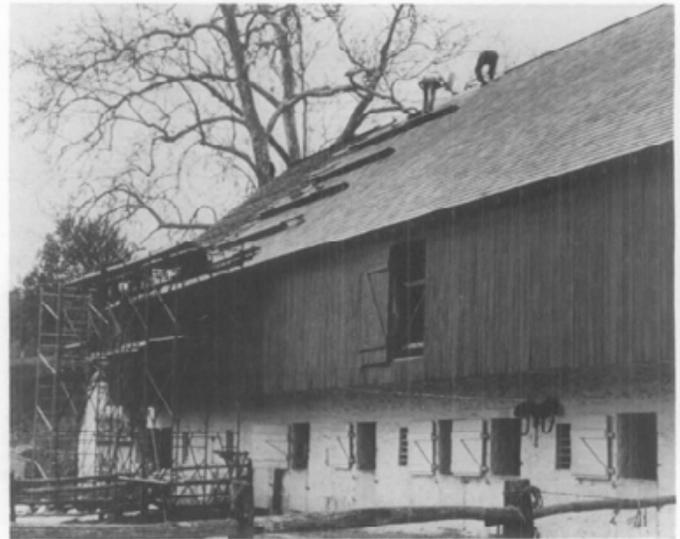
11. The replacement sawn red cedar shingles matched the deteriorated shingles exactly for this barn re-roofing. The old shingles, seen to the far left, were removed as the new shingles were installed. Even the horizontal coursing matched because the exposure length for both old and new shingles was the same. Photo: Williamsport Preservation Training Center.

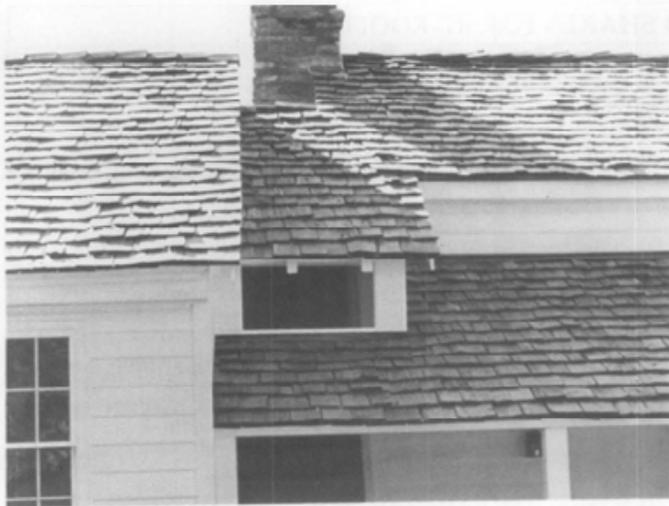
12. Inappropriately selected and installed wooden shingles can drastically alter the historic character of a building. This tavern historically was roofed with handsplit and dressed shingles of a relatively smooth appearance. In this case, a commercially available shake was used to effect a "rustic" appearance. Photo: National Park Service.

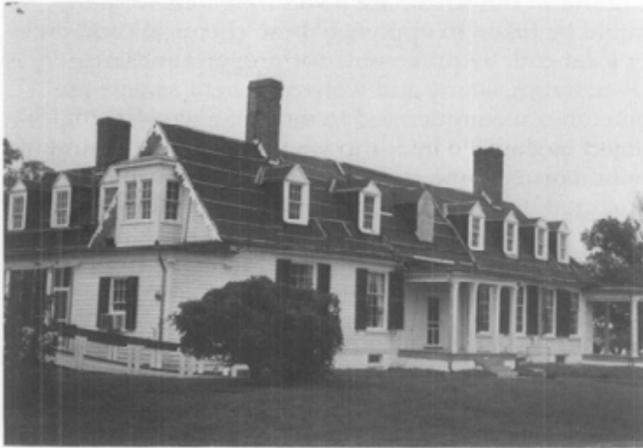
A. The later non-historic shingles were removed from Appomattox Manor (circa 1840 with later additions) and roofing paper was installed for temporary protection during the re-shingling.

14. Original 19th-century handsplit and dressed wooden shingles 18" long, 3"-4" wide, and 5/8" thick were found in place on the Appomattox Manor at Hopewell, Virginia. The butts were curved and evidence of a red stain remained. The specifications and details were researched so that the appearance of the historic shingles and installation patterns could be matched in the re-shingling project. Photos: John Ingle.

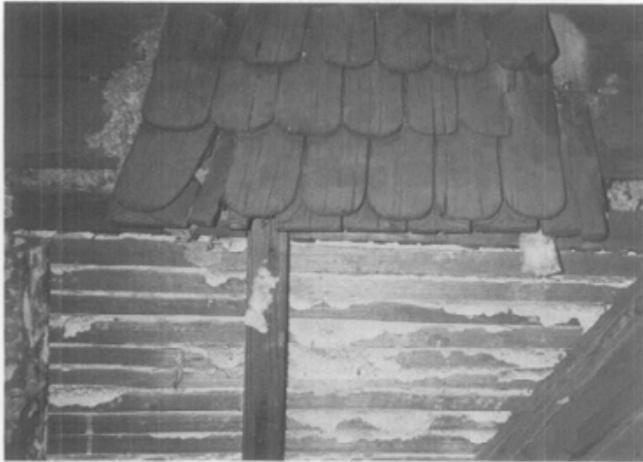
B. These weathered historic 19th-century handsplit and dressed shingles were found in place under a later altered roof. Note the straight butt eave shingles under the curved butts of the historic dormer shingles.

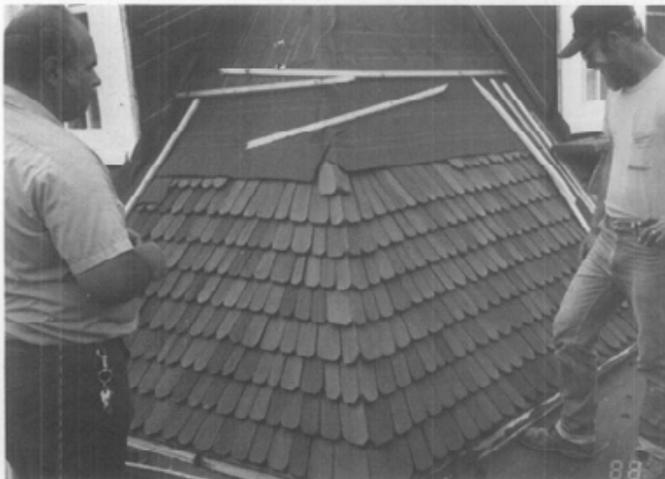
D. The fanned hips (seen here), swept valleys, and projecting ridge combs were installed as part of the re-roofing project. Special features, when documented, should be reproduced when re-shingling historic roofs.

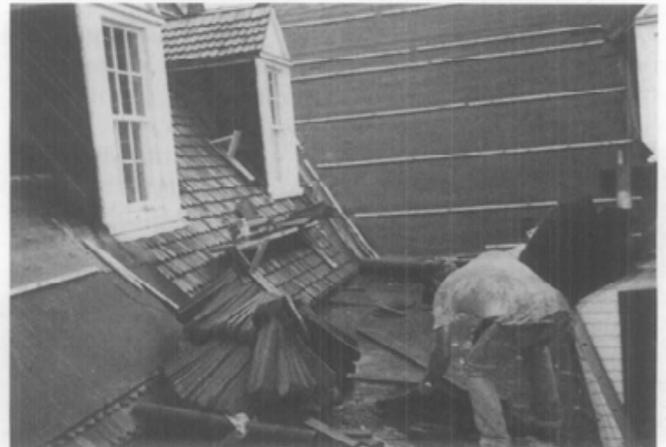
C. The replacement shingles (see specifications above), matched the historic shingles and were of such high quality that little hand dressing was needed at the site. The building paper, a temporary protection, was removed as the shingles were installed on the sheathing boards.

Type of wood to be used: Western Red Cedar.
Grade of wood and manufacturing process: Number One, Tapersplit Shakes, 100% clear, 100% edgegrain, 100% heartwood, no excessive grain sweeps, curvatures not to exceed 1/2" from level plain in length of shake; off grade (7% tolerance) material must *not* be used.
Size of the shingle: 18" long, 5/8" butt tapered to 1/4" head, 3"-4" wide, sawn curved butts, 5-1/2" exposure
Surface finish and any applied coatings: relatively smooth natural grain, no more than 1/8" variation in surface texture, butt thickness to be uniform throughout bundles. Site dipped with fire-rated chemicals tinted with red iron oxide for opaque color.
Type of nails and flashing: double hot dipped galvanized nails sized to penetrate sheathing totally; metal flashing to be 20 oz. lead-coated copper, or terne-coated stainless steel; additional flashing reinforcement to be aluminum foil type with fiber backing to use at hips, ridges, eaves, and valleys.

Type of sheathing: uninsulated attic, any deteriorated 3/4" sheathing boards, spaced 1/2"-3/4", to be replaced in kind.

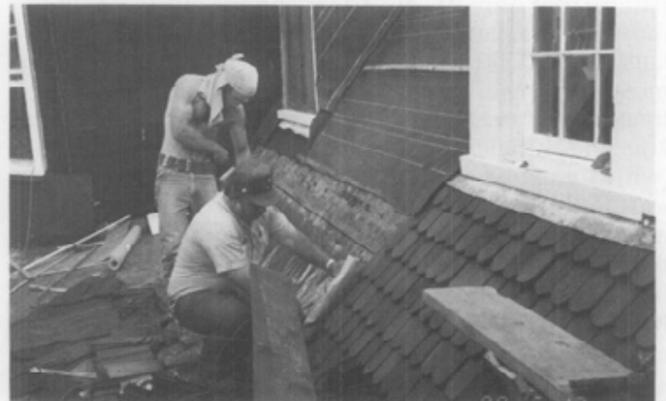
E. In order to achieve a "Class B" fire-rating, the shingles were dipped in fire-retardant chemicals and allowed to dry prior to installation. Iron oxide was added to this chemical dip to stain the shingles to match the historic red color. These coatings will need periodic reapplication.

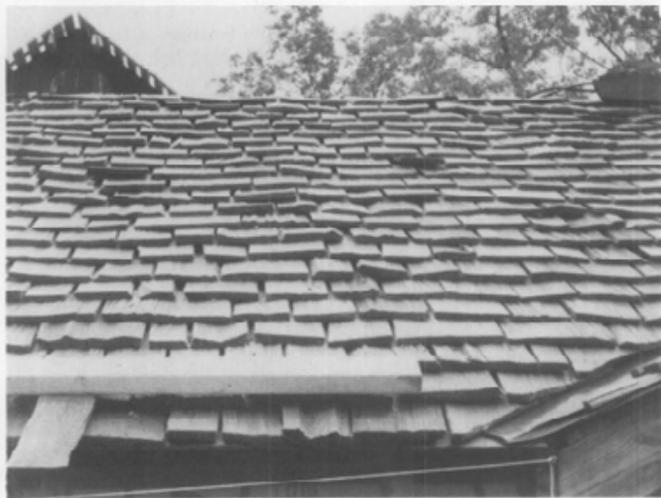
15. These commercially available roofing products with rustic split faces are not appropriate for historic preservation projects. In addition to the inaccurate appearance, the irregular surfaces and often wide spaces between shingles will allow wind-driven moisture to penetrate up and under them. The excessively wide boards will tend to cup, curl and crack. Moss, lichens and debris will have a tendency to collect on these irregular surfaces, further deteriorating the roofing. Photo: Sharon C. Park.

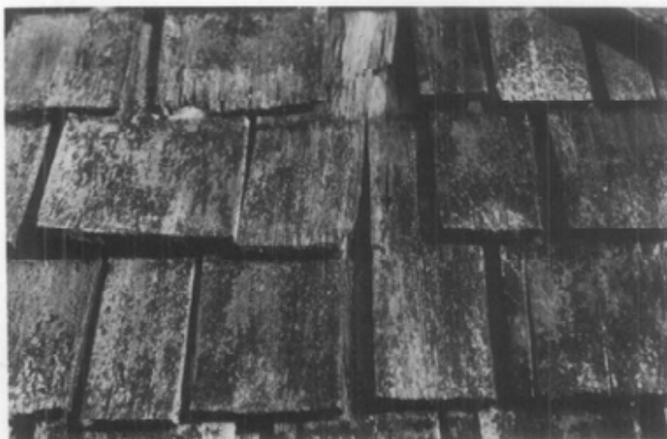
16. Routine maintenance is necessary to extend the life of the roof. On this roof, the shingles have not seriously eroded, but the presence of lichens and moss is becoming evident and there are a few cracked and missing shingles. The moss spores should be removed, missing shingles replaced, and small pieces of metal flashing slipped under cracked shingles to keep moisture from penetrating. Photo: Williamsport Preservation Training Center.

Periodic maintenance inspections of the roof may reveal loose or damaged shingles that can be selectively replaced before serious moisture damage occurs (see illus. 16). Keeping the wooden shingles in good condition and repairing the roof, flashing and guttering, as needed, can add years of life to the roof.
