42 PRESERVATION BRIEFS

The Maintenance, Repair and Replacement of Historic Cast Stone

Richard Pieper

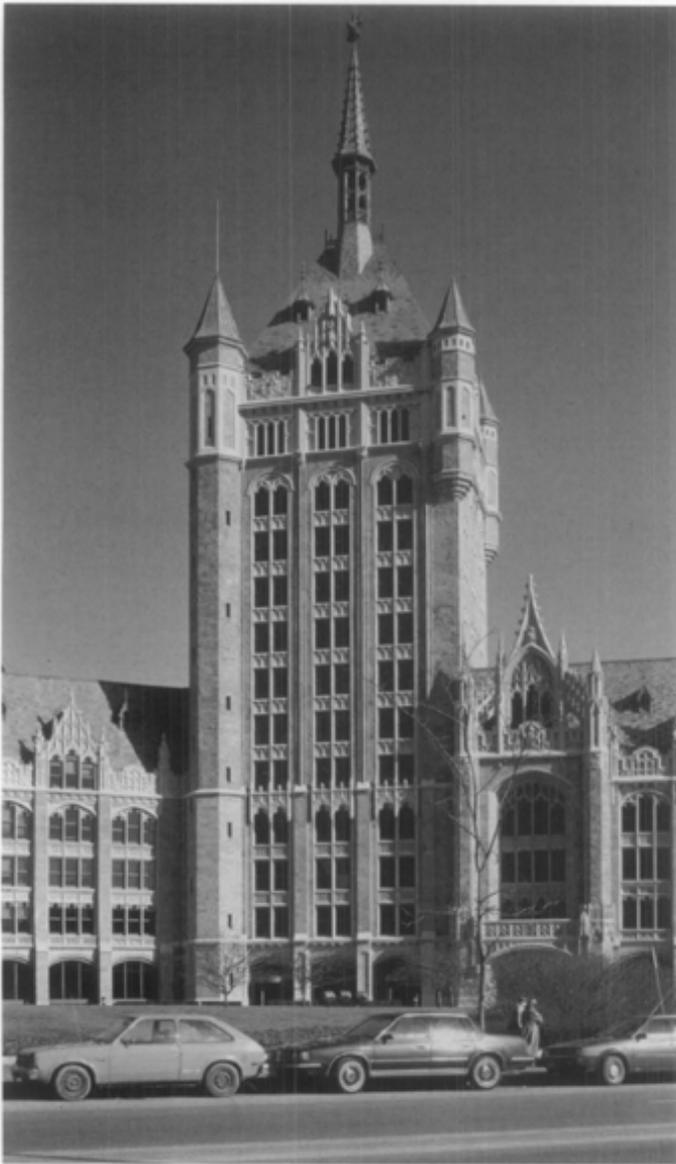
Figure 2. The prominent Delaware and Hudson Building in Albany, New York (1916) made extensive use of cast stone as trim combined with a random ashlar facing of natural granite. The elaborate gothic trim was produced by the Onondaga Litholite Company of Syracuse, New York.

The practice of using cheaper and more common materials on building exteriors in imitation of more expensive natural materials is by no means a new one. In the eighteenth century, sand impregnated paint was applied to wood to look like quarried stone. Stucco scored to simulate stone ashlar could fool the eye as well. In the 19th century, cast iron was also often detailed to appear like stone. Another such imitative building material was "cast stone" or, more precisely, precast concrete building units (Figs. 1, 2 and 3).

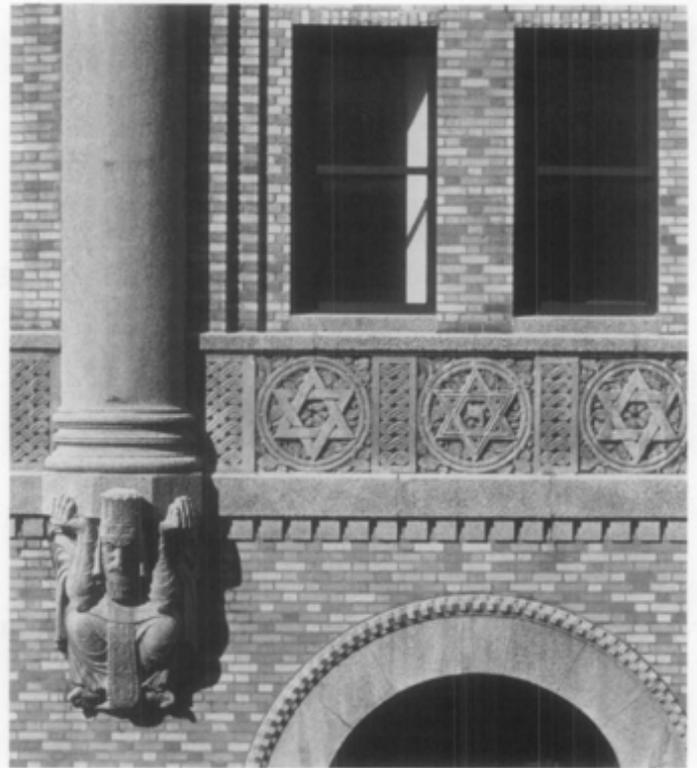
Figure 3. Sculptural ornament was frequently produced in cast stone. Repetitive detail, such as these banding course panels on the Level Club in New York City (1926), were produced much more economically than they could be in natural stone.

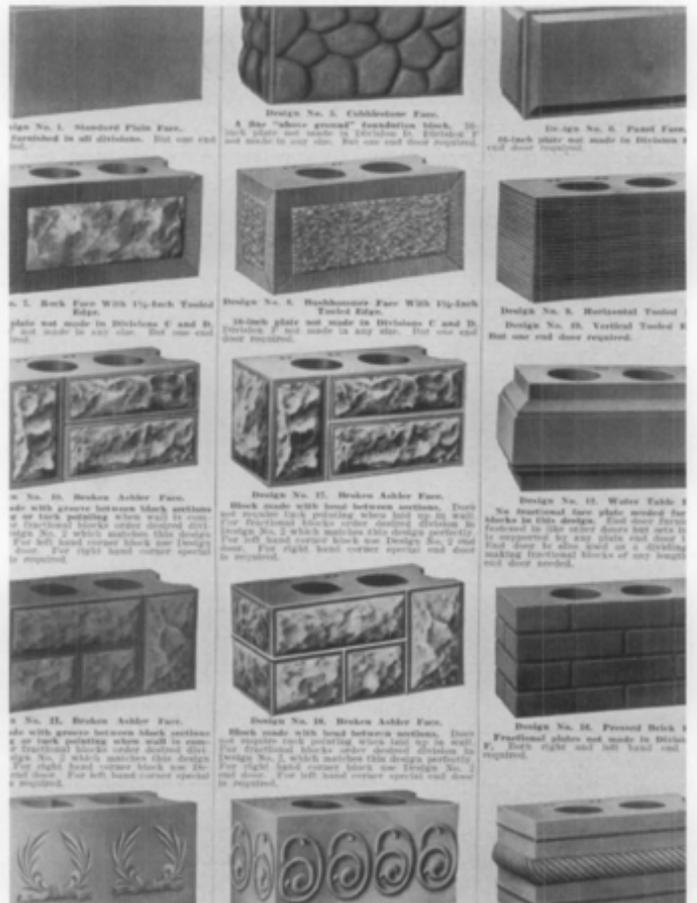
Figure 4. As shown in this Sears, Roebuck and Co. concrete machinery catalog, artistic concrete used standard concrete mixes to produce precast and cast-in-place concrete in molded forms, but made little effort to simulate natural stone.

States in the 19th century. These systems may be contrasted with "Artistic Concrete," decorative molded concrete construction, both precast and cast-in-place, which made little effort to simulate natural stone (Fig. 4).

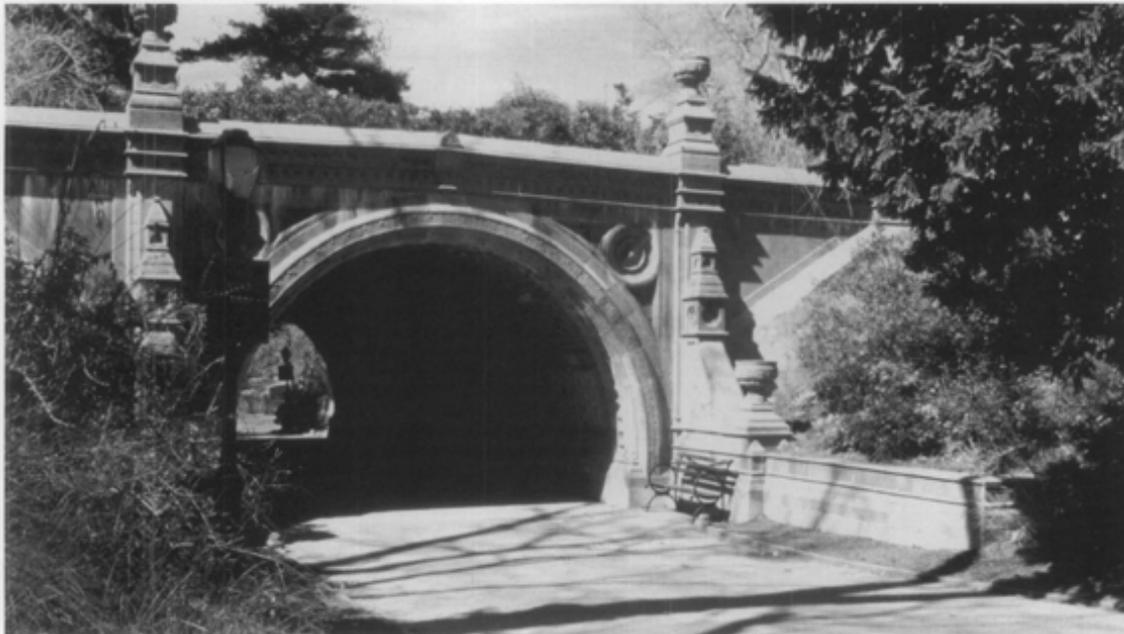
Figure 5. Constructed in 1868 of Beton Coignet, the Cleft Ridge Span in New York City's Prospect Park is one of the earliest extant cast stone structures in the United States.

the cast stone for one of the earliest extant cast stone structures in the United States, the Cleft Ridge Span in Prospect Park, Brooklyn, New York (Fig. 5).

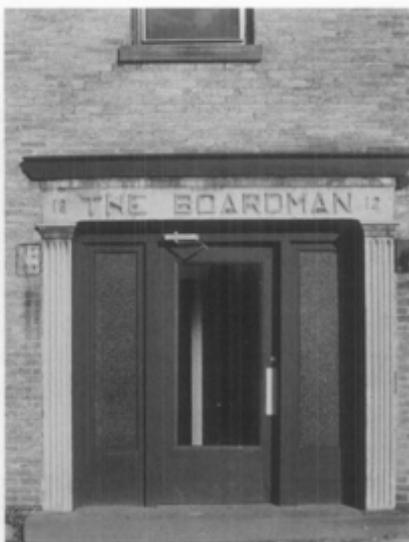
Figure 6. Cast stone was commonly used for molded trim in conjunction with brick or natural stone. This brick building in Rochester, New York, uses cast stone for the entry surround, and natural stone for unornamented window sills, thresholds, and water table units.

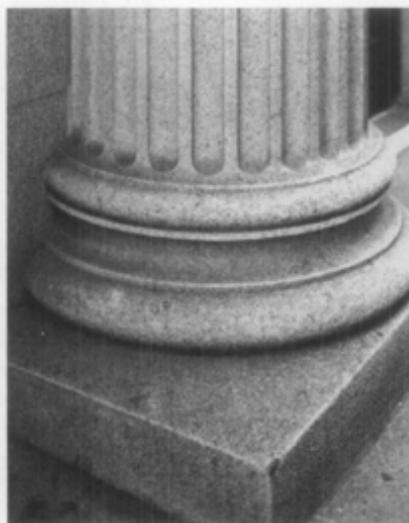
Figure 8. For this column, the appearance of a "pink granite" was simulated by using a pinkish matrix with white and black aggregate. Erosion of a tinted matrix results in a significant lightening of the cast stone surface.

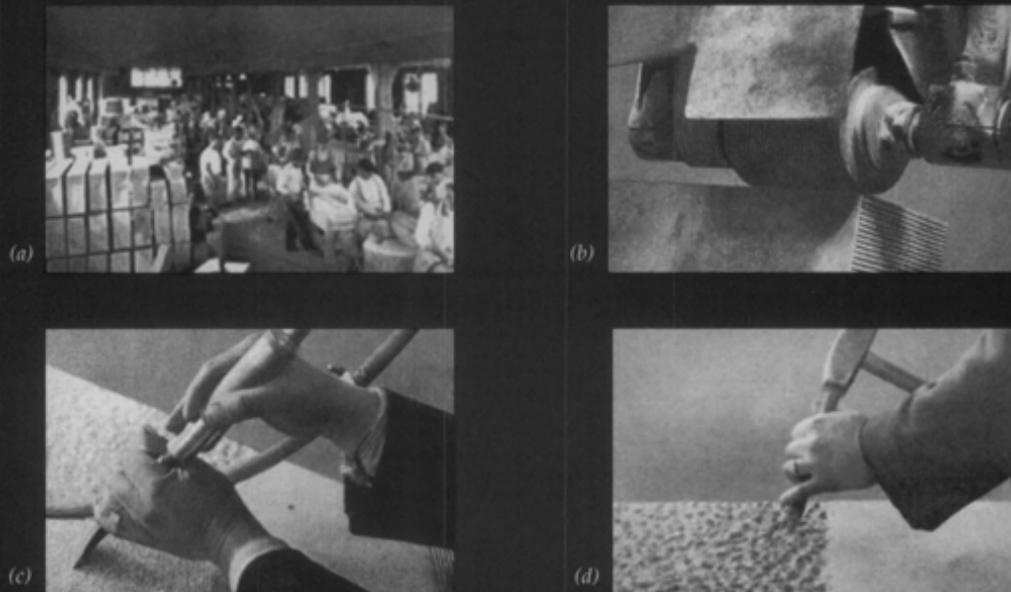
Figure 9. Onondaga Litholite Company Catalog: (a) Section of Hand-Finishing Department. (b) Tooling machines are set up with a series of carborundum wheels that grind grooves into the surface of the stone (c) Pneumatic hammers are used to produce six or eight cut finish (d) Point Finish is put on with a single pointed chisel. Courtesy, Collection of Michael F. Lynch.

High quality cast stone was frequently "cut" or tooled with pneumatic chisels and hammers similar to those used to cut natural stone (Fig. 9). In some cases, rows of small masonry blades were used to create shallow parallel grooves similar to lineal chisel marks. The results were often strikingly similar in appearance to natural stone. Machine and hand tooling was expensive, however, and simple molded cut cast stone was sometimes only slightly less costly than similar work in limestone. Significant savings could be achieved over the cost of natural stone when repetitive units of ornate carved trim were required.

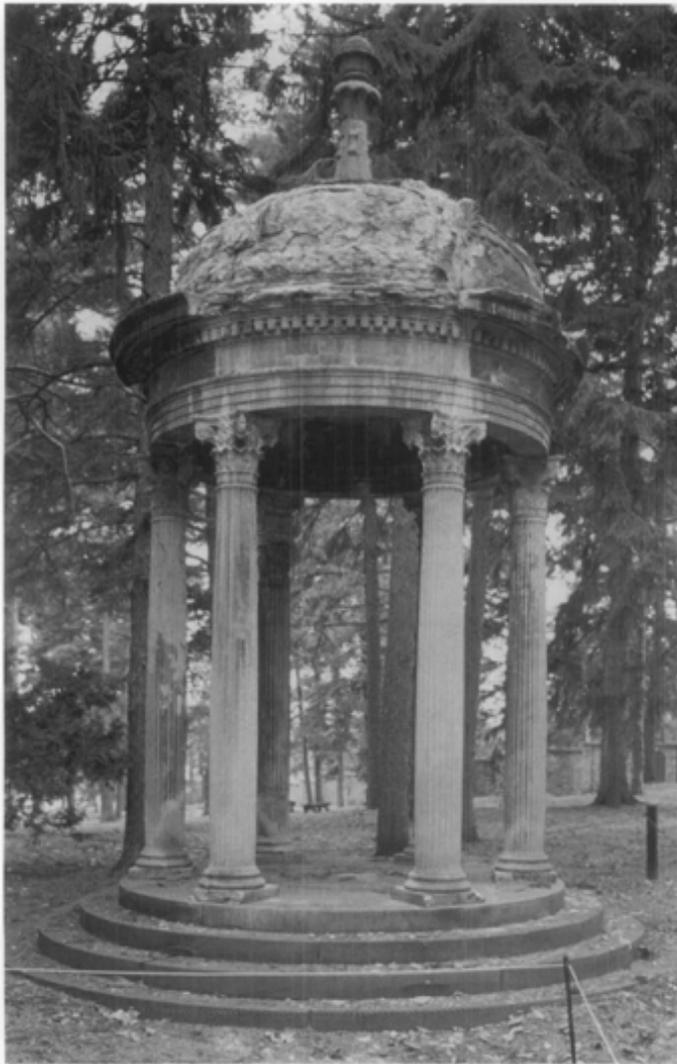
Figure 10. Scaling of cast stone units signals problems with the cementing mix and method of manufacture. Serious deterioration of cast stone, such as this, warrants replacement.

While it is relatively uncommon in twentieth century cast stone, serious deterioration of the cementing matrix can cause extensive damage to cast stone units (Fig. 10). A properly prepared cementing mix will be durable in most exterior applications, and any flaking of exterior surfaces signals problems in the cementing mix and in the method of manufacture. The use of poor quality or improperly stored cement, impure water, or set accelerators can cause cement problems to occur years after a structure is completed. Improper mixing and compaction can also result in a porous concrete that is susceptible to frost damage and scaling. Severe cement matrix problems may be impossible to repair properly and often necessitate replacement of the deteriorating cast stone units.

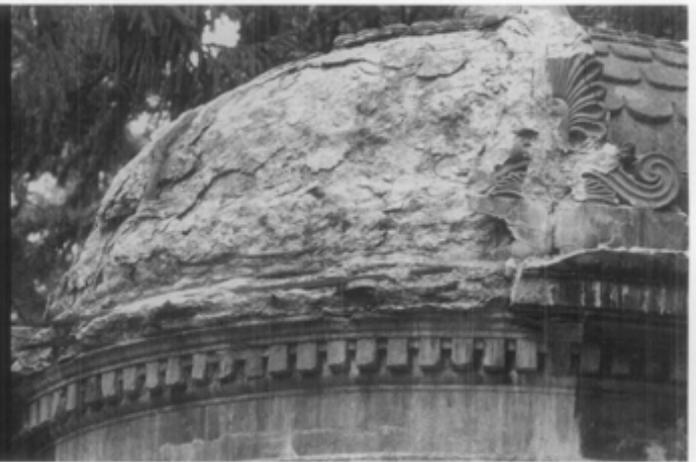
V DETAIL OF SCALING V

Figure 11. Erosion of the cementing matrix on the surface of cast stone is common in areas exposed to water runoff, such as window sills and copings. If no other deterioration is present, this condition does not warrant repair or replacement, but should be considered normal weathering. The unweathered surface at the left of this photograph shows the appearance of the original hammer-dressed finish. At right, the matrix has eroded, and the aggregate is much more prominent than on the unweathered surface.

More common and less serious than flaking or scaling caused by deterioration of the cementing matrix is the erosion of the matrix surface (Fig. 11). This usually occurs on surfaces of projecting features exposed to water runoff, such as sills, water tables, and window hoods. In these areas, the matrix may erode, leaving small grains of aggregate projecting from the surface. The resultant rough surface is not at all the intended original appearance. In some historic cast stone installations, the thin layer of cement and fine sand at the surface of the cast stone units was not originally tooled from the molded surface, but was finished with patterns of masonry pigments in a stylized imitation of highly figured sandstones or limestones (Fig. 12). Erosion of the pigmented surface layer on this type of cast stone results in an even more dramatic change in appearance.

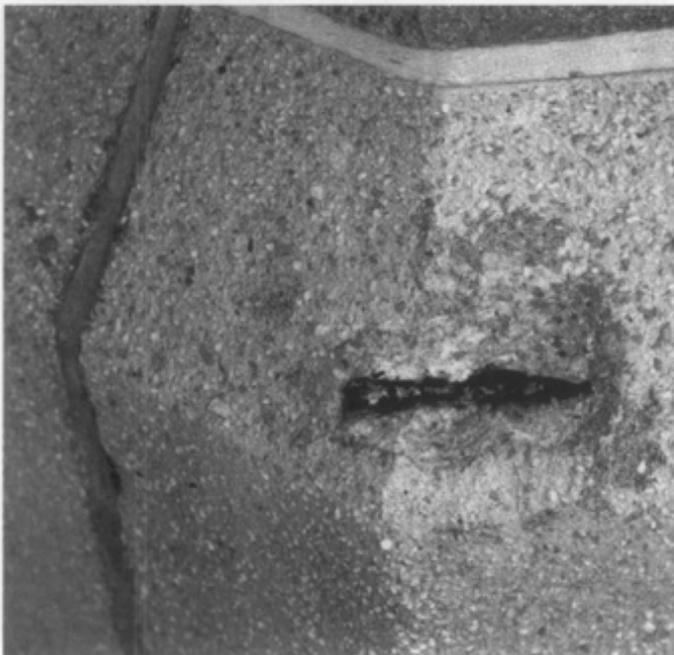
Figure 13. Rusting of reinforcement near the surface of the stone may result in spalling. Sections of reinforcement, such as this, may be cut out and the spall repaired with a matching composite mortar.

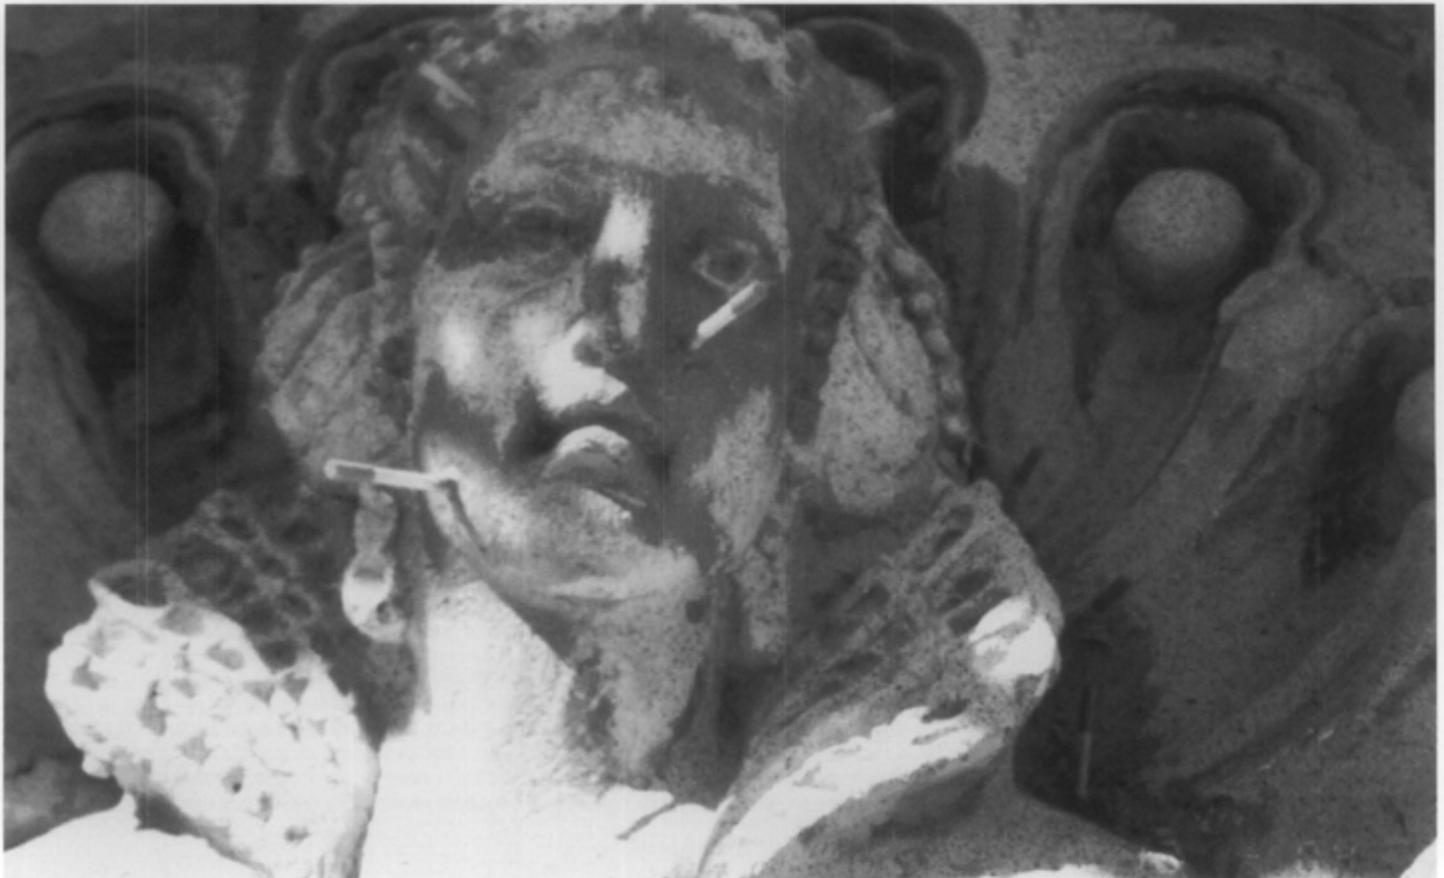
Figure 15. A delaminated layer of ornamental cast stone on the Orpheum Theater, San Francisco, California (1925), was successfully re-attached using epoxy. The multiple delivery ports for the epoxy are removed after treatment and the holes patched. Photo: David P. Wessell.

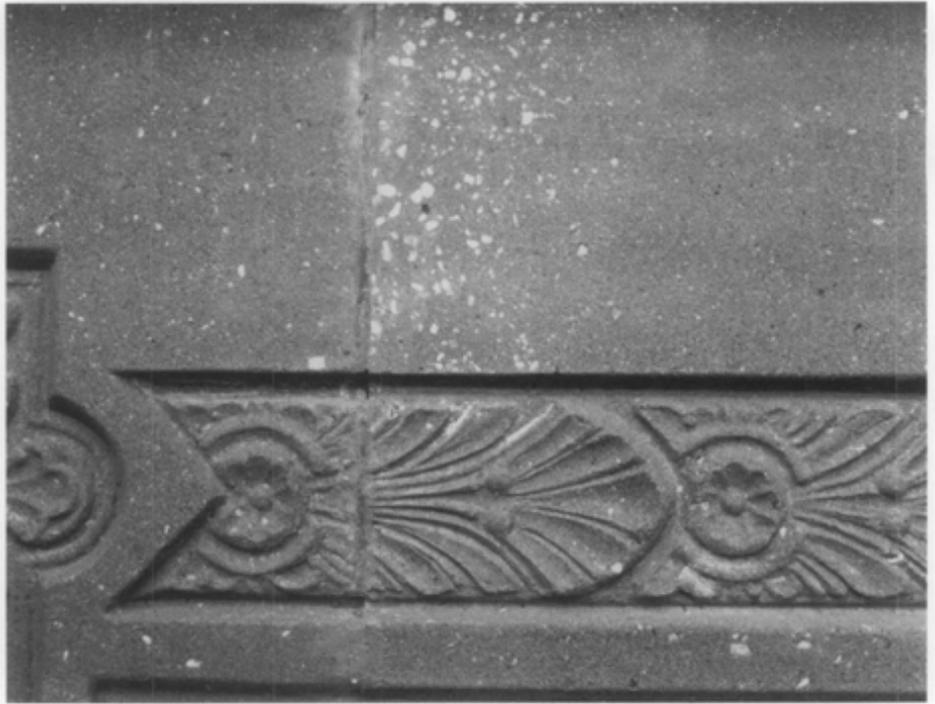
Figure 17. Unlike natural stone, cast stone generally may not be tooled in place to reduce lippage of uneven surfaces at joints. Tooling often exposes coarse aggregate from below the surface.

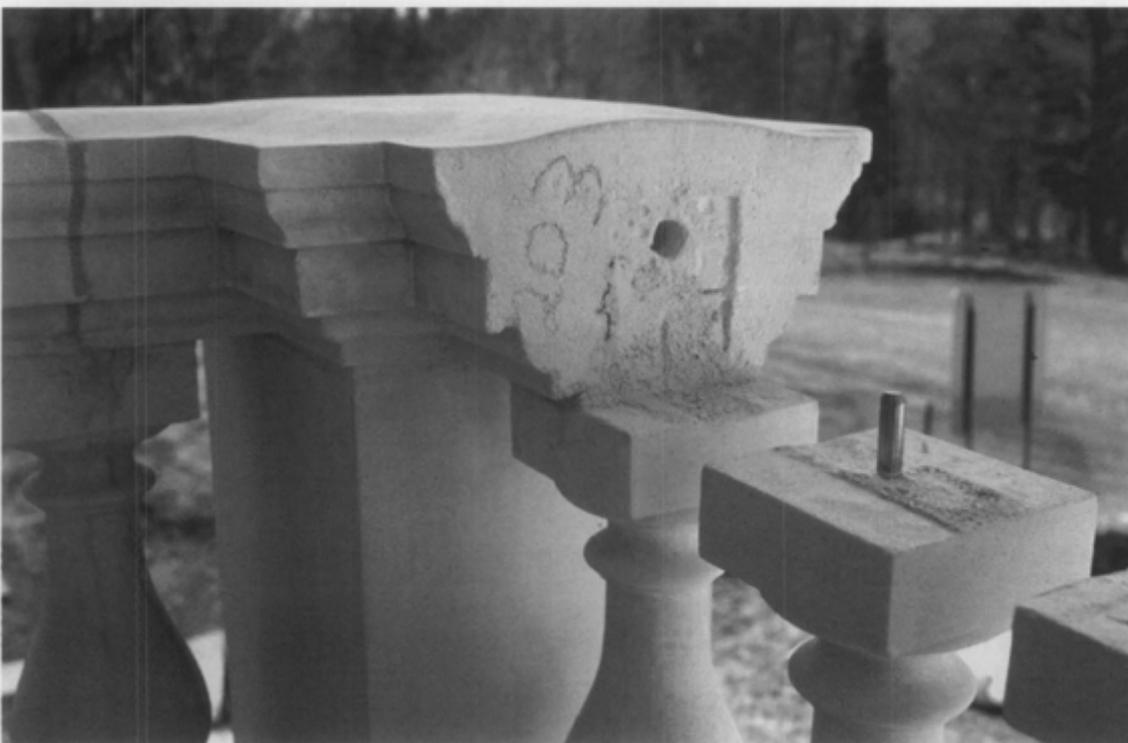
Figure 18. Long or thin cast stone elements require reinforcement. When possible, reinforcement of new cast stone should be made of stainless steel.

Individual cast stone units, which are subject to repeated wetting (such as copings, railings and balusters) and exhibit severe failure due to spalling or reinforcement deterioration, may require replacement with new cast stone (Fig. 18). Fortunately, a number of companies custom manufacture precast concrete units and can replicate deteriorated units in existing buildings (Fig. 19). The variables involved in manufacture are considerable, and it is wise to use a firm with experience in ornamental and custom work rather than a precast concrete firm which manufactures stock structural items, concrete pipe, or the like. Several trade organizations, including the Cast Stone Institute, the National Precast Concrete Association, and the Architectural Precast Association, have developed recommendations and/or guide specifications for the manufacture of cast stone and precast concrete. These specifications set standards for characteristics such as compressive strength and water absorptivity, and discuss additives such as air entraining agents and water reducing agents, which influence the longevity of new cast stone. Trade references and guide specifications should be consulted before contracting for replacement of historic cast stone.

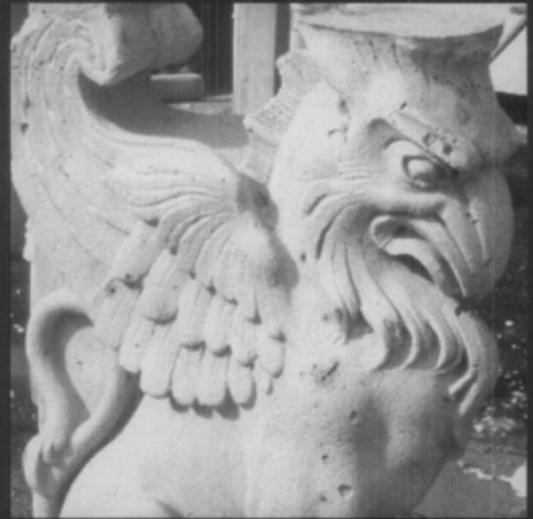
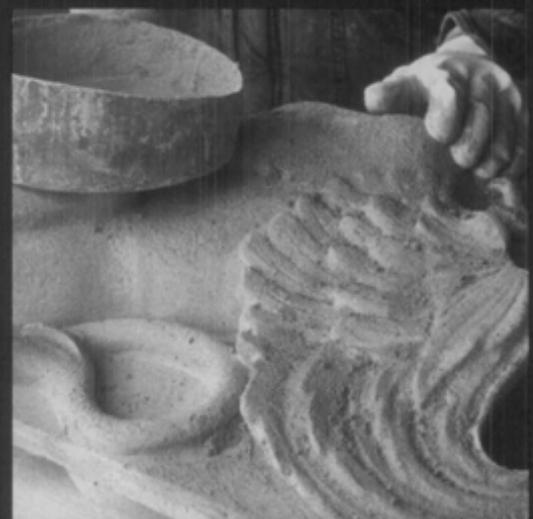
Figure 20. (top) After removal from the mold, new cast stone units are so finished as shown, to remove surface paste and expose underlying aggregate. (middle) And cast surfaces, such as columns or sculpture, may have numerous air bubbles at the surface. (bottom) The holes on the surface of the casting are filled with a mortar similar to the concrete mix used to cast the element.

when end casting long items such as columns or railings, where it is difficult to vibrate bubbles away from the finish surface of the unit (Fig. 20).

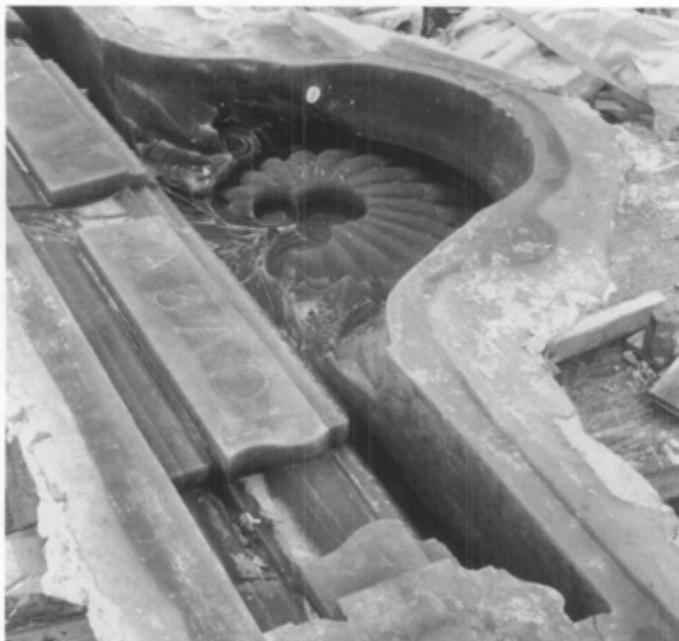
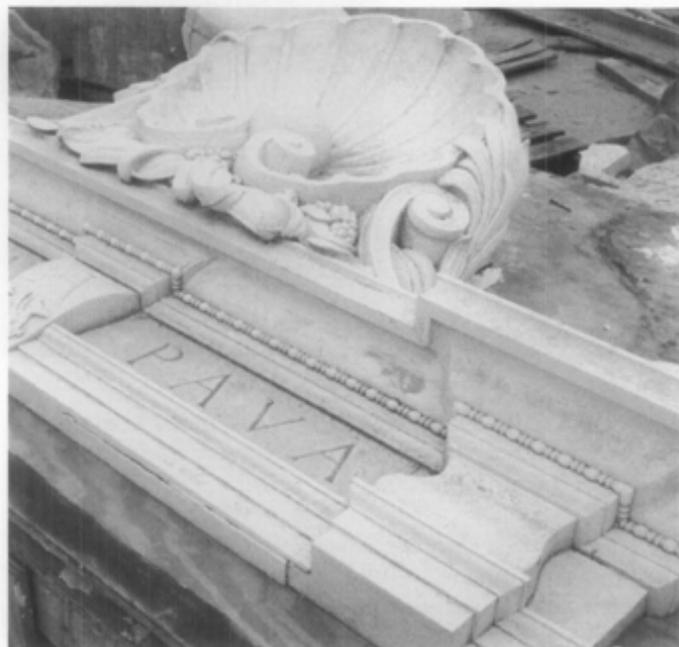
Figure 23. Production molds (left) made of durable rubbers backed with wood and plaster supports are used to fabricate new cast stone. Production molds may be made from original elements which have been repaired with epoxies and plaster, or from new plaster mockups. (below)

Surface rippling or irregularity. Production molds for fabrication are often made of rubber mold facings encased in larger "mother molds" of plaster and wood (Fig. 23). Vibration can loosen the rubber facing from the outer mold and result in rippling or irregularities on the surface of the finished casting (Fig. 24). Even when rippling is not noticeable, irregularity caused by mold movement can make it difficult to line up surfaces of adjacent units when assembling cast stone installations.

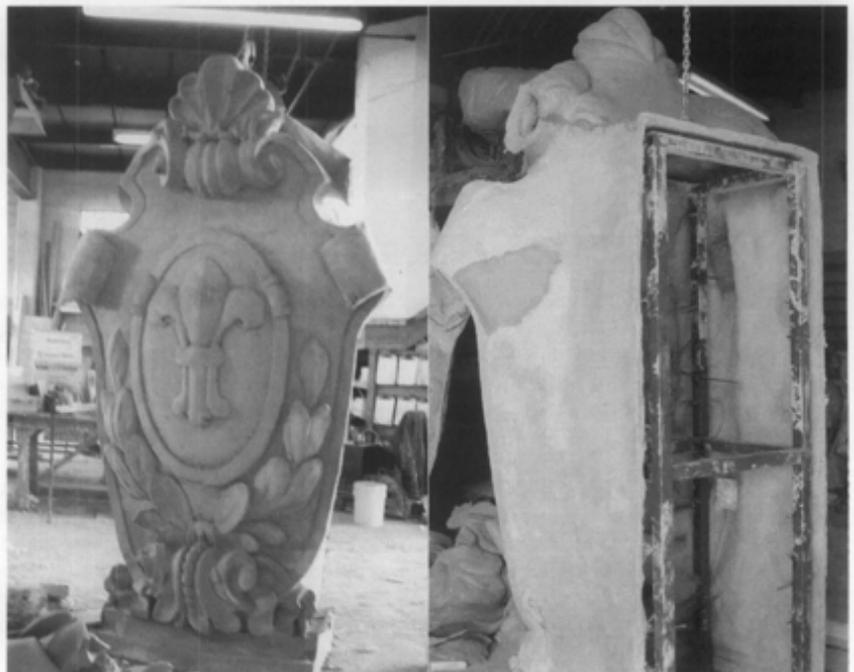
Figure 25. Glass Fiber Reinforced Concrete (GFRC) is sometimes used to replicate deteriorated elements of cast or fine grained natural stone. Because the GFRC element is a rigid, but relatively thin shell, it must be supported and attached with an interior framework of steel. The attachment hardware inside this GFRC cartouche (left) will not be visible when the unit is installed (armature visible at right). Photos: Towne House Restorations, Inc.

Glass fiber reinforced concrete (GFRC) is more and more frequently encountered in building rehabilitation and is used to replicate deteriorated stone and cast stone, and even architectural terra cotta (Fig. 25). This is a relatively new material that uses short chopped strands of glass fiber to reinforce a matrix of sand and cement. GFRC has become a popular low-cost alternative to traditional precast concrete or stone masonry for some applications. Fabricators use a spray gun to spray the mortar-like mix into a mold of the shape desired. The resulting concrete unit, typically only $\frac{3}{4}$ " thick, is quite rigid, but requires a metal frame or armature to secure it to the building substrate. The metal frame is joined to the GFRC unit with small "bonding pads" of GFRC.
