The Secretary  
of the Interior's  
Standards for  
Rehabilitation &

# Illustrated Guidelines for Rehabilitating Historic Buildings

U.S. Department of the Interior  
National Park Service  
Cultural Resources  
Heritage Preservation Services

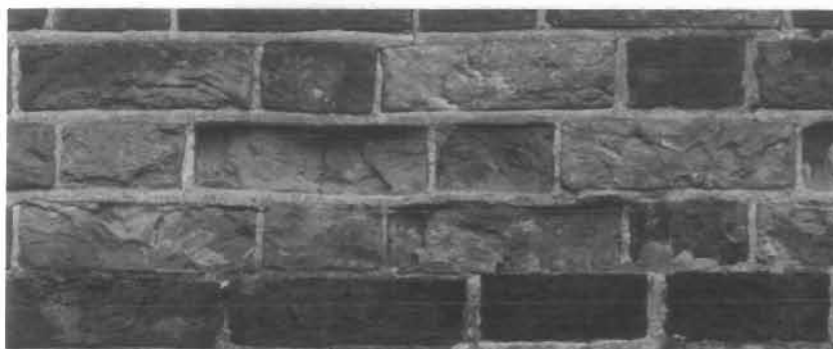
*Too hard and inflexible a mortar has caused this soft, 18th century brick to spall.*

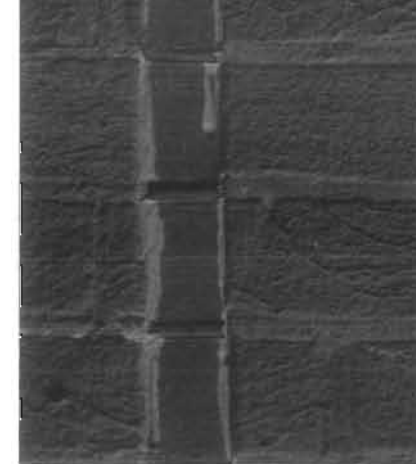
*When this brick wall was sand-blasted, a down-spout (since removed) protected the original smooth surface of the center strip from damage.*

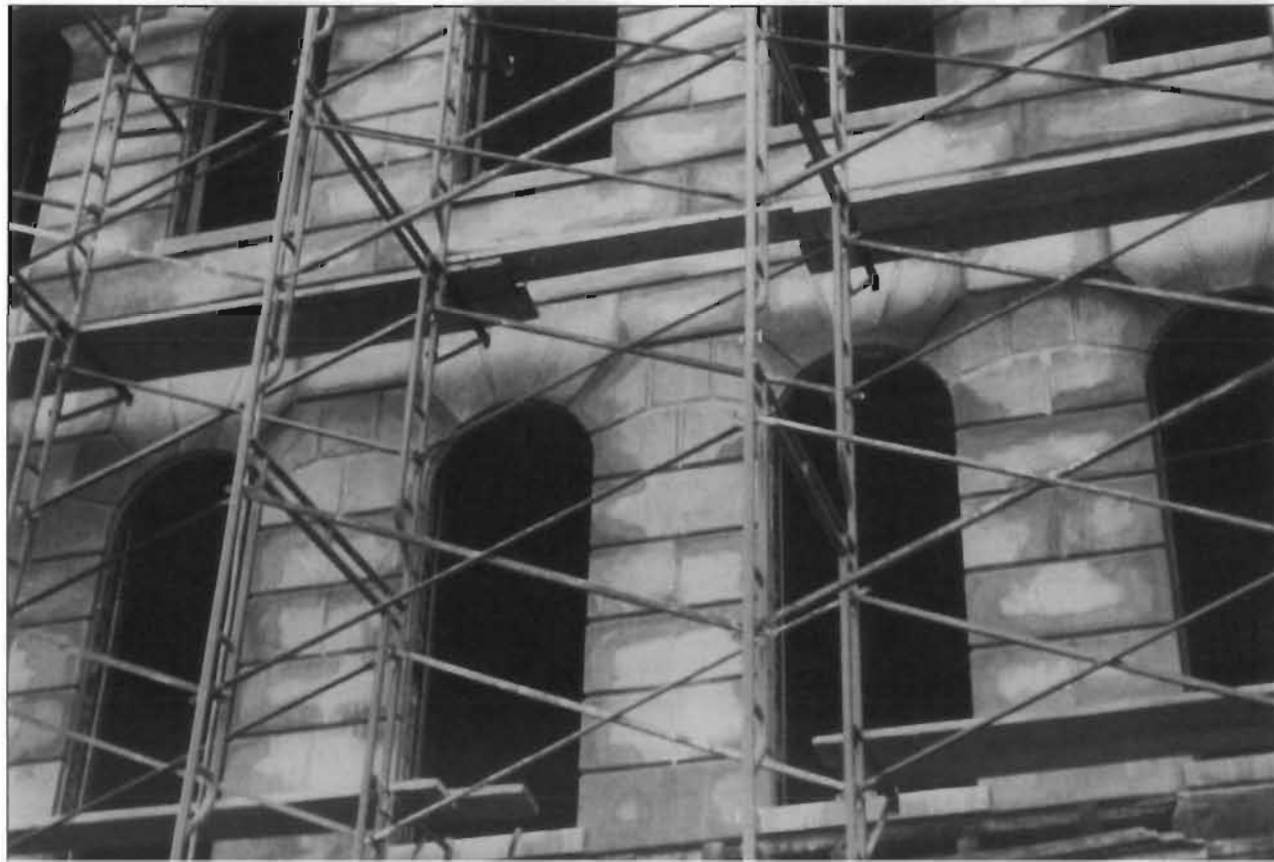
*Composite patching with a cementitious mixture is being used to repair eroded areas of this sandstone facade.*

*Moisture from a faulty roof and drainage system has been trapped inside this limestone cornice by a waterproof coating, causing severe damage to the stone.*

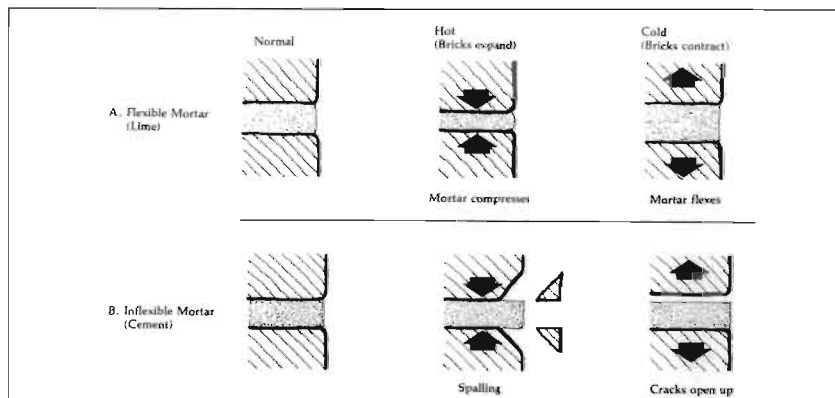
*Flexible mortar expands and contracts with temperature changes. Bricks bonded by inflexible mortar tend to spall at the edges in hot weather and separate from the mortar when it is cold. Temperature fluctuations result in cracks which permit water to enter, causing additional deterioration.*

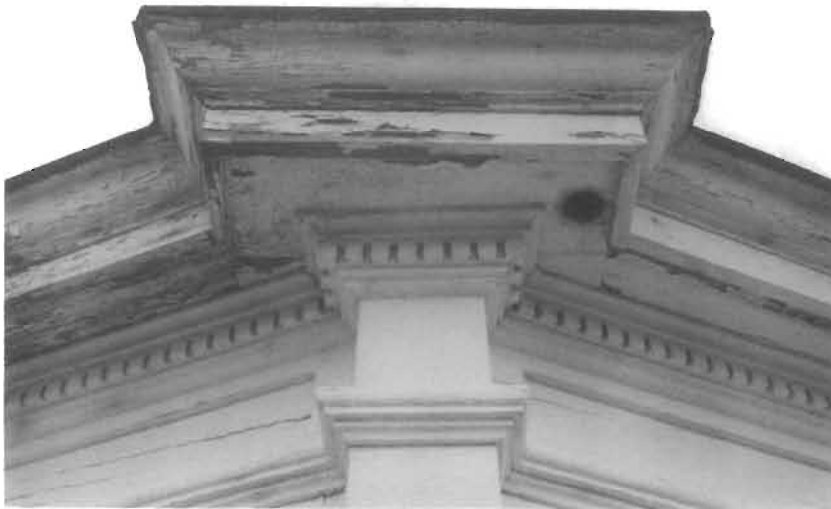
*Due to lack of maintenance, the paint has peeled to bare wood. In order to survive, this cornice will need to be scraped, sanded, and re-painted together with other essential repairs.*

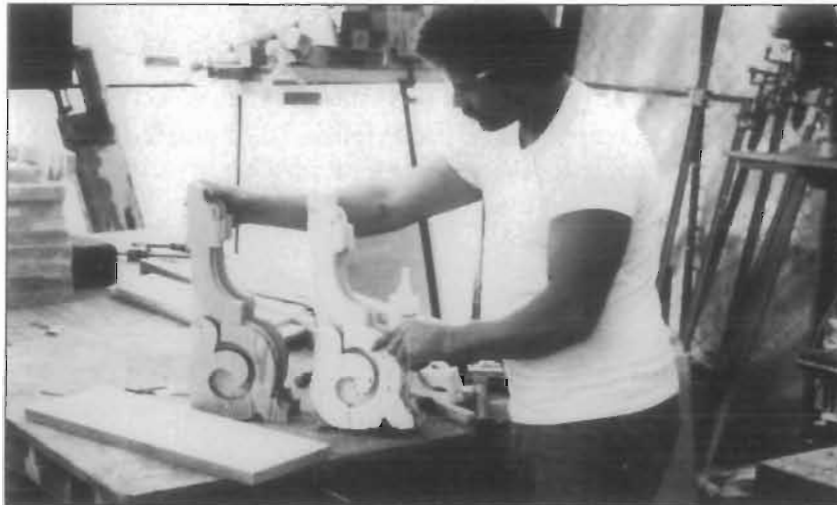
*If a character-defining feature is missing, it should be replaced with a matching feature. This shop artisan used traditional tools to replicate a missing porch bracket; after the new bracket is painted, both original and duplicate will be installed on-site.*

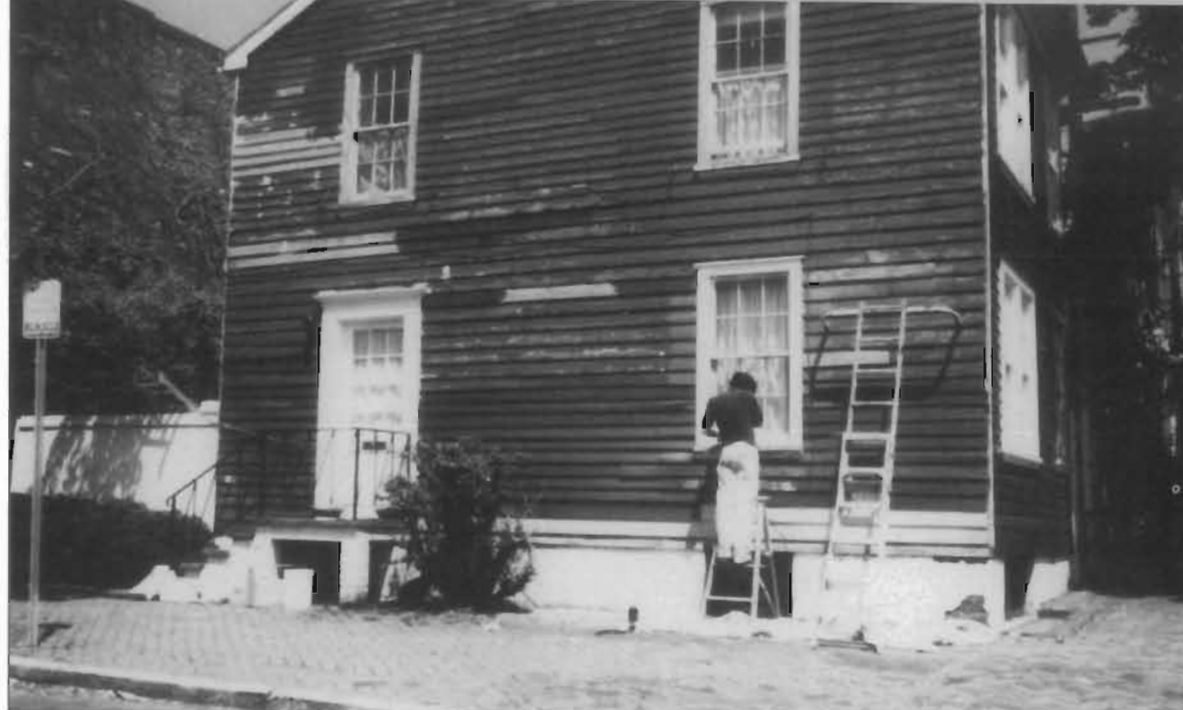
*Deteriorated clapboards are being selectively replaced, thereby maximizing retention of the historic siding.*

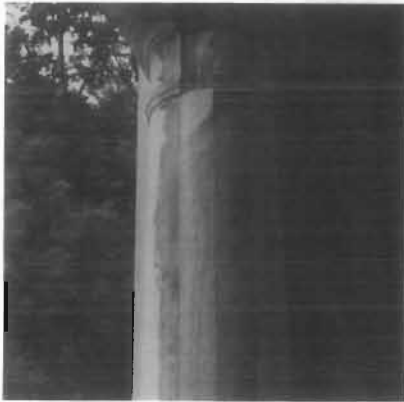
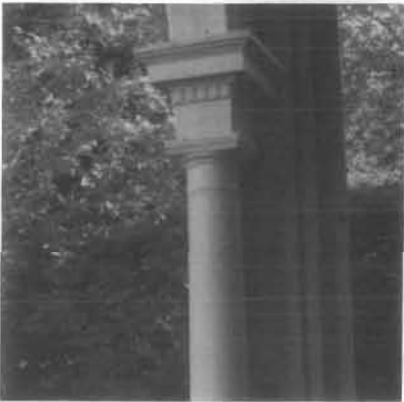
*To replace deteriorated portions of the column, strips of new wood were milled to conform to the shape and appearance of the old column framework, glued in place, then back-primed and painted.*

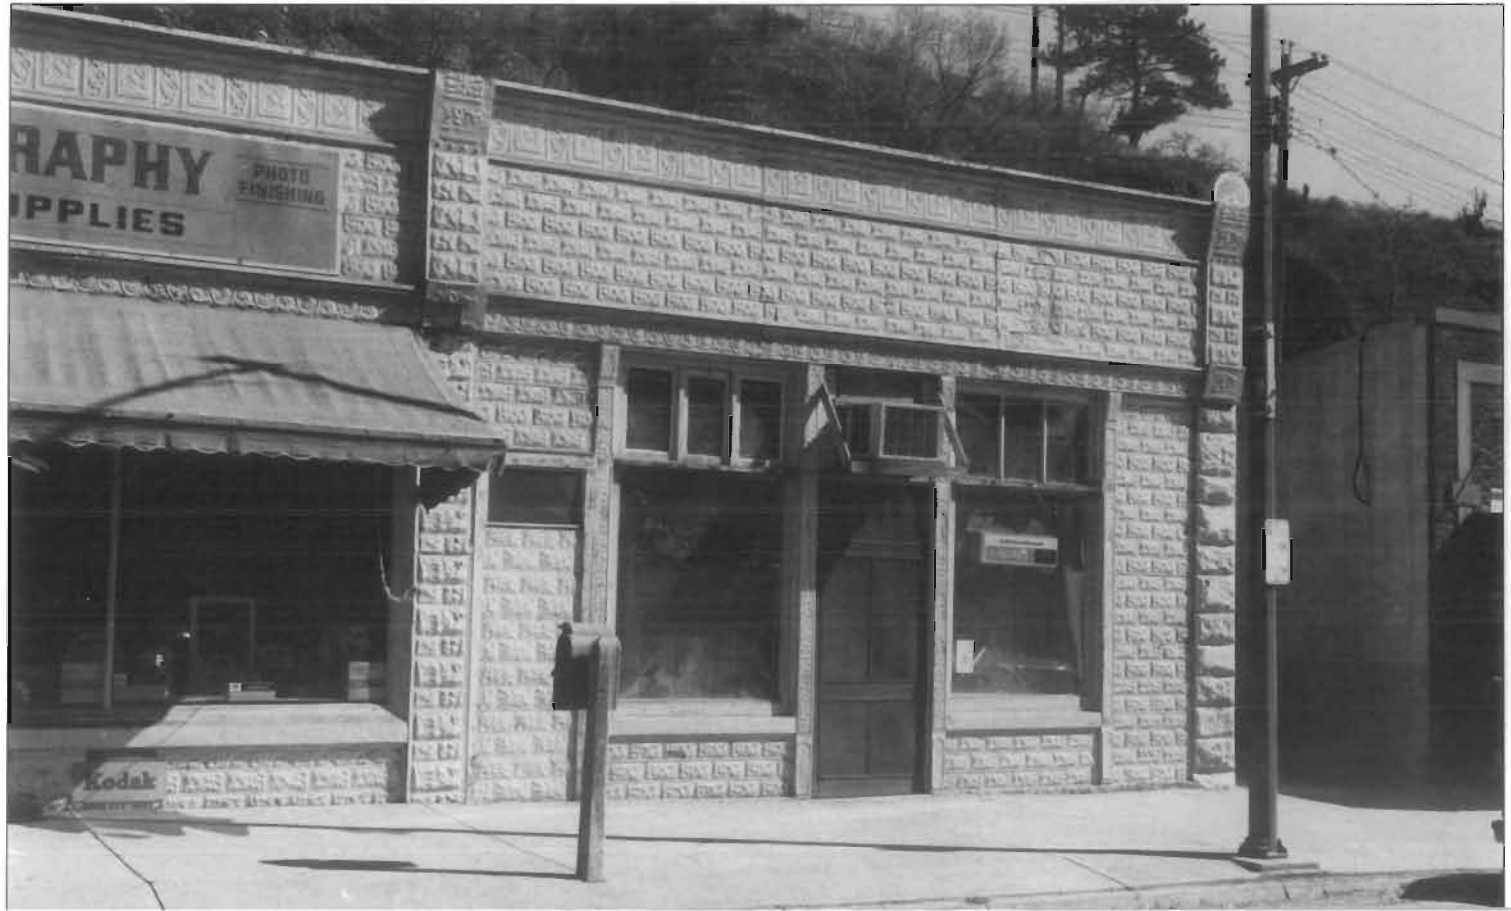
*Although these pressed metal storefronts have been well maintained over the years, gaps in the seams between the metal sheets above the door and slight stains along the cornice line indicate a possible roof leak. The roof should be investigated and repaired before the moisture results in rust and more severe metal deterioration.*

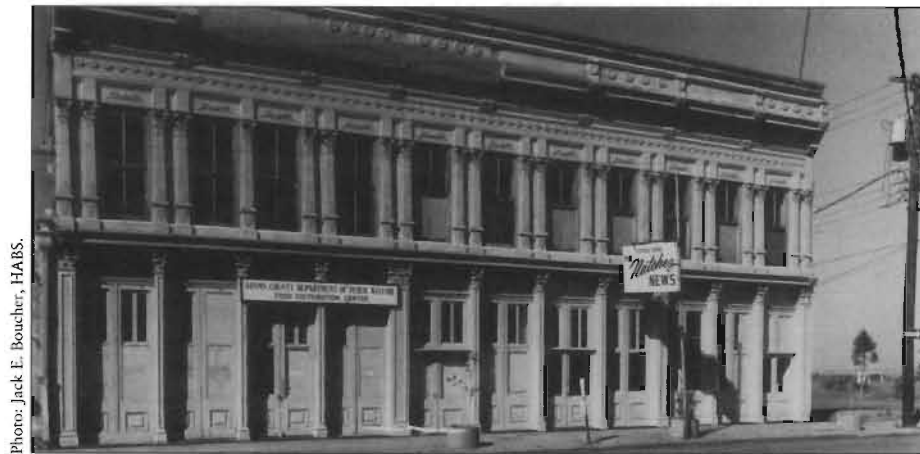
*Deteriorated portions of the decorative pressed metal cornice have been inappropriately replaced with non-matching, plain metal sheets, adversely affecting the historic character of this building.*

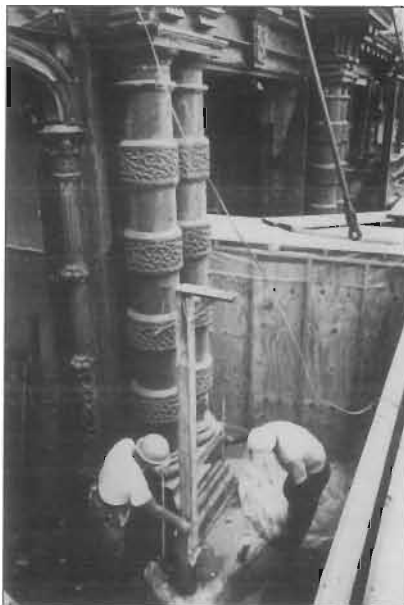
*The cast-iron columns of this theater are being repaired during rehabilitation. Some of the cast iron elements such as the smaller, non-structural columns missing from the bay on the right will be replaced with a lightweight substitute material such as cast aluminum, an acceptable alternative according to the Standards.*

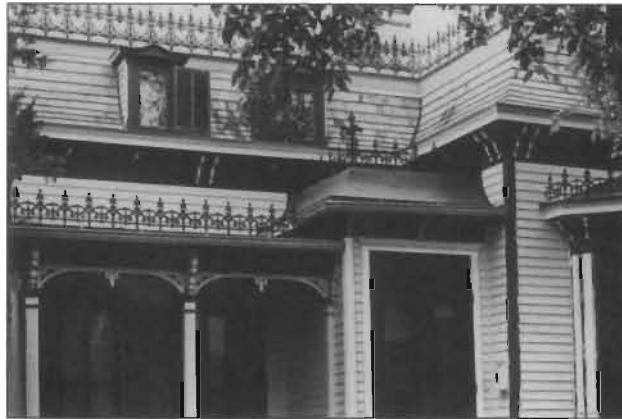
*This well-maintained mansard roof displays its handsome and varied decorative detailing—cast-iron cresting, wood shingles, and pedimented dormers.*

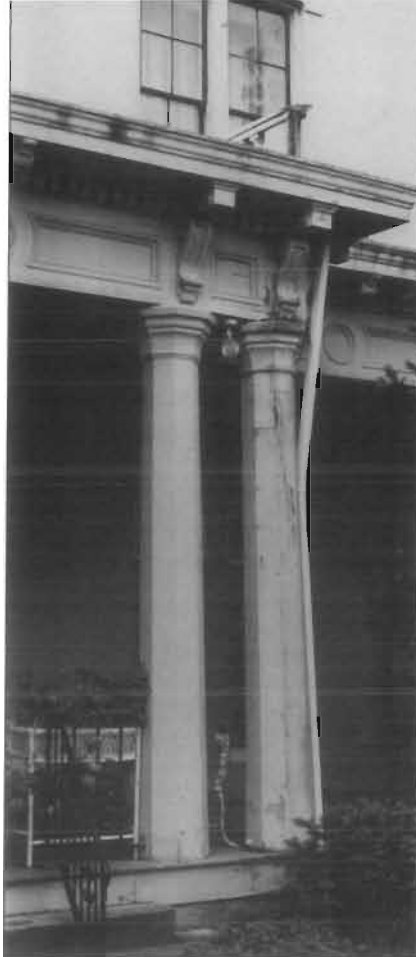
*The roof drainage system has been neglected for such a long time that, as a result, the wood cornice and a porch column are both severely deteriorated.*

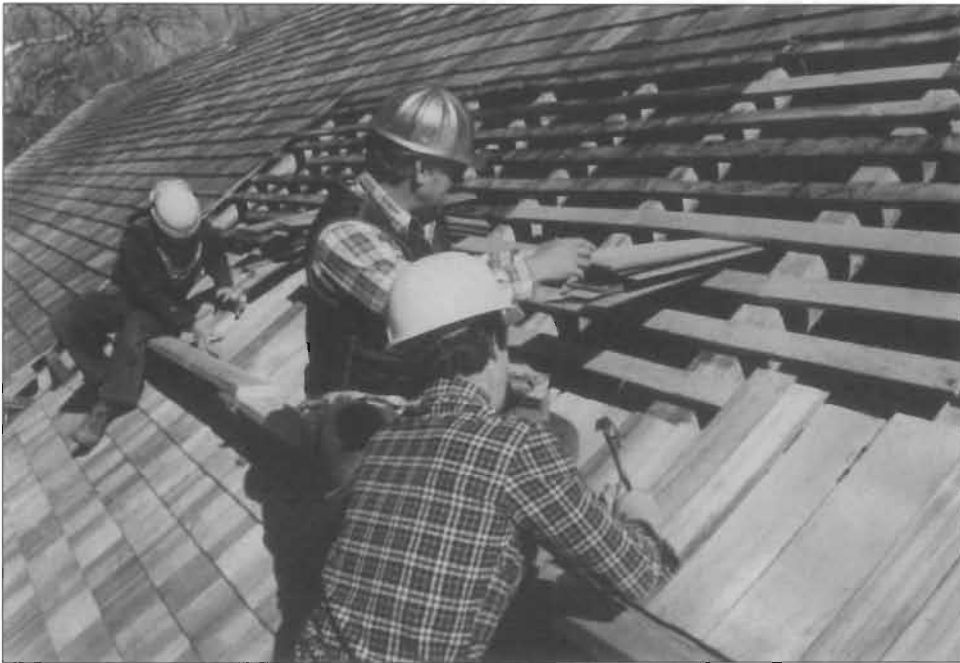
*The size, shape, and detailing of the historic shingles as well as the method of fabrication and installation were carefully researched prior to selecting this new wood-shingle roofing.*

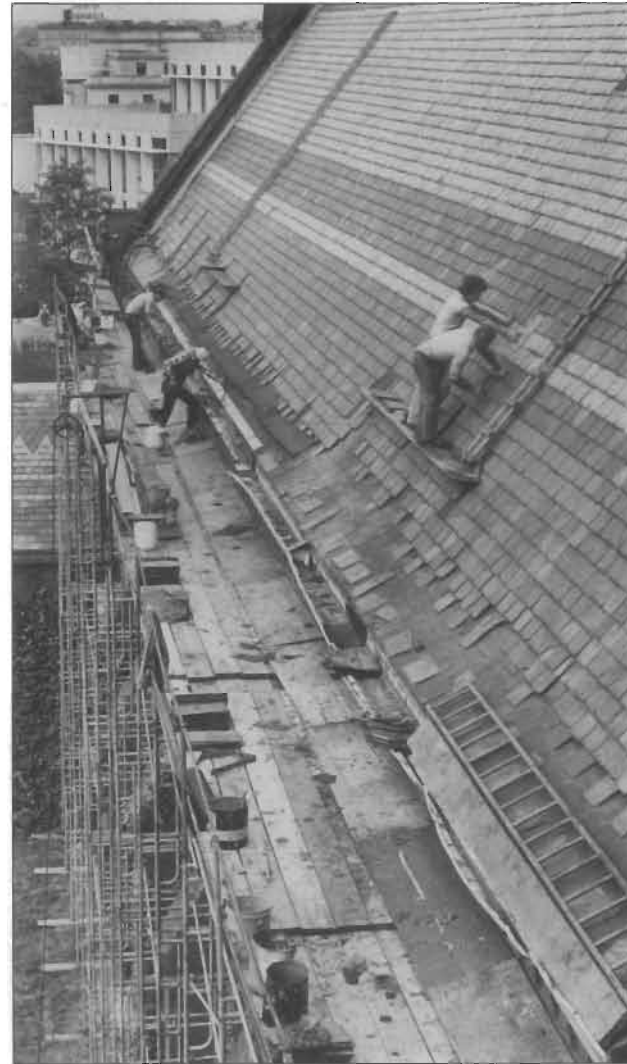
*Workmen are in the process of removing deteriorated roofing slates and replacing them with new matching slates.*

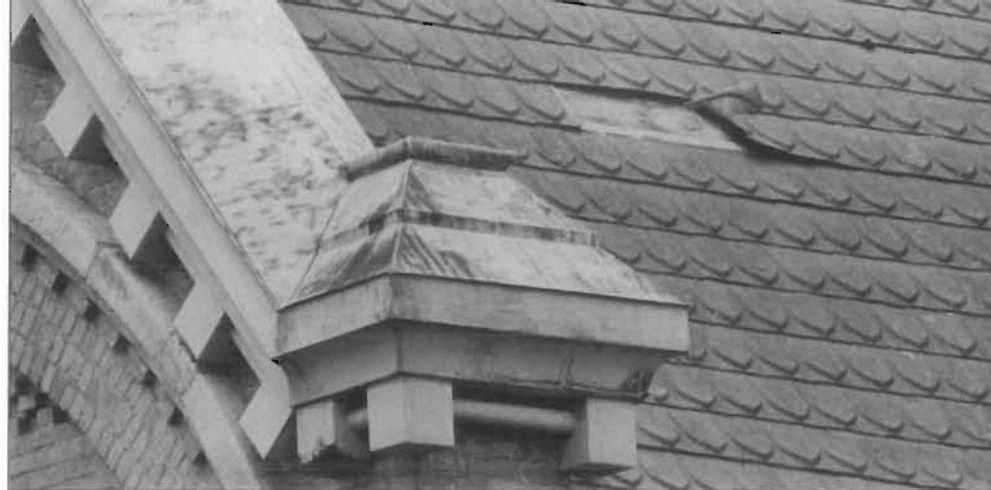
*New galvanized sheet-iron shingles will need to be reproduced using the pattern of the original shingle.*

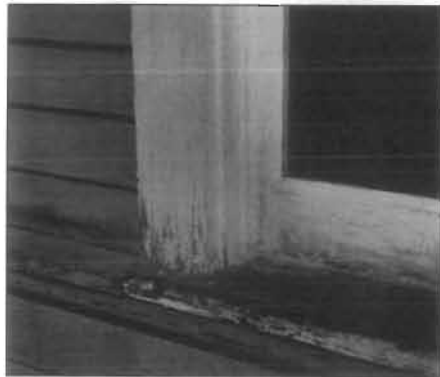
Deterioration of poorly maintained windows usually begins on horizontal surfaces where water collects. Problem areas on this sill are clearly indicated by paint failure due to moisture.

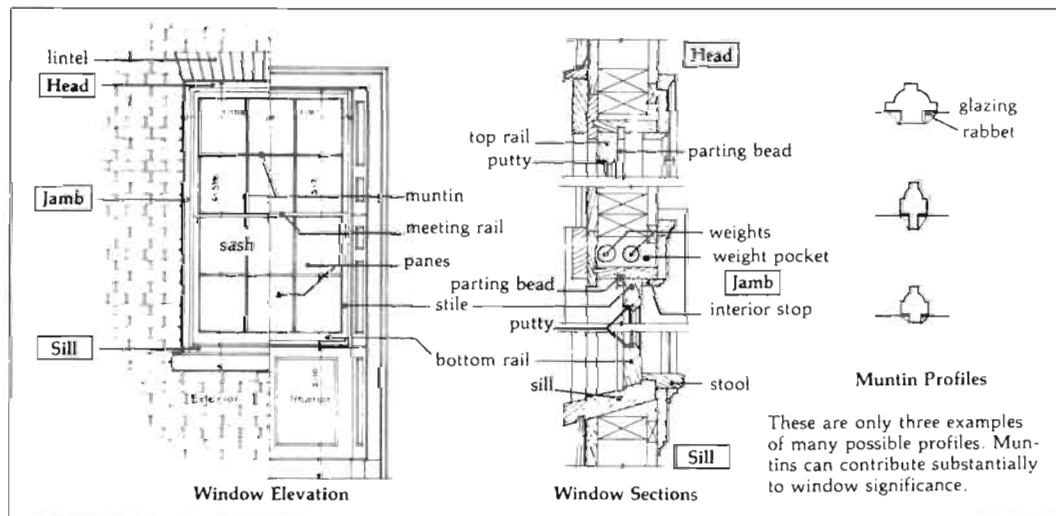
These drawings identify individual parts and fabrication details of a historic wooden double-hung window.

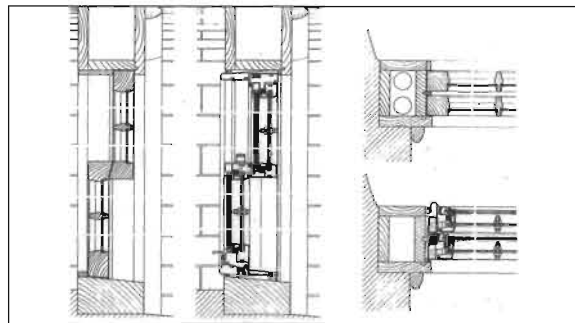
*For some larger buildings, it may be appropriate to replace seriously deteriorated windows with new ones that replicate most of the historic visual qualities. This two-part drawing shows the original windows in a mill and the rehabilitation solution that retained the wood frames, then utilized an aluminum sash with true divided lights and a piggyback interior storm panel.*

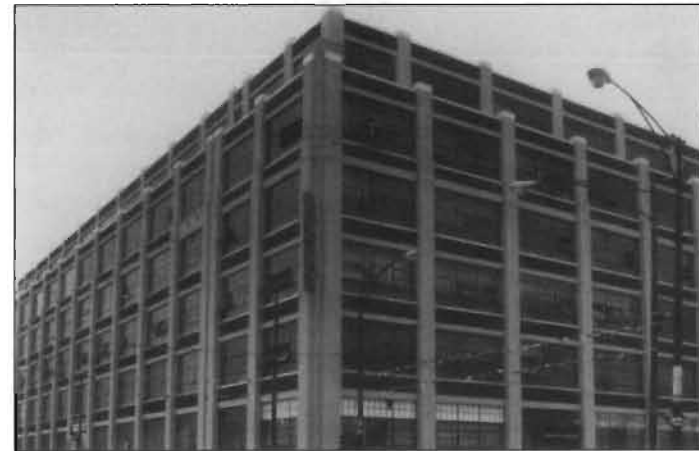
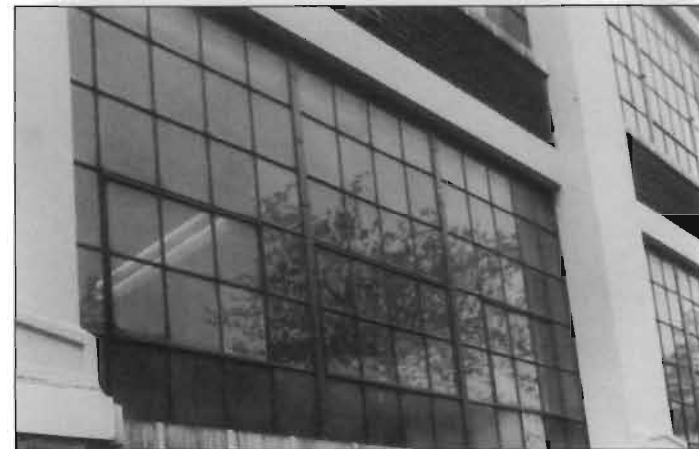
*The steel pivot windows in this historic manufacturing building were replaced with new windows which matched the multi-lighted originals.*

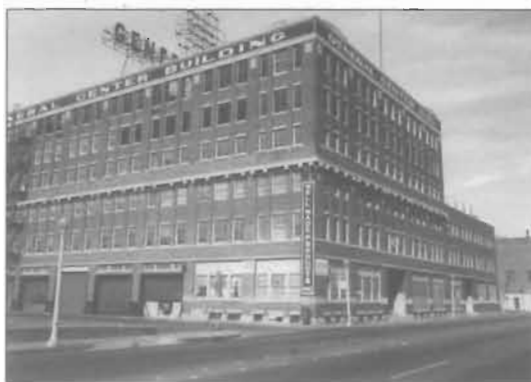
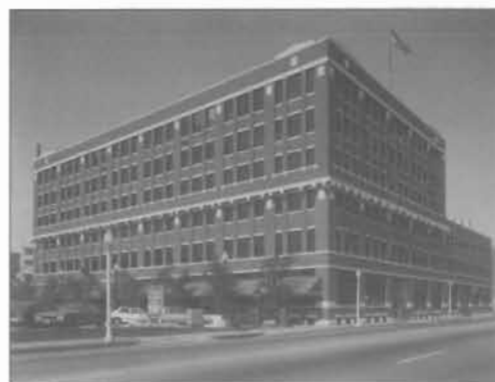
*When the six-over-six windows were replaced with inappropriate single sheets of tinted glass, the historic industrial character of this building was lost.*

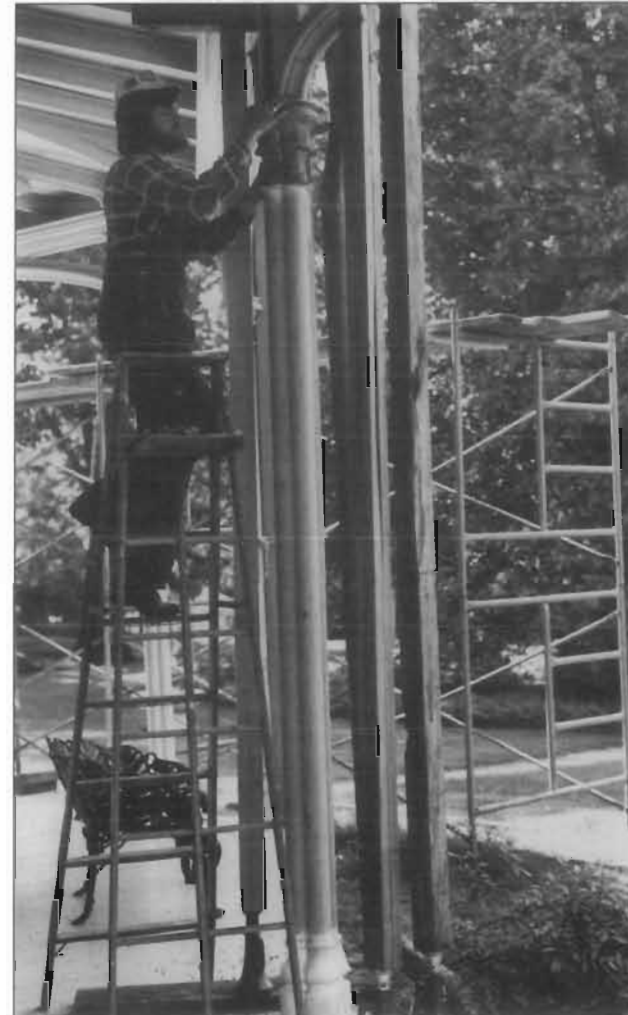
*Careful inspection of porch features such as these column capitals is necessary before initiating a rehabilitation project.*

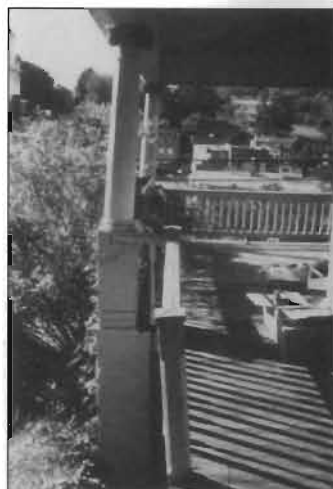
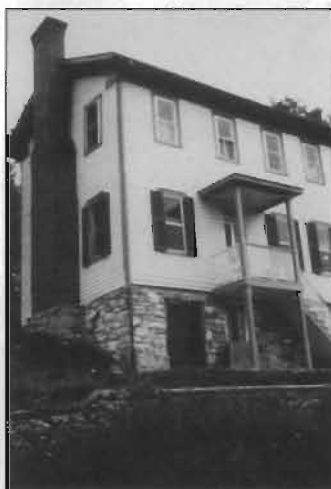
*A 1910 wrap-around porch was removed from this 1830 house during rehabilitation. Although a later addition, the porch should not have been removed because it had acquired significance over time and was thus an important feature in defining the character of this historic structure.*

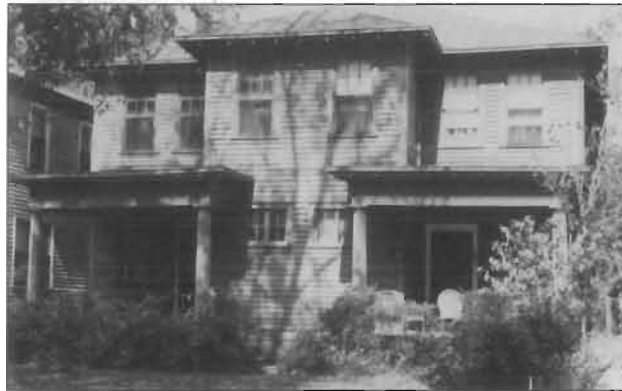
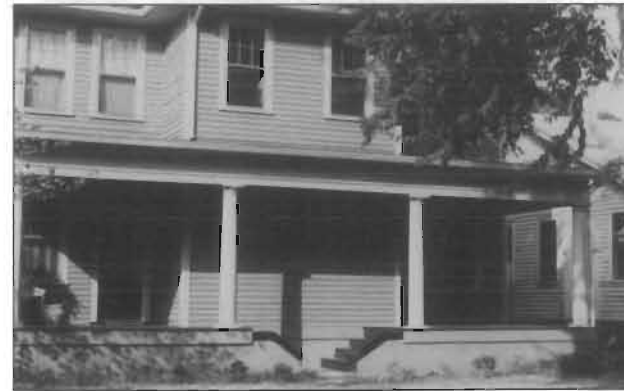
*This rehabilitation connected two separate porches, resulting in the creation of a large continuous porch that obscures the historic twin porch design; it is thus incompatible with the historic character of the house.*

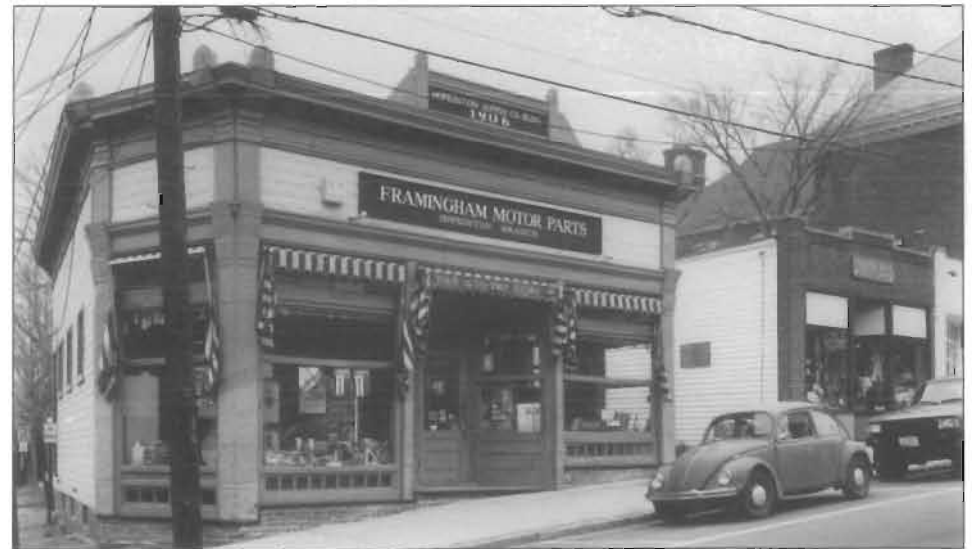
*These architectural details are typical of historic commercial buildings (this particular one is No. 4016 in the George L. Mesker and Company catalog of 1905). The design utilized both cast and galvanized iron.*

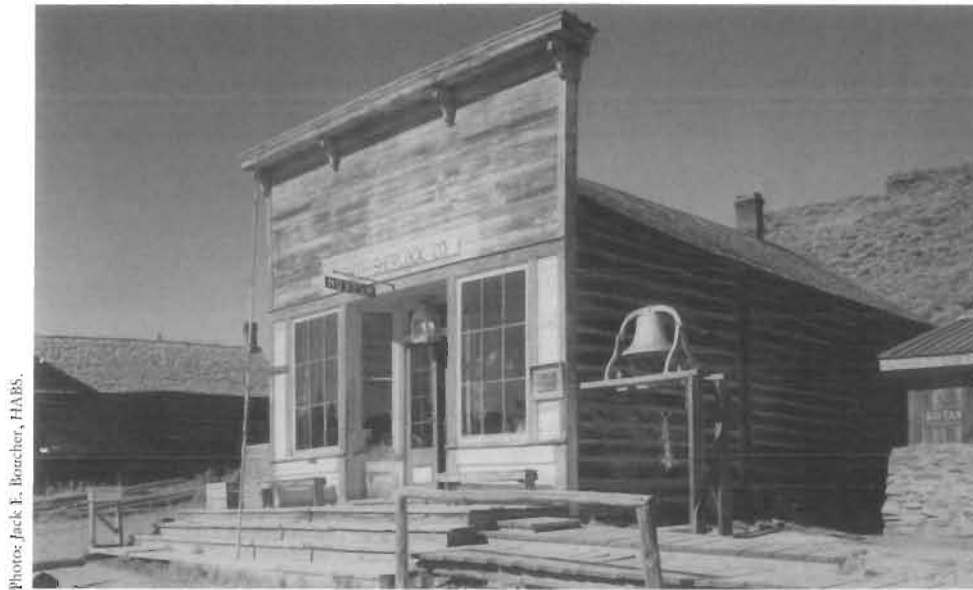
*A false-fronted wood store is now used as a museum. Although the weathered wood is part of its charm, repainting is recommended as a good maintenance practice to protect the wood.*

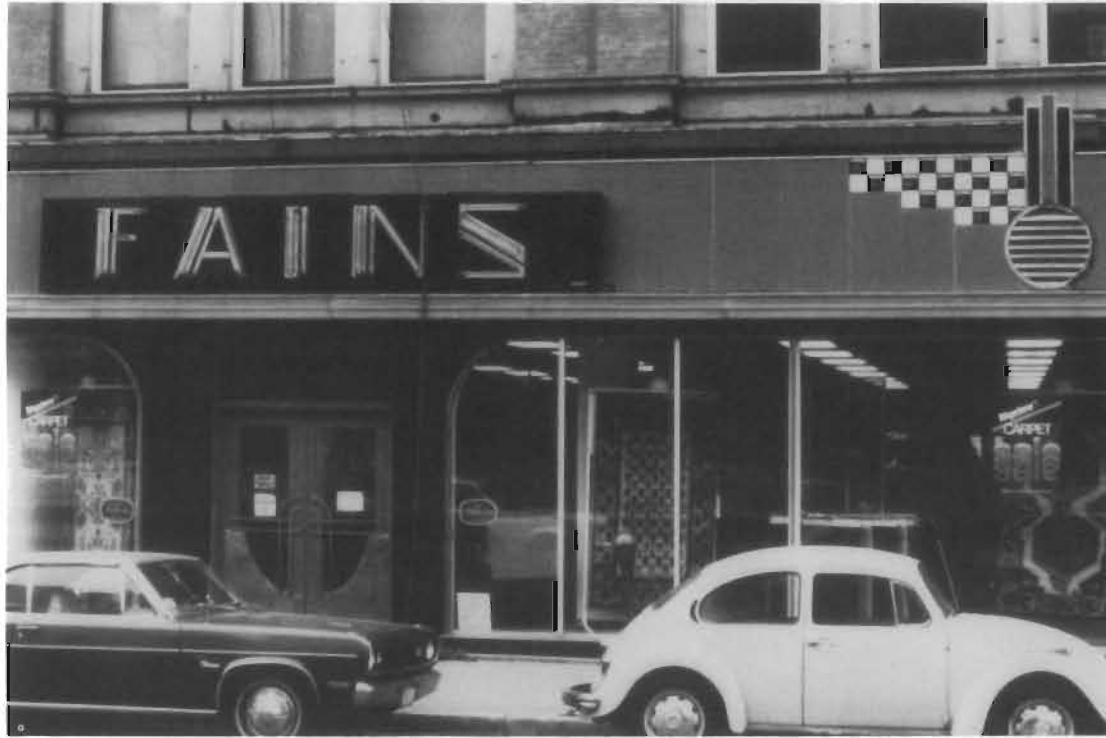
*This sleek red and black Moderne storefront was added to a more staid late-19th century commercial building in the 1930s—both are now in need of repair. According to the Standards, later storefronts that have acquired significance over time should generally be retained in rehabilitation.*

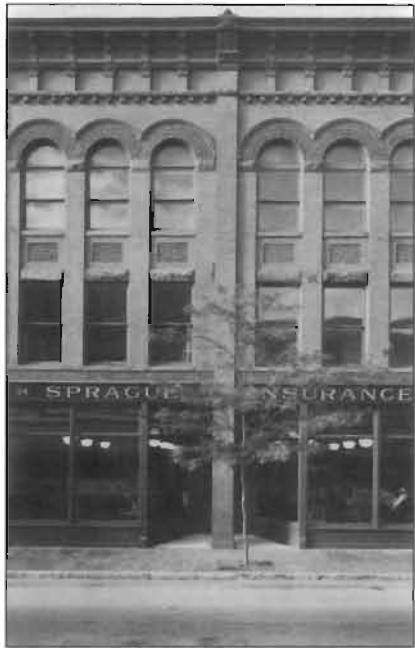
*This appropriate new storefront replaces an old one that was too deteriorated to save. It features a recessed doorway based on the historic design and respects the scale and proportion of the existing building.*
