Building
Interior

*Structural
Systems*

Structural Systems

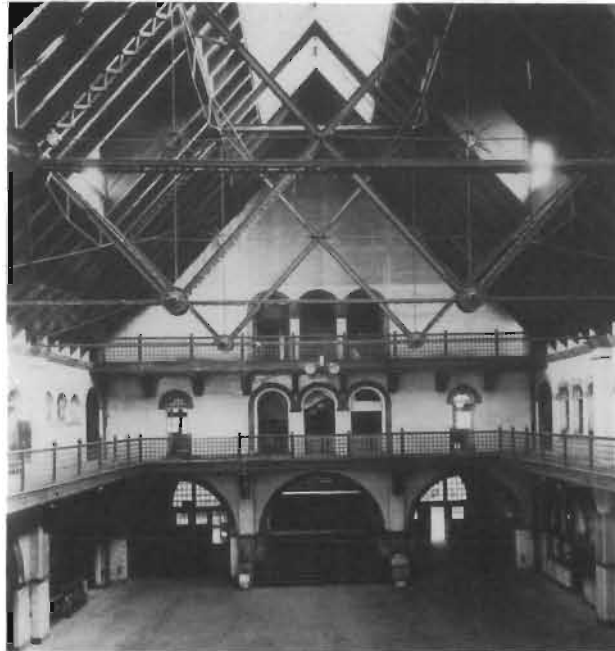
The exposed metal roof-truss system of this waiting room not only provides structural support, but is also important in defining the interior character of the train station.

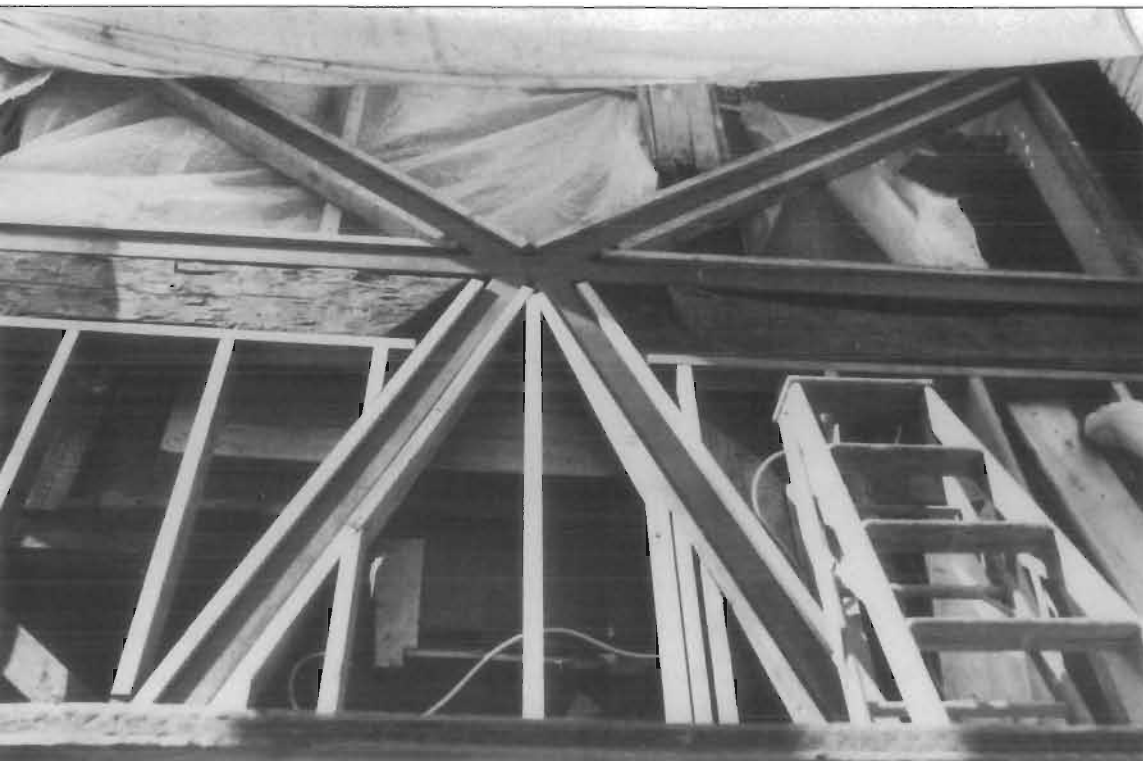
Photo: Irving B. Haynes and Associates

In order to preserve this historic wood-frame building, new steel framing was inserted to reinforce the wood post and beam structure. Original wood framing members were notched to accommodate the new steel frame.

Repairing the structural system by augmenting or upgrading individual parts or features. For example, weakened structural members such as floor framing can be paired with a new member, braced, or otherwise supplemented and reinforced.

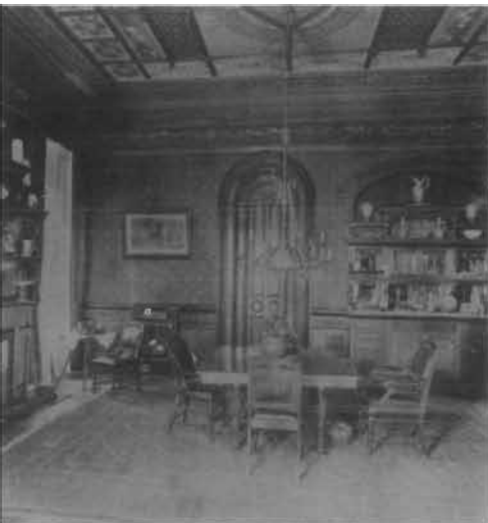
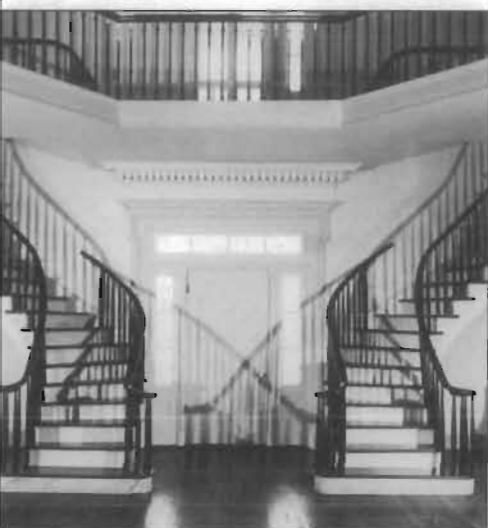
Photo: Jack E. Boucher, HABS.

This historic character of these 19th century residential interiors was protected and maintained during rehabilitation.

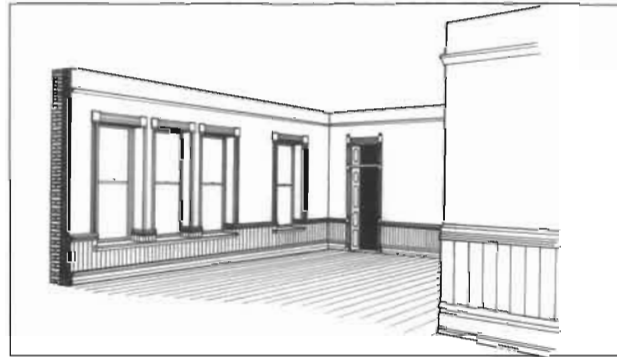
Furring out exterior walls to add insulation and suspending new ceilings to hide ductwork and wiring can change a room's proportions and can also destroy or obscure significant decorative detailing.

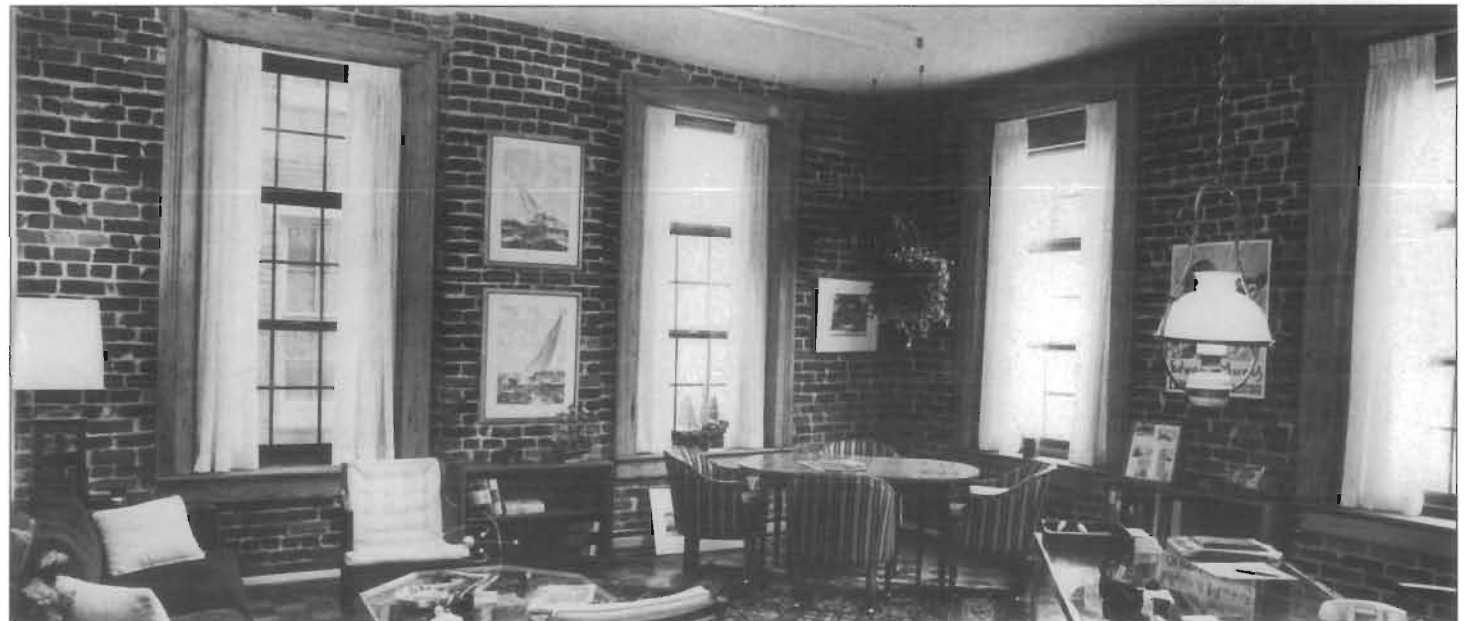
During rehabilitation, the historic plaster was removed from perimeter walls, leaving the brick exposed; in addition historically painted wood trim was stripped. Removing finishes not only destroys historic materials that should be retained and preserved, but it also gives the interior an appearance it never had historically.

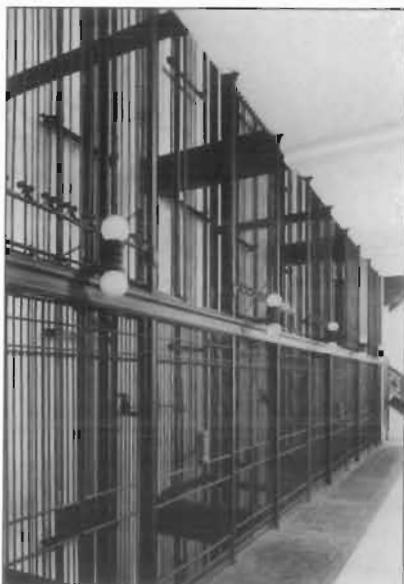
Both function and design elegance are evident in this row of cast iron elevator cages and light fixtures adorning an early-20th century commercial building.

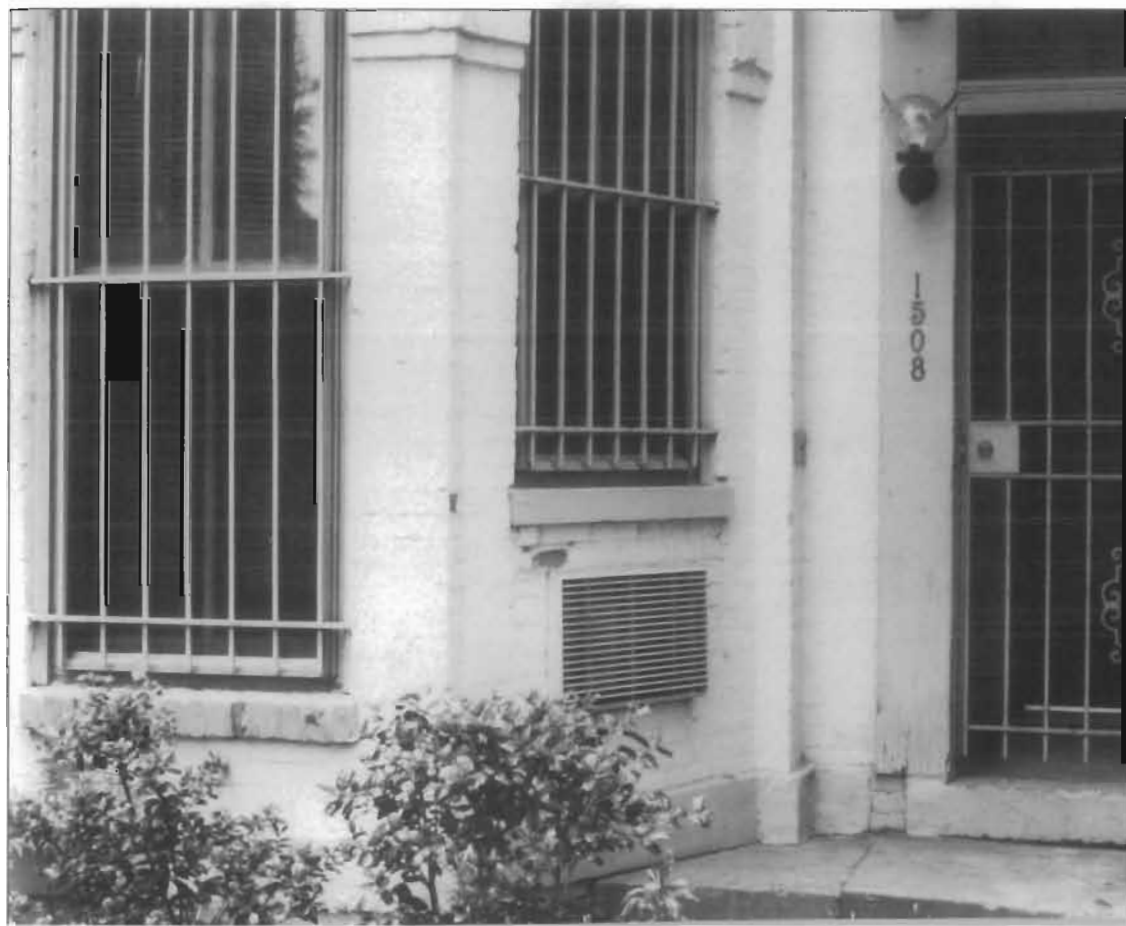
The historic window on a primary facade has been shortened and the area below it filled in with brick in order to install a through-the-wall air conditioning unit. In addition to changing the window size and destroying the sill, the unit itself is visually obtrusive.

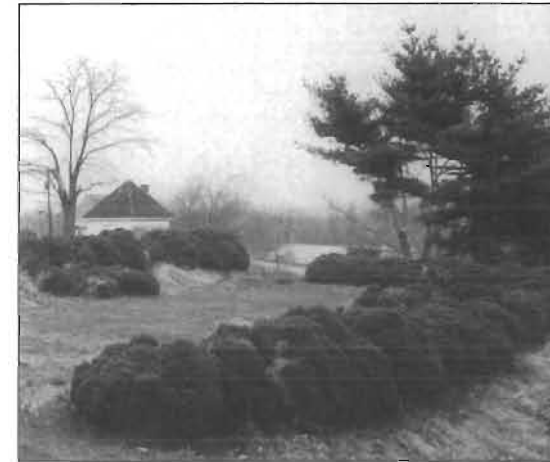
The stream and circular wagon approach are important features of this historic mill site.

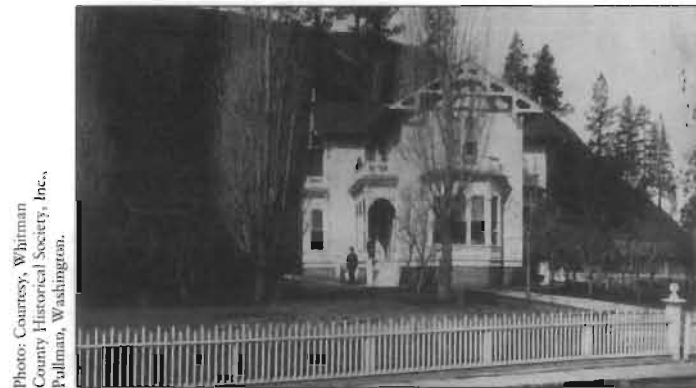
Photo: Courtesy, Whitman County Historical Society, Inc., Pullman, Washington.

Landscape features that are important in defining the historic character of a building site may include fences, walks, and small outbuildings, as well as trees, bushes and topography that may be unique, such as the hill behind the house.

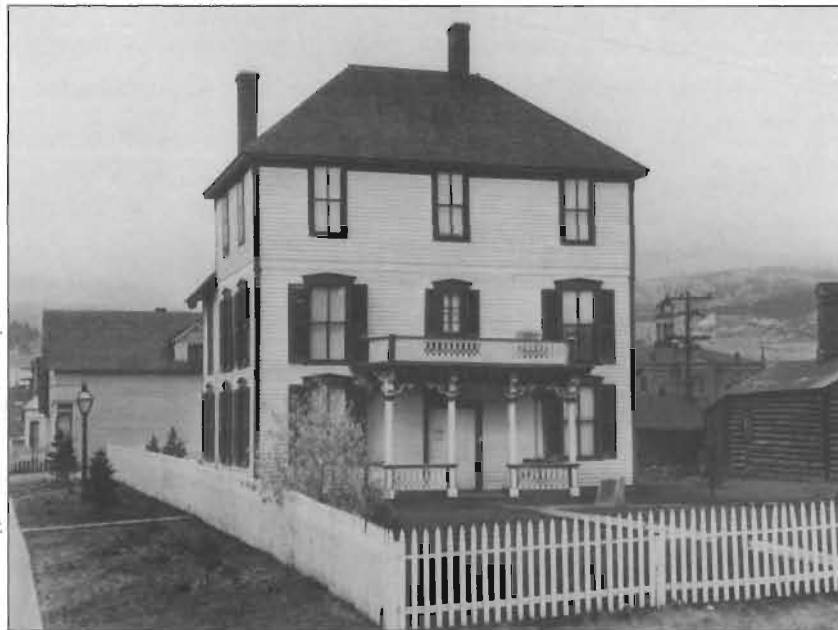
This wood picket fence is as important to the site as the shutters, porch detailing, and clapboards are to the house. As such, the fence was carefully repaired and painted as part of an overall project to preserve the historic residence.

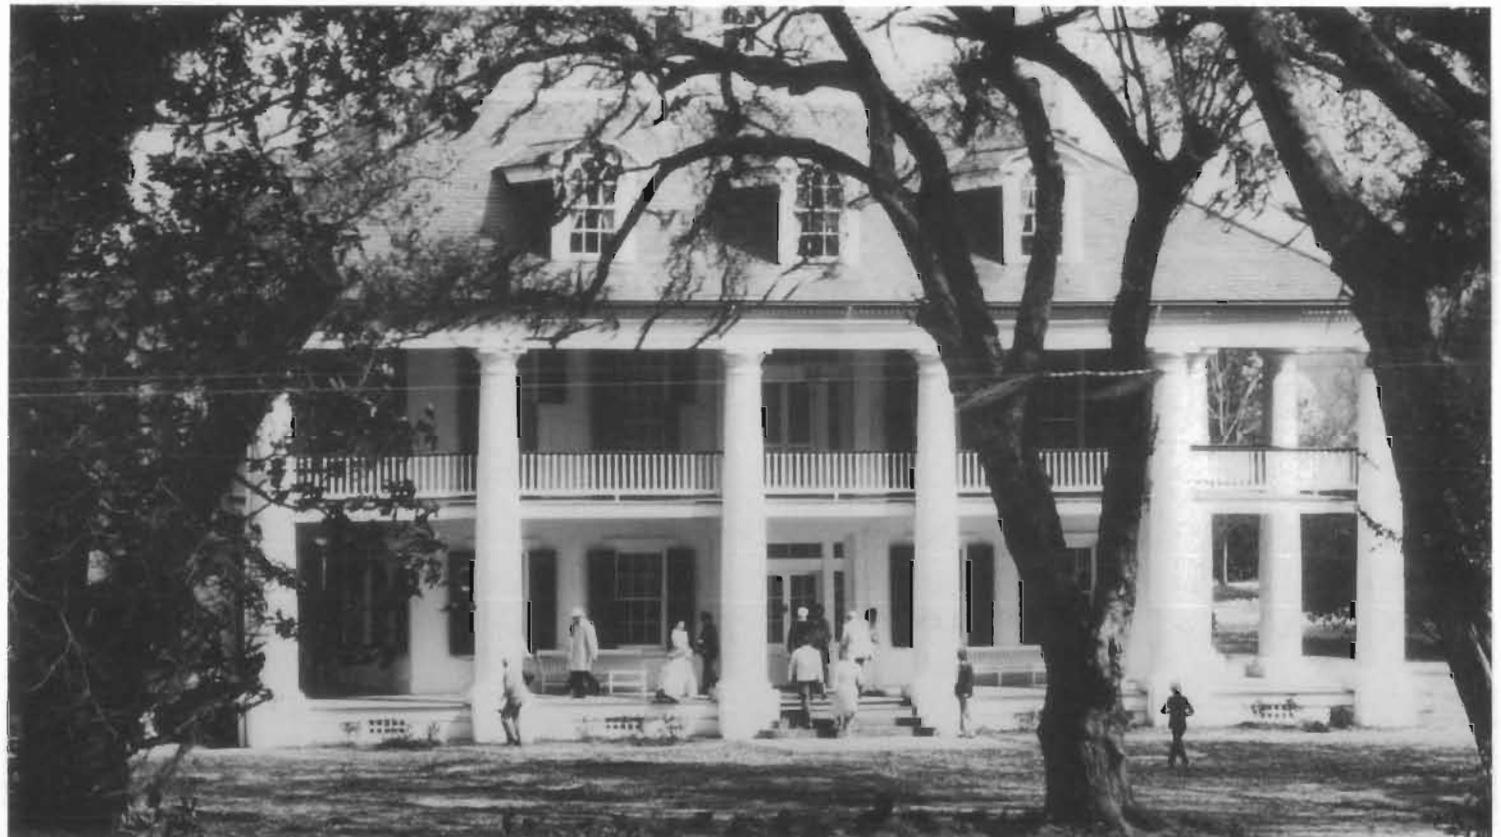
In hot climates, buildings were historically designed to minimize the heat gain from the summer sun. The wide roof overhangs, exterior porches, shutters, shade trees, and heavy masonry walls (painted white) are all energy saving characteristics.

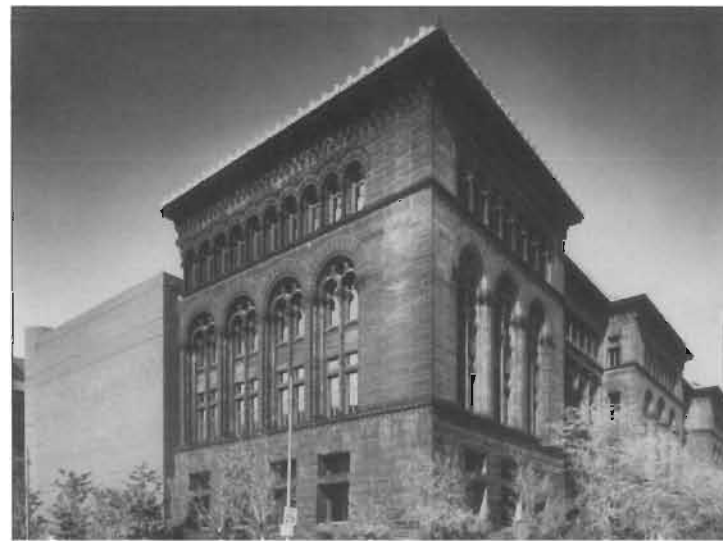
A new 10-story wing added to the back of a historic library constitutes major expansion, yet is compatible because it reads as a subsidiary unit to the much larger historic building.

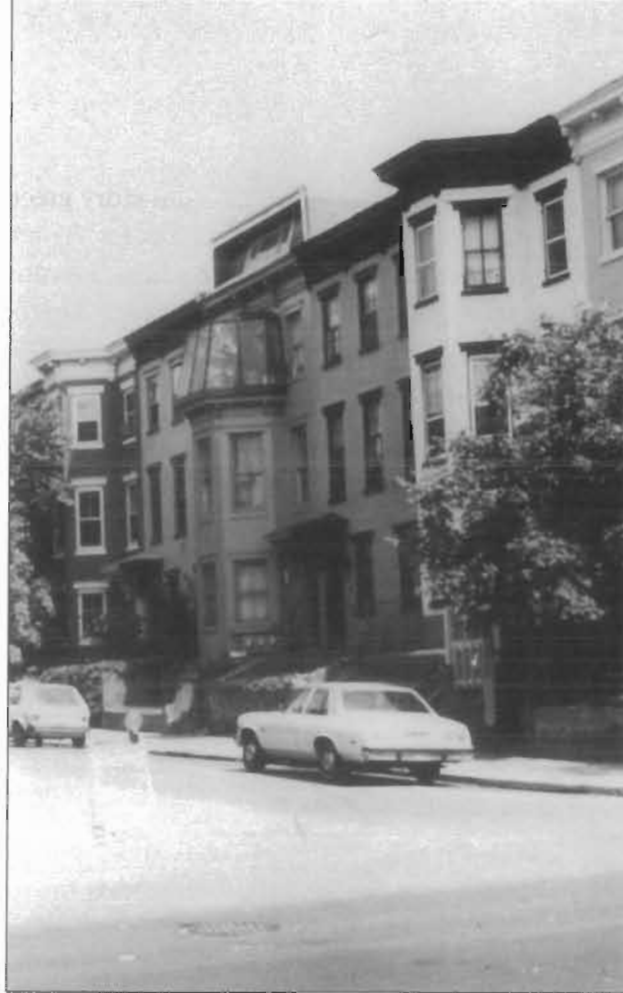
Left: This rooftop addition has substantially altered the historic profile and proportions of a three-story row house; more important, it has interrupted the uniform roof height of the block. The greenhouse is also a jarring element in an otherwise intact 19th century streetscape. Below: A sizeable employee lounge was added atop this four-story historic commercial building. Because the rooftop addition has been set back from both the front and side roof edges against a party wall, the historic character of the building and the district have been preserved.

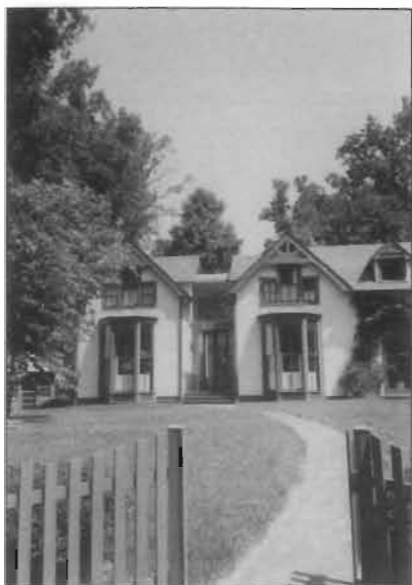
The historic residence is on the right. By copying the decorative gable and three-part window in the new addition, the old and new portions are virtually indistinguishable. This approach violates the Standards for Rehabilitation.

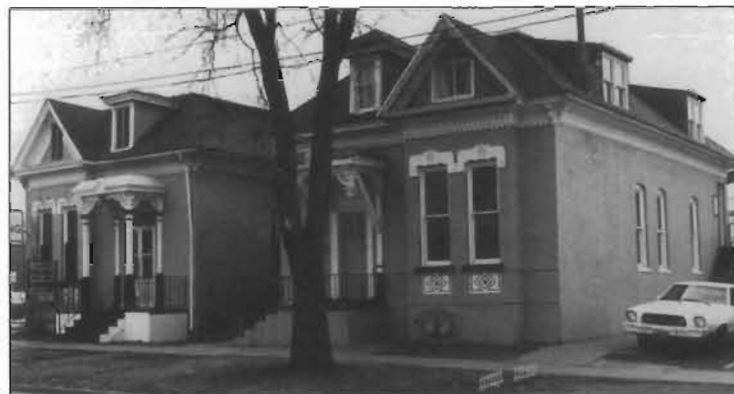
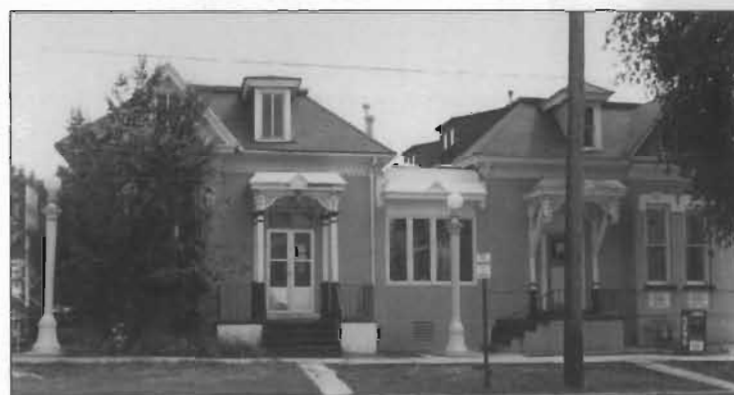
Two small Victorian cottages, above, were connected to provide additional floor space in a commercial rehabilitation. The inappropriate infill connector, below, is on the same plane as the historic facades, essentially making the two cottages appear as one building. If the new infill had been substantially set back from the facade, the distinct form of each cottage would have been retained.

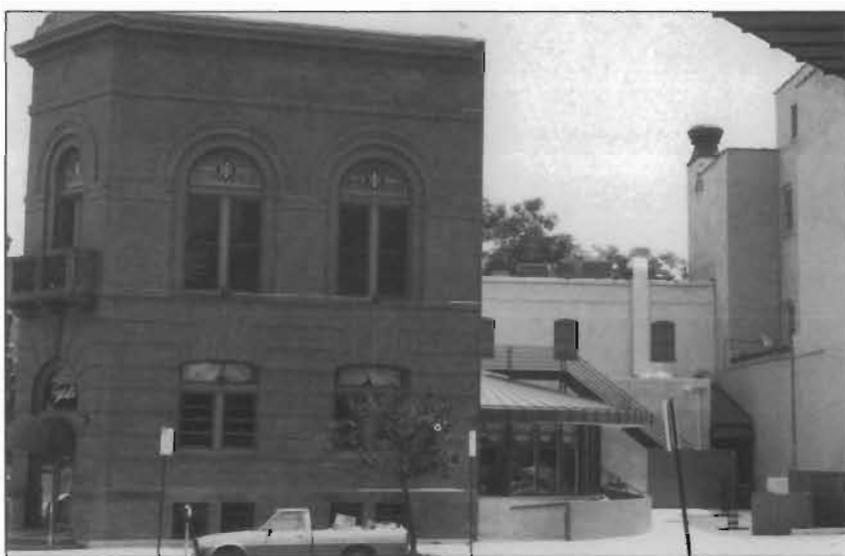
In rehabilitating a historic bank for a new use, a small restaurant addition was built on the rear. The new addition is compatible with the historic building primarily because of its scale and location.

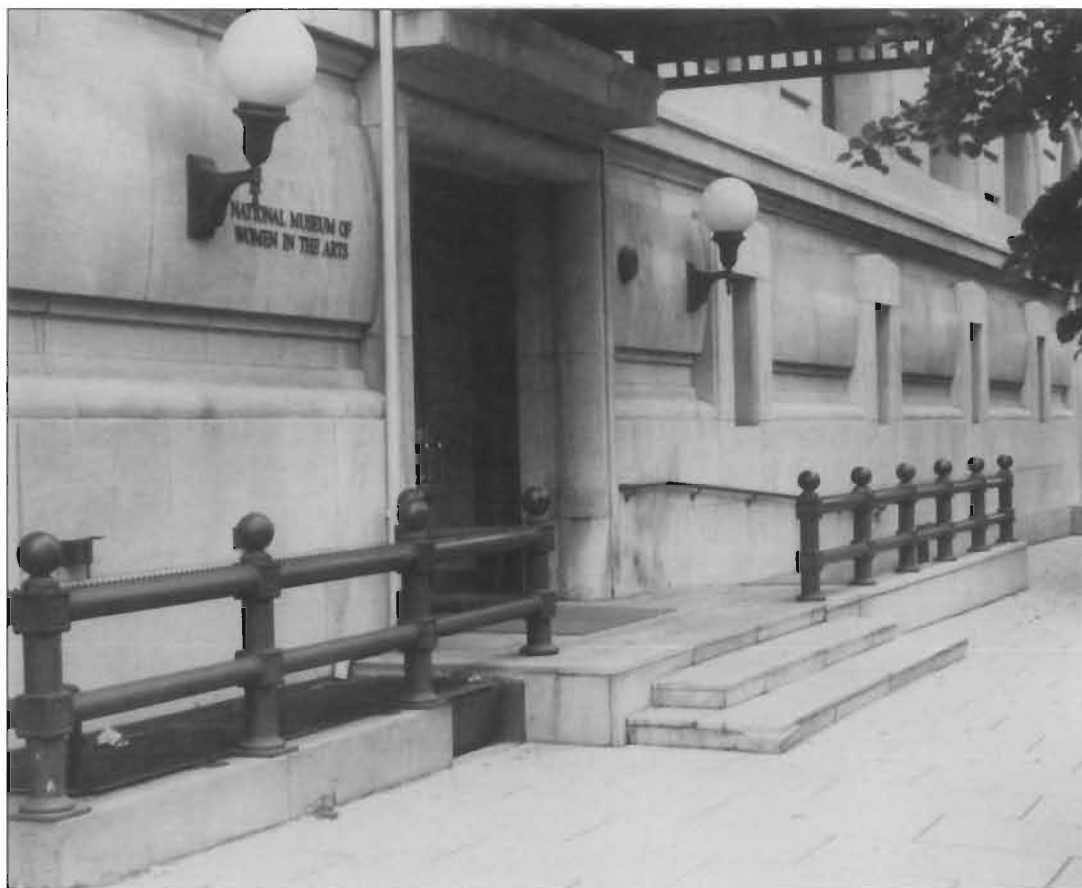
The historic cast iron railing was preserved when a permanent ramp was designed for this museum's main entrance.

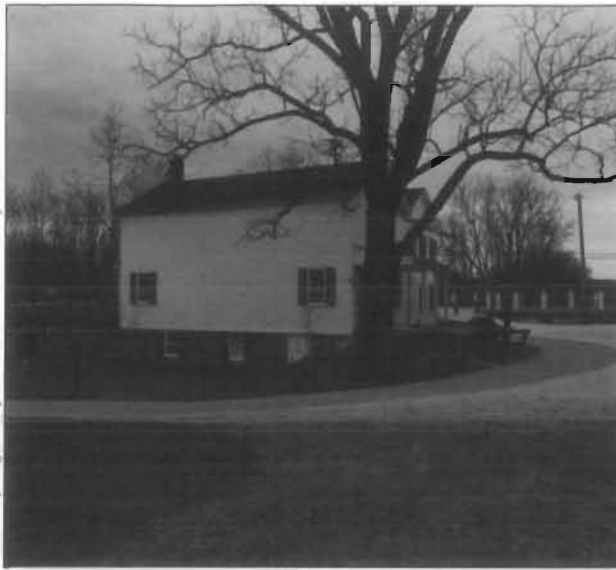
Access to this rural historic site has been improved to include designated parking areas, properly graded ramps and walkways around the site, and access within the building to all services.

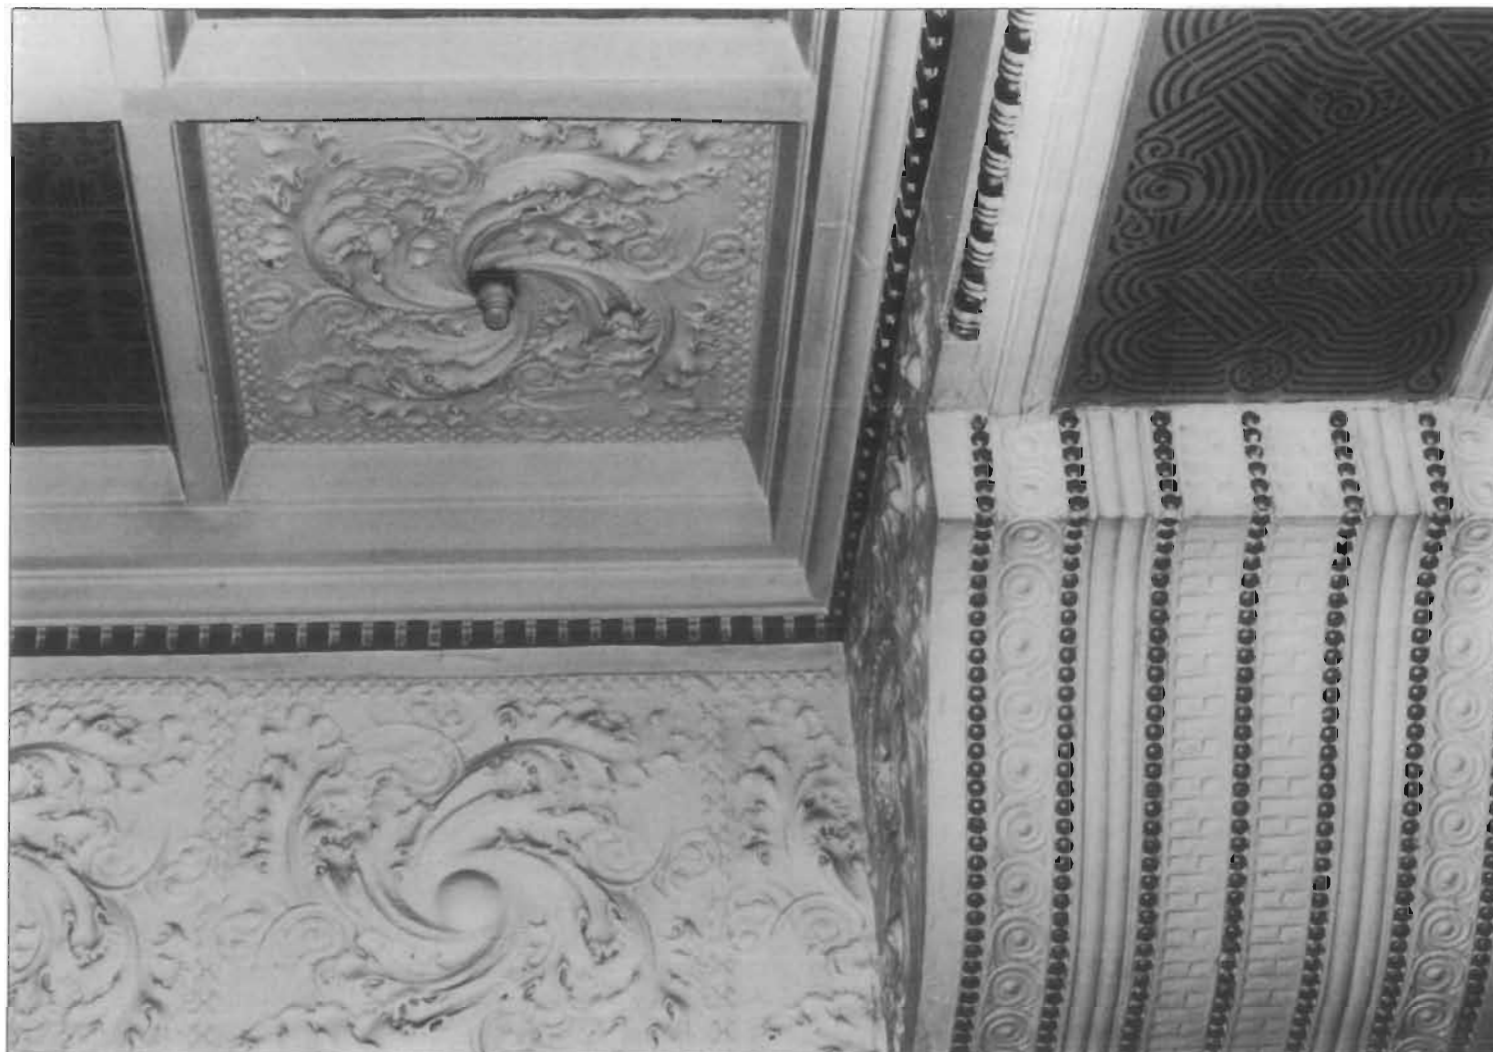
A sprinkler system has been sensitively installed in this highly ornamental plaster ceiling during the building's rehabilitation. Sprinkler heads have been unobtrusively located in the center of the decorative plaster relief.

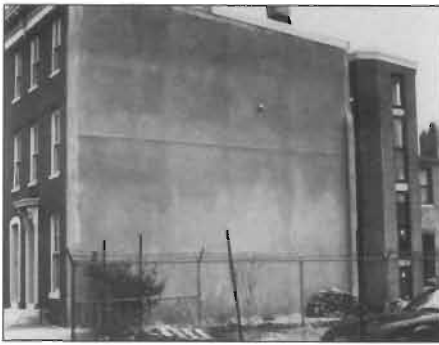
In order to comply with safety codes, it may be necessary to add an exterior fire stair to a historic building as part of a rehabilitation project. The brick stairtower shown on the top is compatible in materials and scale, and inconspicuously attached to the rear elevation of the historic rowhouse. The example on the bottom shows a large-scale concrete and glass stairtower that is incompatible in materials and scale, located as it is on a highly visible elevation of the historic brick building.
