THE SECRETARY  
OF THE INTERIOR'S  
**STANDARDS** FOR  
THE TREATMENT  
OF HISTORIC  
PROPERTIES

WITH  
**GUIDELINES** FOR  
PRESERVING,  
REHABILITATING,  
RESTORING &  
RECONSTRUCTING  
HISTORIC  
BUILDINGS

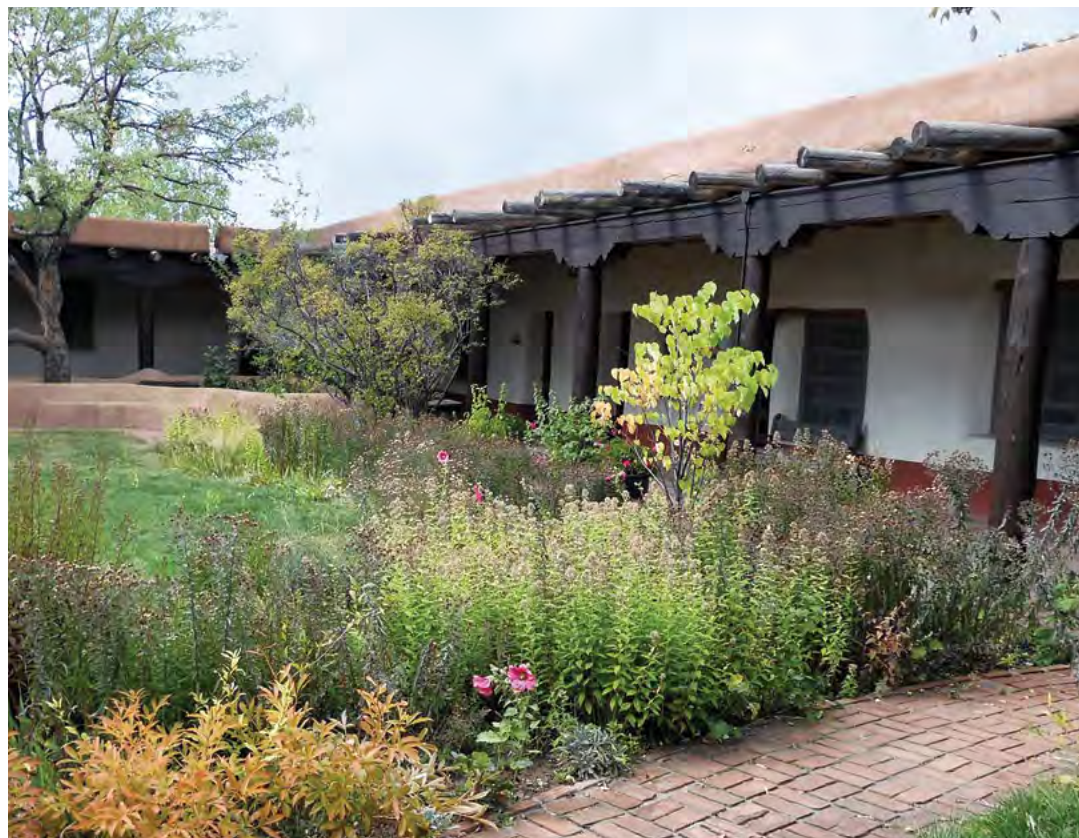
### Standards for Preservation

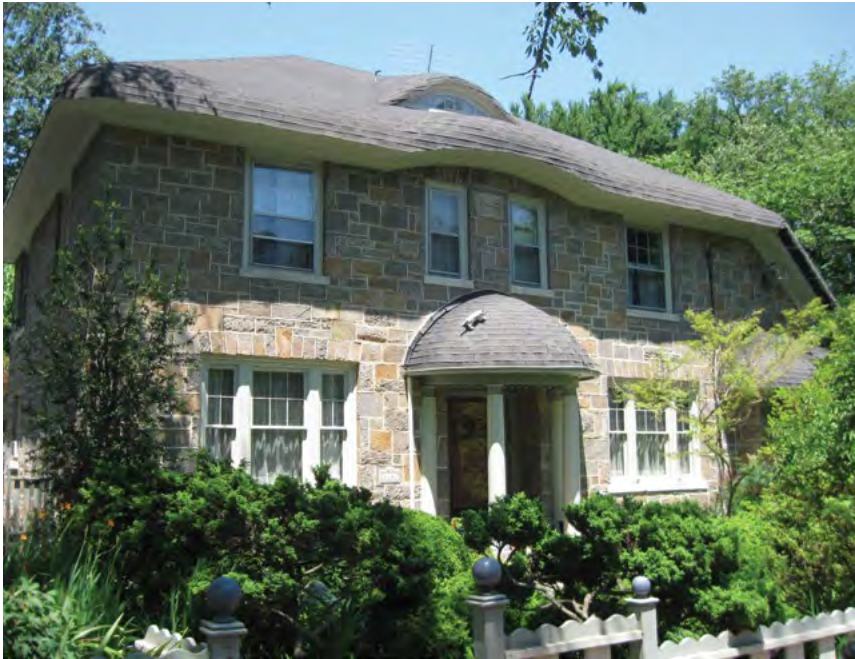
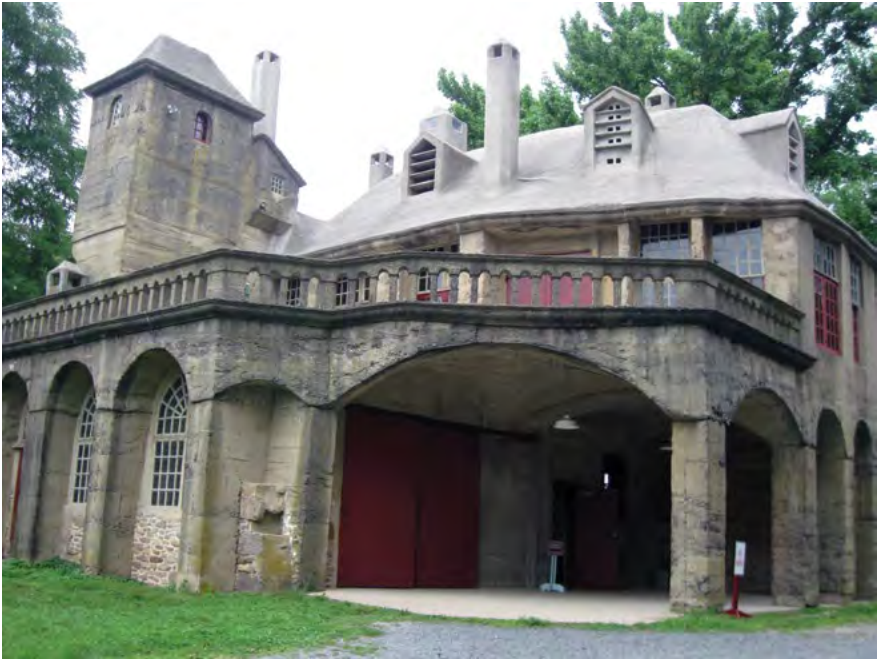
[9] Distinctively-shaped roofs are important in defining the historic character of these early 20<sup>th</sup>-century structures: (a) an asphalt shingle roof on a house; (b) and a concrete roof on Fonthill, Doylestown, PA (1908-1912), designed and built by Henry Chapman Mercer.

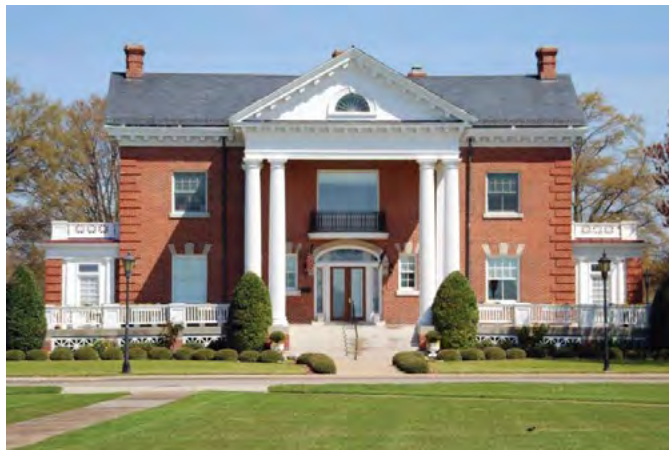
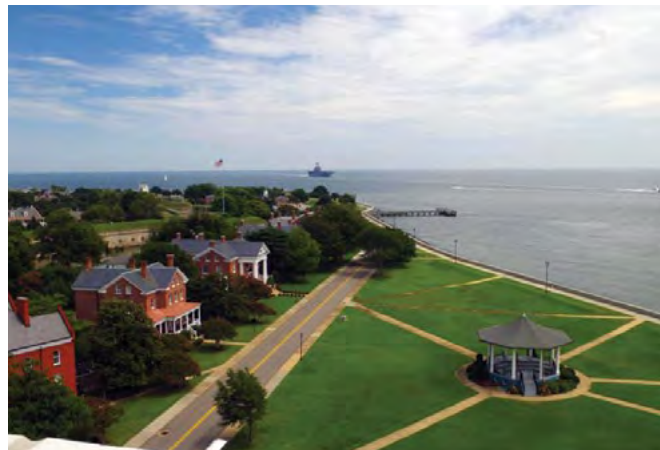
SETTING (DISTRICT / NEIGHBORHOOD)

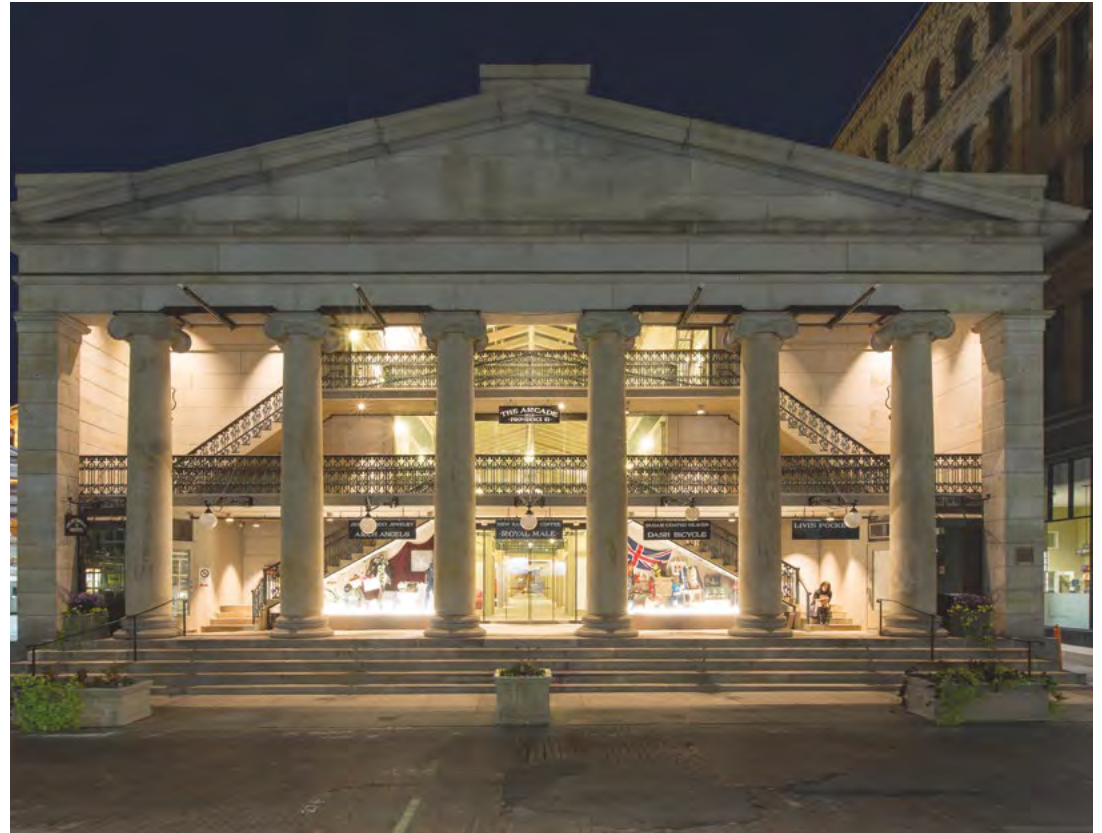
## Standards for Rehabilitation

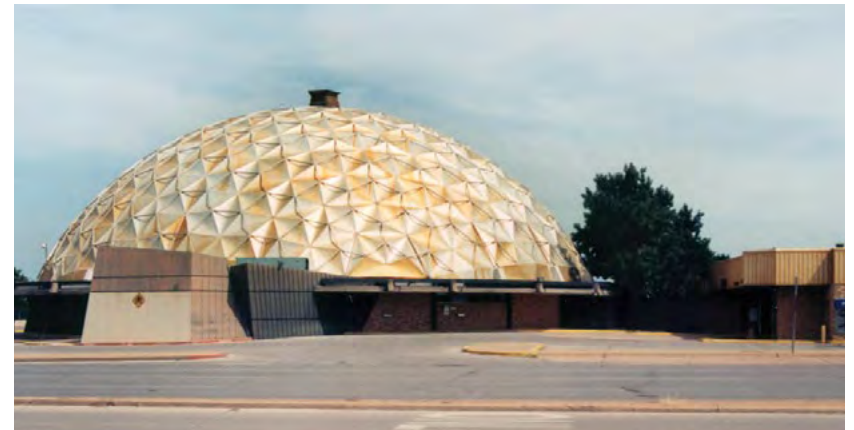
[13] The gold-colored, anodized aluminum geodesic dome of the former Citizen's State Bank in Oklahoma City, OK, built in 1958 and designed by Robert Roloff, makes this a distinctive mid-20th century building.

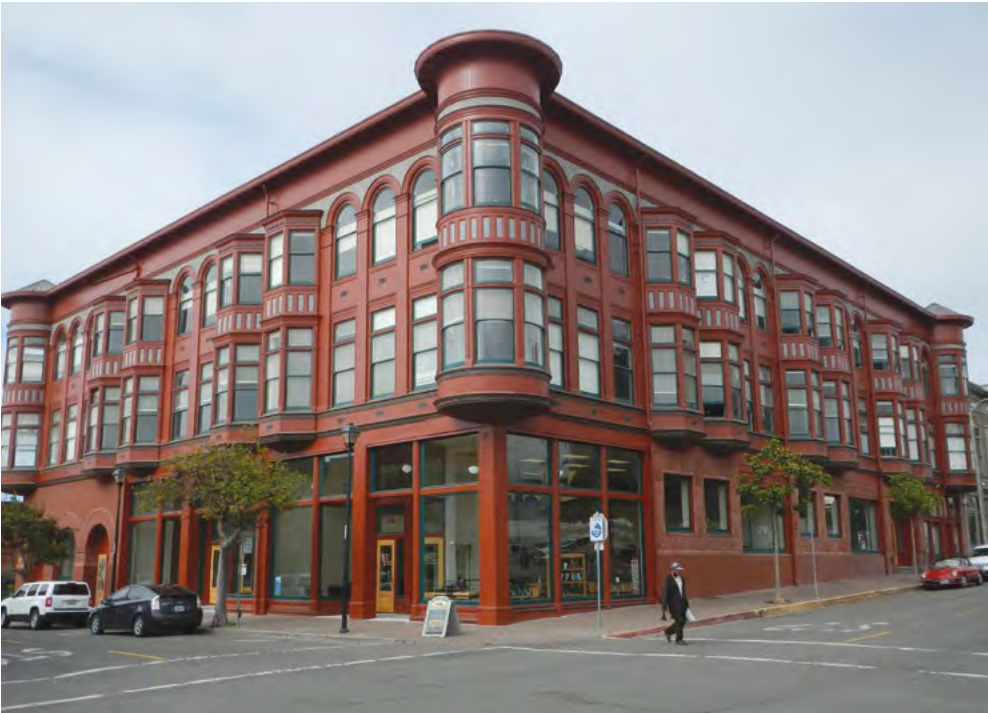
## STRUCTURAL SYSTEMS

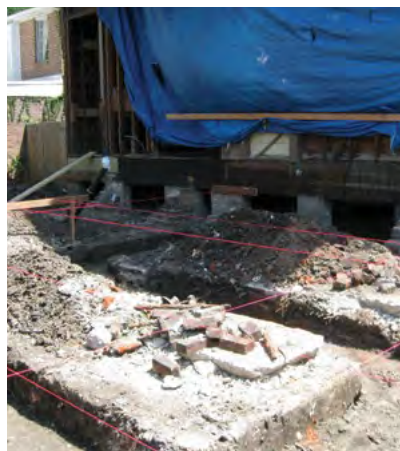
[45] Undertaking a survey to document archeological resources may be considered in some rehabilitation projects when a new exterior addition is planned.

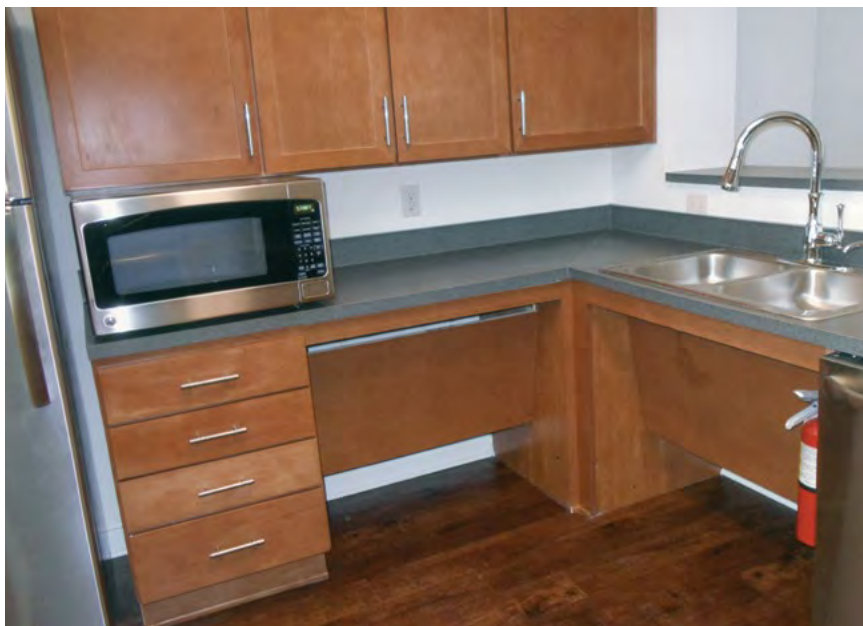
[51] A new interior access ramp with a simple metal railing is compatible with the character of this mid-century-modern building.
