## Yellowstone National Park

**Rehabilitate/Replace Old Faithful Water Treatment Plant (WTP)**

# Replace/Rehabilitate Old Faithful Water Treatment Plant

## FY22 Wastewater Treatment Facilities

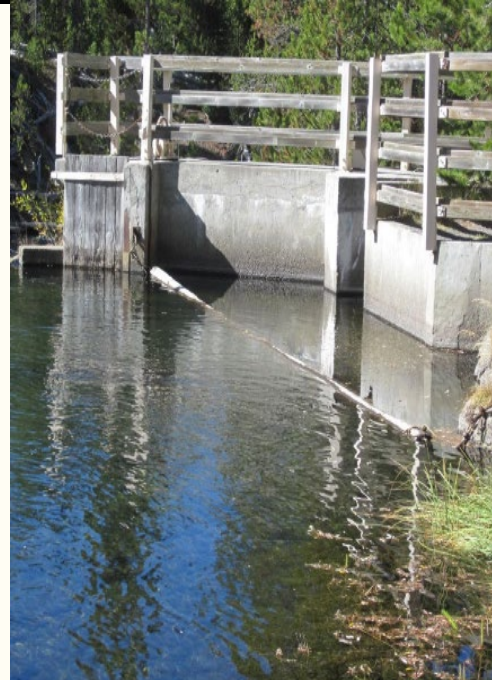
Raw water  
Intake - Firehole  
River

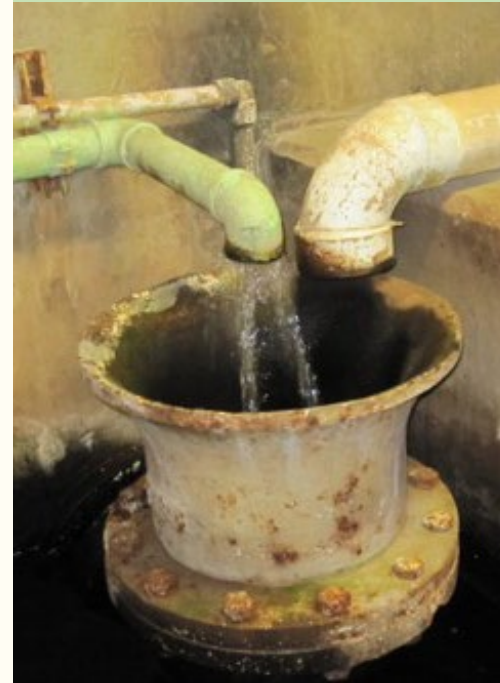
Aging Plant  
Components

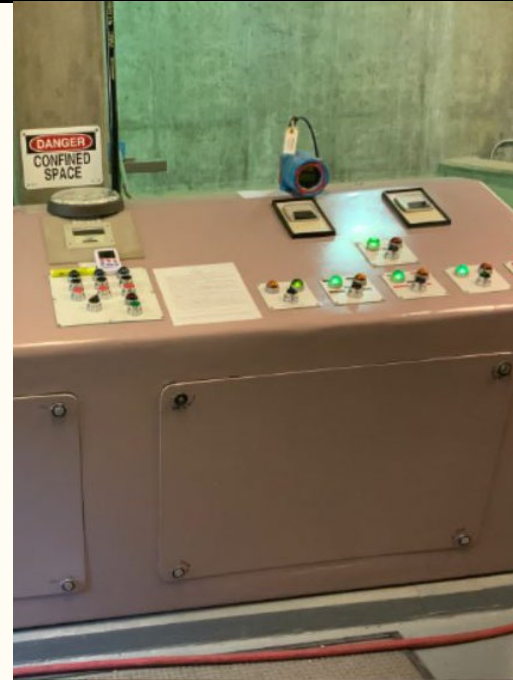
Lack of modern  
controls/SCADA

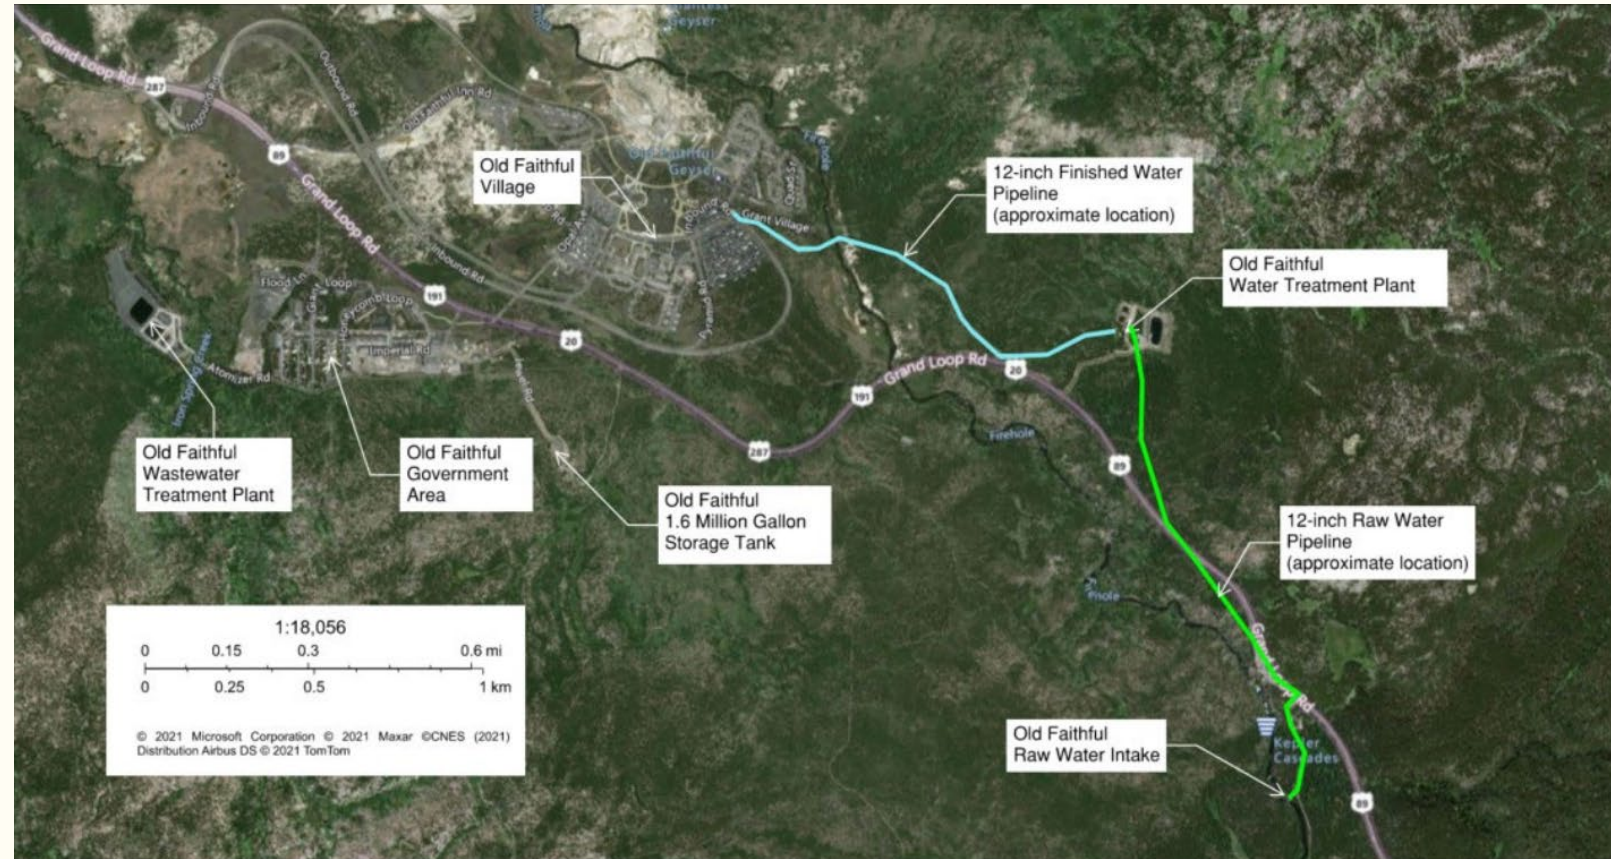
Additional Challenges: Existing raw water and finished water lines are "Techite" brand pipe. Known to be brittle and result in catastrophic failure.

Replacement will require a temporary bypass line to ensure continued potable water supply to Old Faithful Village.

Raw Water Intake Structure will be rehabilitated

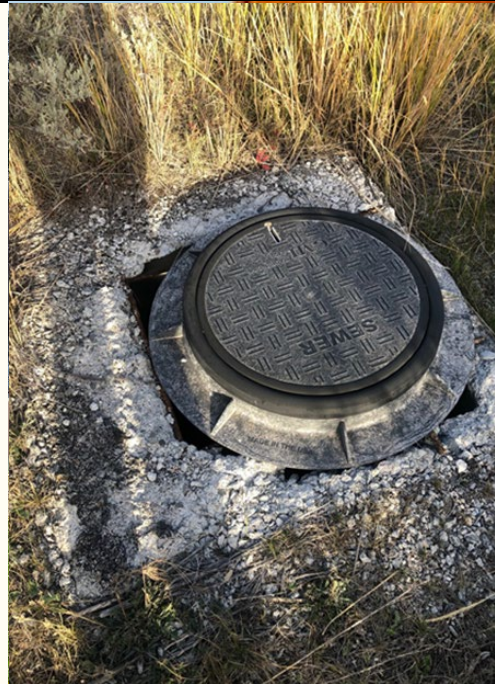
Aging Collection System components

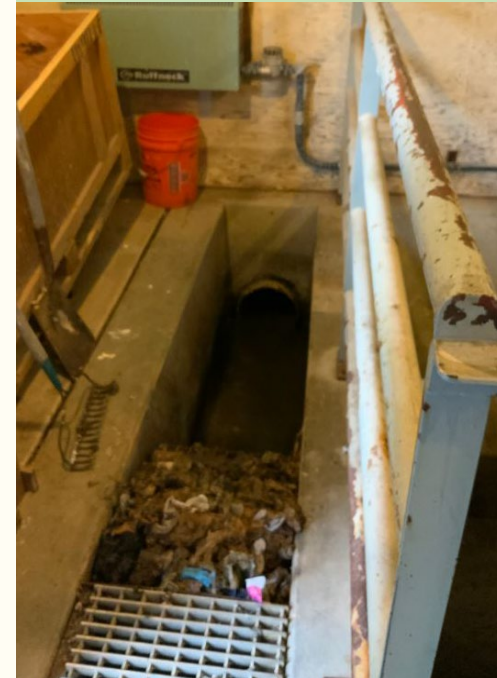
Headworks facilities:  
Inadequately sized, poor ventilation, require modern pre-treatment technology

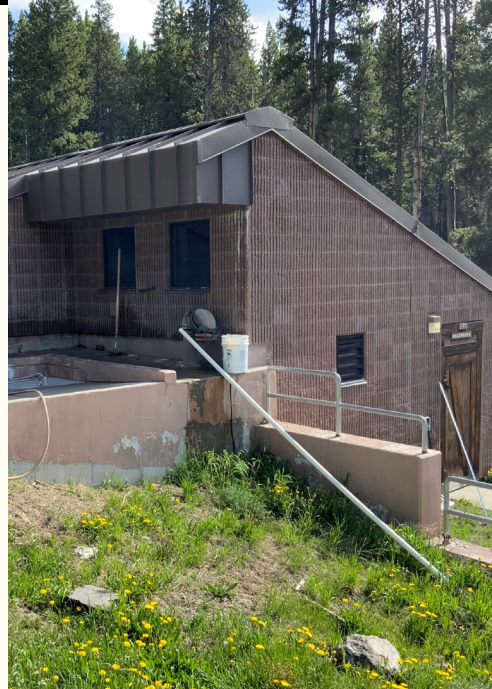
Canyon Headworks/  
Septage Receiving  
requires  
full replacement

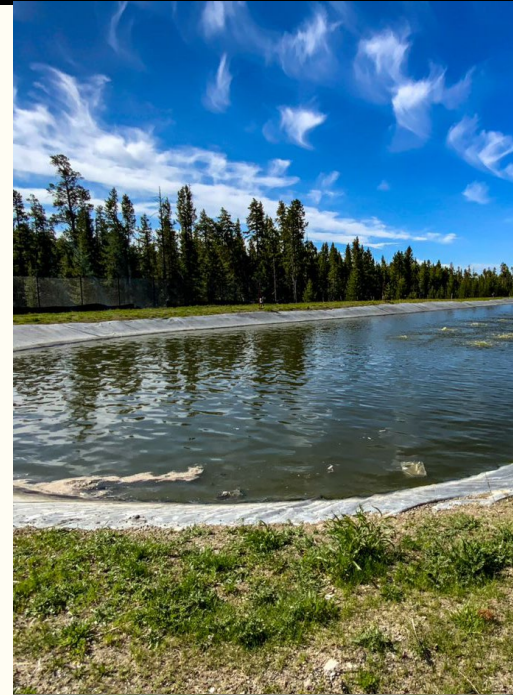
Canyon Village  
WWTP Lagoon -  
surface aeration  
system

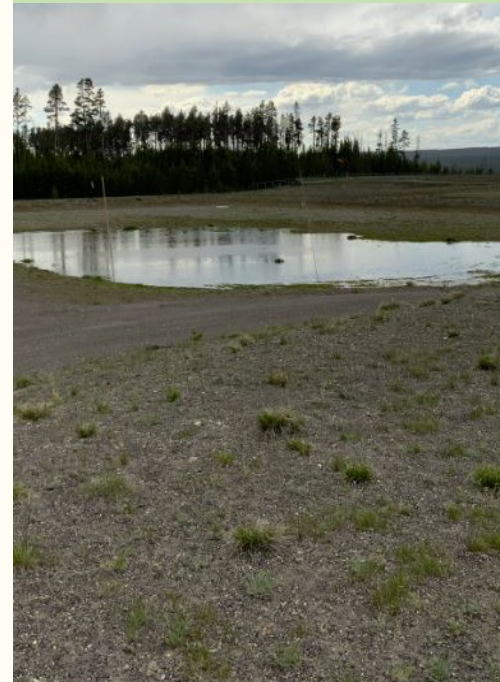
Percolation  
Pond: Inadequate  
treatment has led to  
high nitrates  
percolating into the  
Groundwater leading  
to concerns of  
contamination in  
Yellowstone lake

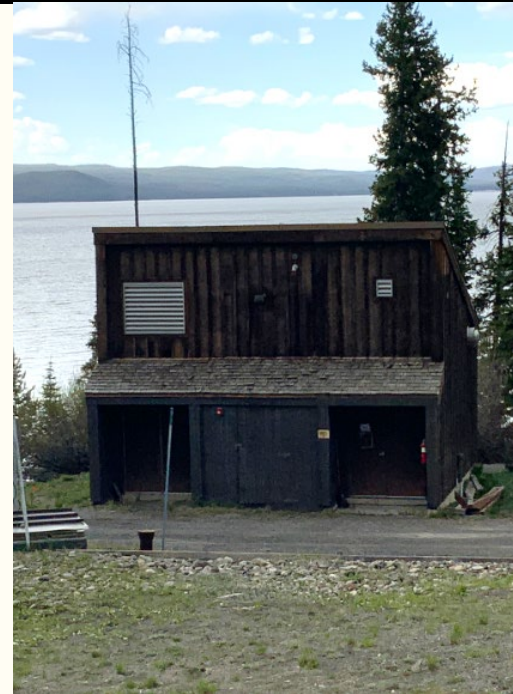
Grant  
Headworks Lift  
Station with  
Yellowstone  
Lake behind
