# PRESERVING HISTORIC TRAILS

CONFERENCE PROCEEDINGS

OCTOBER 17-19, 2000

ACADIA NATIONAL PARK, MAINE

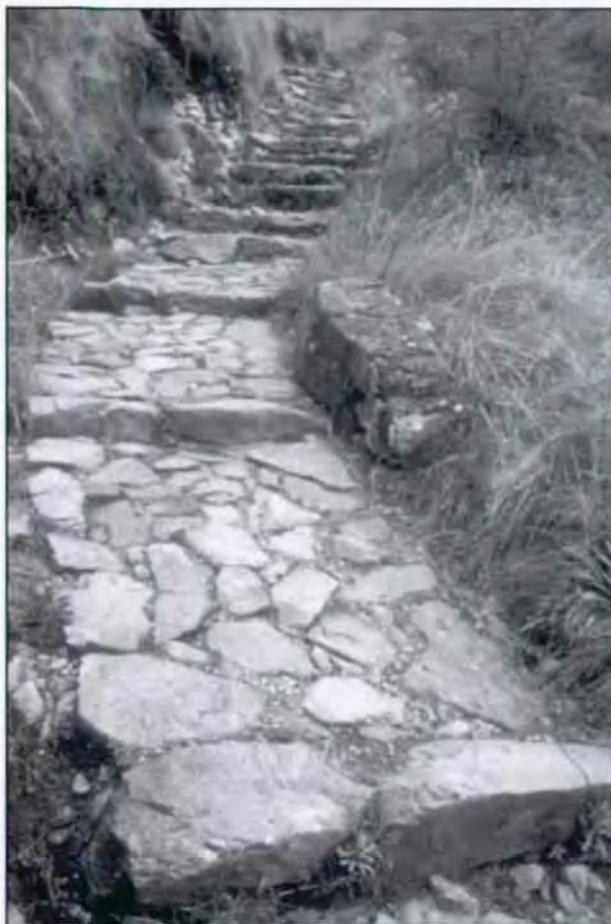
Figure 1-1: Rockwork on the Inca trail.

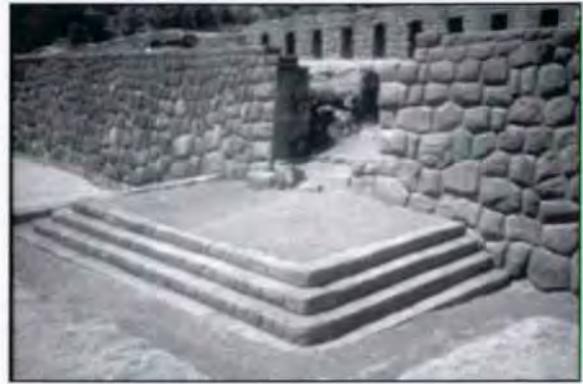
Figure 1-2: Stonework at Tarabuzasi.

Local guides explained the history, theories, and construction practices. The two basic types of Inca wall work are a tiered style where the rocks are laid in rows similar to bricks, and the polygonal style, thought to be stronger, where the rocks are tightly laid by shape. INC has been actively reconstructing sections of the Inca trail and some of the ruins along this route. As funding permits, the ancient trails are repaired and maintained by the INC in keeping with the original design style. The crews spend weeks on short sections to replicate the high quality work (Figures 1-4, 1-5).

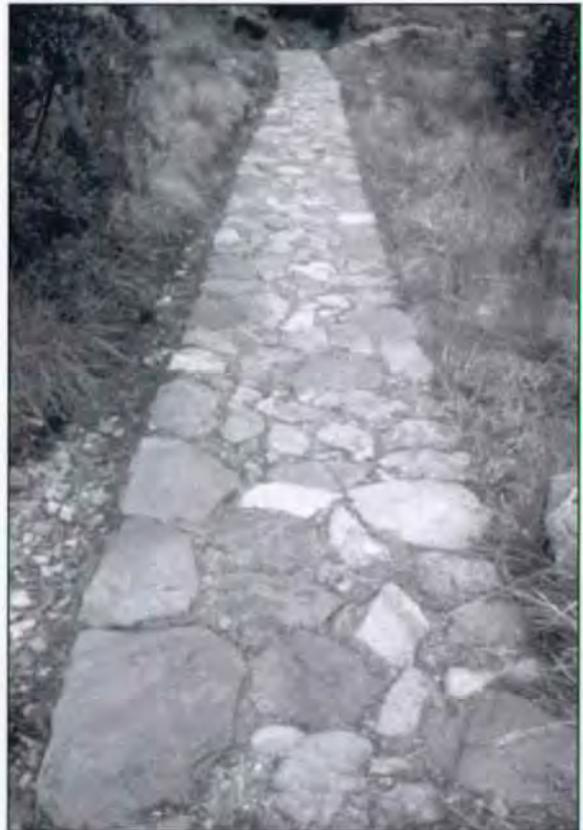
Figure 1-3: Riprap trailhead on the Inca trail.

**Riprap:** Most of the trail is similar to what we in the United States would refer to as high-quality riprap – a solid laid rock tread that is locked in place by the careful placement of each rock against its neighboring rocks (See Figures 1-1, 1-3). This kind of tread is extremely erosion and impact resistant. It is impermeable to the effects of water as long as the drainage needs of each trail section are provided for. Most noteworthy was the consistent construction of inside walls to form an elevated edge on the uphill side of the riprap trail tread. This facilitates the drainage and protection of these trail sections. In our experience in the United States we would not have laid the rock with as consistent an inside edge, rather we would have tied it more directly into the landscape. This difference reflects the Incas extreme attention to drainage and the potential effects of water movement, and to some extent the local environmental differences in rainfall.

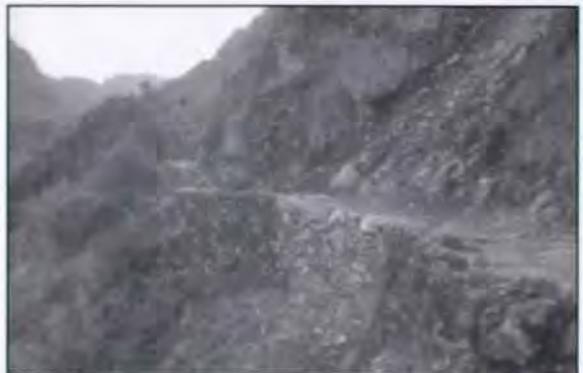
Figure 1-4: A wall reconstructed by the INC.

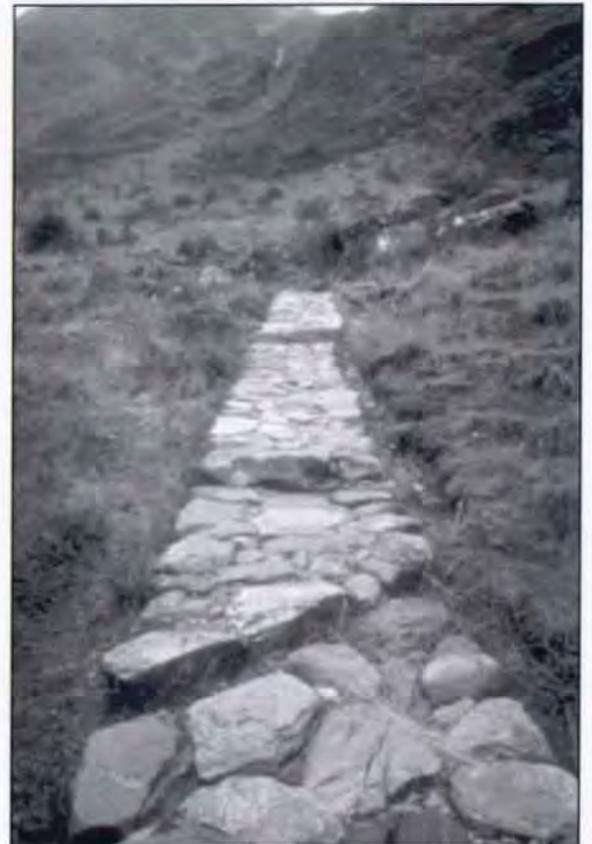
Figure 1-6: Inside drain along right side and cross drain.

efficient drainage systems incorporated within the trail. The most effective drainage for any trail system imitates the natural drainage patterns of the landscape. Drainage structures facilitate the flow of water with a system of inside drainage channels and out-sloping drains across the tread (Figure 1-6). The riprap tread surface itself is a nearly impermeable drainage structure, resisting the eroding effects of the moving water, and the inside drainage system allows water to move parallel to the trail edge until encountering a cross-trail drain which facilitates the water to move across and off the trail on the downslope side.

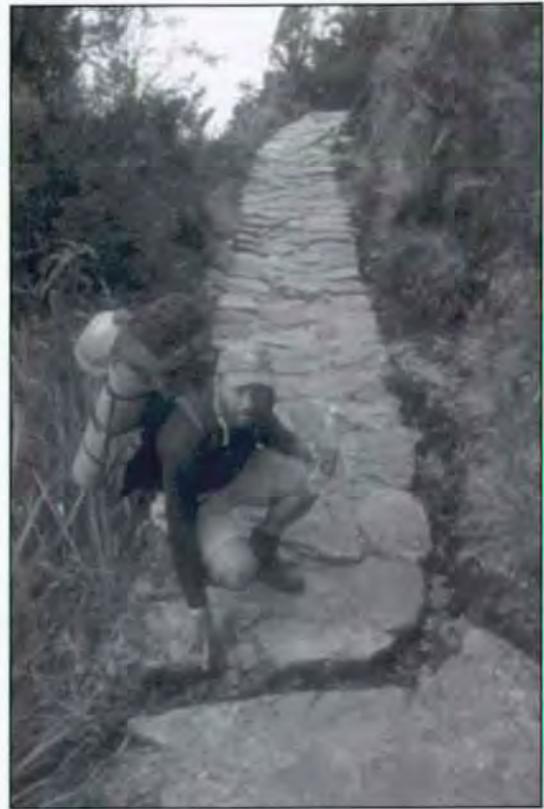
Figure 1-7: Cross-trail drainage on the Inca trail.

The drainage features so dominate the Inca trail rockwork that we found ourselves wishing that we could visit the trail during the wet season in order to see the drainage structures functioning under the most demanding of conditions. I'm sure that our respect for the Inca engineers would be even greater as we would observe the extensive sections of rockwork protected from the monsoonal flow of water by the well thought-out drainage system (Figures 1-7, 1-8).

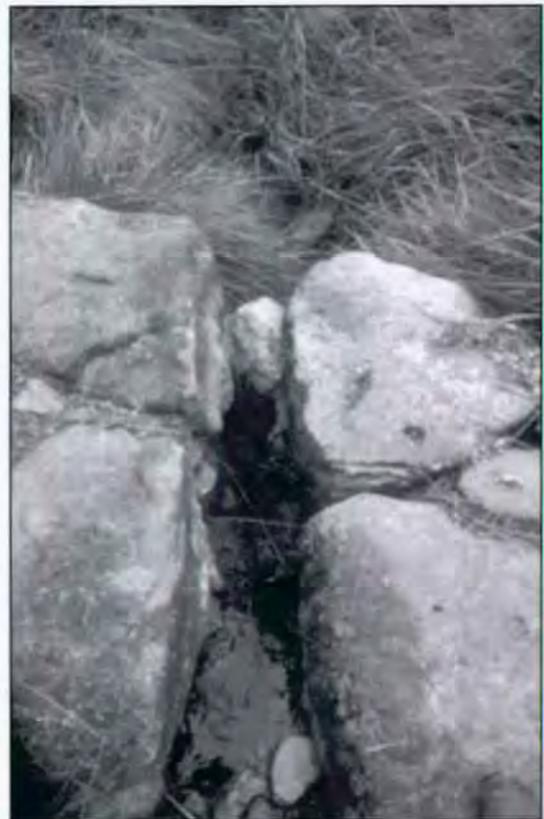
Figure 1-8: A rock keeping the drain open.

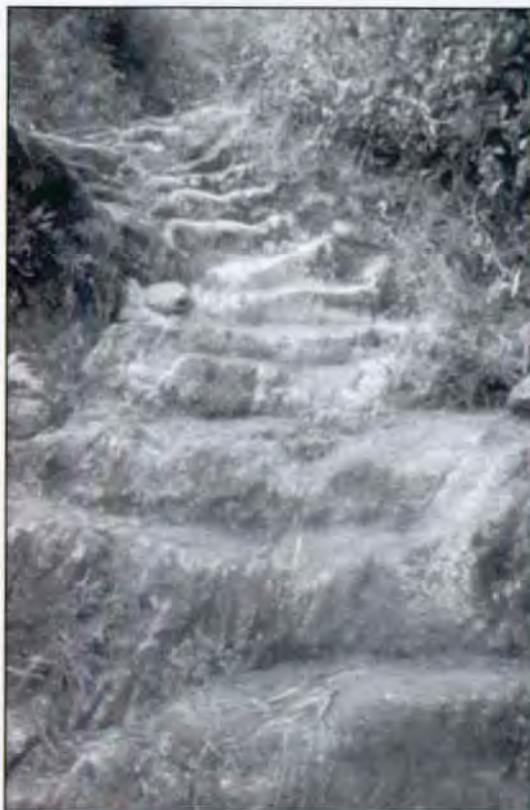
Figure 1-10: Steps carved into the bedrock.

**Natural Features:** Rather than regard natural features as obstacles, the Incas took advantage of natural rock outcrops both large and small to anchor the footings of their trail segments. Bedrock was meticulously carved to contact closely the rocks that were laid above it, or smaller rock outcrops were used to anchor sections of trail or a drainage feature. In our trailwork here in the United States, we may be tempted to drill and blast such obstacles. The Inca work provides an excellent example of working with natural features that improves the quality of each section and makes each segment unique.

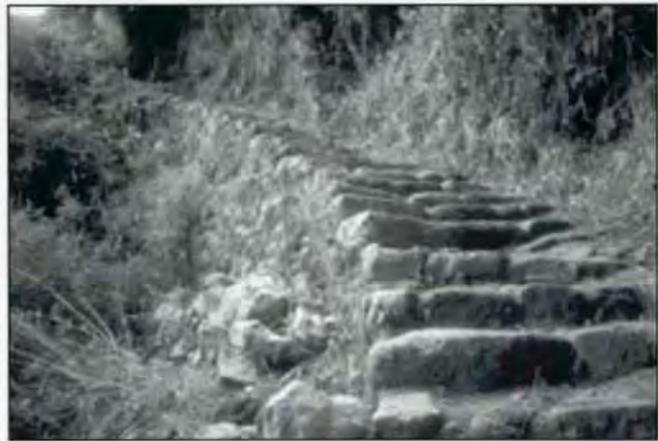
Figure 1-12: Steps laid on bedrock.

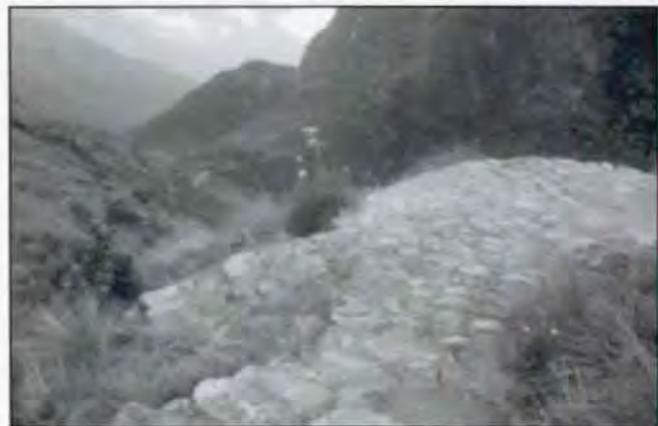
Figure 1-13: An overlook on the Inca trail.

**Overlooks:** One of the most pleasant features of the Inca trail is the frequent stone overlooks that are placed along the trail at locations to allow for passing, resting, and perhaps to take advantage of the tremendous views. These overlooks are paved stone, or riprap, with drainage structures (Figures 1-13).

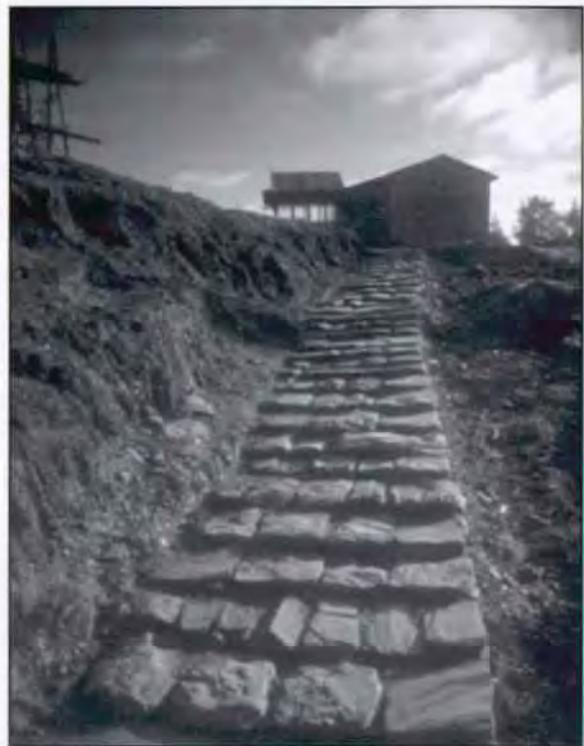
Figure 1-15: Sloped steps that shed water in Anapurna foothills.

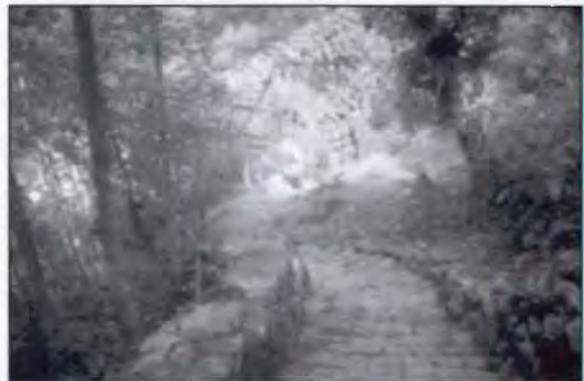
Figure 1-16: Sloped steps with retaining walls in Anapurna foothills.

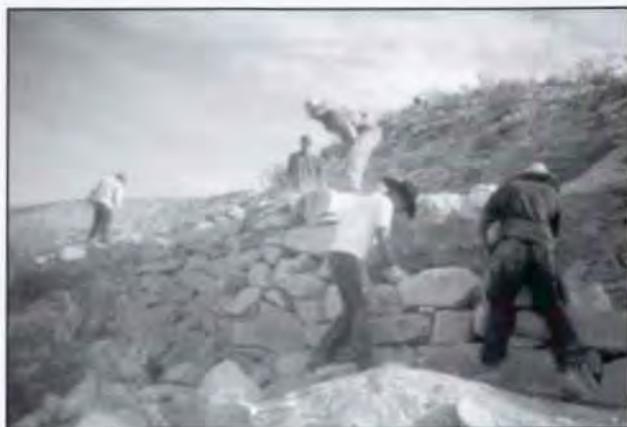
Figure 1-17: Stones laid in varied orientations at Big Bend.

On the Hot Springs Road in Big Bend National Park, a long retaining wall originally built by early homesteaders and perhaps the Civilian Conservation Corps was in poor condition due to poor maintenance. The roads crews were bringing in tread material, which first blew out the coping and then damaged the wall. The park developed a rehabilitation plan then mobilized a large work crew to implement the work. Richard Tufnell who heads the Dry Stone Conservancy, based in Scotland and Lexington, Kentucky, led the project. The project team also included an archeologist, who photographed the wall prior to rehabilitation. Most of the wall was dismantled since the key to a strong wall is a good foundation. To rebuild the wall in the historic style, the stonework had to appear rough but also be stable. The result was a face wall where the emphasis was not on tiers or horizontal layering but on varied orientation, whereas the back fill was not rubble but semi-laid stone (Figures 1-17, 1-18). By tightly laying the stone back fill, the wall is much more durable. The wall was again topped with very large coping stones. The load component was transferred down through the semi-laid stones (Figure 1-19).

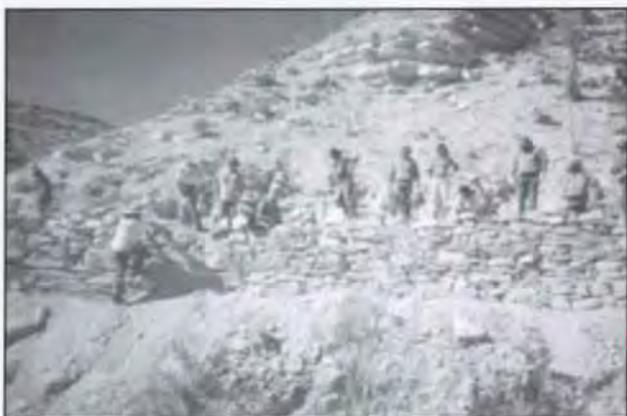
Figure 1-18: Nearly complete rebuilt wall at Big Bend.

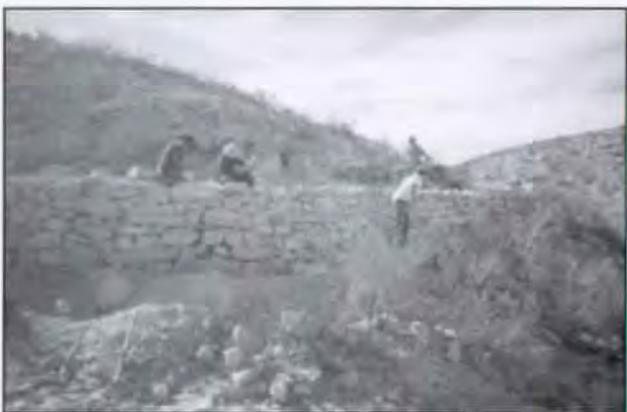
Figure 1-19: Wall at Big Bend with a top layer of large coping stones.

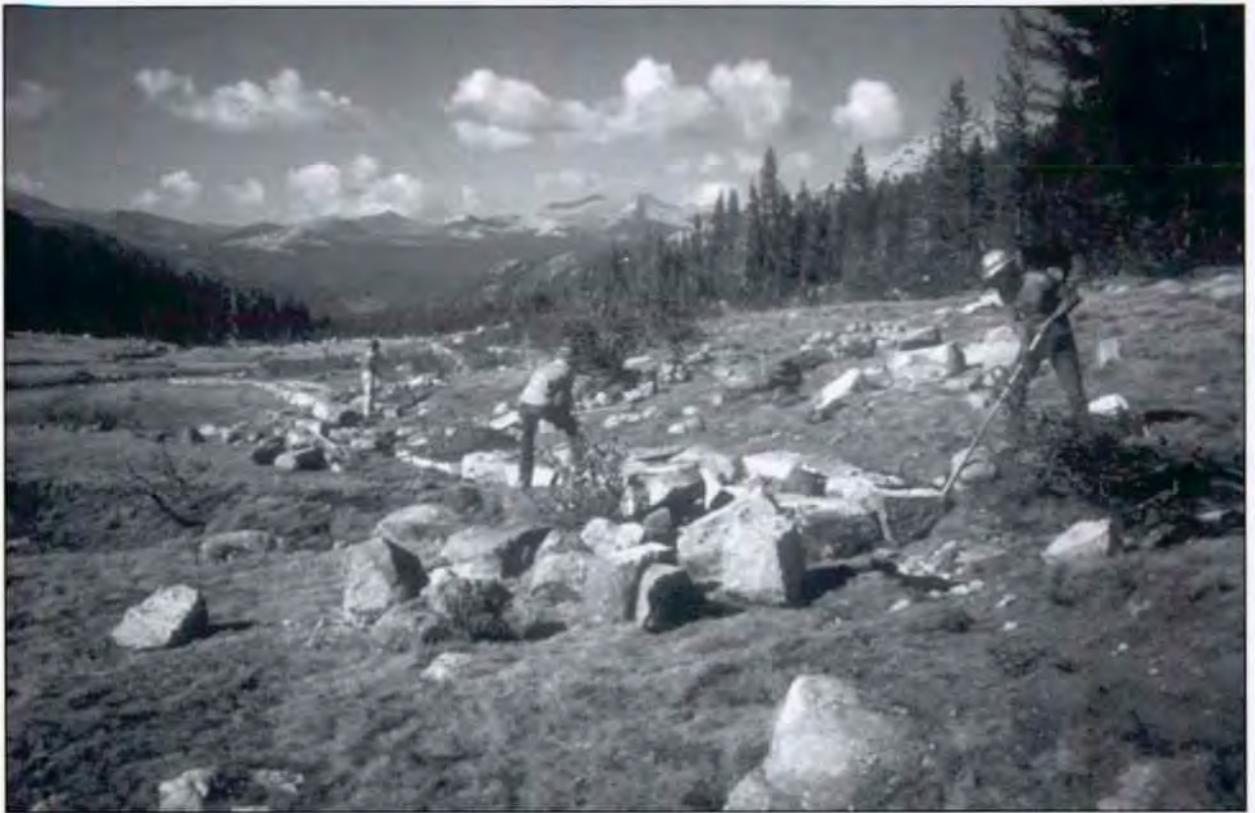
*Figure 1-20: Building rock causeway in Rafferty Meadow.*

Rock quarries were established and large stones were moved to the project site using stoneboats and teams of pulling mules. Impact to the meadow was minimized by performing the work in the dry early fall of the High Sierra. Tread material was obtained from nearby natural drainages and streambeds and transported to the project sites using strings of mules equipped with hinged dirtboxes. Additional materials were transported by helicopter (Figure 1-22). (Techniques to construct rock causeways are described in Birkby, 1996; and Griswold, 1998).

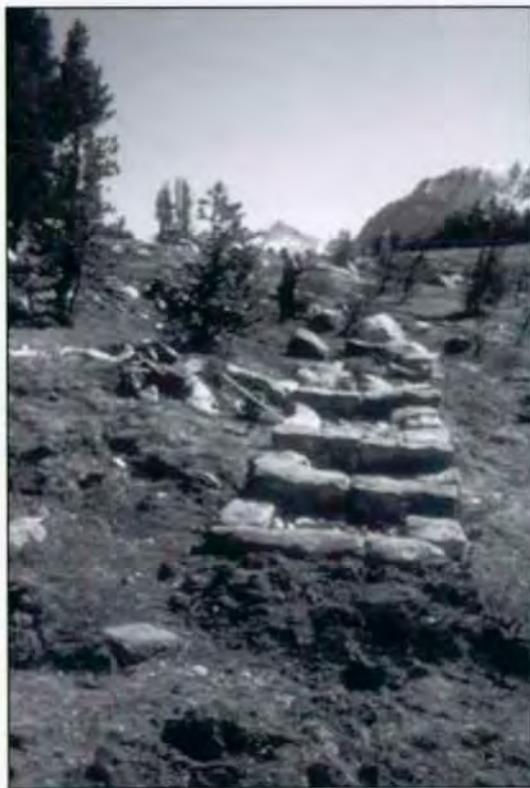
*Figure 1-21: Causeway under construction with terraced stone steps in Rafferty Meadow.*

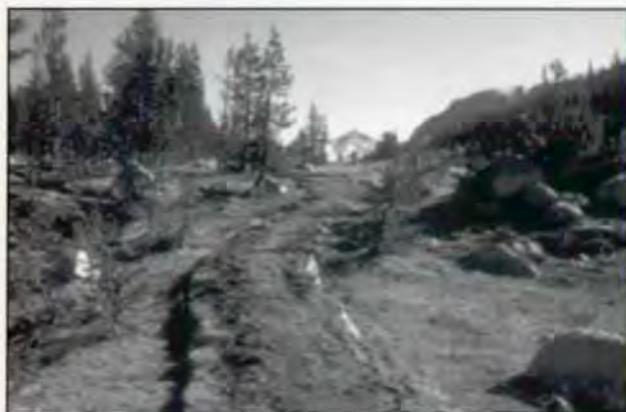
*Figure 1-22: Finished causeway with crowned tread material over rock work at Rafferty Meadow in Yosemite National Park.*

doned ruts were thoroughly revegetated. Fundamental to the success of the project was the re-establishment of an effective natural drainage system to facilitate water movement across the trail alignment. Overall, over 2500 feet of rock causeway was constructed, providing both hikers and stock a high and dry trailtread.

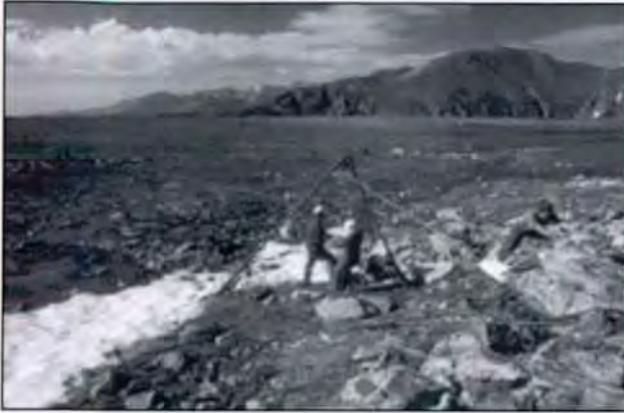
Figure 1-23: Tripod system for moving rock on the Continental Divide Trail National Scenic Trail section in Rocky Mountain National Park.

A packable steel tripod system was used to transport rocks without damaging the fragile tundra (Figure 1-23). Tread material was quarried whenever possible from the existing trail, and also flown to the site using a high-elevation heavy-lift helicopter in the fall of 1998 (Figure 1-24). Project budget was \$60,000 for the crew in 1998 and \$100,000 for the helicopter time.

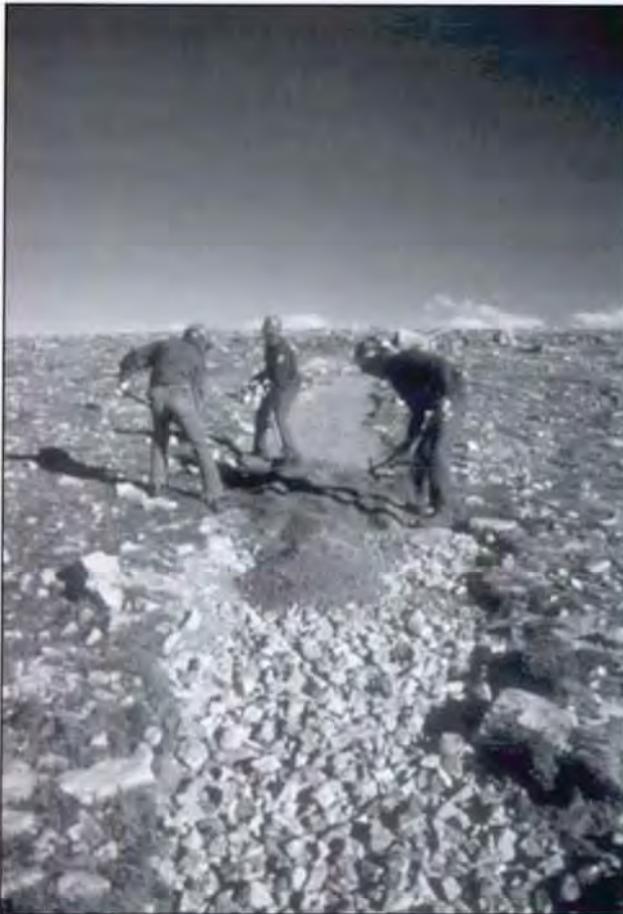
Figure 1-24: Crew spreading tread material on finished section of Continental Divide National Scenic Trail.

**Reusing Tread Material:** In locations such as Kings Canyon and Rocky Mountain National Parks where soil for trail tread is very difficult to obtain, crews have successfully quarried soil from the existing rutted trail alignment. Soil is stockpiled adjacent to the trail on tarps or plastic (to protect the underlying vegetation) by first digging up and removing as much soil as possible from the damaged trail, essentially making the trail rut deeper. Reconstruction of the trail then follows by laying rock steps, drainage structures etc. over a bed of crushed rock and backfilling the old rut with crushed rock to within approximately 4 to 6

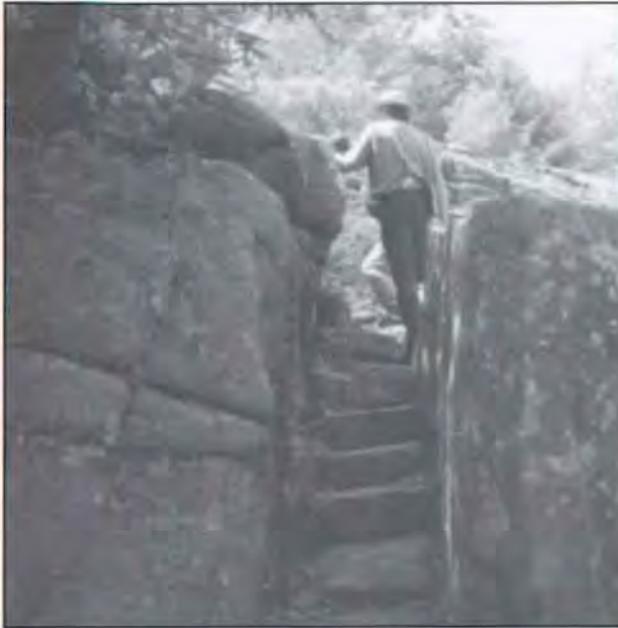
*Figure 5-1: Stairs built by the local village improvement society in the early 1900s on the Emery Path.*

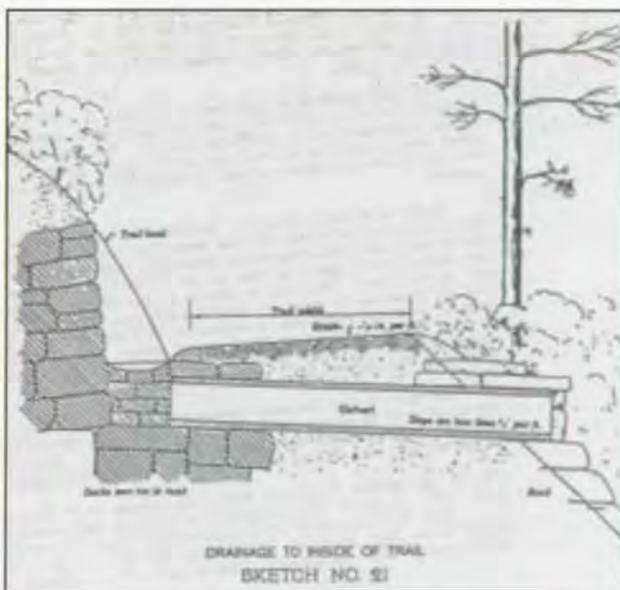
Figure 5-3: Detail for a closed culvert from 1937 manual by Gray Arthur, "Construction of Trails, CCC Field Training."

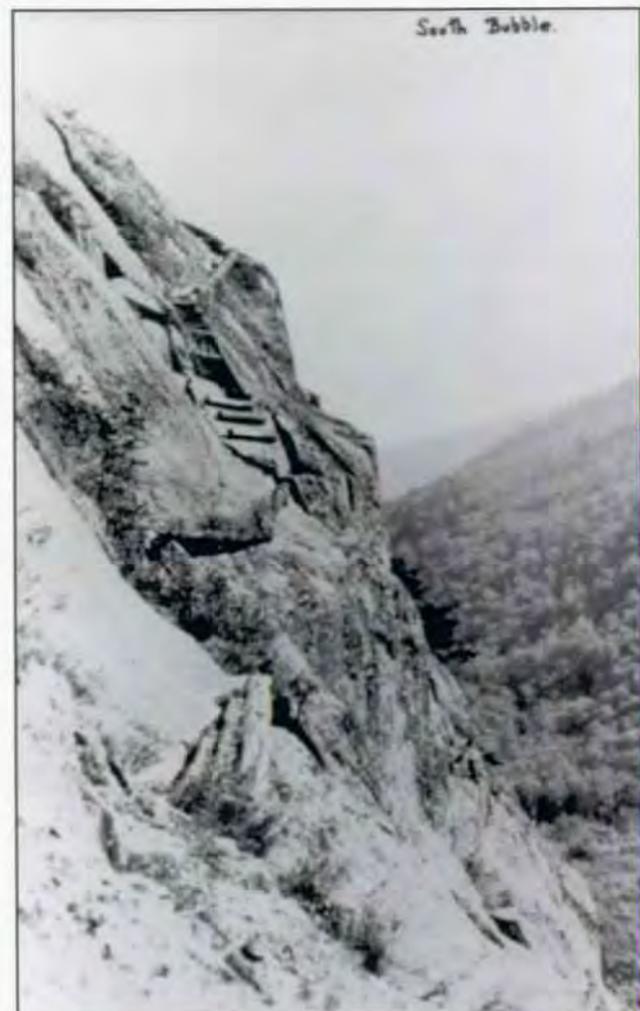
Figure 5-8: The South Bubble Cliff Trail, built in about 1919 by the local village improvement societies, was considered adventurous by some and too dangerous by others. The trail was closed by the park service in the 1950s (Bar Harbor Historical Society).

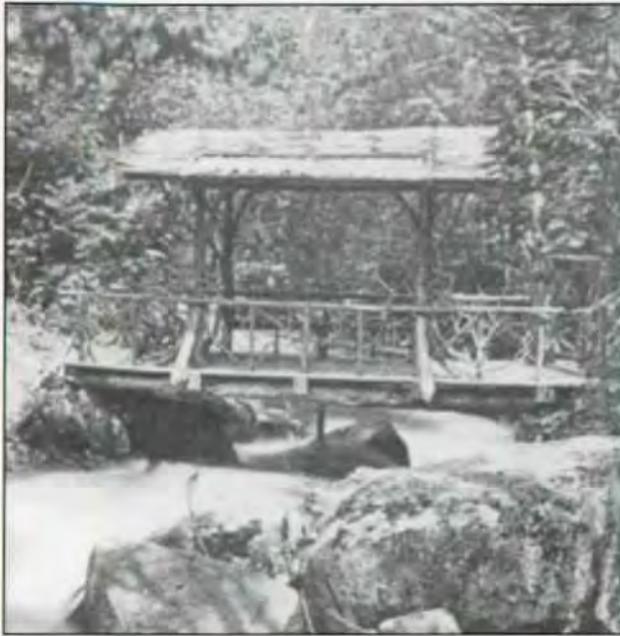
Figure 5-7: An early path led to this rustic foot bridge, built by the landowner in the 1870s (Maine Historic Preservation Commission).

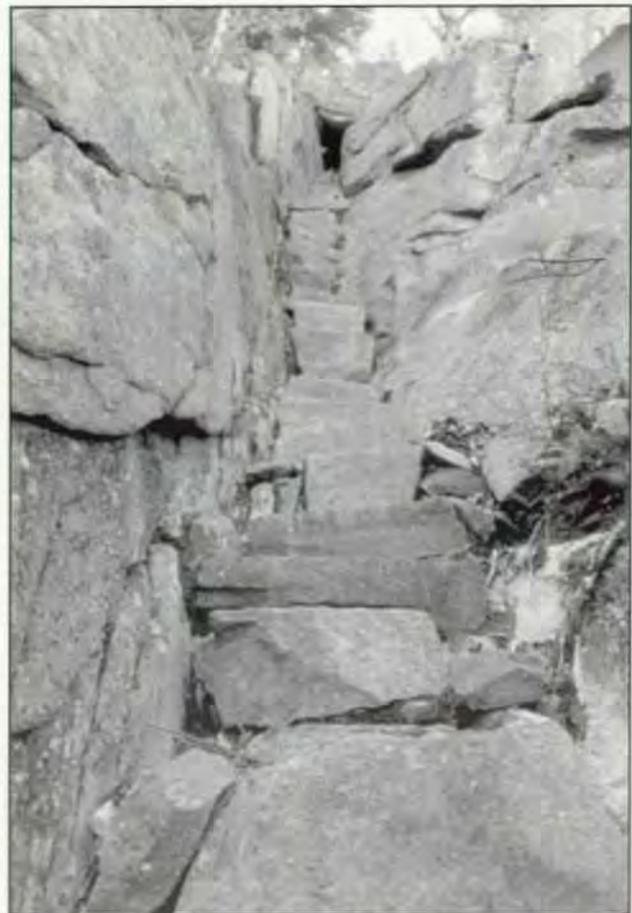
*Figure 6-2: Steps built by the Bar Harbor Village Improvement Society on the Champlain East Face Trail.*

Similar efforts followed as the Northeast Harbor Village Improvement Society, the Seal Harbor Village Improvement Society and the Southwest Harbor Village Improvement Society incorporated in 1897, 1900, and 1914 respectively. These groups distinguished themselves from their counterparts in other parts of the country by extending their community development efforts well beyond the boundaries of their towns. The four societies ultimately worked cooperatively across the island through a joint path committee. Eventually, this resulted in the construction of approximately 250 miles of recreational walking paths on Mount Desert Island, that linked of the villages with the island's natural scenery (Figures 6-2, 6-3).

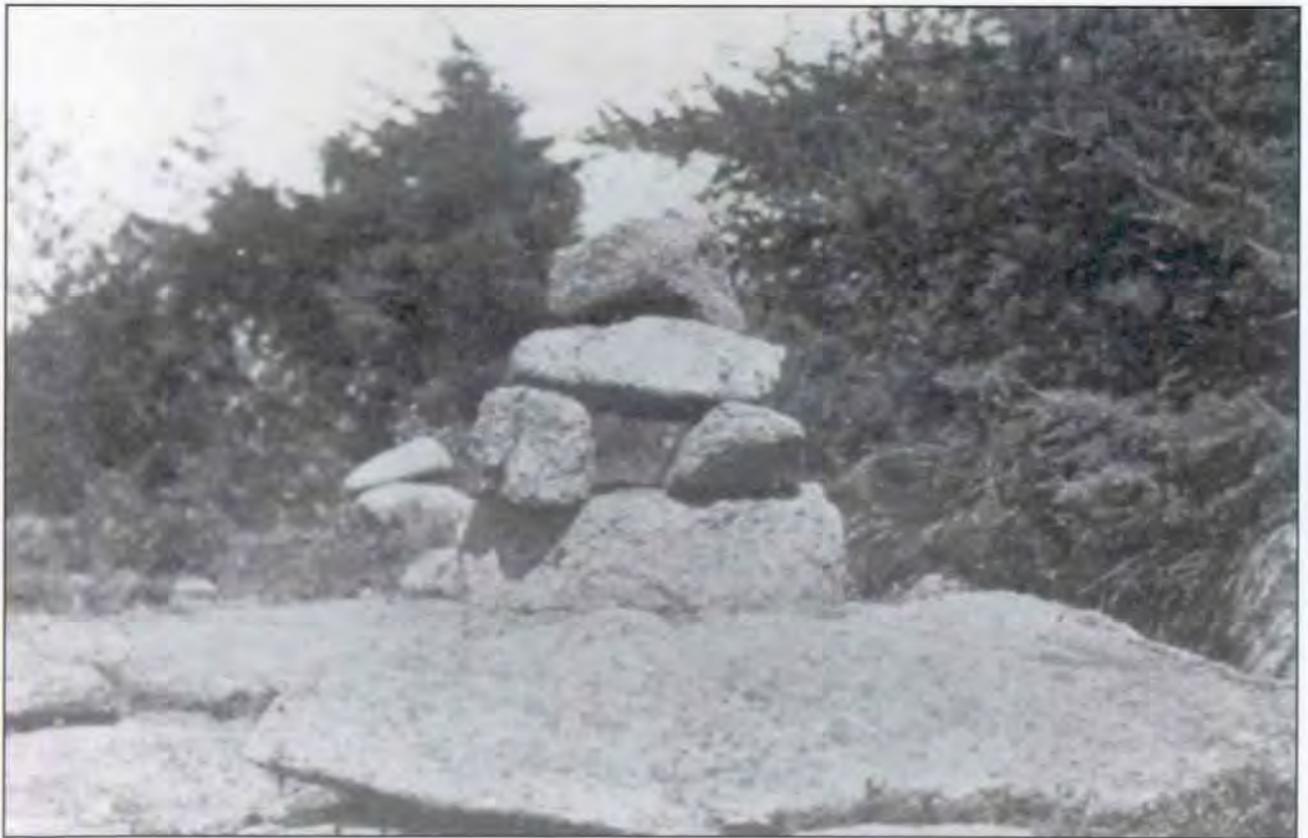
Figure 6-3: "Bates" style cairn used on all island paths as recommended by the joint path committee of the village improvement societies (1928 Path Guide).

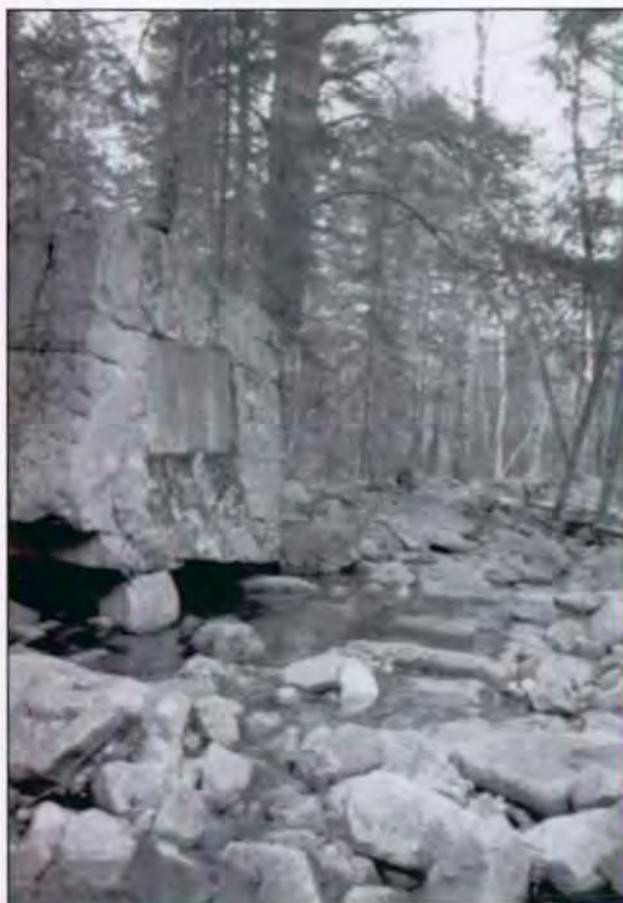
*Figure 6-4: The Andrew Murray Young Trail was constructed in 1926 by the Bar Harbor Village Improvement Association and endowed with a maintenance fund by Mrs. Young. The trail included a memorial tablet and extensive stonework.*

associated features (Figure 6-4). Many are highly constructed works of art that fit beautifully into the Acadian landscape, utilizing endemic materials that harmonize with the natural environment. It is these qualities that also exemplify the picturesque design style, a subset of the rustic style described in the multiple property listing. The trails contain an assemblage of rustic features that include steps, drainage features, walls and coping, bridges, and stone paving that remain as outstanding examples of the picturesque style.

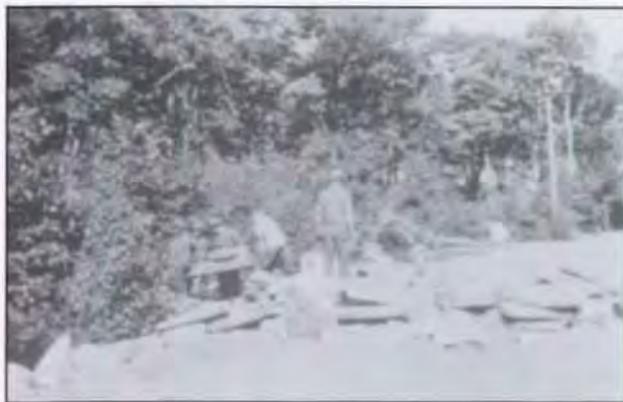
Figure 6-5 CCC stonework at the base of the Ladder Trail (National Archives, Waltham).

In addition to its picturesque character, the trail system is also significant as representative of the NPS rustic design implemented at Acadia beginning in 1916. During the New Deal, workers in federal and state programs such as the Civilian Conservation Corps (CCC) laid and constructed several hiking trails at Acadia and rebuilt and rerouted others as part of the park's recreational trail system. Between 1933 and 1942, the programs of the New Deal contributed greatly to the construction of recreational park facilities at Acadia, including campgrounds, picnic areas, roads, and trails. The CCC constructed eighteen miles of new trails during this period, and about two hundred miles of trails were enhanced and maintained by New Deal programs including the CCC (Figures 6-5, 6-6).

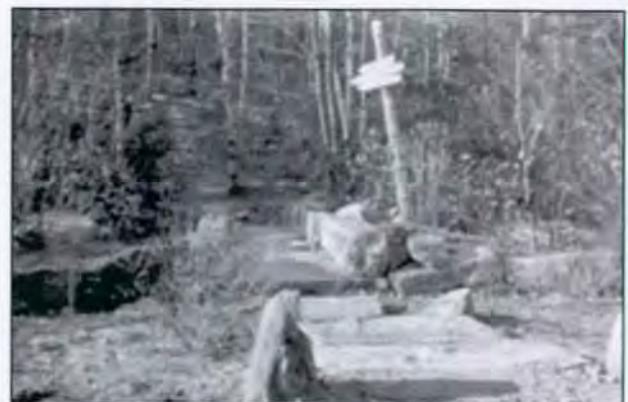
Figure 6-6 Completed CCC stonework at the base of the Ladder Trail (National Archives, Waltham).

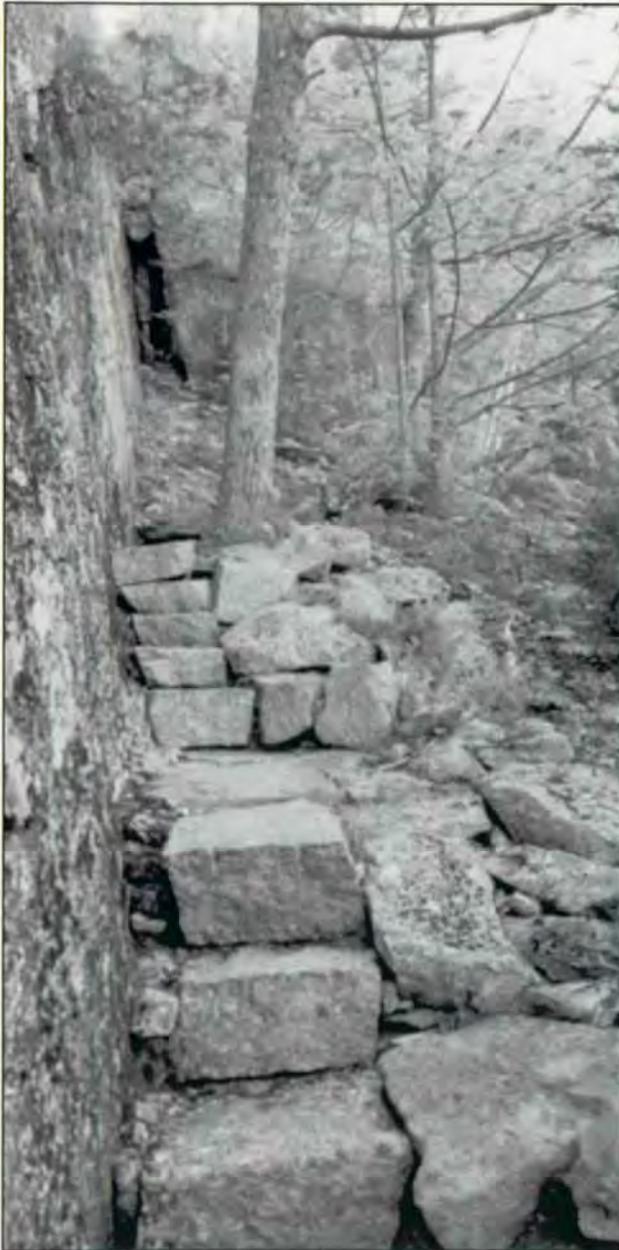
Figure 7-1: Steps along the Ladder Trail.

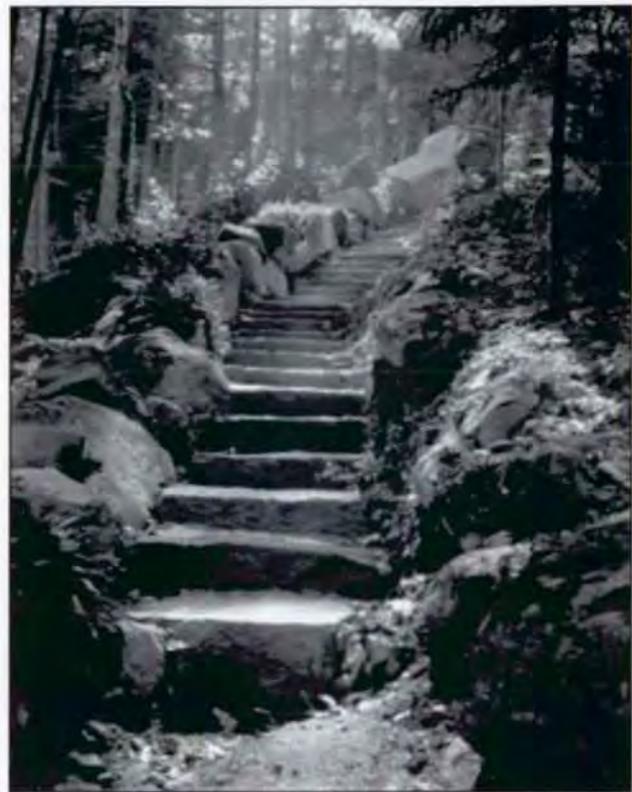
Figure 7-3: Historic view of the Emery Path, example of Acadia style stonework (Acadia NP Archives).

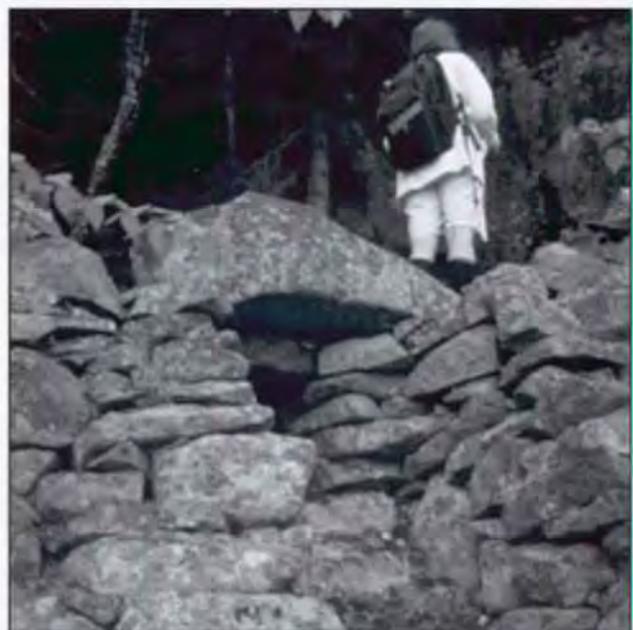
Figure 7-4: Closed culvert built by the CCC on the Perpendicular Trail.

For example, a CCC culvert like the one on the Perpendicular Trail might be lost because this trail might fall into the category of Other Trails (Figure 7-4). When the feature needed to be rehabilitated, the recommendation would not necessarily be to replace in kind. Similarly, VIA stepping stones might not be maintained, since they were not on an Acadia Style trail. In light of these anticipated results, we decided that each of the trails would have to be looked at individually to see what types of features gave the trail its unique character and what types of features should and should not be maintained or added to that trail. In the resulting plan, an individual trail history would be provided. This information, along with a general description of the character of the trail and specific recommendations would be useful for the worker trying to make a decision on what features might be appropriate for certain trails.

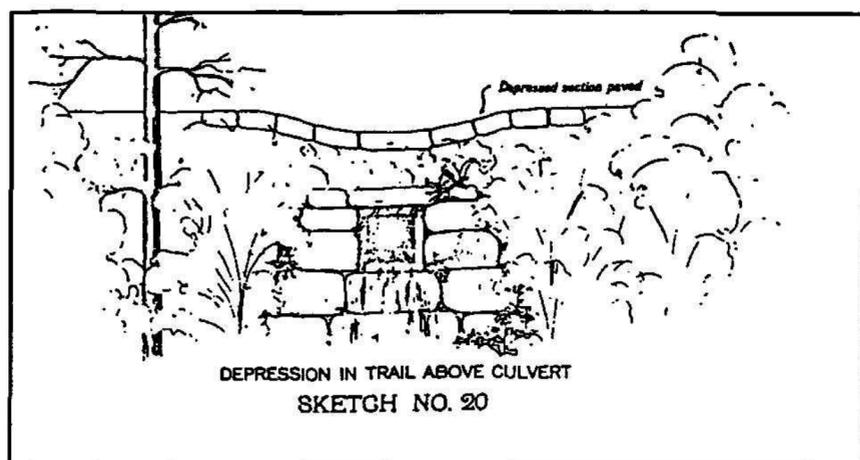
Figure 7-5: CCC specifications for closed culverts in Guy Arthur's 1937 manual "Construction of Trails, CCC Field Training."

Acadia system. Included in this section are photographs, sketches, and written specifications for each feature type. Information on specific features is gathered from a variety of sources, including historical documentation like a CCC trail maintenance booklets (Figure 7-5). In this section of the guidelines, the history of the feature's use at Acadia is discussed, and there are guidelines for when to use certain features, and on what trails they are most appropriate. The resulting document consists of three sections:

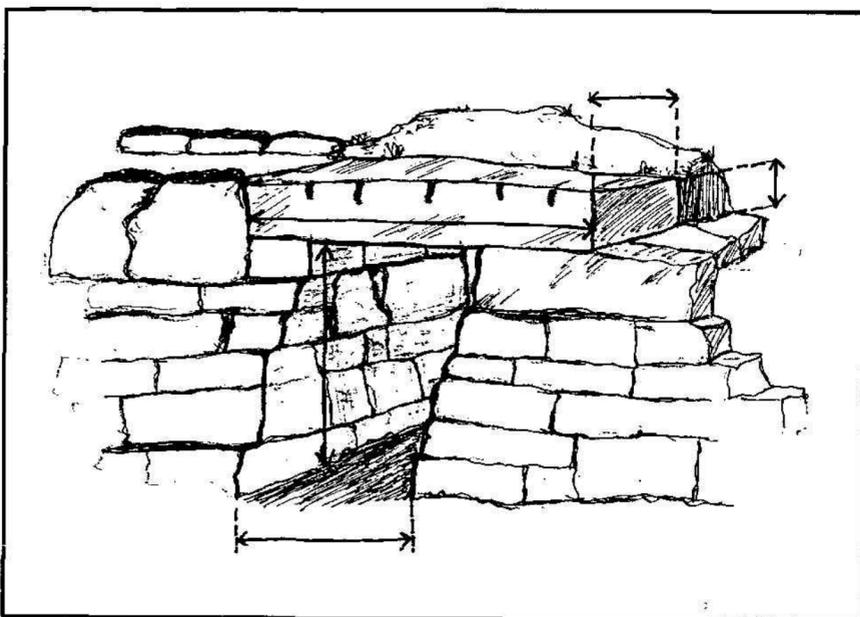
Figure 7-6: Specification sketch for CCC capped culverts in Acadia (drawn by Chris Barter).

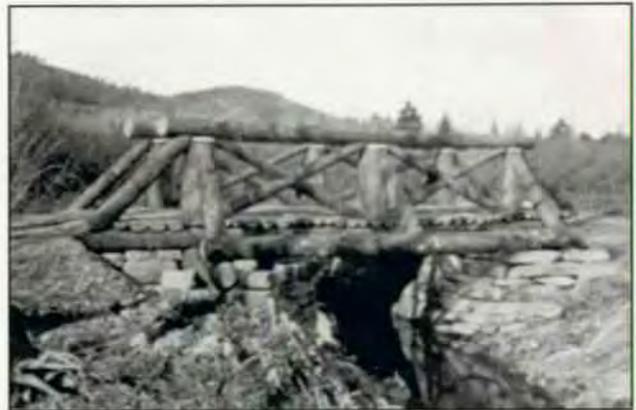
Figure 7-7: 1930s photograph of CCC bridge in the Great Meadow (National Archives, Waltham).

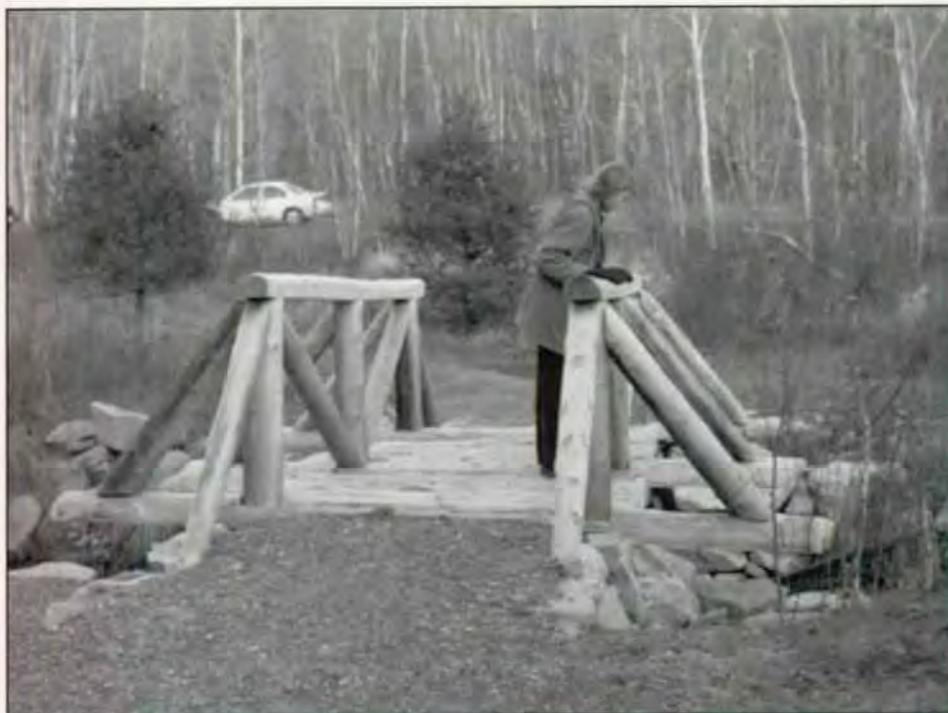
Figure 7-8: 1999 photograph of recently constructed bridge on new Great Meadow Loop Trail.

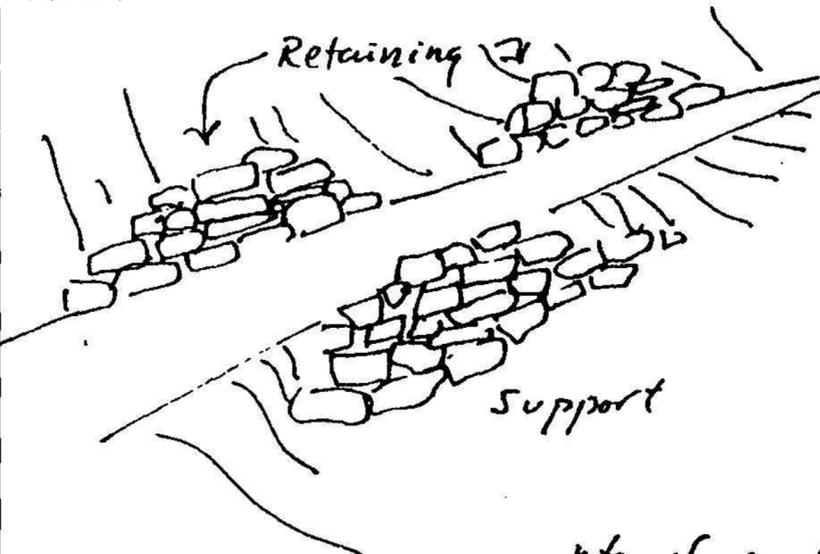
### ROCK WALLS

Retaining

Support

note any characteristics of wall - rock size, curving, any pins into ledge, condition of wall, obscure or very visible.  
 Remember to note walls in conjunction with stairs or sidewalks, etc.

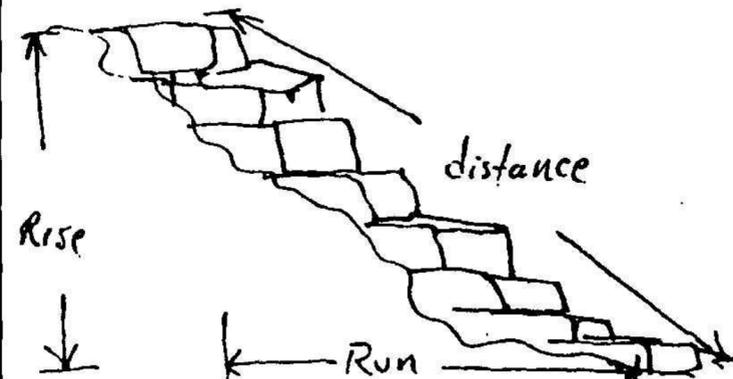
### STEPS

Rise

Run

measure trail distance to top or bottom step. Measure rise, run, and distance. Count steps.  
 Note construction: any pins, walls, coping, missing stones, Note width of stairs, average. Note if steps go up or down in relation to direction of travel.

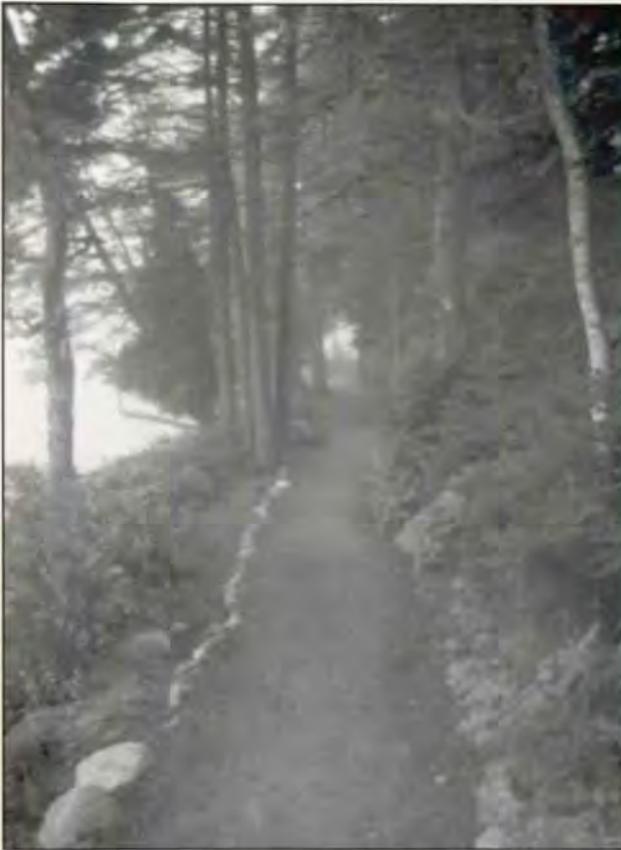
*Figure 9-1: Rehabilitated section of the Jordan Pond Trail.*

Figure 9-6: Section of trail after rehabilitation, also see Figure 9-1.

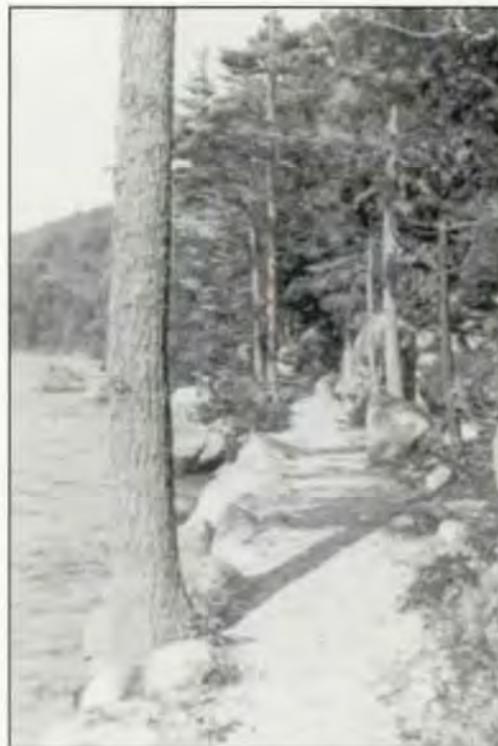
Figure 9-2: Circa 1920 photograph by Charles Townsend.

wall on the sides, indicated that the condition of the trail had eroded substantially since this time (Figure 9-2). The third source, field work, involved looking at what was left along the trail. We also examined a nearby but less trodden path, the Seaside Path, also built by the Seal Harbor Village Improvement Society in the late 1800s using the same construction techniques. Because the trail is virtually abandoned, its not tinkered with as much, and there is more original work. As a broad rule, the abandoned trails on Mount Desert Island are good resource for research on historic trail work. Nearly half of the early 1900s trails are no longer mared. These abandoned trails are like little museums in the woods.

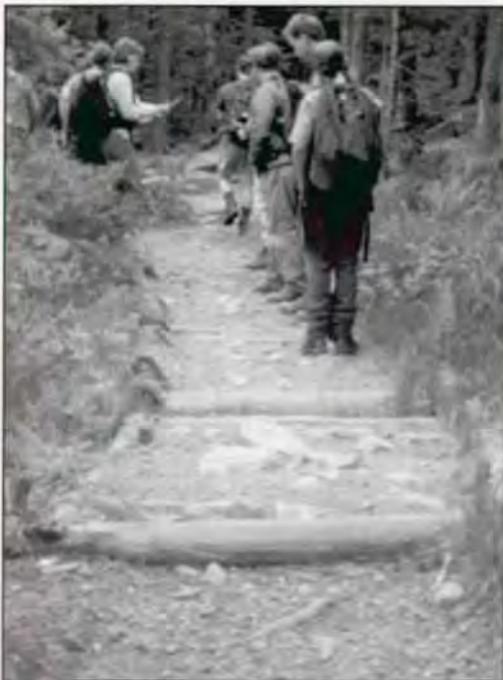
Figure 9-3: Log and boulder turnpiking was not historic work and was removed during the rehabilitation.

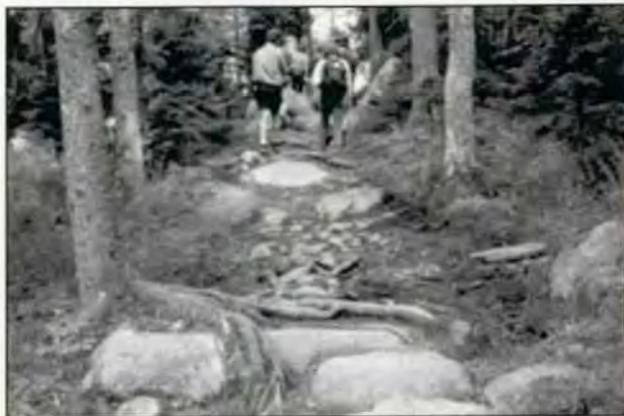
Figure 9-5: Eroded section of trail before rehabilitation.

These solutions are documented in our treatment guidelines as described by Tracy Stakely. Let’s let the Jordan Pond Trails speak for itself with before and after photographs (Figures 9-5, 9-6).

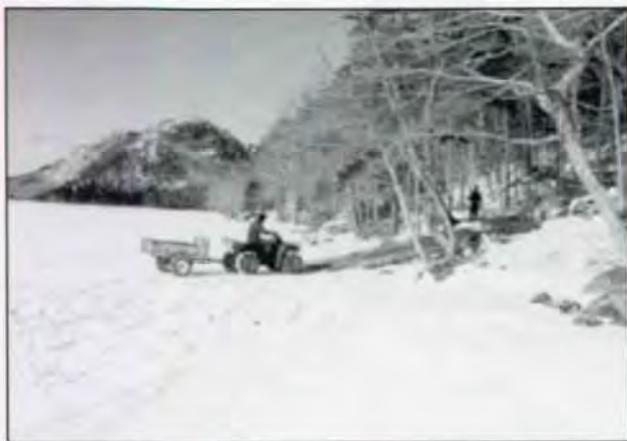
Figure 11-4: Acadia crew hauling gravel across ice for the Jordan Pond Trail rehabilitation.

On average, \$29,000 a mile for existing trails, \$79,000 a mile for abandoned trails.<sup>12</sup> Trail work is labor-intensive, involving muscle power and simple mechanical devices (Figures 11-1, 11-4). It is conducted in the rugged backcountry, away from most roads and utilities. Almost no heavy equipment can or should be used. (Compare: rebuilding Acadia's carriage roads cost \$150,000 a mile; constructing park automobile road costs about \$1 million a mile.)
