# PRESERVING HISTORIC TRAILS

CONFERENCE PROCEEDINGS

OCTOBER 17-19, 2000

ACADIA NATIONAL PARK, MAINE

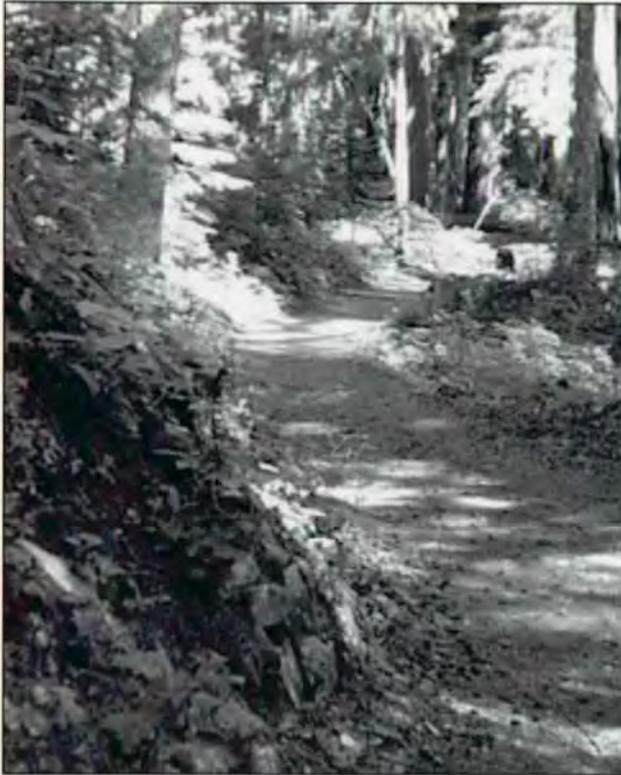
*Figure 12-1: Contemporary photograph showing the curvilinear alignment and generous width of the Wonderland Trail. (July 2000)*

The Wonderland Trail at Mount Rainier National Park is a 93-mile system of connecting trails that completes a loop around Mount Rainier (14,410') in Mount Rainier National Park (Figure 12-1). This presentation describes the history and significance of the trail, as well as current efforts to document and maintain the characteristics and features that make the trail an important cultural landscape. First, Ethan Carr provides a historical overview and describes the significance of the trail as a contributing resource in the 1997 National Historic Landmark nomination for Mount Rainier. Second, Susan Dolan, describes the Cultural Landscape Inventory, completed in the summer of 2000, of 25 miles of the trail. The inventory team found a broader range of characteristics and features than formerly acknowledged, particular in terms of the integrity of the trail's alignment and historic structures. And third, Carl Fabiani, Rainier's Trails Crew Foreman, describes his responsibility for all aspects of maintenance on the trail, including practices such as replacing wood structures with permanent or simpler structures in order to reduce maintenance costs. He also describes compliance issues related to NEPA, the Wilderness Act, and the National Historic Preservation Act. Together the panelists present a case for how research, documentation, and maintenance can and should be coordinated in the management of a nationally significant hiking trail.

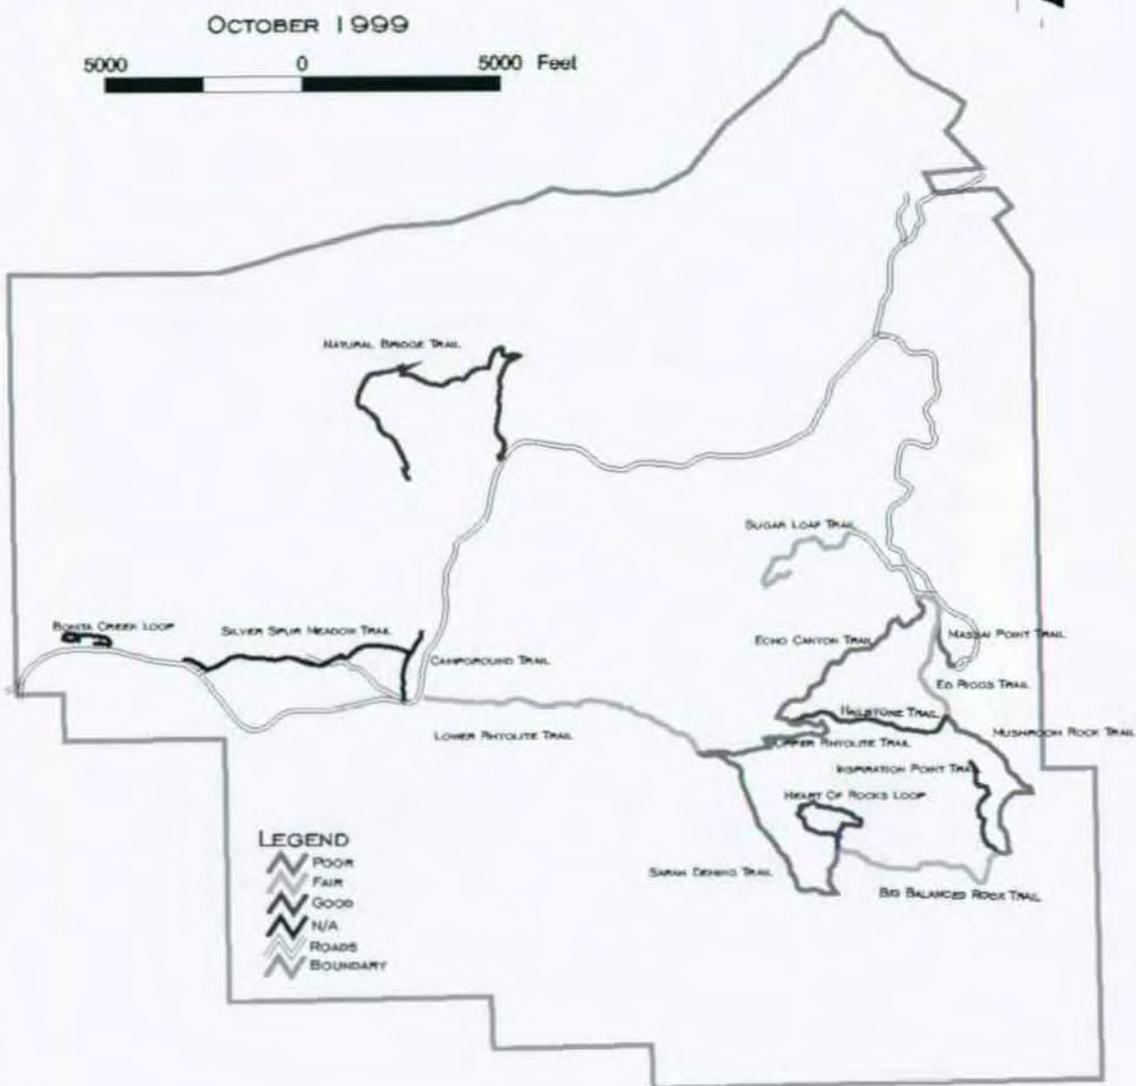
FIGURE 1. COMPARATIVE CONDITION OF TRAILS. TRAIL IN POOR CONDITION EXHIBITS SUBSTANTIAL LOSS OF FABRIC WITH ACTIVE COLLAPSE OCCURRING AT ONE OR MORE LOCATIONS. A TRAIL IN FAIR CONDITION EXHIBITS MODERATE LOSS OF FABRIC WITH POTENTIAL COLLAPSE AT ONE OR MORE LOCATIONS. TRAIL IN GOOD CONDITION EXHIBITS MINIMAL LOSS OF FABRIC WITH TRAIL FEATURES RETAINING HISTORIC INTEGRITY.

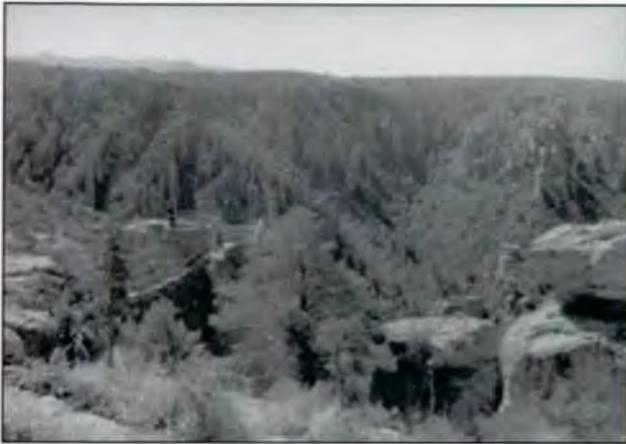
Figure 13-2: Historic photograph, October 1935 of lookout platform at Mastai Point constructed by the CCC. (NPS, Harpers Ferry)

1. Examination of all available information regarding the history of the trail system (e.g. original plans, project reports, preservation/maintenance reports, photographs, oral histories, etc.) within the historical context of CCC trail and National Park Service landscape design (Figure 13-2).
2. Documentation of the character and condition of each trail and associated features by utilizing a standard recordation format that includes overall schematic maps, detailed maps, attributes of trail features, photography, and field sketches where applicable. This documentation will facilitate understanding of the overall trail design and contextual landscape, structural character, use of the trail through time, variations in condition, and all agents of deterioration presently affecting the

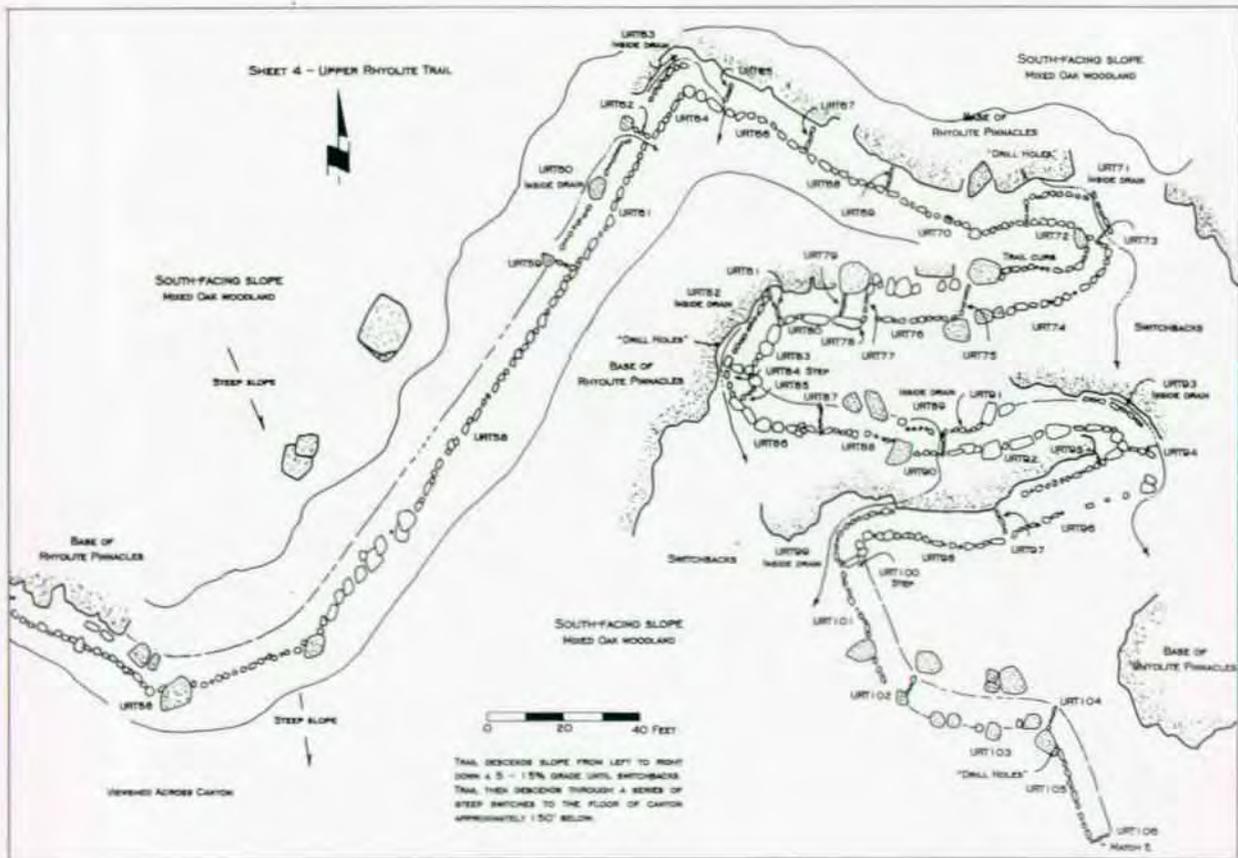
Figure 13-5. Example of trail corridor map that covers same area as schematic map shown in Figure 13-3 of the Upper Rhyolite Trail.

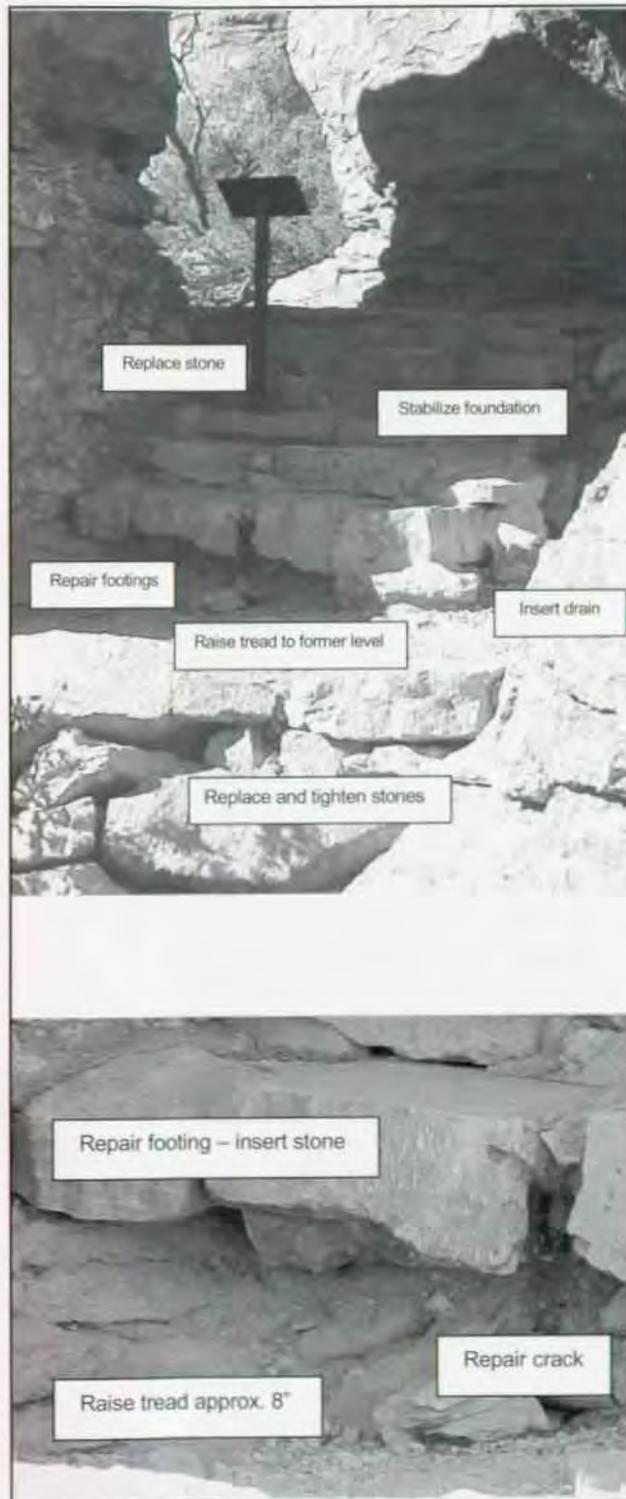
**Figure 13-8: Feature Form**

**Trail:** Massai Point Nature Trail

documentation prior to and after treatment. Measured maps, drawings, and photographs, prepared at appropriate scale and augmented with interpretive or analytical sketches illustrate function, construction details, aspects of deterioration, etc. (Figures 13-8 and 13-9).

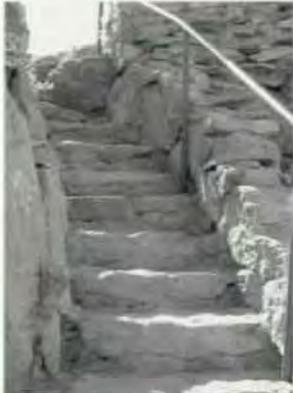
<p style="text-align: center;">Massai Point Nature Trail</p>
Steps	<ul style="list-style-type: none"> <li>❑ Steps are relatively small to large flat tabular stones generally placed below a retaining bar to provide a shorter or intermediate platform. Steps are not set into trail tread surface or integrated with other trail features.</li> </ul>	<ul style="list-style-type: none"> <li>❑ Stabilize and/or repair steps by repositioning individual stones, repairing associated tread surfaces, and reinforcement with additional retaining bars without altering the historic character or appearance of step.</li> </ul>

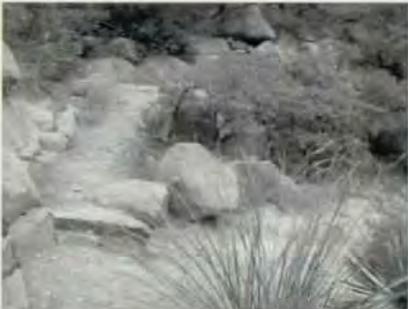
<p style="text-align: center;">Upper Rhyolite Trail</p>

Switchback Corner	<ul style="list-style-type: none"> <li>❑ Complex dry wall structure that integrates multiple walls on either side of a trail with a variety of trail features (e.g. open culverts) to ensure the integrity of trail at turning point. Switchback corners may be viewed as either an integrated structure or as individual features and range in size from relatively small to very large.</li> </ul>	<ul style="list-style-type: none"> <li>❑ Stabilize and/or repair switchback corners to insure proper function. Specific features may require stone replacement, cleaning, moderate rerouting across tread surfaces, and reinforcement with additional retaining bars without altering the historic character or appearance of the corner.</li> <li>❑ Monitor all switchbacks for any changes in condition or integrity</li> </ul>

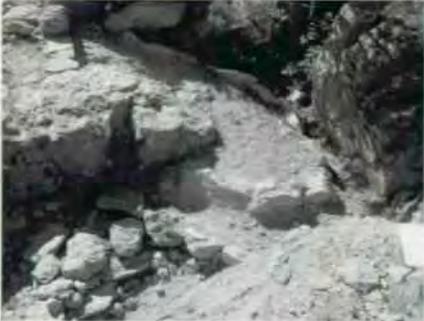
<p style="text-align: center;">Ed Riggs Trail (Echo Spur)</p>
Trail Curb	<ul style="list-style-type: none"> <li>❑ Single stone-width features that demarcate trail boundary and minimally inhibit erosion of tread surfaces. This type of feature, placed on the margin of a trail, is often minimally embedded in the trail tread and is consequently easily displaced.</li> </ul>	<ul style="list-style-type: none"> <li>❑ Stabilize and/or repair trail curbs by resetting individual stones, repairing associated tread surfaces, and reinforcement with additional retaining bars without altering the historic character or appearance of curb.</li> </ul>

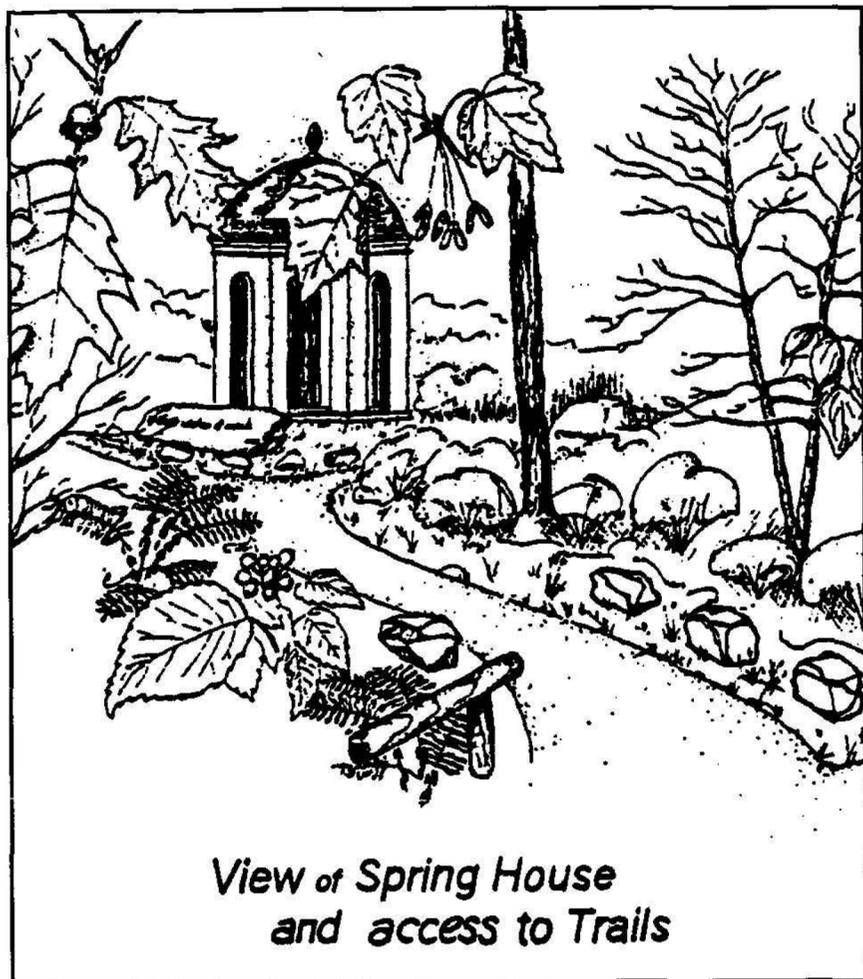
**View of Spring House  
and access to Trails**

*Figure 14-1: Views can be especially useful in landscape documentation, revealing relationships of complex design features and circulation patterns (HAER drawing for Acadia's Roads and Bridges).*

For the past twelve years, the Historic American Engineering Record (HAER) has been conducting a systematic survey of roads and related resources in America's national parks and parkways. The goal of this program is to create a thorough visual and textual record of historically significant roads, bridges, and ancillary landscapes in America's national parks and parkways. The documentation includes large-format photographs, measured and interpretive drawings, and detailed historical narratives. The results of these studies are provided to park managers and added to the HABS/HAER collection at the Library of Congress. The graphic documentation component initially focused on bridges and other engineered structures, but as the program evolved it expanded in scope to address broader cultural landscape concerns. Traditional site plans and elevations have been augmented with conceptual drawings illustrating design concerns, construction practices, experiential factors, and temporal changes (Figure 14-1).

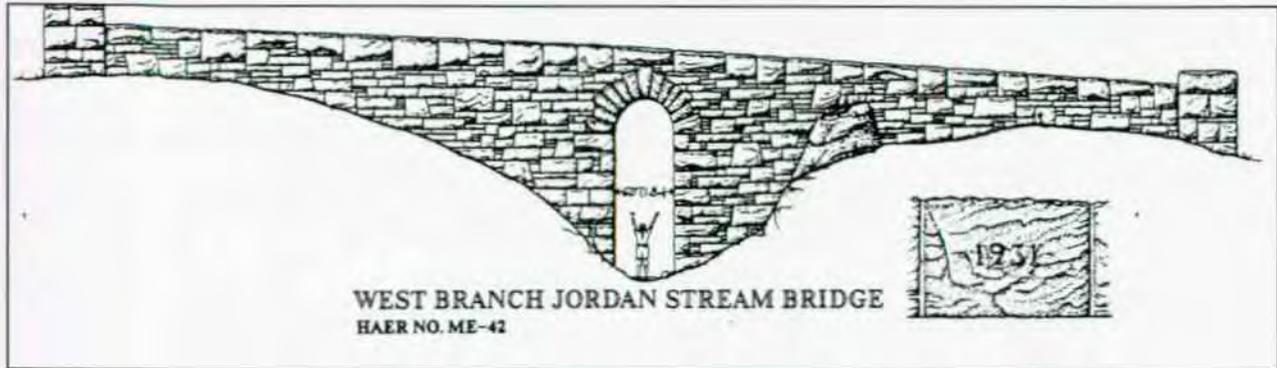
Figure 14-2: A section illustrates the relationship of roads and trails (HAER drawing for Acadia's Roads and Bridges).

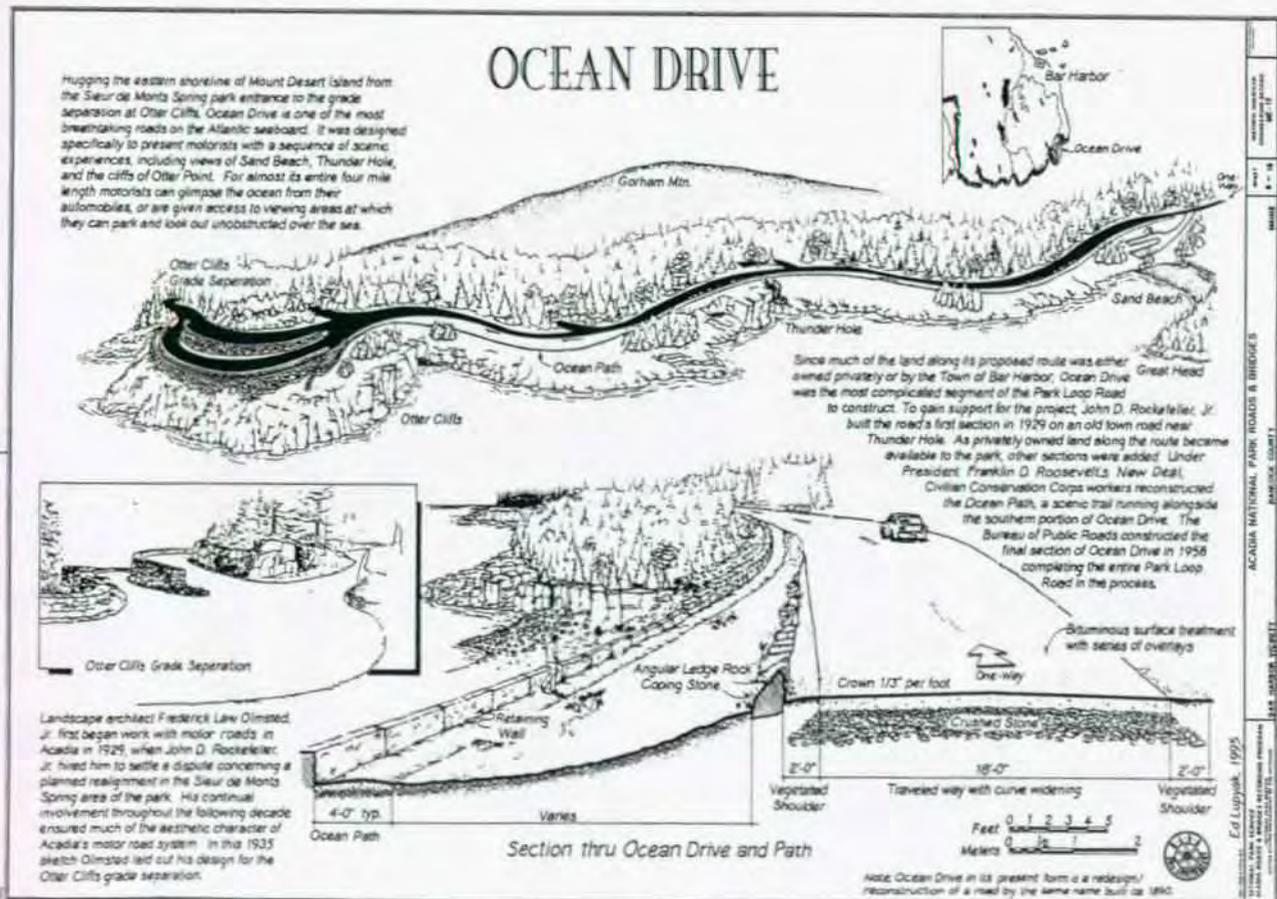
Figure 14-3: Perspective drawings, sections, and descriptive text broaden our understanding of the built environment (HAER drawing for Acadia's Roads and Bridges).

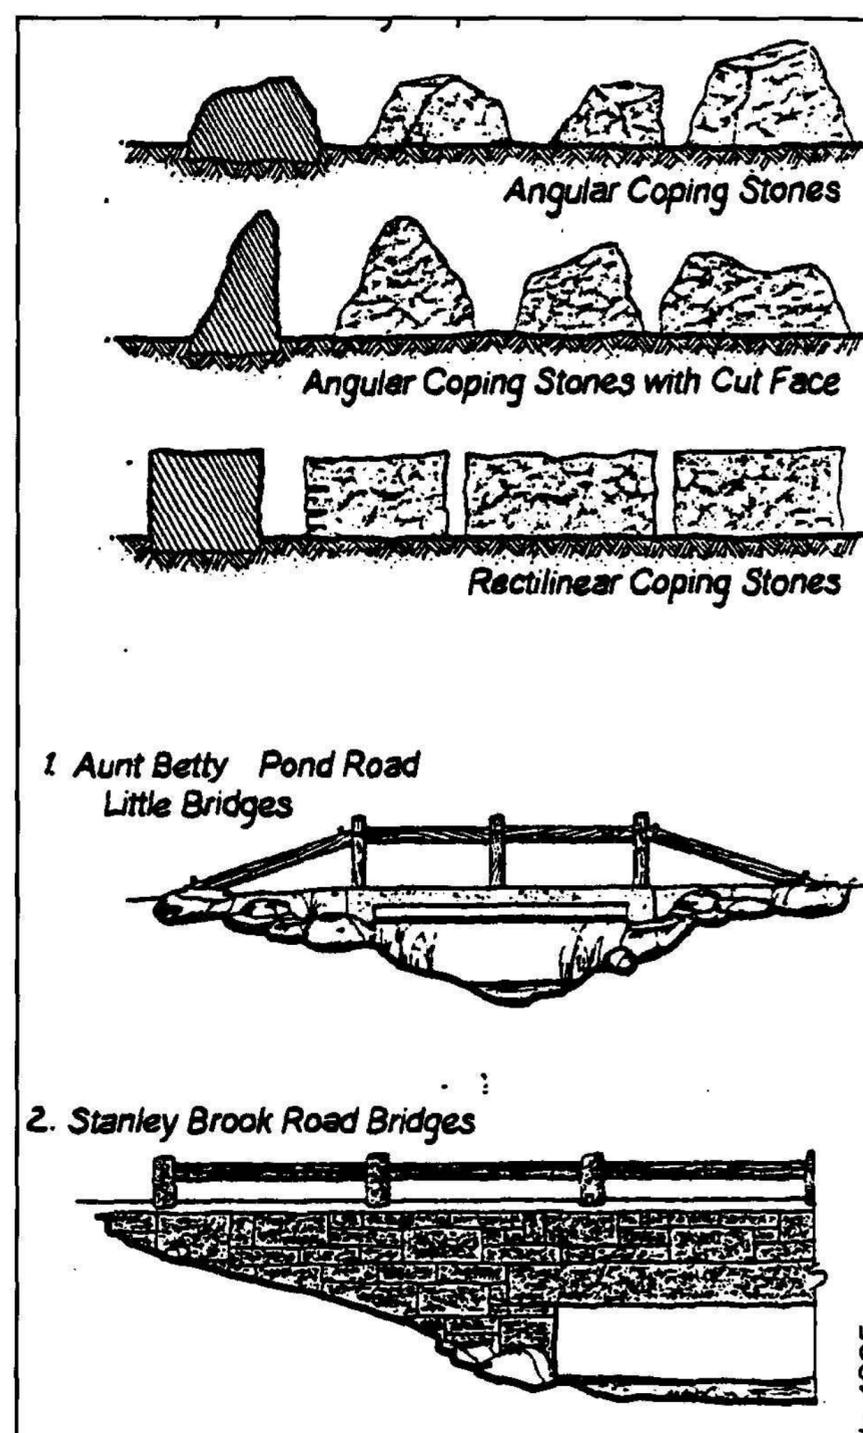
Figure 14-4: Many objects associated with linear landscapes can be identified, surveyed, and drawn through the use of measured drawings (HAER drawing for Acadia's Roads and Bridges).

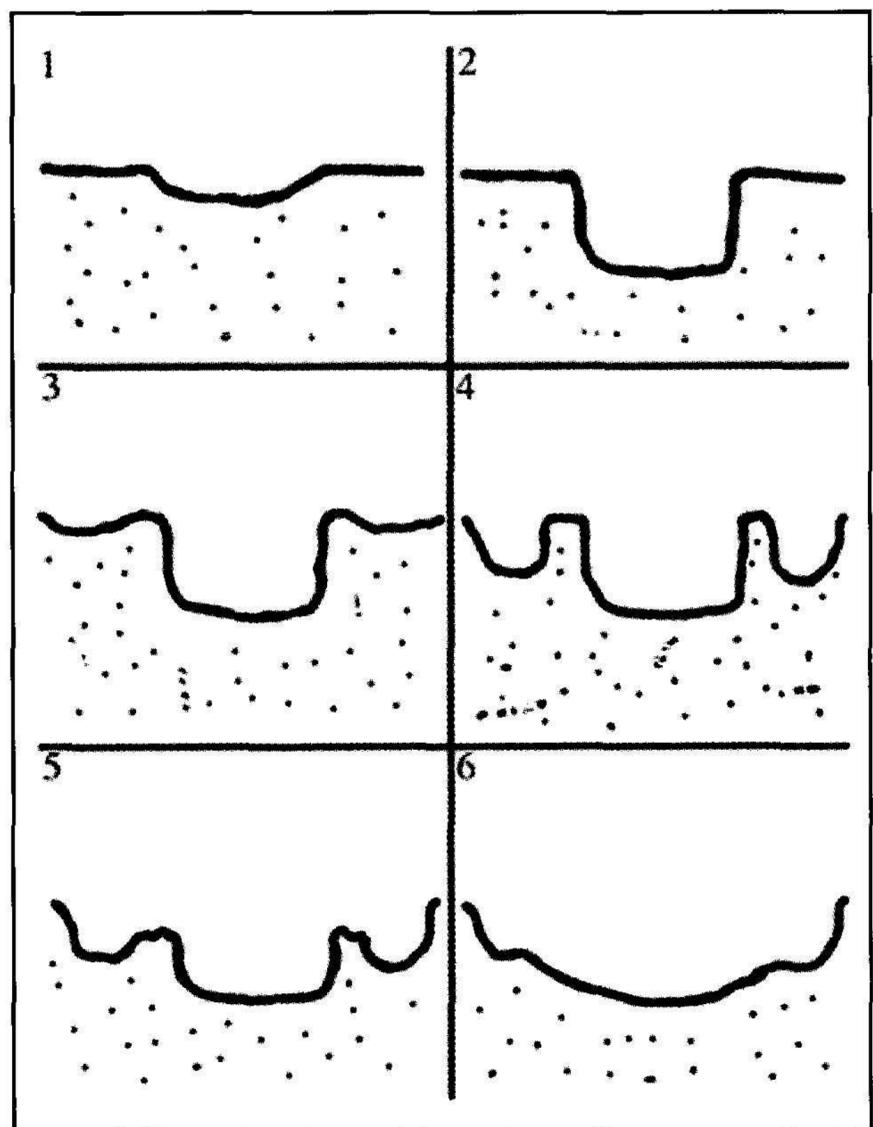
Figure 15-3: Section diagrams showing the progression and extent of erosion in the tufa rock.

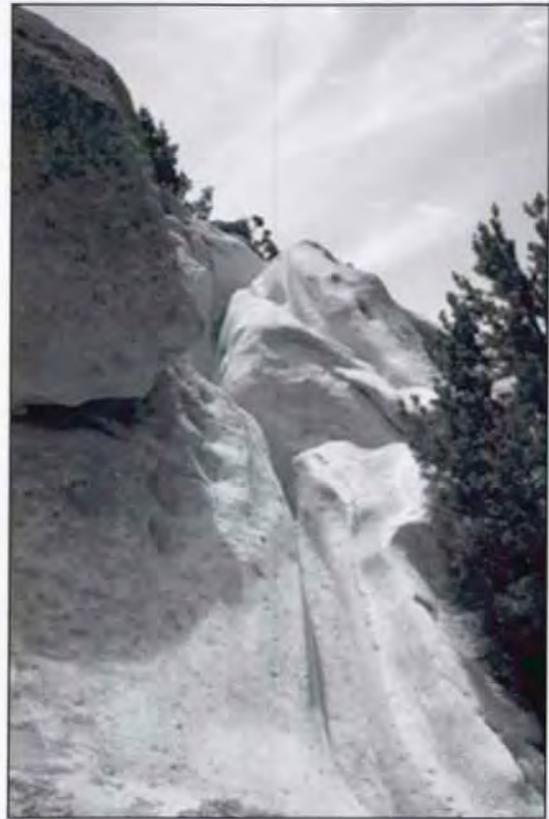
Figure 15-4: Visitor use has eroded Puebloan routes.

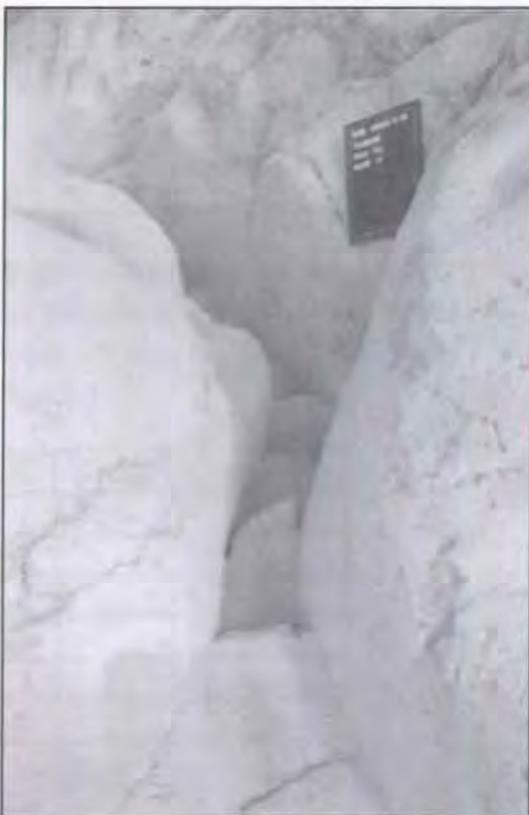
Figure 15-5: Horizontally placed overlapping steps installed for visitor trail.

and smaller rocks were carefully pounded in around the anchor to wedge the stone in place. After the initial stone was placed, the best route was selected for the remaining upslope steps. If the section was particularly deep, these prime locations (narrow spots, curves) were used to wedge larger, less well shaped stones to act as anchors for the heavier amount of fill to be placed behind and on top. In these deeper sections, this was a crucial element to the design as to prevent too much pressure building up in one place (the bottom anchor stone). As well, particularly deep sections required a higher rise to bring hikers up to a safe level of travel within the trail. This was done in two places with two stair-like methods. First, by stacking larger, shaped stones on top of one another with only a slight overlap, a deep spot with little anchoring could be sufficiently raised with more vertical than horizontal force holding the stones in place. Secondly, for a location with a sufficiently narrow pinch, larger shaped stones were placed high and against the back (set-behind) of the preceding stone (Figures 15-5 and 15-6). Rubble fill supported each successively higher stone.

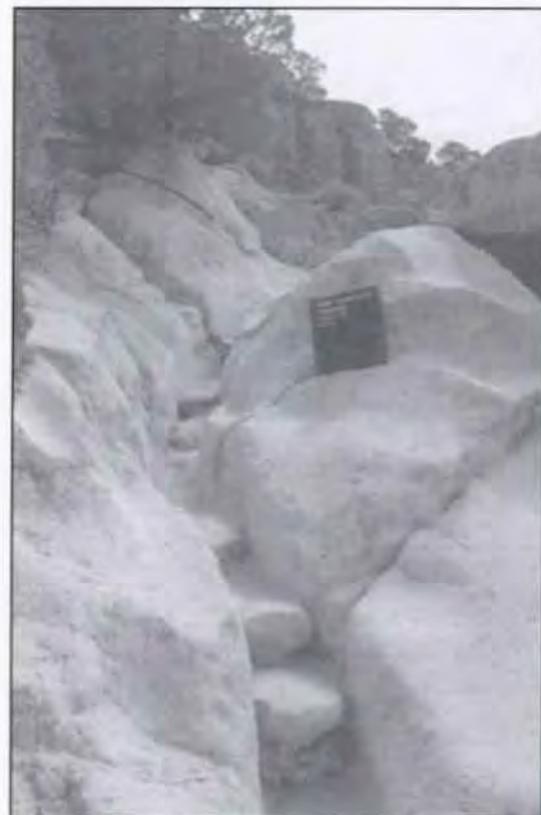
Figure 15-6: Back to back, set-behind steps installed for visitor trail.

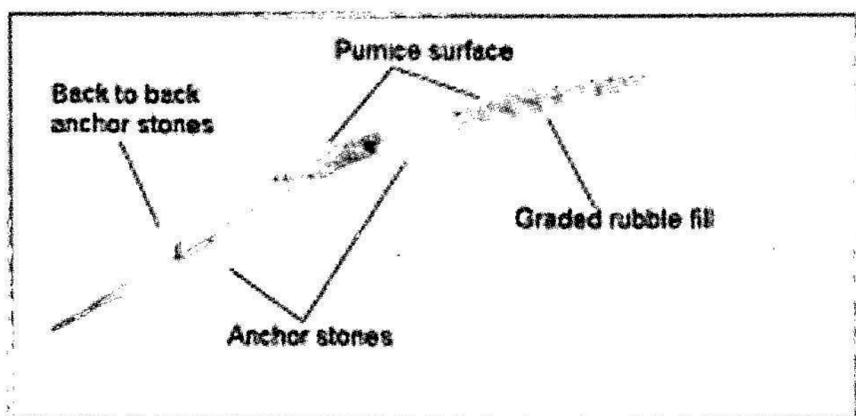
Figure 15-7: Section of trail construction materials.

Larger crushed tufa, approximately five inches in diameter was then placed in the bottom of the trail between steps and anchor stones and more finely crushed tufa was placed on top to a depth three inches below where the final level of fill was to be. The remainder of the surface was filled with pumice for a walking surface. However, just under the surface of the pumice layer, at the places where footsteps were most likely to land, a slightly larger stone was placed to provide a solid impact point that would prevent foot traffic from digging into the pumice while retaining the pumice in situ (Figure 15-7).

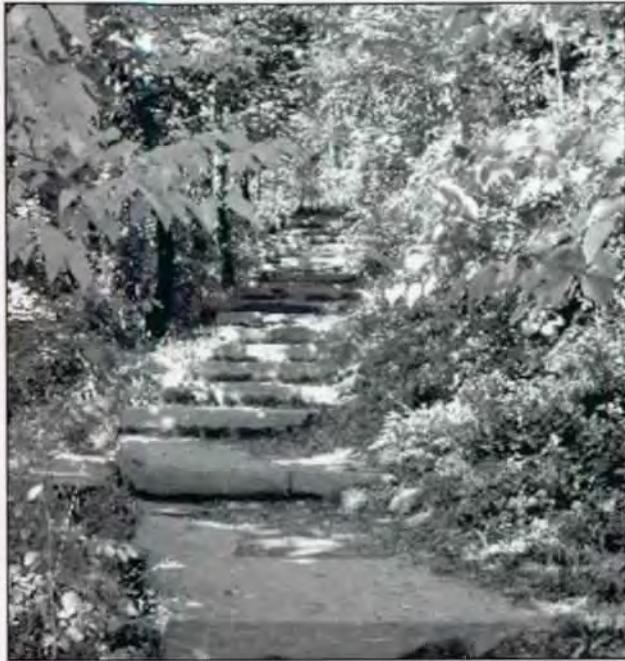
Figure 16-4: Completed rehabilitation of the Appalachian Trail in the Jefferson Rock area, September, 2000.

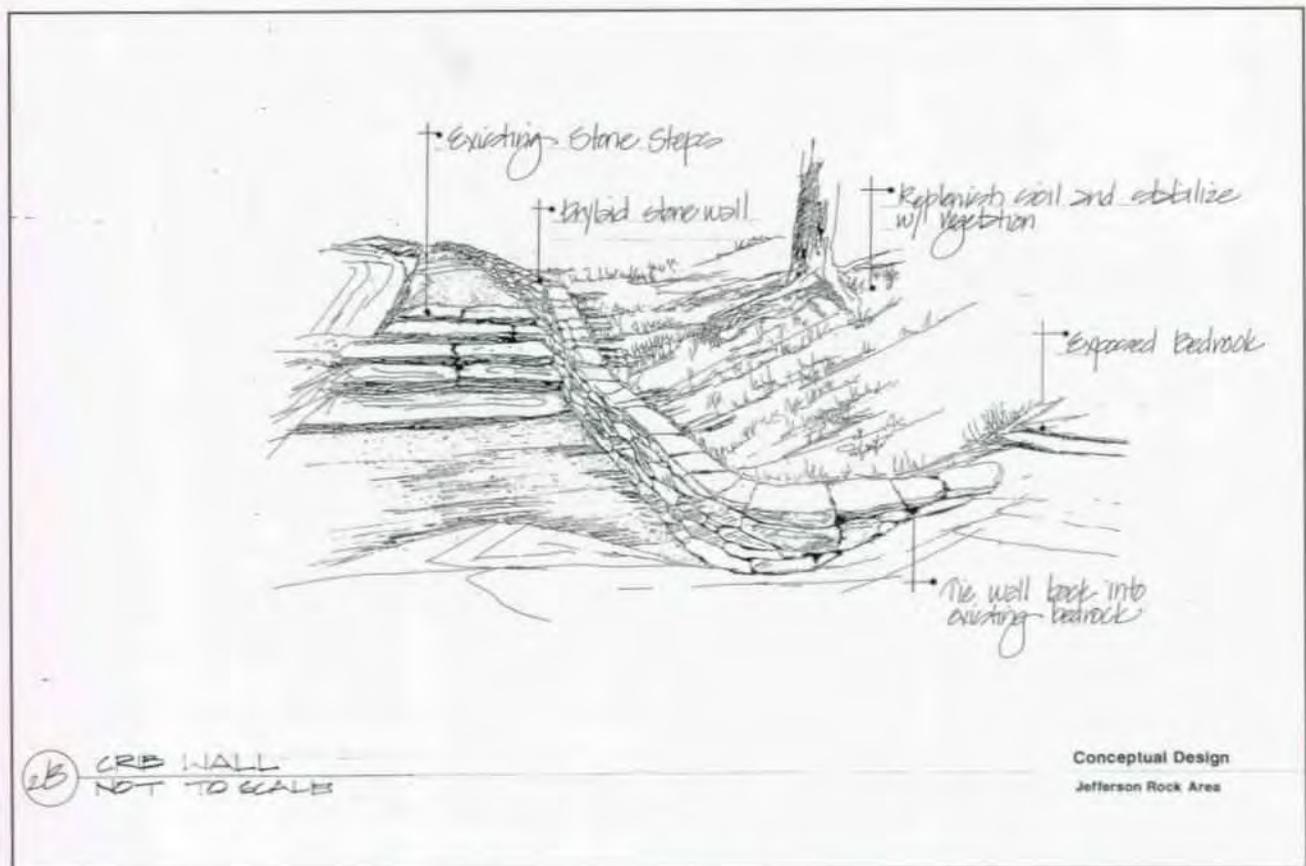
Figure 16-3: Conceptual design for the Jefferson Rock area to preserve existing steps and stabilize eroded slope with a dry laid retaining wall.

*Figure 16-6: Completed dry laid walls as proposed in Fig.16-3, using imported stone similar in color and texture to the original local Harpers Shale.*

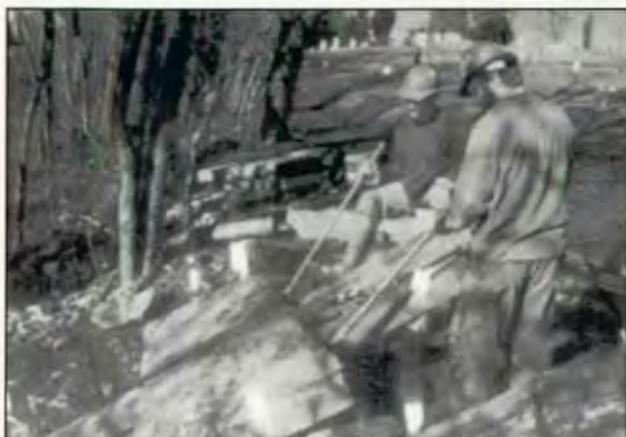
*Figure 16-5: Moving 1,500-pound stone steps down the hill to the work site.*

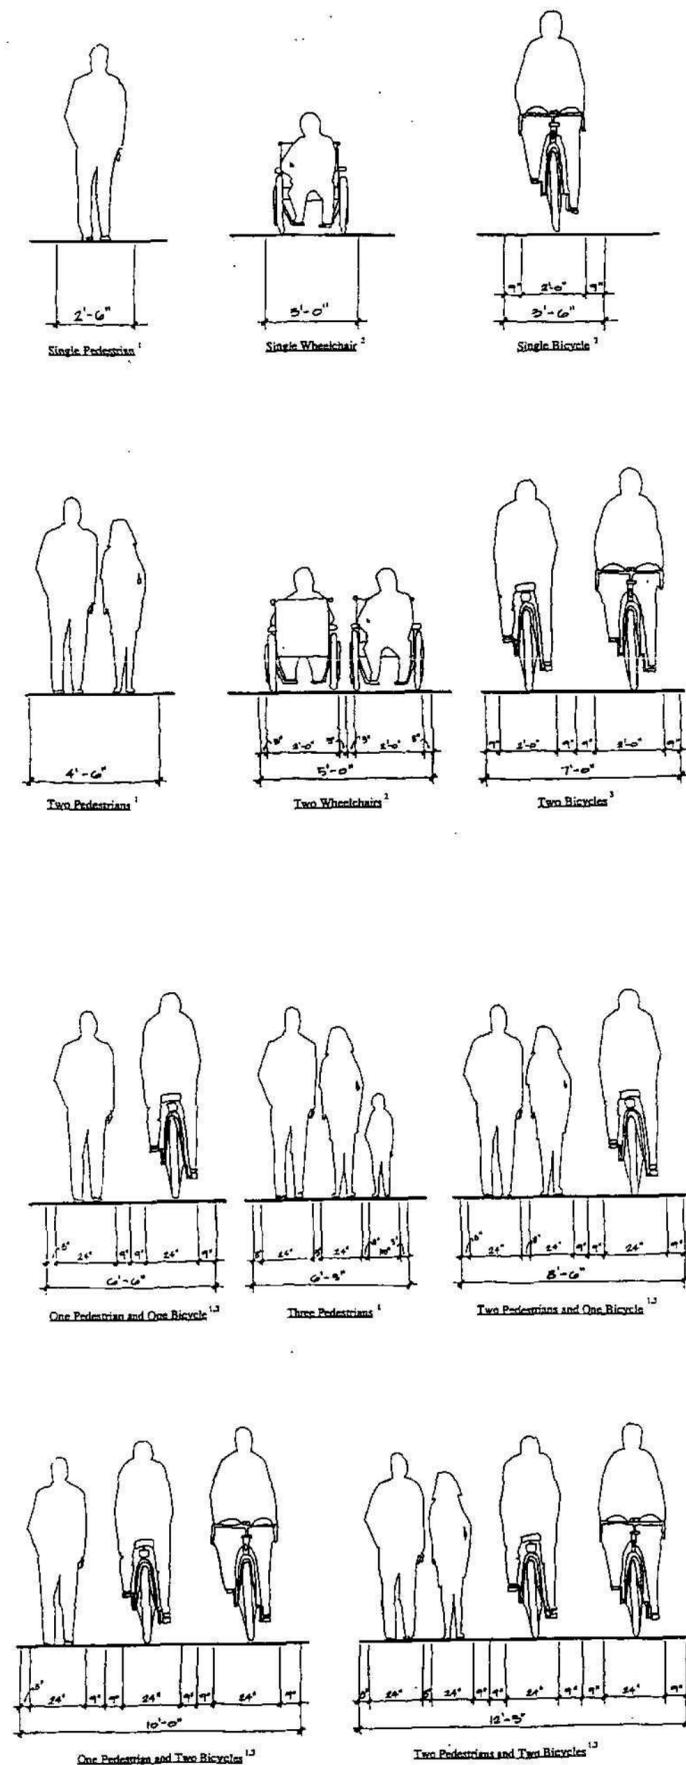
Figure 17-2: Width studies for different sections of the trail.

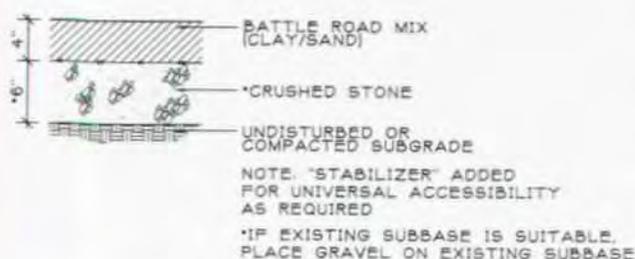
Figure 17-3: Cross section of Battle Road materials.

The "Battle Road" construction was actually much easier than the new trail (Figure 17-2). The alignment was predetermined since it followed the original 1775 route. The existing asphalt was removed and a clay/sand mixture was installed (Figure 17-3). The trail surface was designed based on NPS archaeologists recommendations from original battle road sampling.

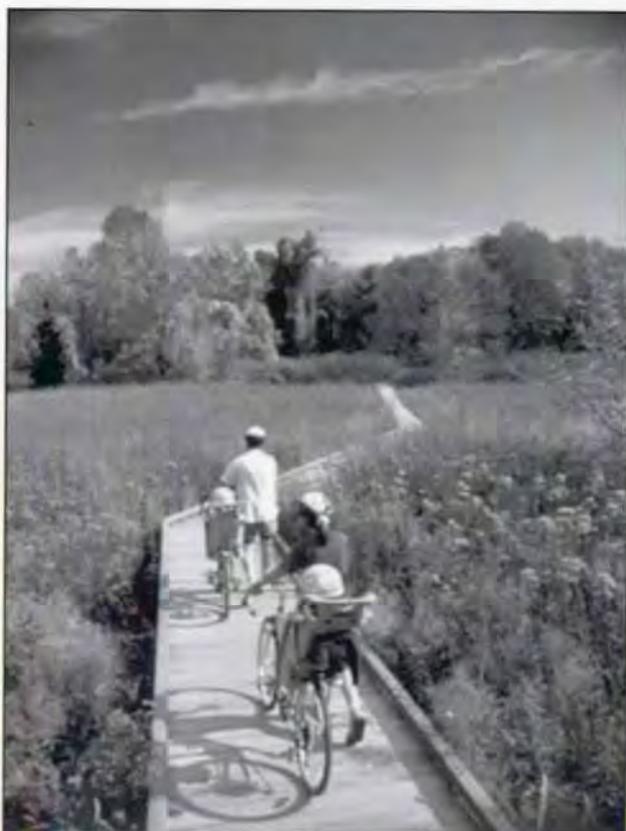
Figure 17-5: Bikers are required to walk on boardwalks, which are five feet wide and partially made of recycled plastic.

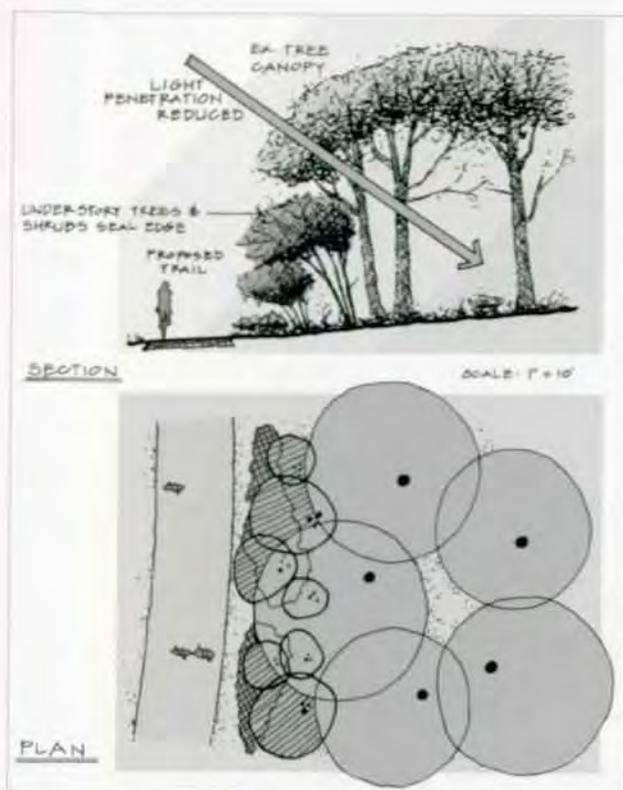
Figure 17-9: Forest edge sealing with tree and shrub seedlings to prevent encroachment by invasive species.

A very important aspect of the Staple Bend Tunnel project was the revegetation of disturbed areas with native planting. We specifically identified seed mixes that were native to this site and installed seed collected from Pennsylvania. Seed mixes included forest understory, meadow, low velocity swale and high velocity swale. A very aggressive seeding program with herbaceous plug and tree seedling installation was proposed to limit the growth of Japanese Knotweed—a very invasive plant (Figures 17-9, 17-10).

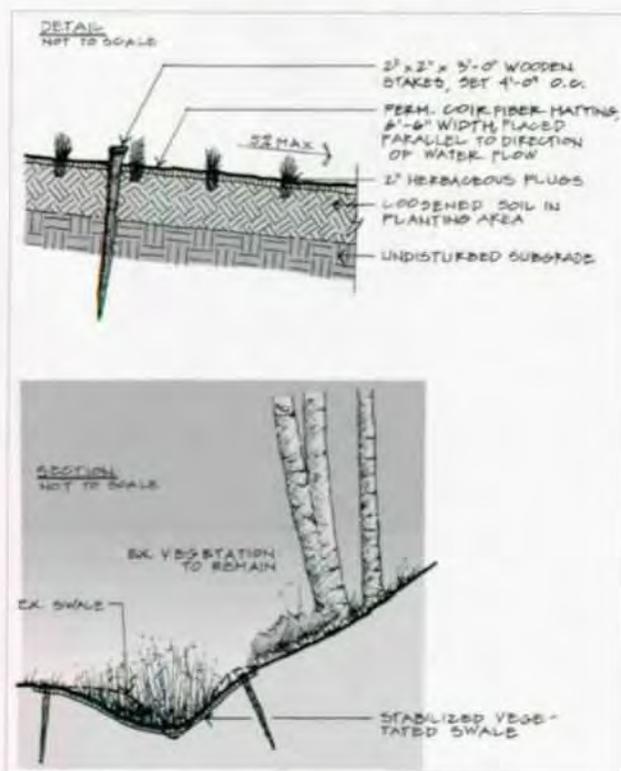
Figure 17-10: Swale seeding and plug planting.

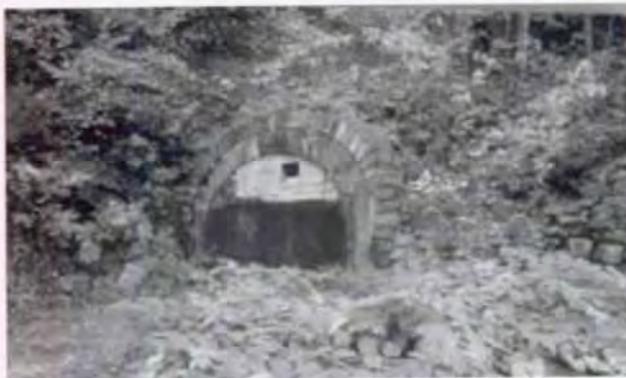
*Figure 17-11: East portal before repairs*

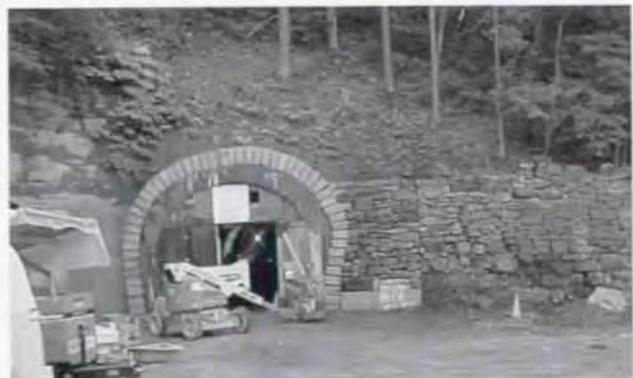
*Figure 17-12: East portal with repaired retaining walls and improved drainage.*

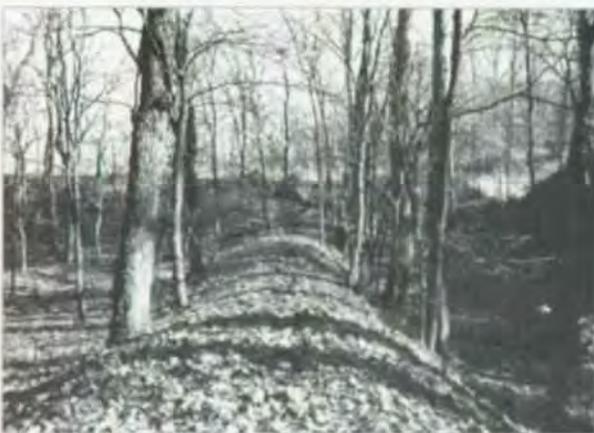
Figure 18-5: Canal prism near Valley Railway, before rehabilitation.

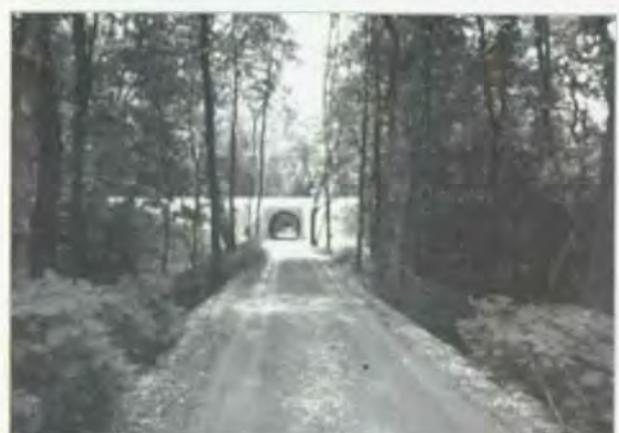
Figure 18-6: Same section as 18-5 after tunnel installation.

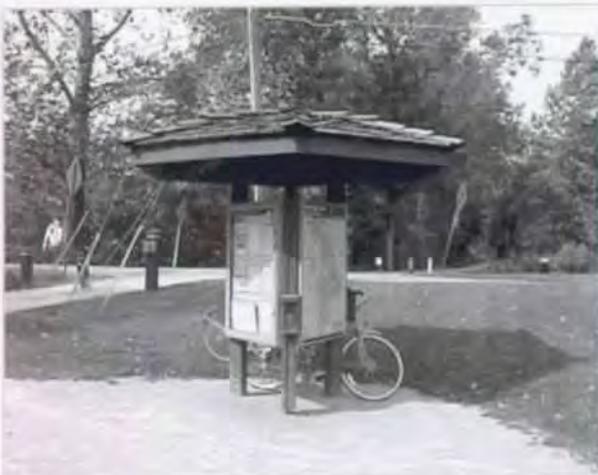
Figure 18-7: Typical towpath trail kiosk.

Waysides, signs, bollards and mileposts are an integral component of the Towpath Trail (Figure 18-7). Three sided informational kiosks were designed and installed at each trailhead and major visitor use facility along the 20-mile length of the Towpath Trail in the park. The kiosk design is so popular that the local metropolitan park districts have adopted it for use in their parks. The canal was still extant north of Ira Road, but beaver had created a wetland that needed to be accommodated. A boardwalk was built and interpretive waysides developed to tell their story. A bench and wayside were installed immediately adjacent to the site of the aqueduct over Furnace Run Creek (Figure 18-8). The wayside below depicts the style of aqueduct that was installed. The park utilized the bow string truss bridge design at several locations along the Towpath Trail.

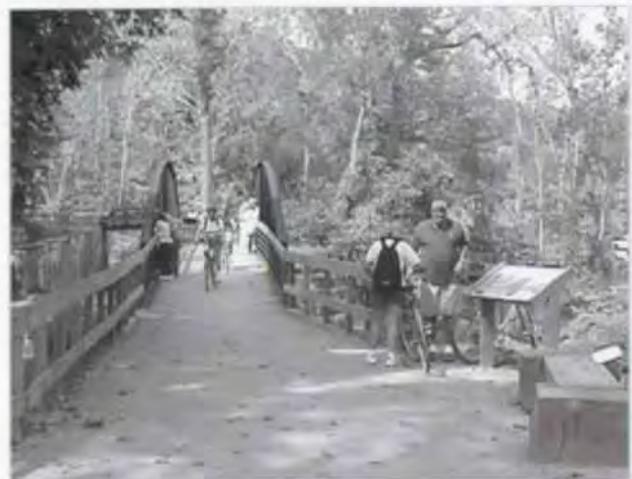
Figure 18-8: Towpath in Peninsula, Ohio. Typical bench used along towpath in foreground.

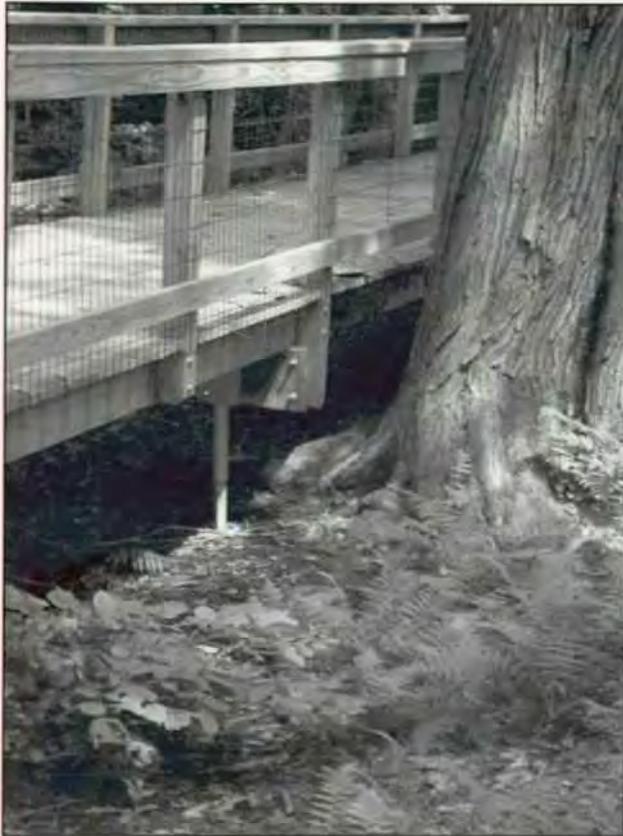
Figure 19-1: Accessible trail in Arcadia Sanctuary in Easthampton, Massachusetts.

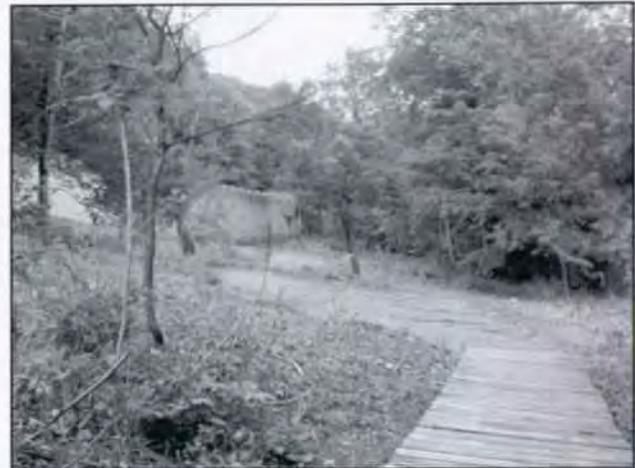
Figure 19-3: Accessible path to Dinosaur Footprints.

Efforts to improve visitation to the site were not much more successful. The steepness of the site (most of it over 15%) made it very difficult to expand the parking facilities from the existing six cars capacity without regrading the site and destroying the possibility of future finds. Strategies were discussed, from fencing and closing the site to await more opportune conditions, to staging an archeological dig to uncover the entire site so that the dig facilities (policing, scaffold, temporary staging and access) could be used to expand visitation. In the end, despite the financial burden to the Trustees, it was determined that improvement to the facilities – accessible trails and more parking – coupled with a local education program were the best if not only course of action (Figure 19-3). The master plan recommended a boardwalk to contain walkers and protect the dinosaur tracks. Boardwalks were designed to span the rocks with tracks and an adjacent stream. The connecting paths were formally defined, using an old road bed and some of the existing social paths.

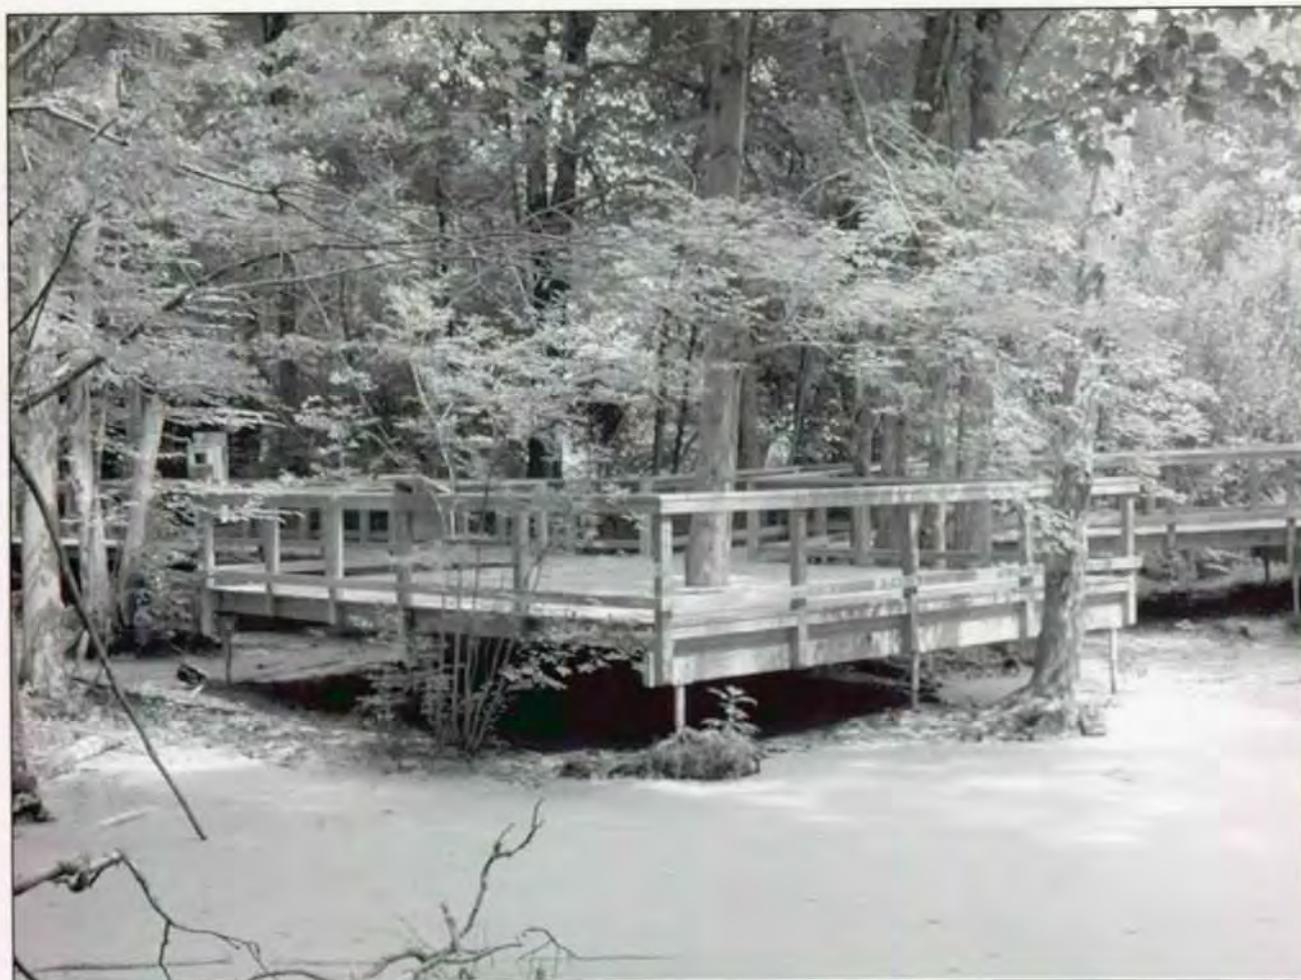
*Figure 19-5: Boardwalk constructed on helical metal piers.*
