CEDAR PASS DEVELOPED AREA  
BADLANDS NATIONAL PARK  
CULTURAL LANDSCAPE REPORT

JUNE 2005

PREPARED FOR  
NATIONAL PARK SERVICE  
MIDWEST REGIONAL OFFICE  
AND  
BADLANDS NATIONAL PARK

PREPARED BY  
JOHN MILNER ASSOCIATES, INC.  
ARCHITECTS • ARCHEOLOGISTS • PLANNERS • LANDSCAPE ARCHITECTS  
103 WEST MAIN STREET  
CHARLOTTESVILLE, VIRGINIA 22902  
(434) 979-1617

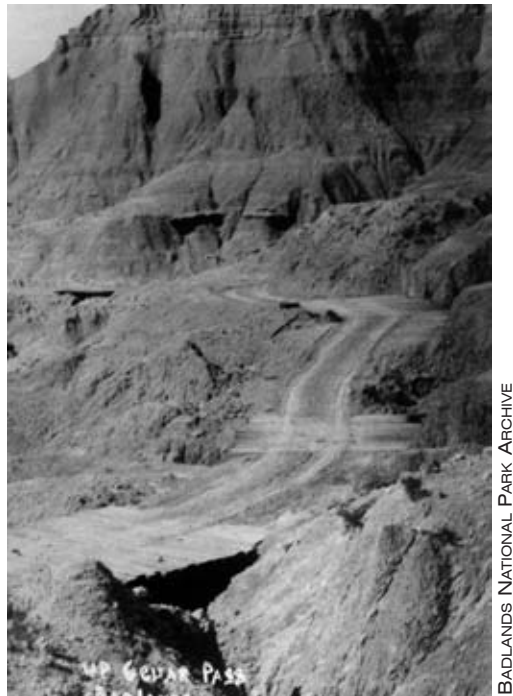
Figure 2-17: Early road through Cedar Pass, 1908. (BADL-1908-13)

Documentation regarding the development of roads in the vicinity of and within the Badlands National Monument is somewhat sketchy. It is clear from visitors' descriptions and historic photographs that an unpaved road led from Cedar Pass through the Badlands as early as 1919 when Louis Knowles reported on conditions in the area for the US Forest Service. The road was rough and often treacherous. Attempts to master the steep incline often resulted in overheated engines. Tired and frustrated drivers parked precariously on the rugged verges of the trail with no hope of help or refreshment in sight (*see Figures 2-17, 2-18, and 2-19*). Settlers likely created

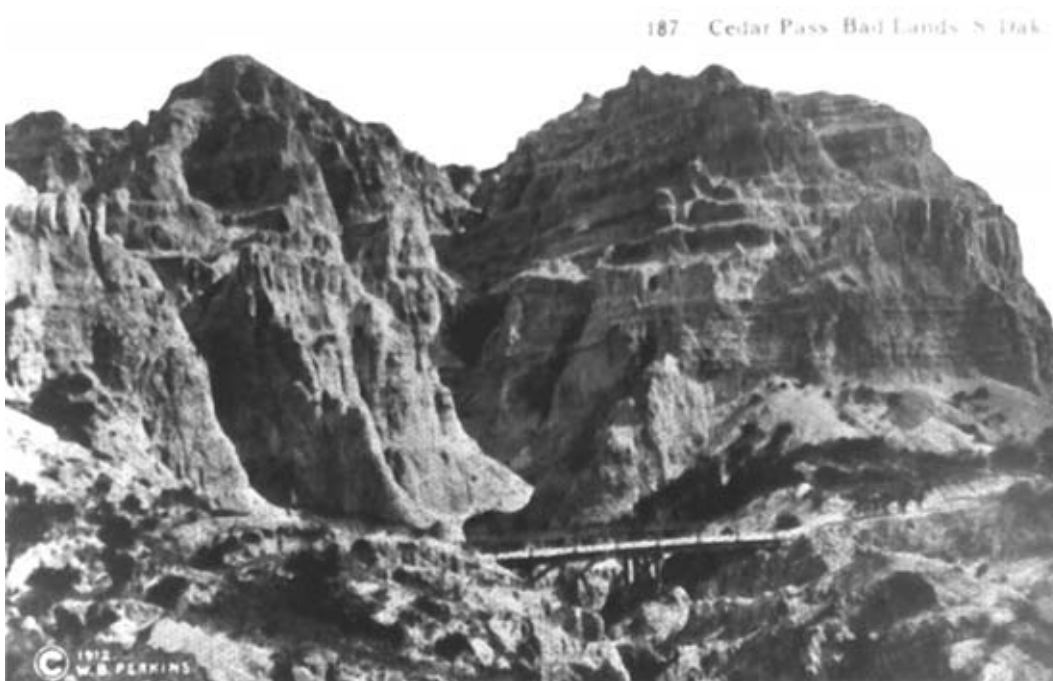
Figure 2-18: Bridge on early road through Cedar Pass, 1912. (BADL-1917-119)

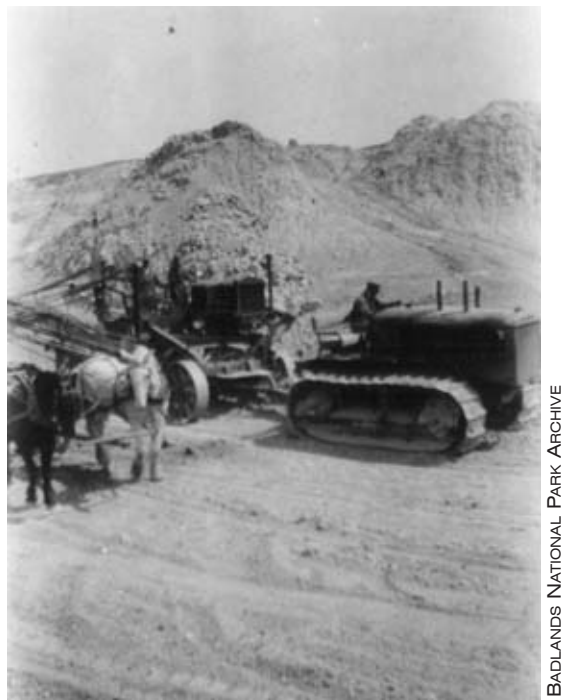
Figure 2-20: Monument Highway construction, ca. 1931. (BADL-1931-1)

By the late 1920s, US Highways 14 and 16 stretched east to west through local townships in the area, Cottonwood, Quinn, and Wall. US Highway 16 approached the badlands region from Chamberlain, to the east, and turned sharply north about seven miles west of Kadoka, only to turn sharply west again ten miles further where it joined US highway 14. These two highways skirted the badlands north of the Monument boundary<sup>58</sup> (see *Figures 2-20 and 2-21*).

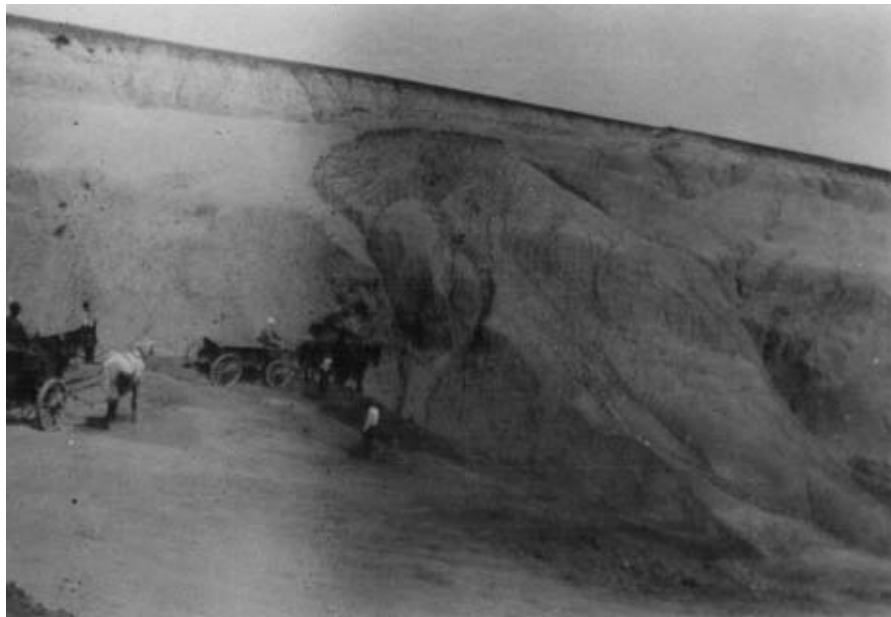
Figure 2-21: (BADL-1931-2) Monument Highway construction, ca. 1931.

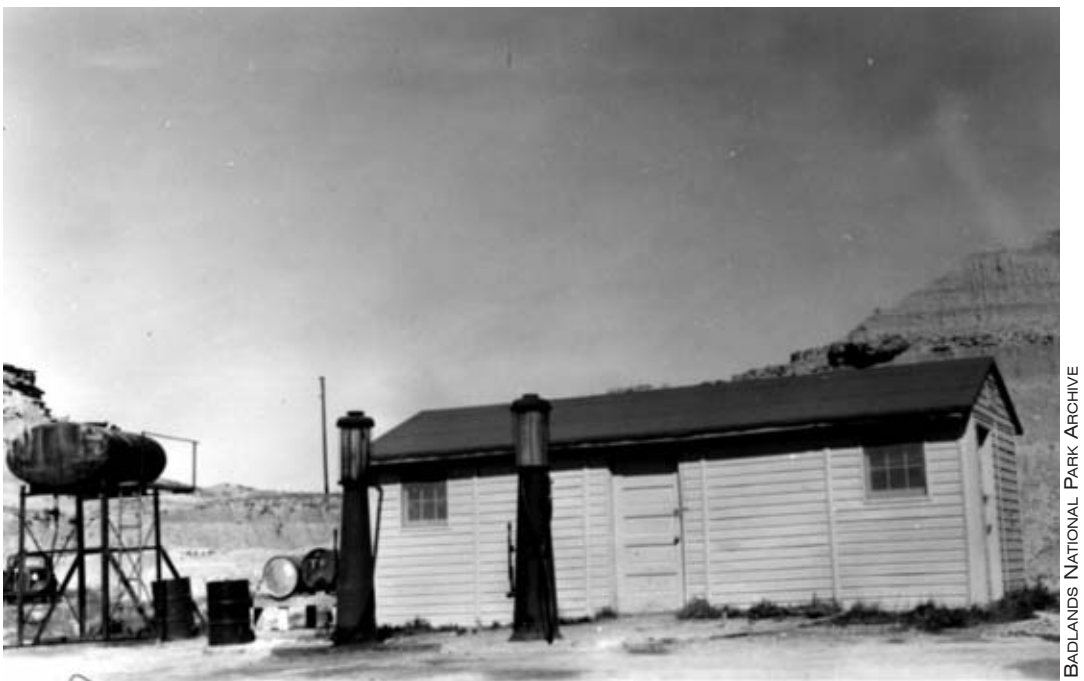
Figure 2-33: Photograph of gas pumps relocated to the CCC utility area. (BADL-1951-4)

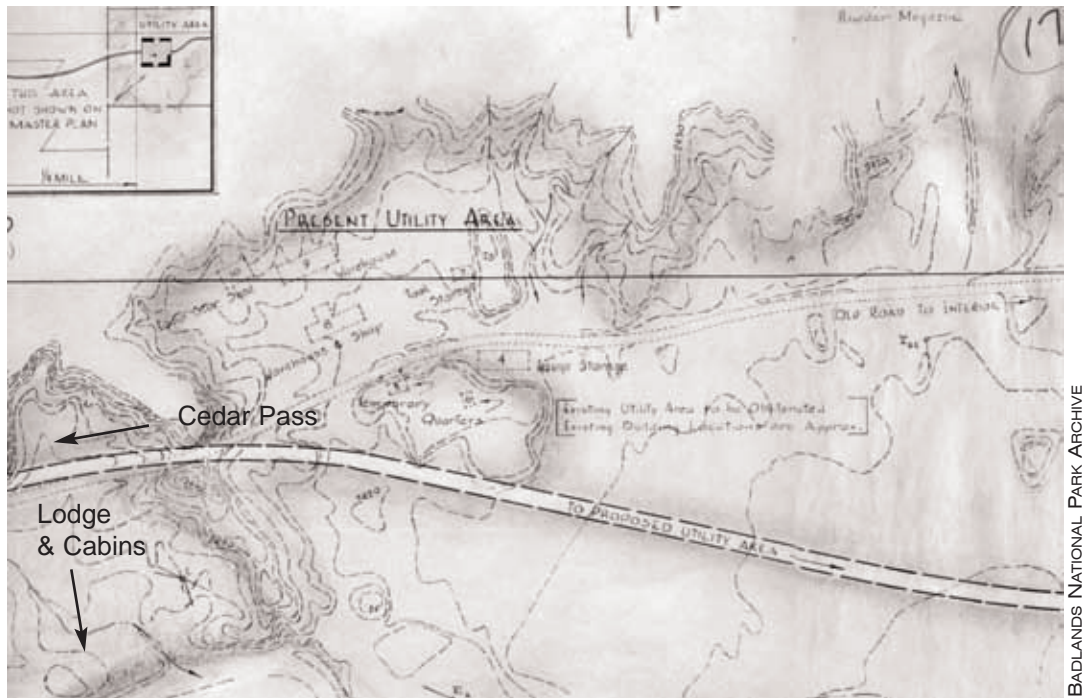
Figure 2-34: (detail) CCC utility area on 1950 Master Plan.

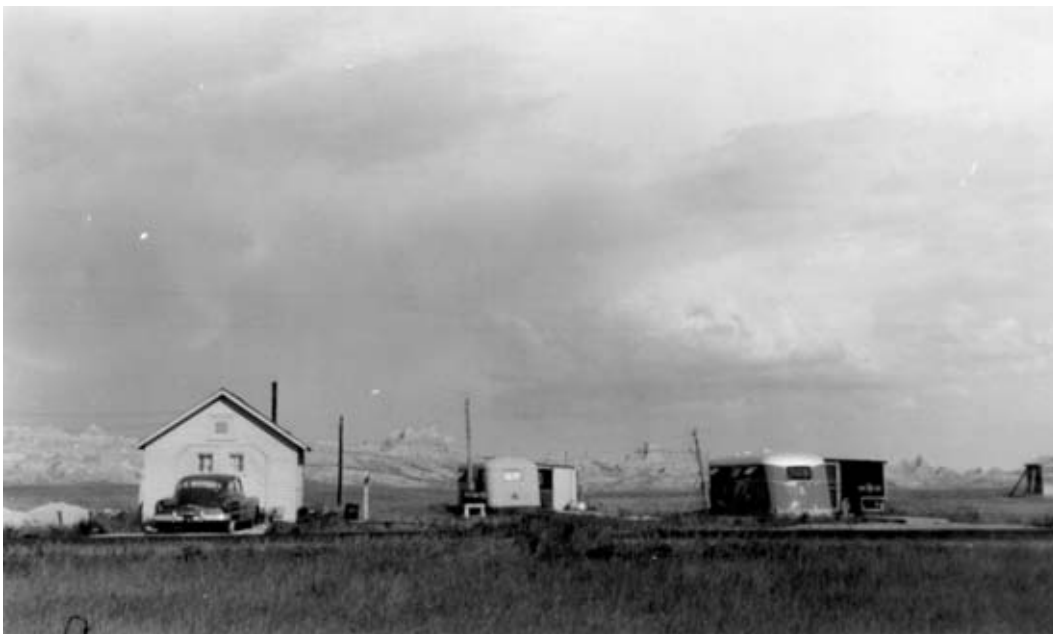
Figure 2-37: 1949 photograph of garage (white building on the left) refitted as temporary residence . (BADL-1950-25)

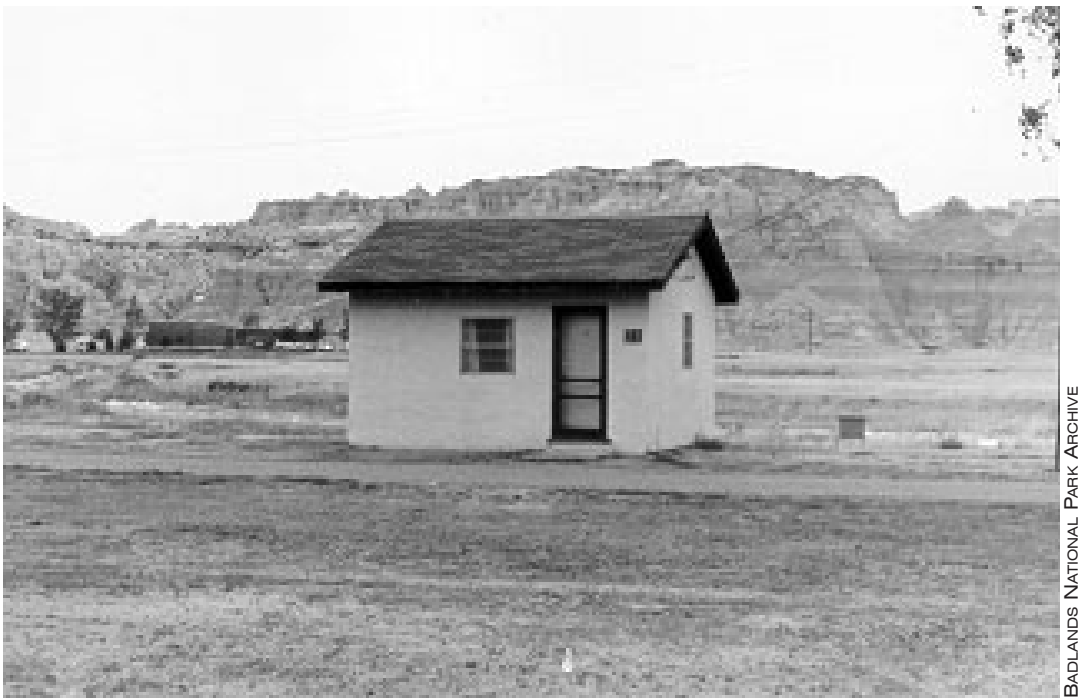
Figure 2-41: 1949, Millard cabin newly stuccoed.

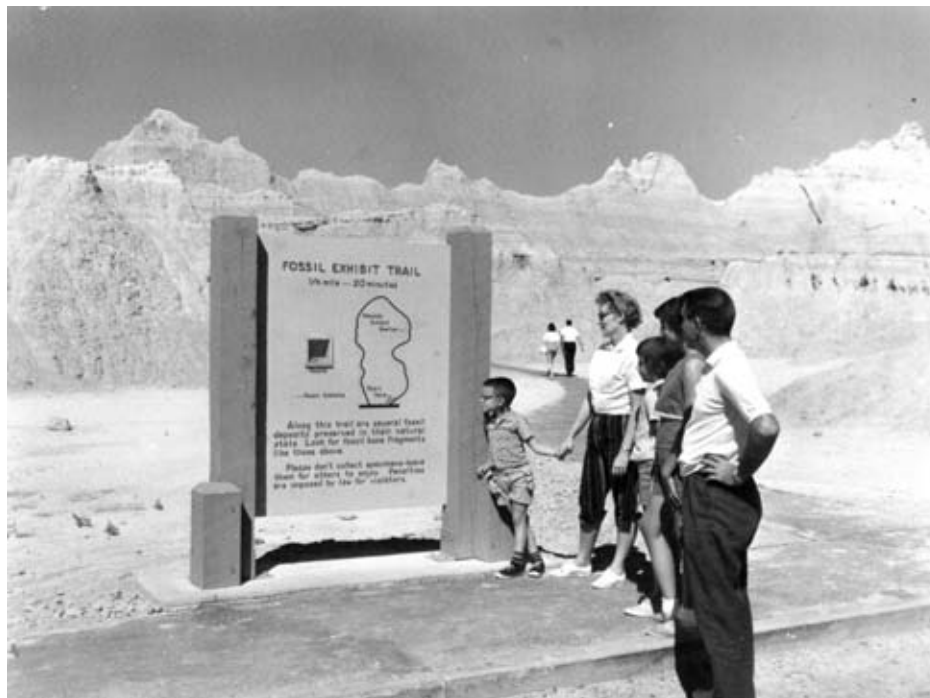
Figure 2-52: Mission 66 interpretive exhibits, ca. 1962. (BADL-1962-24)

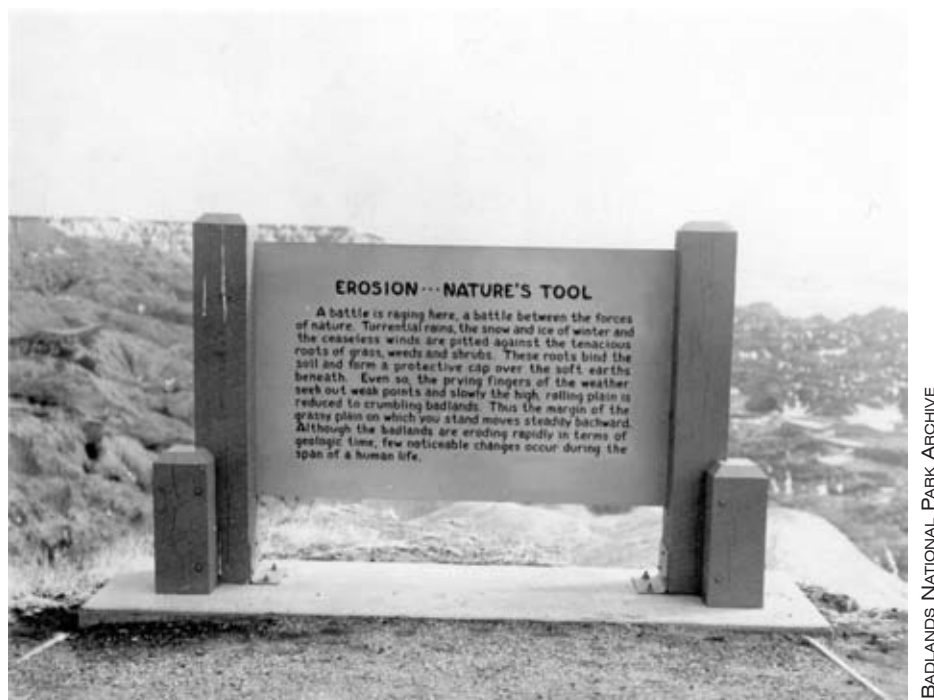
Figure 2-54: Mission 66 interpretive exhibit on trail. (BADL-1961-6)

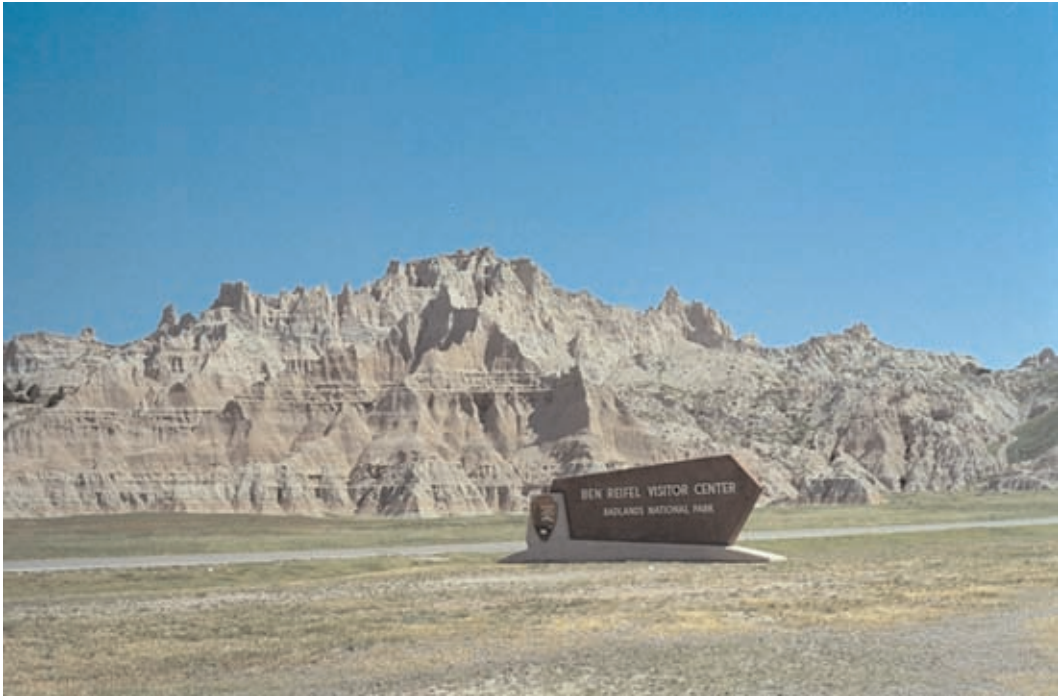
Figure 3-1: (2A-16) View northeast of Badlands formation, the Wall, and Visitor Center sign.

The most distinctive geological feature in the study area, the Wall (described above), extends through the Cedar Pass Developed Area; Cedar Pass is a break within this formation<sup>23</sup> (*see Figure 3-1*).

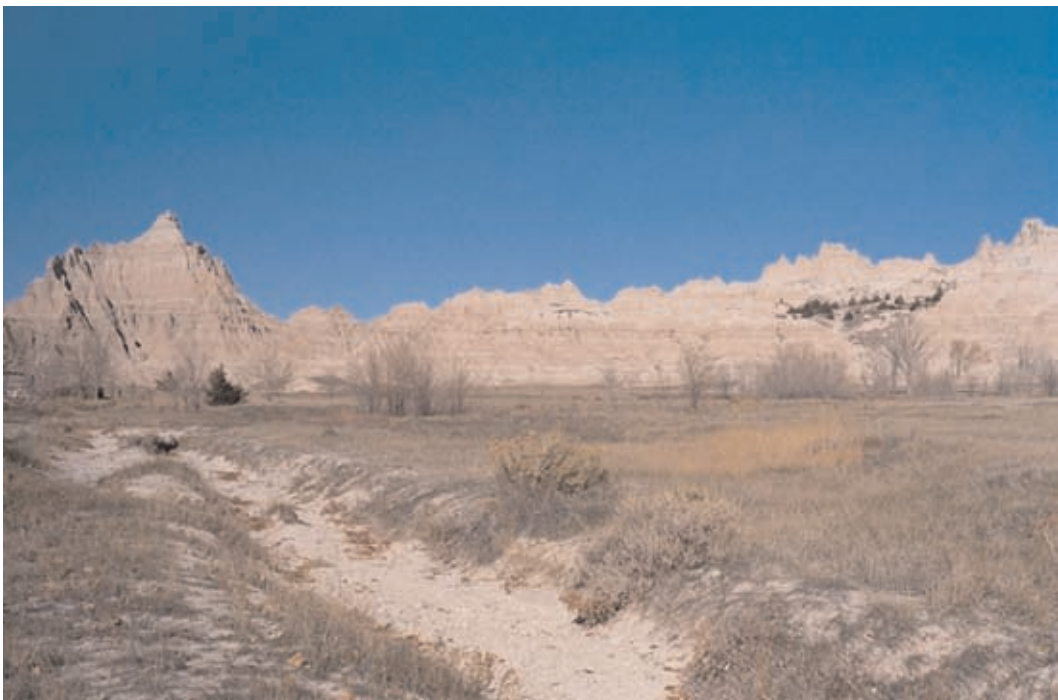
Figure 3-2: (G-09) View north of eastside wash with Badlands formations in the background.

Surface water is almost non-existent within the study area; there are no perennial streams, floodplains, or natural wetlands. Gullies and washes provide drainage during rainstorms and after snowmelt (*see Figure 3-2*). Although little data exists on water quality within the park, it is believed to vary seasonally and from stream to stream.<sup>25</sup>

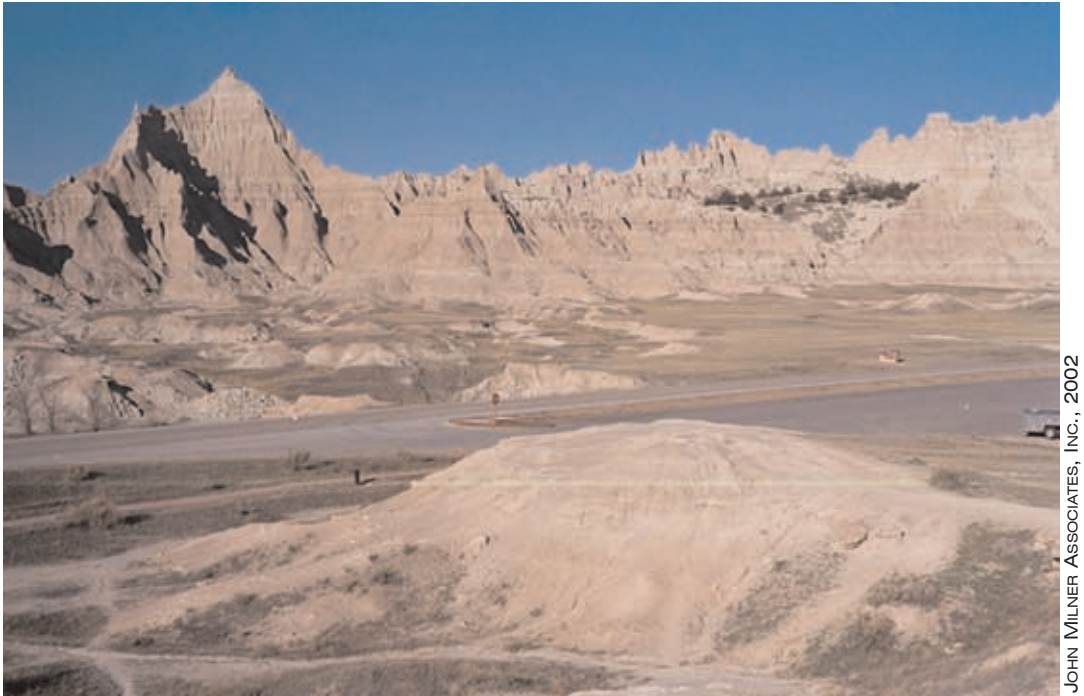
Figure 3-3: (I-22) Badland Sparse Vegetation Complex and Badlands Loop Road corridor.

- 1) Badland Sparse Vegetation Complex includes four associations, with the most sparsely vegetated—the Eroding Great Plains Badlands Complex—the one most likely present within the study area. This complex typically occurs on steep shale slopes and other heavily-eroded areas where moisture is scarce and temperatures are extreme. Approximately 15 percent of the study area falls in this category; these areas were almost barren of vegetation. Plant species most often present within this association include small-flowered wild buckwheat (*Eriogonum pauciflorum*), snakeweed (*Gutierrezia sarothrae*), and curly-cup gumweed (*Grindelia squarrosa*) (see Figure 3-3).

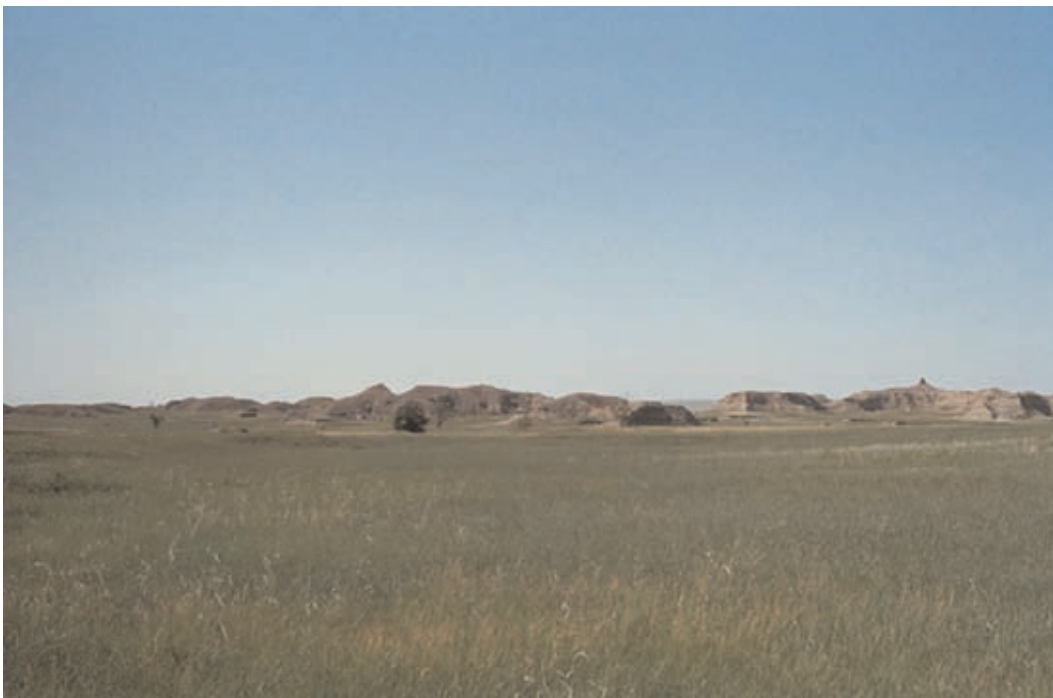
Figure 3-4: (2A-08) View northwest of Western Wheatgrass Alliance Grassland.

- 2) Western Wheatgrass Alliance Grassland covers the majority of the study area—approximately 53 percent—including most of the areas not occupied by Badlands formations or developed areas. This association is dominated by western wheatgrass (*Pascopyrum smithii*), a sod-forming grass that thrives in clay soils. It can range from almost pure, monotypic stands, to a true mixed-grass prairie. Other common species in this alliance include Japanese brome, blue grama (*Bouteloua gracilis*), Kentucky bluegrass, green needlegrass (*Nassella viridula*), and buffalo grass (*Buchloe dactyloides*) (see Figure 3-4).

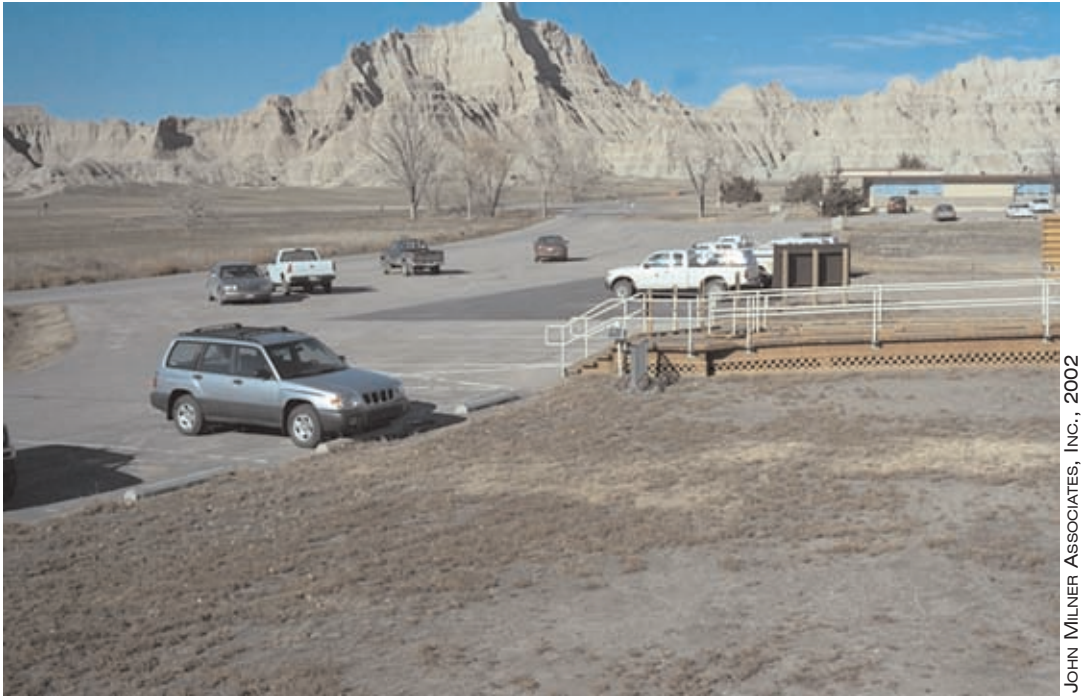
Figure 3-9: (T-14) View north of administrative and overflow parking behind the Visitor Center.

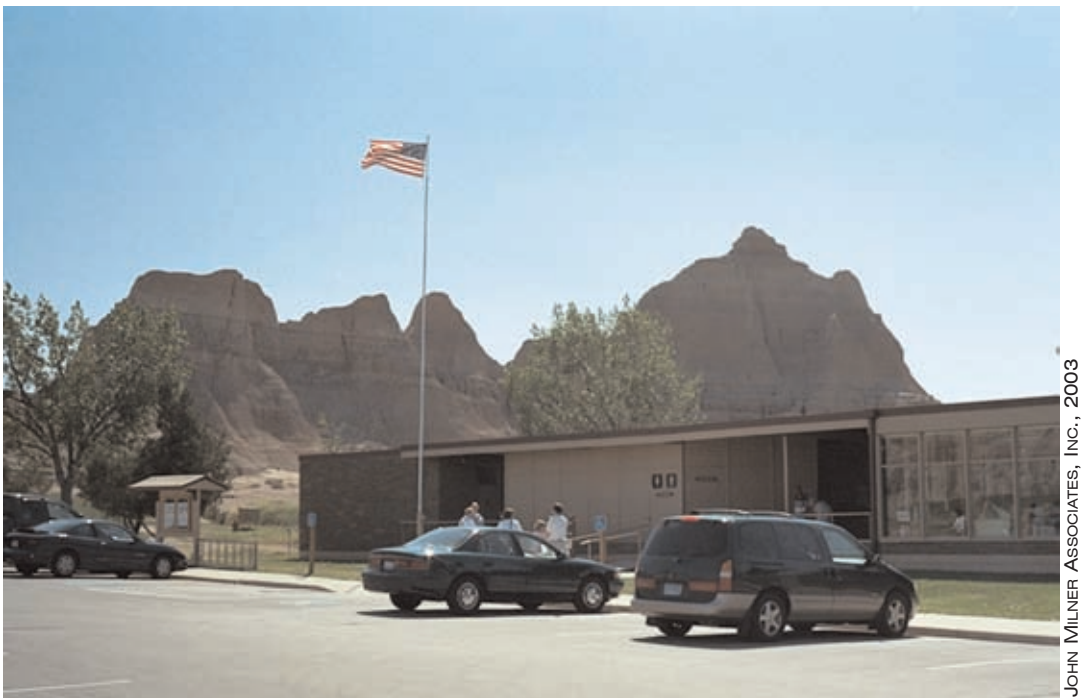
Figure 3-10: (2A-18) Front of Visitor Center including parking lot, sidewalks, flagpole, bike rack, kiosk, and informational signs.

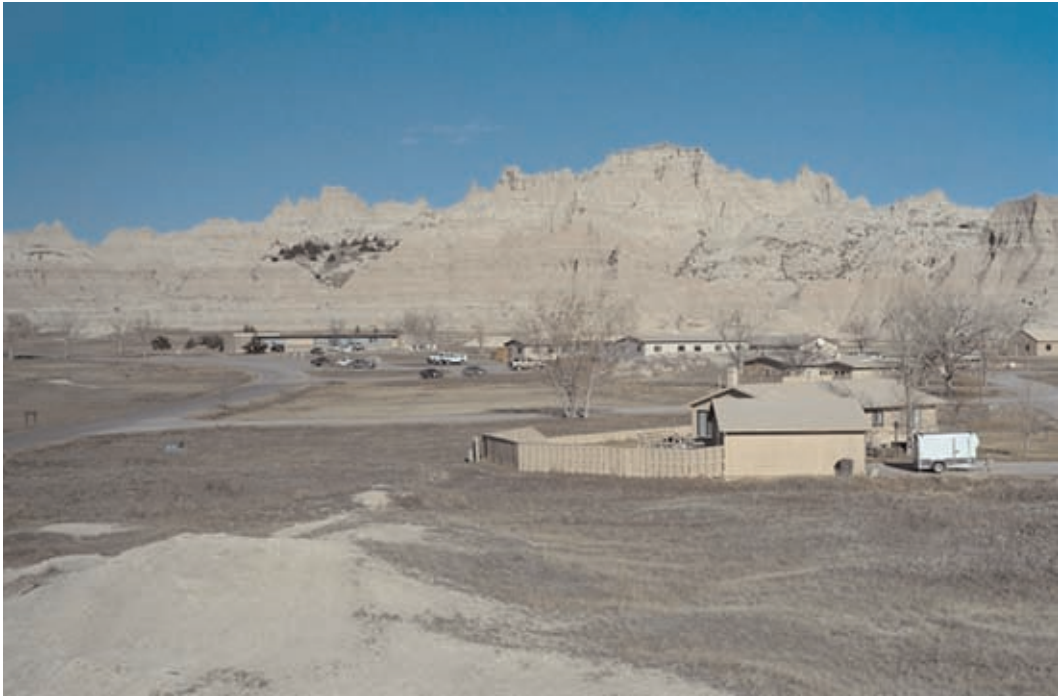
Figure 3-13: (R-15) Spur connecting the service road to a section of the former service road.

Further south and oriented along the old service road segment is the residential portion of the cluster. A short road spur connects the service road with the residential streets (*see Figure 3-13*). The northern half of the residential cluster is comprised of eight one-story single-family residences that edge the old service road segment as well as a loop drive to the east (*see Figure 3-14 and Figure 3-15*). Five of the houses have detached garages, which form a small courtyard space. Fencing and vegetation creates intimate spaces around each house. Front lawns lack fencing but have more trees and shrubs, while the rear lawns are often partially fenced but have few plantings (*see Figure 3-16*). The southern half of this cluster is comprised of four, one-story, seasonal employee apartments at the terminus of the old service road segment. The apartment units are arranged to create a central courtyard. A formation surrounds the units to the south, east, and west sides. Walks connect the two units to each other and to two small parking areas (*see Figure 3-17*). A few trees are scattered throughout the area. A small fenced clothesline area lies just east of the apartment units (*see Figure 3-18*). The arrangement of streets and buildings,

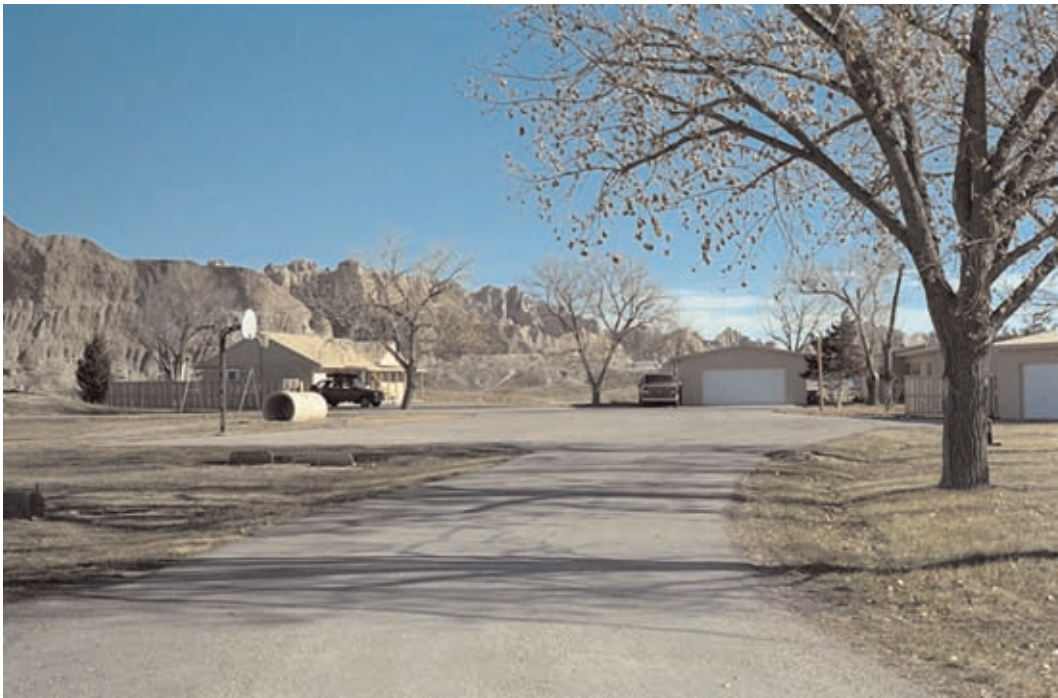
Figure 3-14: (Q-24) View east into the residential area drive and various small-scale features including a basketball goal, play equipment, and vertical board fencing.

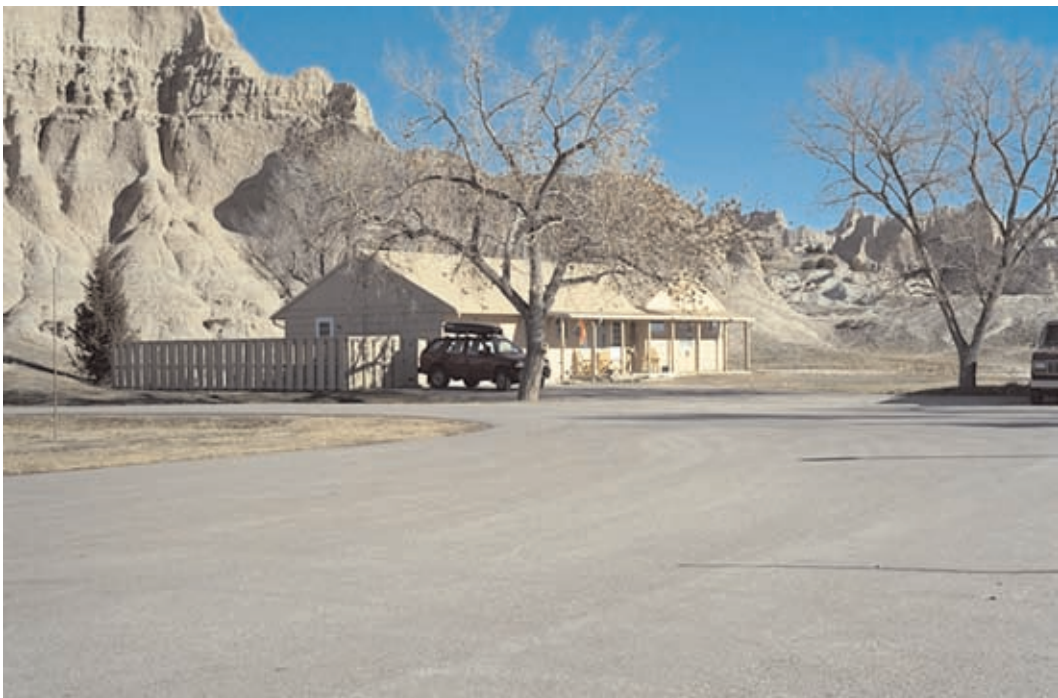
Figure 3-16: (R-06) Representative view of the fencing and vegetation around residences.

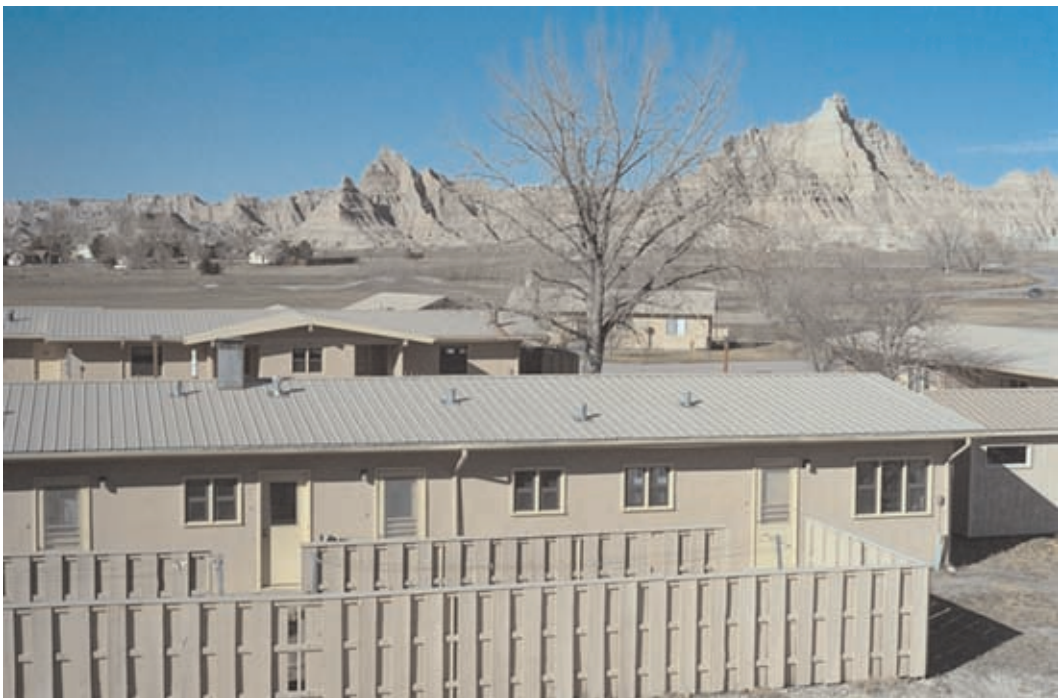
Figure 3-18: (S-07) Vertical board fencing enclosing a clothes drying yard east of the apartment cluster.

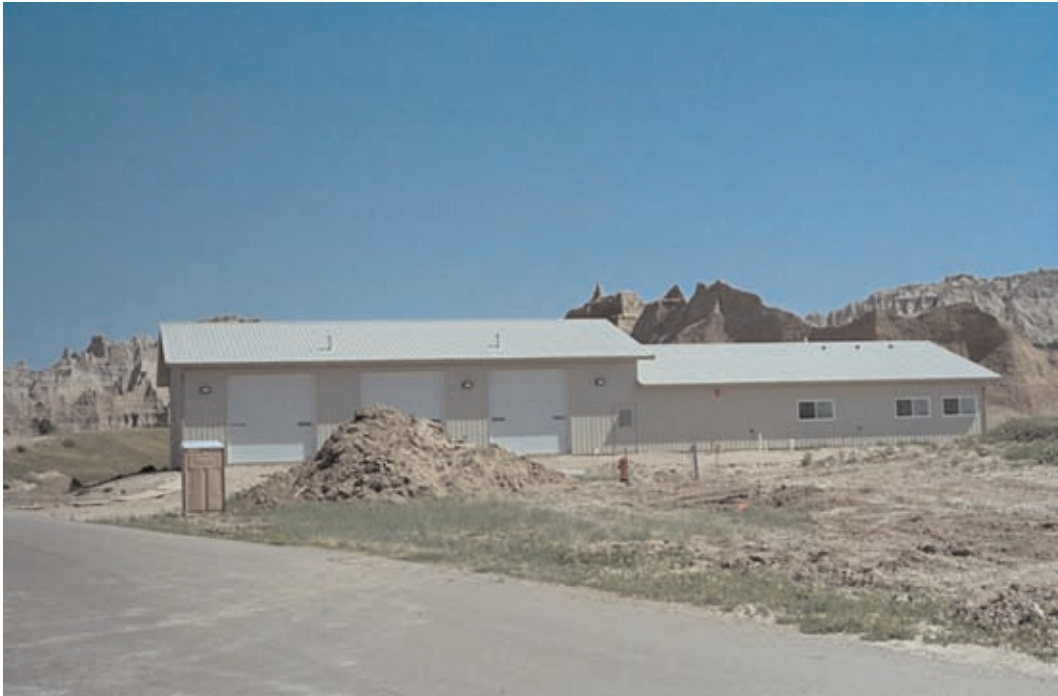
Figure 3-19: (2A-23) View north of the fire cache and its surrounds.

A new two-story fire cache lies just east of the service road approximately 600 feet south of the apartment complex and outside the developed nodes. Although the site was under construction during the June 2003 field visit, it was noted that the appearance of this building will differ significantly from other buildings visible from the visitor areas due to its two-story profile. The base of the building is partially screened by a formation just to its north (*see Figure 3-19*).

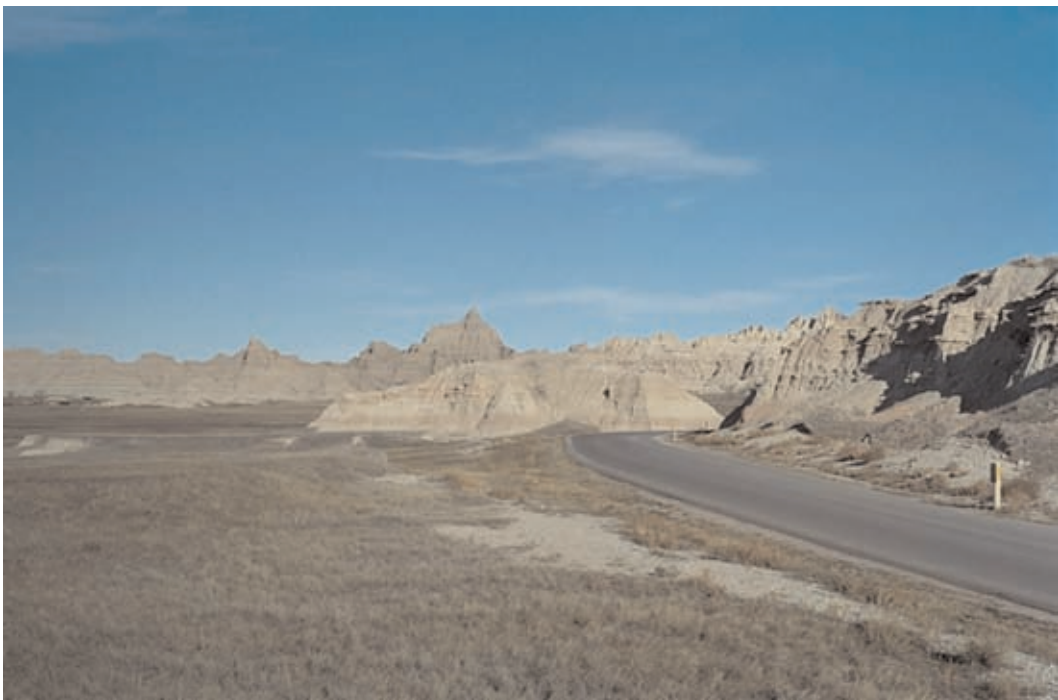
Figure 3-20: (O-08) The service road passing through a gap in the formations.

The maintenance developed node is located in the far south portion of the study area to either side of the service road; although the bulk of development lies to the west of the road. From the fire cache, the service road crosses a narrow strip of prairie before passing through a gap in a large formation and reaching the maintenance area. This formation completely screens the maintenance area from visitor areas (*see Figure 3-20*). The primary maintenance yard lies immediately south of the formation. It consists of three large rectangular buildings situated perpendicular to the service road (*see Figure 3-21*). Several smaller structures edge the yard. Employee parking, a fenced tree nursery, and site fencing separate the area from the service road. South of these buildings, a gravel drive loops around a formation peak with piles of discarded building materials and equipment lining its edge and a mixing circle at its south end (*see Figure 3-22*). This central formation peak screens much of the debris from the service road and maintenance yard. A small shed and fenced area for horses lies between the mixing circle and service road.

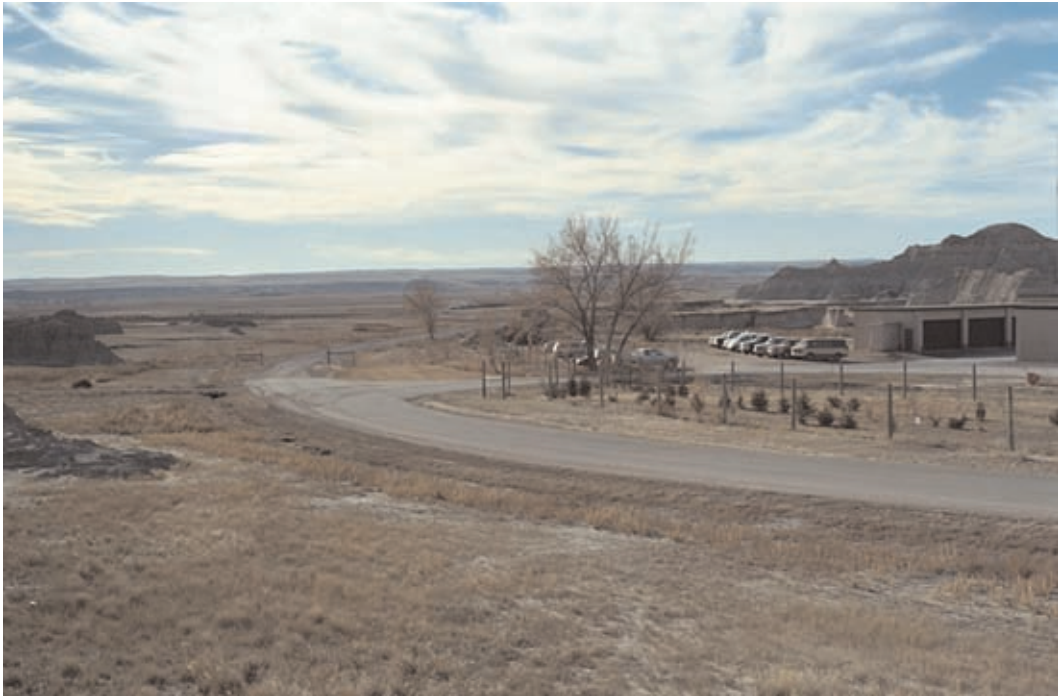
Figure 3-21: (O-11) View south, capturing the maintenance building complex, parking area, and plant nursery.

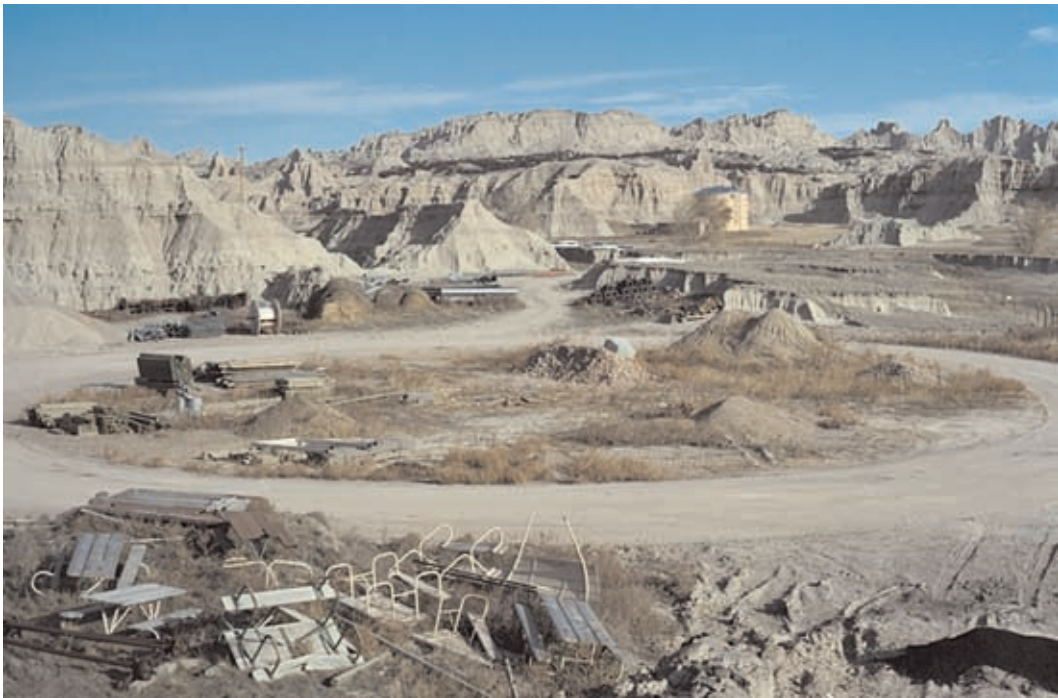
Figure 3-22: (P-05) Mixing circle and debris piles south of the maintenance area.

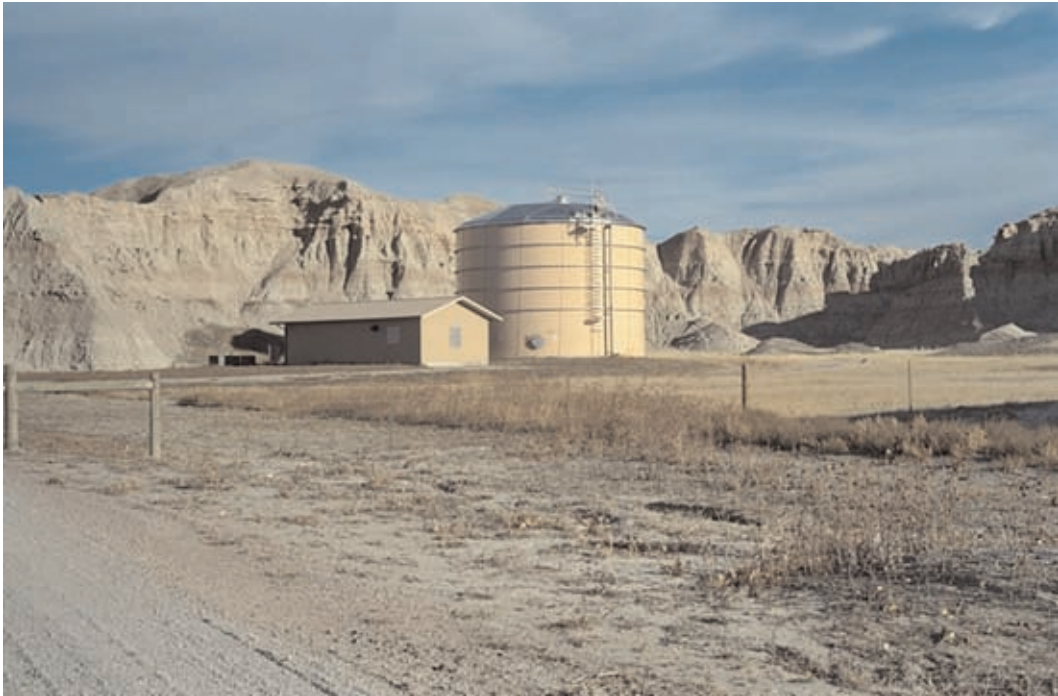
Figure 3-23: (N-23) The water tank and building connected to the service road via a short gravel drive.

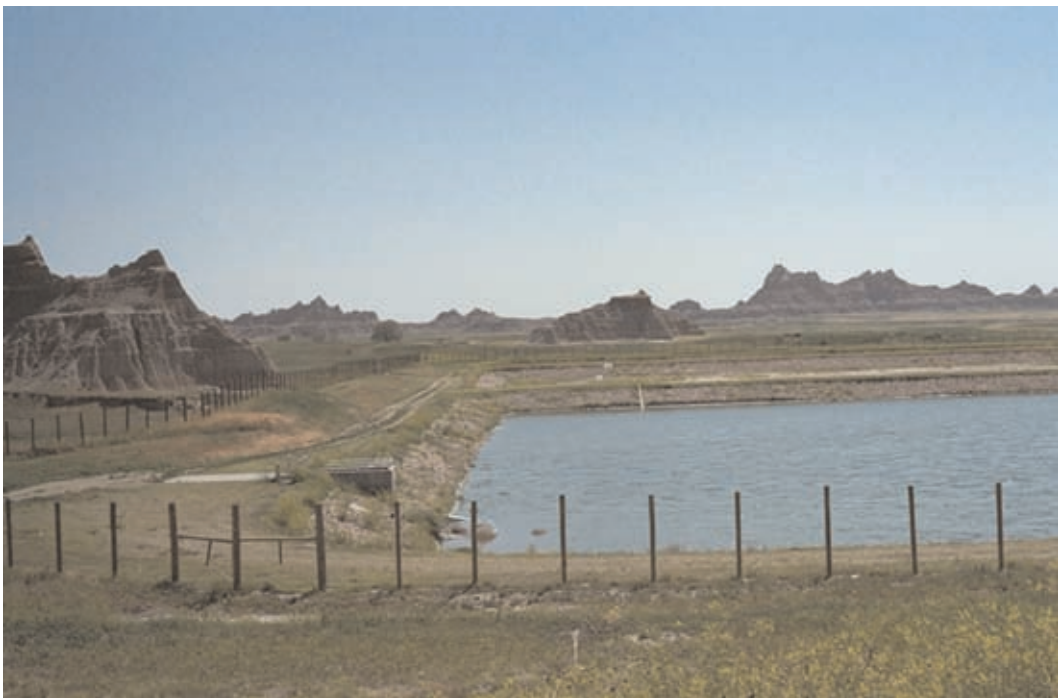
Figure 3-24: (2B-01) View east of the wastewater lagoons and access drive.

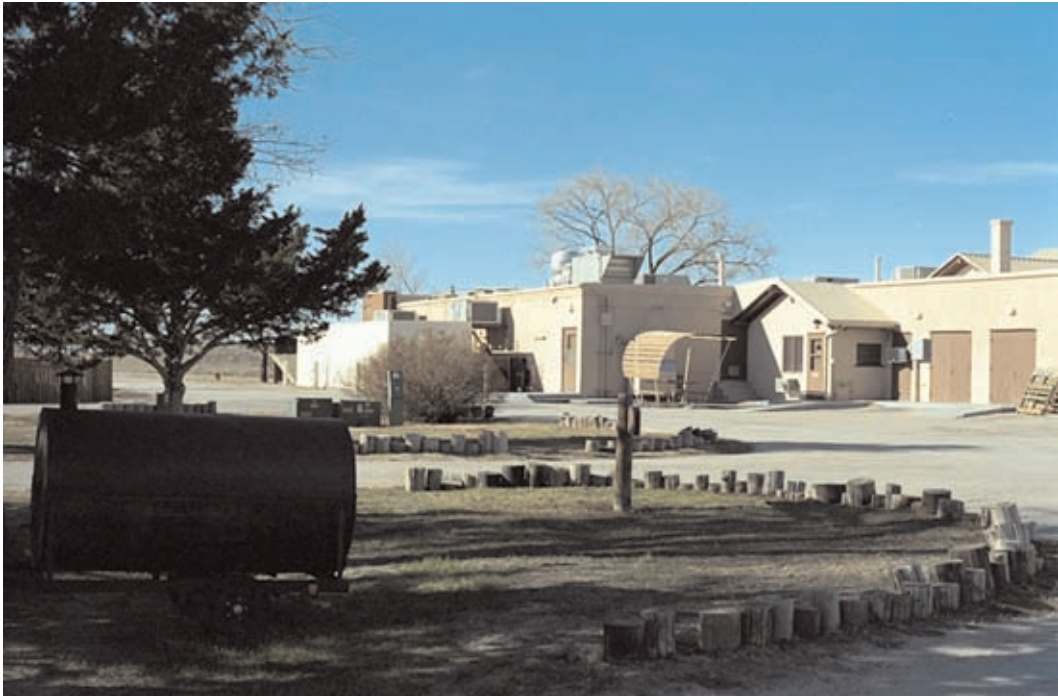
Figure 3-25: (E-03) View of the service area at the rear of the Lodge building.

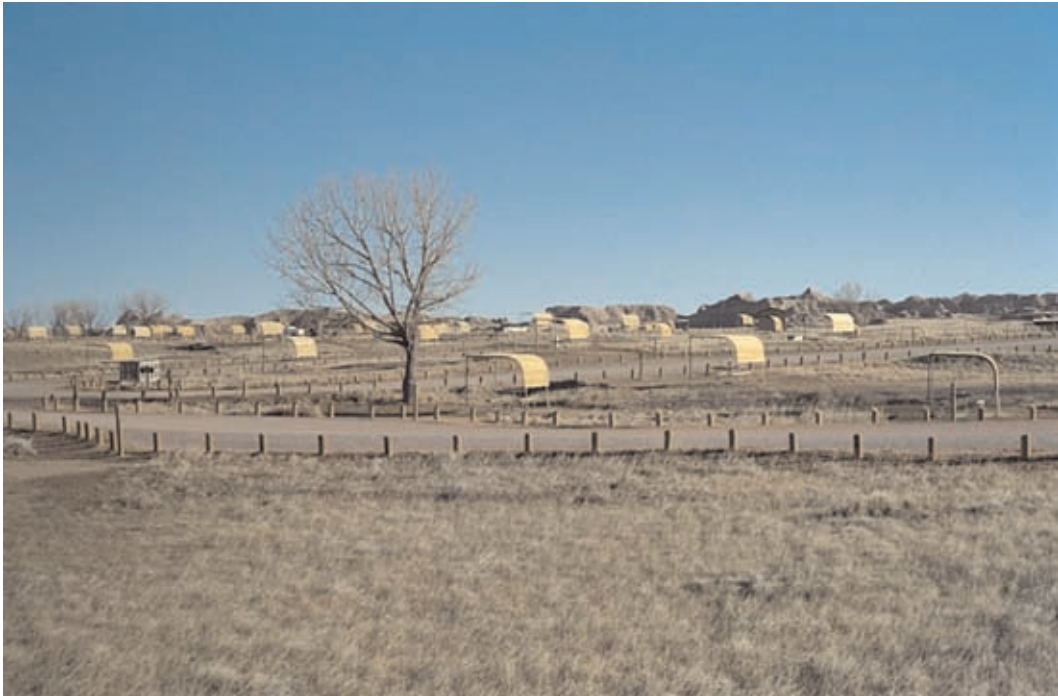
Figure 3-28: (2A-03) View west of the cabins to Lodge employee RVs and modular homes.

The view north from the Lodge and parking lot also focuses on the surrounding Wall formation. Due to the flat topography of the developed area, most of the formation is visible from the Lodge cabins. The service area at the rear of the Lodge building is highly visible from the cabins and is incompatible with the residential setting (*see Figure 3-25*). Views to the northeast from the cabins capture the rear of the Visitor Center, parking lot, administrative cluster, residential area in the distance, and the fire cache (*see Figure 3-107*). The administrative cluster and fire cache are most prominent in this view due to the light color of the administrative buildings, which contrasts with the surroundings, and the two-story height of the fire cache, which contrasts with the one-story buildings that otherwise characterize the study area (*see Figure 3-108*). The southern formation blocks the view into the maintenance area. The view southwest from the Lodge extends across the grasslands to the campground picnic shelters in the distance. To the west, the formation cluster between the Lodge and campground is visible. However, located at the base of the formation, a mobile home and two RVs interfere with this expansive view (*see Figure 3-28*).

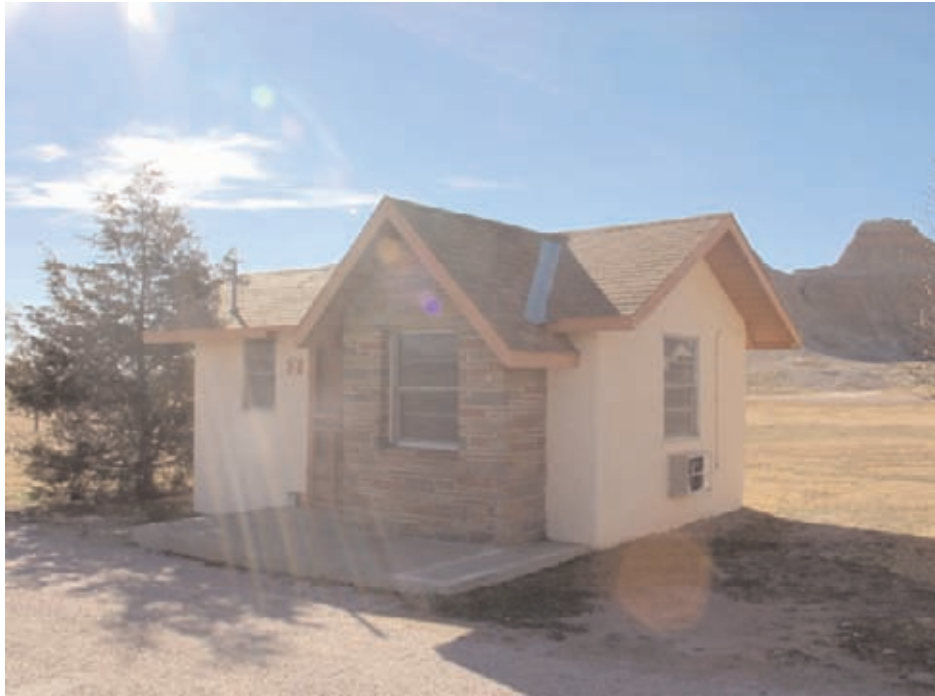
Figure 3-52: (BVH-14) Window detail of cabin.
