CEDAR PASS DEVELOPED AREA  
BADLANDS NATIONAL PARK  
CULTURAL LANDSCAPE REPORT

JUNE 2005

PREPARED FOR  
NATIONAL PARK SERVICE  
MIDWEST REGIONAL OFFICE  
AND  
BADLANDS NATIONAL PARK

PREPARED BY  
JOHN MILNER ASSOCIATES, INC.  
ARCHITECTS • ARCHEOLOGISTS • PLANNERS • LANDSCAPE ARCHITECTS  
103 WEST MAIN STREET  
CHARLOTTESVILLE, VIRGINIA 22902  
(434) 979-1617

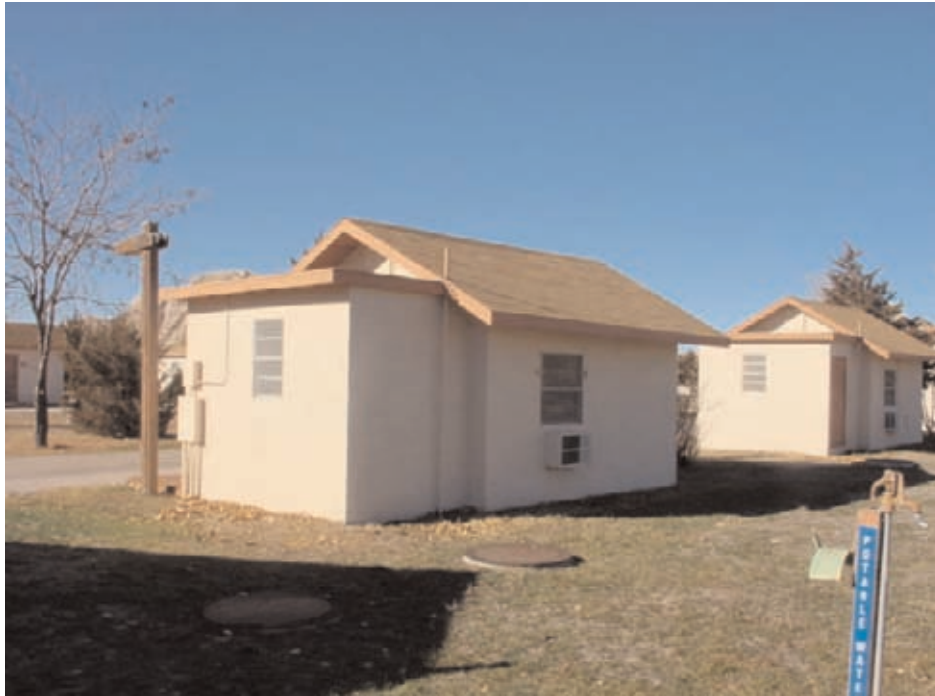
Figure 3-60: (BVH-22) Detail of original window, Cedar Pass Lodge cabin.

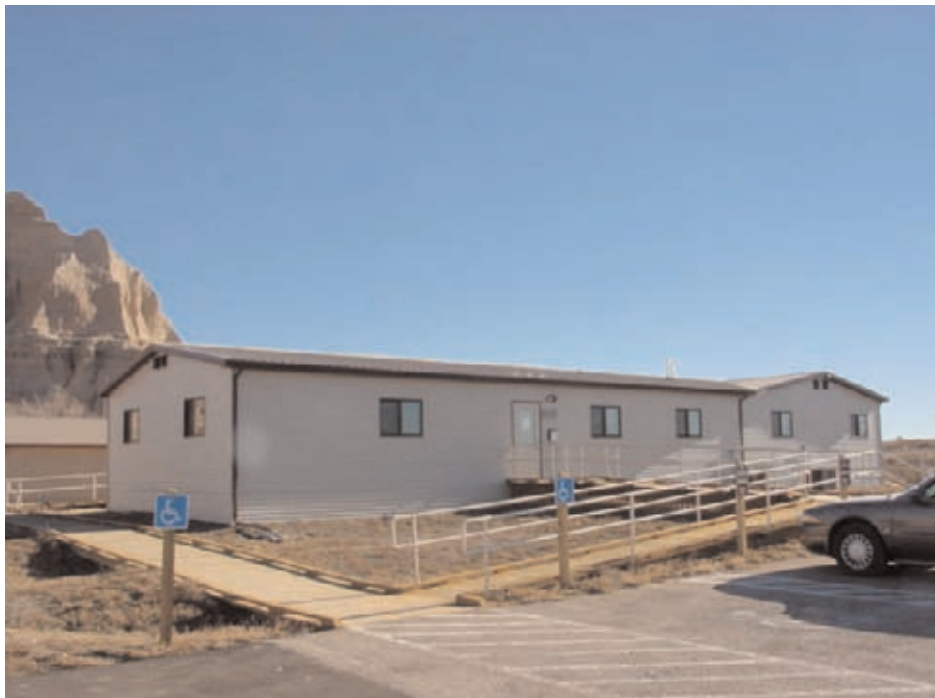
The administration building, constructed in 1999, is a one story, modular, L-shaped, prefabricated building with simple end gables (*see Figures 3-67 and 3-68*). It is located south of the Visitor Center at the far south end of the parking lot. The roof material is a pre-finished steel with pre-finished aluminum K-style gutters and rectangular downspouts. The exterior wall finish is vinyl siding. Windows are aluminum clad horizontal sliders. The three entry doors are pre-finished steel with vision panels and are all wheelchair accessible with ADA-conforming wooden ramps with tubular steel railings. The color of the building is in keeping with the traditional colors of the majority of the older buildings within the park.

Figure 3-67: (BVH-29) View south of administration building.

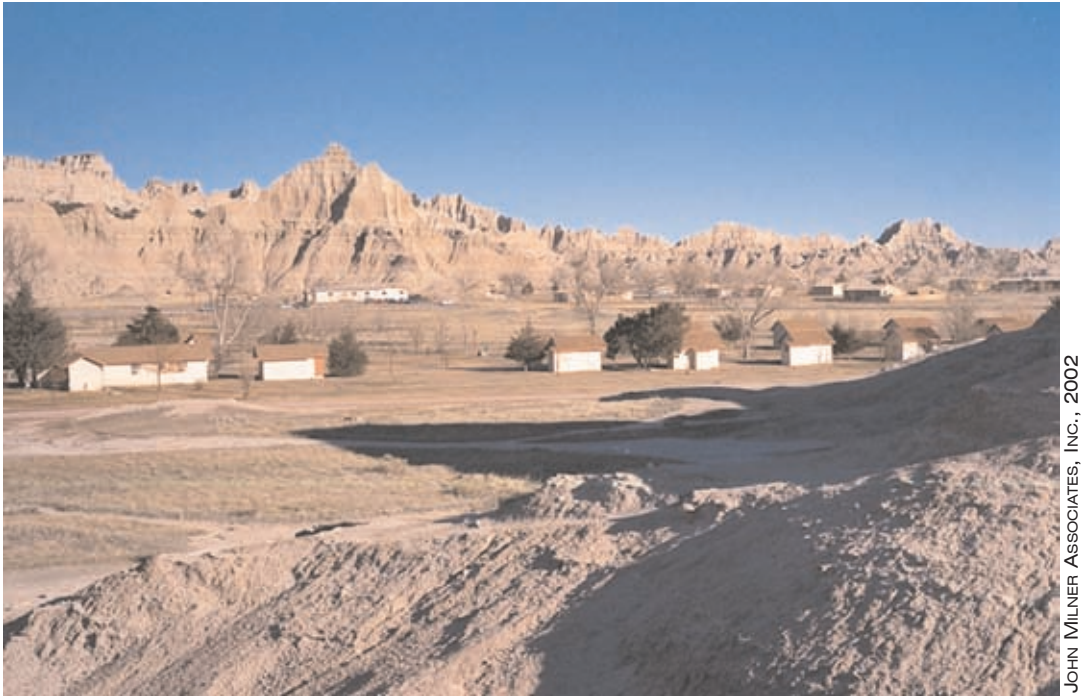
Figure 3-109: (I-25) View of cabins from the top of the small formation between the Lodge and the campground.

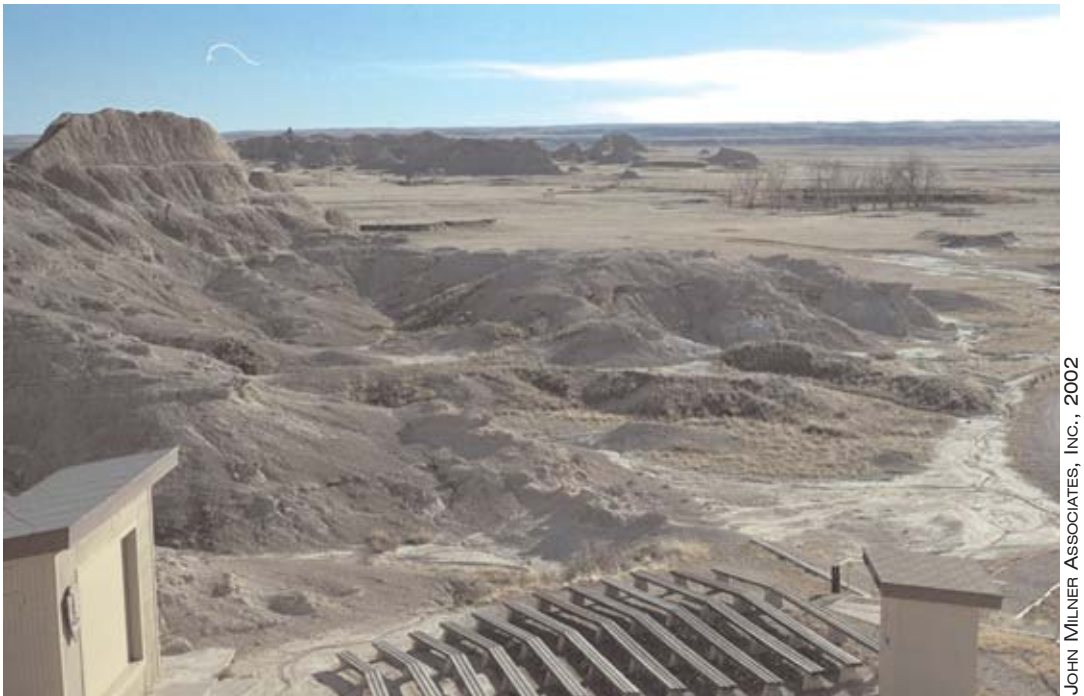
Figure 4-1 View south from amphitheater toward former wastewater lagoons in 2002; amphitheater projection booth, screen, and benches are visible.

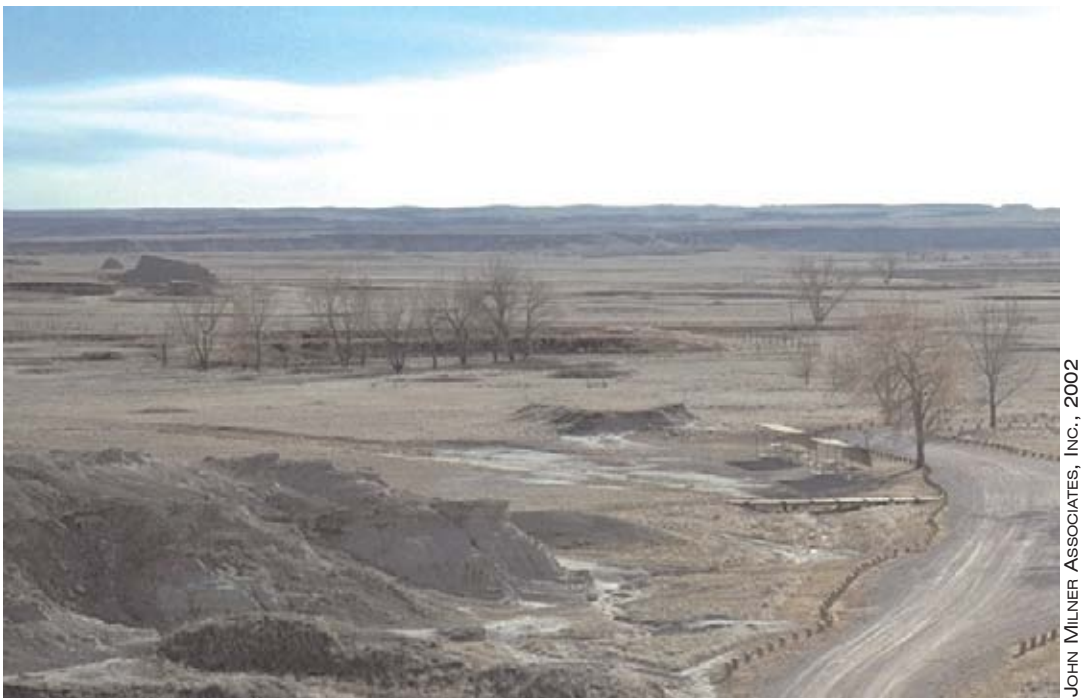
Figure 4-2 View southwest from amphitheater across group campground loop in 2002; a foot bridge, picnic shelters, scattered shade trees, and bollards are visible.

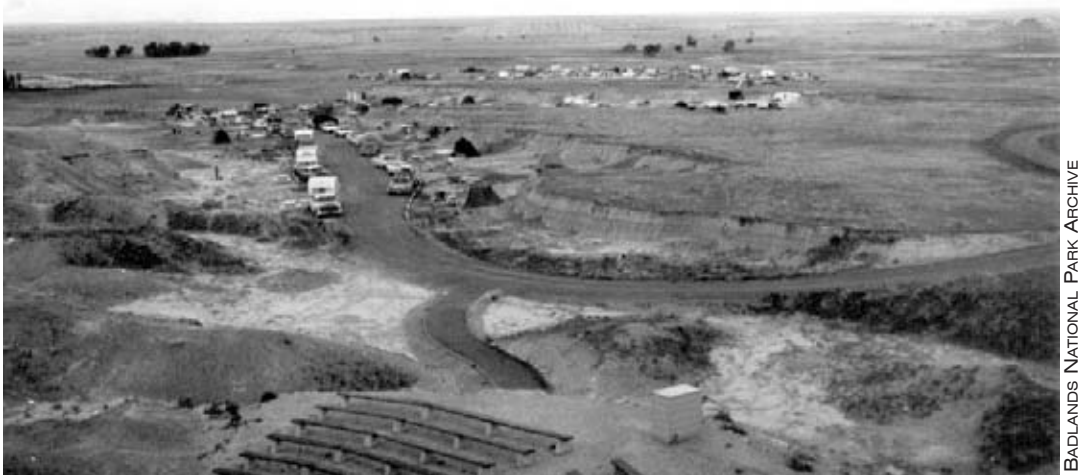
Figure 4-3 View across group campground in 1959 from amphitheater; pullouts for campground sites and bollards are visible. No trees are visible.

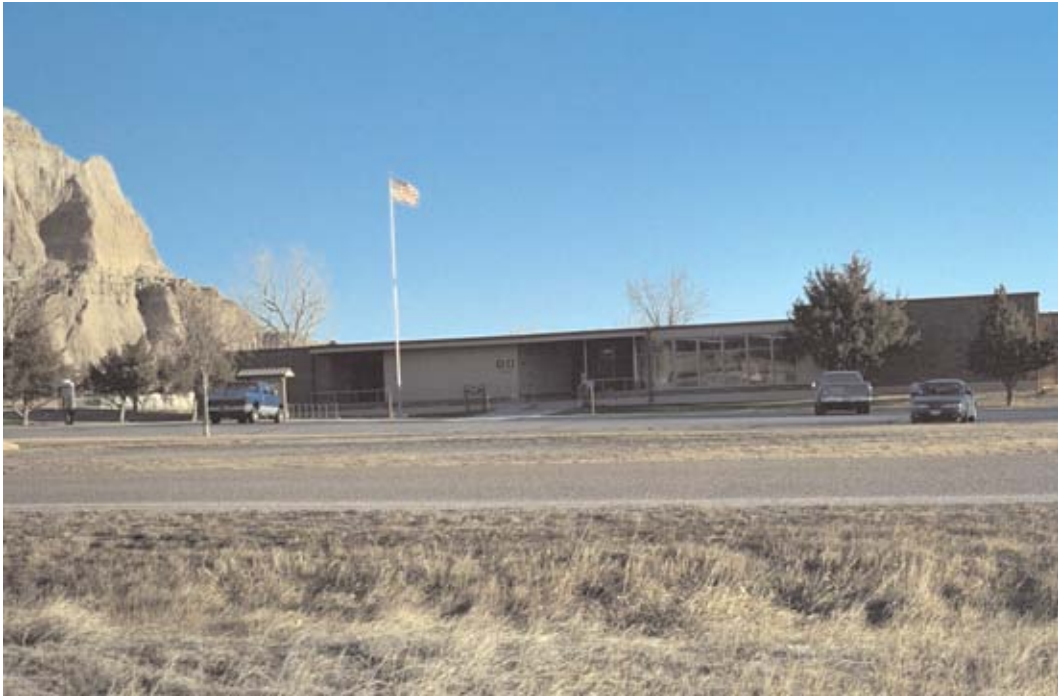
Figure 4-5 View of Visitor Center façade looking south in 2002; the flagpole, mature plants, and kiosk are visible. The addition of the theater on the porch diminished the cool and inviting “veranda” appearance of the entrance area.

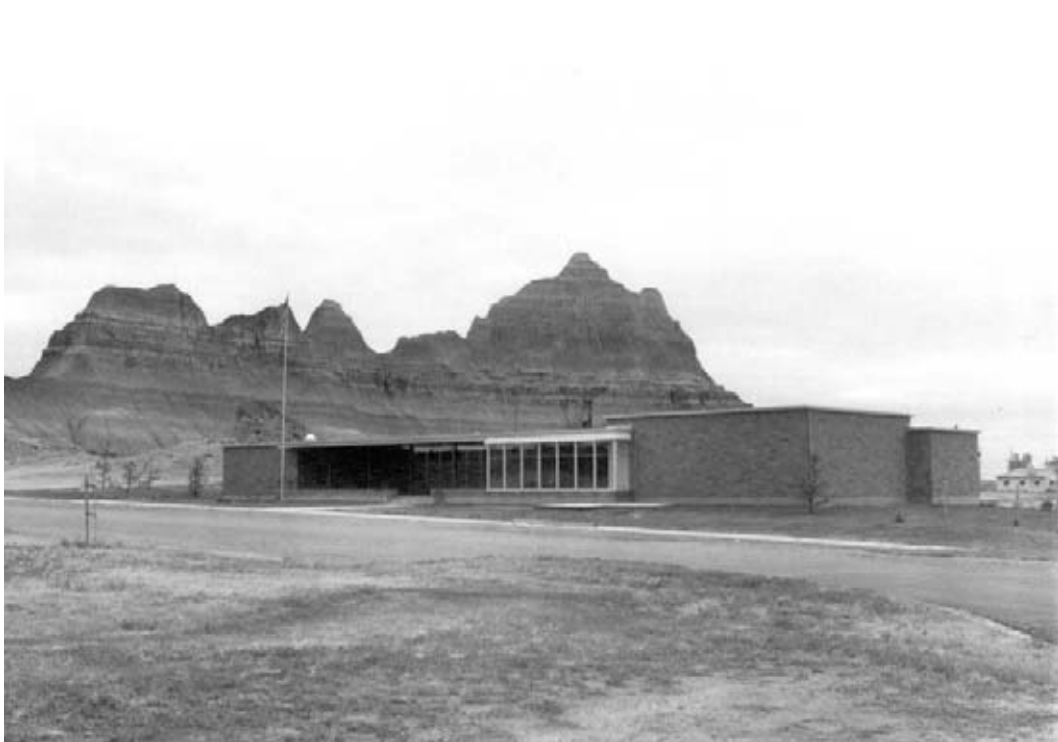
Figure 4-6 View of Visitor Center façade looking southeast in 1959; the flagpole, immature plants, and resource protection office are visible.

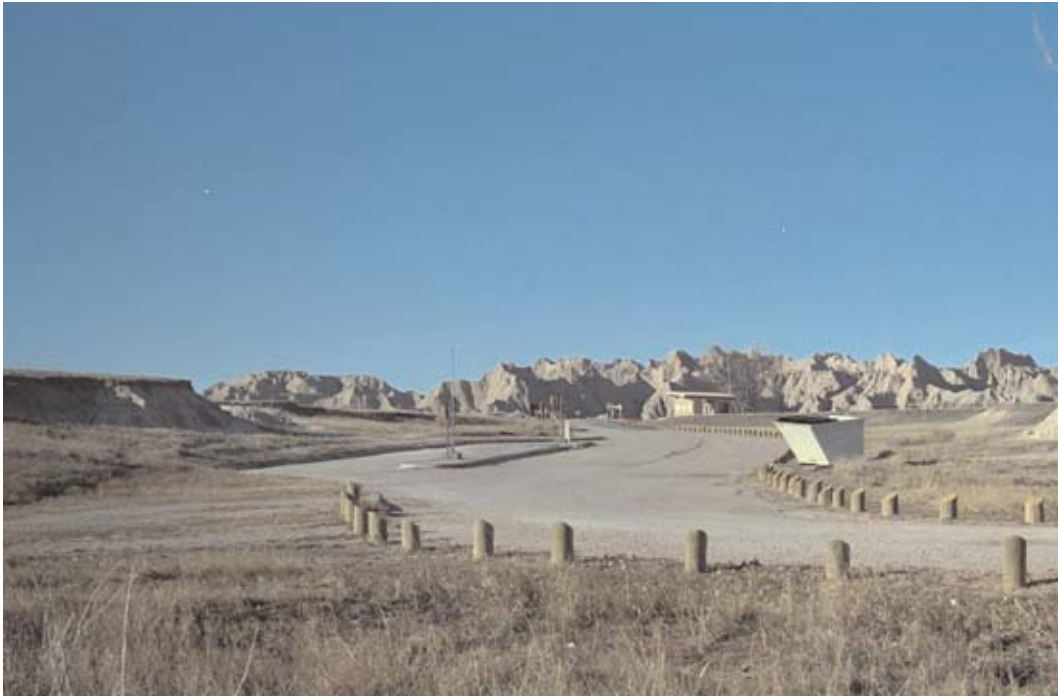
Figure 4-7 View of campground in 2002 with RV waste disposal station, bollards lining road, dumpster, and comfort station.

Today, most of the circulation features that were present during the period of significance survive. Key changes have included the realignment of the service road south of the Visitor Center and the addition of parking areas behind the Visitor Center and along the new service road. The realignment of the service road left an isolated segment of the former road at the residential area; a short spur was created to connect these two roads. Other circulation features that have been added or modified since the end of the period of significance include a trail from the Visitor Center to the campground area (a trail was likely present during the period of significance but has been replaced), an expansion of the amphitheater parking lot, new sidewalks associated with new buildings, an access drive west of the Lodge to temporary housing, and an expanded maintenance yard. A small service loop off the service road has been removed. Its removal was part of the Mission 66 relocation of the maintenance area, although the work was completed after the period of significance. *Map 2-1, 1966 Period Plan* illustrates the original orientation of the service road as well as the missing service loop. Since the end of the period of significance, very little has changed in association with the Visitor Center front parking lot, the Lodge parking and cabin access loop, three campground loops, and the southern portion of the service road. *Figures 4-7 and 4-8* illustrate the campground circulation from the period of significance and today.

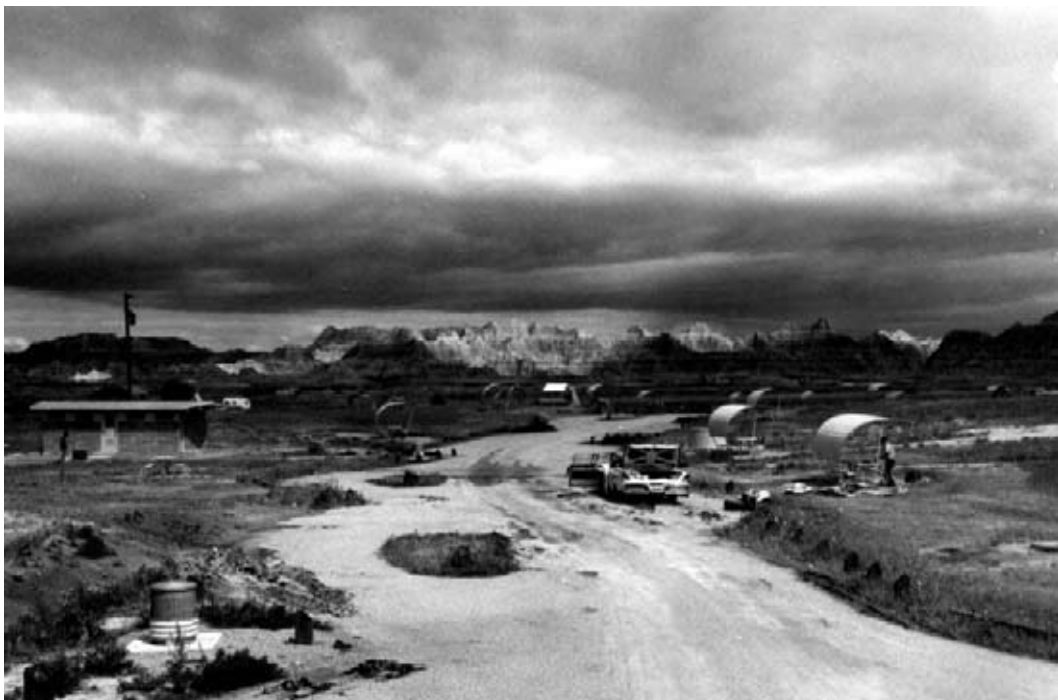
Figure 4-8 View of campground pull-offs, picnic shelters, trash receptacles, comfort station, and bollards along road in 1965.

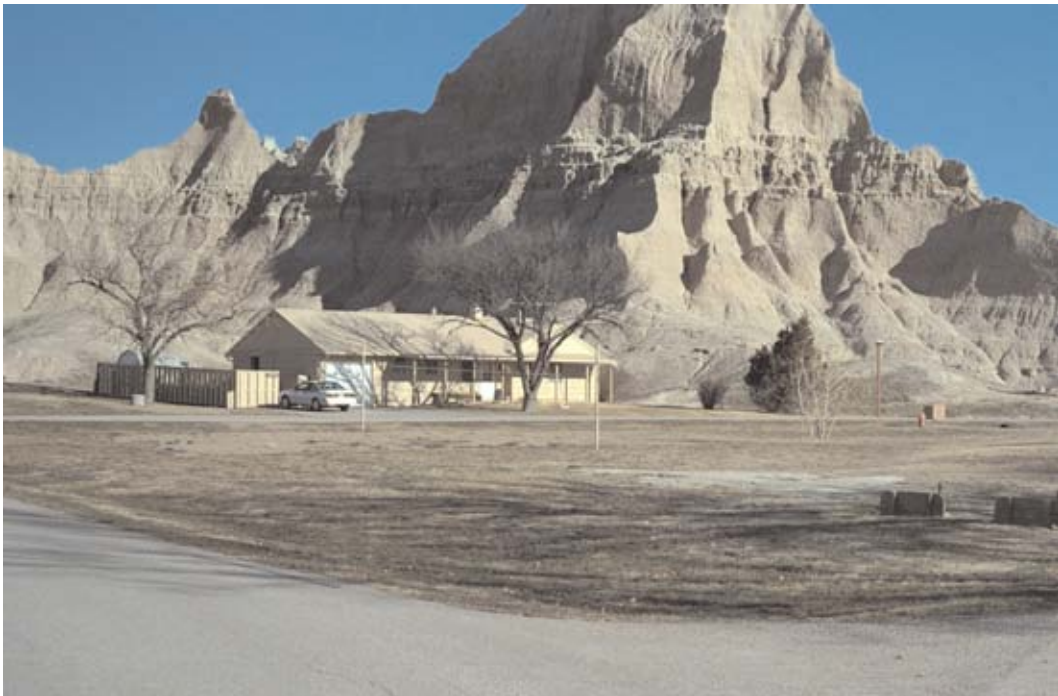
Figure 4-9 Single-family residence at foot of Wall formation with large trees and board fencing in 2002.

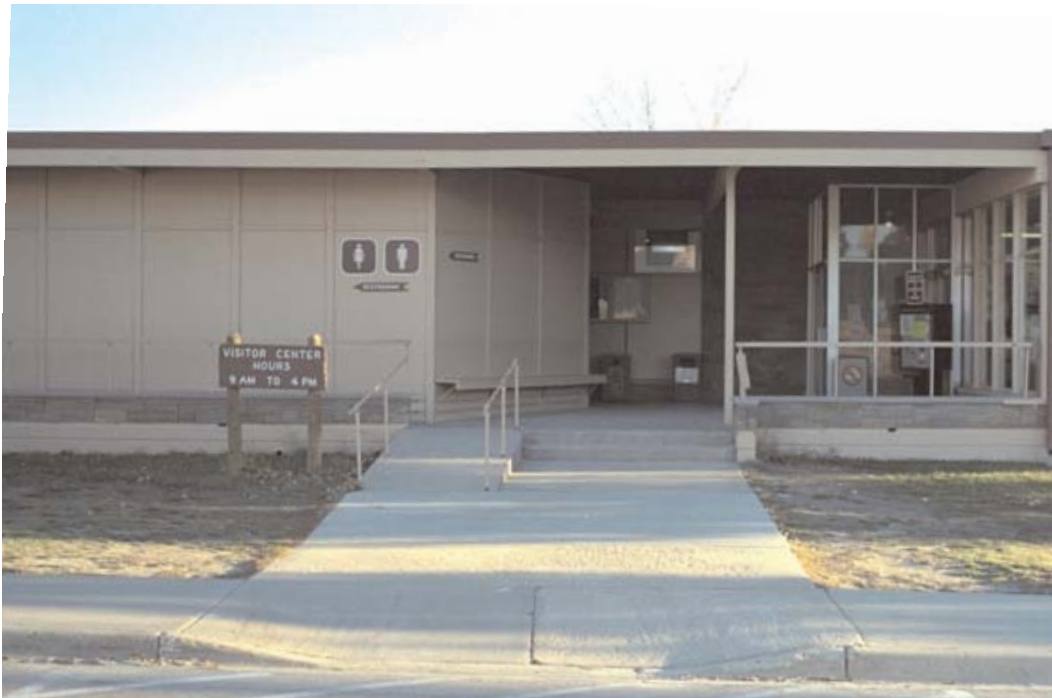
Figure 4-11 Entrance to Visitor Center in 2002 with informational sign and ramp.

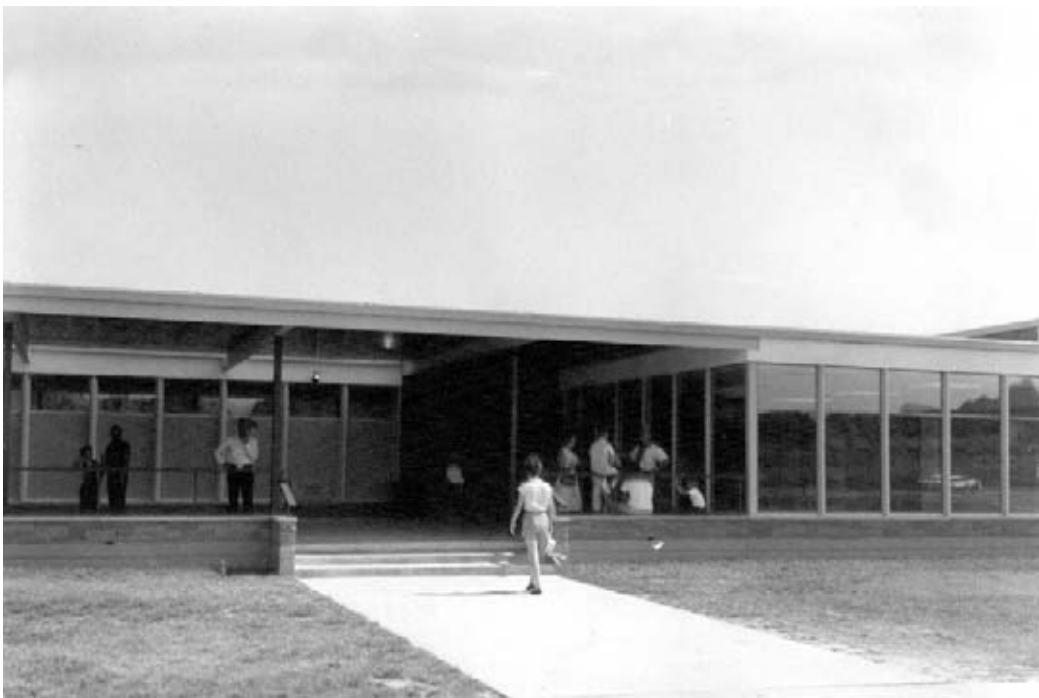
Figure 4-12 Visitor Center entrance in 1959 with open porch.

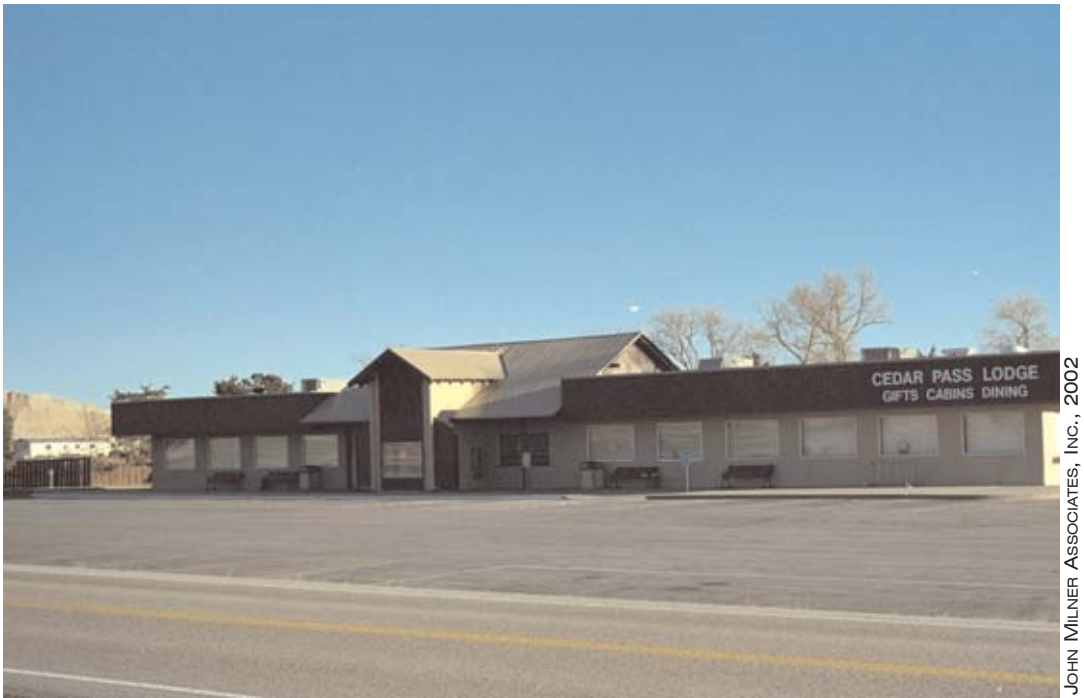
Figure 4-13 Cedar Pass Lodge in 2002 with additions to the original Lodge on either side, board fencing to east, and large trees behind the building.

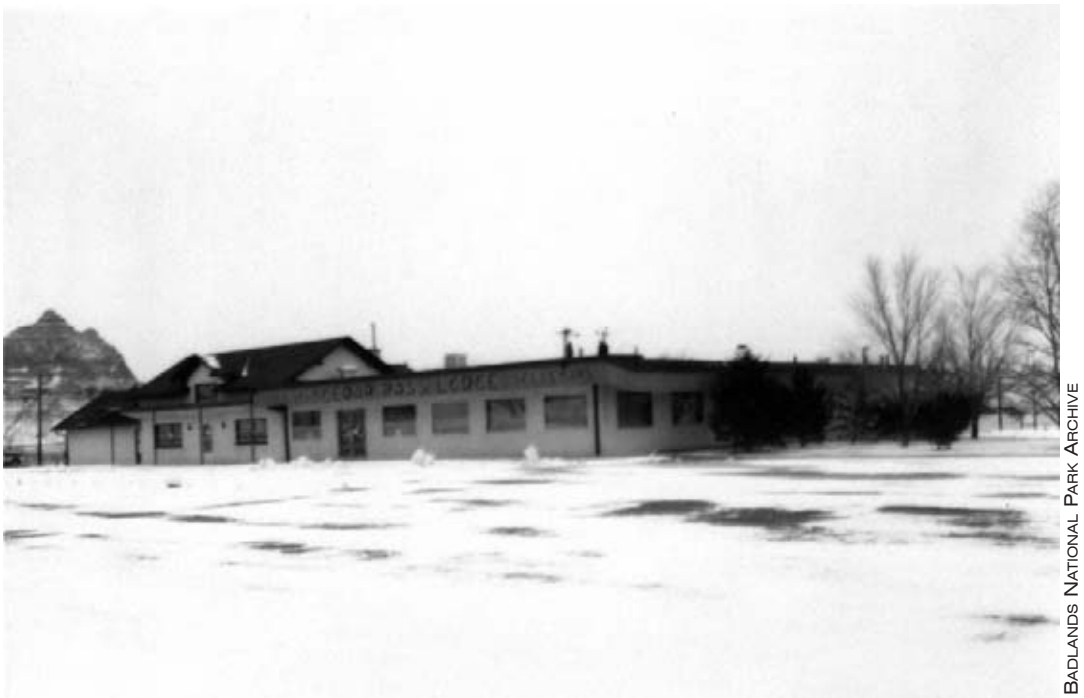
Figure 4-14 Cedar Pass Lodge in 1969 with a massing of plants to the west side of the building.

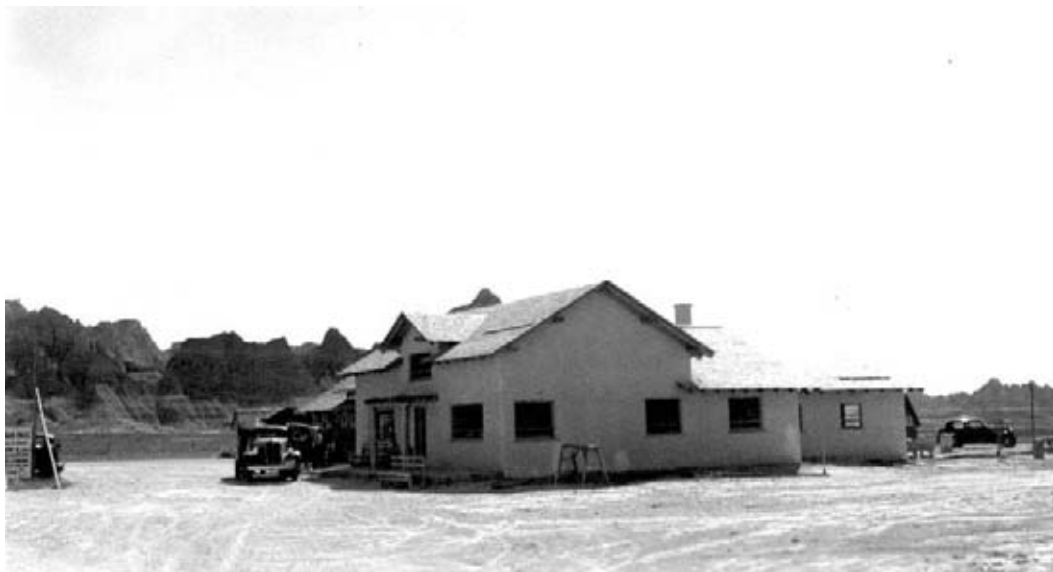
Figure 4-16 The original Cedar Pass building in 1940, built by Ben Millard.

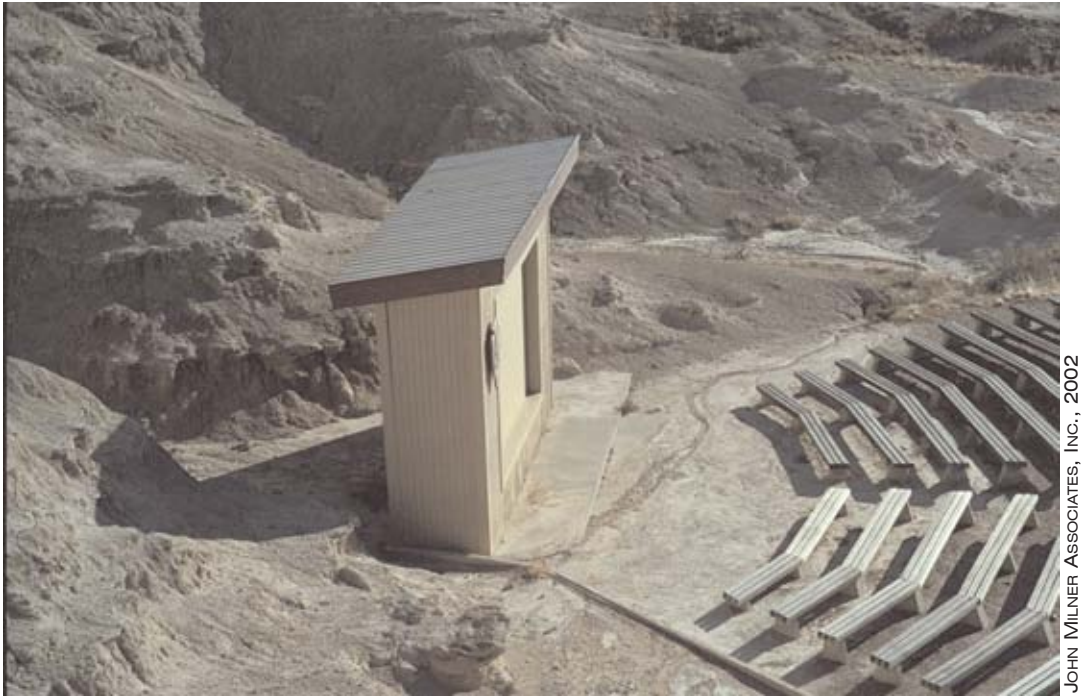
Figure 4-17 View of amphitheater screen, wood benches on concrete supports, and concrete retaining wall along the perimeter in 2002.

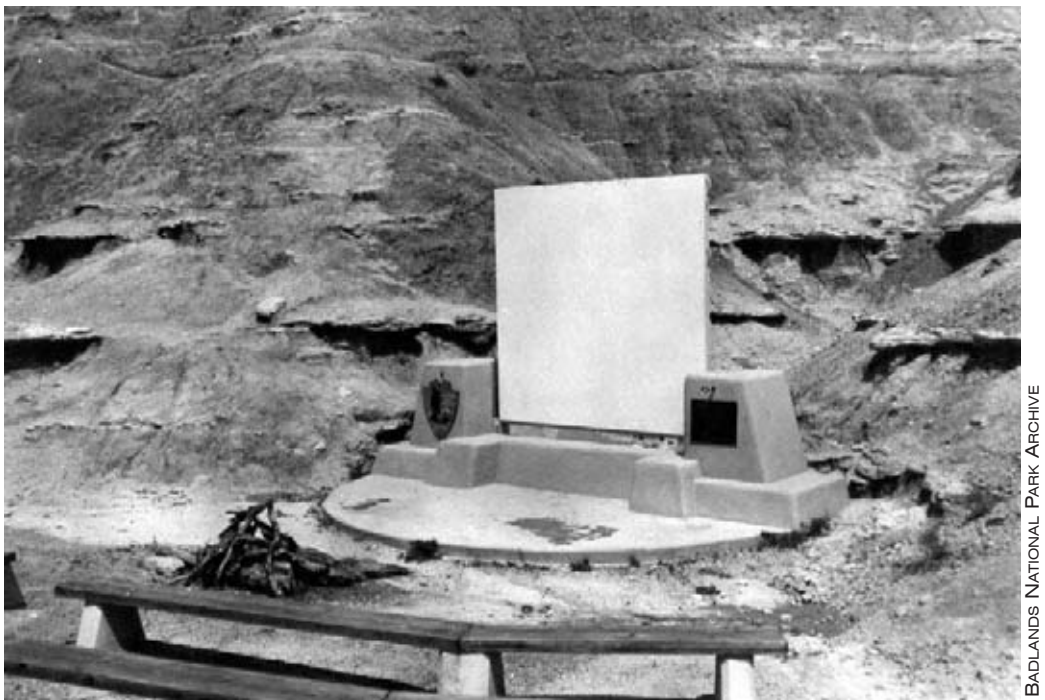
Figure 4-18 View of amphitheater screen and base, simulated campfire, and wood benches on concrete supports in 1962.

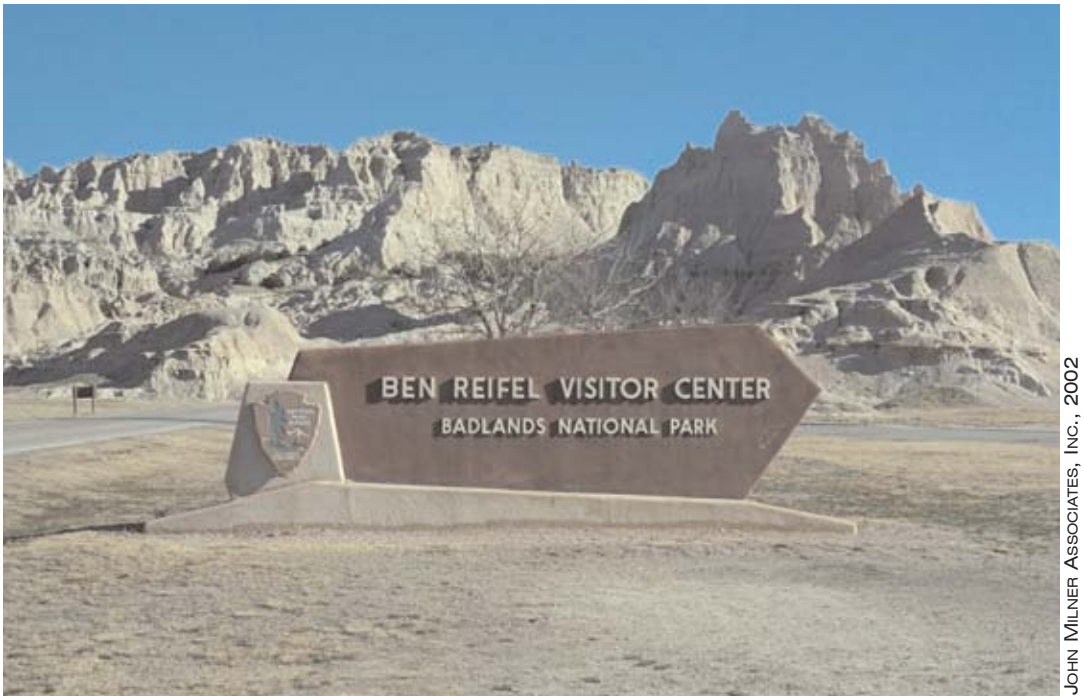
Figure 4-19 View east of Visitor Center sign in 2002 with raised lettering and the Wall formation in the background.

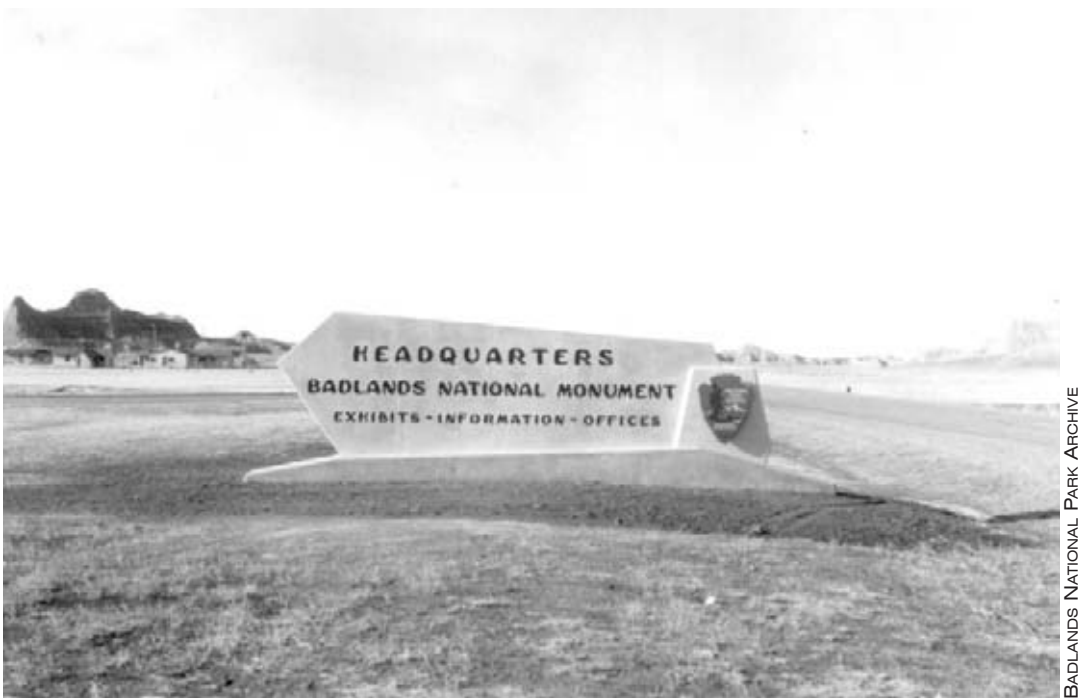
Figure 4-20 View west of Mission 66 sign for Headquarters.

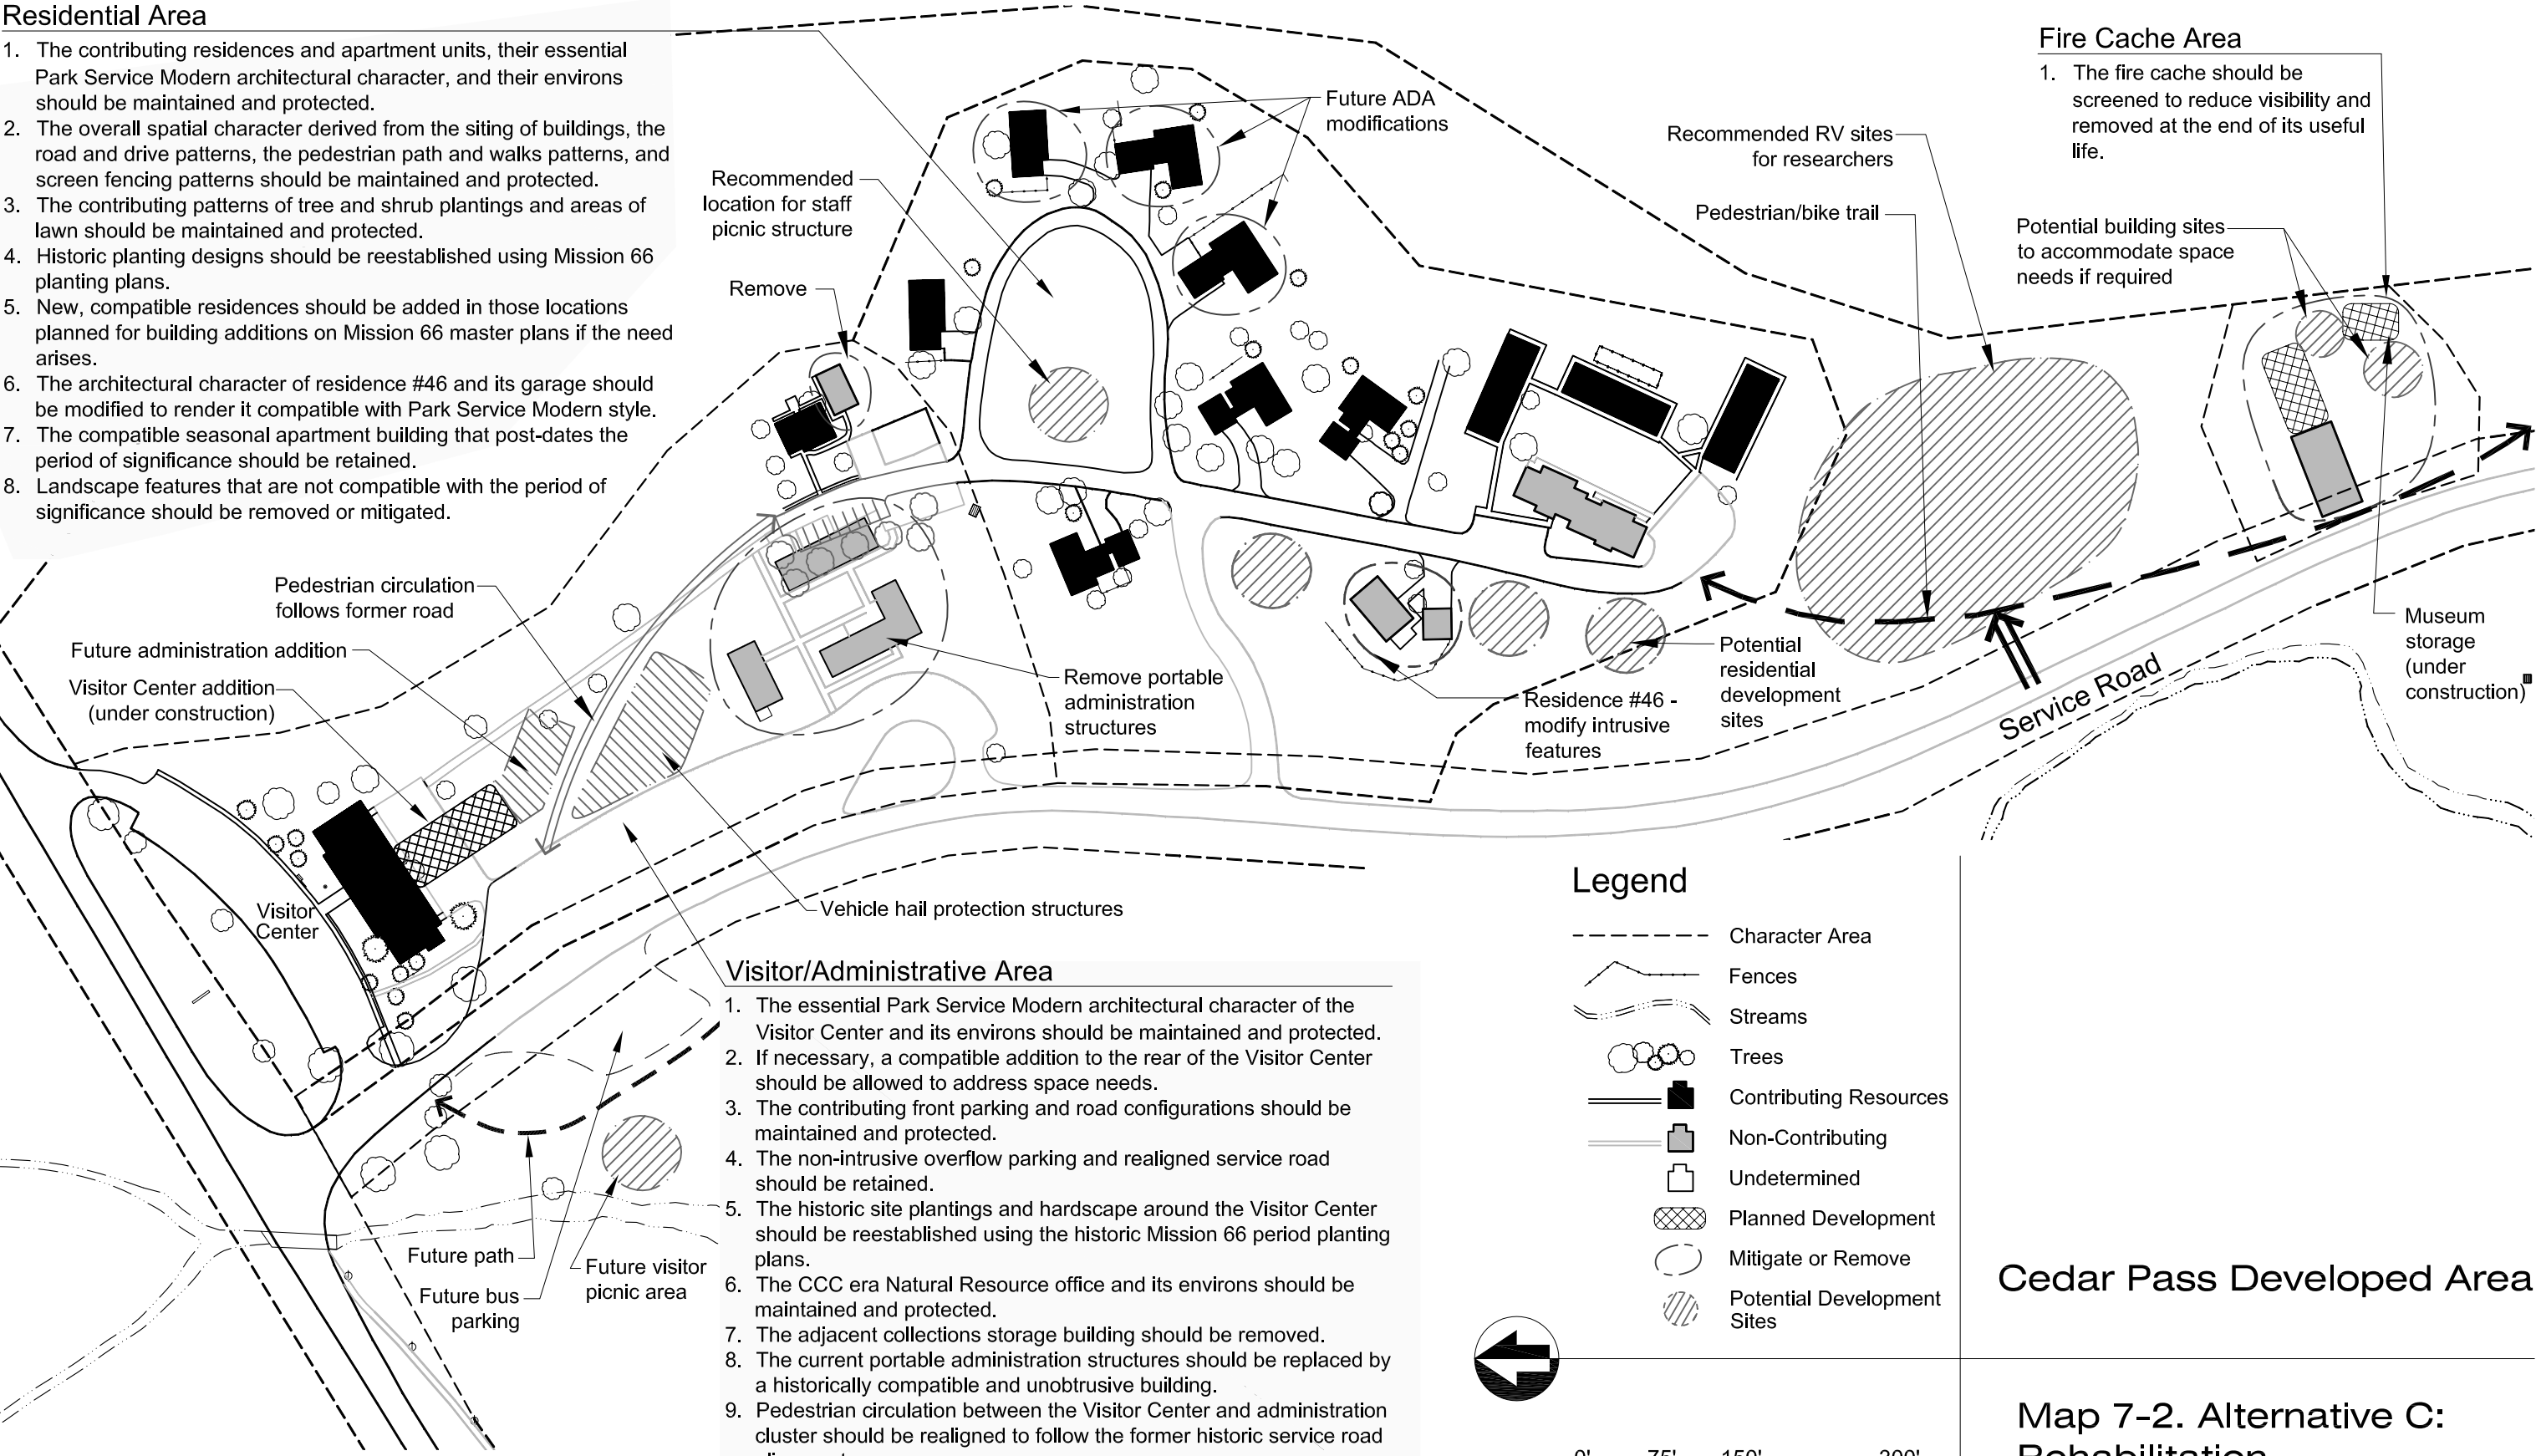
Map 7-2. Alternative C:  
Rehabilitation  
Detail Visitor Center & Residential  
Cultural Landscape Report  
Badlands National Park, South Dakota  
National Park Service  
June 2005

- 7. The compatible seasonal apartment building that post-dates the period of significance should be retained.
- 8. Landscape features that are not compatible with the period of significance should be removed or mitigated.
