building 136

august 1982

HISTORIC STRUCTURE REPORT
ARCHITECTURAL DATA AND
ARCHEOLOGICAL DATA SECTIONS
BUILDING 136
CHARLESTOWN NAVY YARD
BOSTON NATIONAL HISTORICAL PARK
MASSACHUSETTS

DENVER SERVICE CENTER
BRANCH OF CULTURAL RESOURCES
MID-ATLANTIC/NORTH ATLANTIC TEAM
NATIONAL PARK SERVICE
UNITED STATES DEPARTMENT OF THE INTERIOR

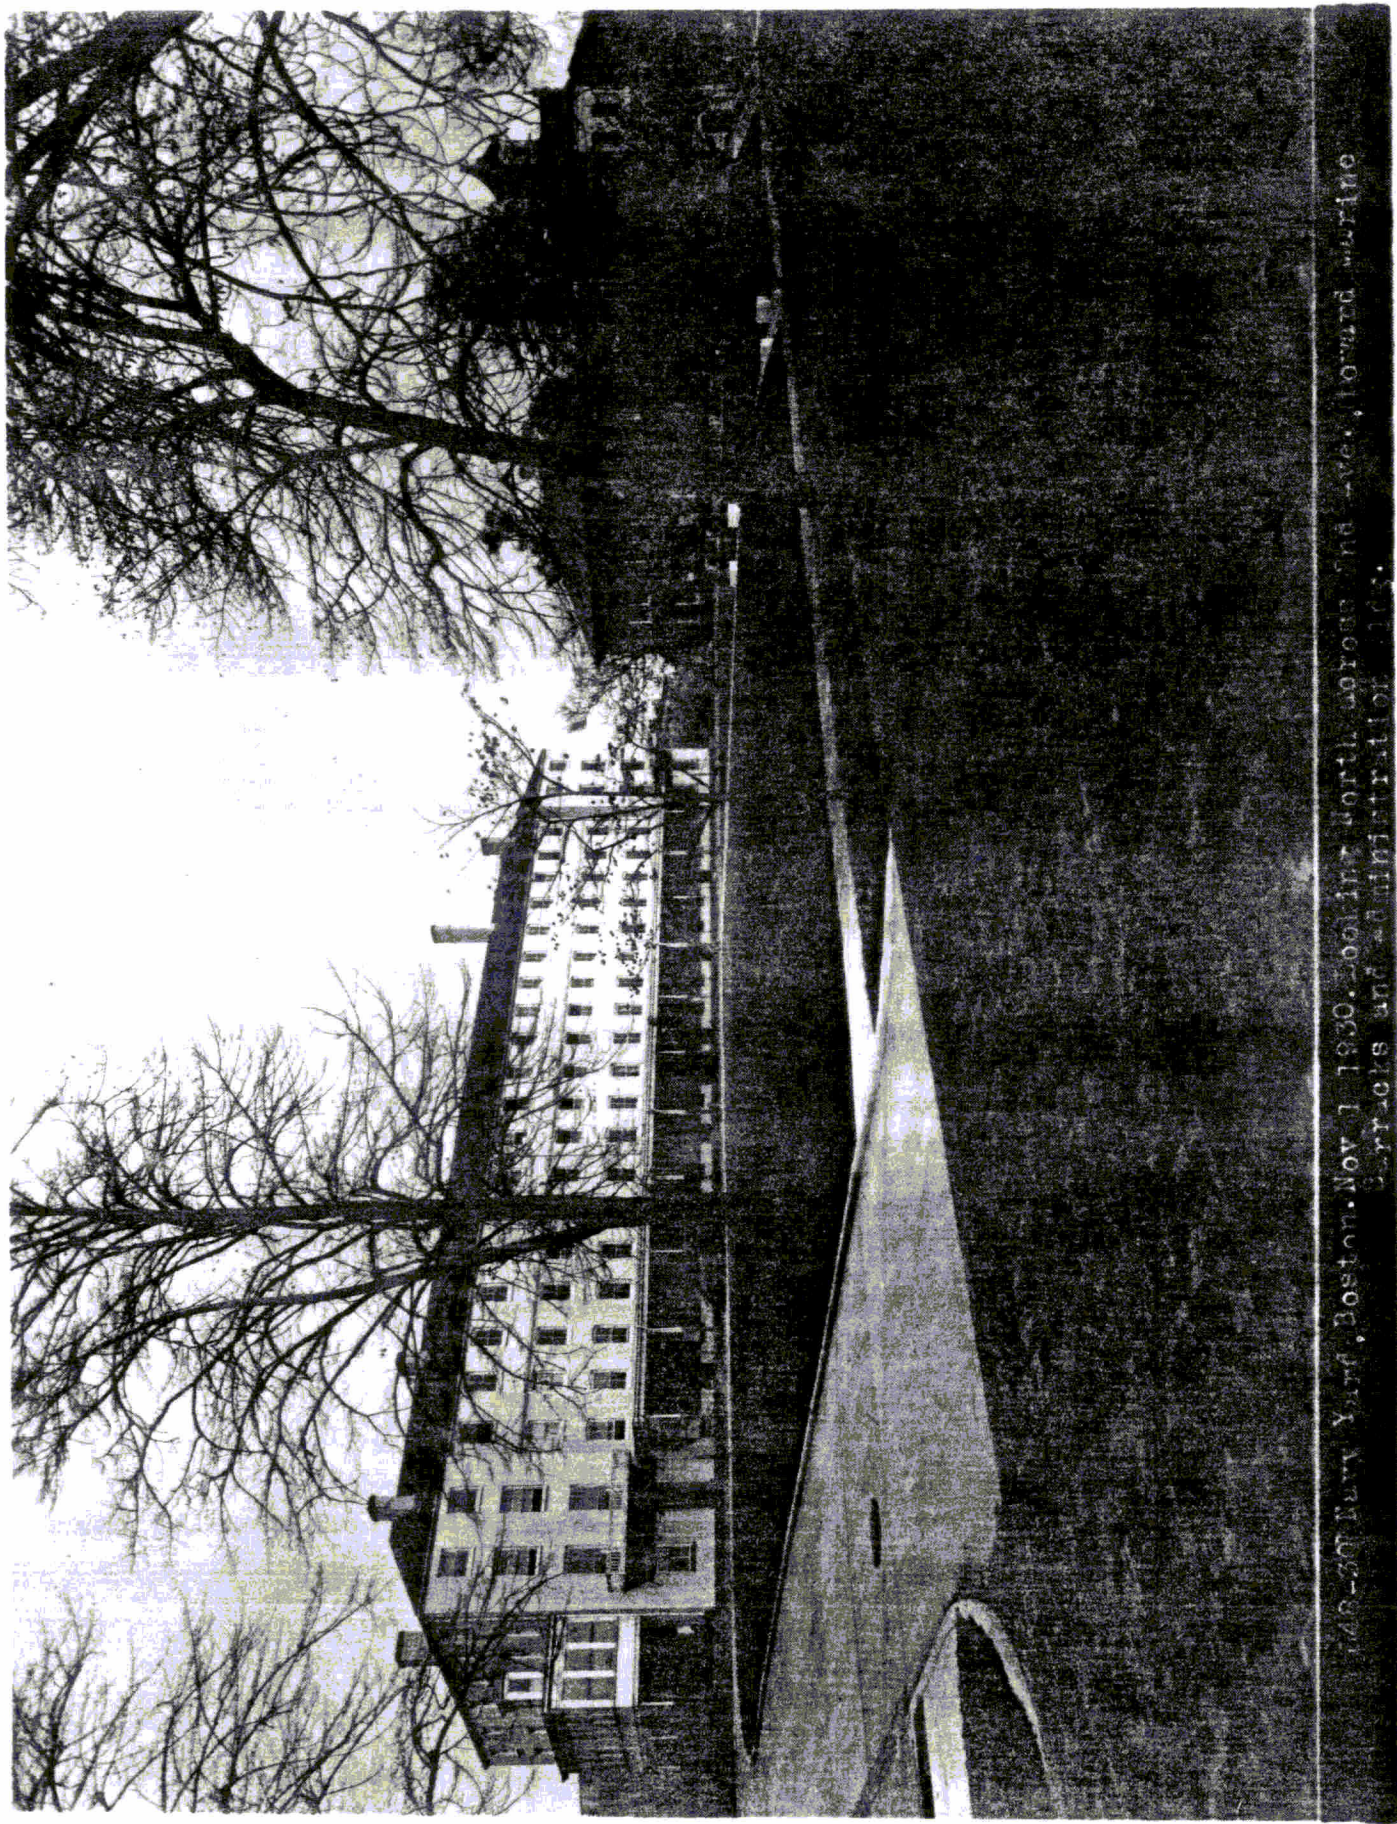
2. The original 1909 appearance of Building 136, on right.

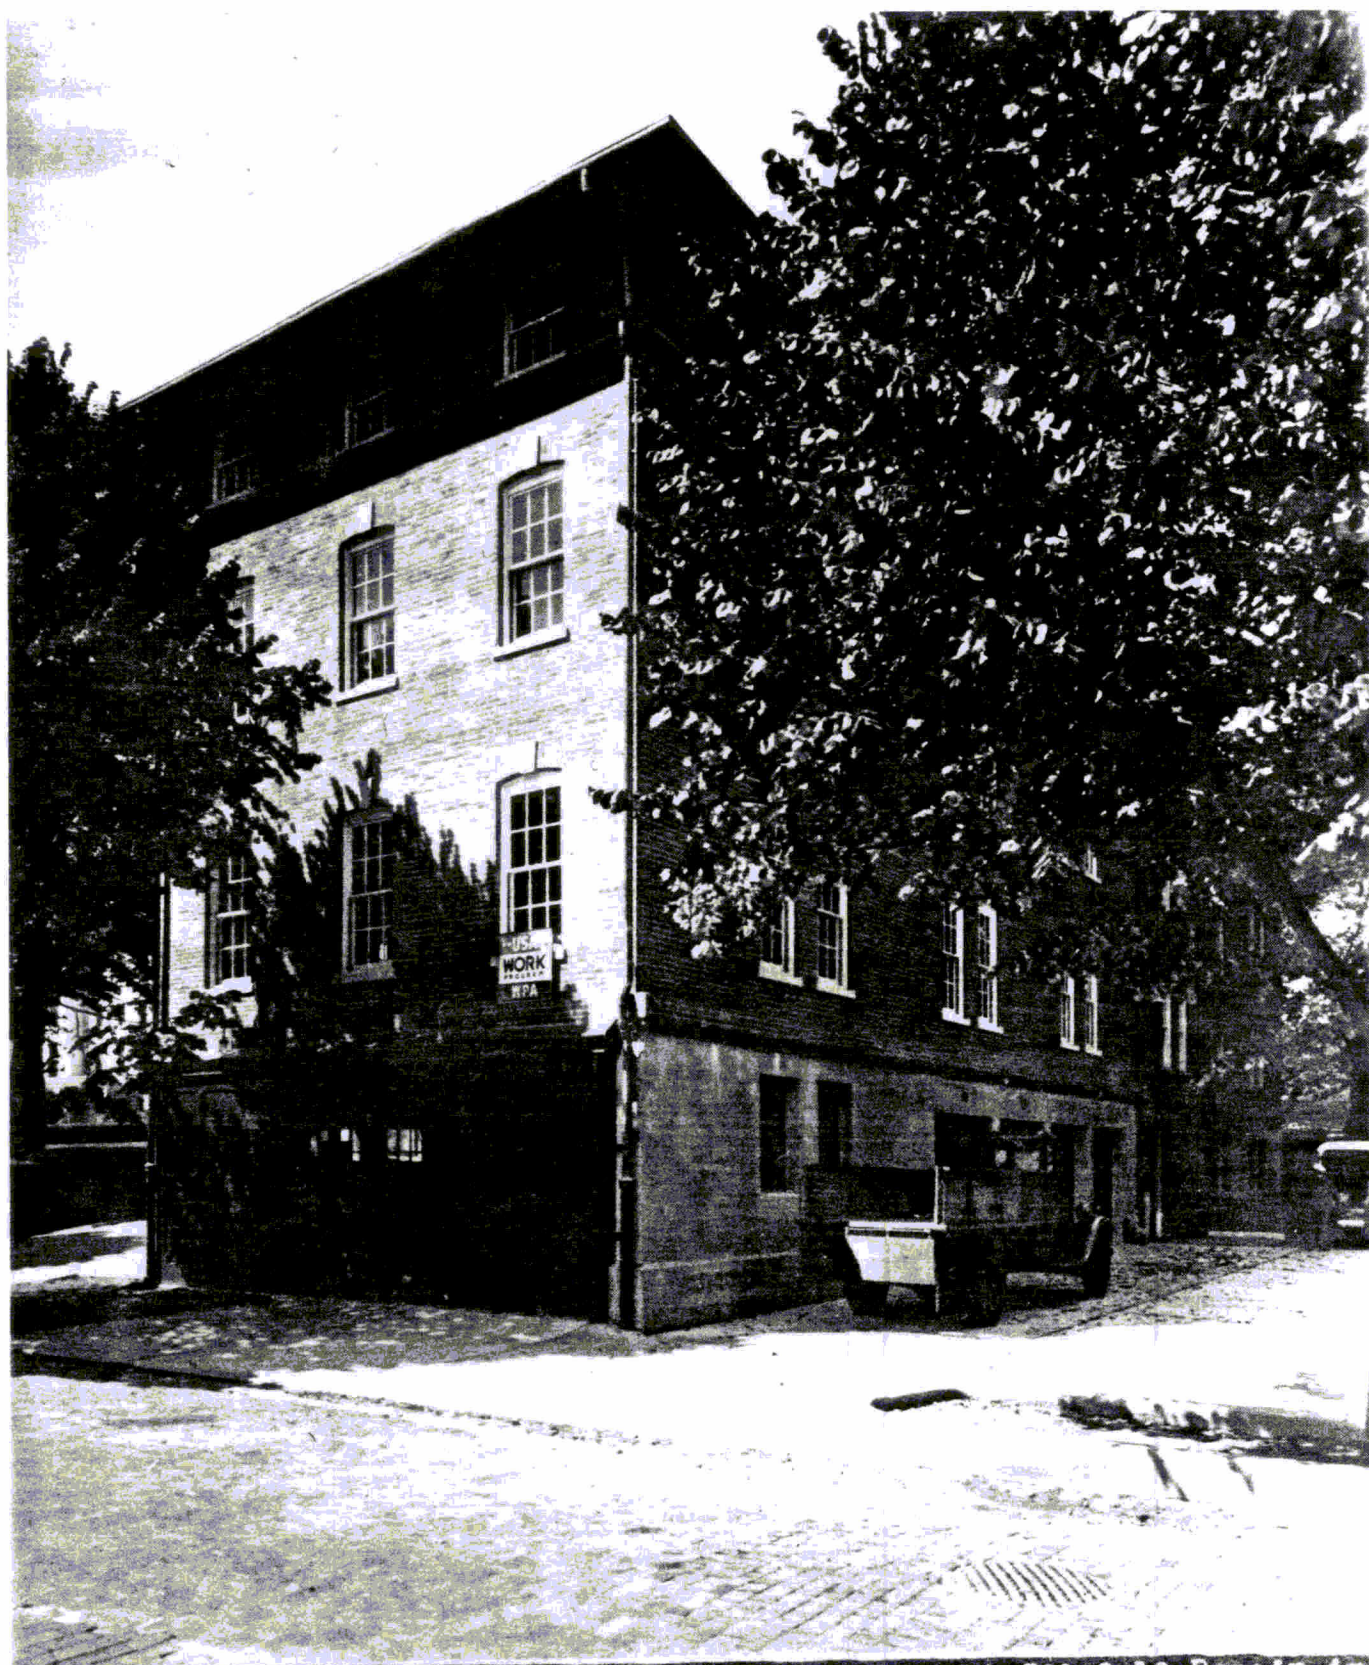
7. Completed 1937 addition - south
and east facades.

705-37 Boston Navy Yard. Sept 14 1937. WPA Project 509-2-19-Repair, improvement and construction of Bldgs, waterfront structures, etc. Marine Administration Bldg. South and East sides. Work completed.

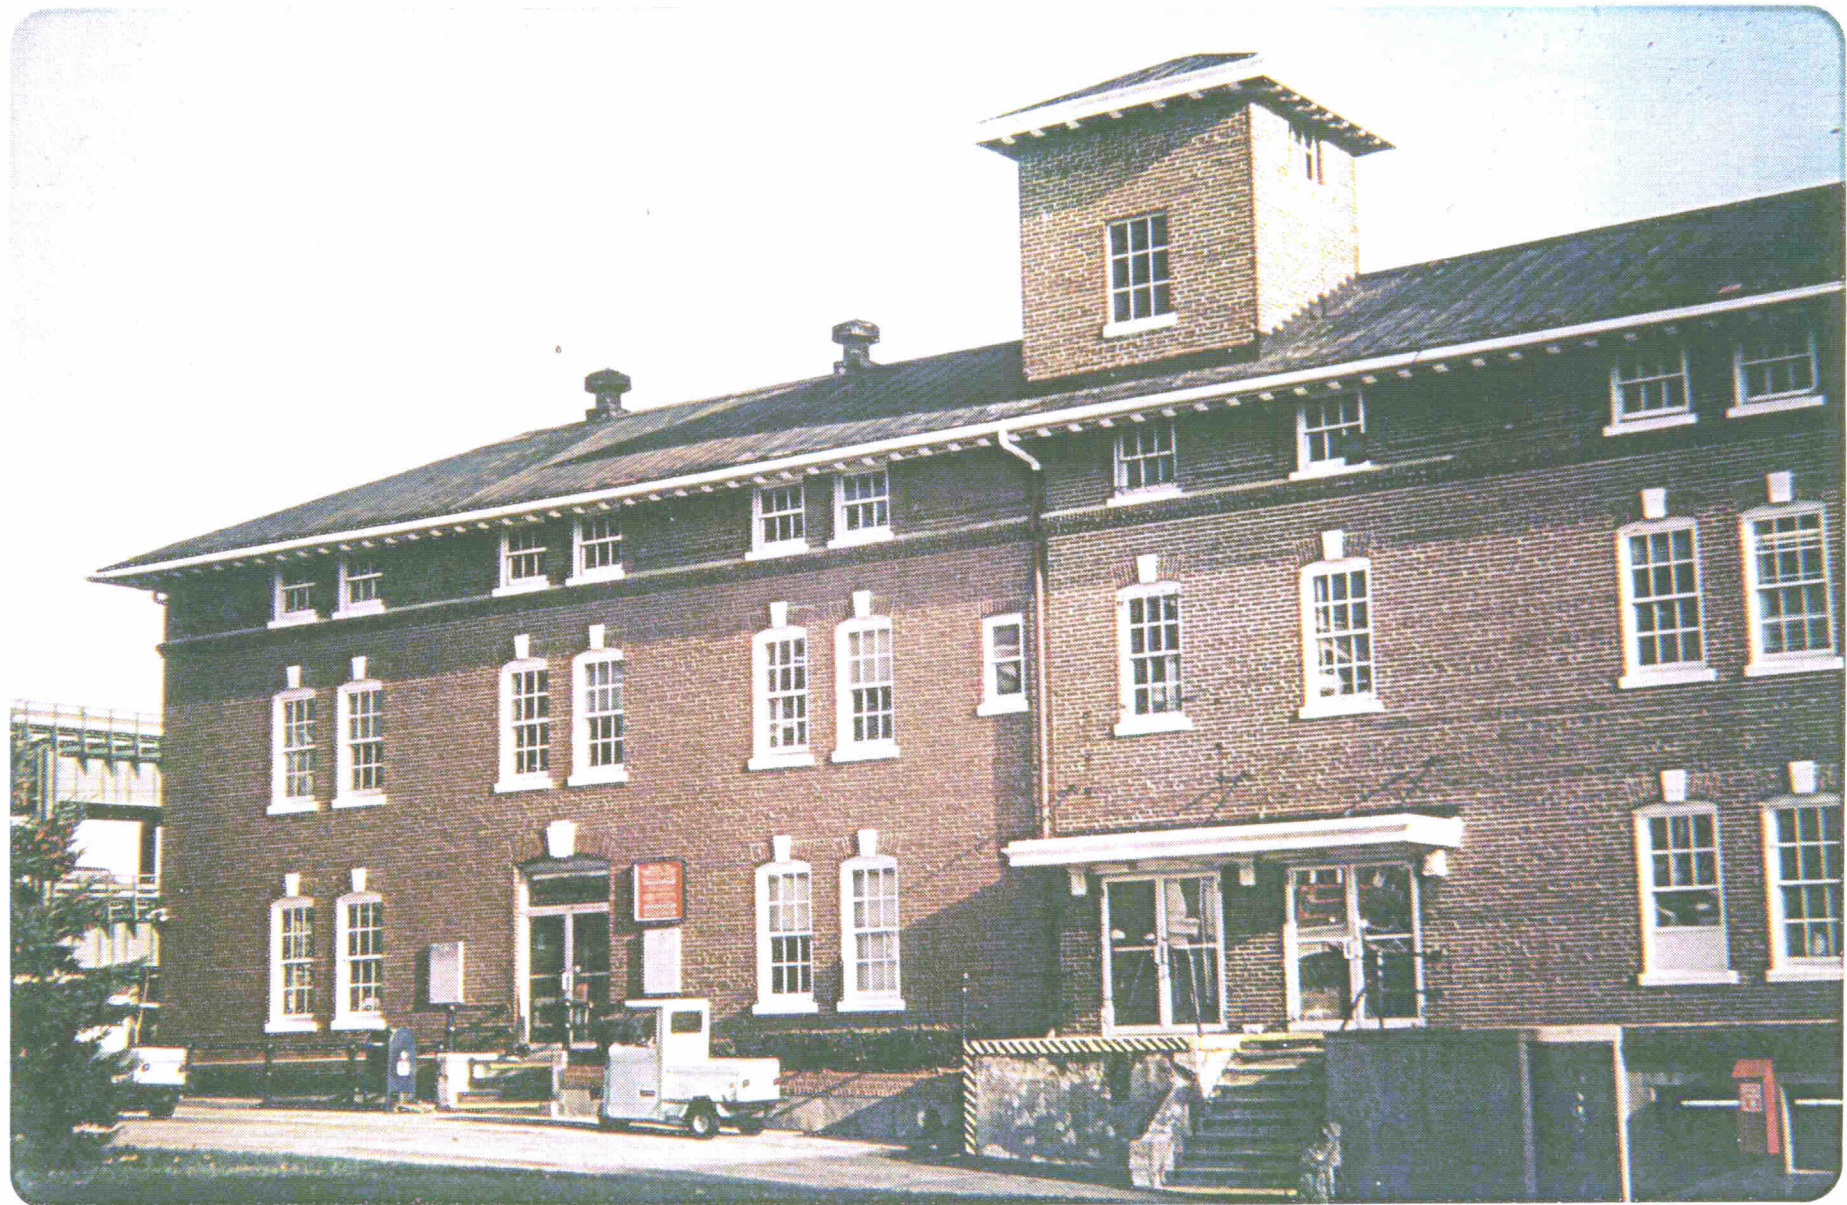
The exterior remains basically as it was constructed with the changes described above and the following exceptions: on the west facade, the areaway at the basement level is walled in at the stairway to the first floor. A planter has been built above the remainder of the former areaway space. Bars were added over the second floor window directly below the penthouse. There were five vertical bars and two horizontal. The double wood or kalamein doors to the original building, the elevator, and the addition were all replaced with metal frame double glass doors. The wood door from the areaway to the basement was replaced with a solid aluminum door.

9. Existing 1978 Building 136 - west facade.

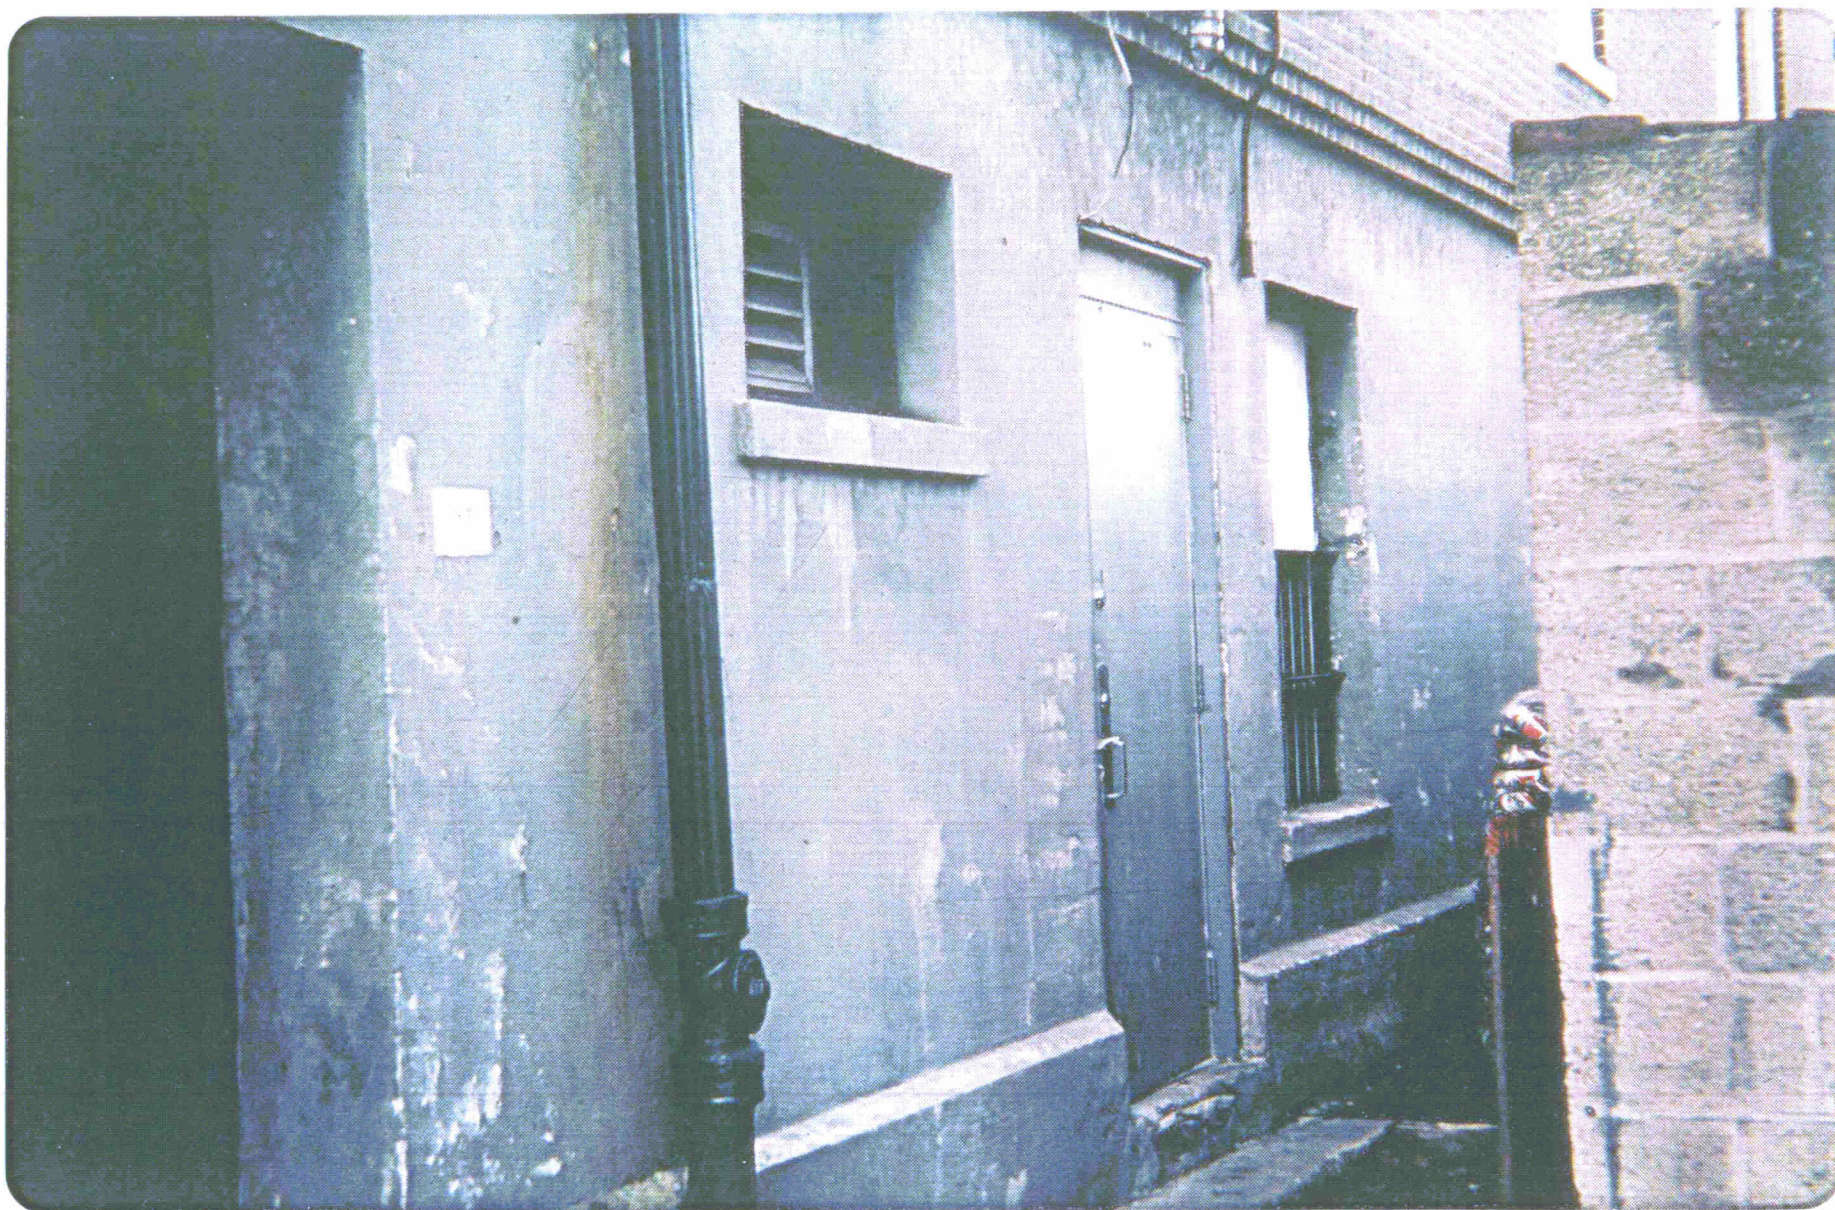
11. Existing 1978 - east facade, entrance to Room 002.

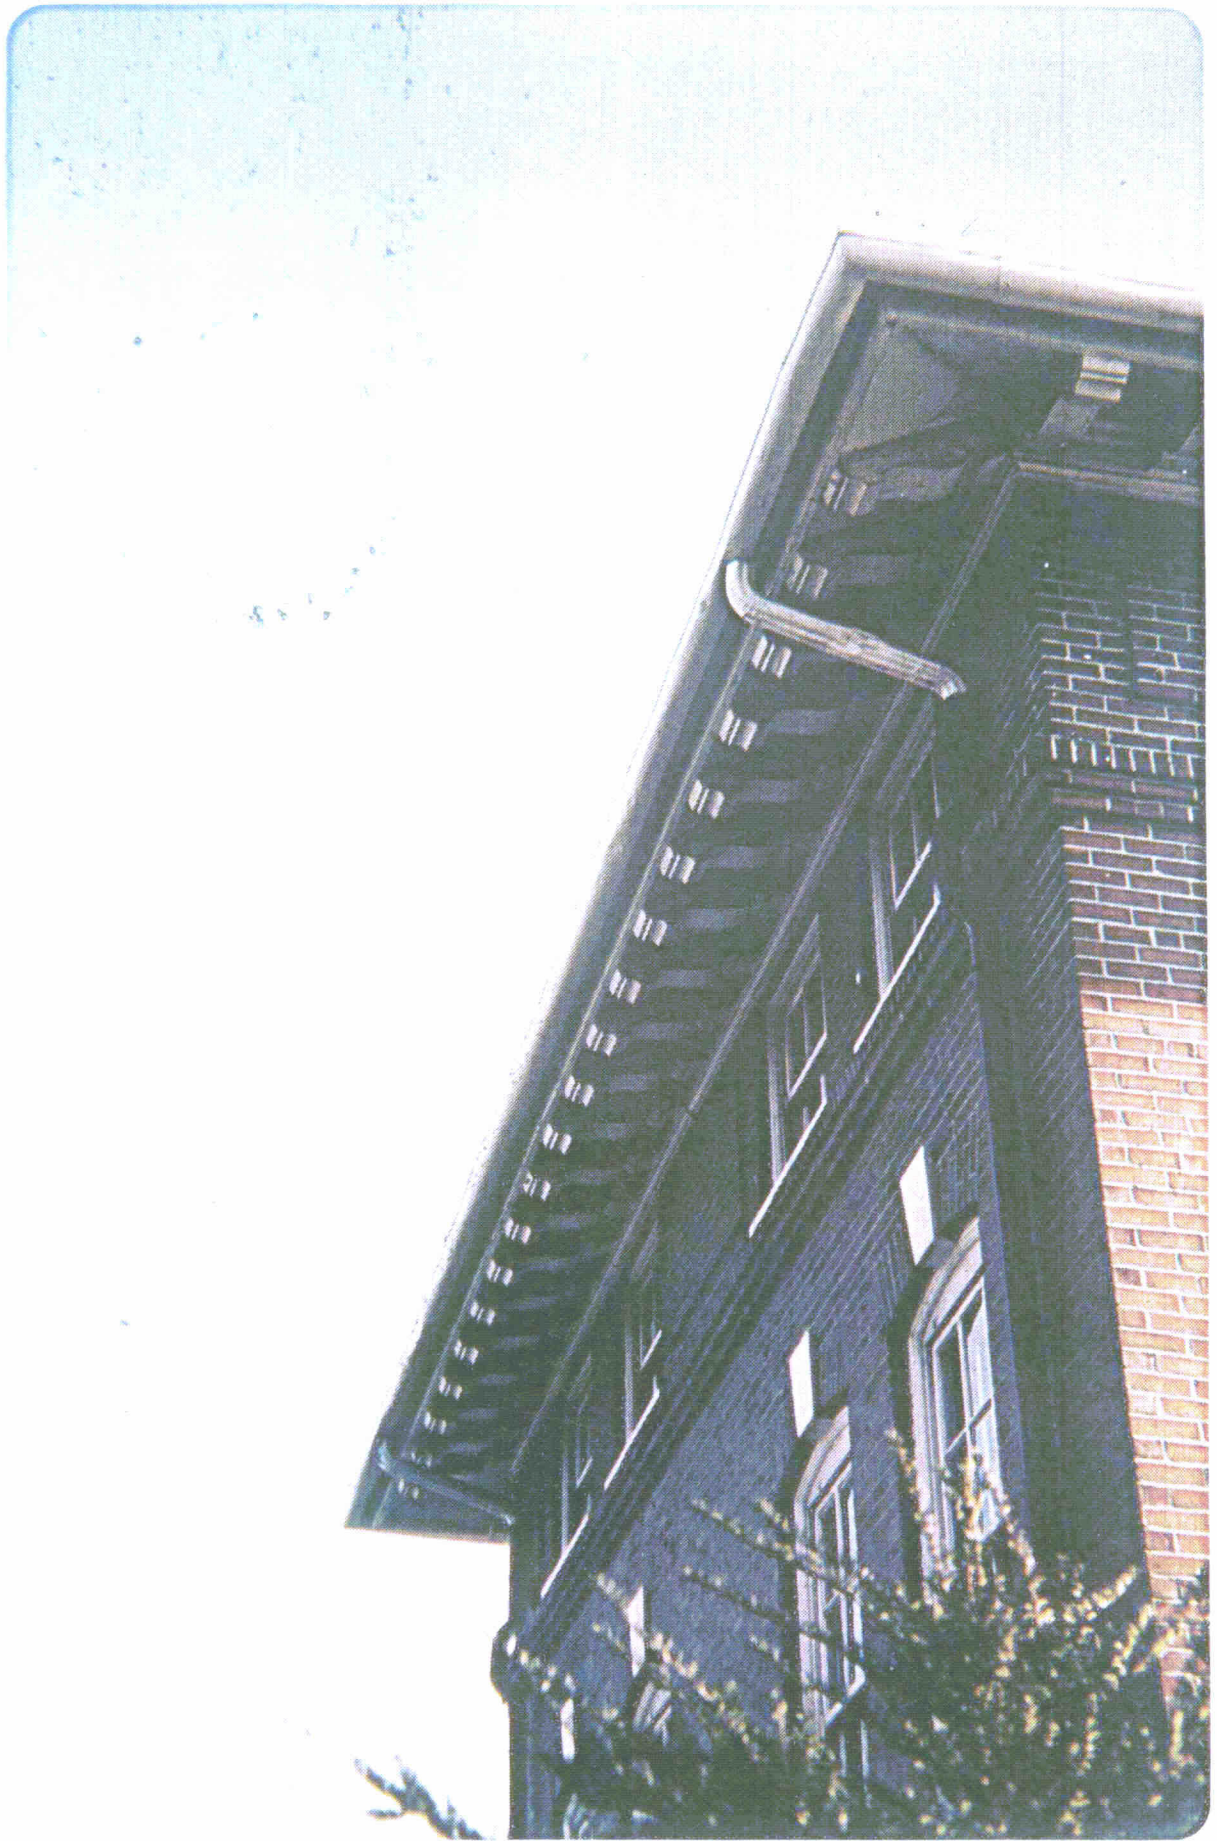
12. Existing 1978 - north facade and cornice.

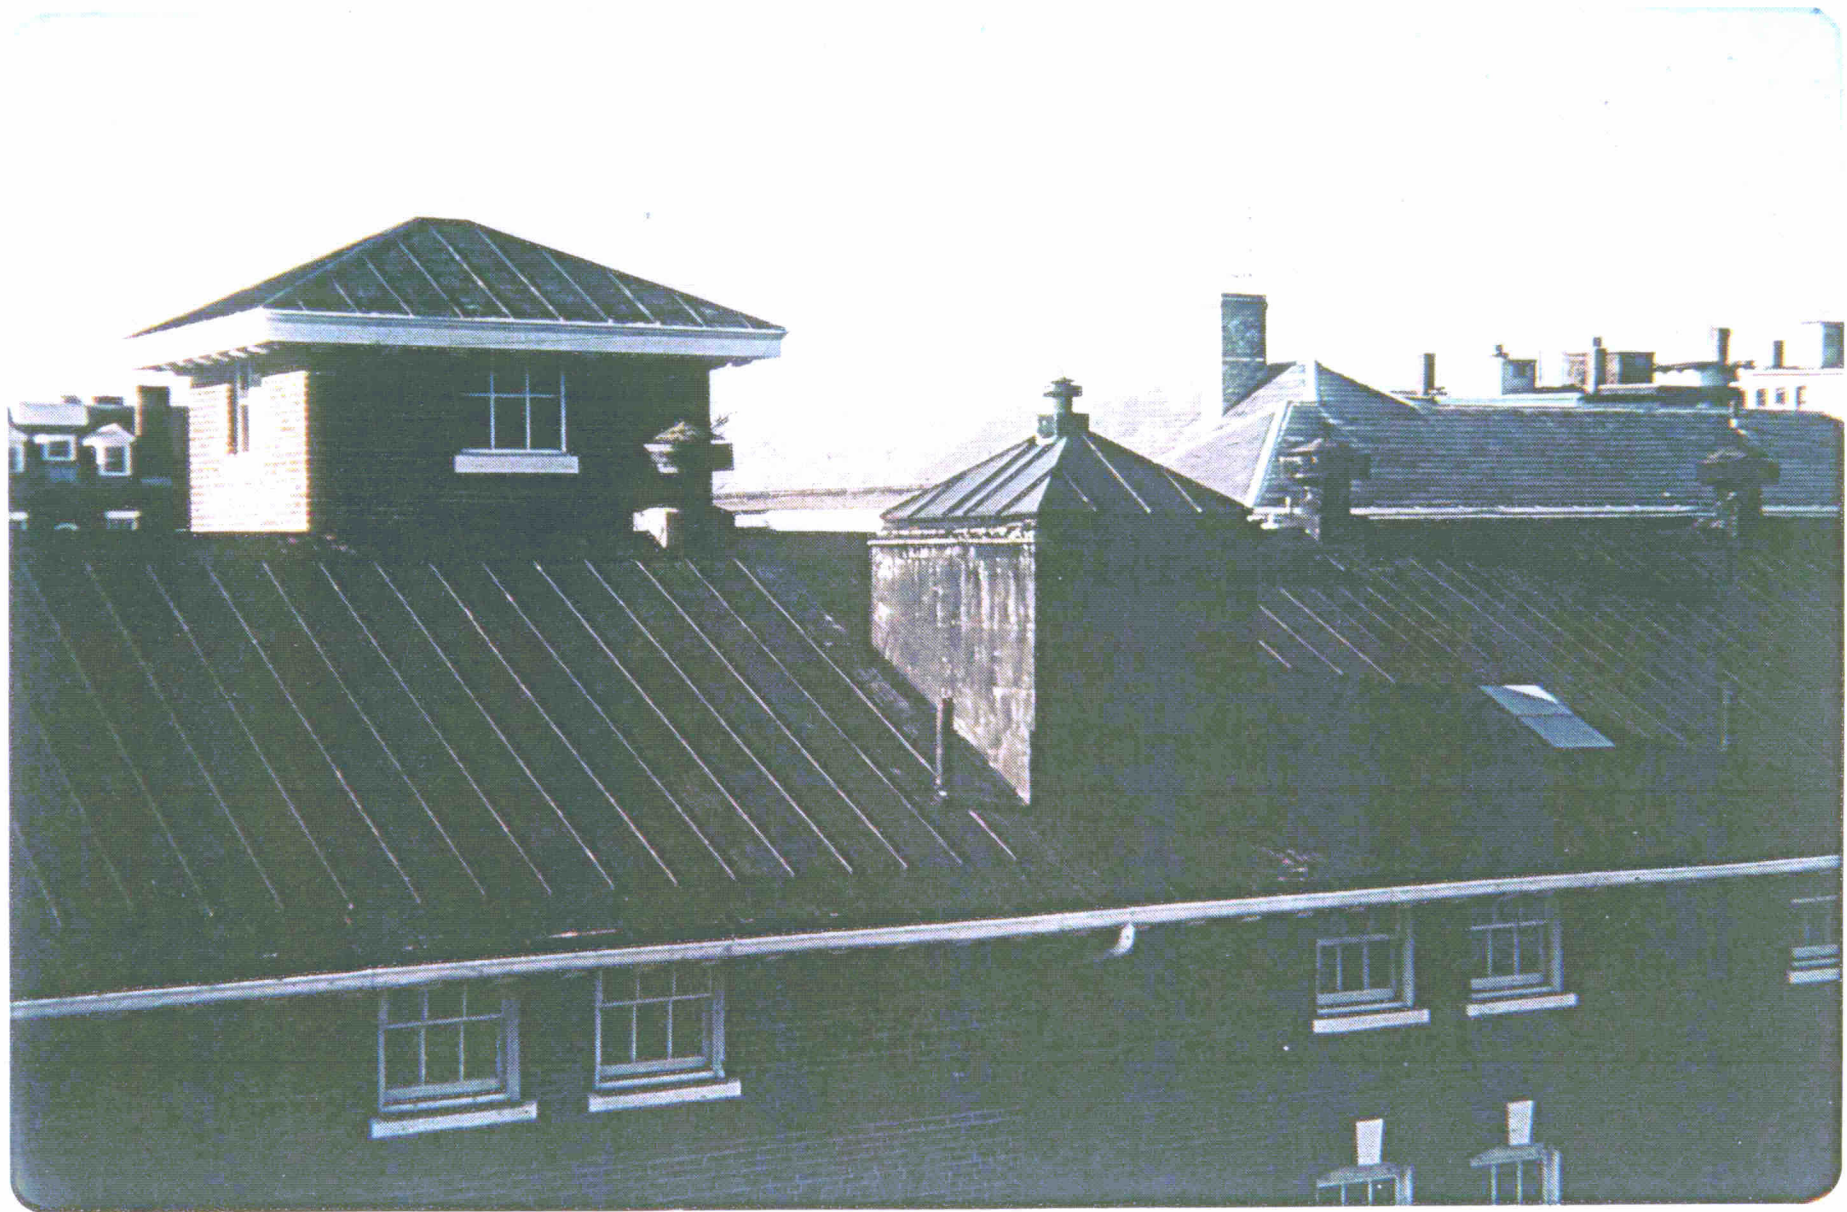
14. Existing 1978 - roof, 1909 penthouse (right)
and 1937 penthouse (left) from east.
