**Chapter 2**  
**LANDSCAPE PHYSICAL HISTORY**

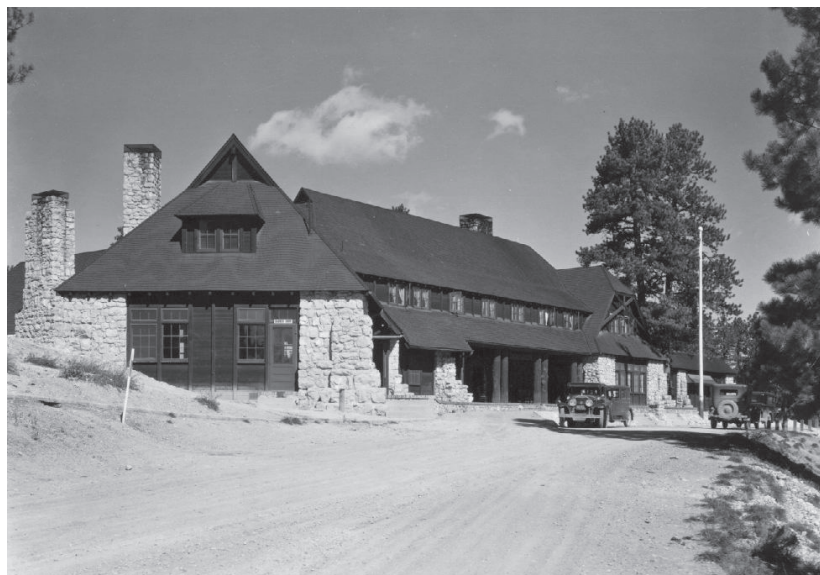
Photograph 10. View of Lodge front after the 1927 additions, 1929  
(BRCA Archives: Photographer George A. Grant #3919 00381)

up by sleeping accommodations for overnight guests. Additional wings were added in 1926, probably to accommodate a quick increase in the number of available sleeping accommodations. A curio store occupied the lower level of the south wing. The addition of a Recreation Hall in 1927 rounded out the Lodge's final configuration. By September 1927 no fewer than sixty-seven standard and economy cabins were grouped about the Lodge. Construction on these had begun during 1925. Concrete walks connected all cabins to the Lodge. The smaller scale of the cabins in comparison to the Lodge and the use of natural building materials resulted in a gentle blending with the surrounding natural and architectural environments.<sup>45</sup> For the sake of aesthetics, electrical wiring was placed in underground conduits. In September 1927 only five deluxe cabins were in existence, but by 1929 ten more augmented the Lodge complex. The building materials for most of this construction came from local sources—stone was quarried a short distance from the site, and logs were cut from the National Forest.<sup>46</sup> Rather than designing the entire complex at one time, Underwood designed and re-designed it over a period of several years as visitation increased and the Utah Parks Company saw the need for expanded development. Even though the development was done in phases, the buildings and surrounding landscape possess unifying qualities that create an outstanding sense of place. The irregular massing and chunkiness of the buildings imitates the irregularities found in nature giving them a rustic honesty and informality characteristic of park architecture from this era.

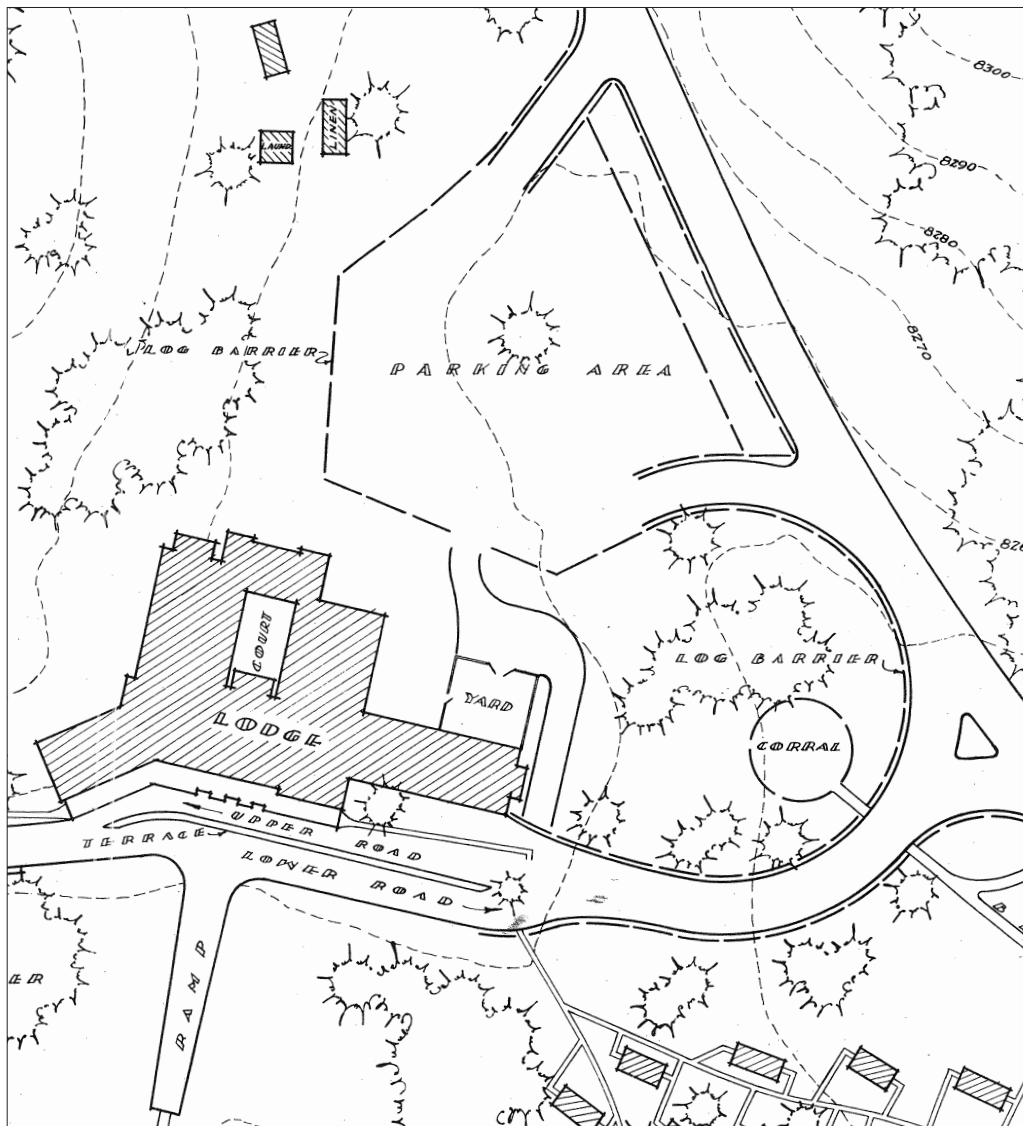
Figure 2. Zoom of Bryce Canyon Lodge and proximity. Bryce Canyon Lodge Area: Part of the 1932 Master Plan for Bryce Canyon National Park (BRCA Archives) Not To Scale

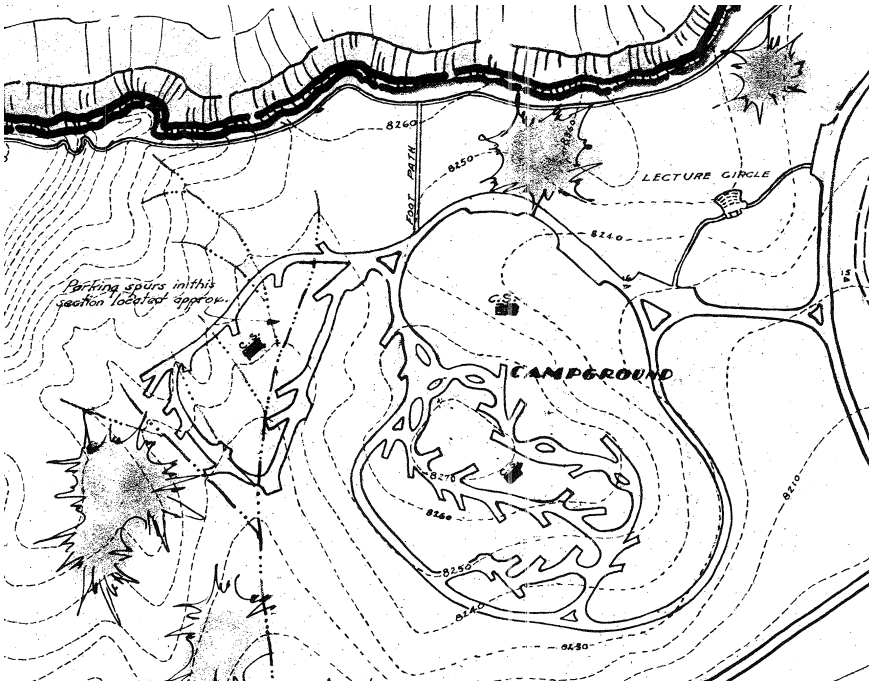
Figure 4. North Campground Development: Part of the 1938 Master Plan for Bryce Canyon National Park (BRCA Archives)

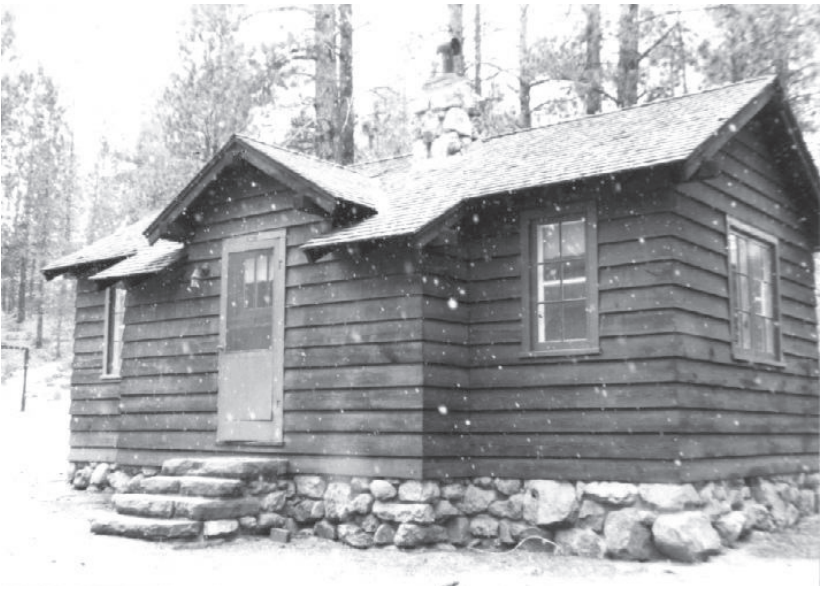
Photograph 20. Employee Residence in Old NPS Housing Area HS-05. Note the ‘simplified rustic’ design (BRCA Archives: BRCA 3943 BRCA-00408)

access), where they did not need to be exceptionally crafted, in fact were supposed to suffice a rather austere and “primitive” lifestyle.<sup>85</sup> Thus all the residences constructed at Bryce during this time were rather modest wood frame cabins, incorporating rustic weatherboard siding and stone foundations.

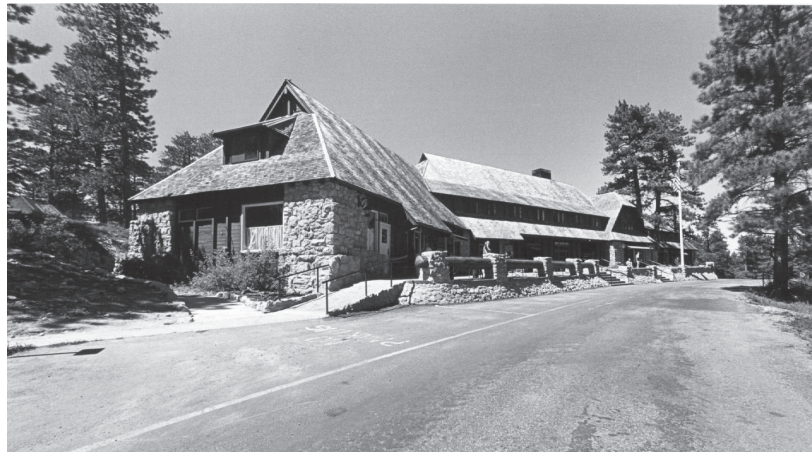
Photograph 42. Bryce Canlon Lodge , c. 1980's after extension of front portico and log-rail fence (BRCA Archives: BRCA 3885 BRCA-00359)

Prior to its protective NRHP listing, the Lodge District had undergone several significant alterations, including the 1983 Lodge Road realignment that changed the traffic pattern around the lodge so that visitors now approach from the rear.<sup>125</sup> A new employee dining room was added to the rear elevation during the winter of 1987.<sup>126</sup> Additionally, the bus-lane in front of the Lodge was removed to create room for a larger portico, fenced in by a log-rail parapet.<sup>127</sup> Extensive roof repairs, interior restoration and rehabilitation projects were initiated for the Lodge as well as for the Deluxe Cabins, the Men's Dormitory and the Recreation Hall.
