## **CHAPTER 4**

### **LANDSCAPE ANALYSIS AND EVALUATION**

### The Old NPS Housing Historic District (Study Area)

### **The Bryce Canyon Lodge Study Area**

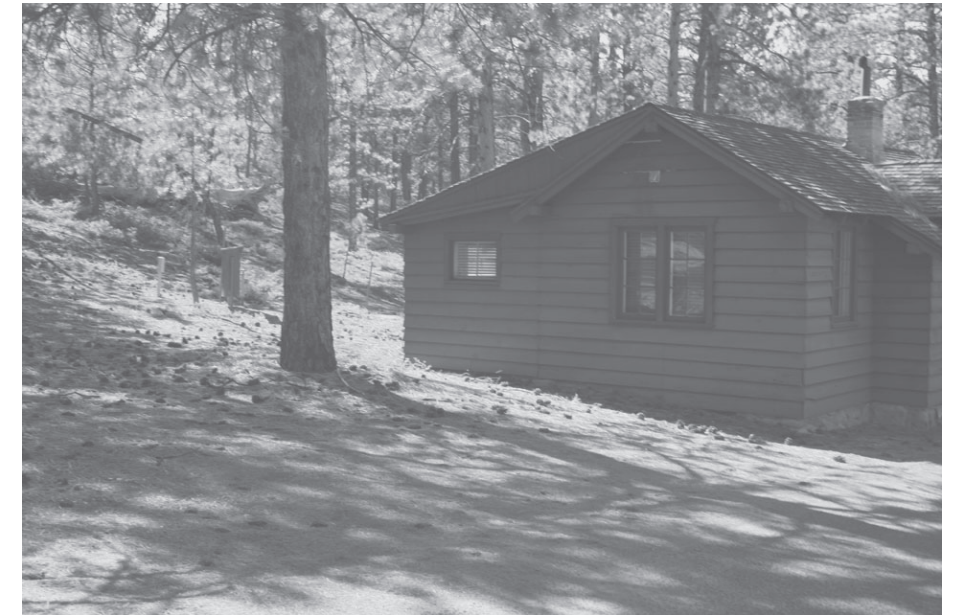
Photograph A/1. Small scale parking area near one of the historic cabins in the Old NPS Housing Study Area.

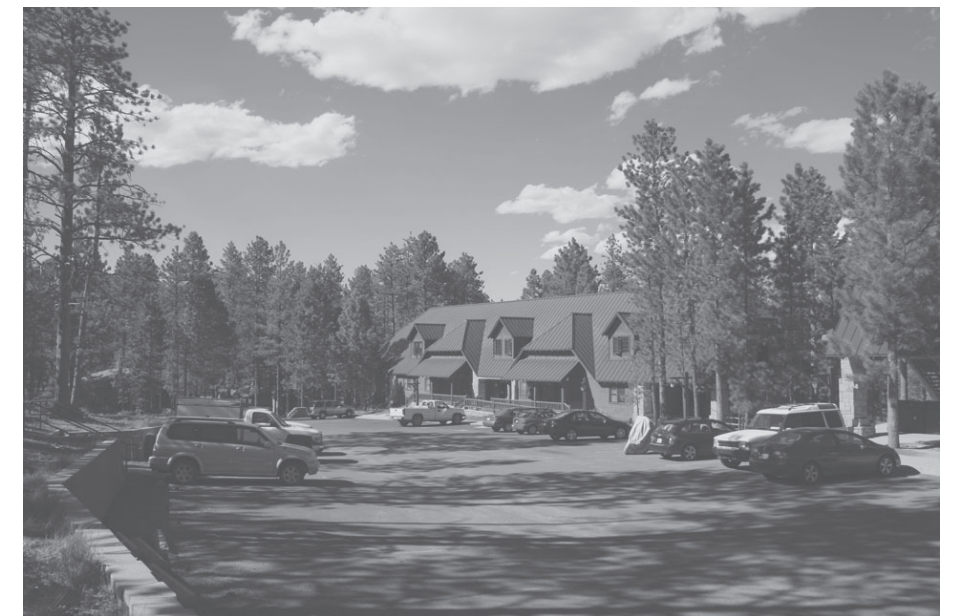
Photograph A/2. The large scale parking area in front of the new Concessionaire Dormitories in the Old NPS Housing Study Area.

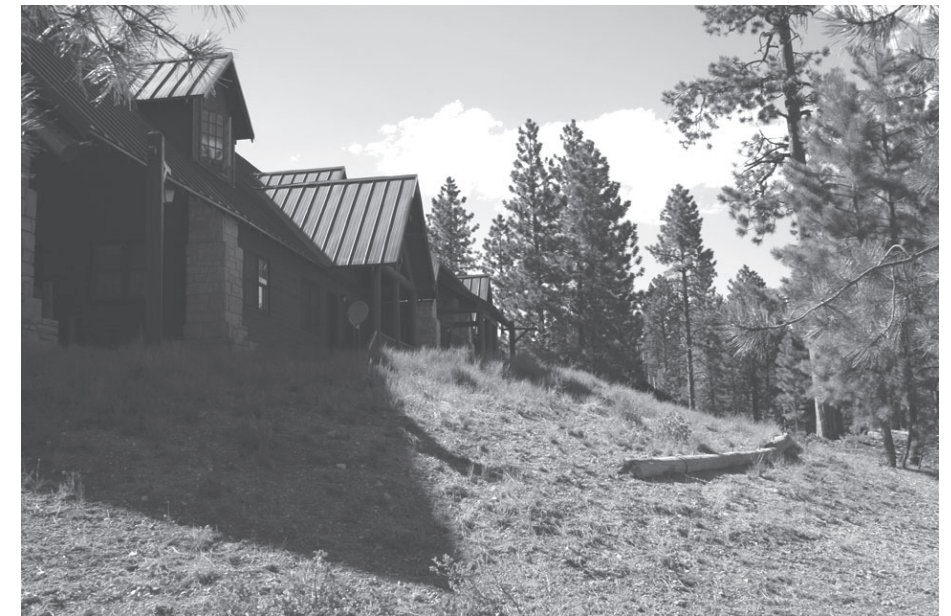
Photograph A/3. The fill area behind the Concessionaire Dormitories. Notice the lack of mature trees near the structure. No new trees have established themselves in this area.

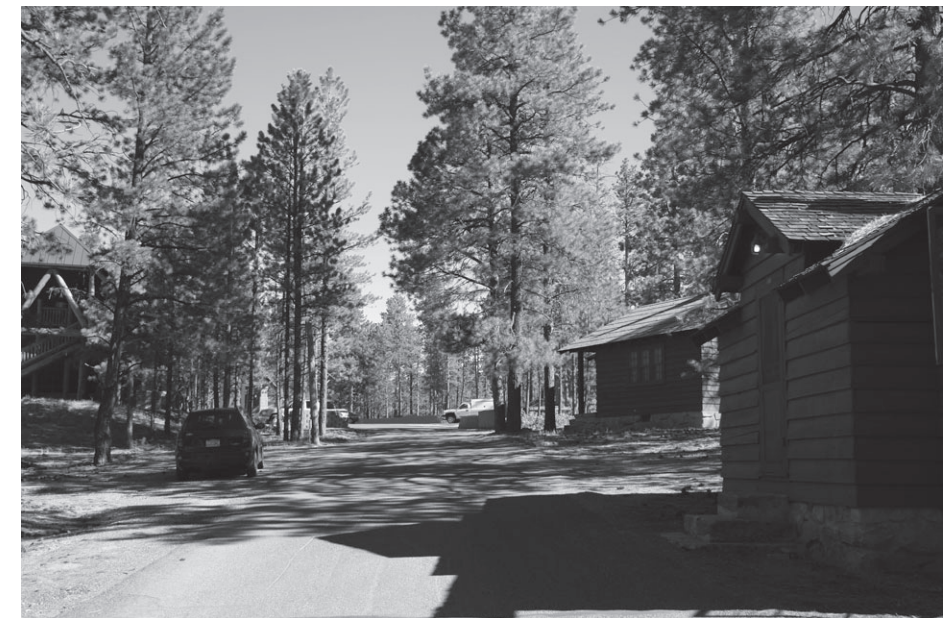
This arrangement of small residential structures was built within a 4 year period starting in 1932 (HS-10 was built slightly later in 1939). Though they are not identical structures, their design follows a uniform selection of materials and use of scale which, combined with their close proximity to one another, has the immediate effect of a small-scale alignment of simple cabins placed in neat rows along either side of a quiet street. Representative of the Simplified Rustic style that was applied to the NPS service buildings during this time period, they remain unadorned and are deliberately void of the more elaborate details of the guest-focused structures (such as cut logs, decorative shingles, and large windows). The natural stone foundations and small entry stoops, painted weatherboard siding and simple gabled roofs reflect the basic tenets of the purity of the Simplified Rustic style. Though there might have been more traffic on the Main Access Road during the period of significance, the road between the cabins would have been a dead end, and would have received only limited, local traffic. The buildings have maintained their intimate relationship with one another, the contour of the land, and the surrounding forest, and only a few small scale features exist to remind one of the contemporary era. The most significant impact to these buildings has been the changes to viewshed caused by the addition of the new Concessionaire Dormitories (*Photograph A/4*).

Photograph A/4. The view from the cabins toward the Concessionaire Dormitories today. During the period of significance, this would have overlooked a forested knoll.

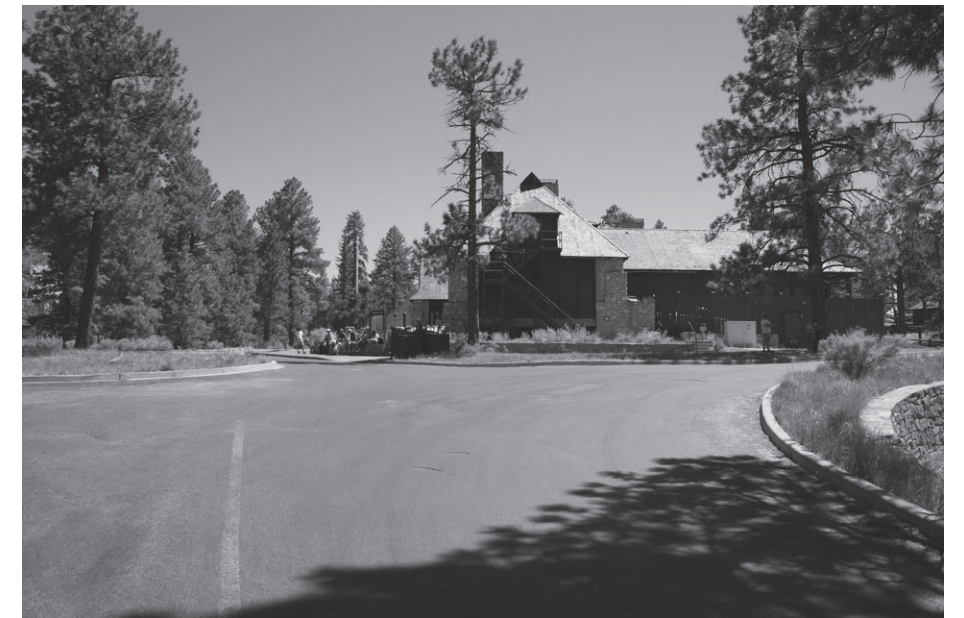
Photograph A/6. The Lodge Access Road as it approaches the Registration and Rear Parking Areas. Registration parking is ahead and to the left behind the trees and vegetation, the larger driveway circles to the right to the Rear Parking area.

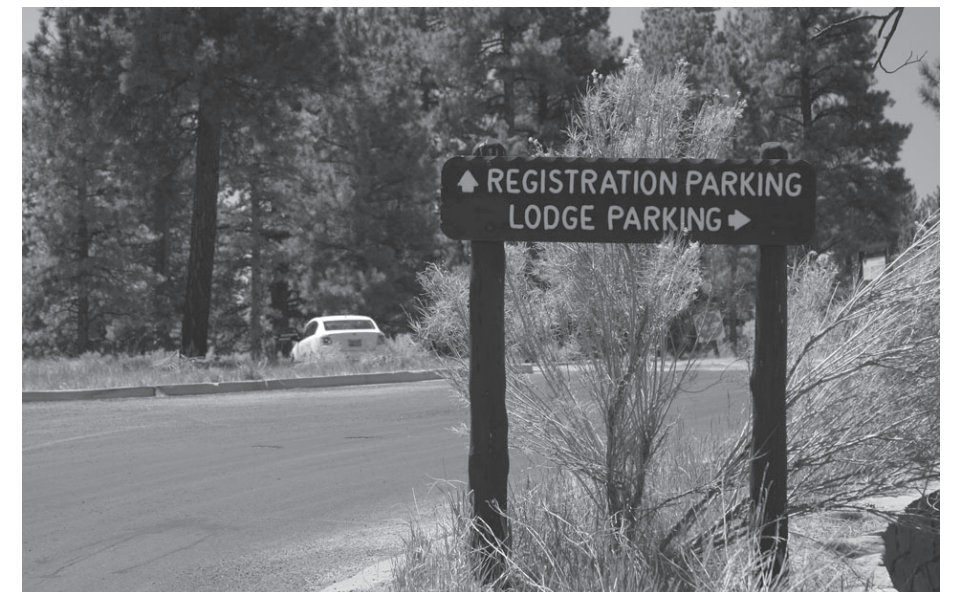
Photograph A/7. Signage indicating registration parking area as separate from Lodge parking, which could create confusion for Lodge visitors.

Signage on the roadways and around the buildings has been changed over time to reflect changes in the layout, circulation and land use. These signs have typically been designed to maintain the Rustic character – often being made of wood or colored in a natural tone. Because the signs evolved over time, they can be inconsistent, confusing or misleading, even to experienced visitors.

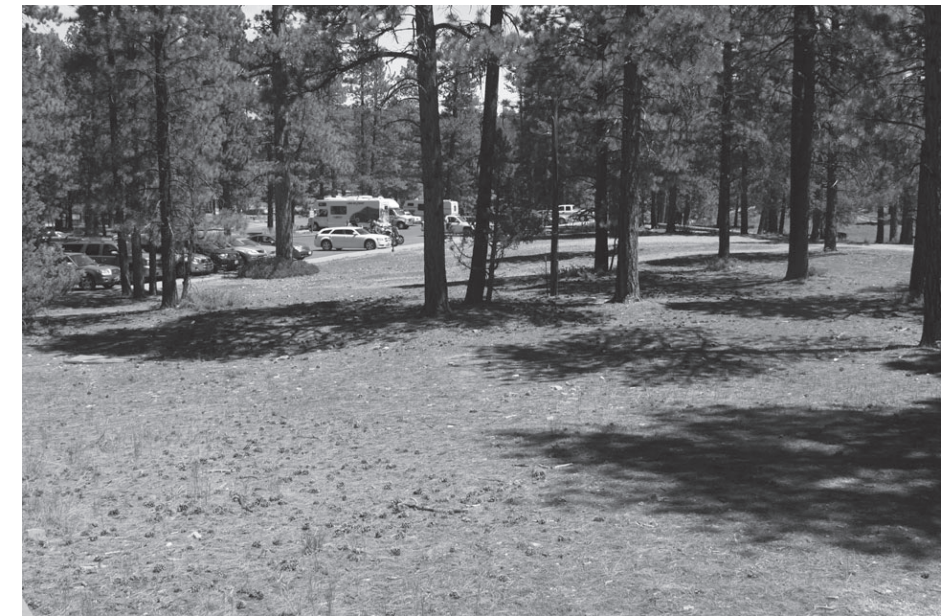
Photograph A/8. The former location of a cluster of Standard Cabin units, now reverted to open space between the Lodge and the Sunrise Motel Unit.

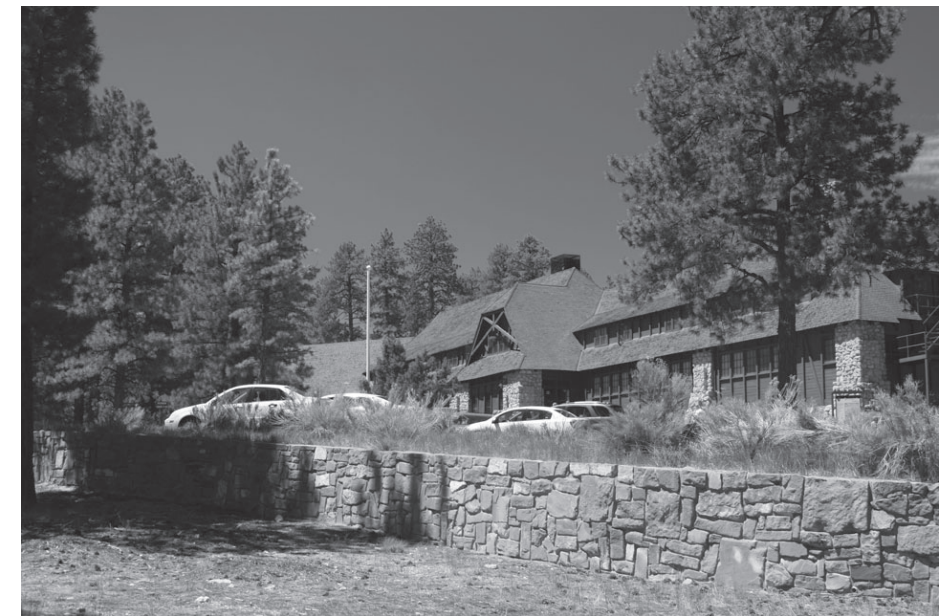
the smaller Standard and Deluxe Cabins, necessitated the creation of areas of cut slopes with retaining walls as well as filled areas which have been seeded and replanted in an effort to return them to a more natural state (see Photograph LD/23 in Chapter 3). Although the clearing associated with Sunset Motel unit in particular has changed the topography immediately around the unit, it did not change the overall topography of the Study Area. The removal of the Standard Cabins from the knolls above the Lodge, however, has changed the way that visitors experience the topography throughout the Study Area. Once a part of the bustling village atmosphere, these knolls now function as open space and occasional parking; the landform now serves as a buffer or barrier, and is not an active part of the visitor's experience.

Photograph A/9. The retaining wall between the Lodge and the Sunrise Motel Unit which creates the space for the Registration Parking Area.

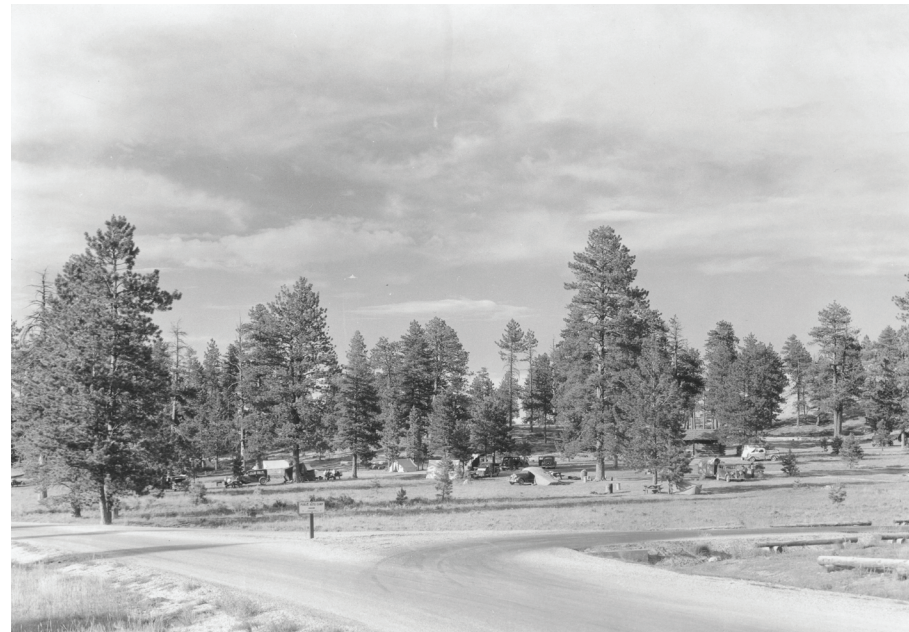
Photograph A/10. The North Campground at the time of its construction in 1935, looking toward the Rim (BCRA Archives ACC381\_CAT3919 #8).

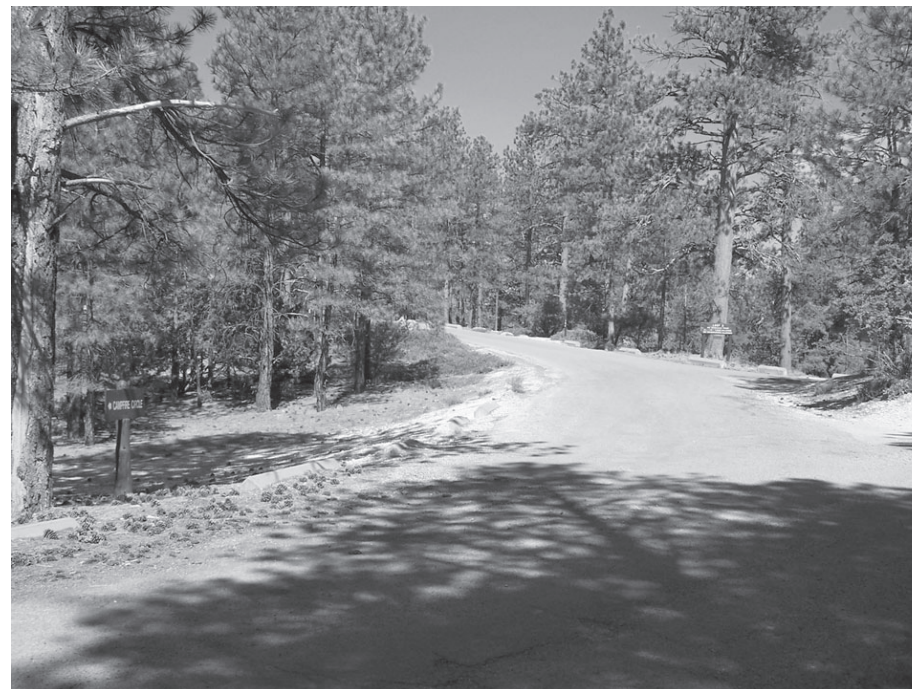
Photograph A/11. The North Campground today. Although this photo is taken from a different vantage point, the change in forest density is obvious.

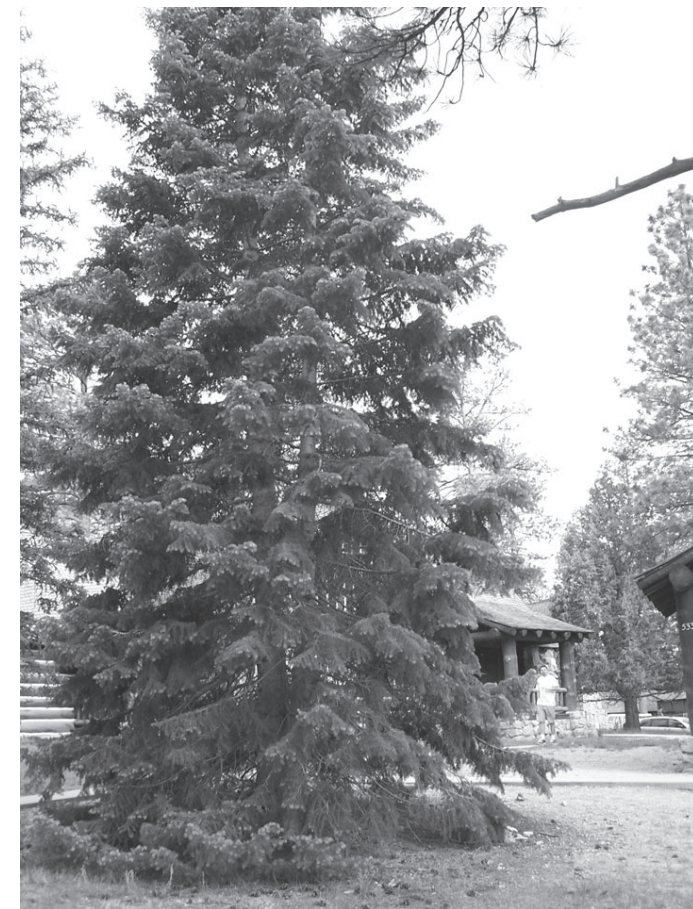
Photograph A/12. A large Douglas Fir in the Deluxe Cabin cluster. This specimen was like planted when the cabins were built, however a number of younger trees in the area indicate that it has naturalized here.

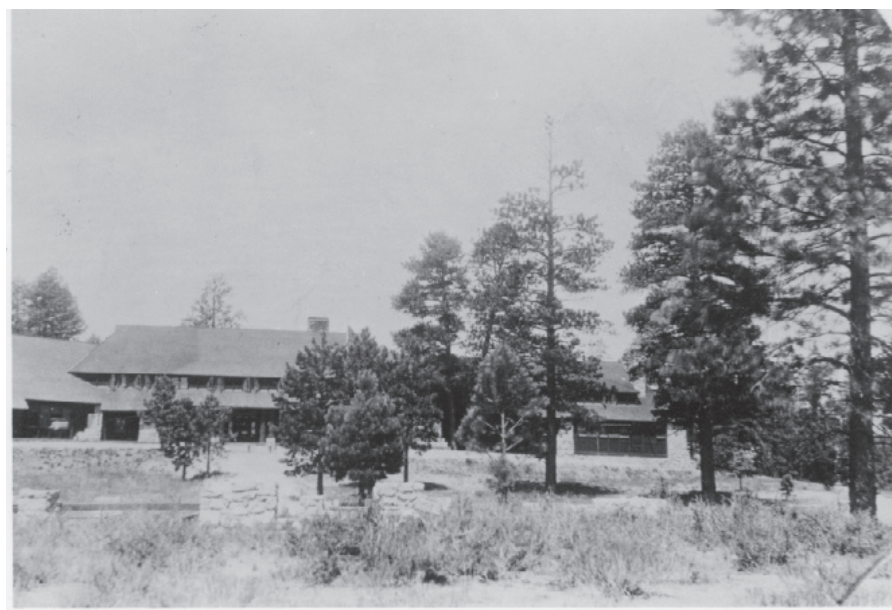
Much of the mature vegetation immediately surrounding the Lodge dates back to the period of significance. Photos of the Lodge show that many of the large pines present today were in place by the late 1930's (*Photographs A/13 and A/14*). Though some of these trees were saplings during the period of significance they are now mature trees and therefore lend a sense of establishment and character to the landscape. Surrounded by mature vegetation the Lodge itself and the landscape context have a blended appearance that is consistent with the Rustic style (the building seems a part of the landscape) and intent of the Park designers.

Photograph A/13. The front of the Lodge circa 1930, before the campfire ring was removed (BCRA Archives Cope BRCA 2).

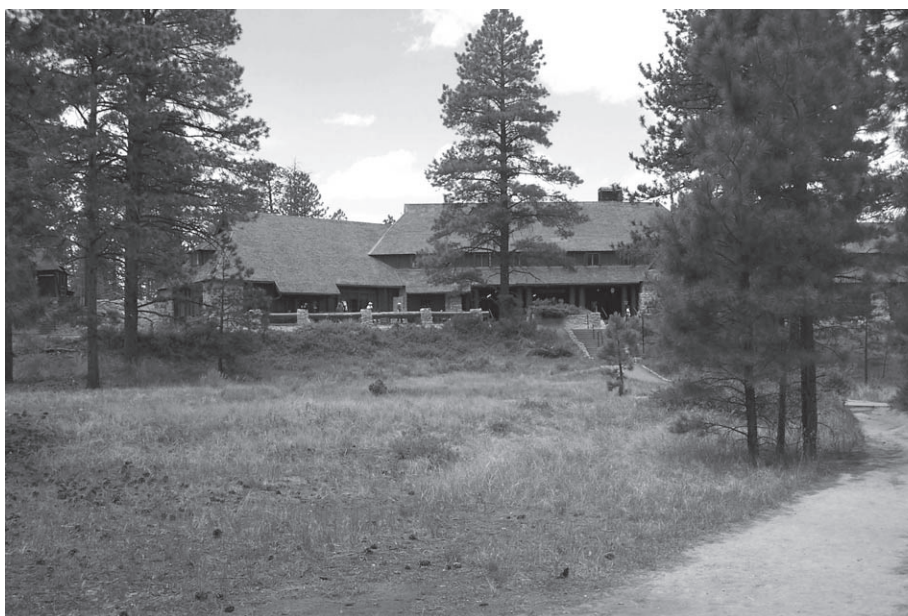
Photograph A/14. The front of the Lodge today. Several trees from the 1930's image have matured, lending a more established feeling to the Lodge.

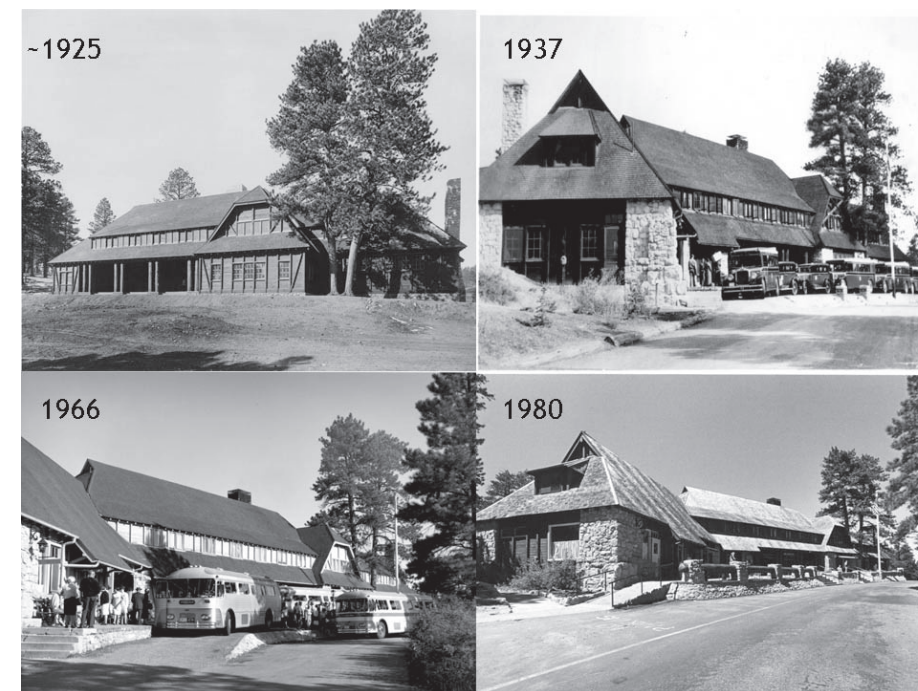
Photographs of the front of the Lodge during the period of significance and later show two specimen Ponderosa pine trees near the building entry (*Photograph A/15 and A/16*). The visibility and distinctiveness of these trees made them an important part of the Lodge's façade, as well as giving the building a sense of having been a part of the forest for some time. These trees were removed in the 1990s as a result of their threat to the foundation of the building, and were not replaced. Although other mature vegetation surrounds the Lodge building to help ensure its forest retreat character, the absence of the landmark trees does have a significant impact on the structure's appearance.

Photograph A/15. A montage of the Lodge with the two prominent Ponderosa pines in place (collected from BCRA Archives).

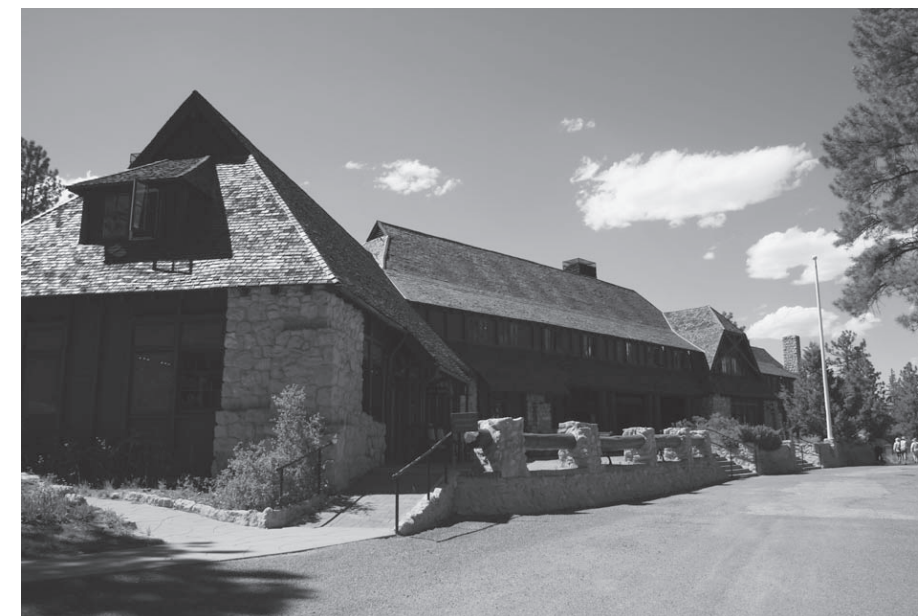
Photograph A/16. The front of the Lodge today from a similar angle with the prominent trees missing.

rear door to the lobby does not communicate the sense of grandeur that the main entrance was designed to evoke. Restoring the intended entry pattern to the building will have a significant impact upon the way visitors to the Park will experience the Lodge, and will contribute to the understanding of the Lodge as an historic structure with a value of its own.

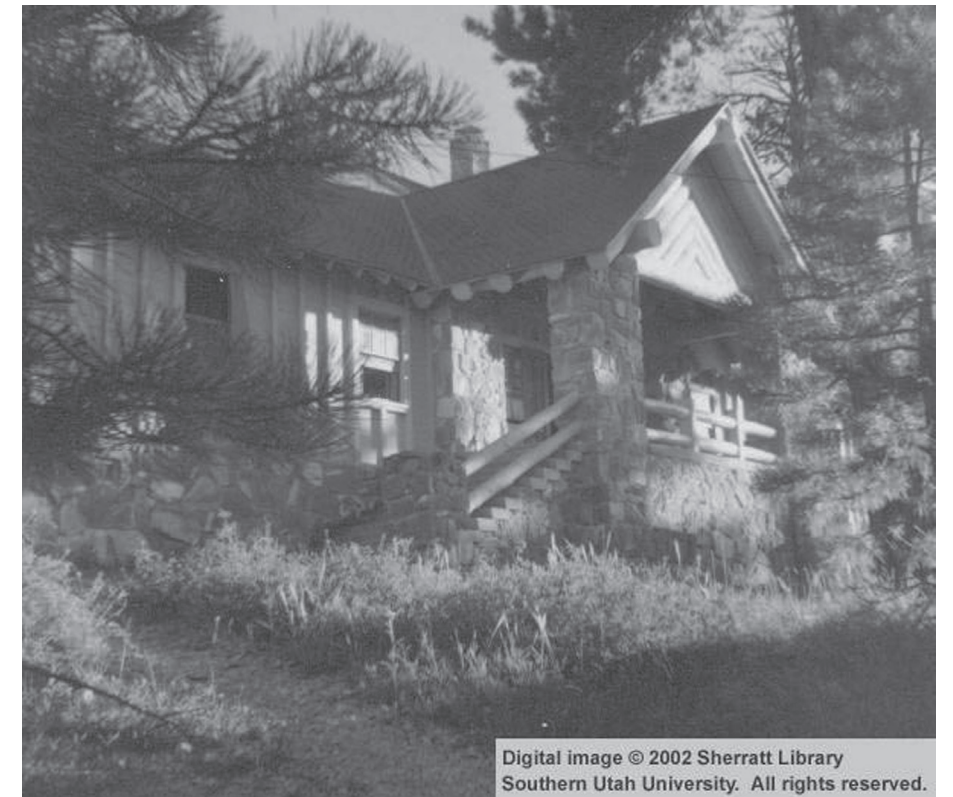
Photograph A/17. The front of the Male Dormitory circa 1940. Note the natural surface path leading toward the entry running bottom, center to left on picture. (Sherratt Library).

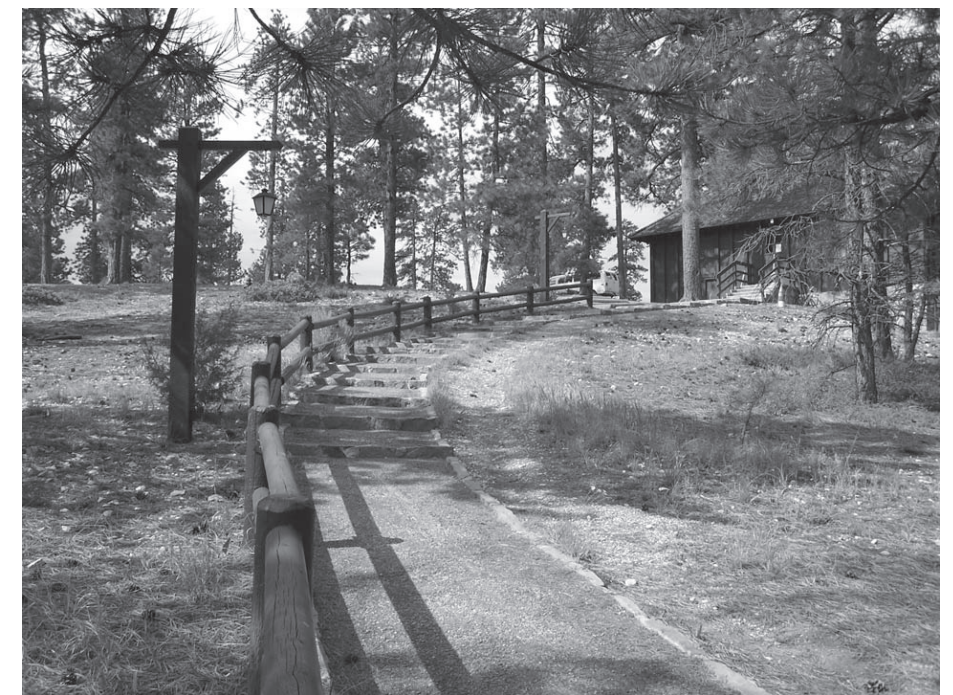
Photograph A/18. The existing path to the side entry to the Male Dormitory.

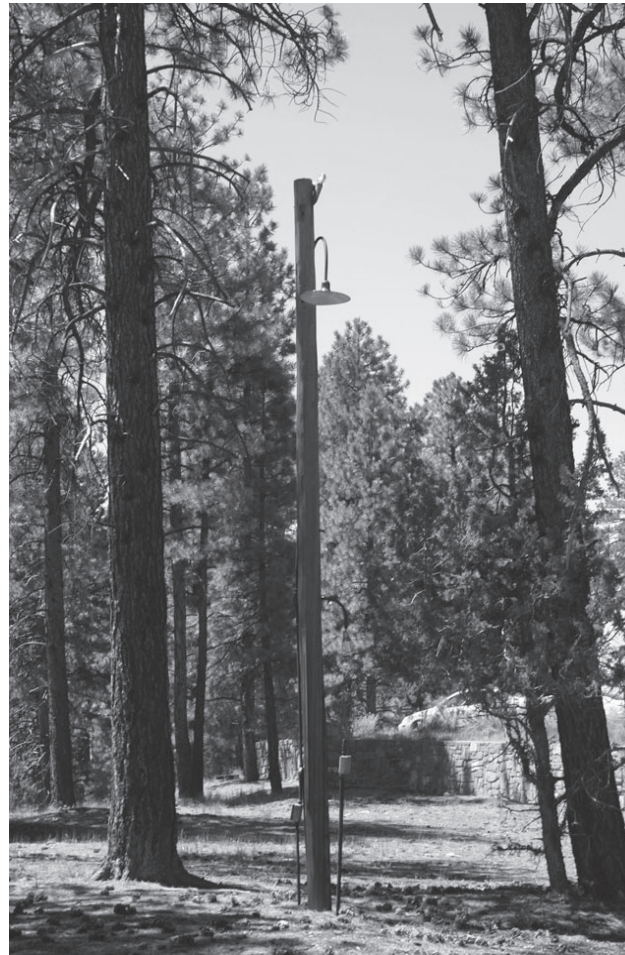
A few small scale features remain in areas where the Standard Cabins were removed that hint at the historic conditions. Items such as electrical boxes, light poles and flat pads seem to float in the forest in certain areas, becoming clues for those interested in the history of the Lodge (*Photograph A/19*).

Photograph A/19. A utility pole with a light remaining in the area where the Standard Cabins were removed between the Lodge and the Sunrise Motel unit.
