CONDITION REPORT AND TREATMENT PLAN FOR TRURO HIGHLANDS HISTORIC DISTRICT

CAPE COD NATIONAL SEASHORE

National Park Service, Boston, Massachusetts, 2007

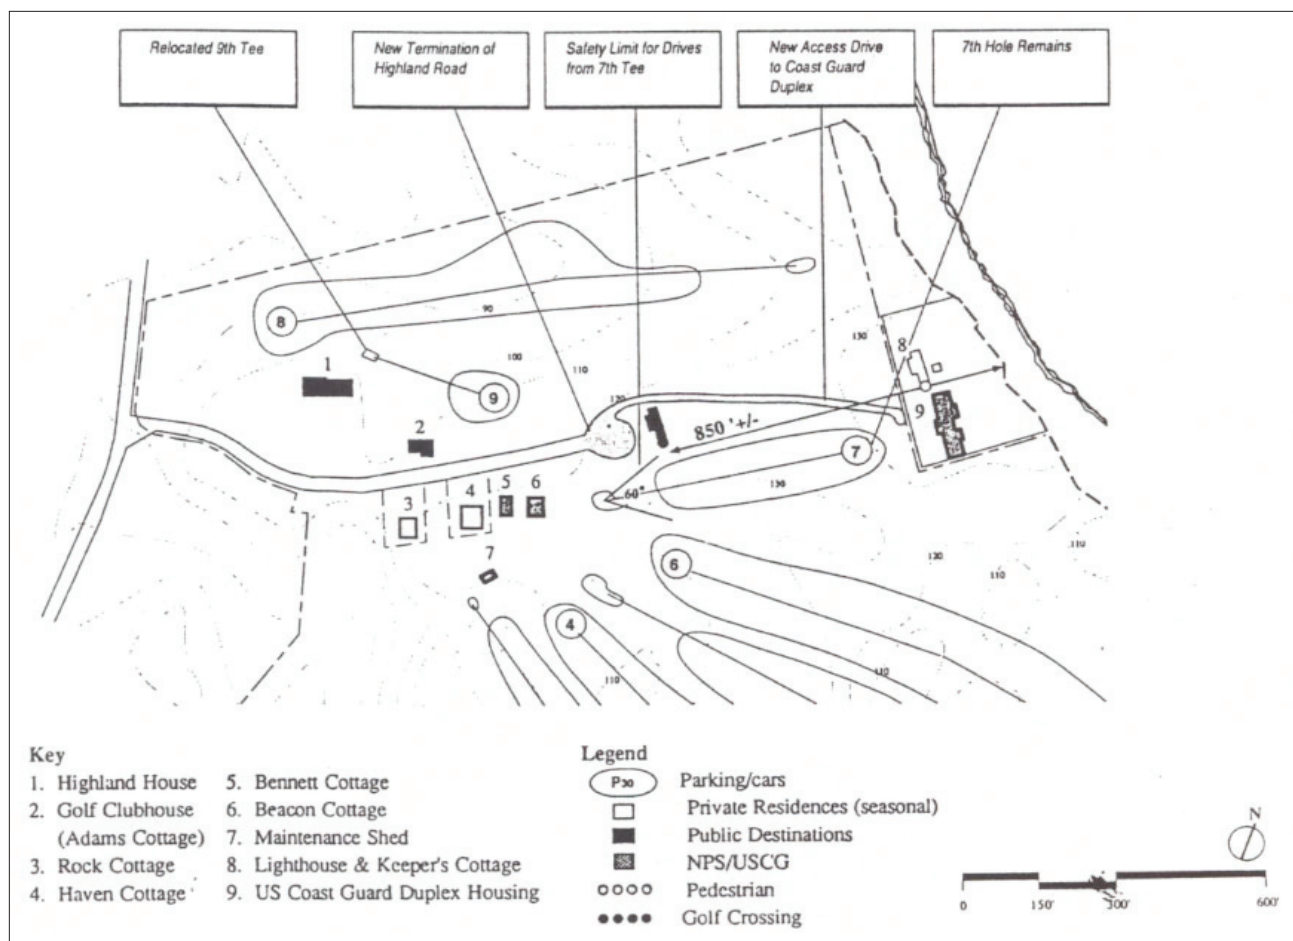
Figure 0.24: Relocation plan for the Highland Light. Source: *Highland Light Relocation Planning Study: Relocation Alternatives Report*. April, 1994.

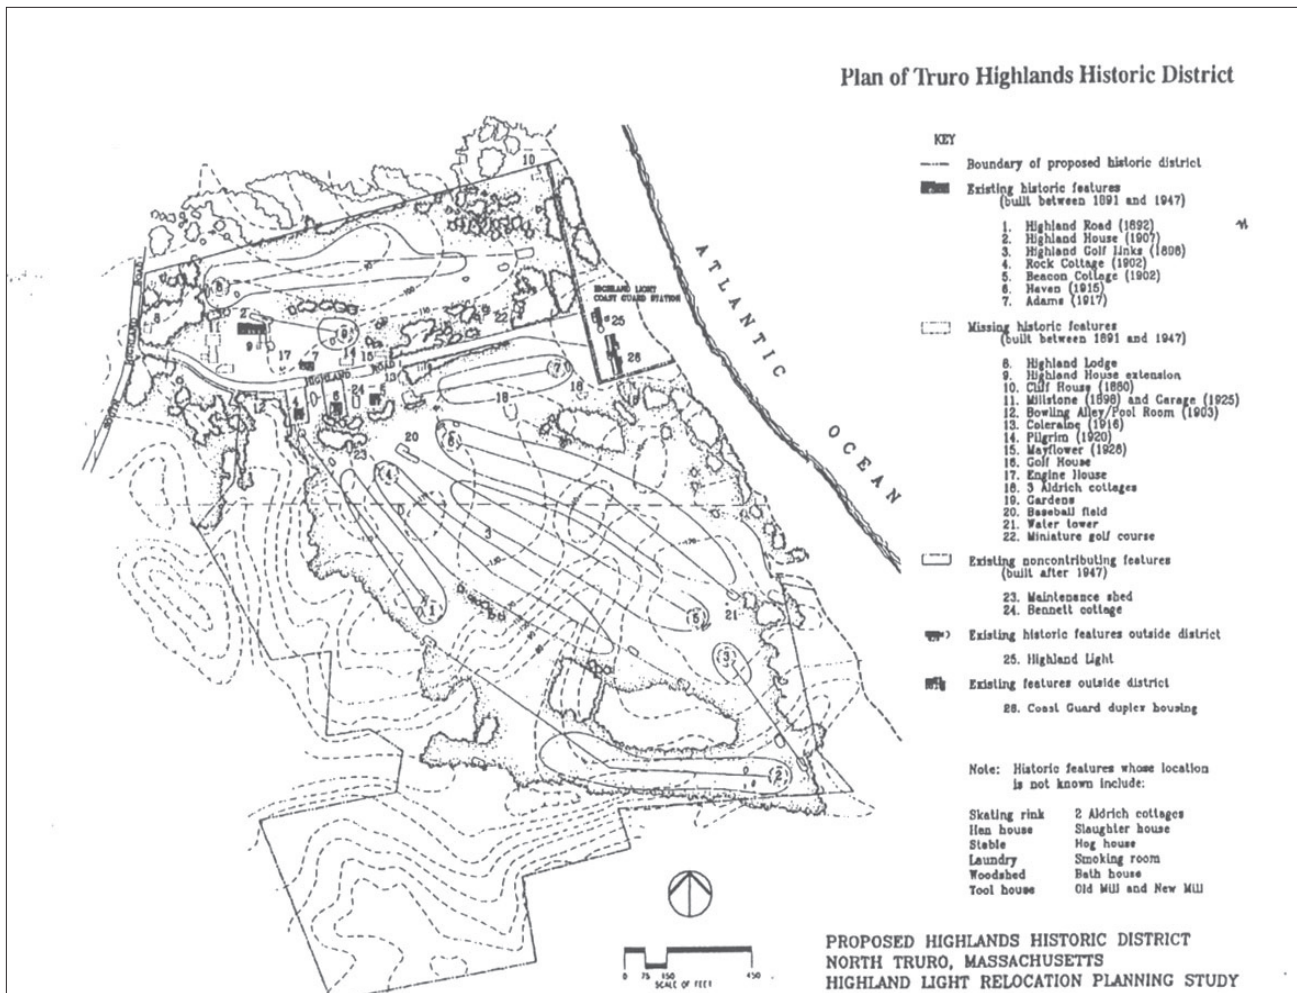
Figure 1.0: Truro Highlands Historic District. Prepared by David Dixon/Goody Clancy and Associates, 1994.

This chapter describes the landscape within and surrounding the Truro Highlands Historic District in 2006. The site is described according to the landscape characteristics as defined in the National Park Service *Guide to Cultural Landscape Reports* and includes natural systems and topography, spatial organization, land use, circulation, buildings and structures, vegetation, views, small-scale features and archeological sites. The narrative is supported by an existing conditions plan and photographs taken in June 2006 (Figure 1.0 and Drawing 1.0).

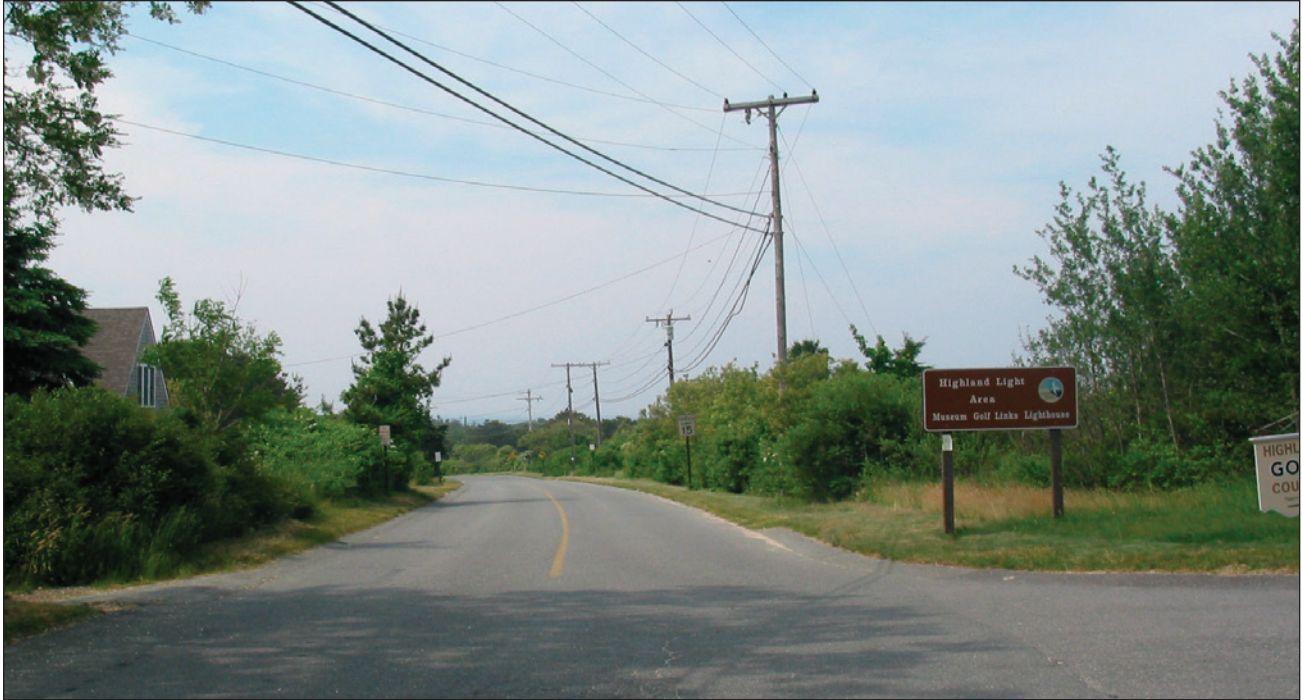
Figure 2.0: Circulation
View of South Highland Road looking northeast. (OCLP, 2006).

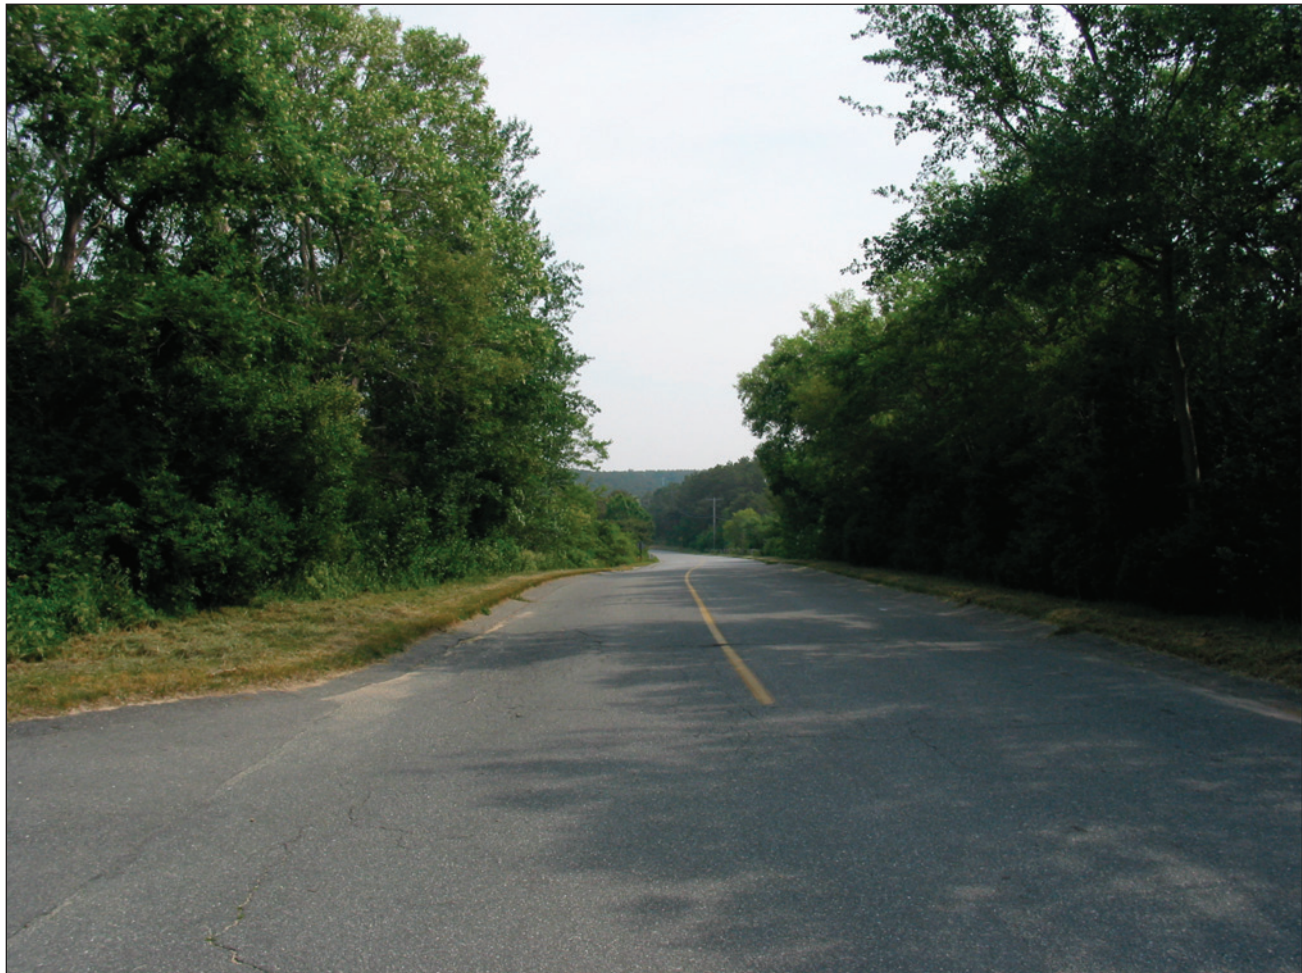
Figure 2.1: Circulation
View of South Highland Road looking southwest (OCLP, 2006).

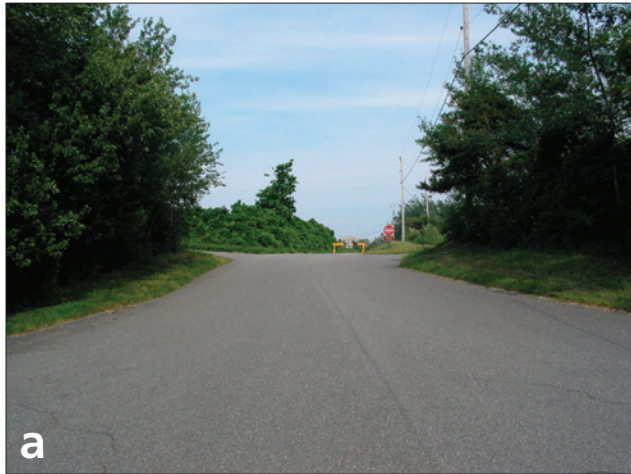
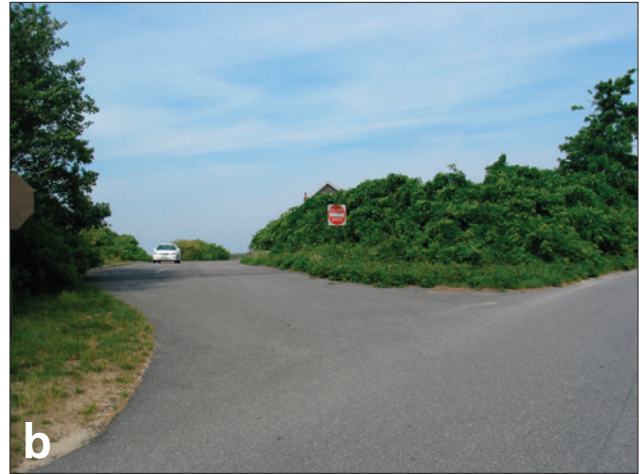
Figure 2.2: Circulation

(a) View of Highland Road entrance looking southeast; (b) View of parking area entrance on north side of Highland Road looking northeast (OCLP, 2006).

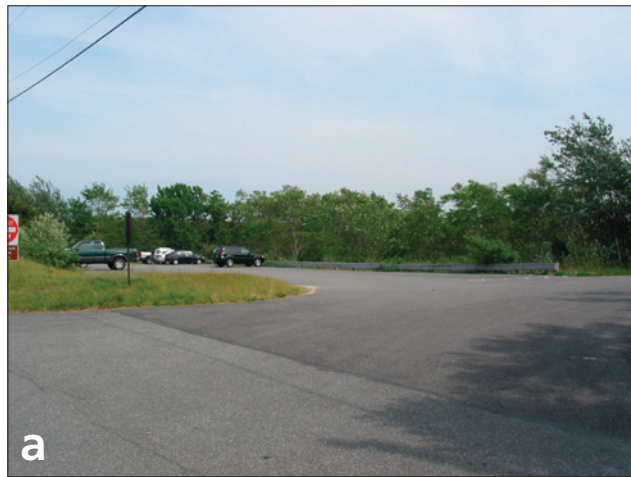
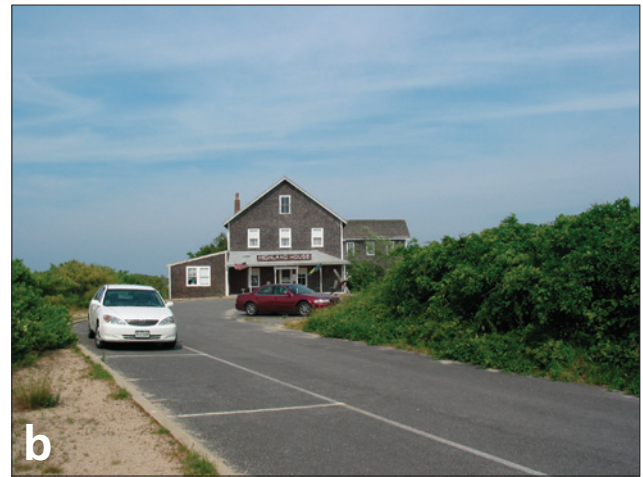
Figure 2.3 Circulation

(a) View of parking area entrance on south side of Highland Road looking southeast; (b) View of parking area entrance, west of Highland House, on north side of Highland Road looking east. Highland House can be seen in the background (OCLP, 2006).

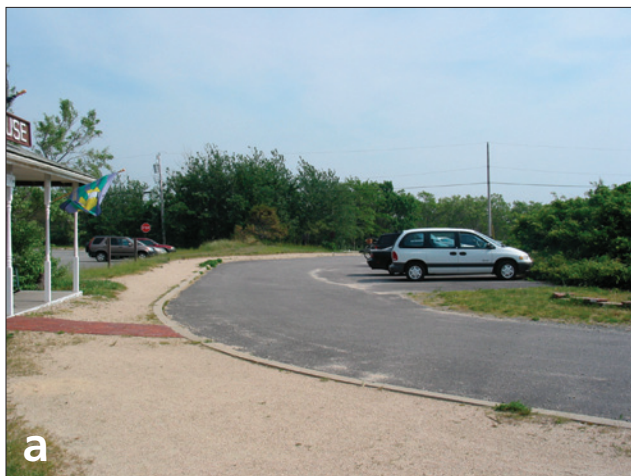
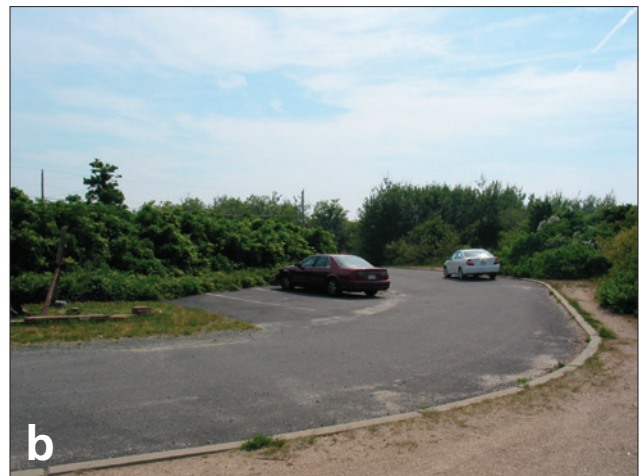
Figure 2.4: Circulation

(a) View of parking area entrance, west of Highland House, on north side of Highland Road looking south; (b) View of parking area entrance on north side of Highland Road looking west (OCLP, 2006).

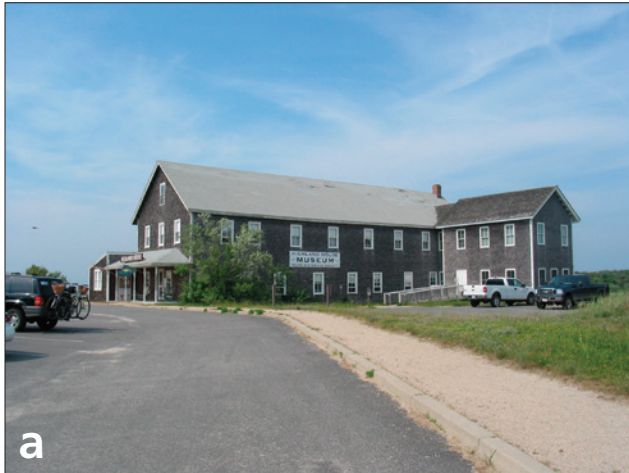
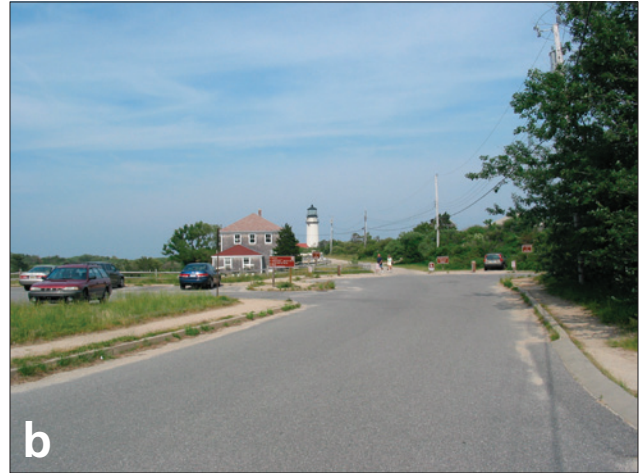
Figure 2.5: Circulation

(a) View of parking area, west of Highland House, on north side of Highland Road looking north; (b) Highland Road looking east (OCLP, 2006).

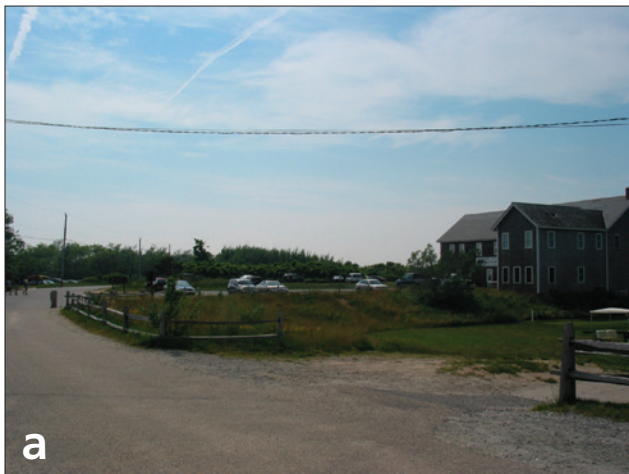
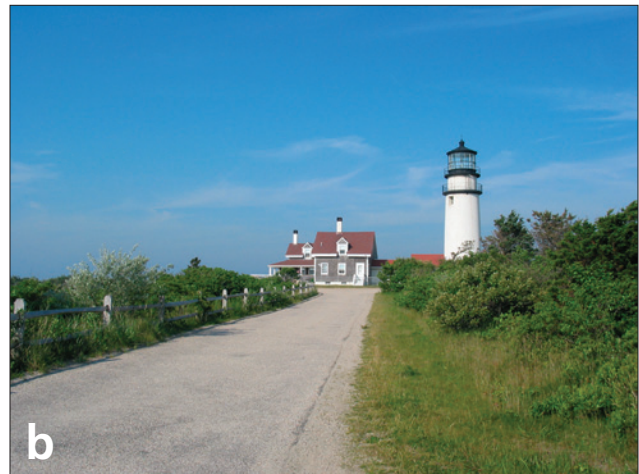
Figure 2.6: Circulation

(a) View of parking area entrance, south of Highland House, on north side of Highland Road looking north; (b) Highland Road and Highland Golf Links club house (Adams Cottage) looking east. The Highland Light can be seen in background (OCLP, 2006).

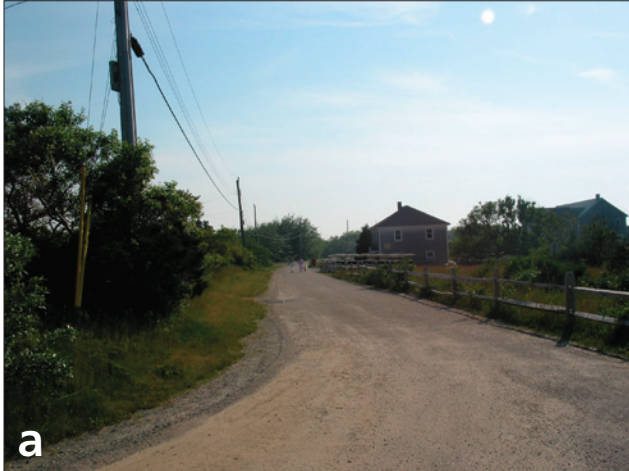
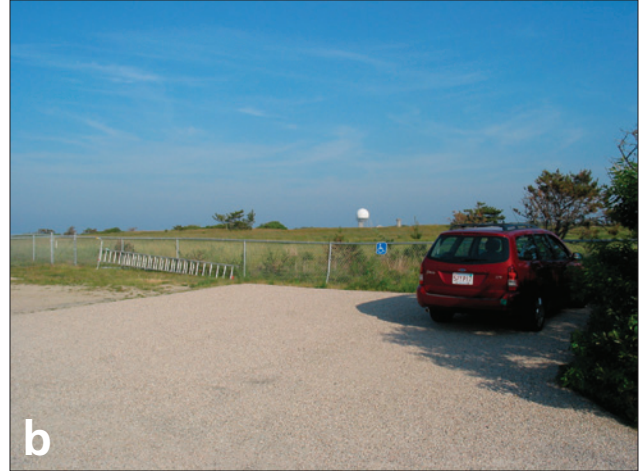
Figure 2.7: Circulation

(a) View of Highland Road looking northwest. Highland House can be seen in seen in background; (b) Highland Road Links looking east. The Highland Light can be seen in background (OCLP, 2006).

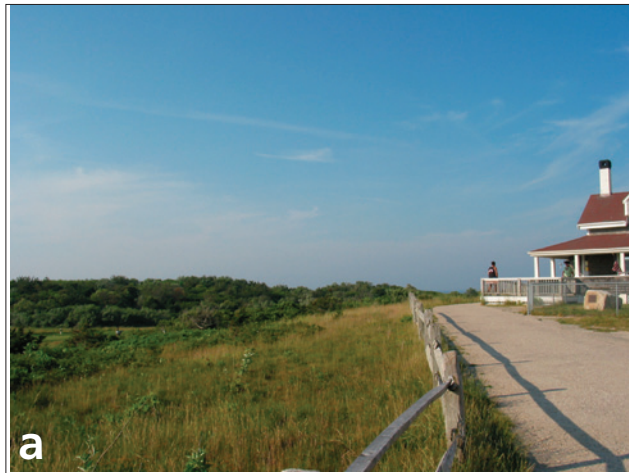
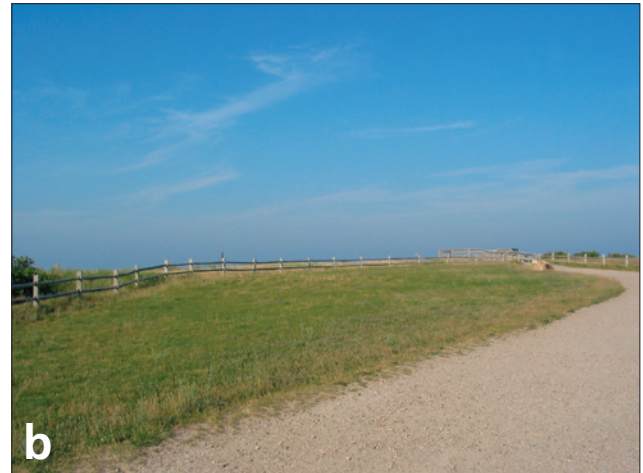
Figure 2.8: Circulation

(a) Highland Road and Highland Golf Links club house (Adams Cottage) looking west; (b) Highland Light parking area looking southeast (OCLP, 2006).

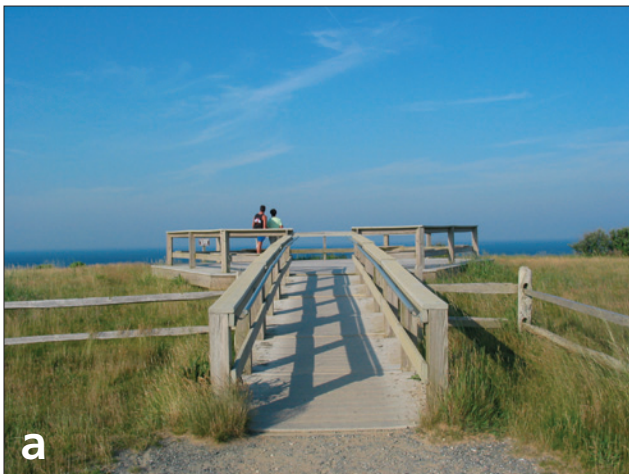
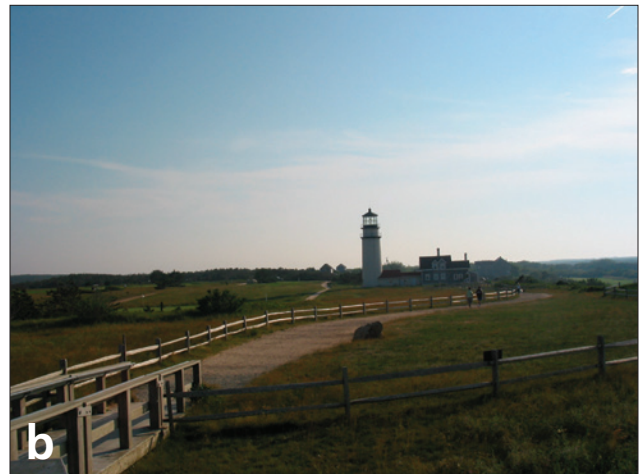
Figure 2.9: Circulation

(a) Photo of Highland Road corridor, presently walking path to Lighthouse. View looking east; (b) View of walking path to observation deck, east of Highland Light, looking southeast (OCLP, 2006).

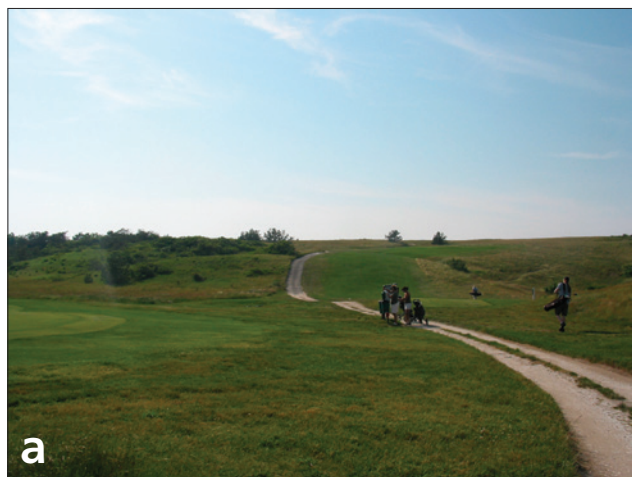
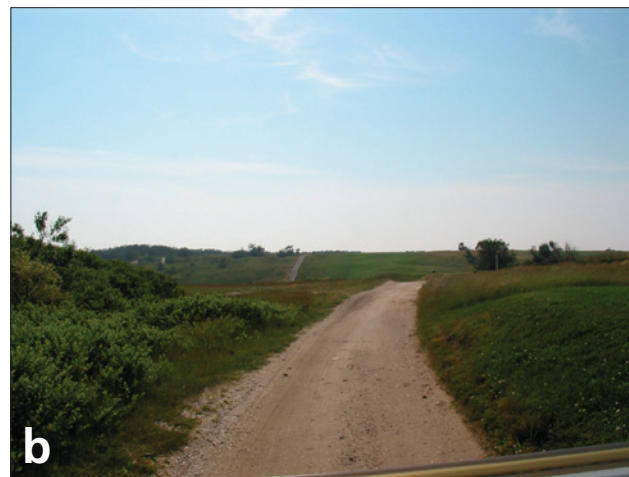
Figure 2.11: Circulation

(a) View of asphalt cart path located on hole #2 looking northwest; (b) View of parallel pathways, naturally formed, located on hole #2, looking northwest (OCLP, 2006).

Recommendation: To minimize the threat of erosion, maintenance paths should be alternated to avoid wear. With exception to areas where scattering is allowed, cart users must be informed of the delicate nature of the area and be aware that once on the course, they must strictly stay on the delineated cart routes.

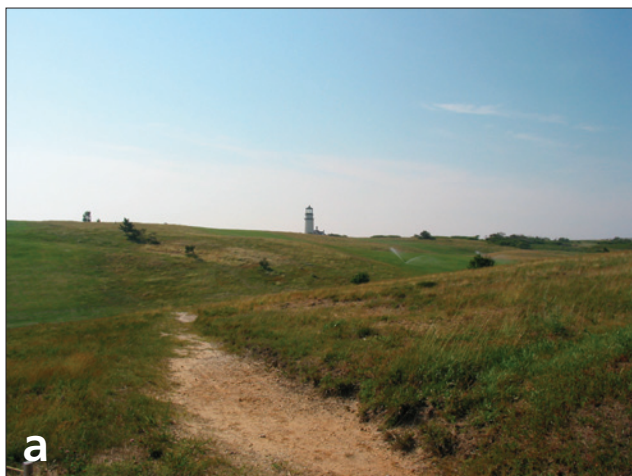
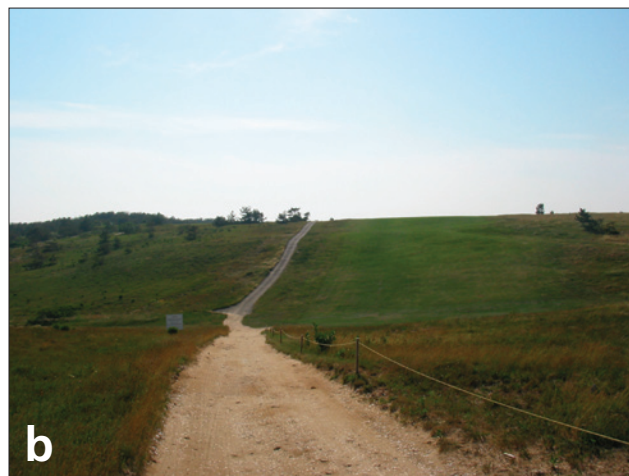
Figure 2.12: Circulation

(a) View of cart path on hole #3 looking southeast. Path consists of crushed oyster shells and gravel; (b) View of cart path on hole #4 looking northwest. Path consists of crushed oyster shells and gravel (OCLP, 2006).

Repairs should be made to existing carts paths that have, over the years, eroded and are now depressed into the landscape. These repairs should aim to fill in and lift such paths and shorten them where possible. In addition, paths should not start or finish on a slope. Path sections that currently reside on a slope have the worst erosion problems. Filling in sunken paths with the appropriate materials and shortening selected paths will reduce the visual impact of the path and restore a more authentic links golf character (Figure 3.25 and Drawing 3.0).

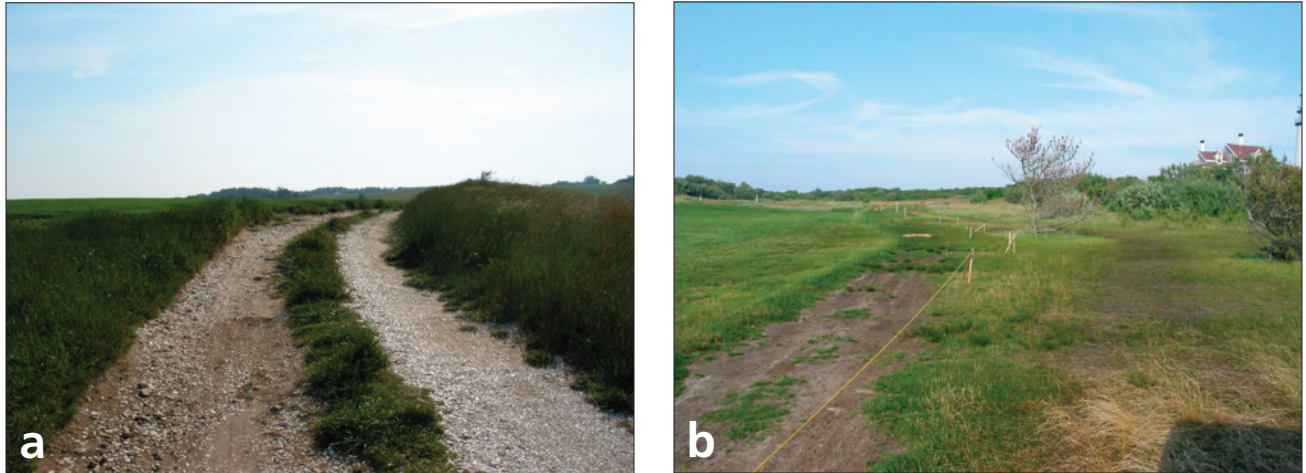
Figure 2.13: Circulation

(a) View of pedestrian access trail located on hole #4 looking southeast; (b) View cart path located on hole #4 looking northwest. As shown in this photograph, cart paths are constructed of many different materials (OCLP, 2006).

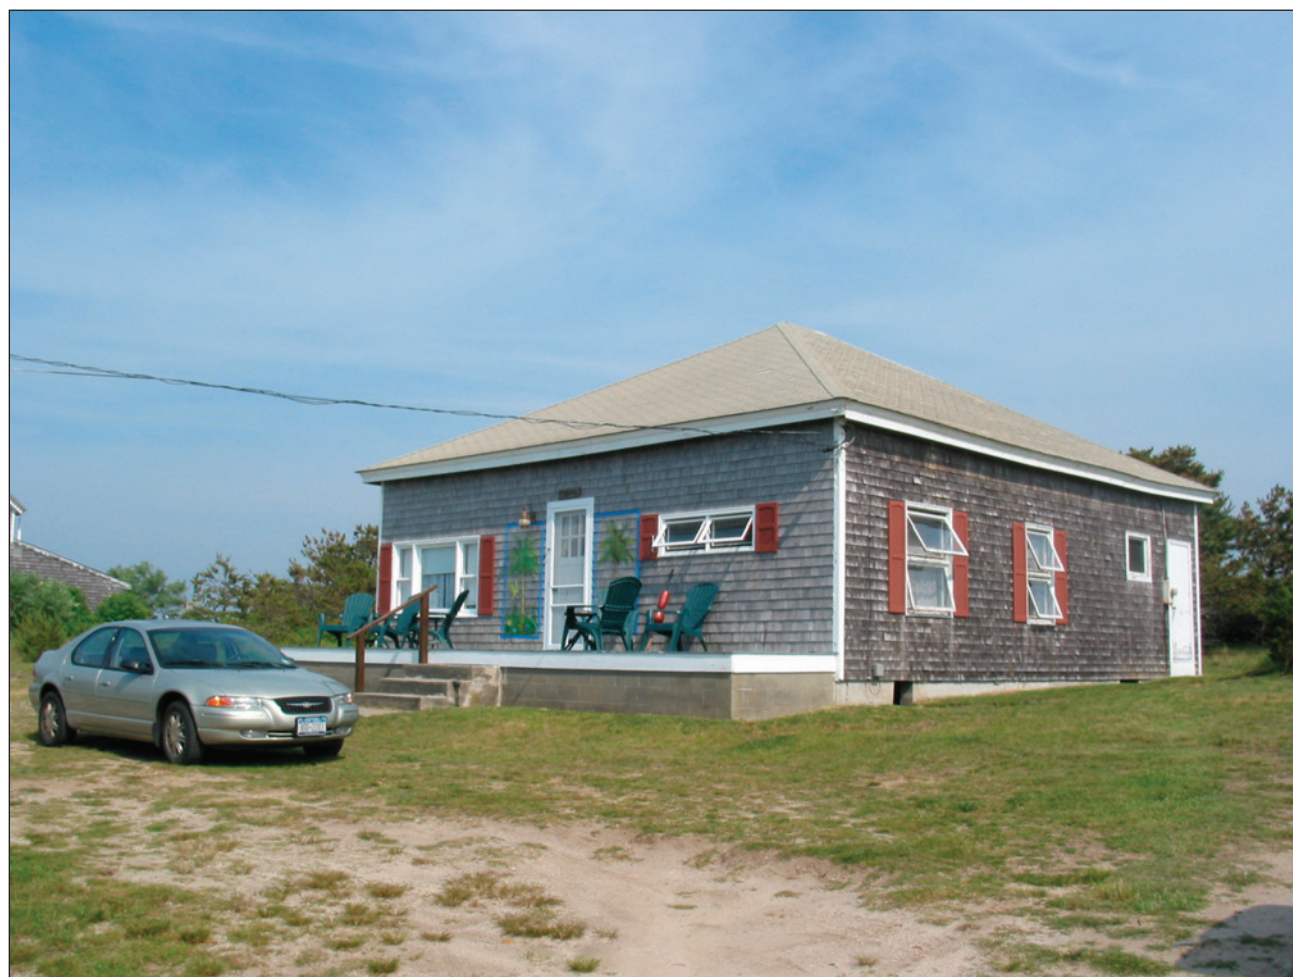
Figure 2.16: Buildings and Structures
View of Rock Cottage, constructed in 1902, looking southwest (OCLP, 2006).

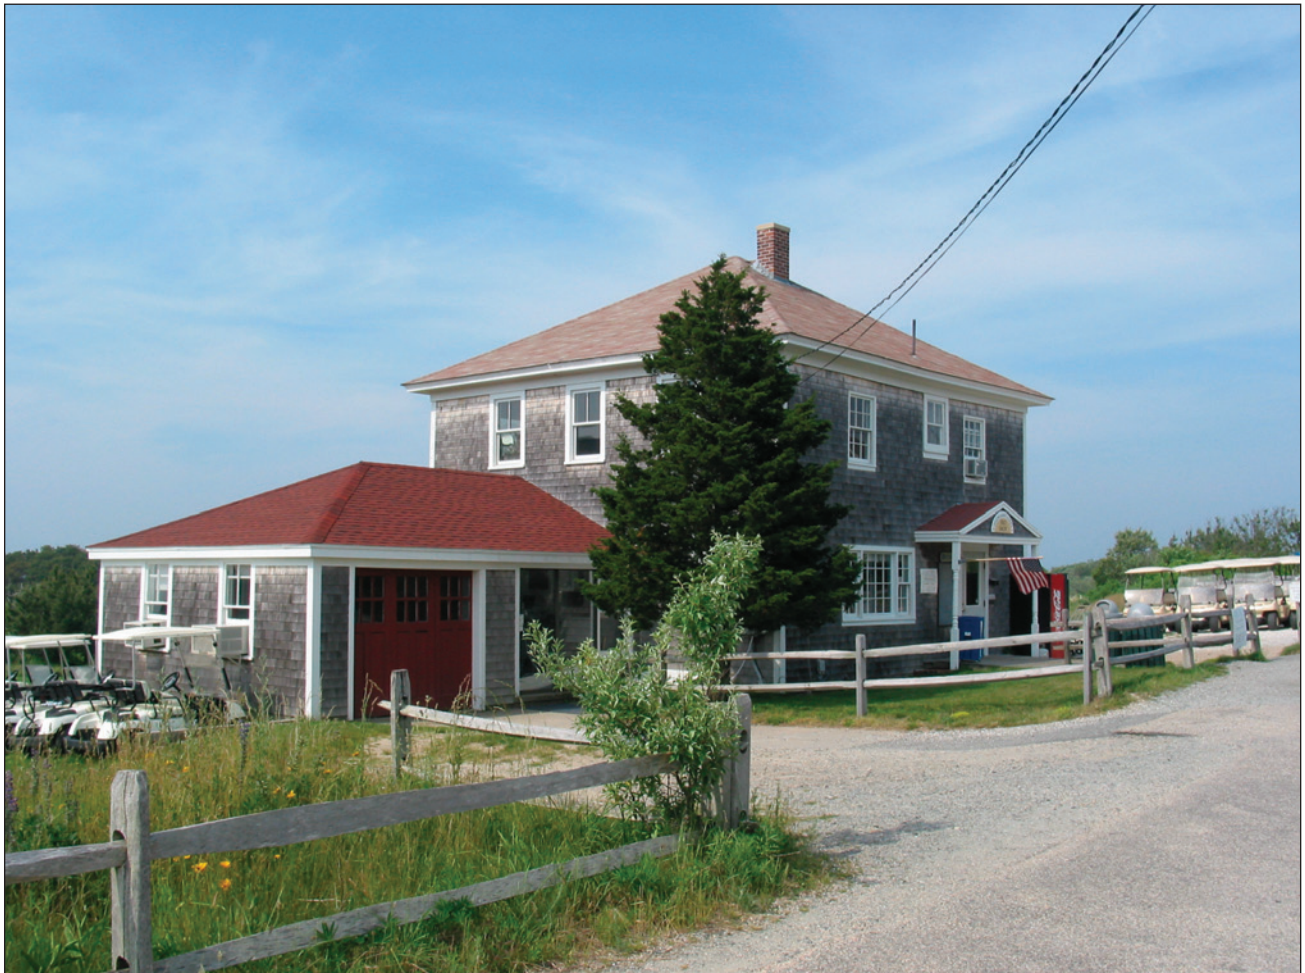
Figure 2.19: Buildings and Structures

View of the Highland House, constructed in 1906-1907, looking northeast. (OCLP, 2006).

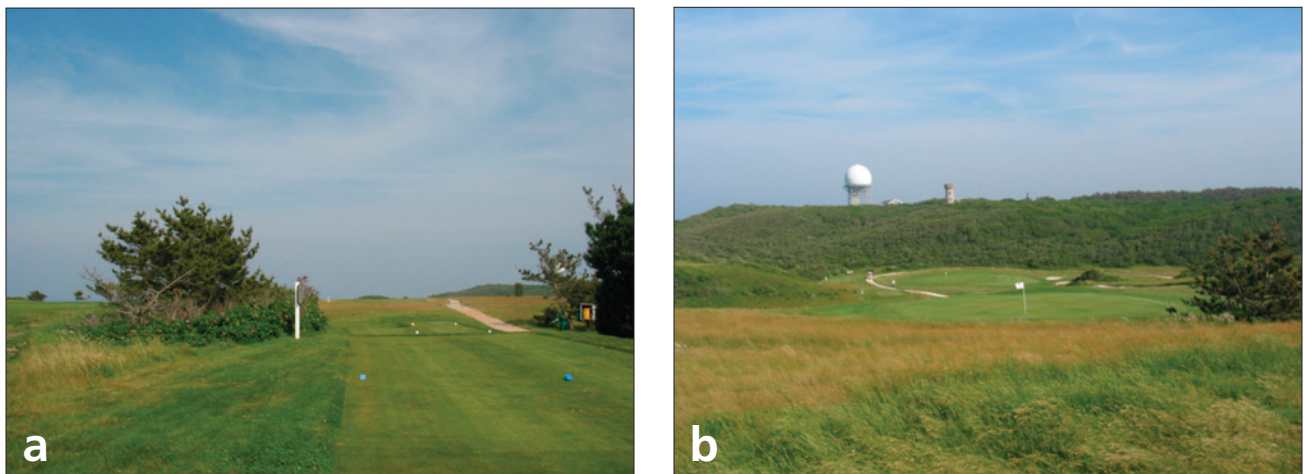
Figure 2.24: Vegetation

(a) Photo of sandplain grasslands with sporadic tree/shrub groupings within highland Golf Links; (b) View looking southeast of fairway, rough and surrounding native vegetation within the Highland Golf Links (OCLP, 2006).

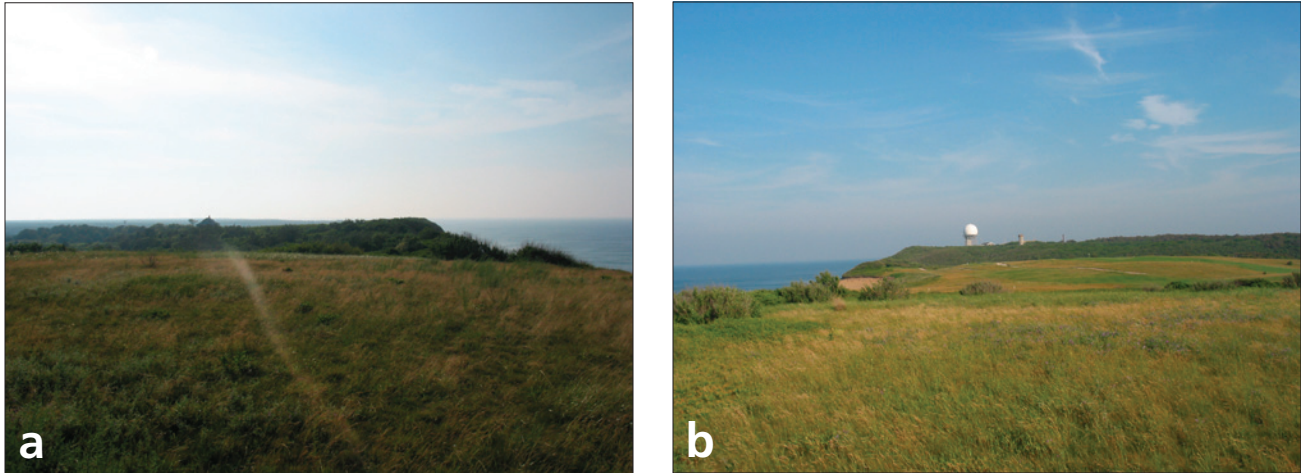
Figure 2.25: Vegetation

(a) View looking southeast of the tee box at hole #4 and a grouping of bushy rockrose (*Helianthemum dumosum*); (b) Photo of sandplain grasslands with sporadic tree/shrub groupings within highland Golf Links. Pitch pine/scrub oak barrens can be seen in the background (OCLP, 2006).

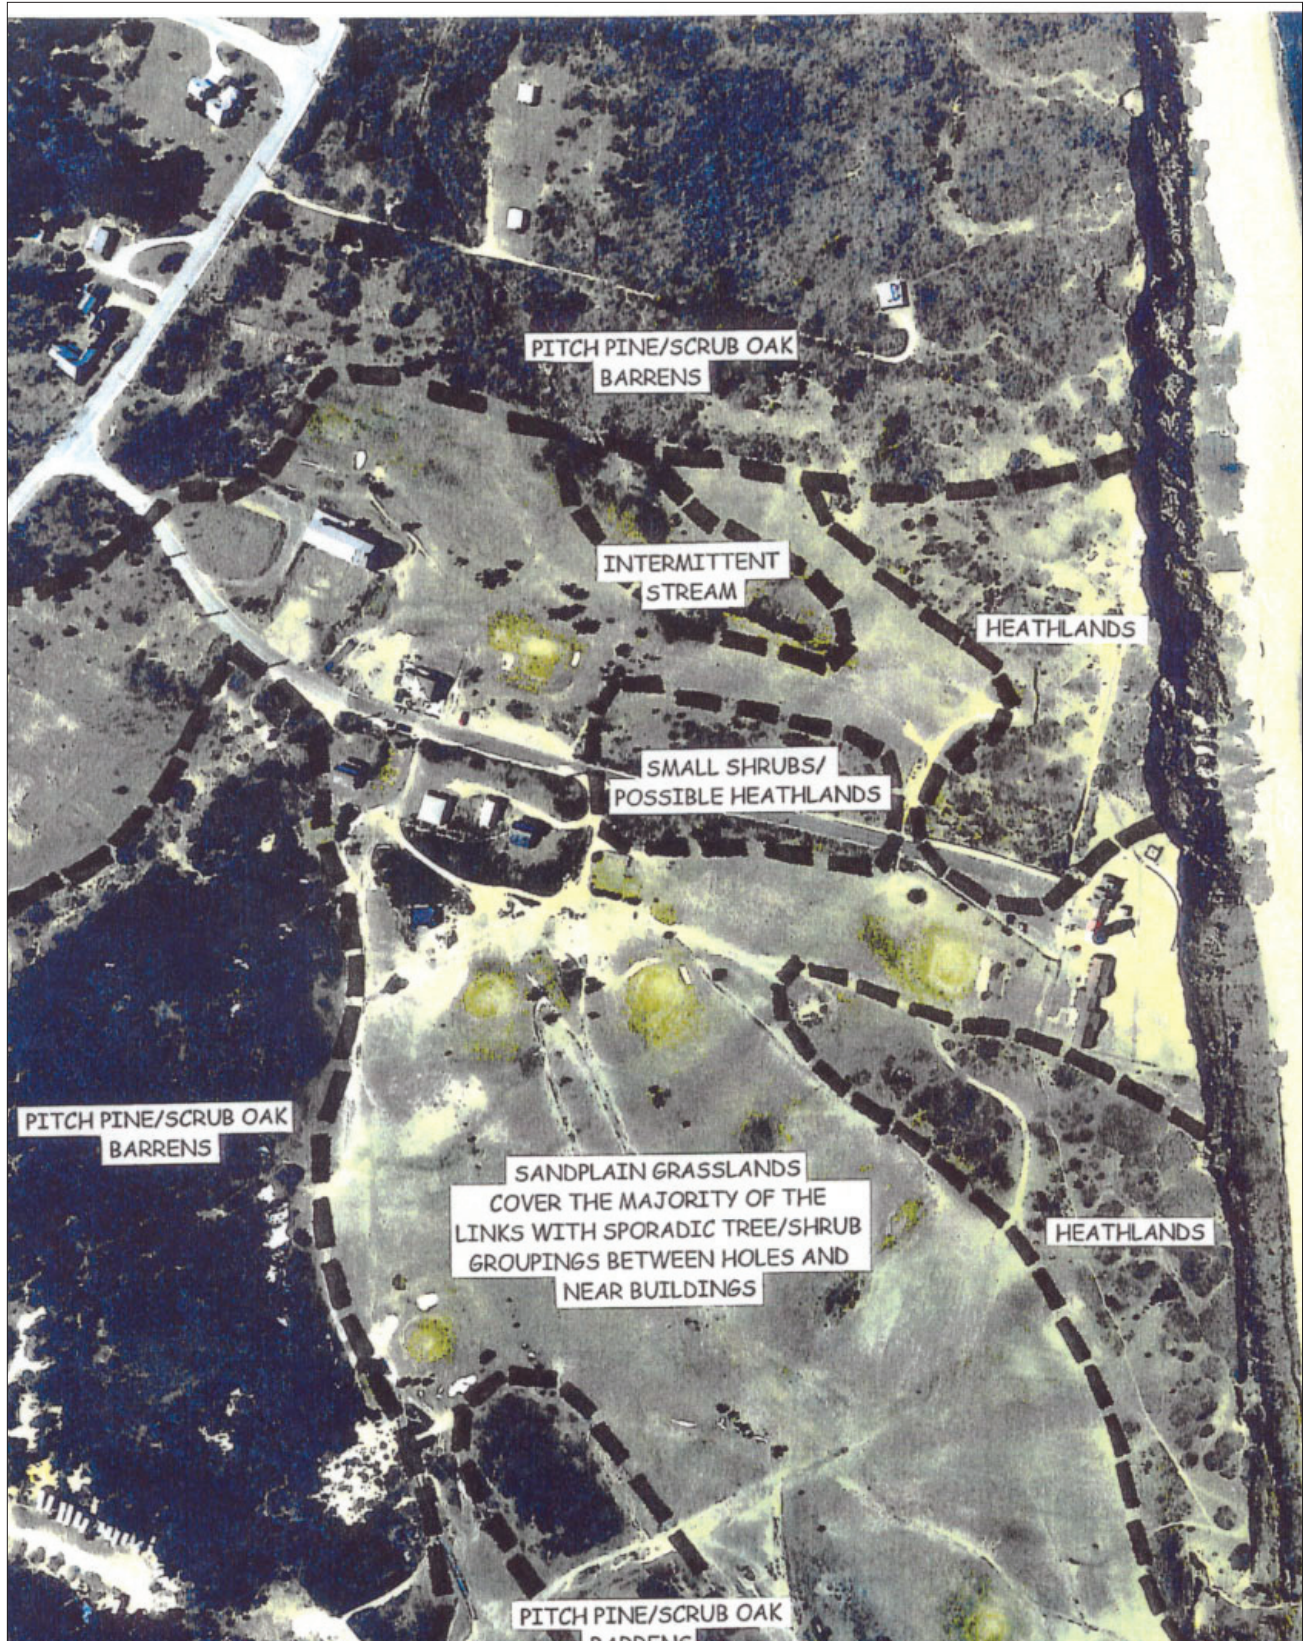
Figure 2.26: Vegetation

(a) View looking north of the heathlands surrounding the western edge of the Highland Golf Links; (b) View looking south of the heathlands, pitch pine/scrub oak barrens, sandplain grasslands and sporadic tree/shrub groupings (OCLP, 2006).

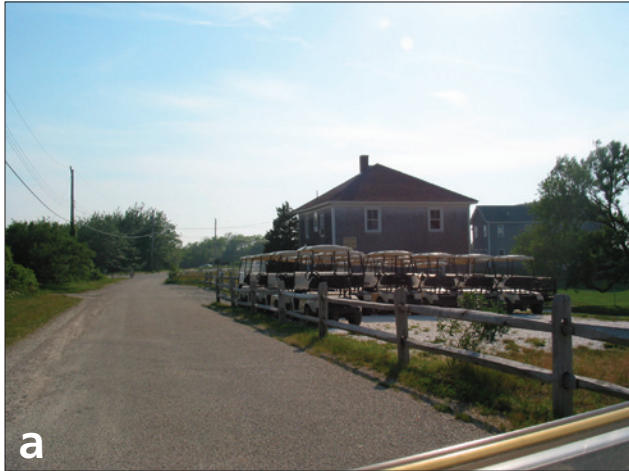
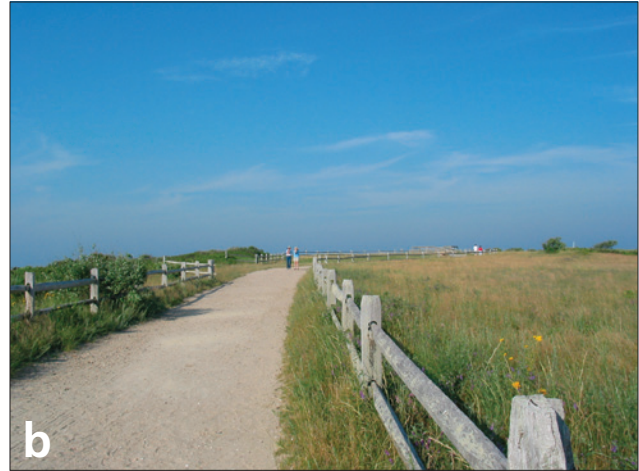
Figure 2.32: Small-scale features- Fences

(a) View of wood post and rail fencing that borders the northern edge of Highland Road from the Highland House to the Highland Light; (b) View of wood post and rail fencing that borders the northern and southern edges of the walking path from the Highland Light to the observation deck (OCLP, 2006).

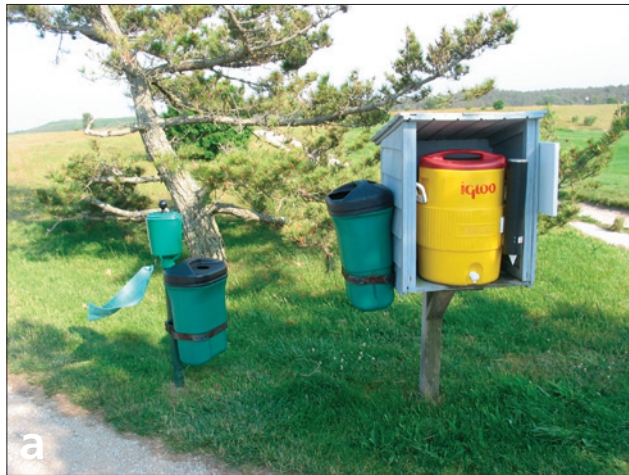
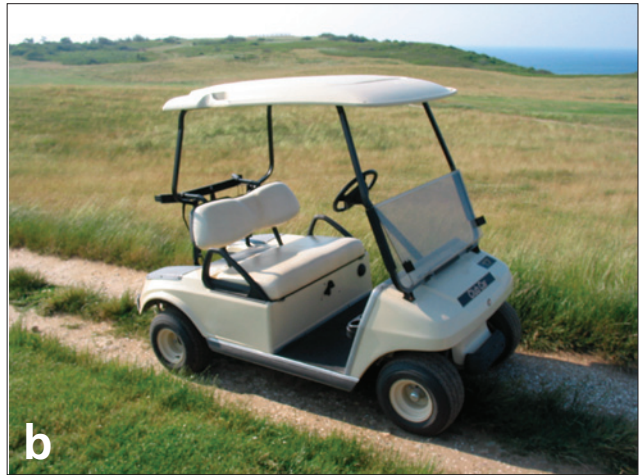
Figure 2.33: Small-scale features- Miscellaneous

(a) View of golf ball cleaner and water cooler. These features are found throughout the golf course; (b) Photo of golf cart (OCLP, 2006).

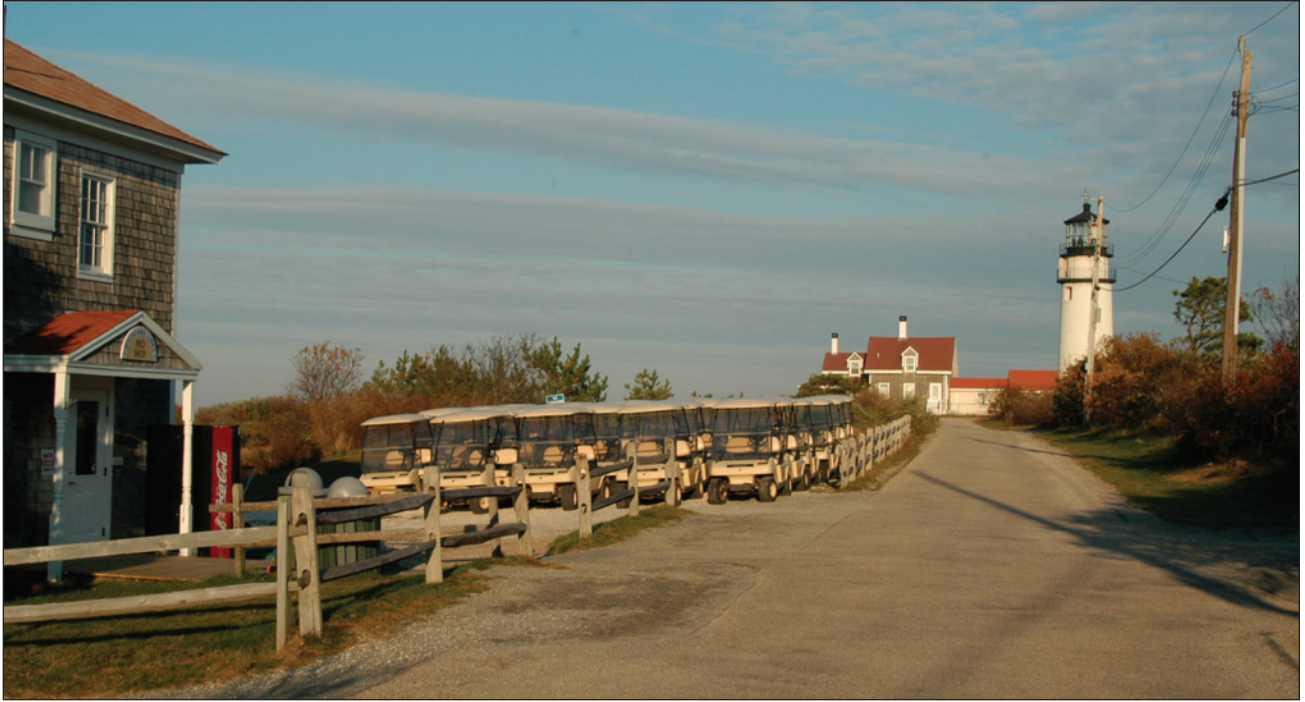
Figure 3.0: Circulation
Photograph of the golf cart parking at the Club House. Source: OCLP, 2006.

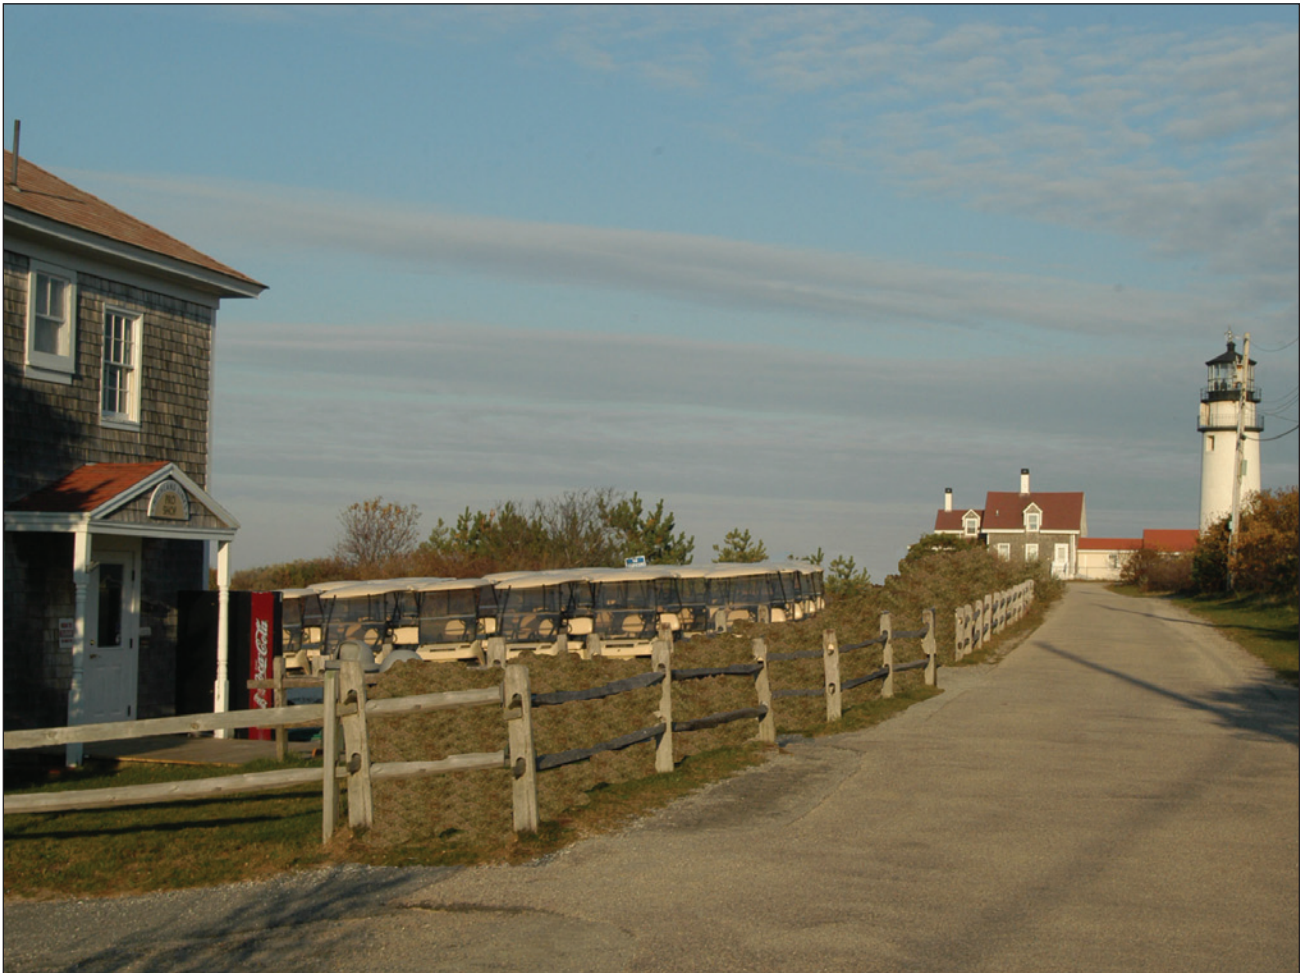
Figure 3.1: Circulation
Photo simulation of the golf cart parking at the Club House, with setback of 10 feet and screening. Source: OCLP, 2006.
