CONDITION REPORT AND TREATMENT PLAN FOR TRURO HIGHLANDS HISTORIC DISTRICT

CAPE COD NATIONAL SEASHORE

National Park Service, Boston, Massachusetts, 2007

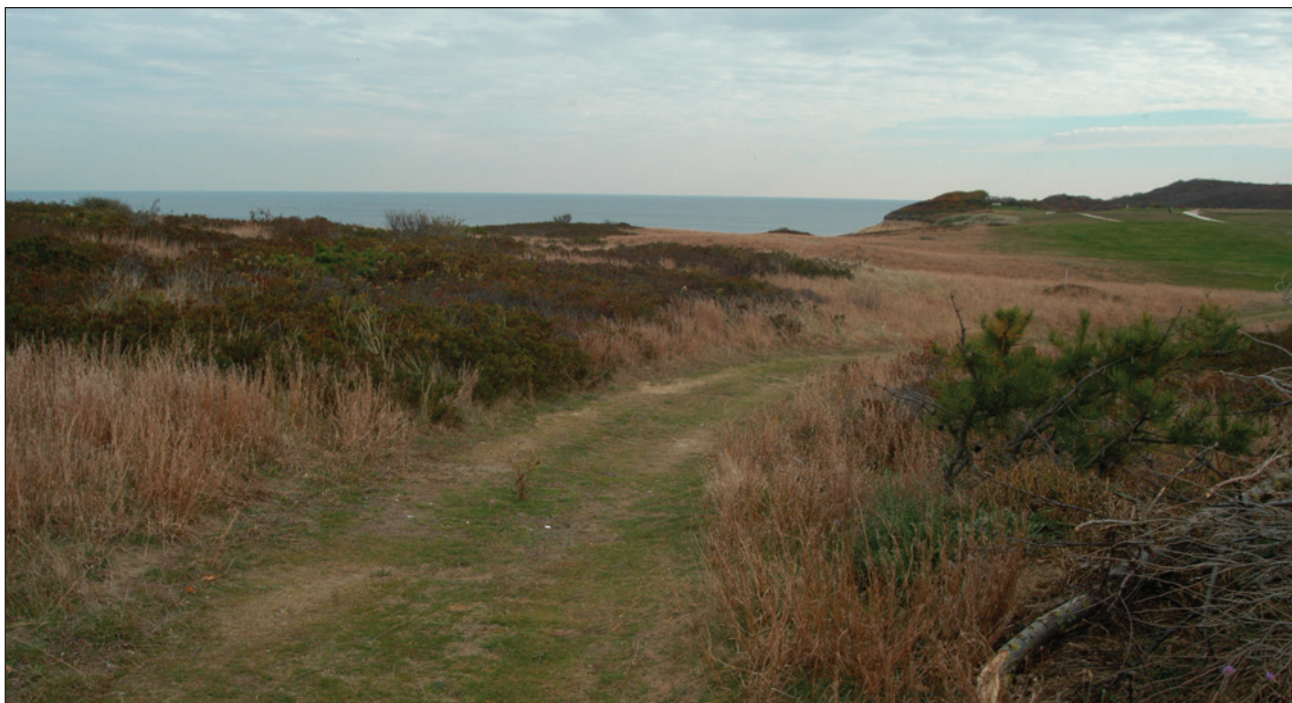
Figure 3.2: Circulation

Photograph of a grass or dirt path for pedestrian and maintenance vehicles use. Source: OCLP, 2006.

On heavily eroded grass or dirt paths that are used for pedestrian, golf cart and maintenance vehicle use, it is recommended that paths be reseeded and regraded upon initial sign of erosion (Figures 3.2 and 3.3-3.13).

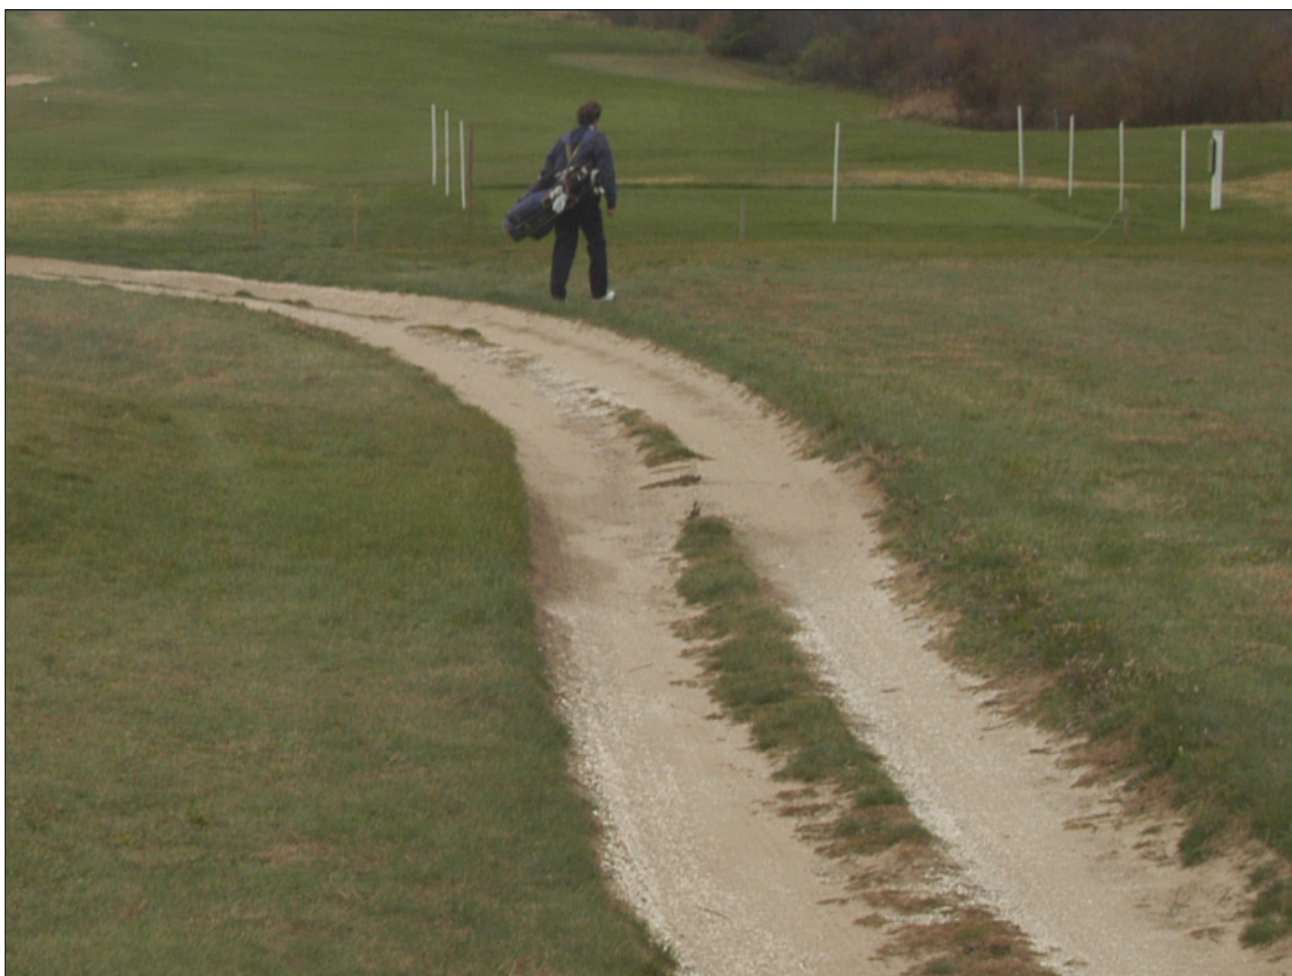
Figure 3.3: Circulation

Photograph of a eroded dirt path that requires repair to halt erosion and to improve visual appearance. Source: OCLP, 2006.

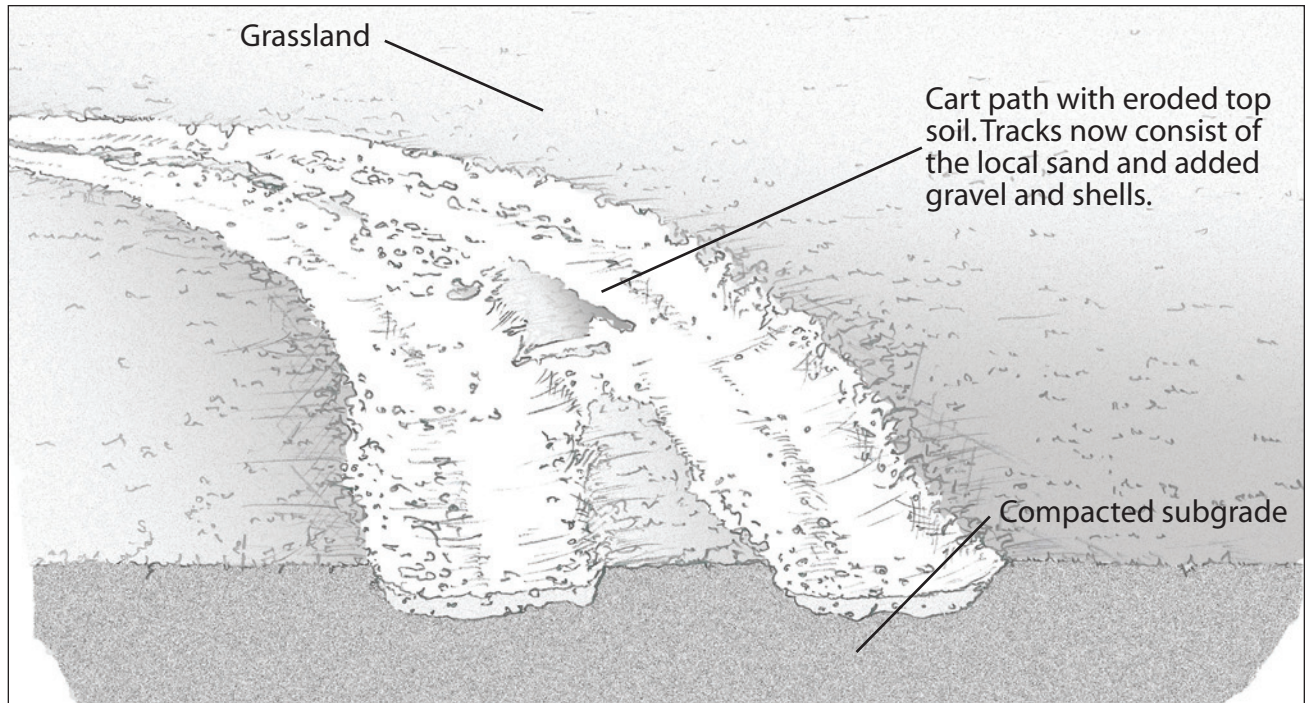
Figure 3.4: Circulation

Diagram of eroded dirt path. These paths should be repaired with a grass surface. Source: OCLP, 2006.

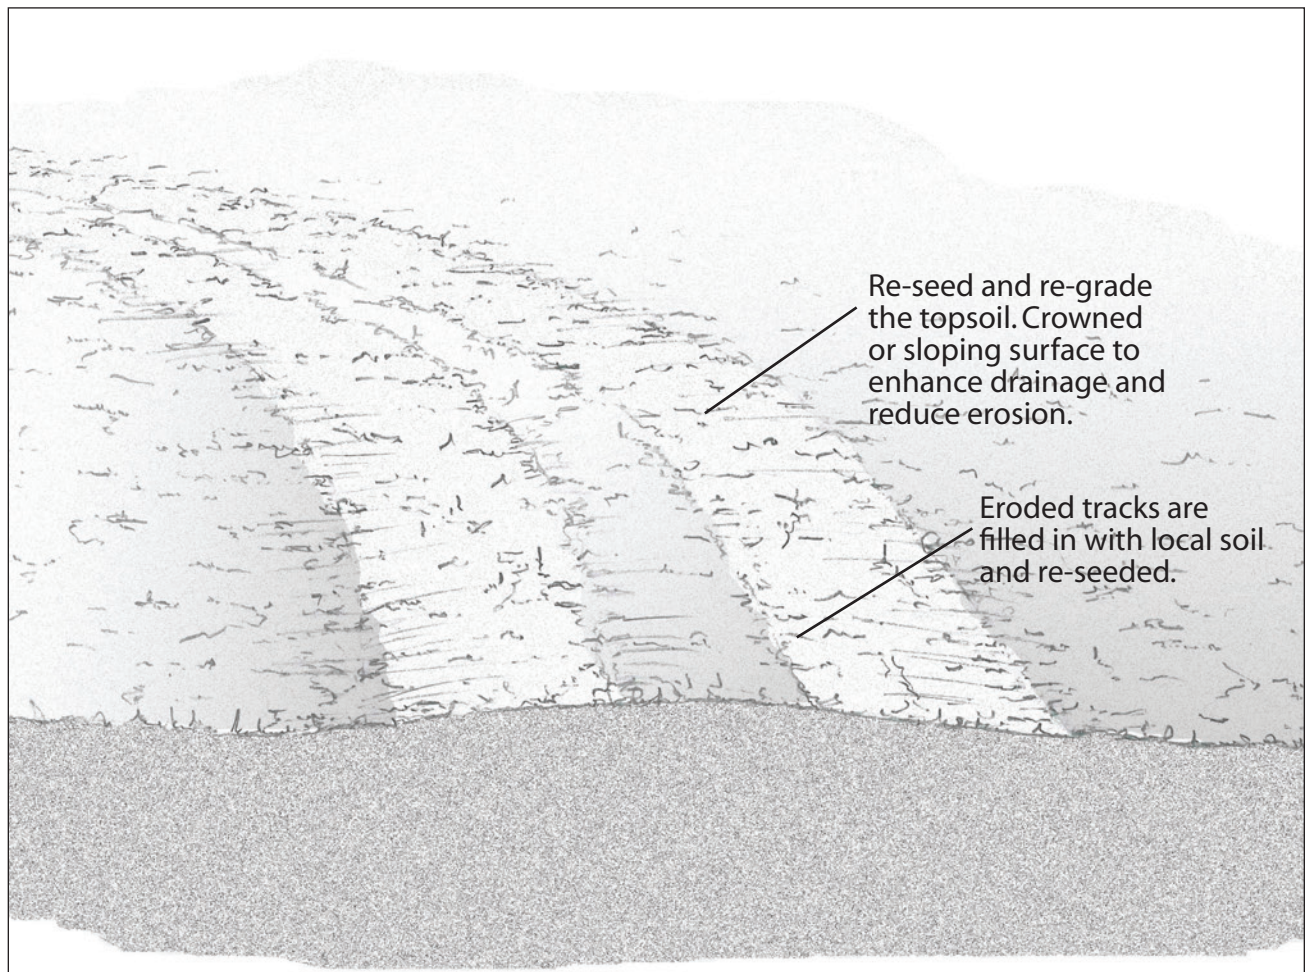
Figure 3.5: Circulation

Diagram of a repaired grass or dirt path for pedestrian, golf cart, and maintenance vehicle use. Source: OCLP, 2006.

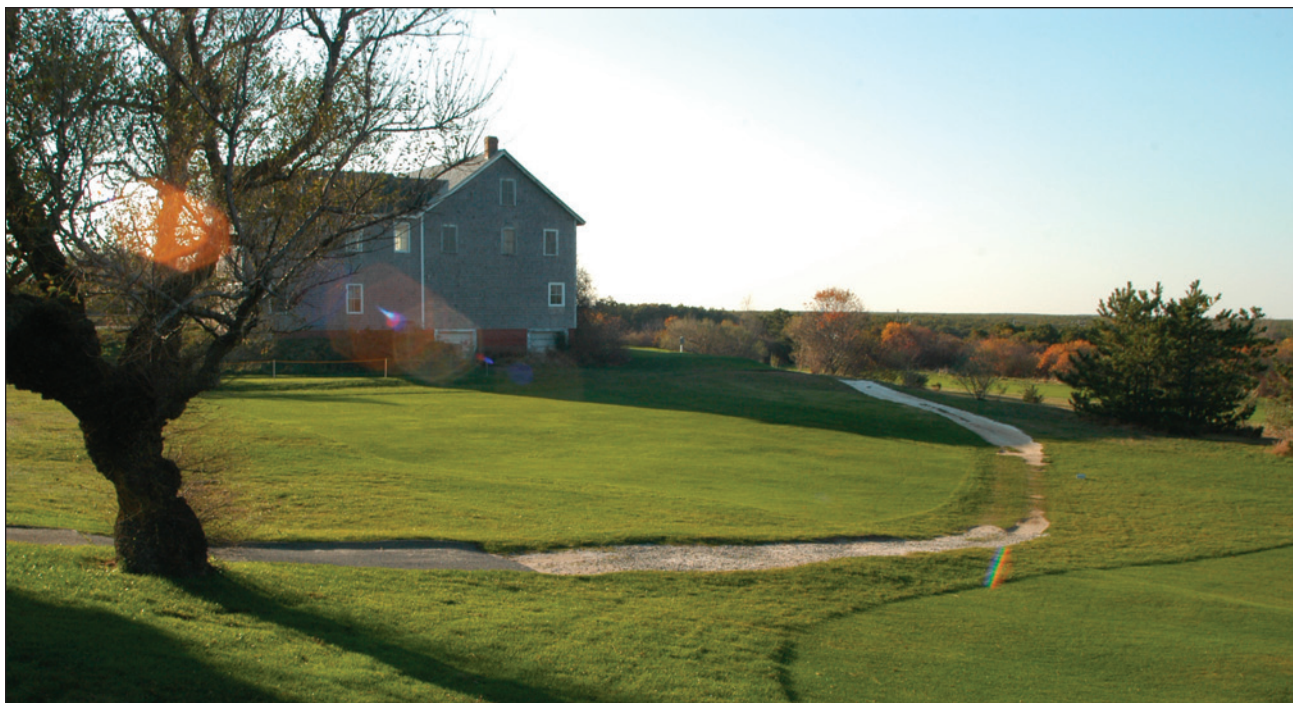
Figure 3.6: Circulation

Photograph of the existing path at hole 9. Although mostly eroded, portions of the path are surfaced with grass. Source: OCLP, 2006.

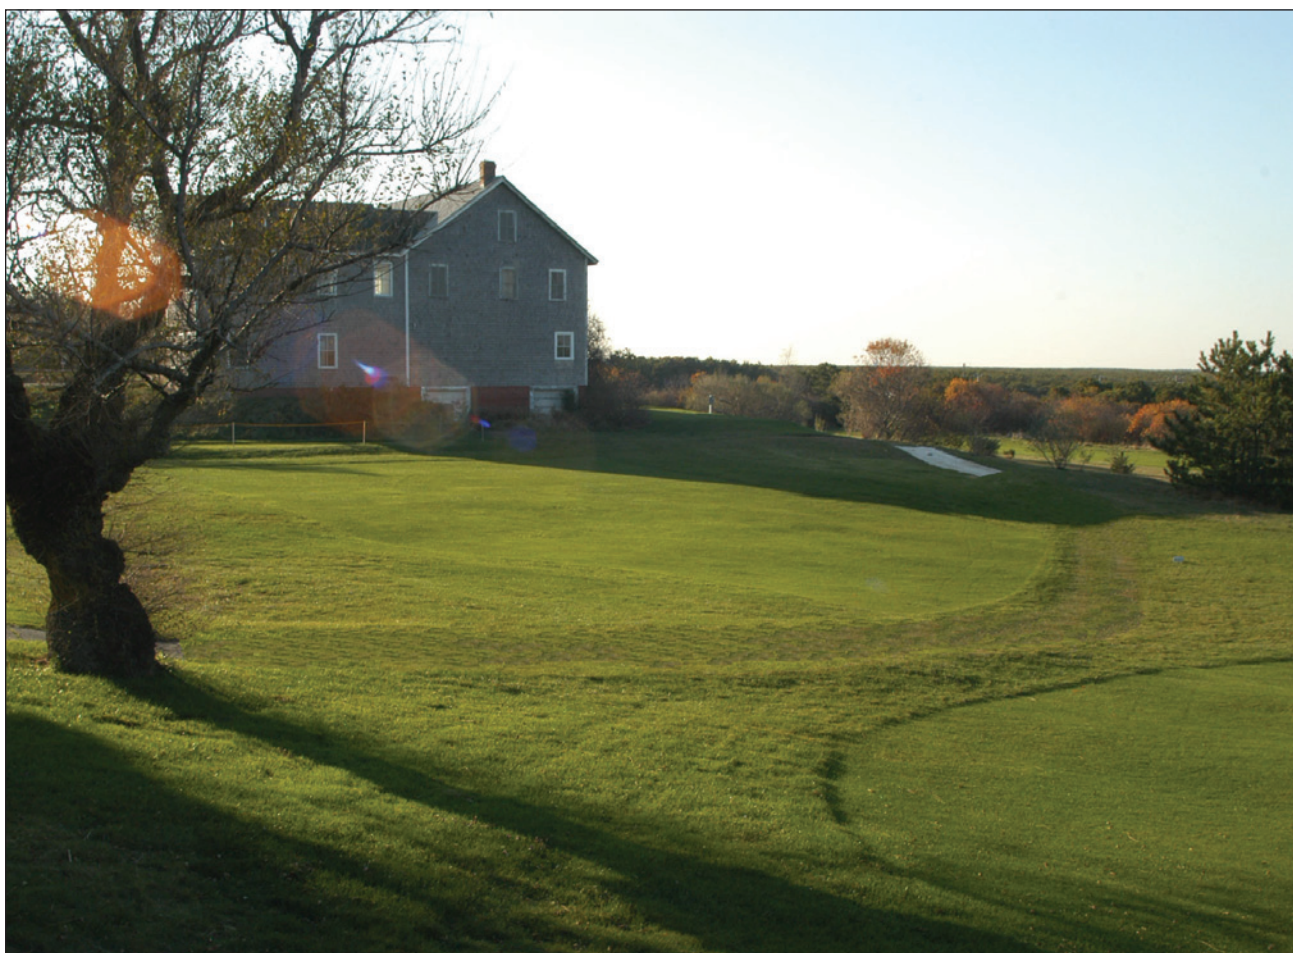
Figure 3.7: Circulation

Photo simulation of the path at hole 9. If further sections are reseeded, the path would be much less intrusive. Once reseeded, paths will remain accessible to golf carts. Asphalt on the left of the photograph should be reduced. Source: OCLP, 2006.

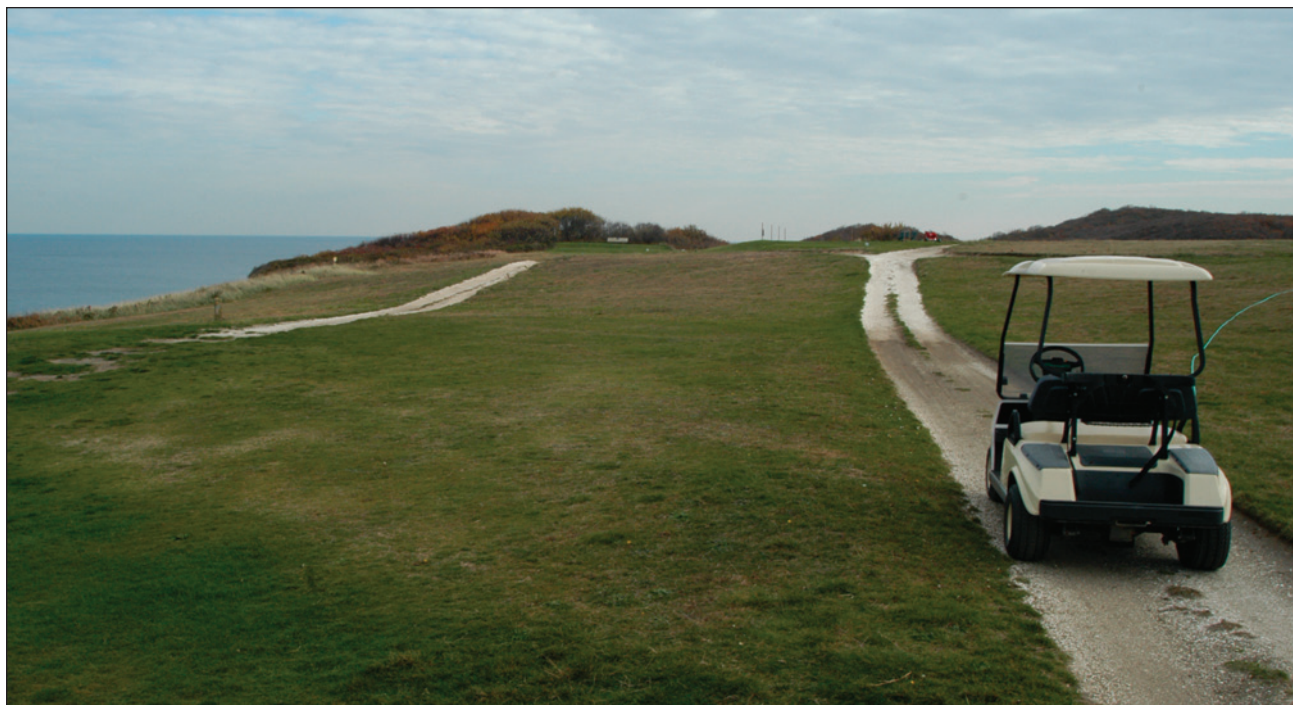
Figure 3.8: Circulation

Photograph of the paths near the tees at hole 6 from the east. Although two parallel paths exist, only the right is needed. Source: OCLP, 2006.

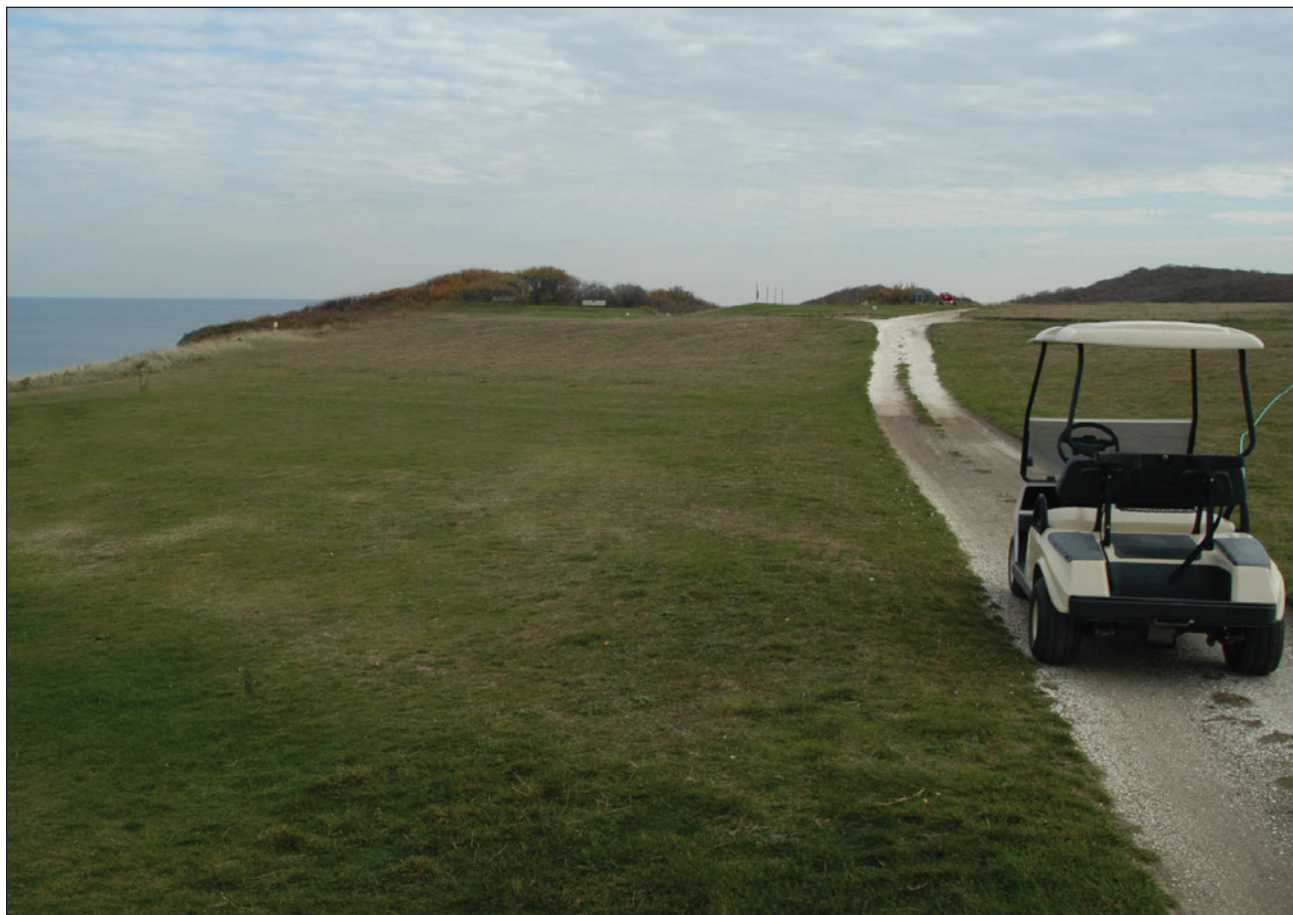
Figure 3.9: Circulation

Photo simulation of the paths near the tees at hole 6 from the east. The path to the left is removed and reseeded. Source: OCLP, 2006.

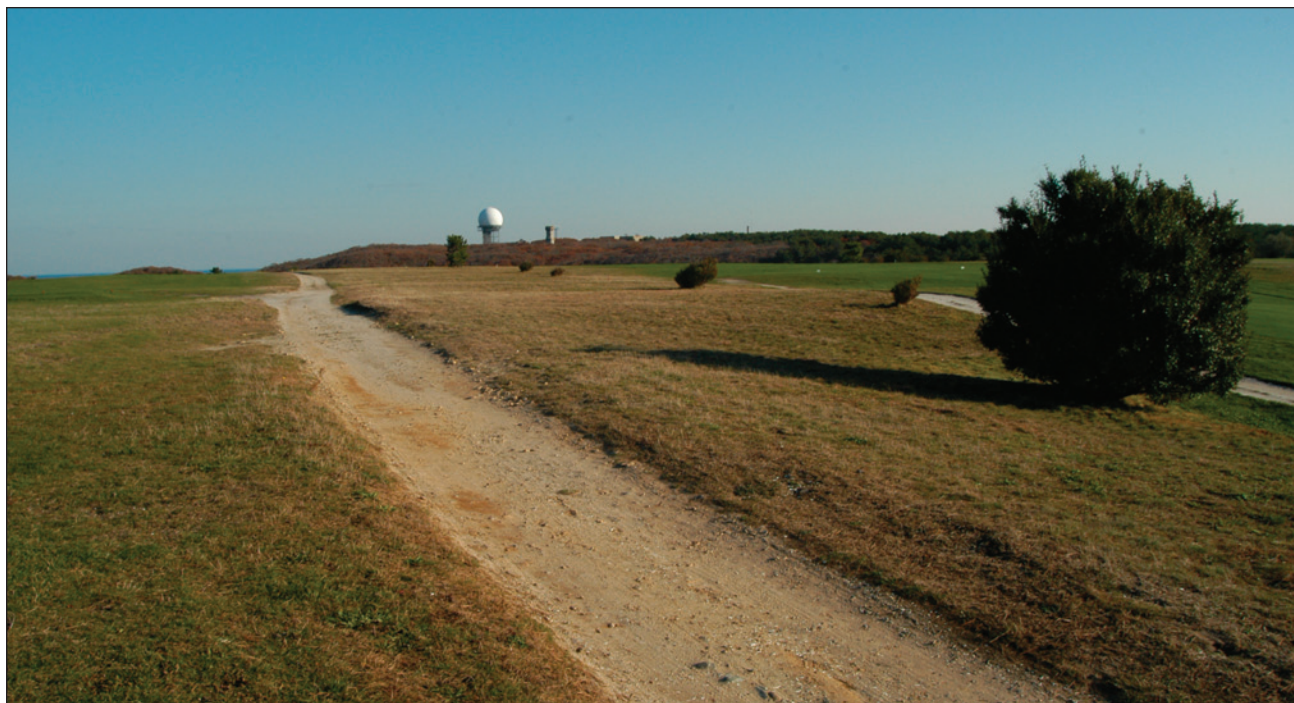
Figure 3.10: Circulation

Photograph of the paths between hole 4 and 5, looking east. Some shrubs are growing in a straight line along the paths, not appearing historically appropriate and natural. The gravel surface of path to the left should be reduced. Source: OCLP, 2006.

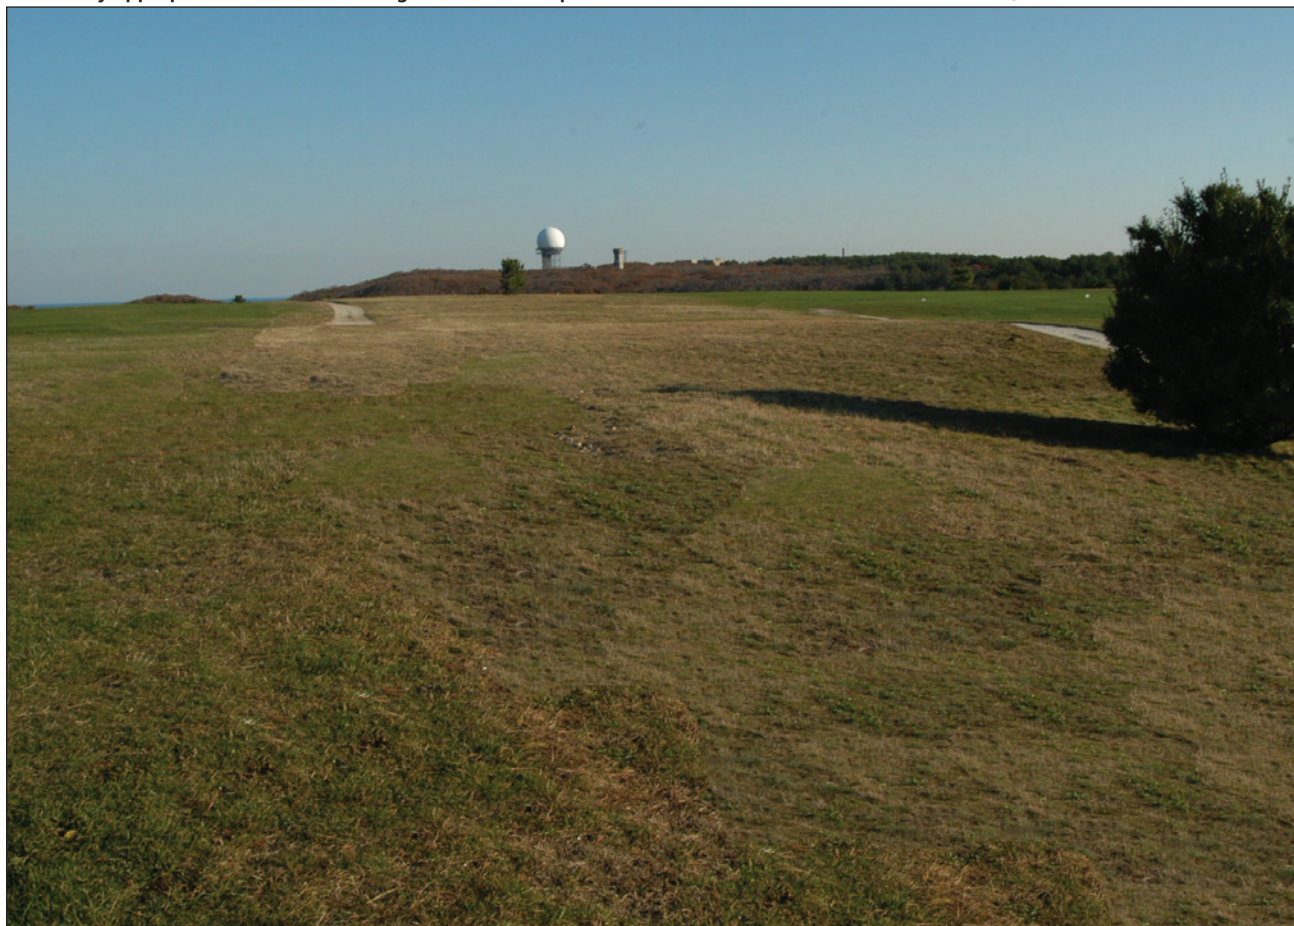
Figure 3.11: Circulation

Photo simulation of the paths between hole 4 and 5, looking east. Inappropriate shrubs are removed and the gravel surface of the path is reduced to reestablish the historic links landscape. Source; OCLP, 2006.

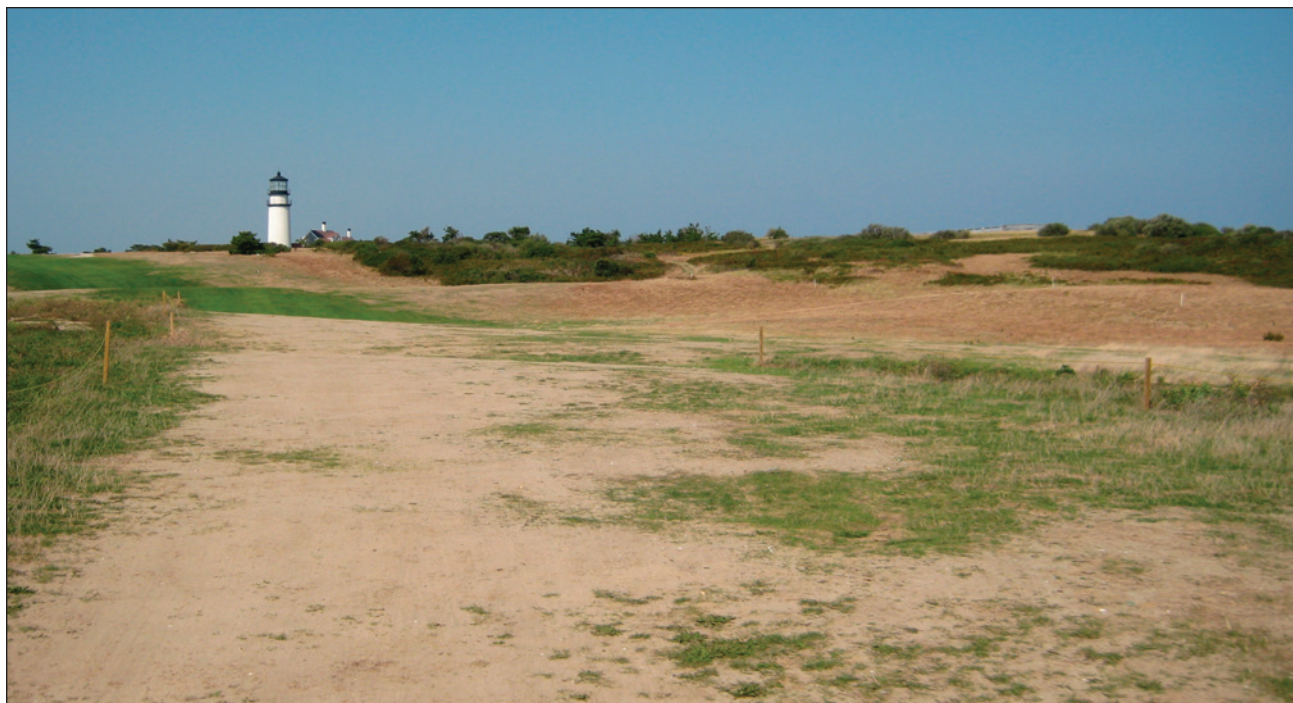
Figure 3.12: Circulation

View of the area which previously contained parallel paths near the tees at hole 6 from the west. While two paths are not necessary, the removal of both paths on hole 6 is discouraged. As shown in the photograph, the turf along the coastline can not handle scattering of golf cart traffic. Source: OCLP, 2007.

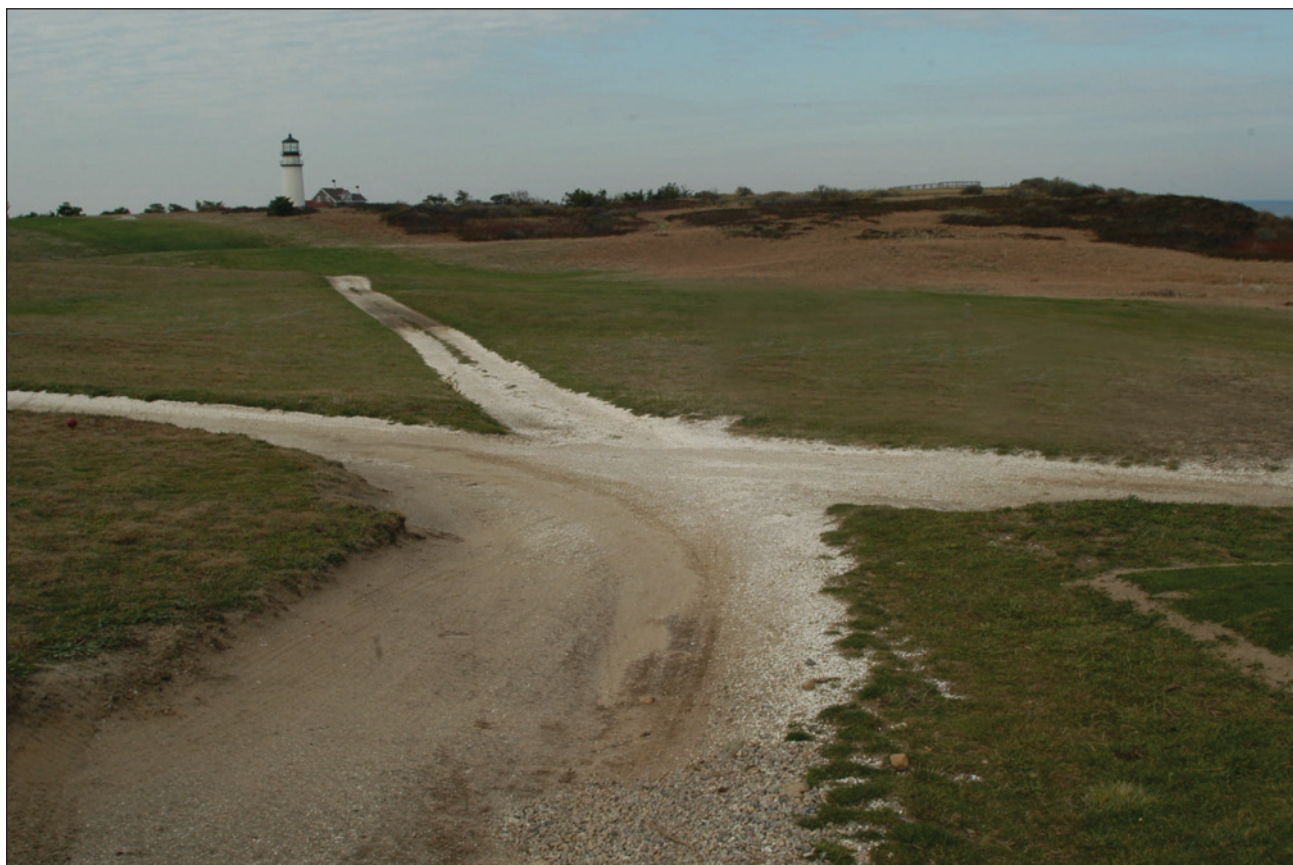
Figure 3.13: Circulation

Photo simulation of the former paths near the tees at hole 6 from the west. The path to the right is removed and reseeded, while the path to the left is retained. Source: OCLP, 2006.

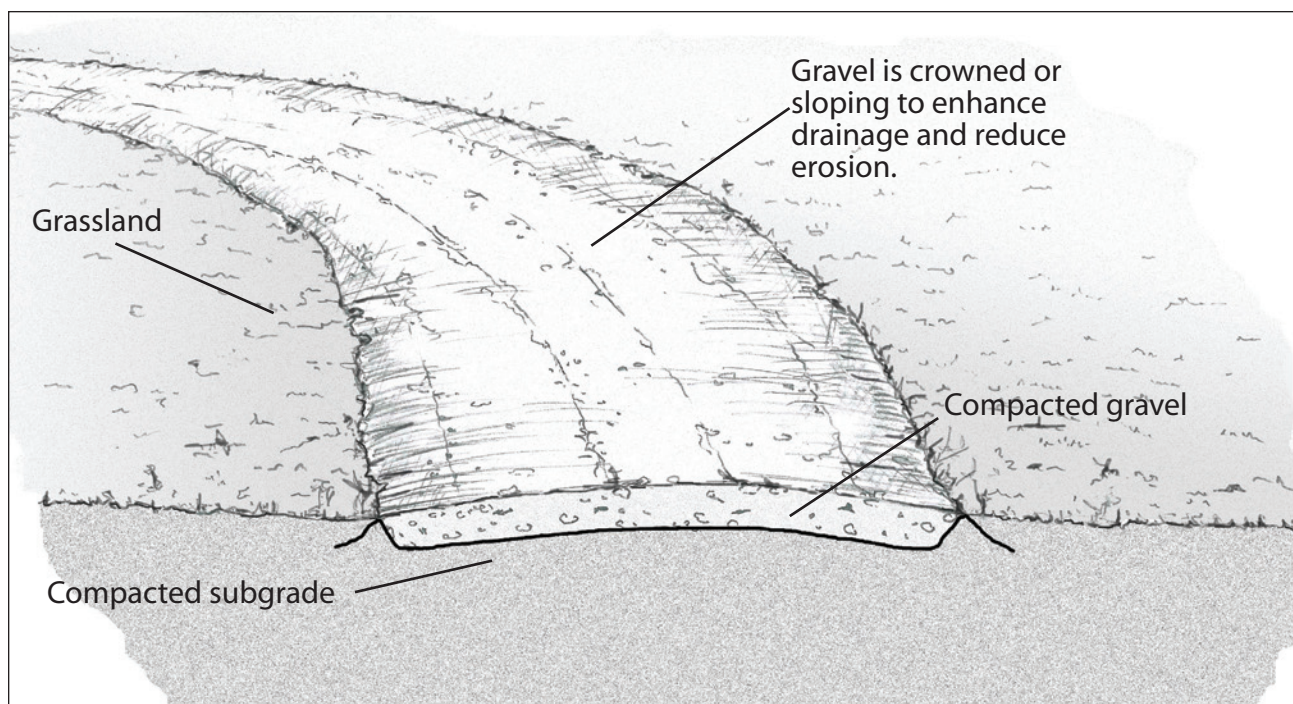
Figure 3.14: Circulation

On paths not feasible for reseeding, the following diagram provides a properly repaired gravel or dirt path for pedestrian, golf carts, and maintenance vehicle use. Source: OCLP, 2006.

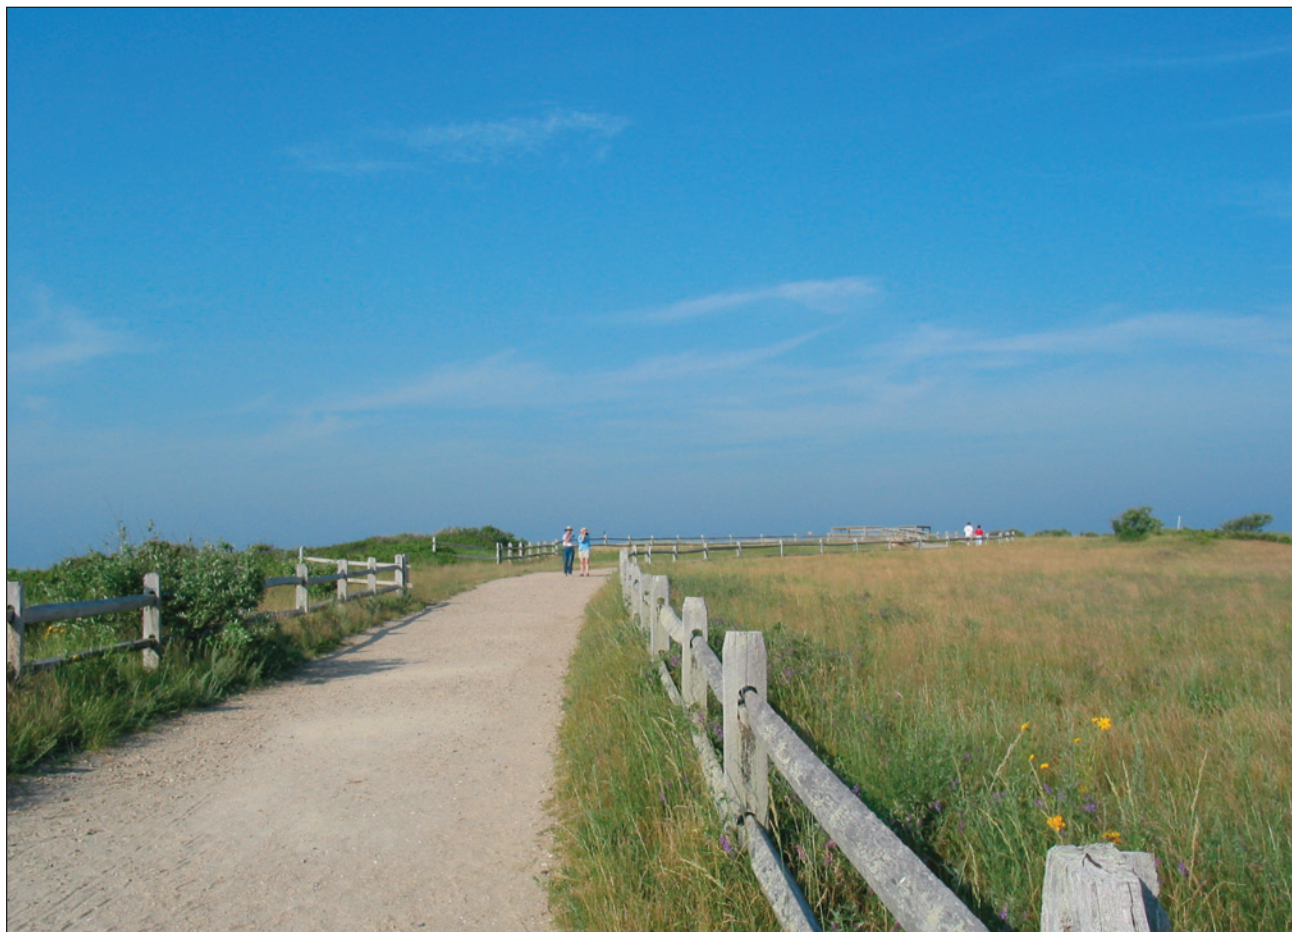
Figure 3.15: Circulation

Photo of a gravel or dirt path for pedestrian, golf carts and maintenance vehicle use. Source: OCLP, 2006.

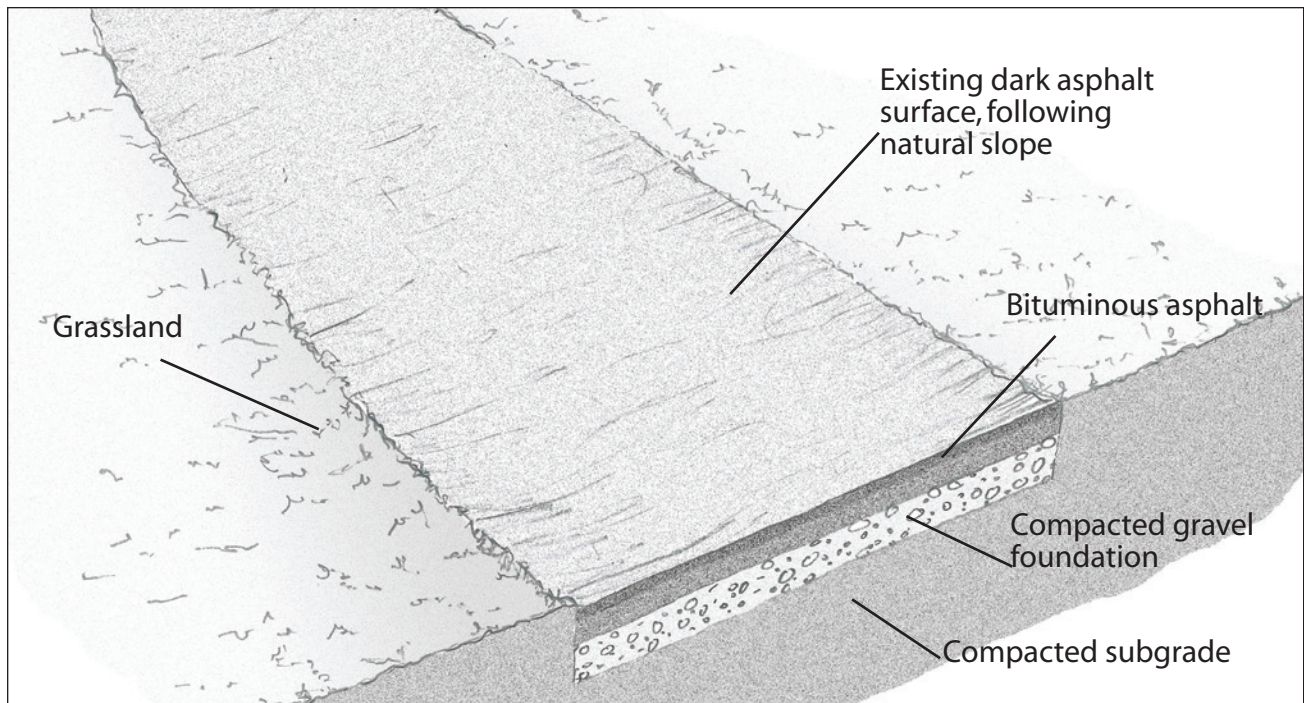
Figure 3.16: Circulation

Diagram of an existing asphalt path for pedestrian, golf cart, and maintenance vehicle use. Source: OCLP, 2006.

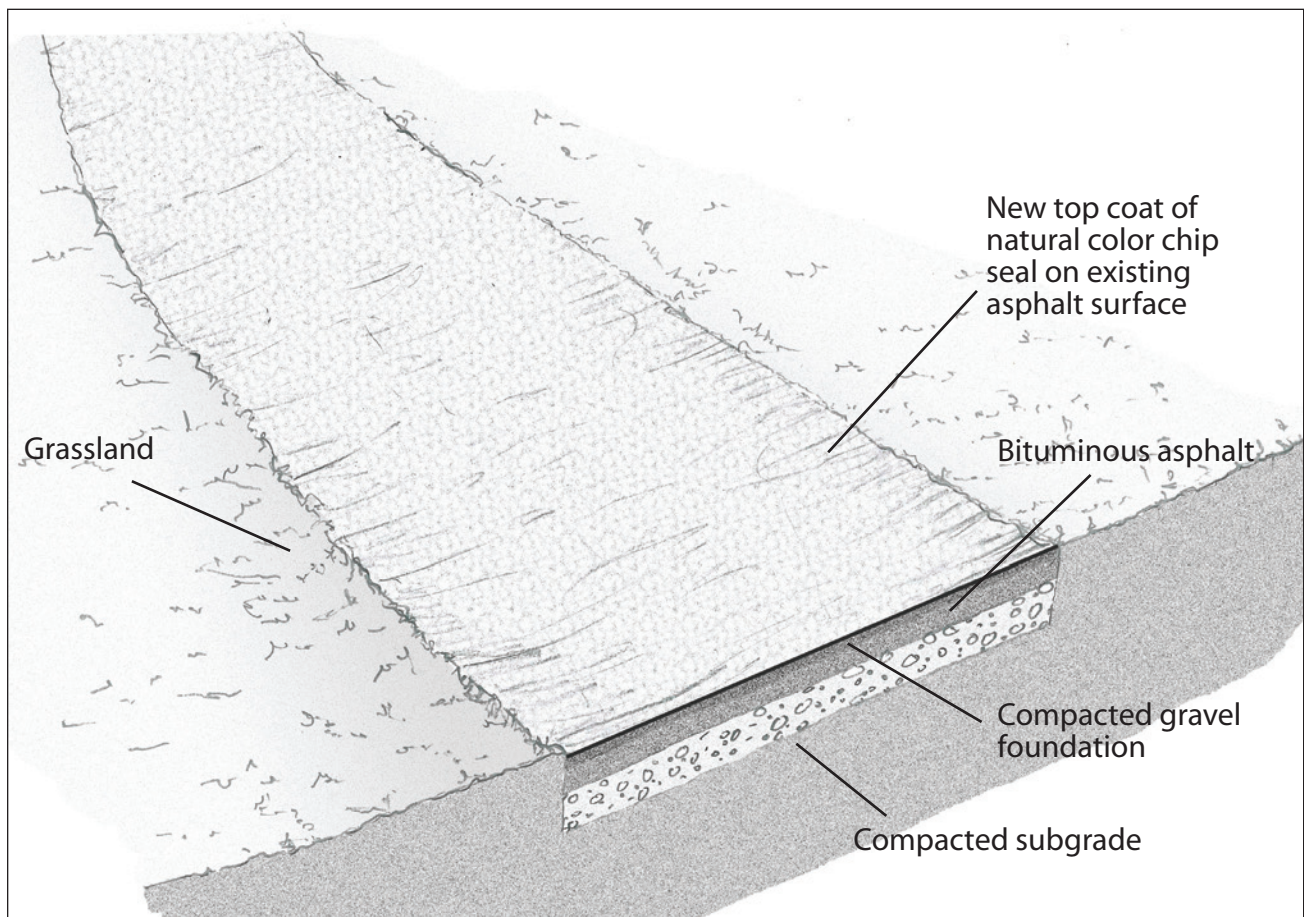
Figure 3.17: Circulation

Diagram of an asphalt path for pedestrian, golf cart, and maintenance vehicle use with a top coat of a natural color chip seal aggregate. Source: OCLP, 2006.

path. If necessary, drains should be installed along or under the paths to improve drainage (Figures 3.16-3.23).

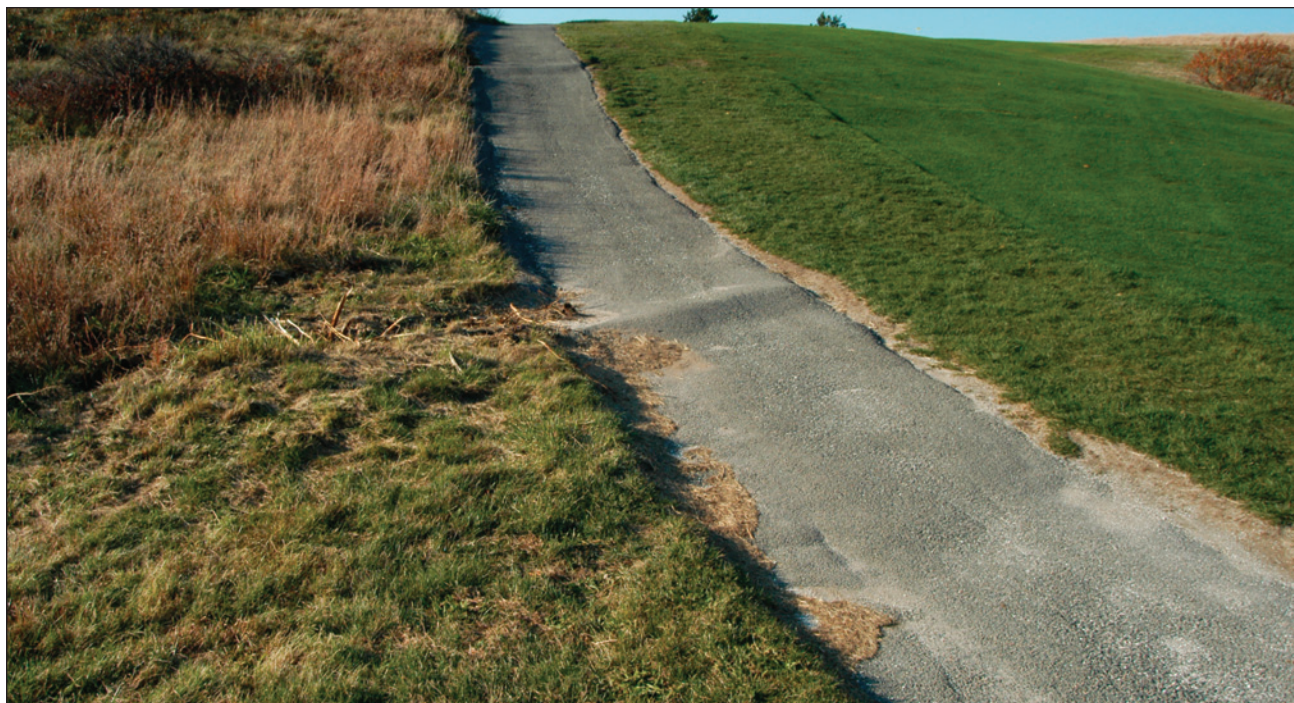
Figure 3.18: Circulation

Photograph of an existing asphalt path for pedestrian, golf cart, and maintenance vehicle use. Source: OCLP, 2006.

Recommendation: By establishing roughs at the edge of the asphalt paths, erosion can be reduced. A softer flattened edge to the asphalt is also preferred to make the path blend in better in the setting and appear less urban (Figures 3.18 and 3.19). In the future the straight asphalt path should be removed and reestablished on the original switchback route.

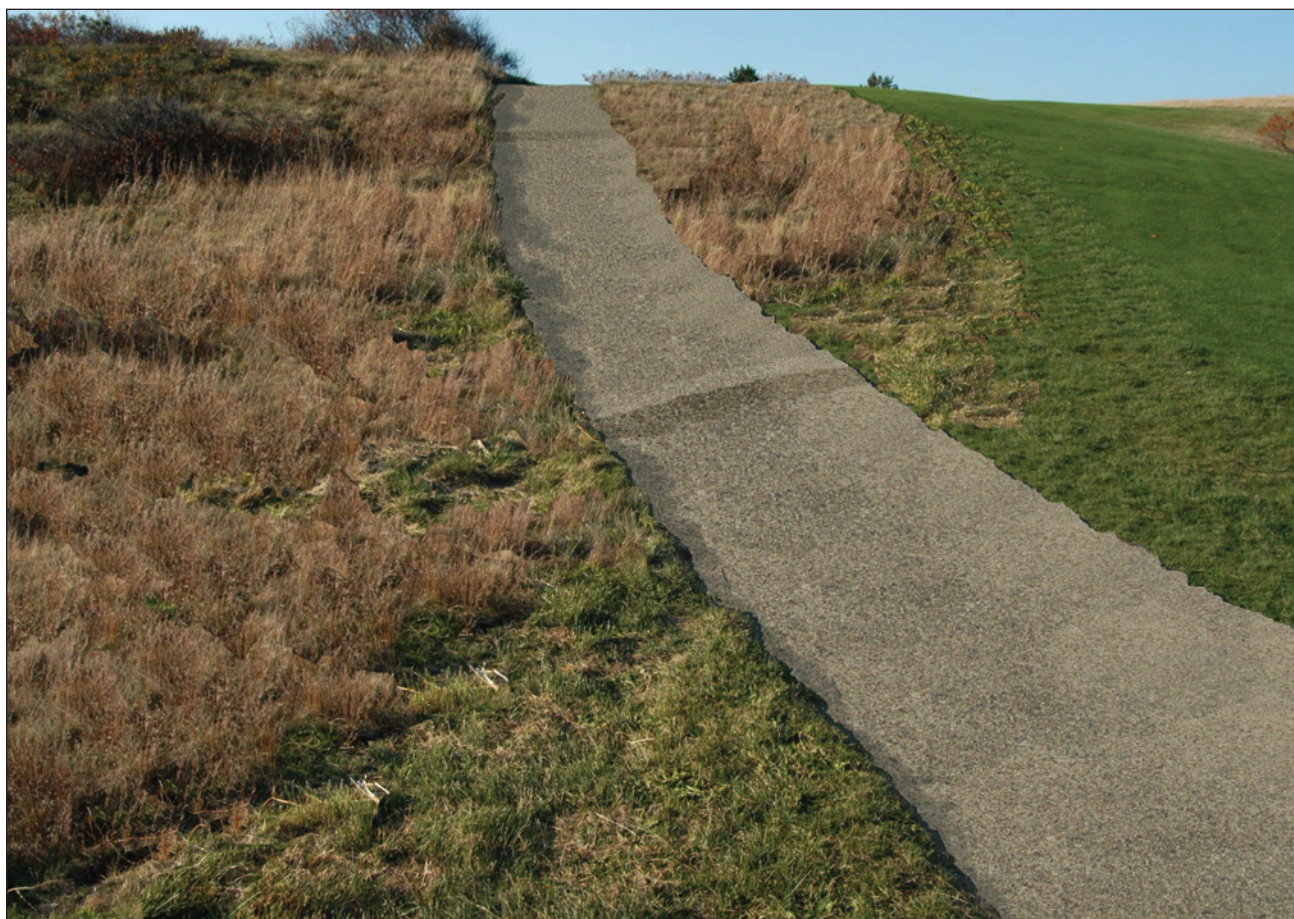
Figure 3.19: Circulation

Photo simulation of an asphalt path. A top coat with a natural color chip seal aggregate surface is applied. In addition, the rough is allowed to grow on both sides of the path. Source: OCLP, 2006.

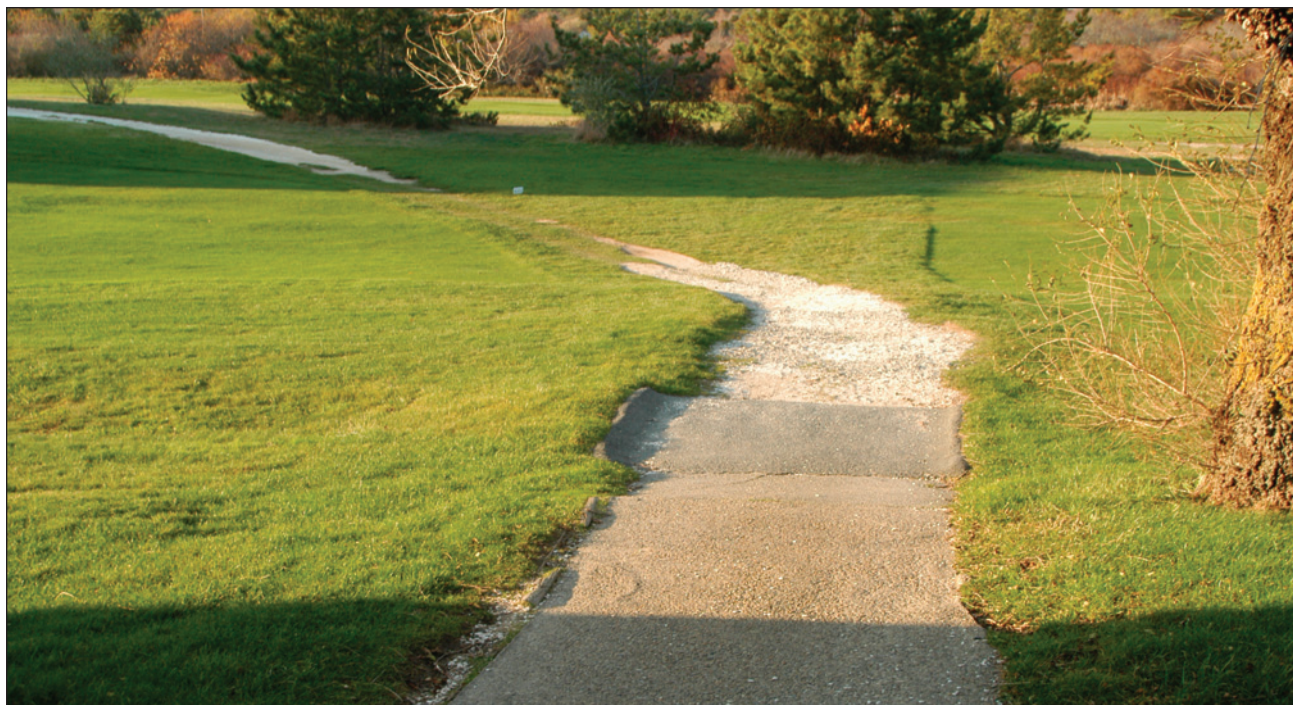
Figure 3.20: Circulation

Photograph an existing path for pedestrian, golf cart, and maintenance vehicle use on hole 9. A mix of concrete, asphalt and gravel has been used to stop erosion of the path. The treatment of such sections should be of a consistent material. Source: OCLP, 2006.

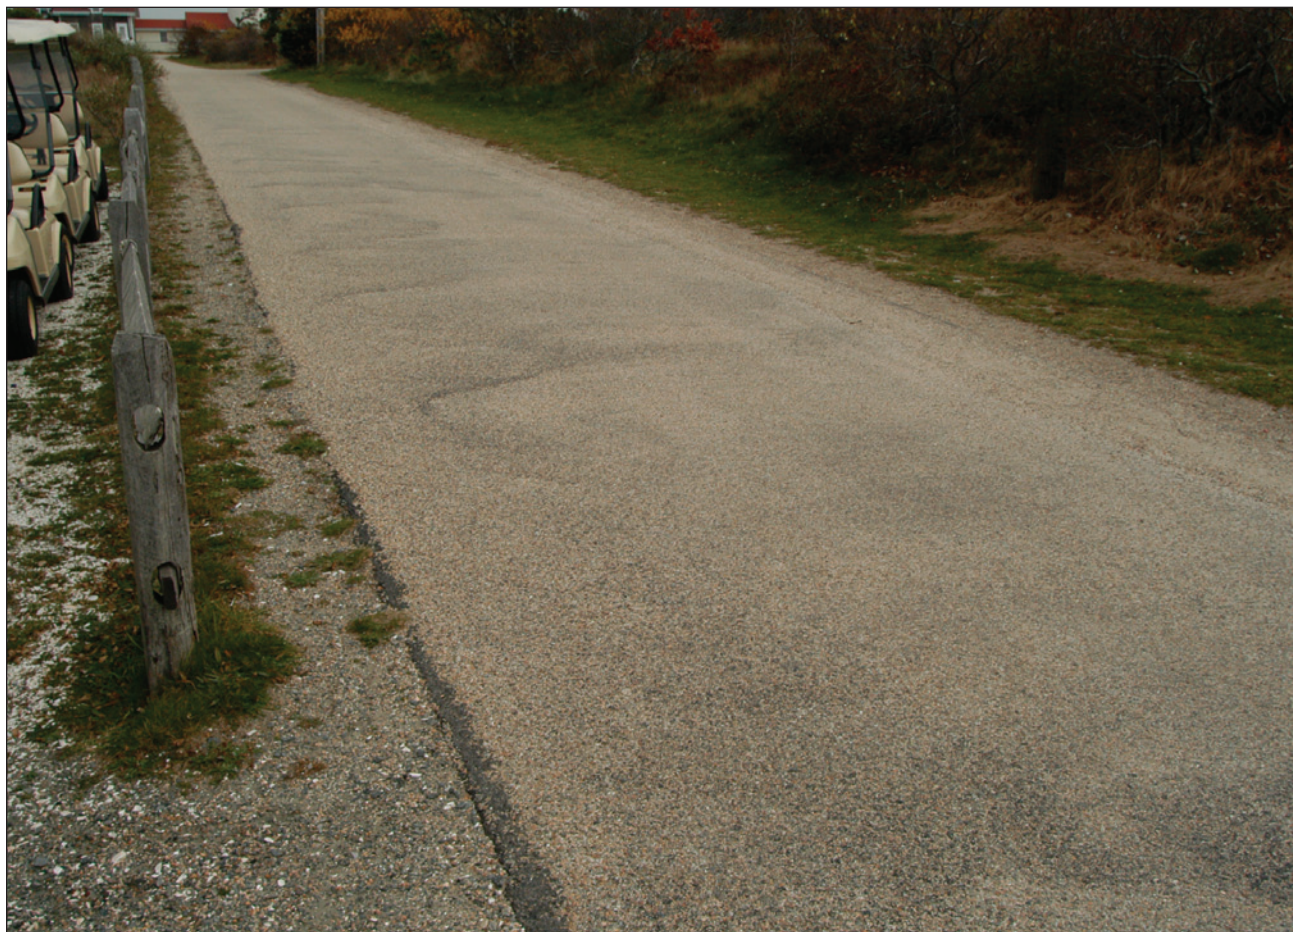
Figure 3.21: Circulation

Photograph of an asphalt road with a natural colored chip seal aggregate. Source: OCLP, 2006.
