CONDITION REPORT AND TREATMENT PLAN FOR TRURO HIGHLANDS HISTORIC DISTRICT

CAPE COD NATIONAL SEASHORE

National Park Service, Boston, Massachusetts, 2007

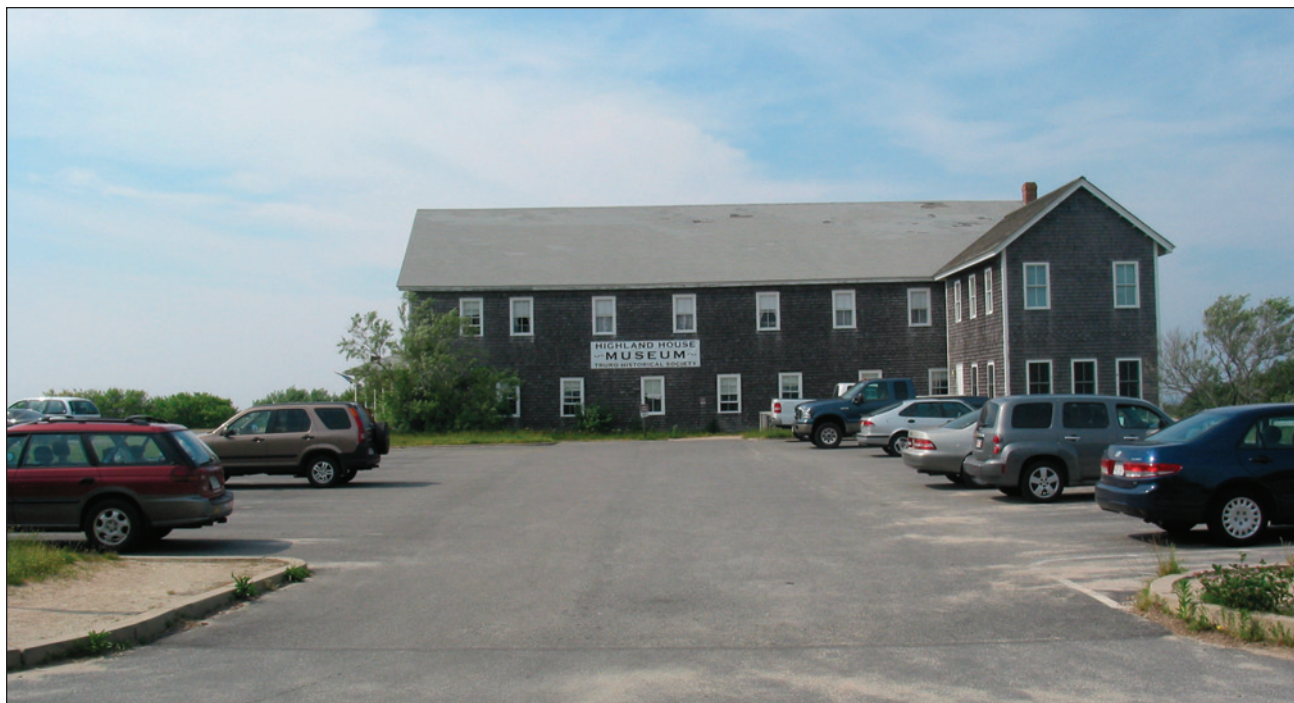
Figure 3.22: Circulation

Photo of an example asphalt road and parking facility. Asphalt roads and parking facilities should be resurfaced with a light colored chip seal aggregate. Source: OCLP, 2006.

path. If necessary, drains should be installed along or under the paths to improve drainage (Figures 3.16-3.23).

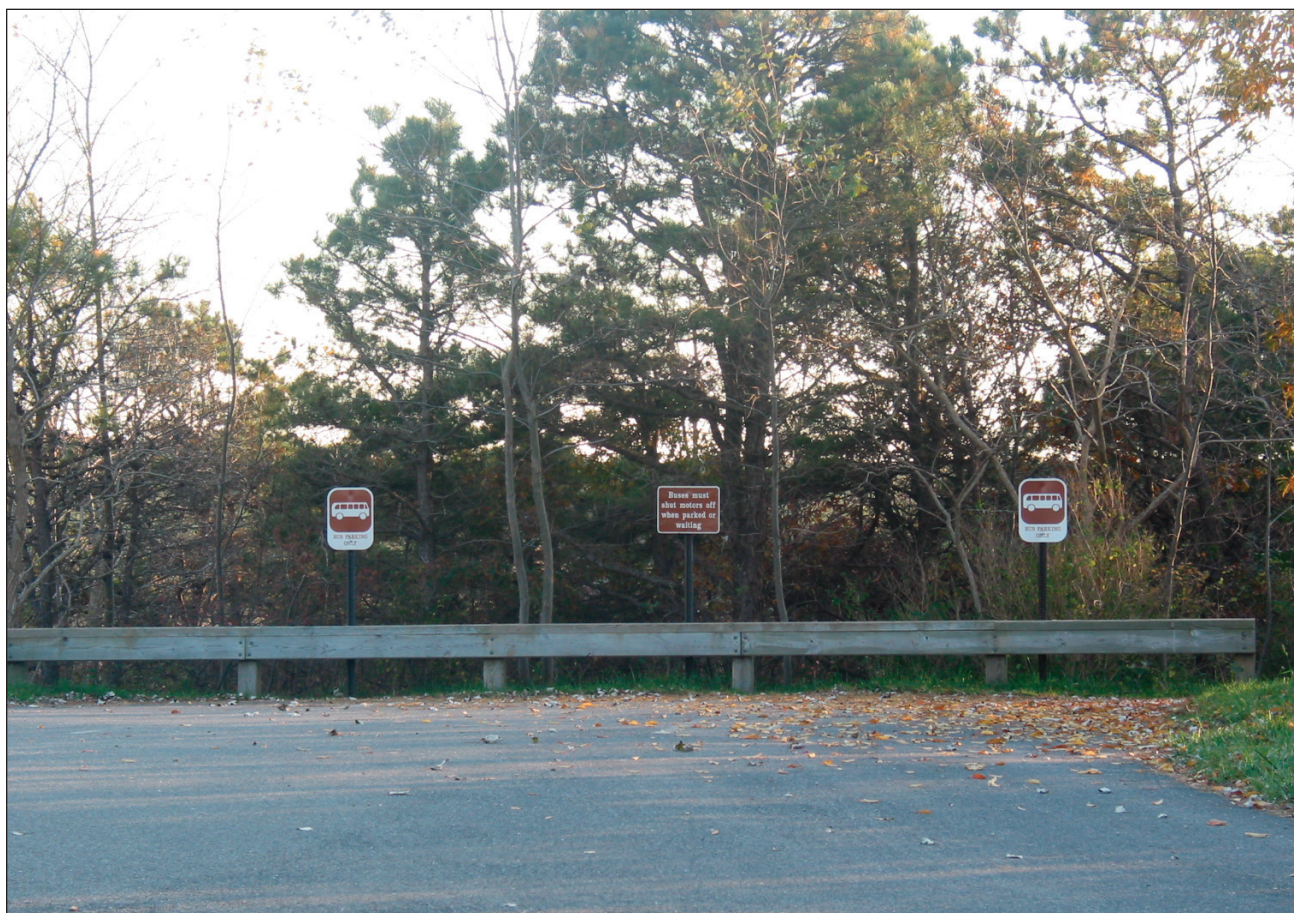
Figure 3.23: Circulation

Photo of the asphalt parking area for buses. Asphalt roads and parking facilities should be resurfaced with a light colored chip seal aggregate. Source: OCLP, 2006.

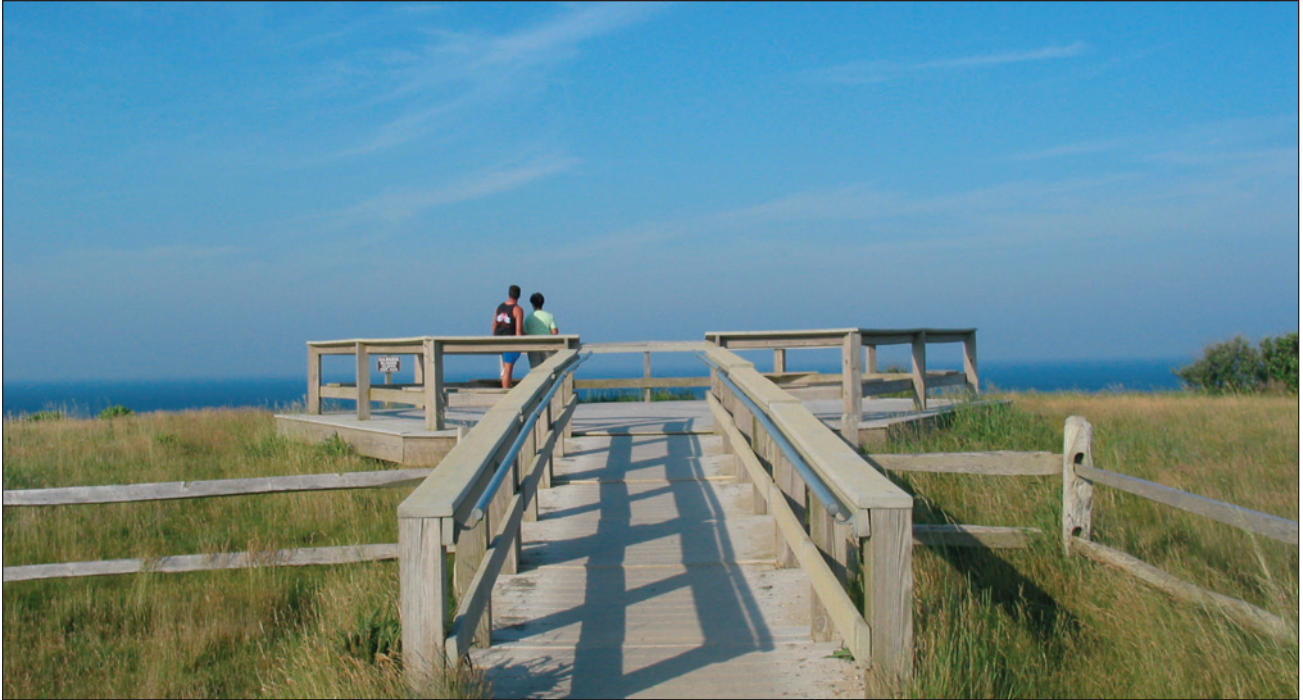
Figure 3.24: Circulation

Photo of a wood surface path. Source: OCLP, 2006.

While wooden surfaces exist at the club house and observation platform, these surfaces should be limited. Paths and surfaces in wood should be repaired with weathered wood as this material is consistent with recommendations for signage and site furniture (Figure 3.24).

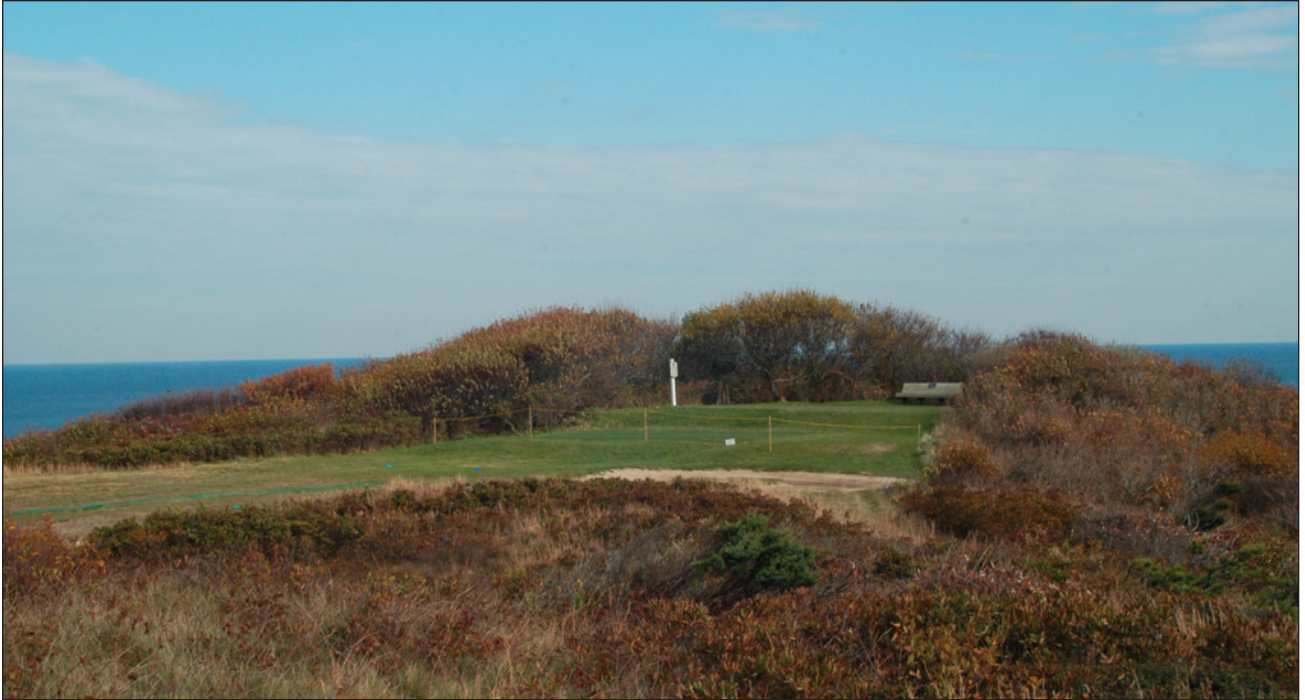
Figure 3.26: Vegetation

Photograph of the tee at hole 6. Shrub planting around the tee creates a wind buffer and blocks views to the sea and appears as a solid block. Source: OCLP photograph, 2006.

Behind the tees of hole 6 and down the green to hole 2 consists of valuable patches of low heathland vegetation. Besides thinning taller shrubs and trees on a routine basis, a 10 to 20-yard buffer zone of natural rough should be established between the fairways and the heathland to enhance the visual transition (Figures 3.26 and 3.27).

Other ways to minimize the contrast in color include, allowing tee and green banks to grow without frequent mowing and reducing the overall area of fairways through the implementation of island fairways. Both techniques are commonly used at St. Andrews Links in Scotland (Figures 3.26 and 3.27).

Recommendation: Views remain an important landscape characteristic within the Highlands area and should be preserved and protected. In order to restore views from the Highland Links to the ocean and views from Highland Road to the Highland Links, native vegetation needs to be kept low and non-native vegetation that does not contribute to the district needs to be removed (Drawing 3.0-3.2 and Figure 3.26 and 3.27).

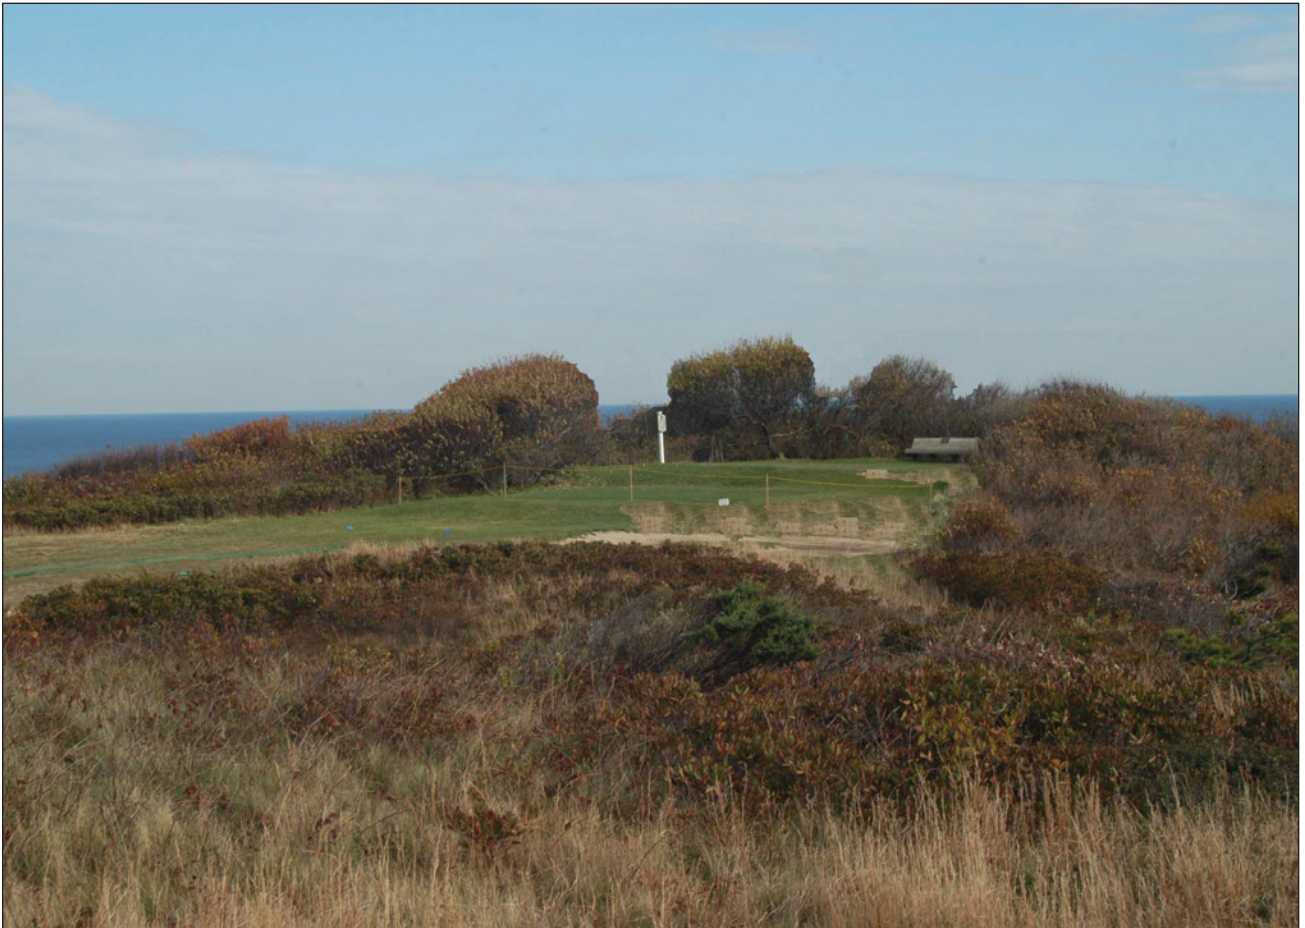
Figure 3.27: Vegetation

Photo simulation of the tee at hole 6. Trimming the shrub plantings around the hole will allow views of the ocean and allowing rough on the banks of the tee will soften the appearance of the tee box. Source: OCLP, 2006.

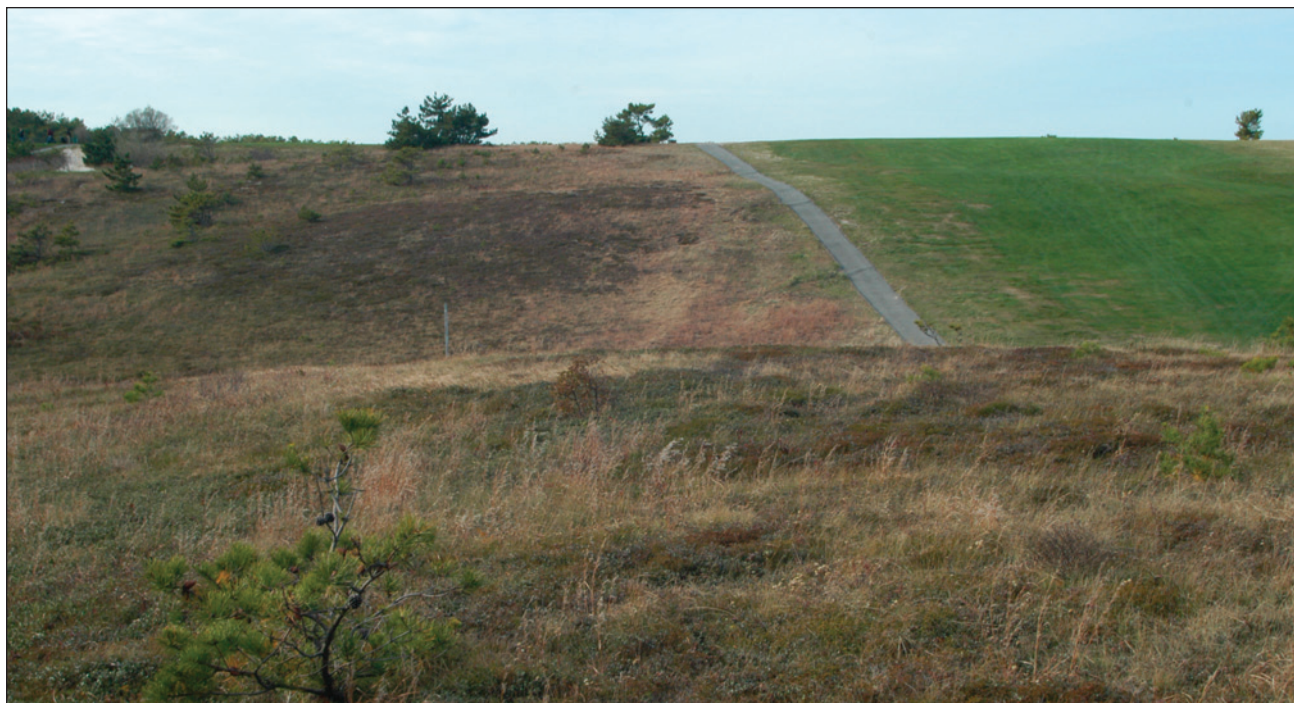
Figure 3.28: Vegetation

Photograph of the asphalt path along hole 4. The linear shape of the path is enhanced by the strong contrast between the green grass of the fairway and the longer fescue in the rough. Source: OCLP, 2006.

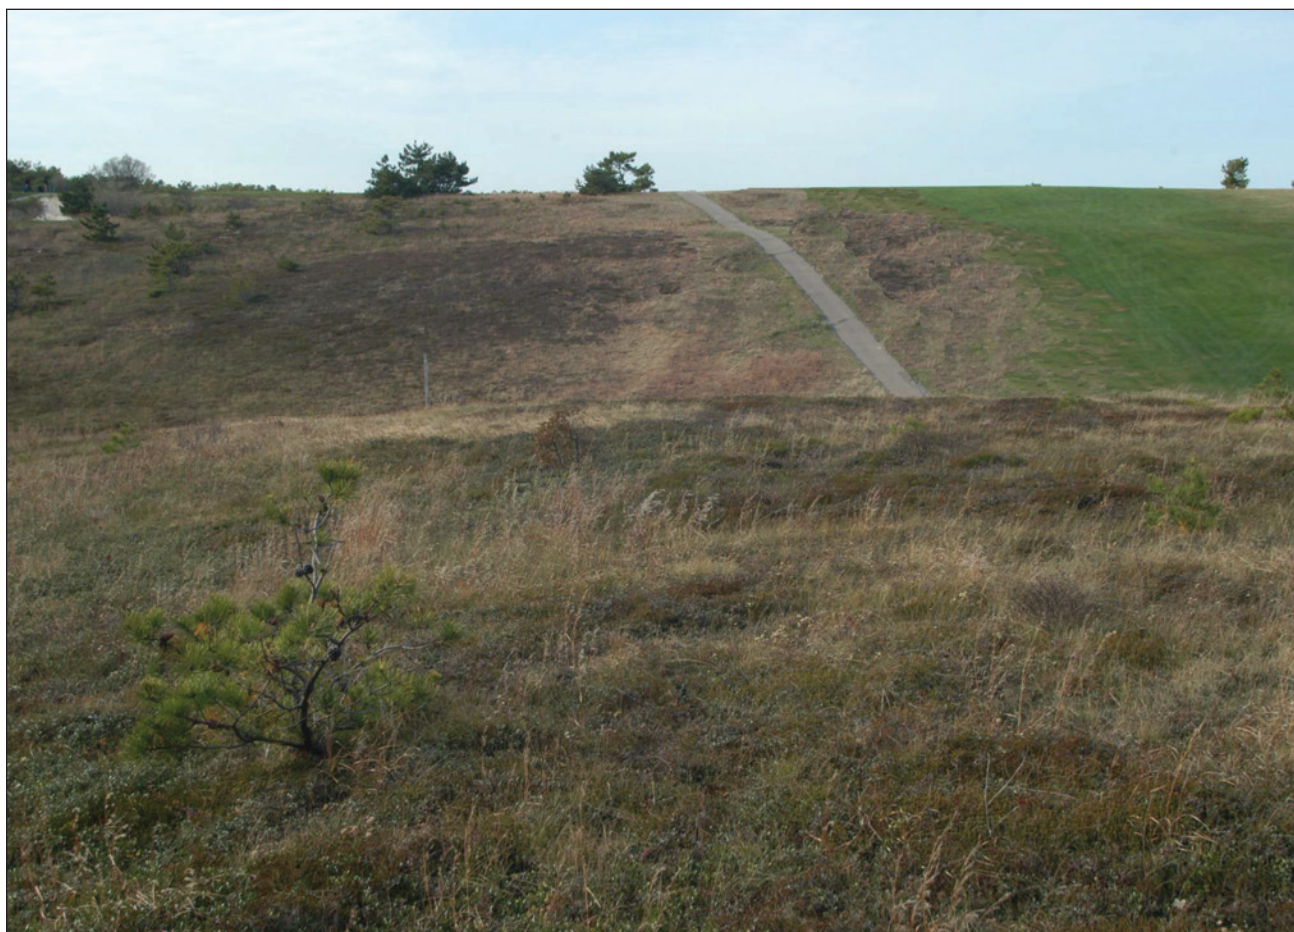
Figure 3.29: Vegetation

Photo simulation of the path along hole 4. By allowing the rough to continue across the path the visual impact of the path is reduced. A chip seal surface on the asphalt path in a natural color will further improve appearance. Source: OCLP, 2006.

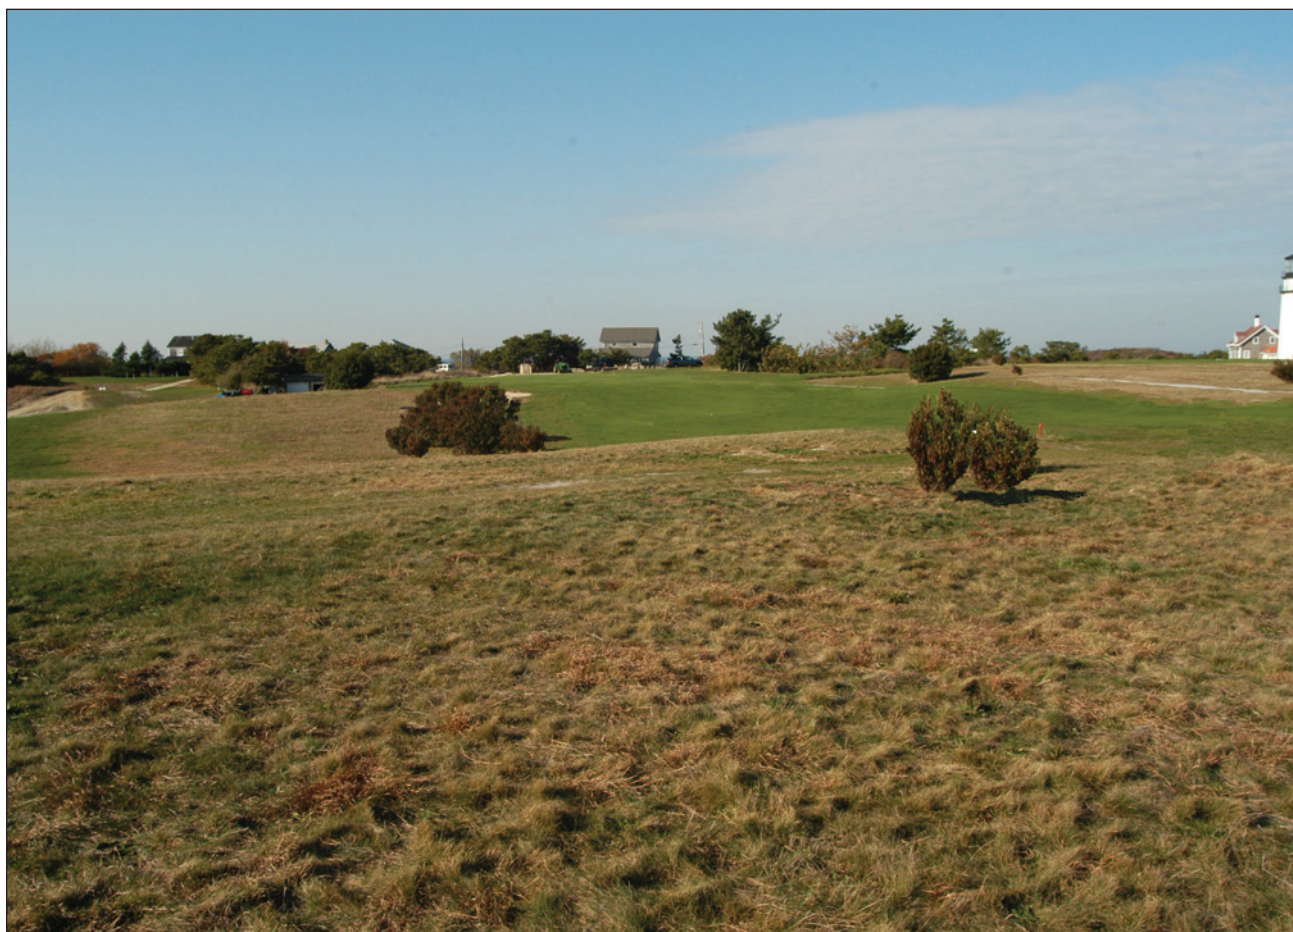
Figure 3.31: Vegetation

Photo simulation of the shrubs planted between hole 1 and 4. Historically, there would have been less shrubs on the golf course. Where shrubs are retained, they should be planted in more natural groupings. Source: OCLP, 2006.

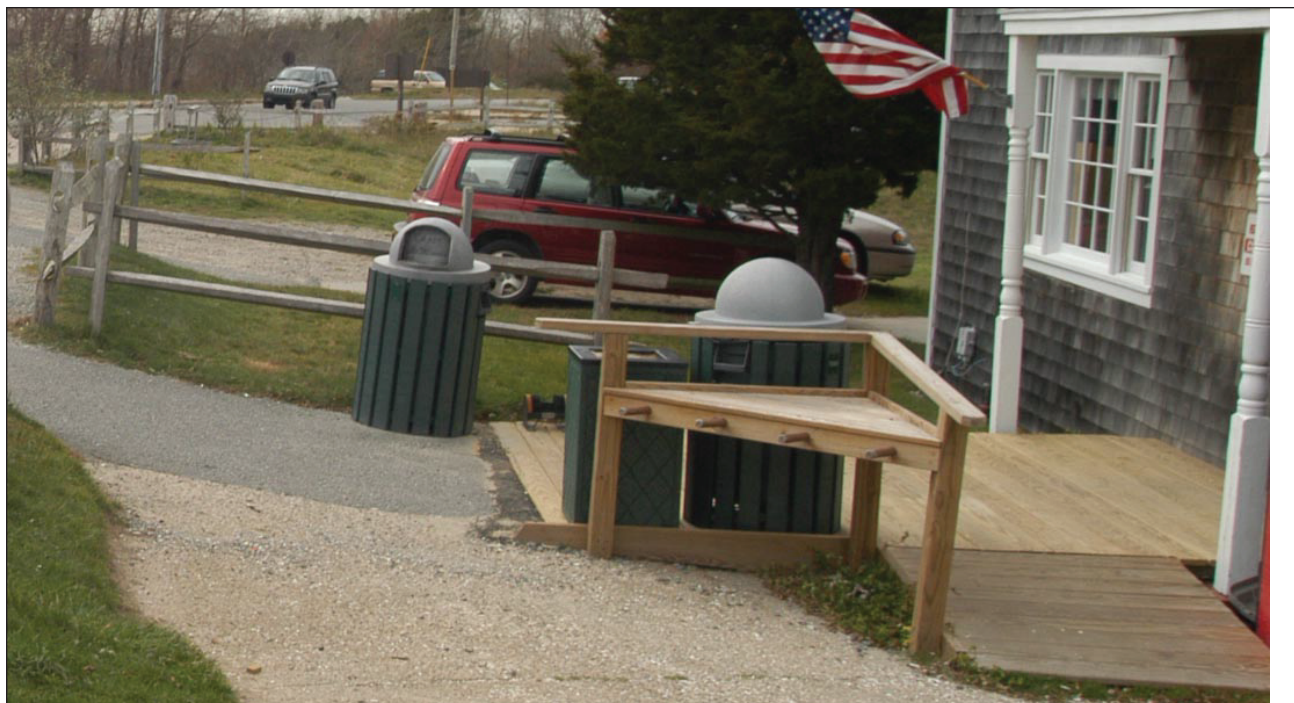
Figure 3.32: Small-scale features

Photo of trash receptacles at the entrance to the club house. Several styles of receptacles are found within the district, resulting in a lack of consistency and unity. Style, location and numbers should be reviewed. Source: OCLP, 2006.

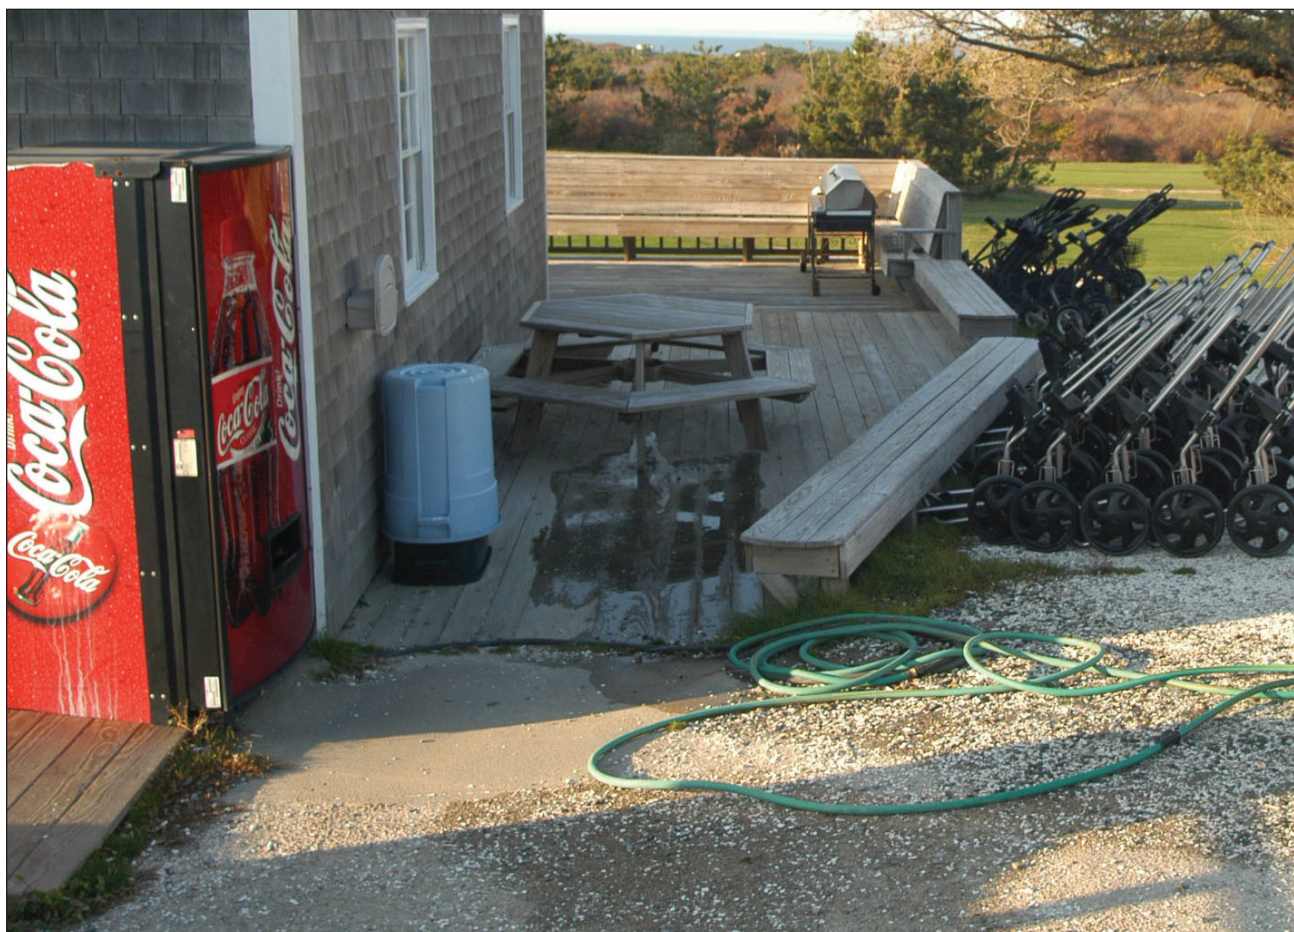
Figure 3.33: Small-scale features

Photo of site furnishings on the terrace at the club house. Style and location should be reviewed. Source: OCLP, 2006.

Recommendation: Incompatible non-contributing site furnishings should be replaced. Replacement site furnishings should be consistent with the weathered wood elements that are present within the district. Care should be taken regarding the location and number of furnishings. The goal should be to have relatively few site furnishings within the historic district and golf course (Figures 3.32-3.39).

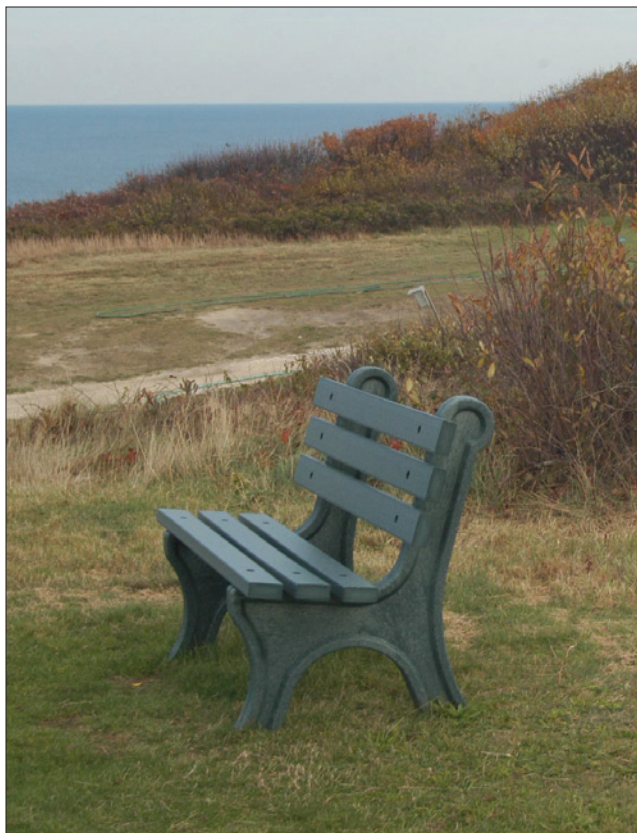
Figure 3.35: Small-scale features

Photo of a bench in recycled material on the golf course. Several types of benches can be found on the links course resulting in a lack of unity and consistency. Source: OCLP, 2006.

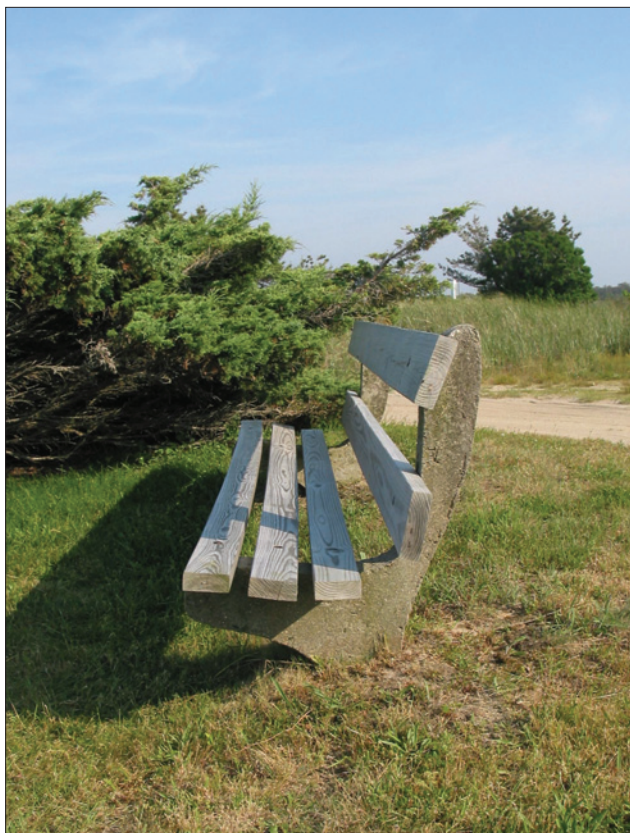
Figure 3.36: Small-scale features

Photo of a wood and concrete bench on the golf course. Source: OCLP, 2006.

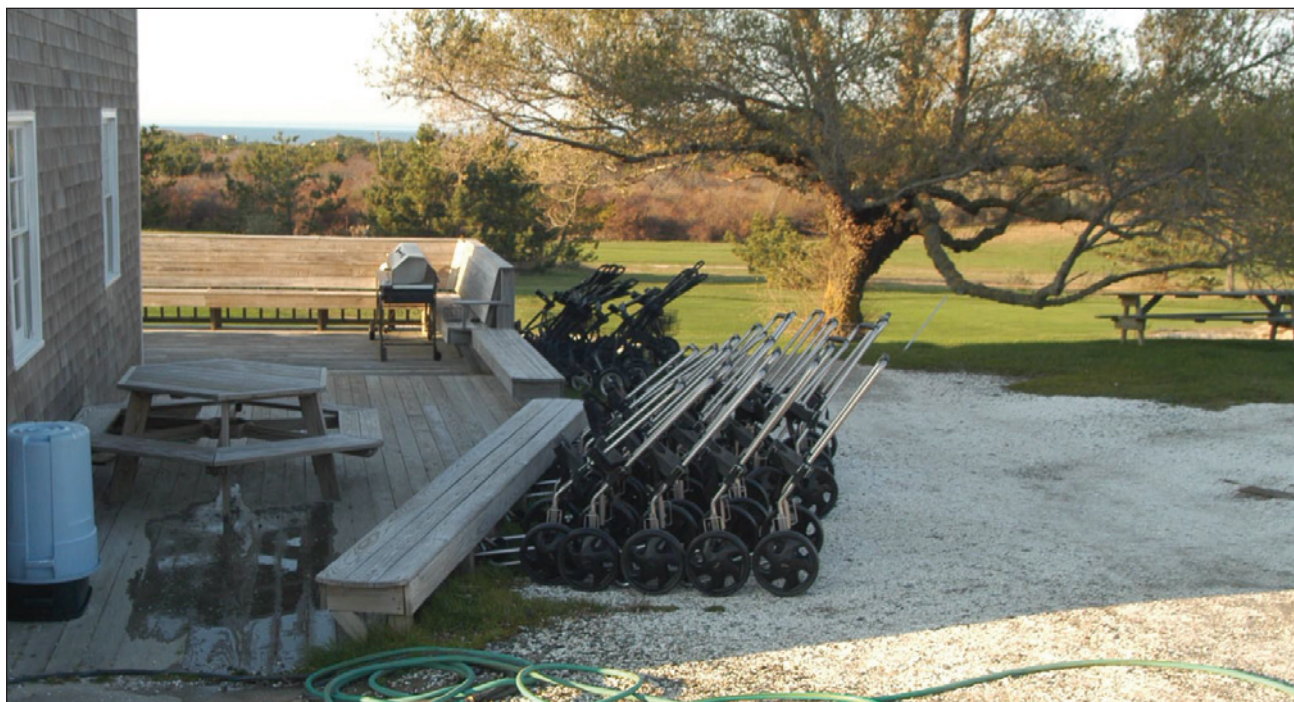
Figure 3.37: Small-scale features

Photo of the benches on the terrace along the club house. Although weathered wood is used throughout, the different bench types results in a lack of unity and consistency. Source: OCLP, 2006.

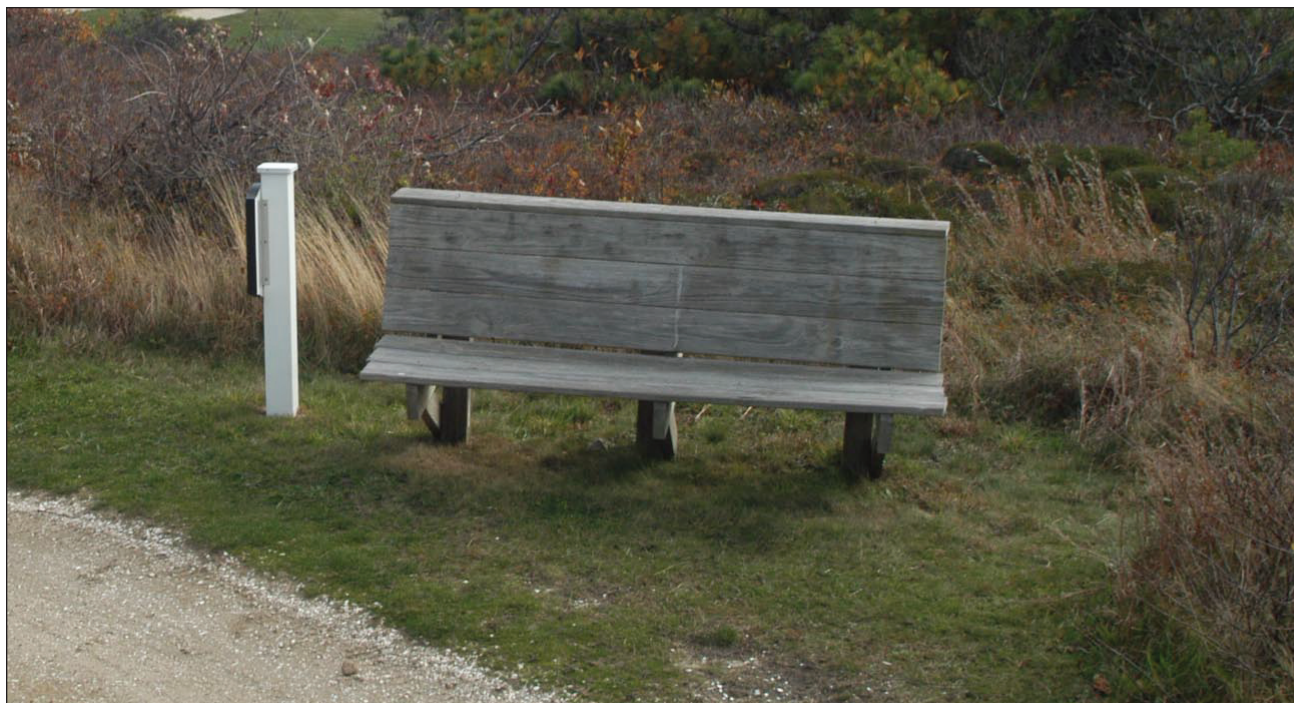
Figure 3.38: Small-scale features

Photo of a bench in weathered wood on the links course and an existing signpost. Weathered wood for the bench is consistent with the treatment recommendations, however, wooden benches are presently inconsistent. Source: OCLP, 2006.

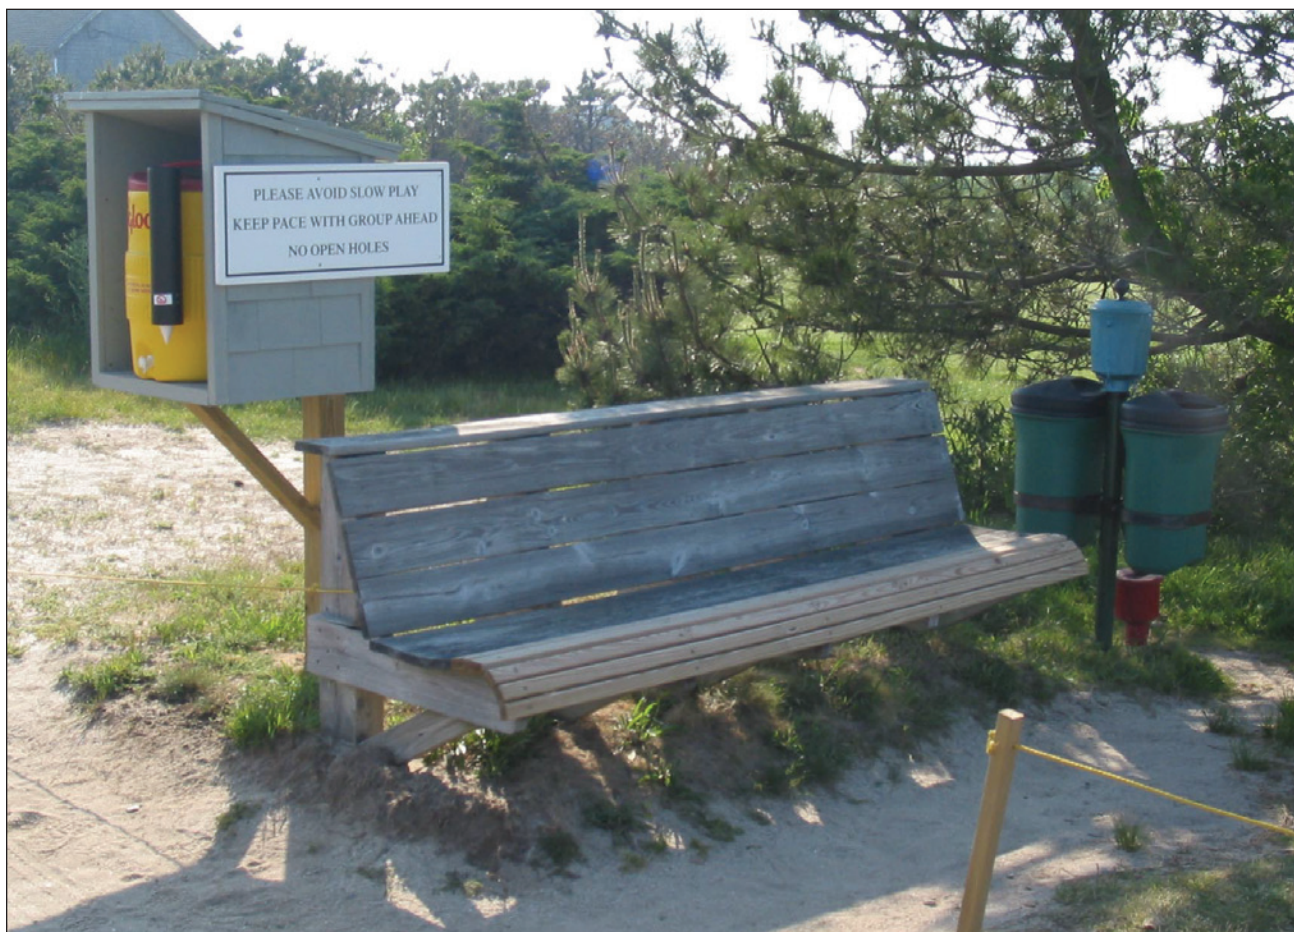
Figure 3.39: Small-scale features

Photo of a preferred weathered wood bench on the links course and other site furnishings. Weathered wood for the bench is consistent with the treatment recommendations, but is inconsistent with other benches throughout the district. Source: OCLP, 2006.

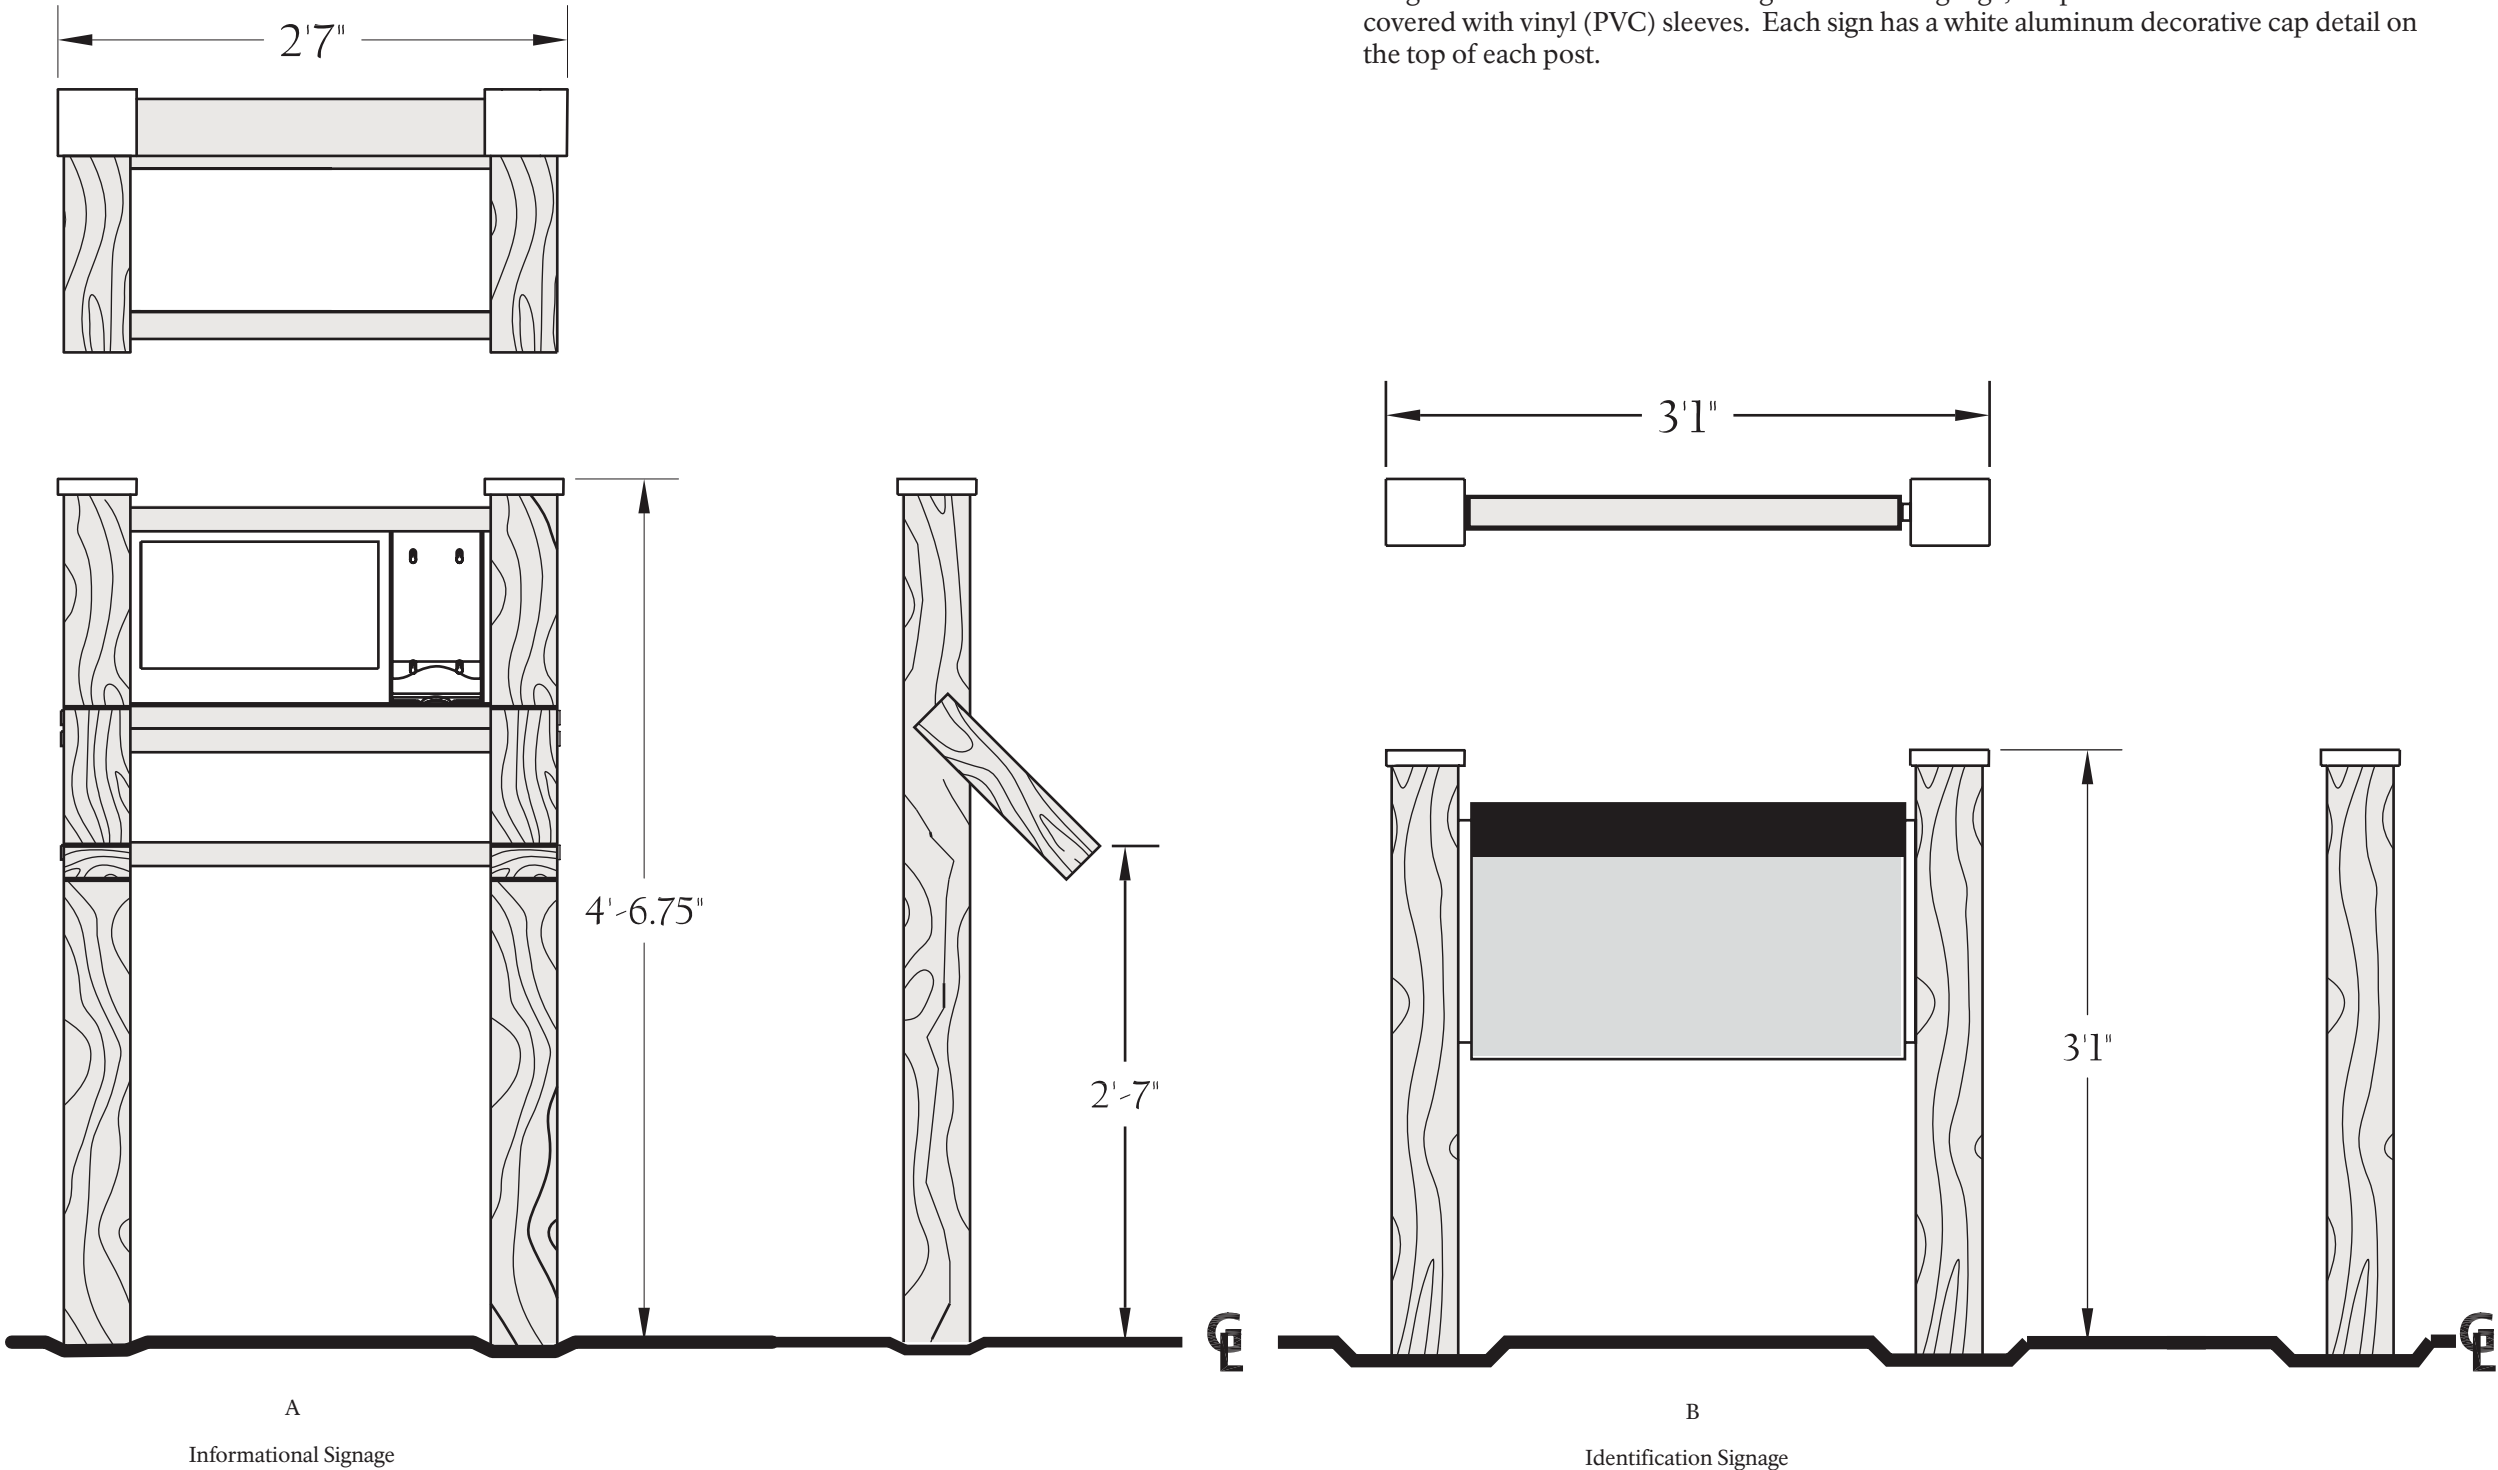
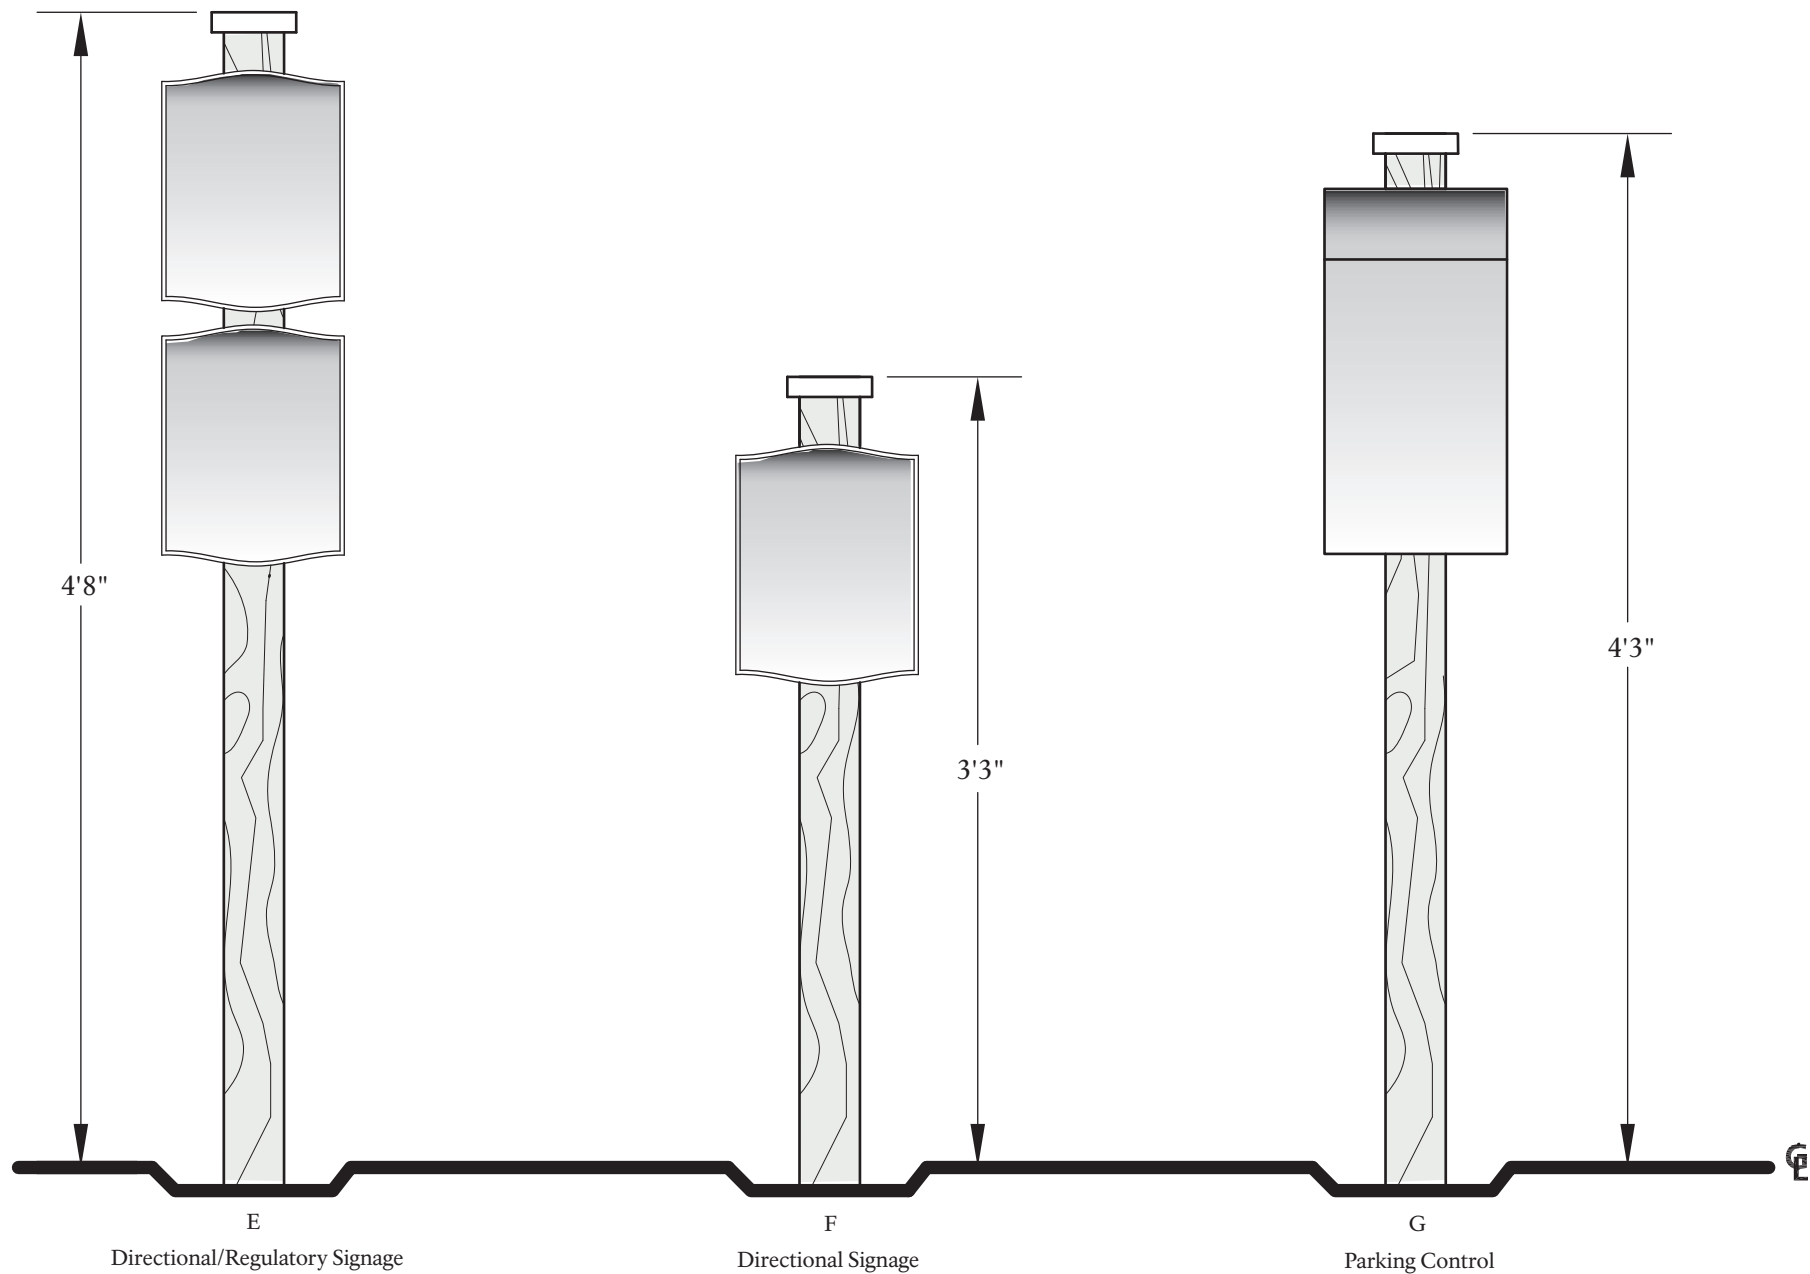
Proposed informational and identification signs are constructed of .125 aluminum panel with screened graphics. Posts are weathered pressure treated 5”x5” wood and extends 26” into the ground. Different from the Highland Links signage, the pressure treated wood will not be covered with vinyl (PVC) sleeves. Each sign has a white aluminum decorative cap detail on the top of each post.

Recommendation: A consistent district-wide signage system should be established for the Truro Highlands Historic District. The implementation of a new sign system would eliminate improperly located signs and repetitive signs (Drawing 3.7-3.9).
