CONDITION REPORT AND TREATMENT PLAN FOR TRURO HIGHLANDS HISTORIC DISTRICT

CAPE COD NATIONAL SEASHORE

National Park Service, Boston, Massachusetts, 2007

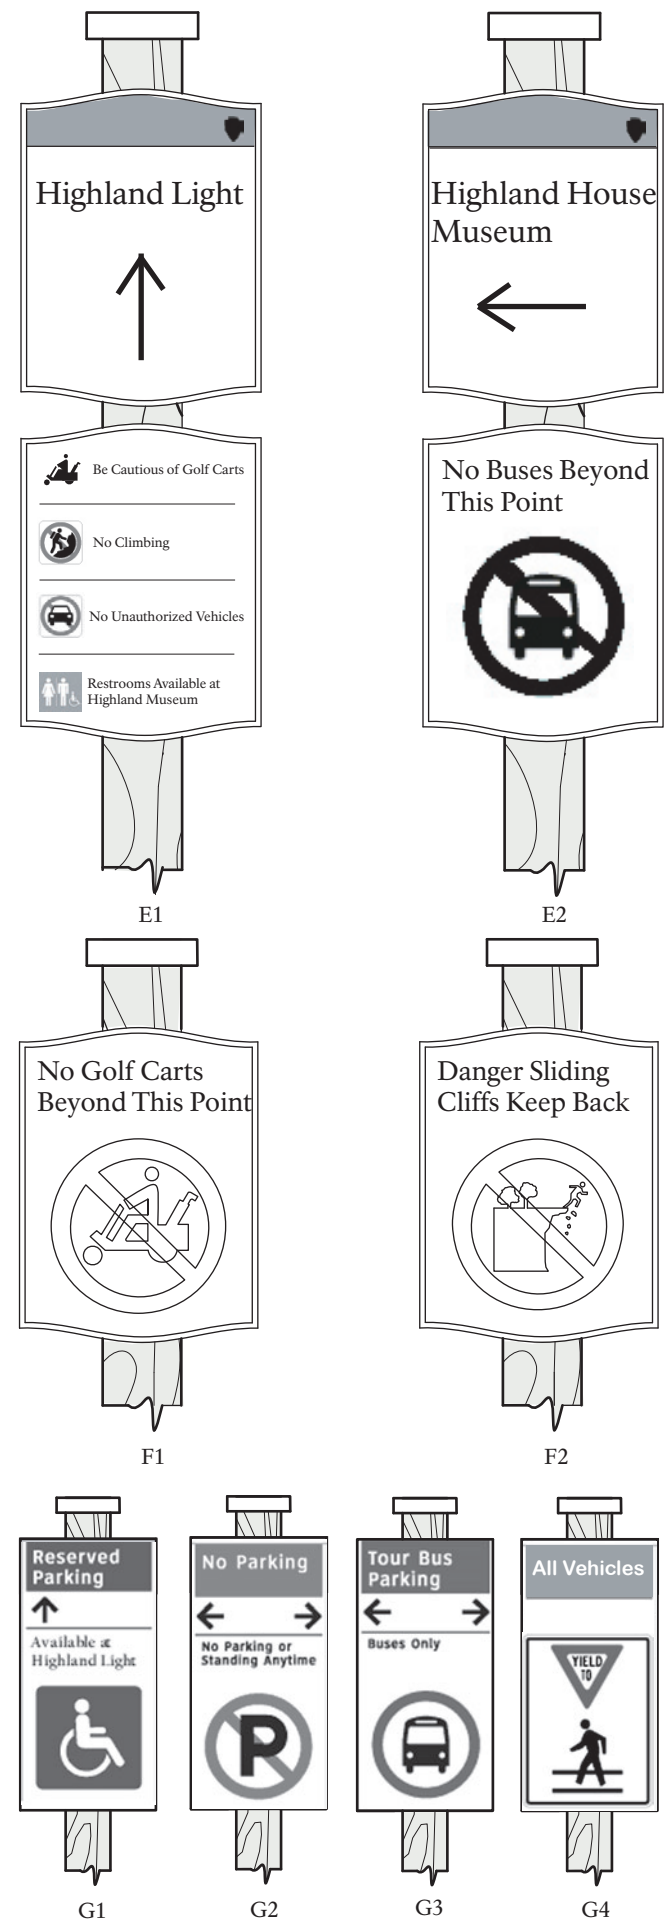
Proposed directional and regulatory signage for the Truro Highlands Historic District will follow similar design standards, including size and shape, as the recently installed signage at the Highland Golf Links. Parking control standards will follow the National Park Service design standards for parking control signage.

Proposed directional and regulatory signage is 16" in width and 24" in length and is constructed of .125 aluminum panel with screened graphics. Posts are weathered pressure treated 4"x4" wood, and extends 26" into the ground. Different from the Highland Links signage, the pressure treated wood will not be covered with vinyl (PVC) sleeves. Each sign has a white aluminum decorative cap detail on the top of each post. Proposed parking control signage is 9" in width and 18" in length and is constructed of .125 aluminum panel with screened graphics. Posts are weathered pressure treated 4"x4" wood, and extends 26" into the ground. Each sign has a white aluminum decorative cap detail on the top of each post.

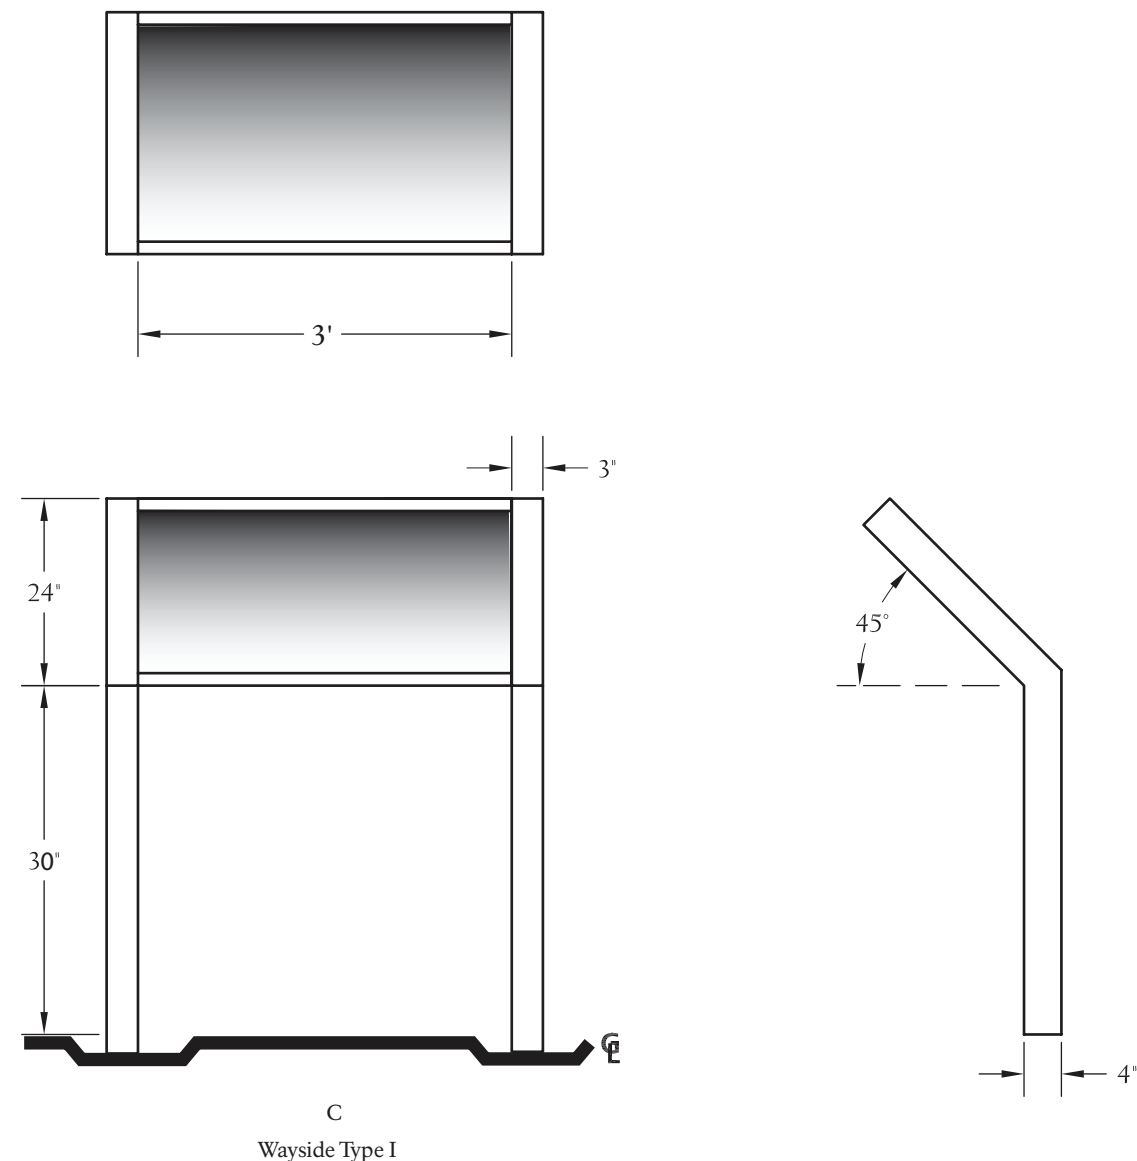
The cantilevered low-profile base wayside exhibit (type I) is the preferred style for NPS interpretive exhibits. The base's simple, unadorned form helps to reduce its visual intrusion on the landscape. Made entirely of welded aluminum extrusions, the base will not rust or otherwise corrode, even in harsh marine environments. It has a textured finish of polyurethane enamel paint. Exhibit panels can be easily replaced by removing rivets that secure the top of the frame assembly. It is recommended that in areas where the wayside exhibits are installed, the bases should be painted in a color that blends well with the natural environment found within the Truro Highlands Historic District.

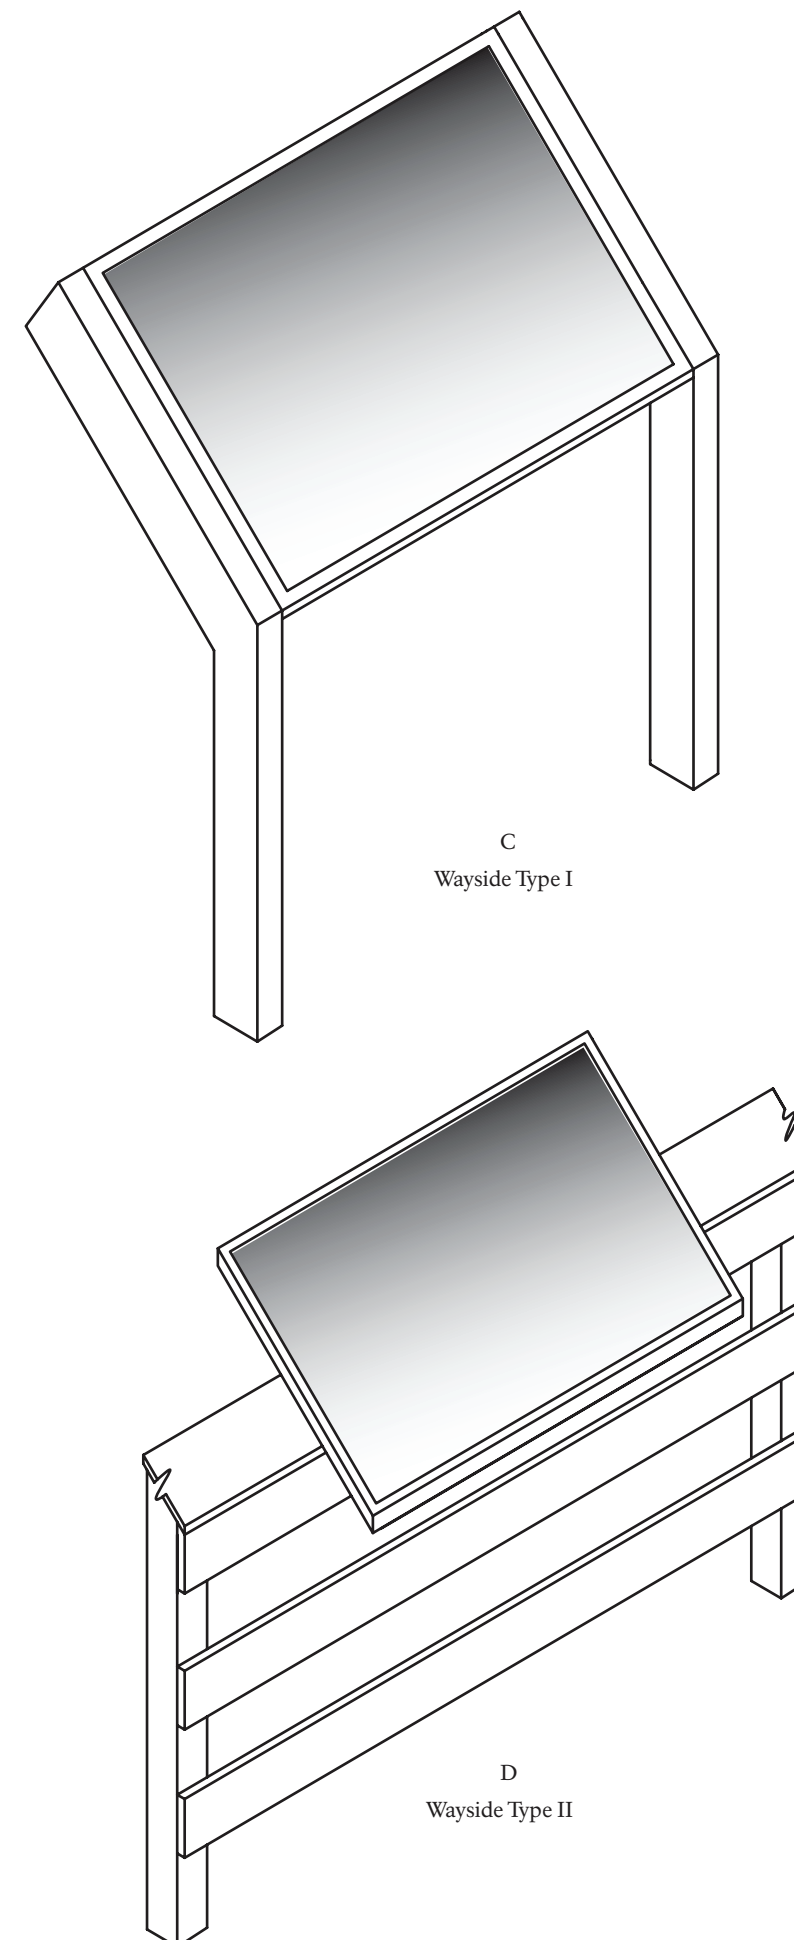
At the observation deck within the Truro Highlands Historic District, custom mounted low-profile bases (type II) with designed metal brackets can be securely attached to wooden or metal rails, allowing interpretation on a wide range platforms and decks.
