CANE RIVER CREOLE NATIONAL HISTORICAL PARK  
OAKLAND PLANTATION

~ PRUD'HOMME'S STORE ~  
HISTORIC STRUCTURE REPORT

2004  
Historic Structure Report  
Prud'homme's Store  
Cane River National Historical Park  
Natchitoches Parish, Louisiana  
LCS#: 91617

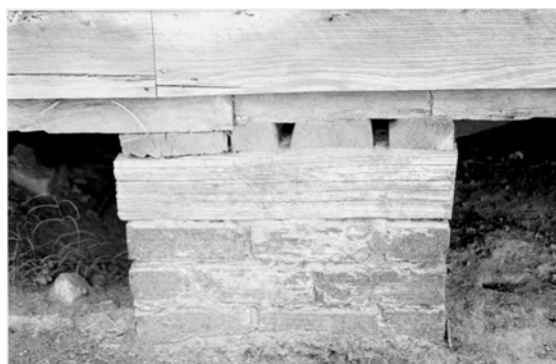
**Figure 17** Typical brick foundation pier with original wood blocking. (NPS-SERO-CRS, 2001)

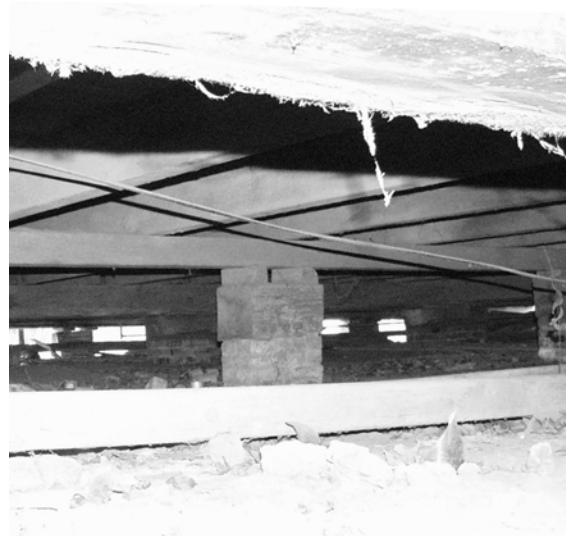
**Figure 18** View of floor framing beneath original building. (NPS-SERO-CRS, 2001)

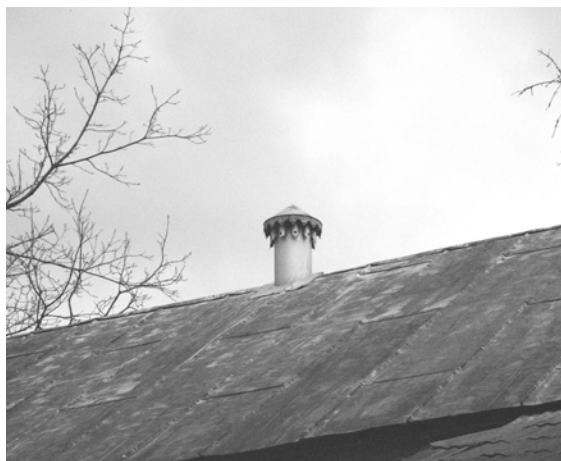
**Figure 20** View of south shed of roof with original ventilator (c. 1900). (NPS-SERO-CRS, 2001)

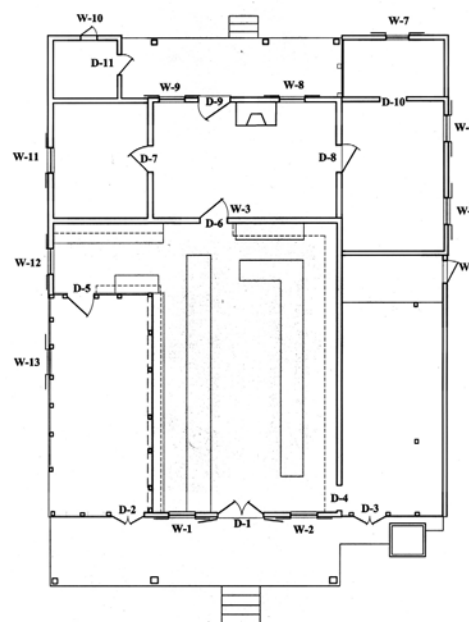
**Figure 21** Doors and Windows, Prud'homme's Store. (NPS-SERO-CRS, 2001)

D- 9: Opening is 3'- 0" by 7'- 6"; interior door is 7'- 0" with the gap at the top filled by leather; nine lights over two vertical panels; moldings similar to front doors; some broken lights have been repaired using multiple pieces of glass. The existing metal latch on the door may not be original, given what appears to be the "ghost" of an earlier latch; the existing latch (at right) is similar to gravity latches found in the Big House and was probably salvaged from another building. A thin metal rod is mounted on the hinge side of the door by two small brackets on the interior face of the door and one on the interior casing. The mechanism appears to

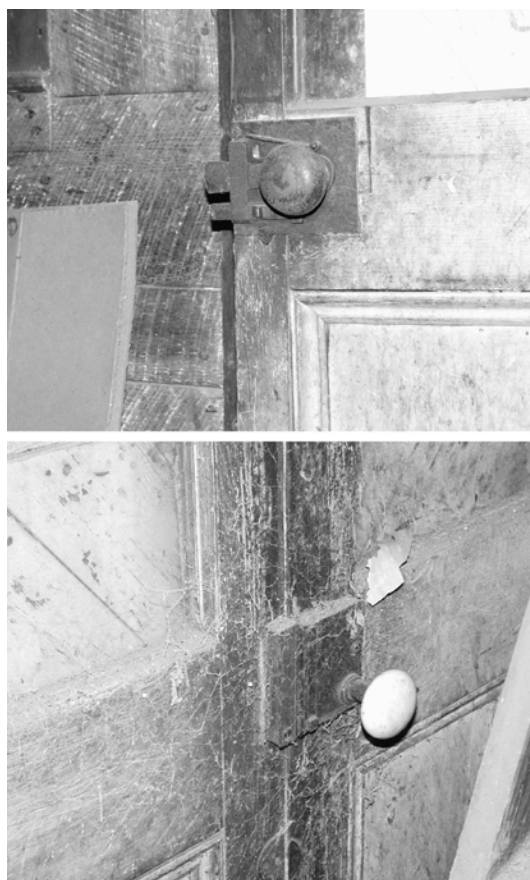
**Figure 23** Top, view of spring latch at back door; bottom, view of rim lock with porcelain knob at front door. (NPS-SERO-CRS, 2001)

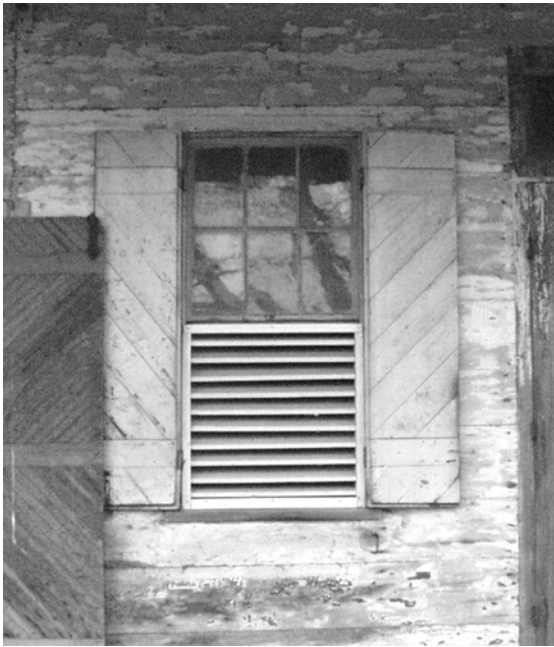
**Figure 24** View of front window, W-2, with temporary ventilator. (NPS-SERO-CRS, 2001)

*W- 2:* Sash is 2'- 8" by 5'- 6", 6/6; shutters and other details like W- 1.

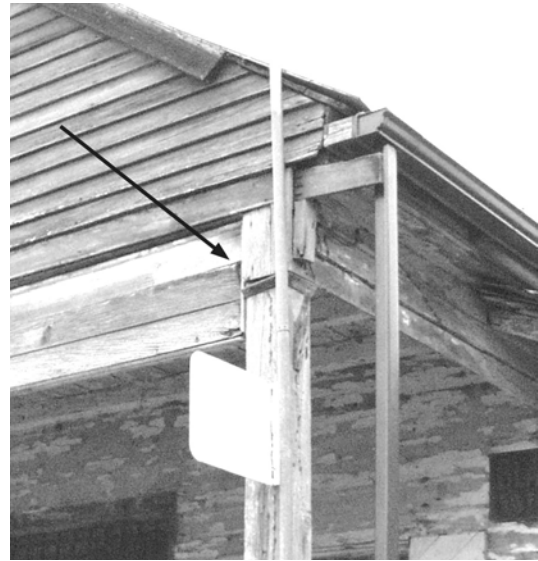
**Figure 27** View of northeast corner of building, showing mixture of exterior finishes. Arrow notes original detail of post top. (NPS-SERO-CRS, 2001)

The 7" by 7" posts that support each corner of the gabled portion of the porch appear to be original. Some of the original drip cap and trim at the top of each post is missing. A plain 4" by

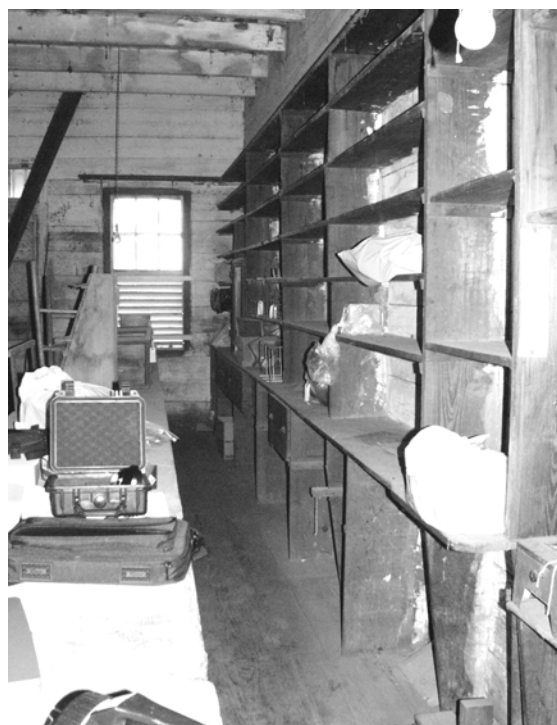
**Figure 32** View of shelving for dry goods on south wall. (NPS-SERO-CRS, 2001)

It is likely that both of these counters were in place within the first ten or twenty years of the building's existence, although both underwent alterations as the building itself was altered and expanded. The first such alteration would have occurred when the north shed (003) was added

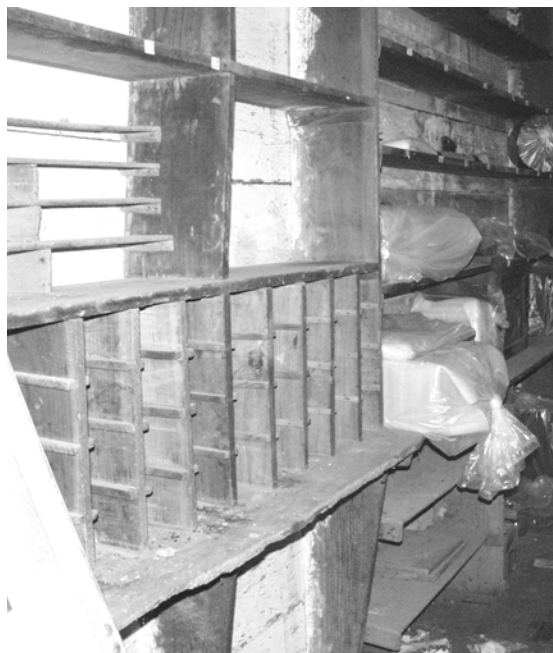
**Figure 33** View of frame on north wall; missing drawers held nuts, bolts, and other hardware. (NPS-SERO-CRS, 2001)

The range of shelving on the north wall is of similar construction to that on the south wall, but paint "ghosts" and relocated cleats indicate that the north range has undergone more alterations. At its east end, construction of the door to the north shed (003) necessitated removal of

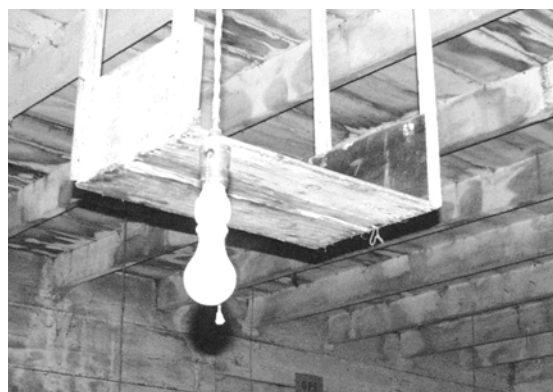
**Figure 36** View of ceiling-hung rack used for match storage. (NPS-SERO-CRS, 2001)
