Carl Sandburg Home National Historic Site

The Swedish House
Historic Structure Report

September 2005

National Park Service

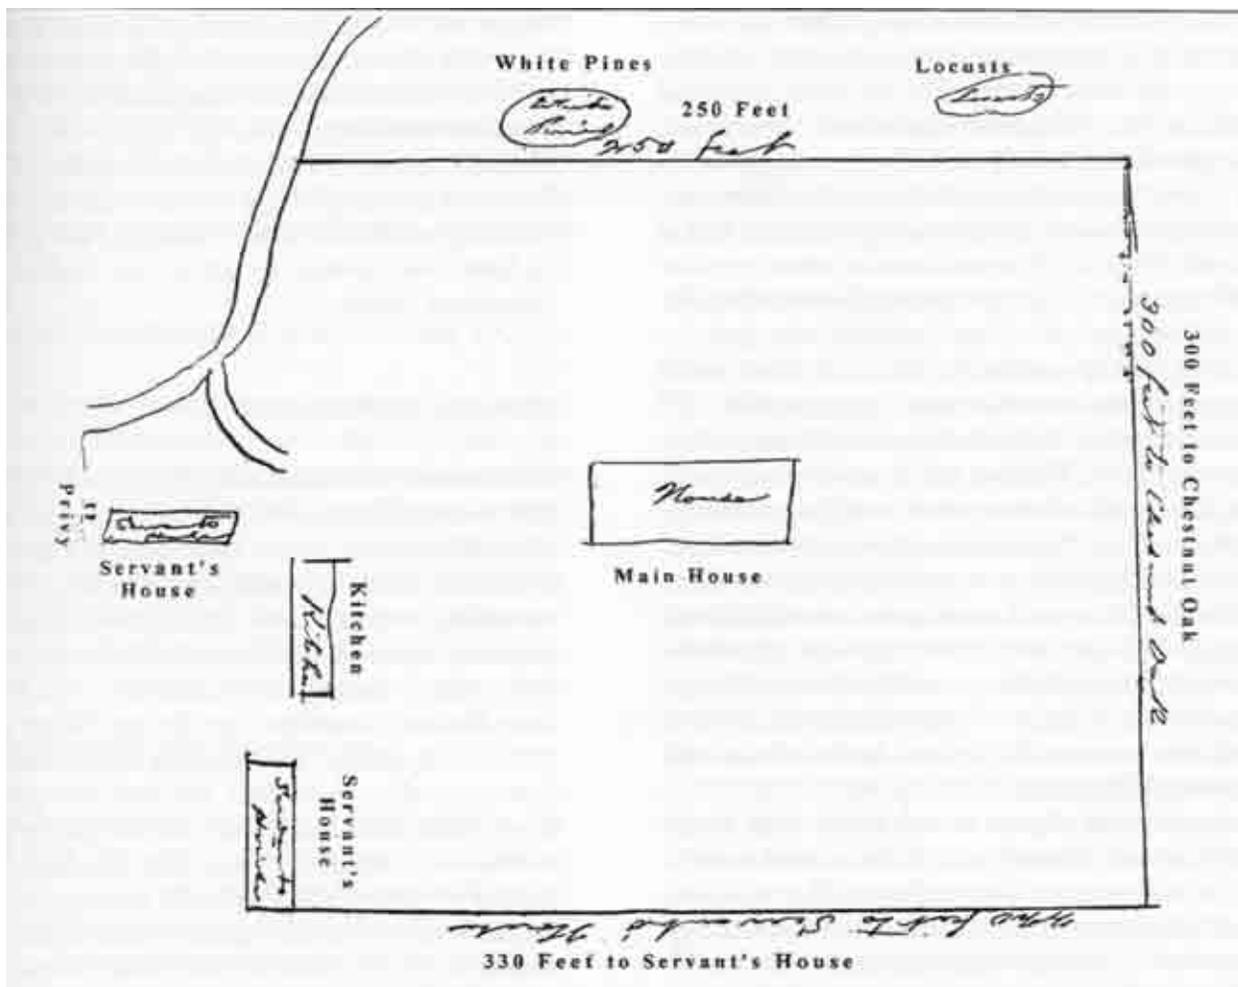
FIGURE 3. Sketch of Rock Hill in Memminger's account book, c. 1852, annotated for legibility. "Servant's House" at left center is the Swedish House. (taken from Pence, *Archeological Overview and Assessment*, 1998)

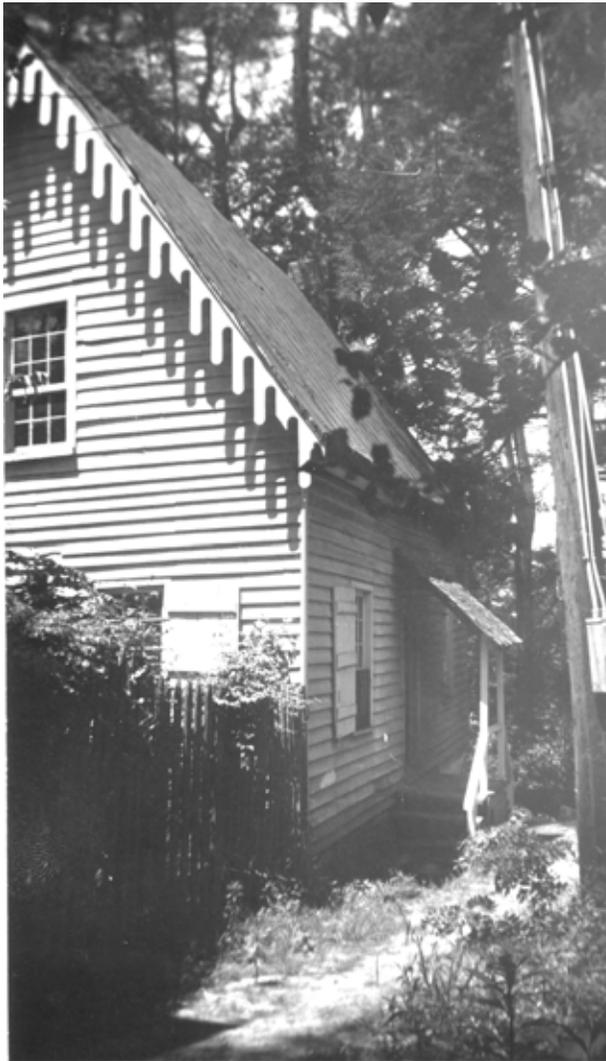
FIGURE 25. Earliest image of Swedish House, 1946, with early wooden steps and porch still intact. (CARL3000/17/1P Coll.)

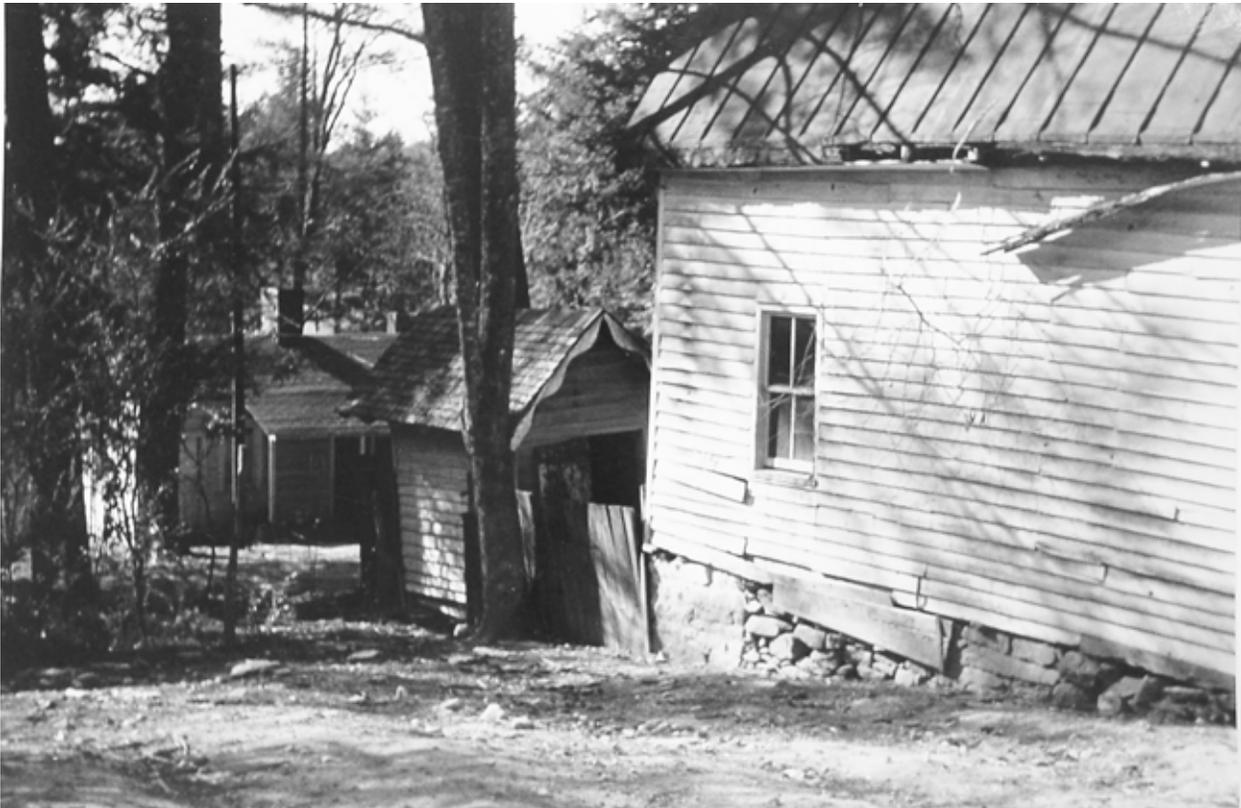
FIGURE 28. View of rear of Swedish House, c. 1964?, with antebellum privy and tenant house in background. (CARL 3000/17/4P)

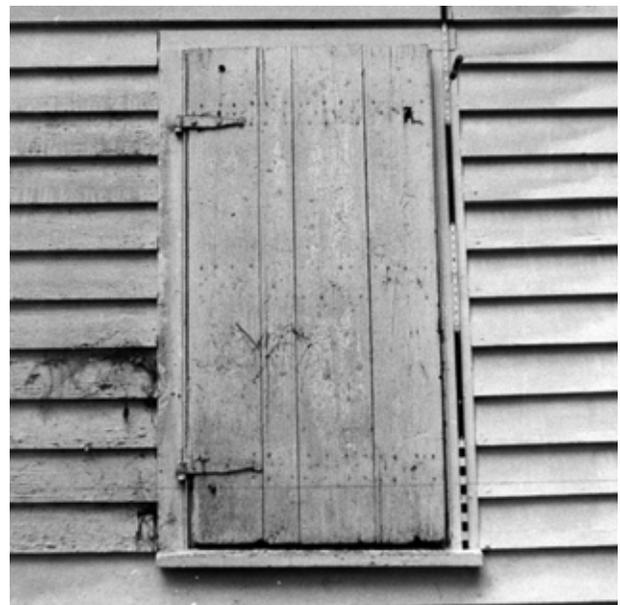
FIGURE 32. View of typical shutter, c. 1970. (CARL5026/2/3P)

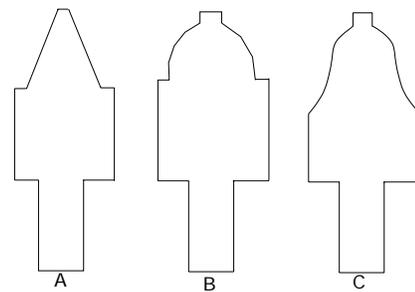
FIGURE 34. Muntin profiles in Swedish House, with Type A representing muntins in original sash and B and C muntins in later replacement sash.

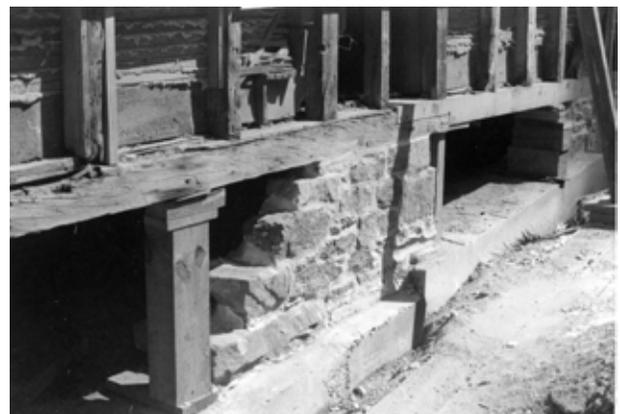
FIGURE 36. View of south foundation during repairs, 1977. (CARL4008/03/25P)

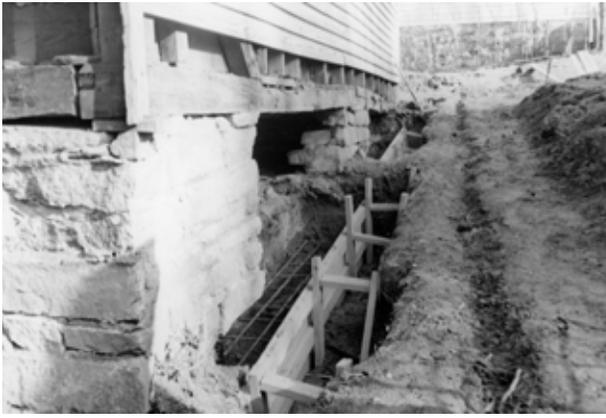
FIGURE 39. View of new footings, 1977. (CARL4008/03/15P)

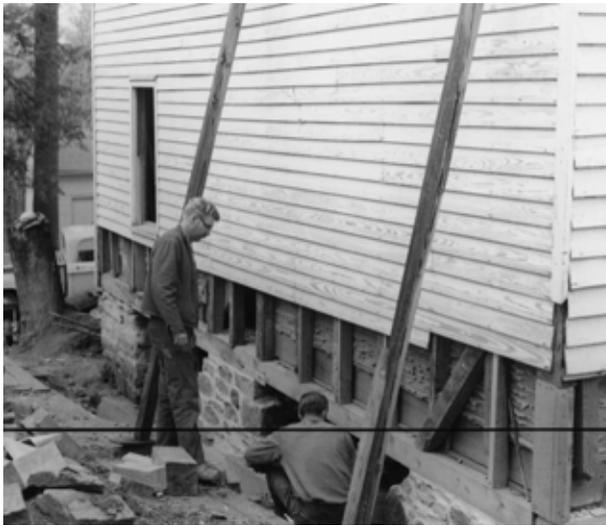
FIGURE 40. Glenn Barnwell, former maintenance employee, standing, inspecting foundation repairs at rear of house, 1977. (CARL4008/03/27P)

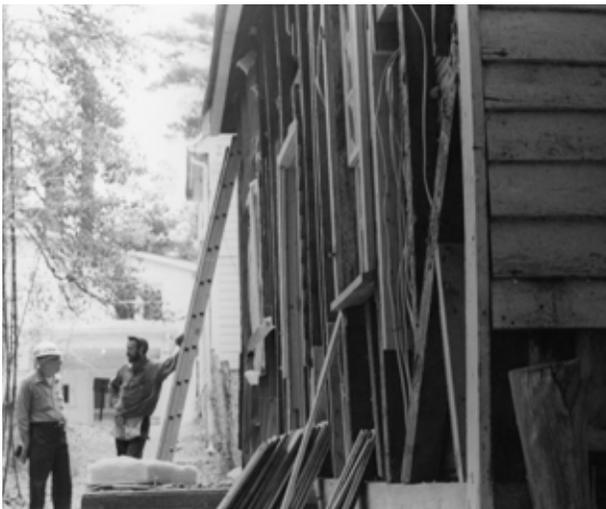
FIGURE 41. Chief of Maintenance Charlie Hamm, left, and Joe Moore, temporary carpenter, at front of house with siding removed, 1977. (CARL4008/03/38P)

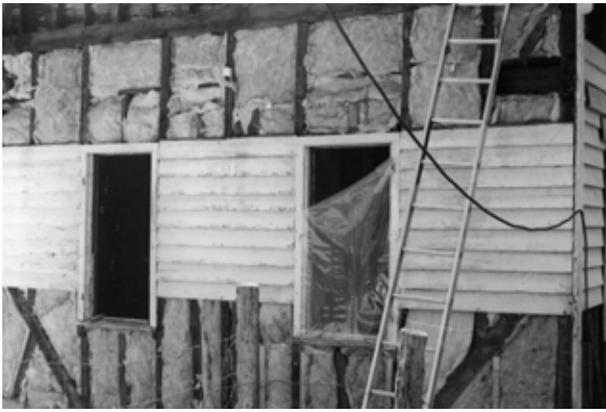
FIGURE 44. View of east end of house after installation of insulation. (CARL4008/03/39P)

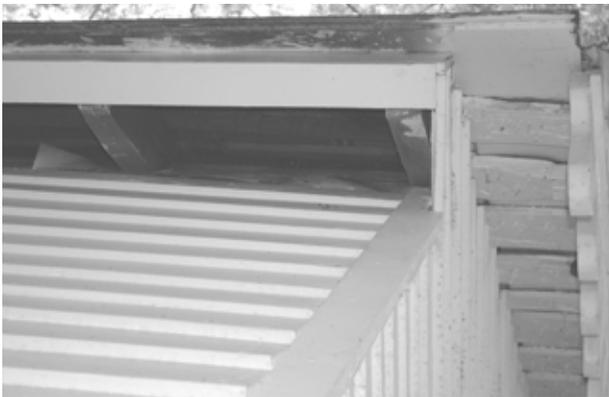
FIGURE 52. View of northwest corner of house, showing typical roof decking and exterior finishes. (T. Jones, NPS, 2004)

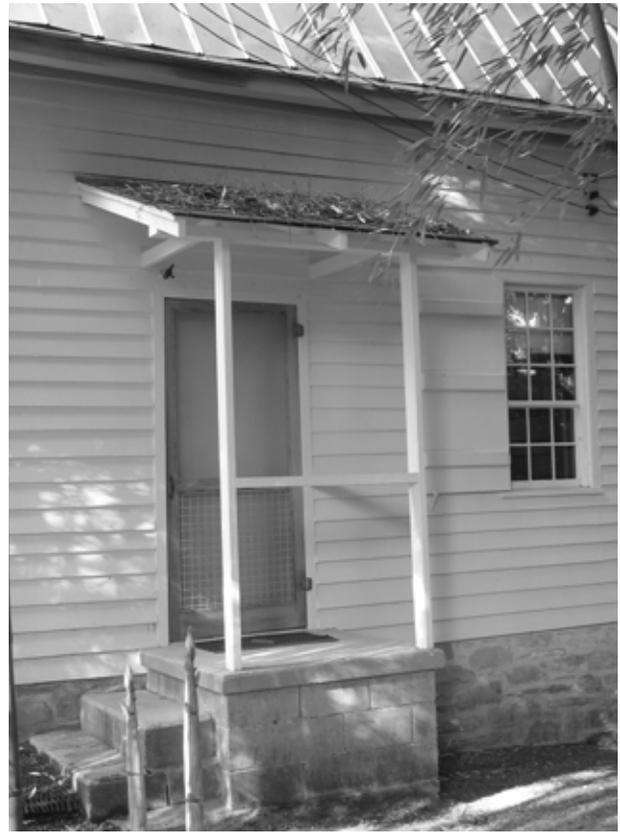
FIGURE 54. View of twentieth-century stoop and shed roof at front door. (T. Jones, NPS, 2004)

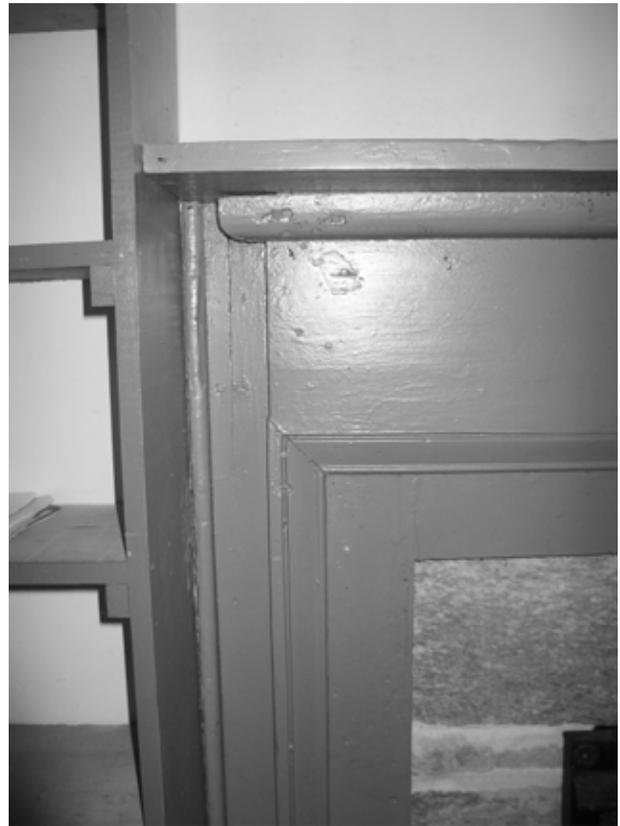
FIGURE 59. Detail view of mantel in Room 100. (T. Jones, NPS, 2004)

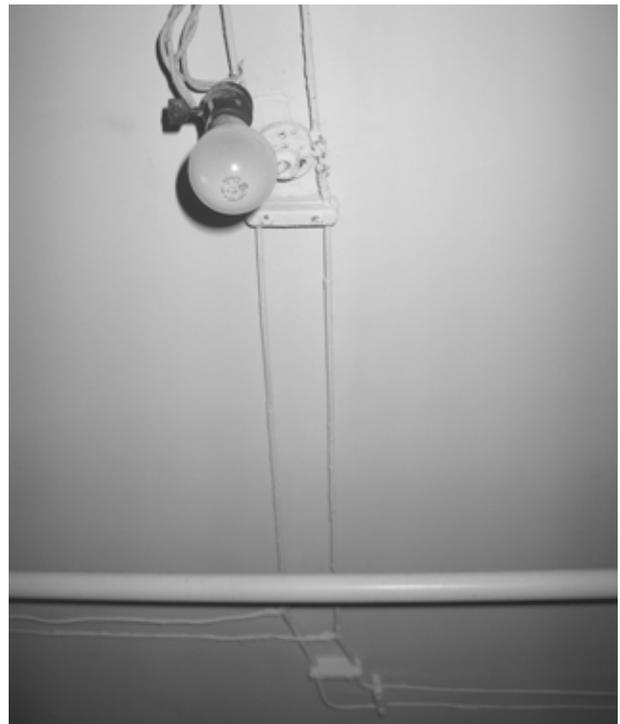
FIGURE 69. View of a portion of the knob-and-tube wiring system, which is no longer active. (T. Jones, NPS, 2004)
