## Chapter 4:

# The CCC Years, 1933-1940

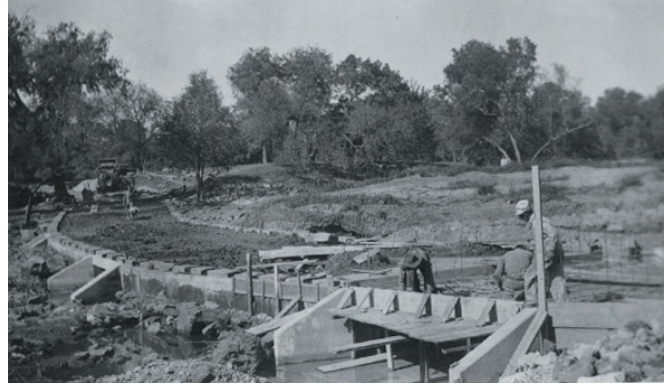
Figure 4-3. Construction of the causeway at Black Sulphur Springs in 1933.

Construction on the causeway began on September 14, 1933 and was completed November 16, 1933.<sup>18</sup> The construction of the new bridge required filling the undermined areas and replacing the retaining wall on the east end of the upstream side of the bridge, as well as pouring a new concrete floor atop the old bridge (Figure 4-3). Although the original plan did not call for it, three openings were cut in the old bridge to allow water to flow underneath the bridge. A new walkway was constructed on the upstream side of the bridge, wider than the old;

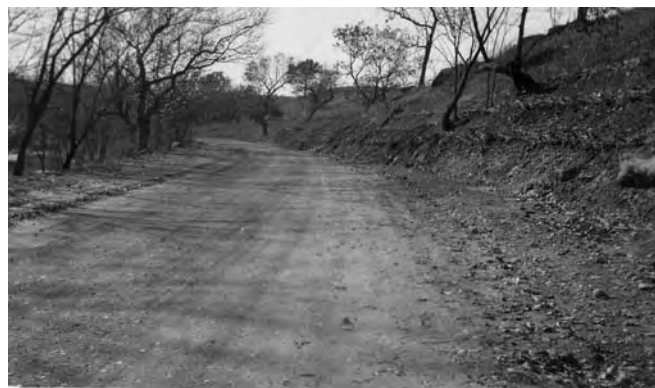
Figure 4-5. Construction of the perimeter road near Rock Creek, circa 1933.

north (Figure 4-5). The work was arduous; it was done with pick and shovel to prevent damaging the nearby sewer line. The second part of the PWA project was the construction of the northern part of the loop road from Sycamore Falls to Antelope Springs. This alignment was staked by the Engineering Department in August 1933 and looped around Travertine Island through the Limestone Creek (known then as “Nigger Run”) ravine. Richey and Popham noted the section “open[ed] up some of the choicest sections of the entire park.”<sup>21</sup> In constructing the road, CCC crews moved hundreds of cubic yards of rock and earth, altering the course of Limestone Creek “to afford better flood run off.”<sup>22</sup> The work was begun by the CCC and finished as part of the Public Works project.

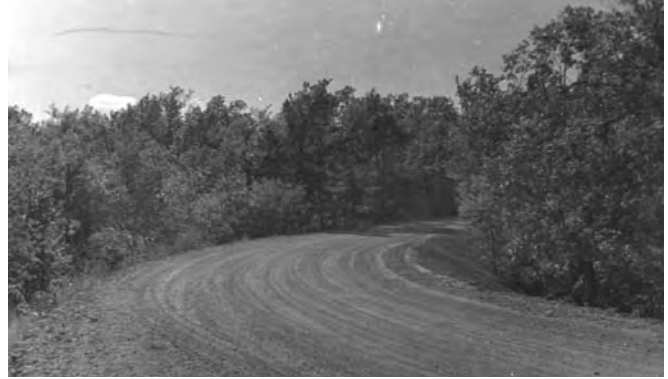
Figure 4-7. Completion of fine grading on Perimeter Road near Buffalo Springs, circa 1935.

The third part of the PWA project was the construction of the southern portion of the loop from Antelope Springs to Horner’s Bluff (Figures 4-6 and 4-7). It is believed this section of construction also included the construction of the Buffalo Spring box culvert, a large bridge-like concrete box faced with limestone masonry. The road construction demanded significant dynamite

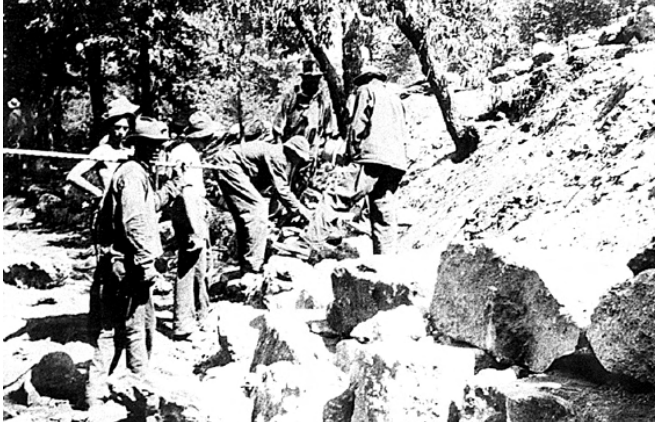
Figure 4-9. Laying rip-rap wall at Horner's Bluff, circa 1934.

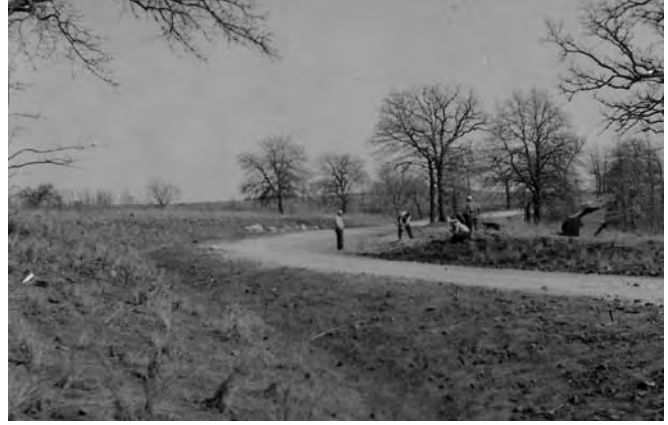
Figure 4-10. Fine grading and planting along Perimeter Road near Bromide Hill, circa 1934.

Construction on the "Bromide Hill Road" began as a PWA project in early spring. By the fall of 1934, CCC crews had taken over the finish work, grading and planting slopes, ditches and approaches to culverts (Figure 4-10). Richey and Miller noted that the finish work was important in merging the road and landscape:

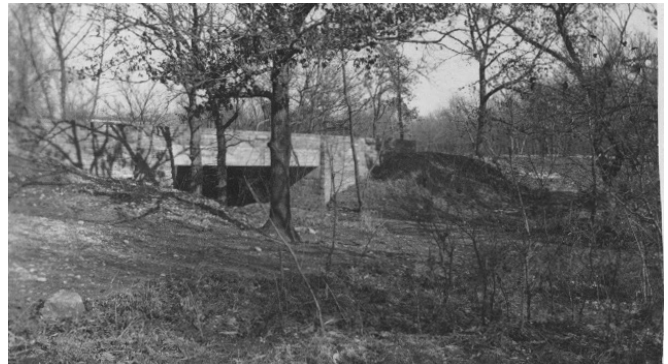
Figure 4-11. Limestone Creek Bridge.

Other work undertaken in 1934 included clean-up and finish grading at both the Limestone Creek and Travertine Creek Bridges. The Limestone Creek Bridge (also known as the "Nigger Run" Bridge) was a concrete box culvert, its deck span supported by steel I-beams affixed to limestone-veneered concrete abutments (Figure 4-11). Begun in the early part of 1934, it was a somewhat problematic project that had not been constructed entirely according to approved plans. In July 1934, Richey recommended that it be converted to an ECW project, so that CCC boys could implement corrections, including rebuilding the handrail and extending the abutments.<sup>27</sup> The Travertine Creek Bridge, located near Flower Park on Highway 177, was a PWA project, similarly finished with ECW monies by CCC boys in the summer of 1934.<sup>28</sup> This bridge replaced a former Y-shaped causeway at the same location.<sup>29</sup> The new structure was constructed of reinforced concrete, and was thirty-eight feet wide, including two four-foot wide walkways on both sides of the bridge (Figure 4-12).<sup>30</sup> Begun on December 20, 1933, it opened for traffic

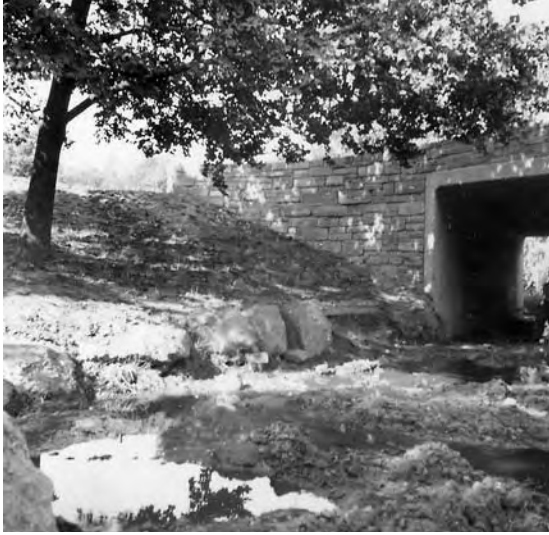
Figure 4-12. Fine grading and rip-rap by CCC crews at the Traver-tine Creek Bridge, circa 1934.

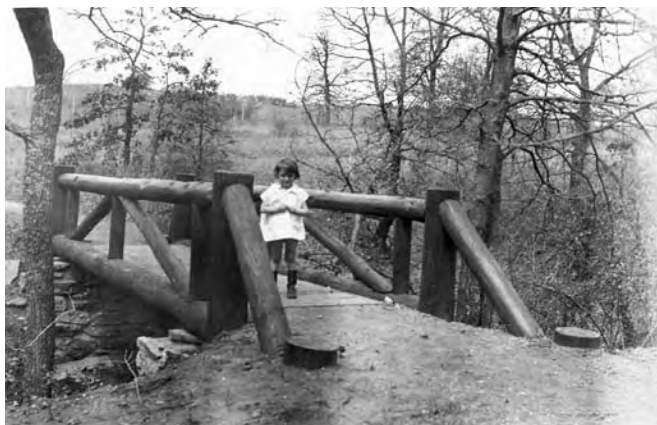
Figure 4-14. Typical peeled log trail bridge, circa 1935.

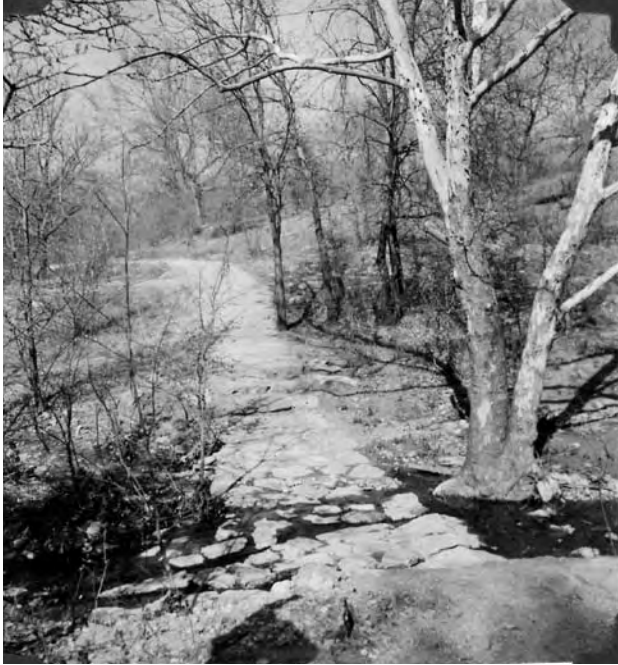
Figure 4-15. Typical stepping stone trail crossing “near Cold Springs Campground,” on Buffalo Springs trail, circa 1935.

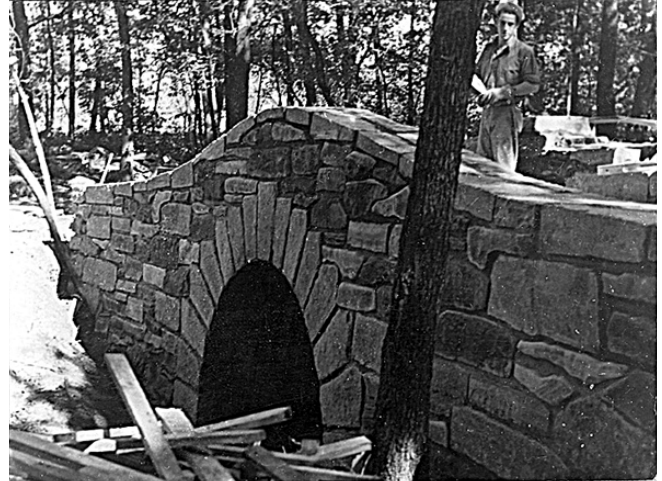
Figure 4-16. Construction of curved stone arch footbridge at Buffalo Springs, 1935.

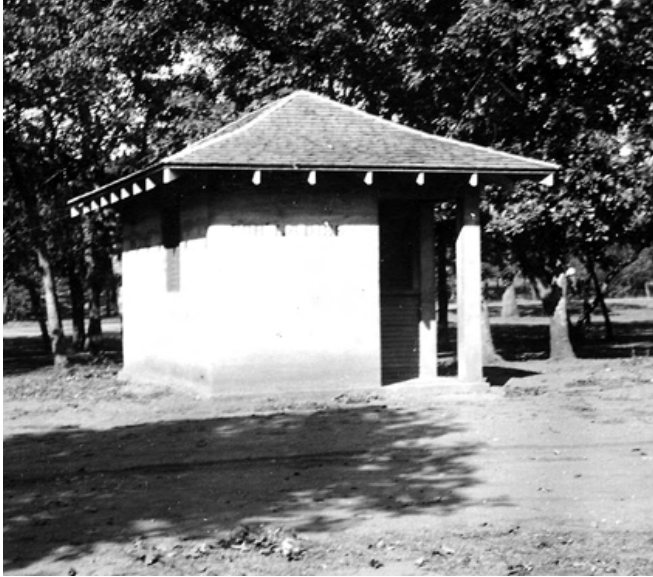
Figure 4-19. New concrete stucco comfort station at Bromide Springs, 1932.

Figure 4-19 shows one of the two identical structures, which had hipped roofs and porch-like entry ways. The new structures were larger than the old ones, and were concrete stucco on metal lath, with two by four

framing and cedar shingle roofs. Each had a men's and women's side and was equipped with frost-proof toilets, wash basins, and electric lights. The appropriation for the work, originally \$1900, was reduced to \$1530, much to

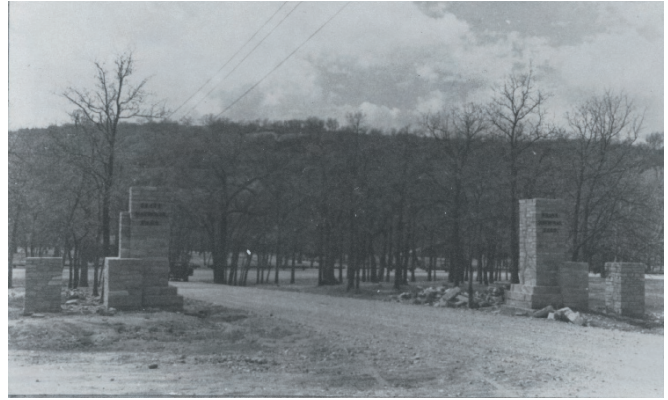
Figure 4-22. Completed set of entry piers at 12<sup>th</sup> Street and Lindsay Avenue, 1935. Note that iron lettering is located on both large piers.

Six stone piers located at the intersection of 12<sup>th</sup> Street and Lindsay Avenue at the park's boundary were the first to be constructed (Figure 4-22). The composition consisted of two taller piers flanking 12<sup>th</sup> Street; on the other side of each pier was a sidewalk and another, smaller pier. Like the rest of the entrance, the piers were constructed of what the landscape architects called "native brown limestone."<sup>63</sup> Black iron art deco lettering of "Platt National Park" was affixed to the large pier (on the right side only or both) as it was built up. This set of entrance piers was completed by March 1935.

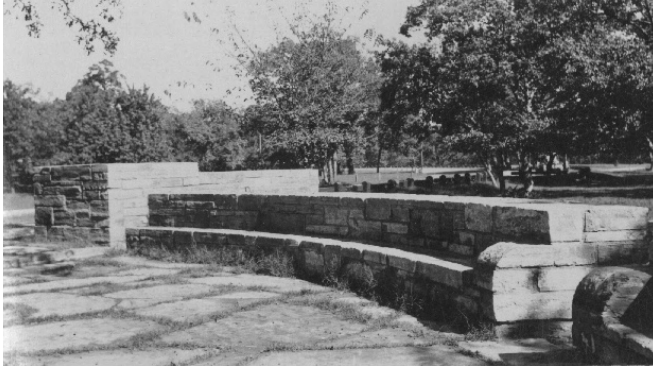
Figure 4-23. Low, semicircular walls at 12<sup>th</sup> Street Fountain 1935.

Work on the rest of the entrance began in April 1935 as part of the fifth CCC enrollment period. From the piers, two flagstone walks flanking 12<sup>th</sup> Street led to the park's perimeter road, where a stone curb and low walls embracing the intersection were constructed. Across the road, a broad paved flagstone court surrounded the circular pool and was enclosed with a low, semicircular seat wall on the south side (Figure 4-23). Two L-shaped walls connected the semi-circular walls to the edge of the street, forming the boundaries of the flagstone court; these L-shaped walls also featured two drinking fountains, which were fed by the same artesian well as the fountain jet.

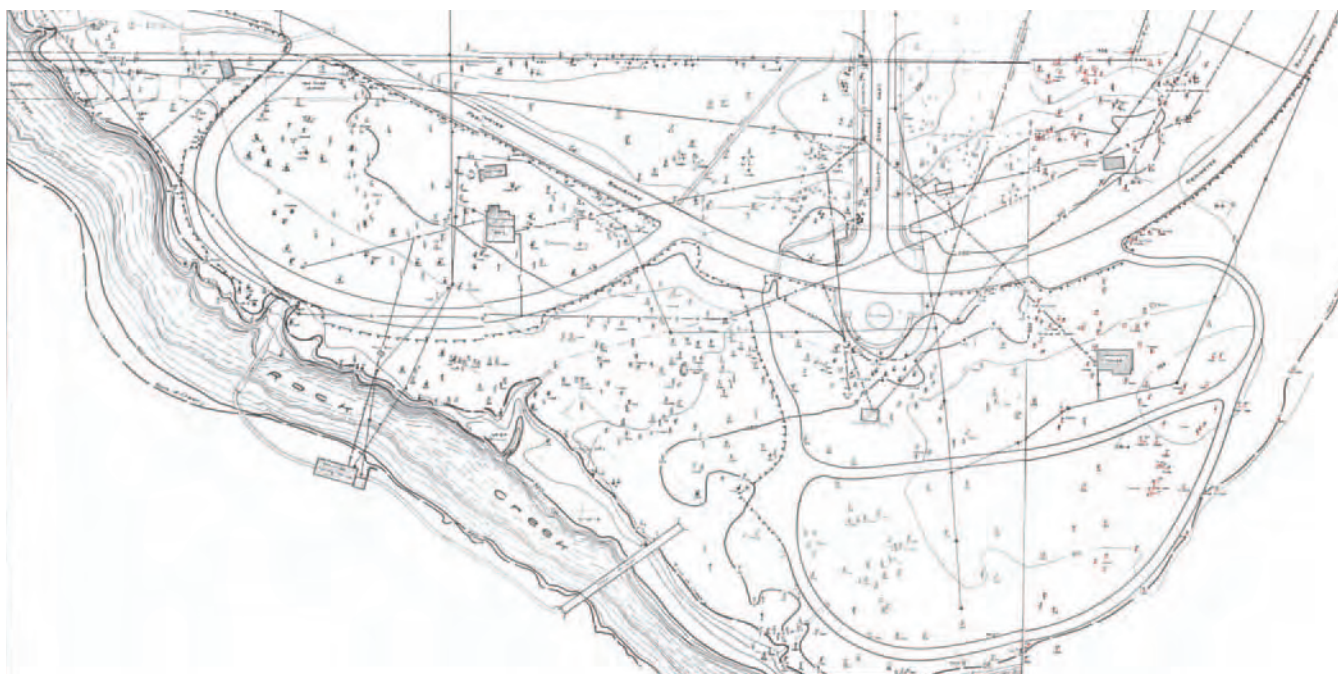
Figure 4-27. "Topographical Map, Bromide Springs Area," Drawing NP-PLA-5036, 1936.

In December 1935 and January 1936 plans were also finalized for a new pavilion on the north bank of Rock Creek. In preparation for this work, a full survey of the Bromide area was undertaken. This useful plan shows the completed 12<sup>th</sup> Street entrance, the four wood frame and stucco comfort stations, and guard-rail lined camp roads (Figure 4-27). The survey also provides good documentation of the large trees that dotted the area. A faint outline of the proposed new pavilion is also seen on the survey.

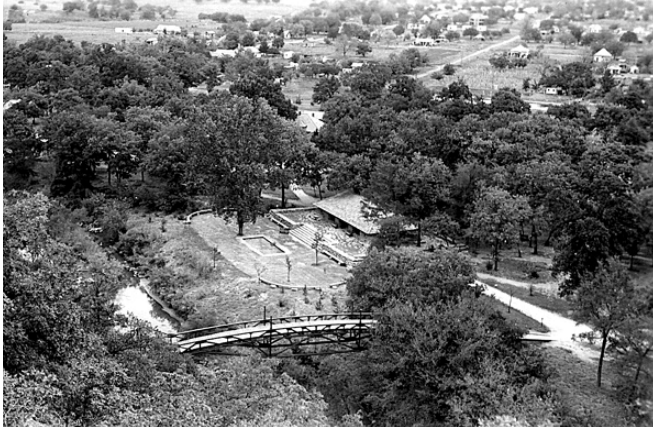
Figure 4-29. Overview of Bromide Area and Bromide Springs Pavilion, circa 1936.

The new pavilion was the focal point of the whole Bromide area. Figure 4-29 provides an excellent overview of the completed pavilion and its context, including the iron bridge and the mown grassy area around the lily pond, shaded on the west by the large cottonwood. Two other smaller trees, no longer extant, were apparently planted to shade the eastern side of the pool and bench. Also interesting in this view are the evergreens planted around the backs of both sides of the wooden bench, which were presumably meant to grow up and enclose the area encompassed by the benches. Also notable are the grass-jointed terrace paving and the trees growing out of the terrace on the building's west side. Figure 4-31 shows a more detailed view of the area, including the laminated nature of the wood bench, its boulder supports, as well as details of the building masonry. Both of these images are early views, taken before July 1937 when the flagpoles were added to the terrace as seen in Figure 4-30. The new pavilion proved popular with the public and the area became a focal point for group activities. In July of 1937, a temporary wooden stage was constructed somewhere in the Bromide area for community entertainment and in the summer of 1938, weekly Wednesday night programs were instituted.<sup>82</sup>

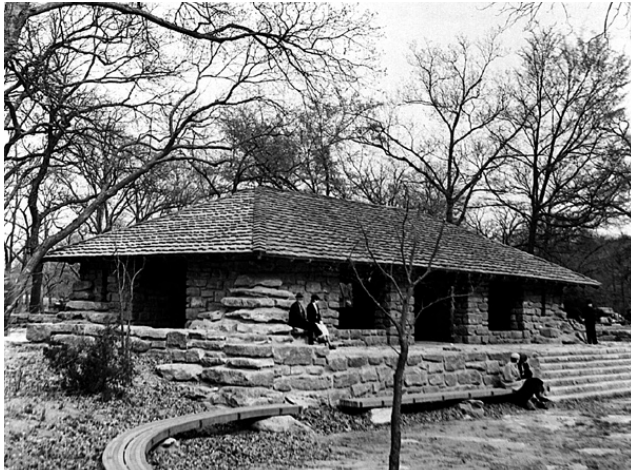
Figure 4-31. Detail of bench and construction at Bromide Springs Pavilion, circa 1936.

The building was situated atop a grass-jointed flagstone terrace, which in turn was surrounded by low stone walls. To the north, the terrace met the surrounding park area more or less at grade. To the south, steps led down to a grassy lawn court, where a rectangular stone and concrete pool was set into the ground. The pool, twelve by twenty-eight feet, was fed by the bathhouse well and was four feet deep, though its depth varied six inches from end to end to aid in drainage and maintenance. The pool's walls and floor were designed to be eight-inch-thick reinforced concrete while the pool's coping, at grade, was flagstone two feet-four inches wide. Enclosing this so-called "lily pond" was a wood and stone bench which lined the terrace wall and ended with two graceful semi-circular ends embracing the pond.

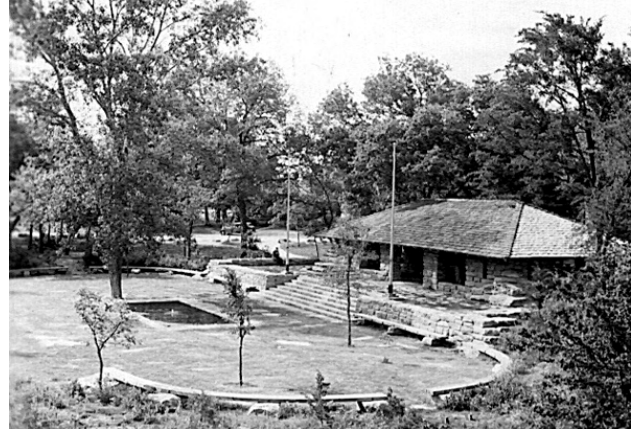
Figure 4-30. Bromide Springs Pavilion, circa 1937.

A comparison of the original plans, historic photographs, and existing conditions reveals that numerous modifications were made to the pavilion as it was constructed. This was a rather standard procedure for construction in the park as site-specific conditions such as grades and trees were encountered. The pavilion was shifted slightly to the northeast, and the size and proportions of the terrace and building were changed. The location of the water storage tanks and office were also switched from the eastern end of the building to the western end; known documentation does not indicate why.

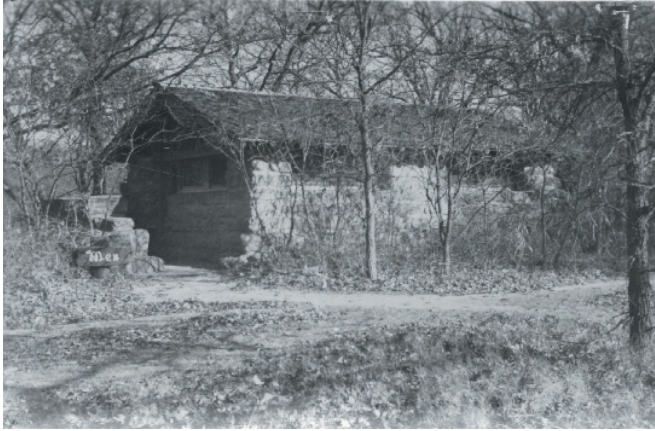
Figure 4-32. Bromide Springs Comfort Station, circa 1949.

Meanwhile, a few more projects were implemented. In May 1937, a contract was awarded for the construction of the Rock Creek Causeway just west of the Bromide area.<sup>83</sup> In January 1938, work began on a new comfort station to replace one of those constructed in 1933-34. Modeled after the rustic style comfort stations in Cold Springs Campground, the new station was located just south of the 12<sup>th</sup> Street fountain. Plans for the comfort station were completed in February of 1937.<sup>84</sup> Construction was completed around June 1938 (Figure 4-32).<sup>85</sup> Sometime between 1940 and 1942 an interpretive sign was installed

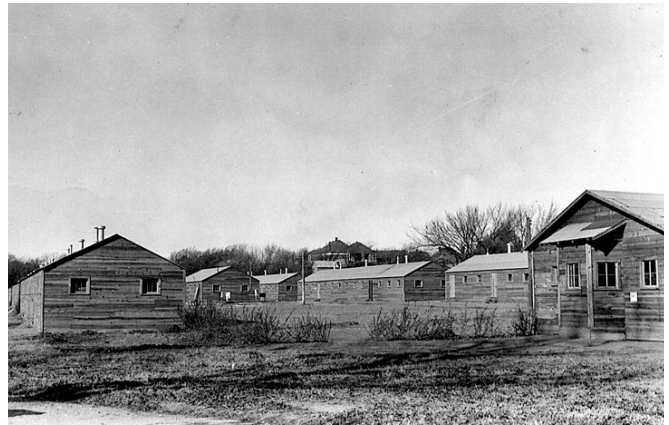
Figure 4-36. Temporary wood buildings at the Walnut Grove site, circa 1935. View taken from the southeastern corner of the camp, looking northwest towards Sulphur.

Though the original camp was an assemblage of tents (Figure 4-35), the new camp featured simple, wooden buildings (Figure 4-36). The camp was built in October 1933, and the CCC men moved into it on November 5, 1933.<sup>87</sup> As shown in an aerial view, (Figure 4-37), the buildings were arranged in a linear quadrangle, oriented east-west along the road to Bromide Springs. The camp facilities included:

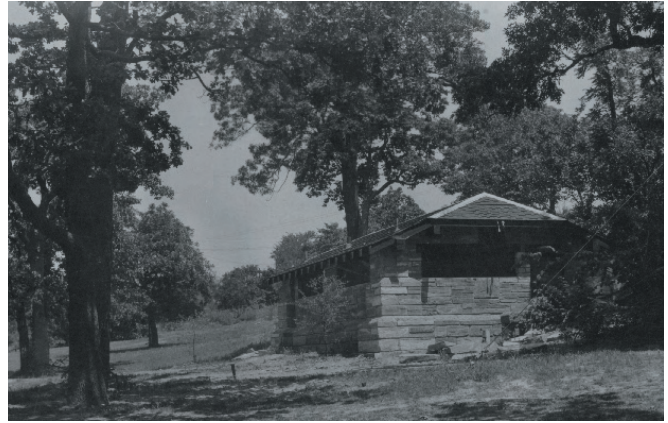
Figure 4-41. Completed Flower Park comfort station, 1935.

Excavation for the building began December 21, 1933 and construction began on February 1, 1934. The process was not easy for the CCC crews, most of whom had never done this type of work before (Figure 4-40). Unlike the other rustic structures in the park, each stone in the comfort station was smoothly faced (or “dressed”) by hand, giving the building a refined, almost elegant, appearance. Above the stone walls, rough-sawn beams and rafters supported a hip-end gable roof covered in wood shingles. The building was approximately thirty-two by twenty-two feet and was completed on June 15, 1934. The finished building nestled into the hillside and vegetation behind it (Figure 4-41). Interestingly, this view shows a few small trees planted in the front of the

building. Also prominent are the roof's exposed rafters and the building's hipped gable end.

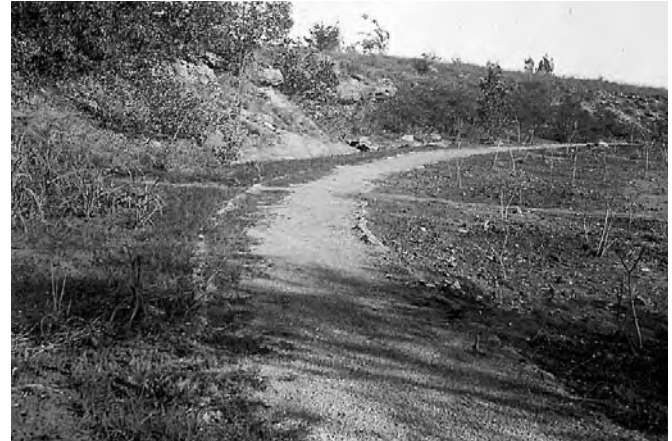
Figure 4-44. Curving alignment of stone paths in Flower Park, circa 1935. Note stone edging and young plantings to the right of the pathway.

walls' foregrounds; behind them, larger trees and red cedars provided a leafy backdrop. The area, described as a “garden wall entrance treatment” was complete by September 1934 (Figure 4-44).<sup>104</sup> The project also included installing curb and gutter around the four corners of the intersection and roadway drainage. Catch basins were installed in the gutters and storm water was directed in an open ditch 600 feet down both sides of the road to Travertine Bridge.

Unfortunately, no planting plans or records of these plantings have been located to confirm the specific locations and types of plantings. Photographs (Figure 4-44) do show some of these plantings which included a large number of shrub beds along the upper trail in Flower Park.

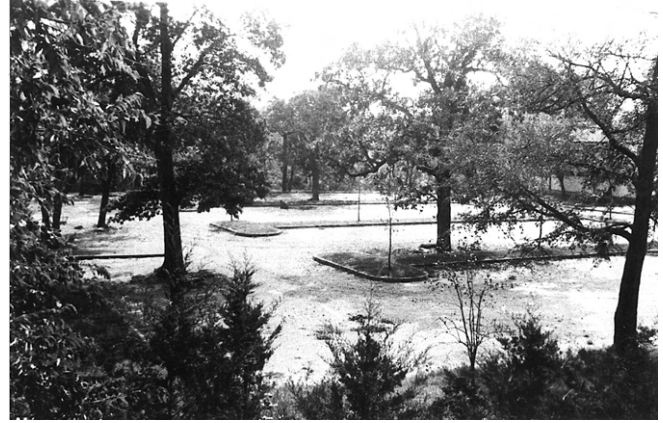
Figure 4-46. Vendome parking area, circa 1935. Note stone curbs and trees in islands.

Another project was the construction of a large parking lot in the northwest corner of the park adjacent to the Vendome Plunge Pool (Figure 4-46). The parking area was intended to “service Flower Park” and Vendome and was designed to accommodate 130 cars.<sup>107</sup> The design was a standard rectangular parking lot, 160 feet by 248 feet, with three interior parking bays, with three islands

with grass and trees. A six-inch tall limestone curb was installed around the islands and parking lot and the whole was paved in gravel. This rather pedestrian parking lot design had one unusual feature: Running beneath the parking lot, on the line of the middle island, was a “siphon” or pipe for the Vendome stream, which then bubbled up on the opposite side of the parking area.

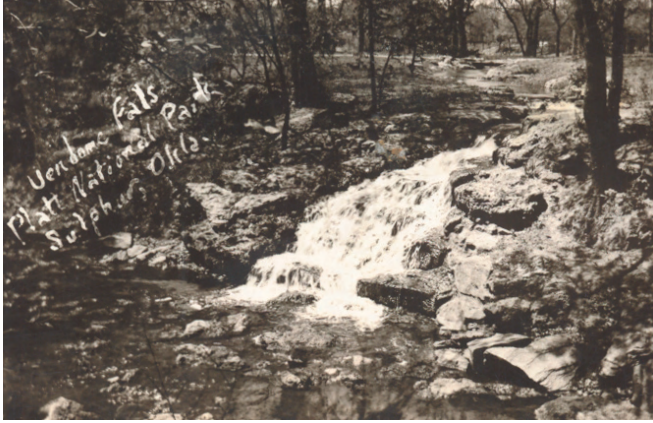
Figure 4-47. Postcard view of Vendome Stream Falls, circa 1935.

The Vendome stream, previously a ditch, was redesigned to create “the most distinctive attraction of the area,” the “artificial creek” with two wading pools located along its length.<sup>108</sup> The stream was given a new, more meandering course through the park and emptied into Travertine Creek where it created a waterfall (Figure 4-47). A park newsletter provided a compelling description of the proposed design:

While the pools will primarily be for children, it is expected that people of all ages will enjoy them, with the winding creek supplying an abundance of everchanging and sparkling water from the Vendome will [sic] before it finally plunges five feet into Travertine creek just north of Lincoln bridge forming a fascinating water-fall.<sup>109</sup>

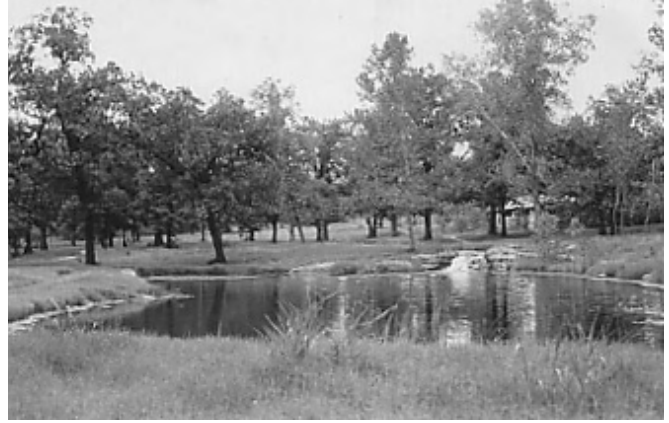
Figure 4-48. Lower wading pool in Flower Park, 1937.

A typical cross section through the pools will show that their maximum depth of water will be about 2 feet, with a gradual decrease in this depth as the bank is approached. The first inch of the foundation’s depth is fine gravel; the next two inches, rough gravel; and below this, impervious clay. The arrangement of shrubs with the existing trees at certain places around the pools, sloping banks will give a naturalist effect, while the placement of rocks here and there will further contribute to the same desired effect. These rocks will also afford seats for those who wish to dangle their feet in the sulphurous water either for its cooling, exhilarating or therapeutic value.

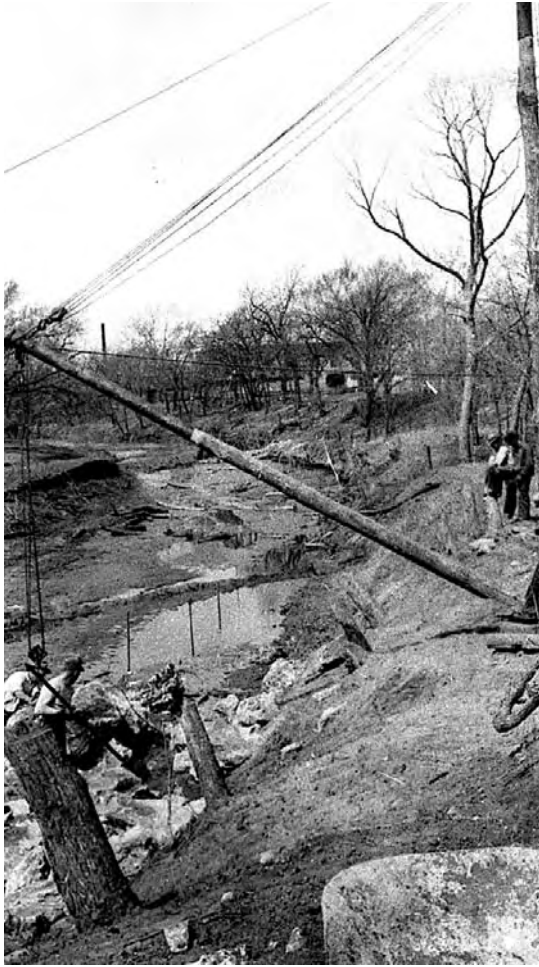
Figure 4-52. Placement of rip-rap using winches at the Flower Park revetment wall, 1934.

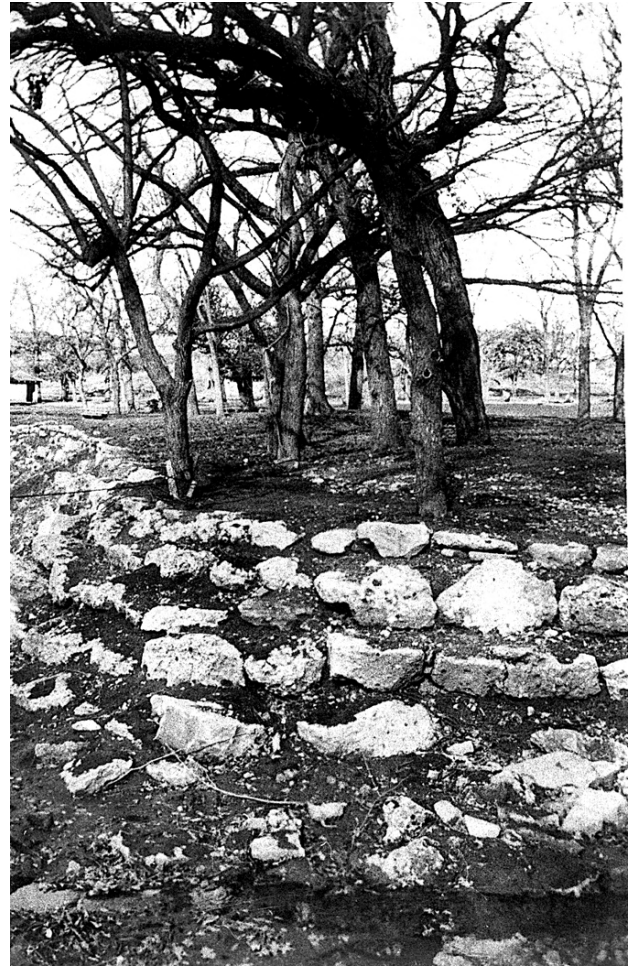
Figure 4-53. Detail of revetment wall construction, 1935. Note comfort station in left hand side of photograph.

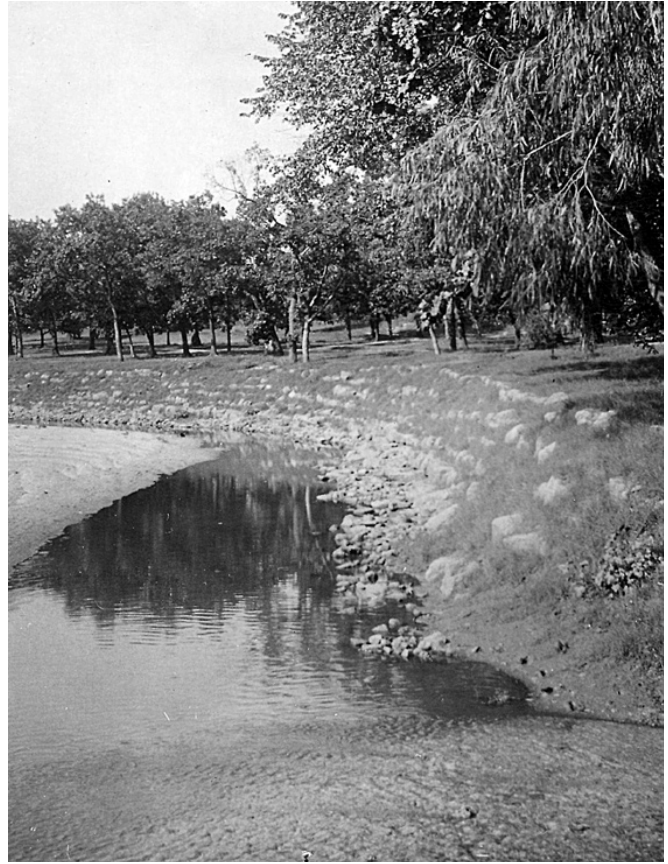
Figure 4-54. Completed revetment wall in Flower Park, 1935.

the wall with no ill effect.”<sup>121</sup> The resulting wall created a sinuous shape in the landscape (Figure 4-54).

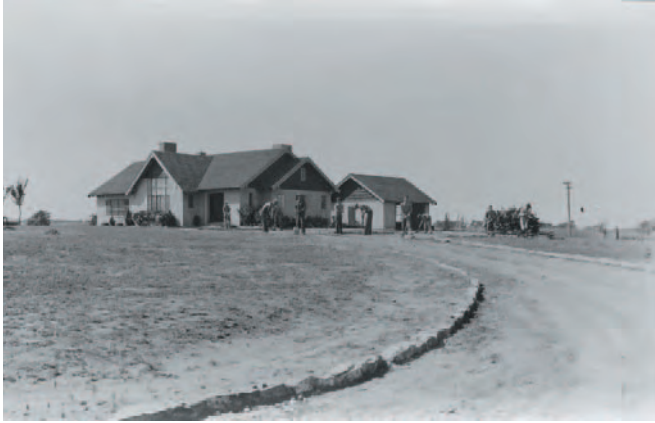
Figure 4-57. Driveway at the Superintendent's Residence, 1933.

with Bermuda grass.<sup>123</sup> Next, a garage for the residence was constructed, along with a driveway edged with stone (Figure 4-57). A turnaround was provided at the front of the house. A picket fence enclosing a square lawn and an arbor or grape trellis near the northwest corner were also built.

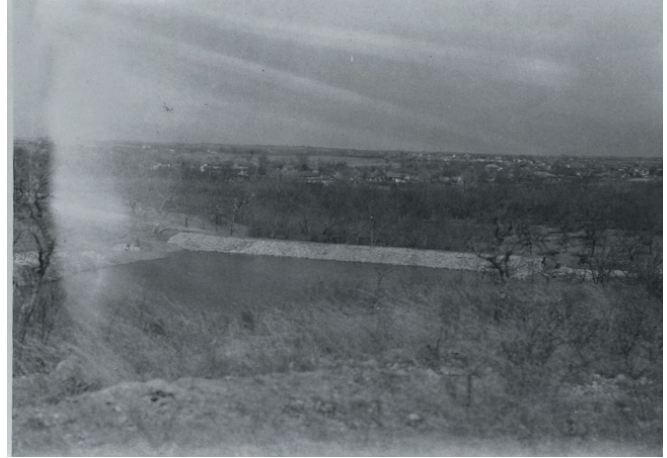
Figure 4-60. Dam in Buffalo Pasture, not quite full, 1933.

The Buffalo were relocated to about seventy-five acres just south of the administration building and extending to the former Sulphur-Bromide Lane. The CCC crews built a fence around the area. It was a "durable fence, built of 6 inch steel oil well casing with adequate corner posts, all set in concrete and on this 52 inches of woven wire and 4 strands of barbed wire."<sup>128</sup> Within the fenced area, to provide water for the buffalo, the CCC crews also constructed a dam in a ravine in the southwest portion of the pasture. Completed in November 1933, the dam was 200 feet long, 70 feet wide at the base and 20 feet high

(Figure 4-60). As described by Richey and Popham, the dam was

The planting technique used on the back of the dam was a slope stabilization method. Small bundles of brush were tied together and staked in horizontal rows three feet apart; between the rows, the crews planted suckering plants that would spread rapidly. The plants used on the dam were "of a particularly thorny nature," and included buckbrush (*Symphoricarpos orbiculatus*), honeysuckle (*Lonicera* species), ground rose (probably *Rosa multiflora*, which was advocated for use in soil erosion by the Soil Conservation Service in the 1930s) and catbrier (*Smilax glauca*). Overall, 7,000 plants were set out on the dam.<sup>130</sup> By the time the project was completed, the dam was full of water and the pond covered about three acres. Six bison and the sole remaining elk were moved to the new pasture in November 1933.<sup>131</sup> The elk seems to have died in 1934, leaving the whole area for the bison.<sup>132</sup>

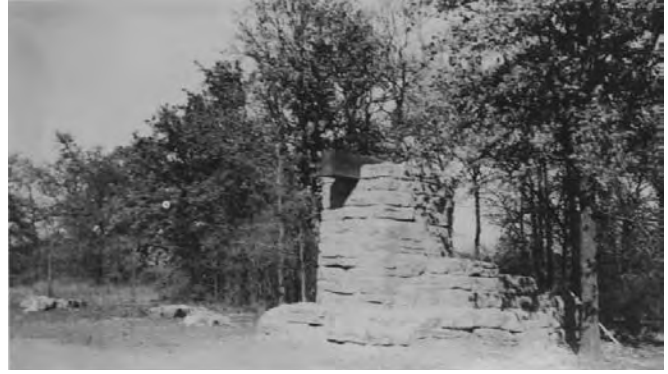
Figure 4-62. One of the paired entry piers at the South Entrance, 1939. Note wooden sign piece, to which letters were attached.

In 1936 Buckhorn Road (State Highway 18) was realigned and resurfaced with asphalt. A previous project, in November 1930, had resurfaced the northern portion of Buckhorn Road, from Davis Avenue to just beyond the Administration Building in cold rolled asphalt as a joint project between the park and the state.<sup>139</sup> A more drastic realignment of the whole road began in 1934. The northern portion of this realignment involved rerouting the road to the west of Pavilion Springs. This portion of the alignment seems to have been readily agreed upon, as it appears on drawings, and may have been completed, as early as 1934. The southern portion appears to have been more contentious, probably because it changed access between the northern and southern parts of Sulphur.<sup>140</sup> The south alignment eventually agreed upon removed the access at Fairland Ave and the Veteran's Hospital; instead, it ran in a southeastern direction past the Superintendent's Resident in a straight alignment through the "notch" in the southern boundary of the park. Work began around September 1936 and was completed by November.<sup>141</sup> Once the road was completed, work resumed on construction of entry piers at the new entrance. This project had been dropped in the summer of 1935 because of the uncertainty about the road's new alignment.<sup>142</sup> The south portal was designed as a set of massive, paired limestone piers (Figure 4-62 and Figure 11-61). They were completed in 1939.<sup>143</sup>

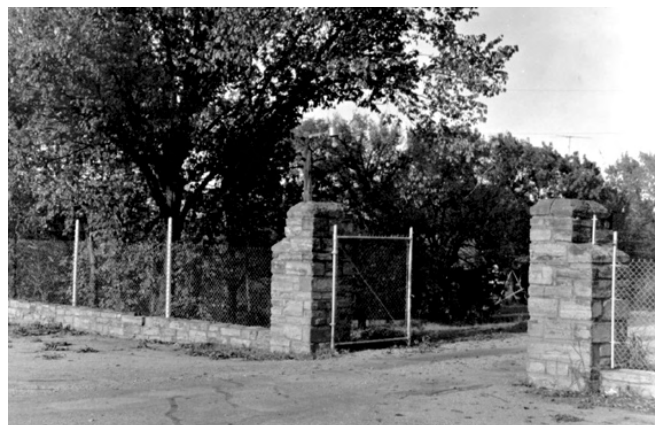
Figure 4-66. Maintenance Area entry way, circa 1935. Note limestone piers and walks and chain link fence.

The new “Industrial Area” or “Utility Area”, as it was also known, was designed as three buildings built in a quadrangle with all buildings facing an open courtyard 100 feet by 90 feet. The area was built on the back side of Hillside Spring hill, and the flat courtyard was terraced into the hillside. A low limestone rubble retaining wall, two feet high and eighteen inches thick, accommodated the cut and fill for the quadrangle and connected the three buildings, further enclosing the utilitarian compound. The low wall was topped by five-foot-high chain link fence with three strands of barbed wire at the very top. A gateway was located on the open, east side of the quadrangle. Limestone piers, three feet square and nine feet tall and similar to those at the park entrances, marked the twelve-foot wide entrance in the wall (Figure 4-66). The road leading past the park office dead-ended at the courtyard; a small parking area for about six cars was located outside the courtyard along the south side of the entry road.

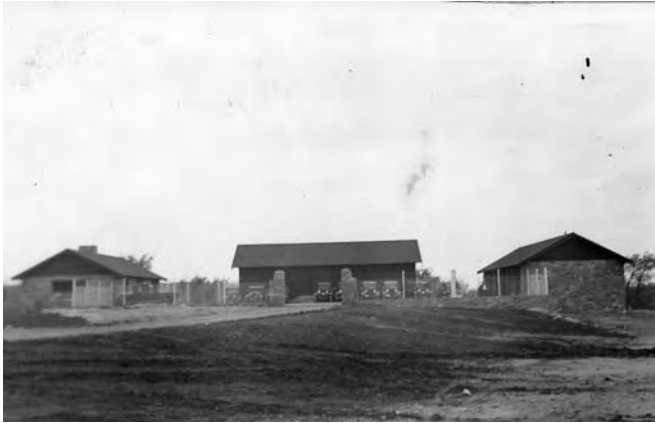
The buildings in the compound consisted of a truck shed or garage on the north, a mule and hay barn on the west, and a maintenance office on the south. The buildings (Figure 4-67 and 4-68) were designed to be in keeping

Figure 4-67. Overview of just completed Maintenance Area, circa 1934.

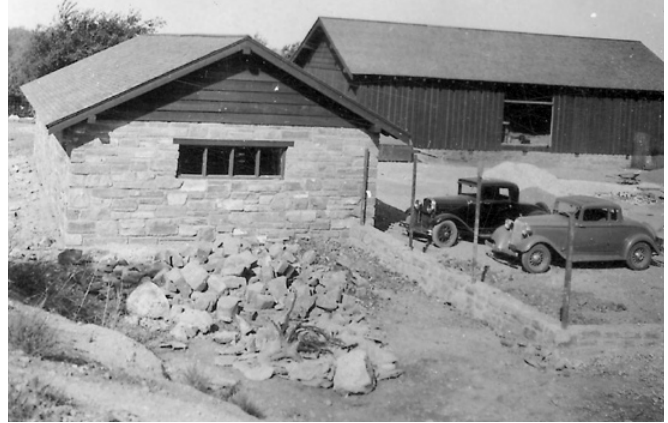
Figure 4-68. Office building (left) and mule barn (right) in the Maintenance Area, circa 1934.

with NPS rustic design, and were constructed of creosote-oil stained wood and limestone masonry. The office, built mostly of limestone, was fifty by thirty feet, and housed the construction superintendent, tool storage and a combined office and drafting room for the landscape architects, engineers and foresters.<sup>163</sup> The garage, sixty feet by twenty-five feet, was the repair shed for the park's nine trucks, and sometimes a carpentry and machine shop. The garage's end walls were limestone, but the side walls were stained wood. In contrast to the truck shed and the office—low, one-story buildings—the mule barn, sixty by thirty feet, was a two story building with the lower story accessed from the lower grade to the rear. Though the basement foundation was constructed of limestone masonry, the upper story was wood framed with vertical board and batten siding. It primarily stored horse, bison, mule, and elk food, and sometimes construction materials.<sup>164</sup> The initial construction of the entire maintenance area cost a total of \$440.00 in materials and 1,224 man-days.<sup>165</sup>

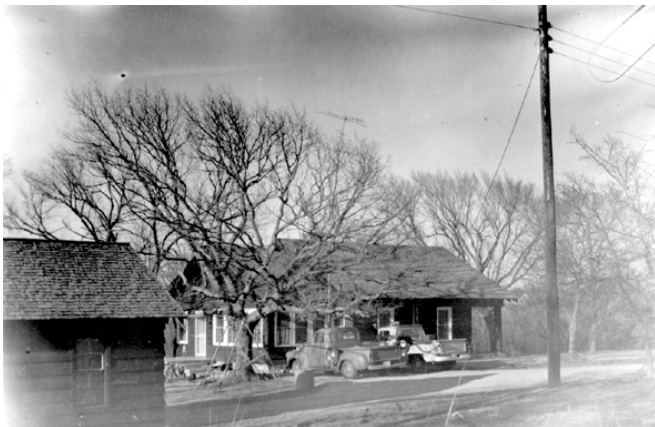
Figure 4-69. Residence 2 (now Building 6) relocated at the Maintenance Area, circa 1935.

Other work was undertaken at then-numbered Residence 2 (now Building 6), which had been moved from the new Buffalo Pasture and relocated into the Maintenance Area (see below). The building was repaired, re-sided with a rough-sawn wood siding and stained brown in the summer of 1934.<sup>157</sup> A planting plan for this residence was completed in January of 1935, but the plan is no longer part of park files and it is unclear if it was ever implemented.<sup>158</sup> A driveway for this residence, along with

Although the compound appears small on the park's 1937 and 1940 Master Plan drawings, the maintenance area actually encompassed a much larger zone. To the east and north was Residence #2, which was relocated there in 1934 to provide a resident to police the area during off hours. The residence and its garage are shown in Figure 4-69. To the west, a network of dirt or gravel roads and parking areas spilled out on the surrounding hillside behind the mule barn. Labeled on some drawings as the "Maintenance Yard," this area beyond the quadrangle contained a number of additional buildings, including an earth-sheltered building that stored explosives (Figure 4-70), and at least two large sheds. The largest of these sheds (Figure 4-71), was a long, three-bay shed apparently used for equipment and vehicle storage. Materials were also stockpiled in the area. To the north of the mule barn and truck shed was another area that on the 1940 aerial photograph appears to be fenced. It is possible, but not known for sure, that this was the mule pasture, since an area adjacent to the Utility Area was graded and fenced

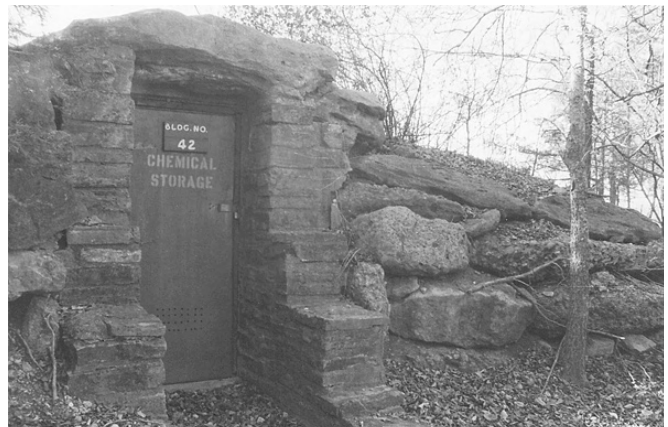
Figure 4-70. Explosives storage, circa 1935.

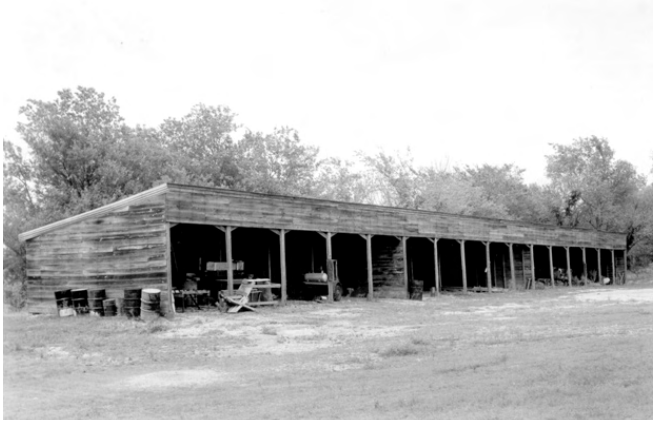
Figure 4-71. Equipment shed, located West of Maintenance Area Quadrangle, circa 1940.

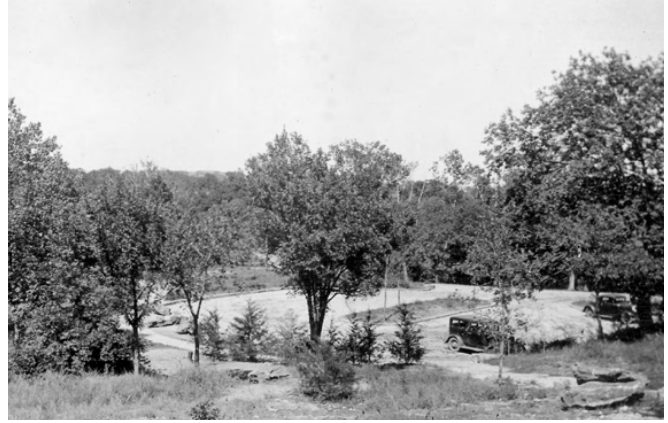
The first element completed was the U-shaped parking area at Hillside Springs, begun in August and completed by December of 1934. The parking area was designed to hold twenty-two cars for both the spring and the administration building up slope,<sup>169</sup> and a stone staircase approximately 120 feet long was constructed from the southwest corner of the parking area up to the park office (Figures 4-72 and 4-73). The parking lot was paved with a gravel surface and delineated with stone curbs. Planting around the parking lot was an important part of the design, and included many cedars. The cedars (Figure 4-52) were intended to screen the parking area and provide vertical interest and enclosure in the otherwise open landscape. Many of these trees are extant today.

Figure 4-72. View of Hillside Springs parking area from above, circa 1935.

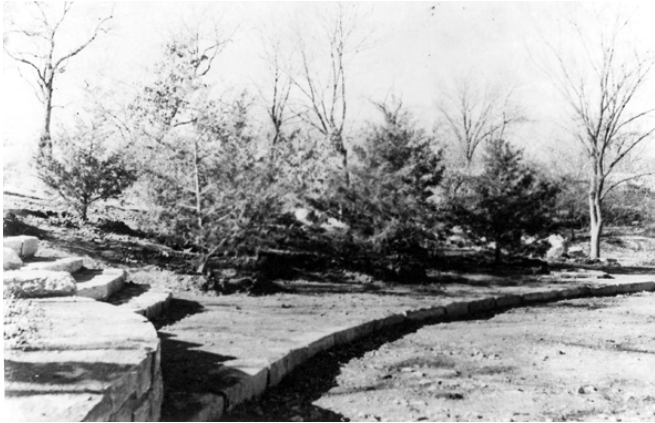
Figure 4-73. View of stairs, cedars and stone curb at Hillside Springs, 1935.

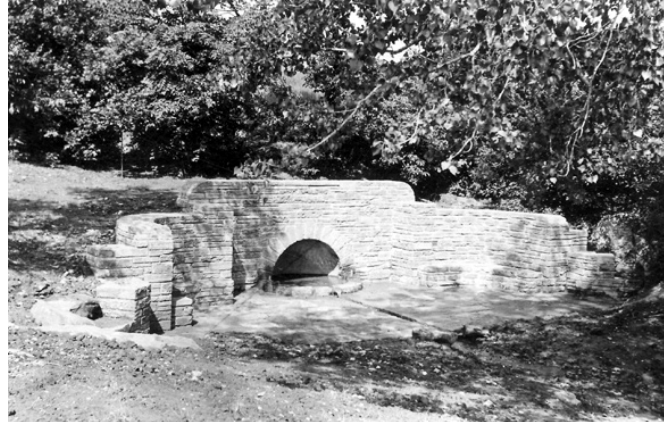
In the early spring of 1935 the CCC removed the old pavilion structure at Hillside. The new spring was designed as a retaining wall inserted into the hillside (Figure 4-74). In the central portion of the wall was a pool situated in an arched grotto. The water, supplied from a concrete holding tank behind the wall, bubbled into the pool from two round bubblers and drained from the pool in a runnel across a flagstone terrace to the slope below. Two curving walls on either side of the grotto wall embraced the terrace, creating a private, enclosed area around the pool. Visitors could collect water in bottles or dip it up in cups, from the bubblers or pool.<sup>170</sup> Access was provided by a flight of stone steps, which led down from the parking lot located above the grade of the enclosed terrace.

Figure 4-74. Hillside Springs, shortly after completion and fine grading, circa 1935.

Landscape foreman Ed Walkowiak supervised the construction and the project was completed in June 1935.<sup>171</sup> The neatly faced blocks of yellow limestone and the curves of the walls were similar to those of the main entrance and the Bromide fountain constructed more or less simultaneously. Much of the stonework at Hillside was done by a crew of foreman in three weeks in February and March when the CCC boys were quarantined during an outbreak of spinal meningitis.<sup>172</sup> Some of the planting around Hillside Springs was also completed by the foremen during this time.

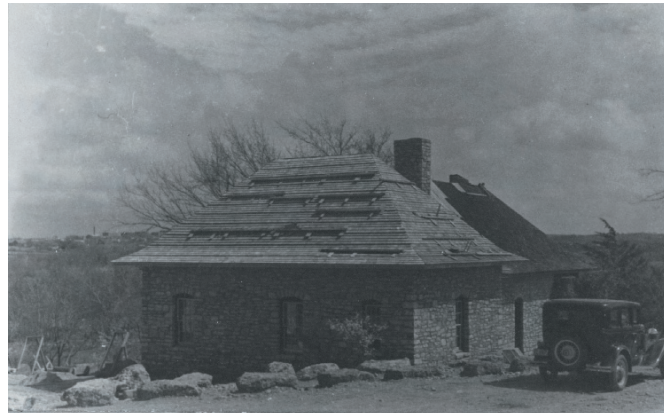
Figure 4-75. Reconstruction of the Leeper House, 1934.

Meanwhile, work was proceeding at the Administration Building, where an addition was constructed on the building's west end. The addition provided space for a museum, a washroom, and a filing room and an opportunity to reorganize the existing office. Work began on November 23, 1934.<sup>173</sup> The addition was thirty-two by forty-three feet and was constructed of a gray-blue

limestone. According to Superintendent Branch, “a very successful attempt was made to duplicate the masonry of the existing structure which was of the rubble type by using rock (a gray-blue limestone) from the quarry where the original rock was obtained.”<sup>174</sup> In addition, the old building was repointed to match the new. The CCC masons also made a concerted effort to replicate the arched windows of the existing building in the new addition, with the exception of a bay window installed on the north side of the addition. The entire building was shingled, new stone steps were installed to access the verandah on the north, and the main entrance to the building was moved from the east end to the south. Based on historic photographs, a few trees and foundation plantings were planted around the building (Figure 4-75). Sometime before 1940, a small stone-lined parking area just southwest of the building was installed along the access road.

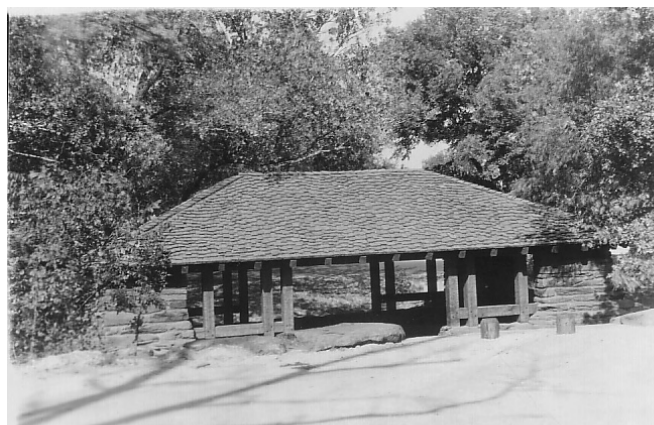
A parking area was laid out in June and July, (Figure 4-76). The pavilion was finally finished and opened to the public on August 22, 1937. Although Miller deemed the building "generally satisfactory," it was still a fine example of NPS rustic architecture (Figure 4-77). The building was low to the ground, emphasizing horizontal lines; the yellow pine used for structural members was rough sawn and hard hewn, for a pioneer look; and

Figure 4-77. Pavilion Springs Pavilion, 1937. Note large wood bollards at entry.

the locally quarried stone married the buildings to its surroundings in color and texture. The building's stonework specifications exemplify typical NPS Rustic architecture standards:

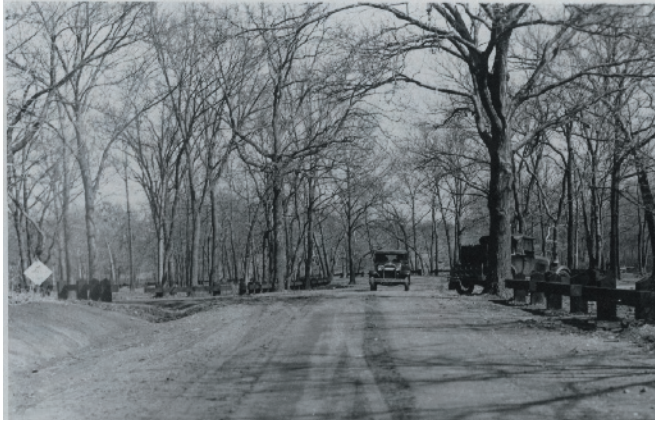
Figure 4-79. Revised roads and guardrails at Cold Spring Campground, along Travertine Creek, 1933.

Guardrail installation was also a significant portion of the 1933 work and more was installed in Cold Springs—1320 feet—than anywhere else in the park. Most, if not all, of it seems to have been installed along Travertine Drive outside the campground and parking areas.<sup>194</sup> The guardrail was constructed in twelve-foot sections of eight-inch by eight-inch rail, set eighteen inches above the ground on ten-inch by ten-inch posts.<sup>195</sup>

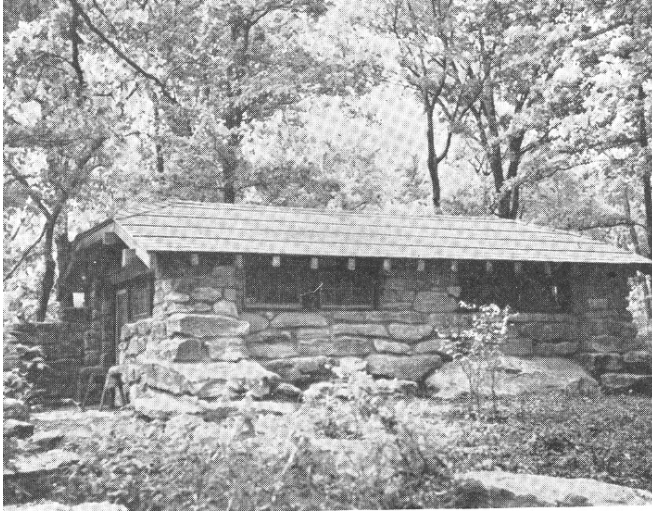
Figure 4-81. Cold Springs Comfort Station, published in *Park and Recreation Structures* by Albert H. Good in 1938.

The buildings were exemplary NPS Rustic architecture, and were eventually featured in the “manual” of NPS design, *Park and Recreation Structures* by Albert H. Good (Figure 4-81). And, in fact, in 1937 Thomas Vint recommended that the comfort stations be used as a model for the design of toilet facilities in a campground in Acadia National Park in Maine.<sup>209</sup>
